LASER INDUCED REACTION FOR PREBOND SURFACE PREPARATION OF ALUMINIUM ALLOYS

Stage 3 report (7-10/93)
Contract No. F61708-93-C005

M. Rotel, J. Zahavi
Israel Institute of Metals, Technion, Haifa, Israel

A. Buchman, H. Dodiuk
Materials and Processes Department,
RAFAEL, Haifa, Israel

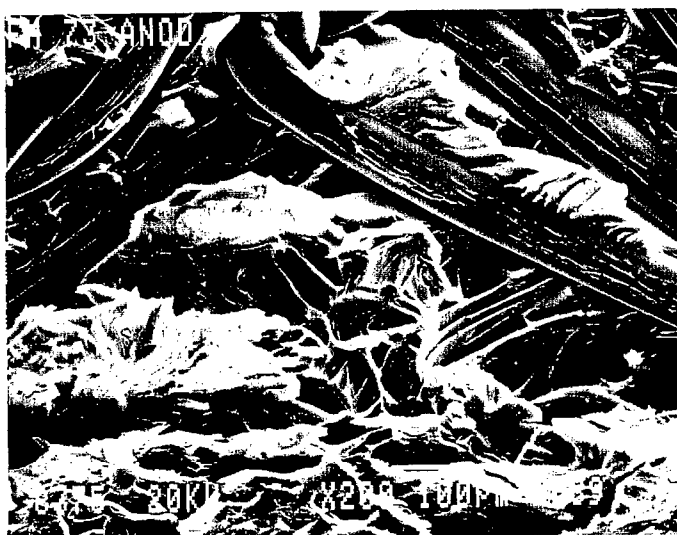
Fig. 3.1: SEM photographs of the surface failure morphology of SLS tests (table 3.1) with adhesive FM73, primer BR127. a: without treatment. b: anodized adherends.

Figs. 3.1-3.7 show the morphology of the failure surface of the shear joints the strength of which were summerized in table 3.1.

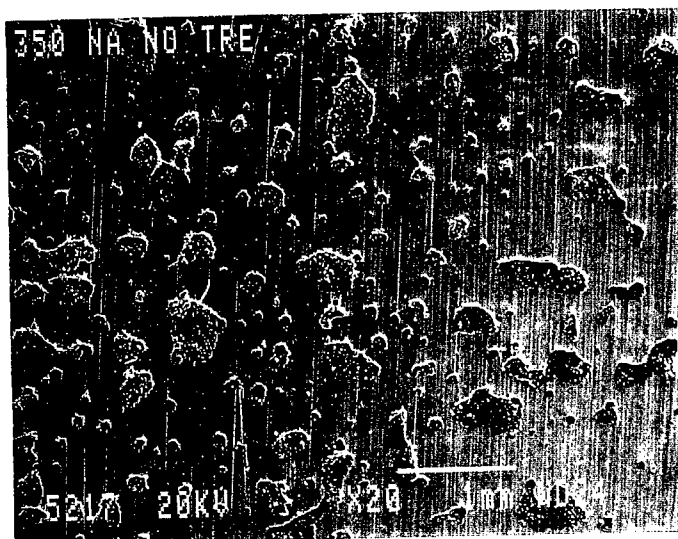
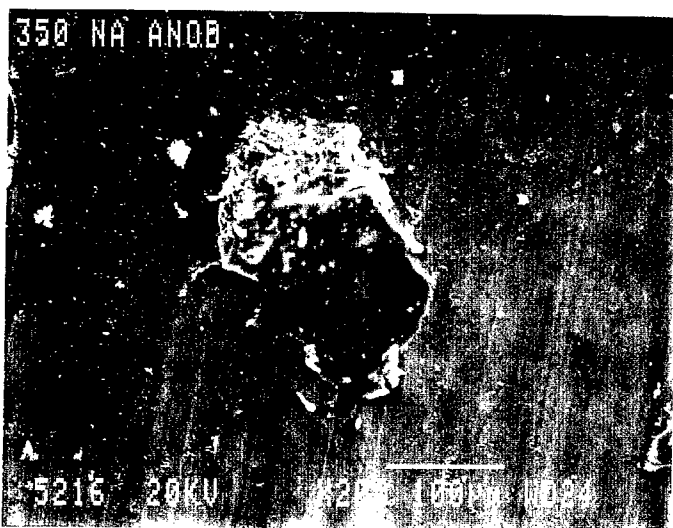
Fig. 3.8: SEM photographs of the surface failure morphology of SLS joints (table 3.3) with adhesive FM350NA, primer A187. a: without treatment. b: anodized adherends.

Figs. 3.8 -3.11 show the failure surface morphology of SLS adherends of joints bonded with FM350NA and primer A187. Comparison between the cohesive failure of the anodized adherends and the adhesive failure of the untreated adherends is shown in fig.3.8.

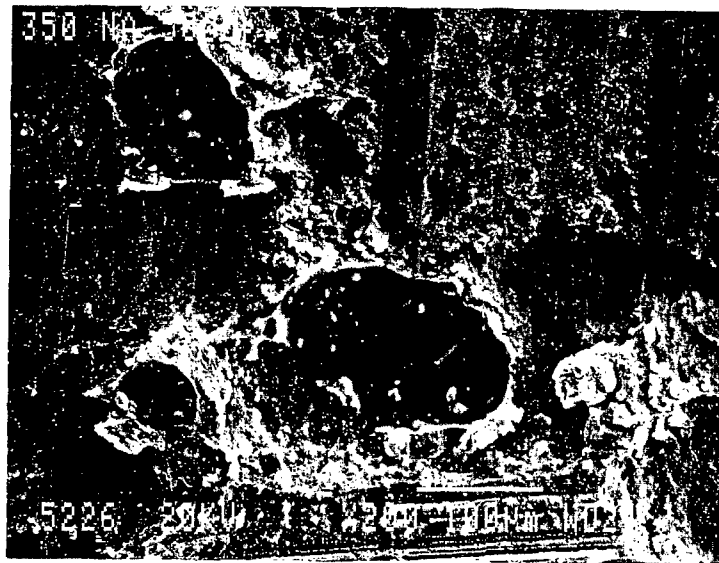
Fig. 3.11: SEM photographs of the surface failure morphology of SLS joints (table 3.5) with adhesive FM350NA, primer A187, laser energy $180\text{mj/p}\cdot\text{cm}^2$, 5000 pulses.

The failure mode of the laser treated adherends (fig.3.9 -3.11) with FM350NA and primer A187 is adhesive even at high number of pulses, probably due to incompatibility of the primer and the high curing temperature of the adhesive.

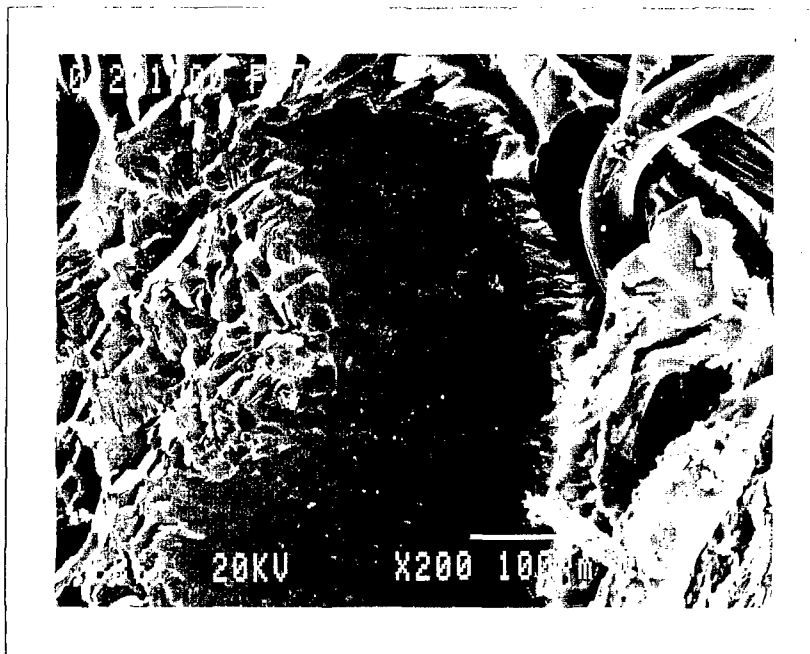
Fig. 3.12: SEM photographs of the surface failure morphology of SLS joints (table 3.4) with adhesive FM73, fresh primer BR127, laser energy $180\text{mj/p}\cdot\text{cm}^2$, 1000 pulses.

Experiments with a fresh BR127 primer and the adhesive FM73 (table 3.4) show that laser treated joints have shear strength similar to those with the primer A187 (329 Kg/cm²). Figs 3.12-3.13 show the cohesive failure mode of laser treated joints bonded with fresh BR127 and FM73. Experiments without a primer (table 3.5) and with an adhesive FM73 show shear strength of 321 Kg/cm². These results prove that the main effect of the surface treatment and improve adhesion strength arise from the laser irradiation while the primer has only a minor effect.

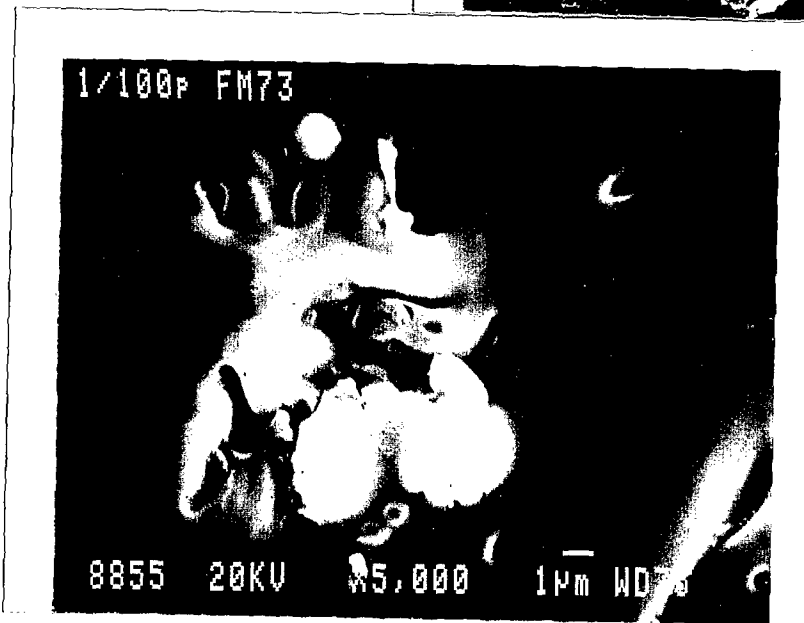
Fig. 3.13: SEM photographs of the surface failure morphology of SLS joints (table 3.4) with adhesive FM73, fresh primer BR127, laser energy $1\text{J}/\text{p}\cdot\text{cm}^2$, 100 pulses.

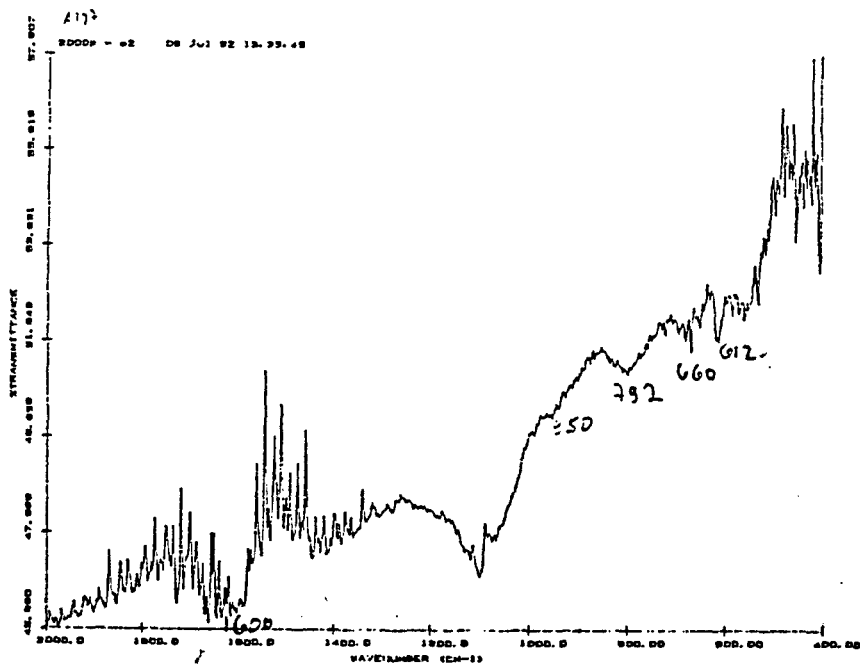
Fig. 3.15: Enlargement of FTIR spectra of fig.3.14 at the wavelength range of 2000-400cm⁻¹. a. without oxygen stream. b. with oxygen stream.

Fig.3.14 is the spectra of the irradiated adherends (400cm^{-1} - 4000cm^{-1}) and fig.3.15 is enlargement of the spectra in the range 400cm^{-1} - 2000cm^{-1} . The absorbance peaks shown in these figs. are:

Comparison between fig. 3.15a and fig. 3.15b show more defined peaks at 1600cm^{-1} , 1450cm^{-1} , 1416cm^{-1} and 1362cm^{-1} for the spectrum of the specimen irradiated without oxygen. This result proves the assumption that the oxygen probably reacts with the active sites reducing their concentration and the chemical activity of the surface .

A new peak at 660cm^{-1} appeared at oxygen atmosphere typical to oxygen rich hydroxide (AlOOH).

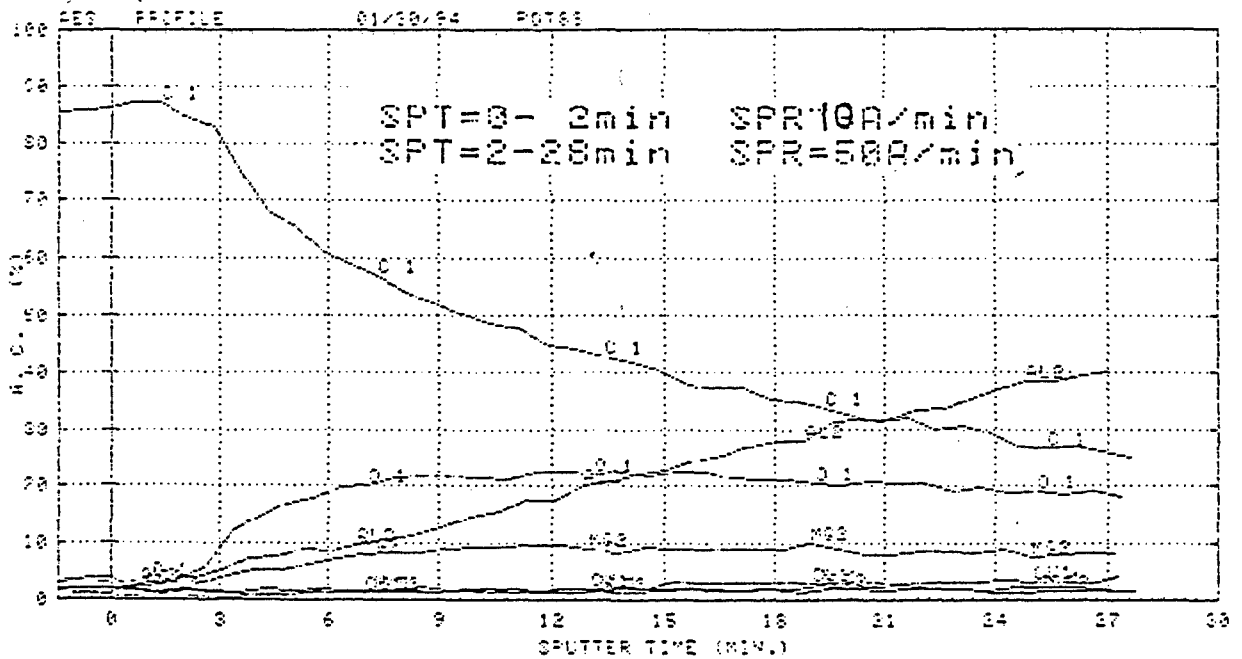
Fig.3.18: Auger depth profile of untreated aluminum.

Fig. 3.18 shows the depth profile of the untreated aluminum. The major component formed on the Al surface was carbon which also penetrated the oxides of aluminum and magnesium. The carbon originated probably from organic contaminations.

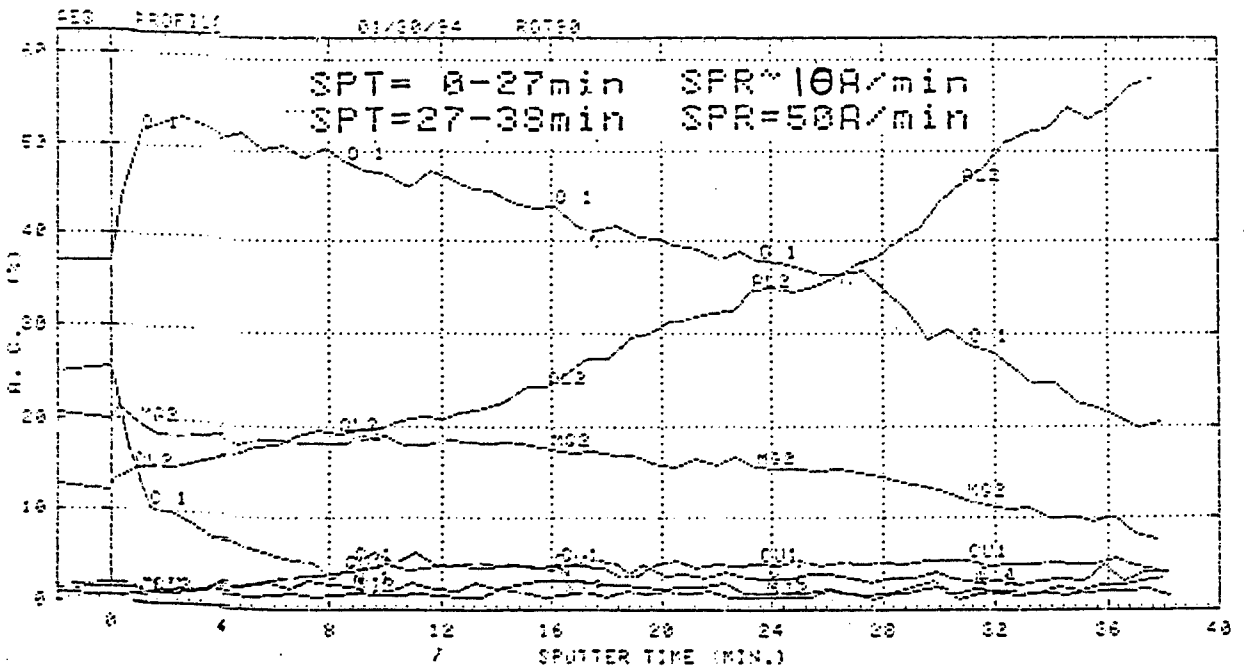
Fig. 3.19: Auger depth profile of Al irradiated at laser energy of $0.18\text{J/p}\cdot\text{cm}^2$. a. 2000 pulses b. 5000 pulses.

Fig.3.19 shows the auger depth profiles of Al specimen treated at laser energy of $0.18\text{J/p}\cdot\text{cm}^2$ with 2000 and 5000 pulses. The major components on the surface were oxygen, aluminum and magnesium. Carbon was absent in the surface which proves the cleaning process of the laser. The magnesium and aluminum oxide layers of the specimen irradiated with 2000 pulses was thicker (about 580Å) than the oxides layer of the specimen irradiated with 5000 pulses (about 270Å) probably due to ejection of volatile at longer irradiation periods. Irradiation at this energy level ($0.18\text{J/p}\cdot\text{cm}^2$) did not produce morphological changes at the Al surface.
