**FATIGUE RESPONSE OF REPAIRED
THICK ALUMINUM PANELS WITH
BONDLINE FLAWS**

THESIS

Presented to the Faculty of the Graduate School of Engineering of the Air Force Institute of
Technology Air University In Partial Fulfillment for the Degree of
Master of Science

March 8, 1999

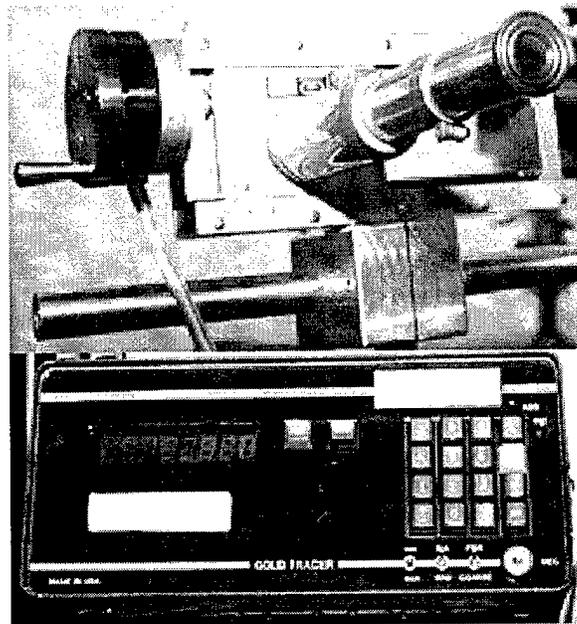
Figure 19. Gaertner Optical Microscope and Digital Readout

The travelling microscope was used on the unpatched side of the specimen to acquire optical crack measurements. A picture of the travelling microscope and digital readout are shown in Figure 19.

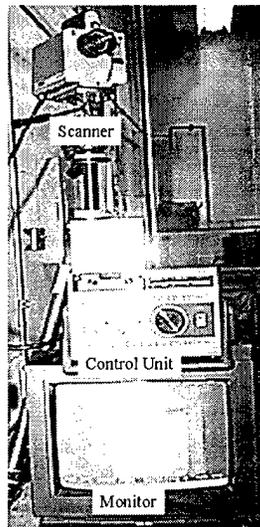
Figure 21. Thermal Imaging System

The thermal imaging system used was the Inframetrics Model 760 IR Imaging Radiometer. The system consisted of Model 760 Scanner and the Model 760 Control/Electronics Unit. On the control unit, a Liquid Crystal Display (LCD) was used to display the infrared image. The control unit also had an analog color video out terminal that could be connected to a separate monitor. The purpose of this system was to use thermography to locate and record disbonds and disbond growth in the bondline during testing. A photograph of the thermal system is shown in Figure 21.

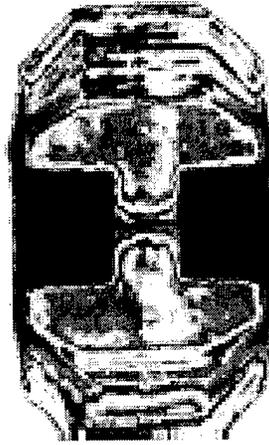
Figure 74. C-scan Crack Tip Disbond (CTD) $2a=101.6\text{mm}$

This appendix contains select C-scan images of specimens detailing disbond size as a function of crack length. A representative of each disbond configuration is presented. Three images from each disbond configuration are included. The first image shows debond size and location at $2a = 25.4mm$, the second at $2a = 63.5mm$ and the third at $2a = 101.6mm$.
