Rapid Stabilization of Thawing Soils for Enhanced Vehicle Mobility

A Field Demonstration Project

Maureen A. Kestler, Sally A. Shoop, Karen S. Henry,
Jeffrey A. Stark, and Rosa T. Affleck

February 1999

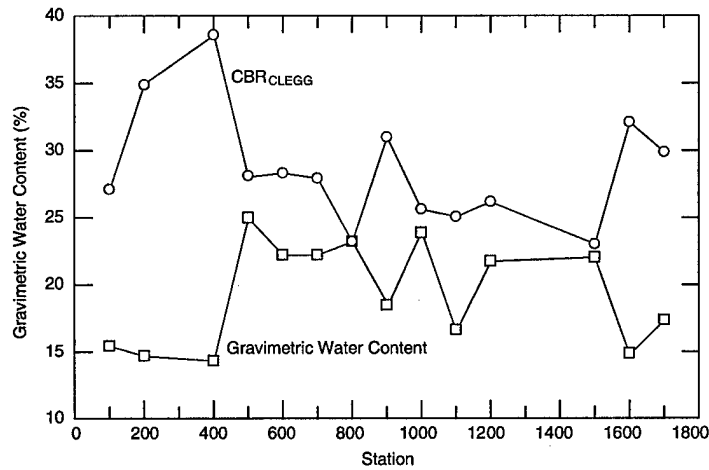
Figure 1 (cont'd). Water content and CBR.

c. Typical CBR_{DCP} profiles—wooded trail.

d. Gravimetric water content and CBR_{CLEGG} —wooded trail.

Based upon CBR_{CLEGG} , the material in the wheel paths was slightly stiffer than that along the centerline. This is probably a result of compaction due to past use/trafficking. Histograms showing the distribution of gravimetric water content and CBR are shown in Figures 1a-d. Typical CBR_{DCP} profiles for stations 6+00 and 18+00 at left, right, and center of the travelway are shown in Figure 1c. CBR in this figure was calculated using DCP values, and plotted using the Pavement-Transportation Computer Assisted Structural Engineering (PCASE) program "DCP" (U.S. Army 1995). The figure shows substantial strength variability both horizontally and vertically. Again, this provides additional evidence pointing toward a possible unequal frame of reference for test section performance evaluation.

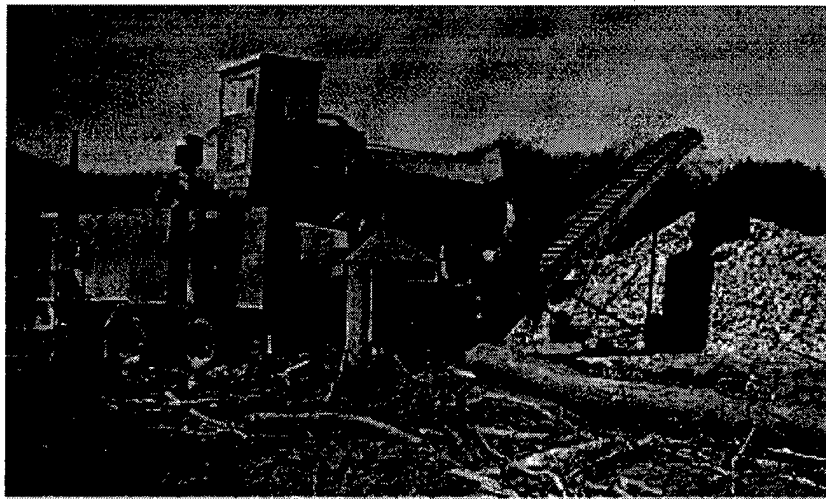
Figure 8. Chunkwood.

a. Chunkwood fill.

b. USDA Forest Service wood chucker.

The chunkwood was produced by shredding whole trees with a USFS prototype wood chunking machine. The resulting wood chunks were approximately 3.8 cm (1.5 in.) thick and were well graded, ranging from 1 to 20 cm (0.5 to 8 in.) in diameter. The chunkwood was mixed with sand in the approximate ratio of three parts chunkwood to one part sand. The density of the chunkwood/sand mix was approximately 796 kg/m³ (50 lb/ft³). The bulking factor appeared to be low. Although testing by the USFS has shown a sheepsfoot or padfoot roller improves compaction, the chunkwood compacted easily with construction vehicle traffic. The compacted surface was relatively smooth and provided a good wear surface (Fig. 8).

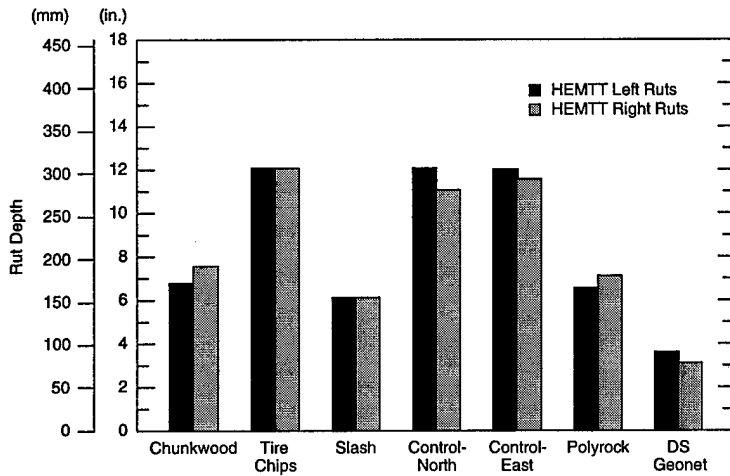
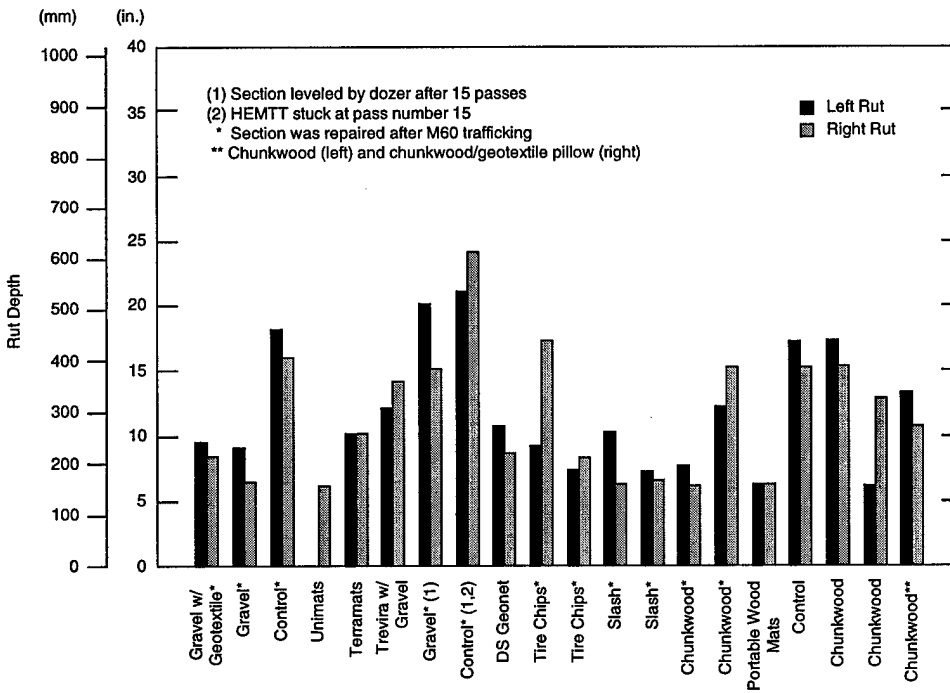
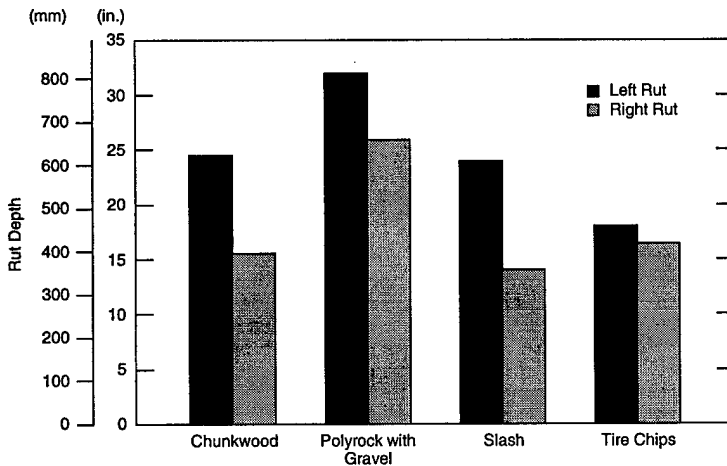
Figure 11. Rut depths.

a. Sloped trail.

b. Wooded trail.

c. Pentagonal loop trail.

Table E1 summarizes observations and test section performance and briefly discusses how each technique could be improved for future testing and use. Detailed observations of each test section are contained in Appendix E. Left and right rut depths for each trail after HEMTT trafficking are shown in Figure 11. As discussed in the site characterization section, in most instances, stabilizing techniques cannot be ranked by directly comparing rut depths, as stabilization techniques separated by any appreciable distance were constructed on virtually different subgrades. Just one of the many factors influencing rut depth is shown

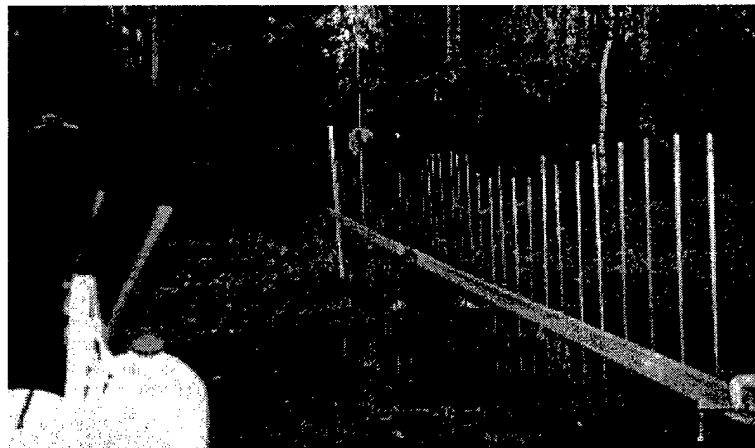
c. Measuring rut depths manually.

Figure B5. Sampling and testing devices.

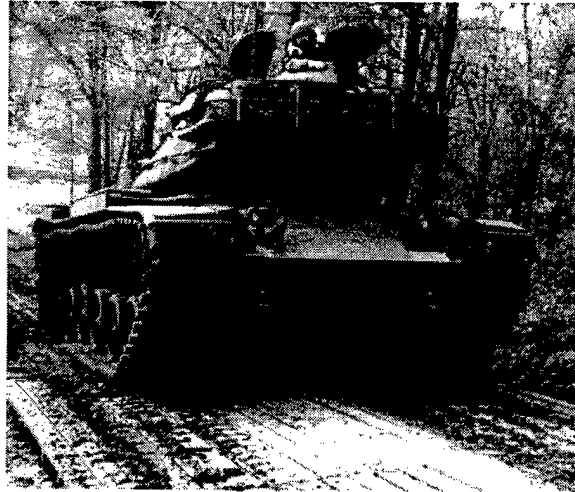
Specifications for the M60A3 Tank	
Crew	4
Combat weight	51,500 kg
Unloaded weight	47,500 kg
Power-to-weight ratio	14.56 bhp/tonne
Ground pressure	0.85 kg/cm ²
Length gun forwards	9.436 m
Length hull	6.946 m
Width	3.631 m
Height	3.27 m
Firing height	2.095 m
Ground clearance	0.45 m
Track	2.921 m
Track width	711 mm
Track adjustment	Hydraulic
Track type	T142 replaceable pads
Length of track on ground	4.235 m
Max road speed	48.28 km/h
Fuel capacity	1420 liters
Max road range	480 km
Fording	1.22 m
Fording with preparation	2.4 m
Gradient	60%
Side slope	30%
Vertical obstacle	0.914 m
Trench	2.59 m
Engine	AVDS-1790-2D
Suspension	Torsion bar

a. M60A1 Tank.
