Flightfax

ARMY AVIATION
RISK-MANAGEMENT
INFORMATION

MAY 1999 ♦ VOL 27 ♦ NO 5

Bosnia success story:
Managing risk in
real-world operations

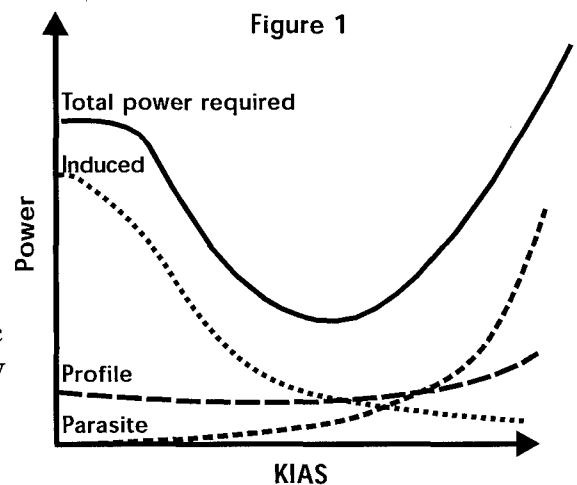
PROFILE POWER

We have the profile power requirement to overcome all form

drag and skin friction that occurs with a rotor blade at a zero-lift condition. In other words, it's the drag of the blade at flat pitch. Look at it as the resistance that results when an object (such as rotor blades and vertical or horizontal stabilizers) moves through the air, producing lift. It is proportional to forward flight speed (squared) and blade pitch, yet inversely proportional to density altitude.

Why? As density altitude increases, it means that less air molecules are available to resist the surfaces. This type of power is dominant in a very small speed range, but it consistently affects power required though all speeds.
