DOT/FAA/AM-99/26

# GPS User-Interface Design Problems: II

Kevin W. Williams  
Civil Aeromedical Institute  
Federal Aviation Administration  
Oklahoma City, Oklahoma 73125

November 1999

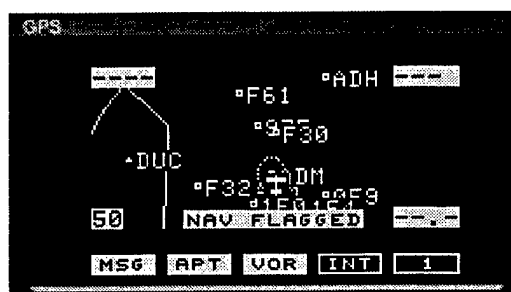
Figure 1: Example of a moving-map display

Looking at the figure, note the amount of overlap of symbols. Of course, the display has options for adjusting the amount and type of symbols that are displayed, whether identifiers are included in the display, and the scale of the map. However, if a pilot

has a need for displaying these options (such as airport identifiers), then a certain amount of clutter is inevitable simply because of the small screen size.

**Moving-Map Displays.** The presence of a moving-map display can greatly increase a pilot's situational awareness and has been shown to greatly improve pilot decision-aiding (Aretz, 1991; Hofer & Wickens, 1997; Williams, 1999b). However, there have been some human factors-related problems noted with moving map displays. One problem relates to the small screen size of most units. Because these units must be installed in the panel to be certified for instrument approach use, manufacturers have been constrained by how much room they have available. While newer receivers are larger, many of the older text displays have room for only 1 or 2 lines of text. Trying to place a moving-map display on these units can lead to a very small and crowded display. Figure 1 shows an example of a moving-map display from one of the larger display units on the market.

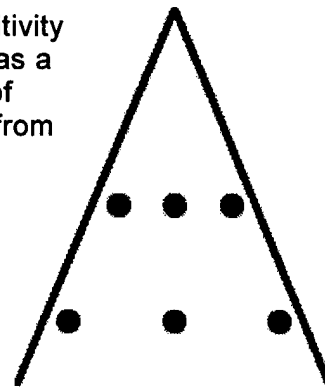
CDI sensitivity changes as a function of distance from origin.

Figure 2: CDI sensitivity for current ILS systems

in Figure 2. For these systems, the sensitivity of the CDI increases continuously as the airplane approaches the signal source.
