ERDC/CHL TR-00-26

## **Navigation Study, Colorado Locks, Colorado River, Matagorda, Texas**

# **Navigation Study, Colorado Locks, Colorado River, Matagorda, Texas**

Final report

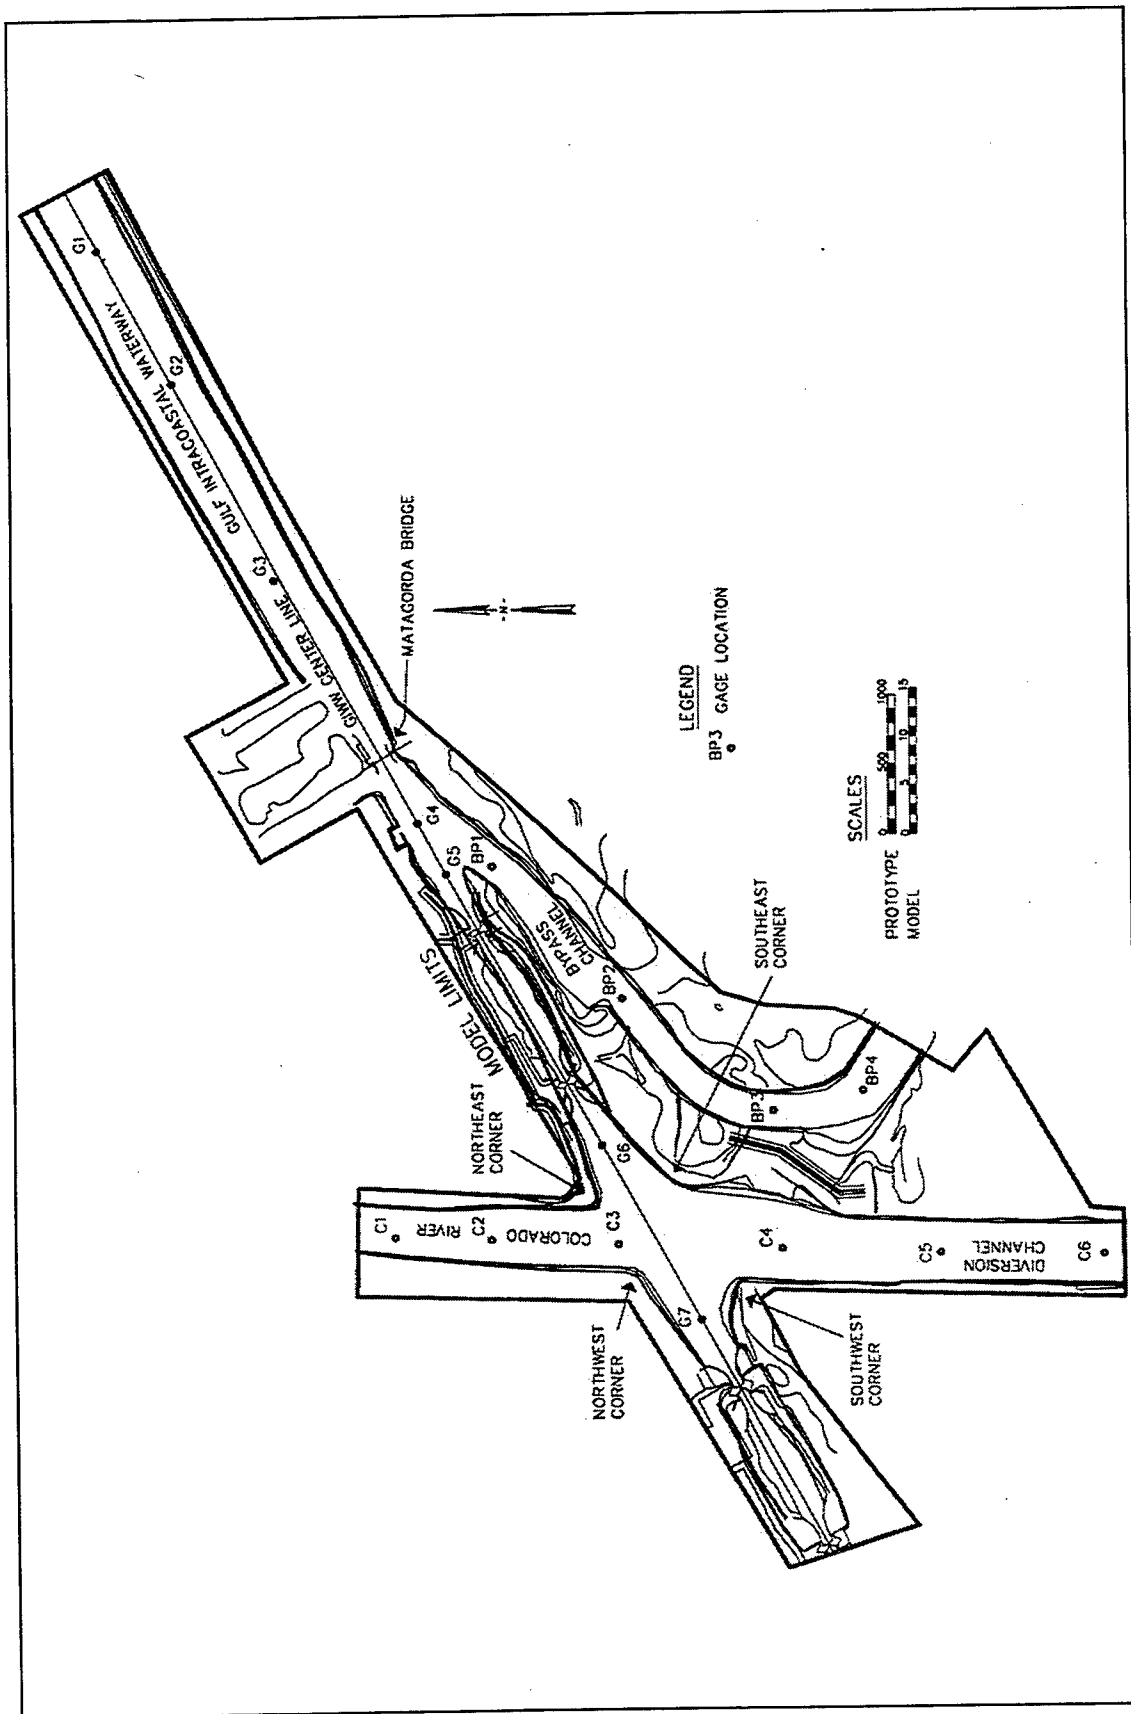
Figure 2. Model layout

The model (Figure 2) reproduced about 0.8 km (0.5 miles) of the Colorado River immediately upstream of the intersection with the GIWW and approximately 1.2 km (0.75 miles) of the Diversion Channel south of the intersection. The model also reproduced both the East and West Locks, along with approximately 2.6 km (1.6 miles) of the GIWW eastward of the East Lock and the Bypass Channel from the junction with the GIWW for approximately 1.5 km (0.9 miles). The model was of the fixed-bed type with overbank areas and channels molded of sand cement mortar to sheet metal templates set to the proper grade. Portions of the model where changes in bank alignment and placement of new structures could be anticipated were molded in sand and overlaid with a thin layer of sand cement mortar to facilitate modifications necessary to determine navigation conditions associated with the various plans. The locks and guide walls were constructed of sheet metal and/or Plexiglas and set at the proper grade. The lock gates were simulated schematically with simple vertical sheet metal slide-type gates. The channel portion of the model was molded to conform to a hydrographic survey dated April 1997, and the overbanks were molded to a topographic survey dated August 1997.

Water was supplied to the model by a 0.28-cu m/s-(10-cfs-) pump operating in a recirculating system. The discharge was controlled and measured by a valve and a 0.15 by 0.075 m (6 by 3 in.) venturi meter. Water-surface elevations were measured by piezometer gages located in the model channel (Figure 2) and connected to a centrally located gage pit. For controlling the water-surface elevation in the Colorado River-Diversion Channel, a tailgate was provided at the end of the model. To enter flow or regulate water-surface in the GIWW/Bypass Channel, a flap-type tailgate and a 0.075 m- (3 in.) Van Leer weir were provided at both the eastern end of the GIWW and at the southern end of the Bypass Channel so flows could be reproduced for both the flood and ebb tide conditions.

Flows from the Colorado River were reproduced by introducing the proper discharge and manipulating the tailgate at the end of the Diversion Channel until the required river stage elevation near the intersection of the Colorado River and GIWW was obtained. During base conditions (existing conditions), the Colorado River stages were controlled at Gage C3, near the intersection of the Colorado River and GIWW and for subsequent experiments, the water surface was controlled at Gage C6, near the end of the Diversion Channel to elevations obtained during the base experiments. For the GIWW and Bypass Channels, the river stages were controlled at Gage G5, near the eastern entrance to the East Lock and during subsequent experiments were controlled at either Gage G1 or B4, depending on the direction of flow being reproduced (Gage locations shown in Figure 2).

Base experiments were conducted with the model reproducing existing conditions as shown in Figure 2. The purposes of the experiments were to verify that the model was reproducing known prototype conditions and provide information and baseline data that could be used to evaluate the effect of the proposed modification on water-surface elevations, current direction and velocities, and navigation conditions. The principal features reproduced in the model, as shown in Figure 2, include the following:

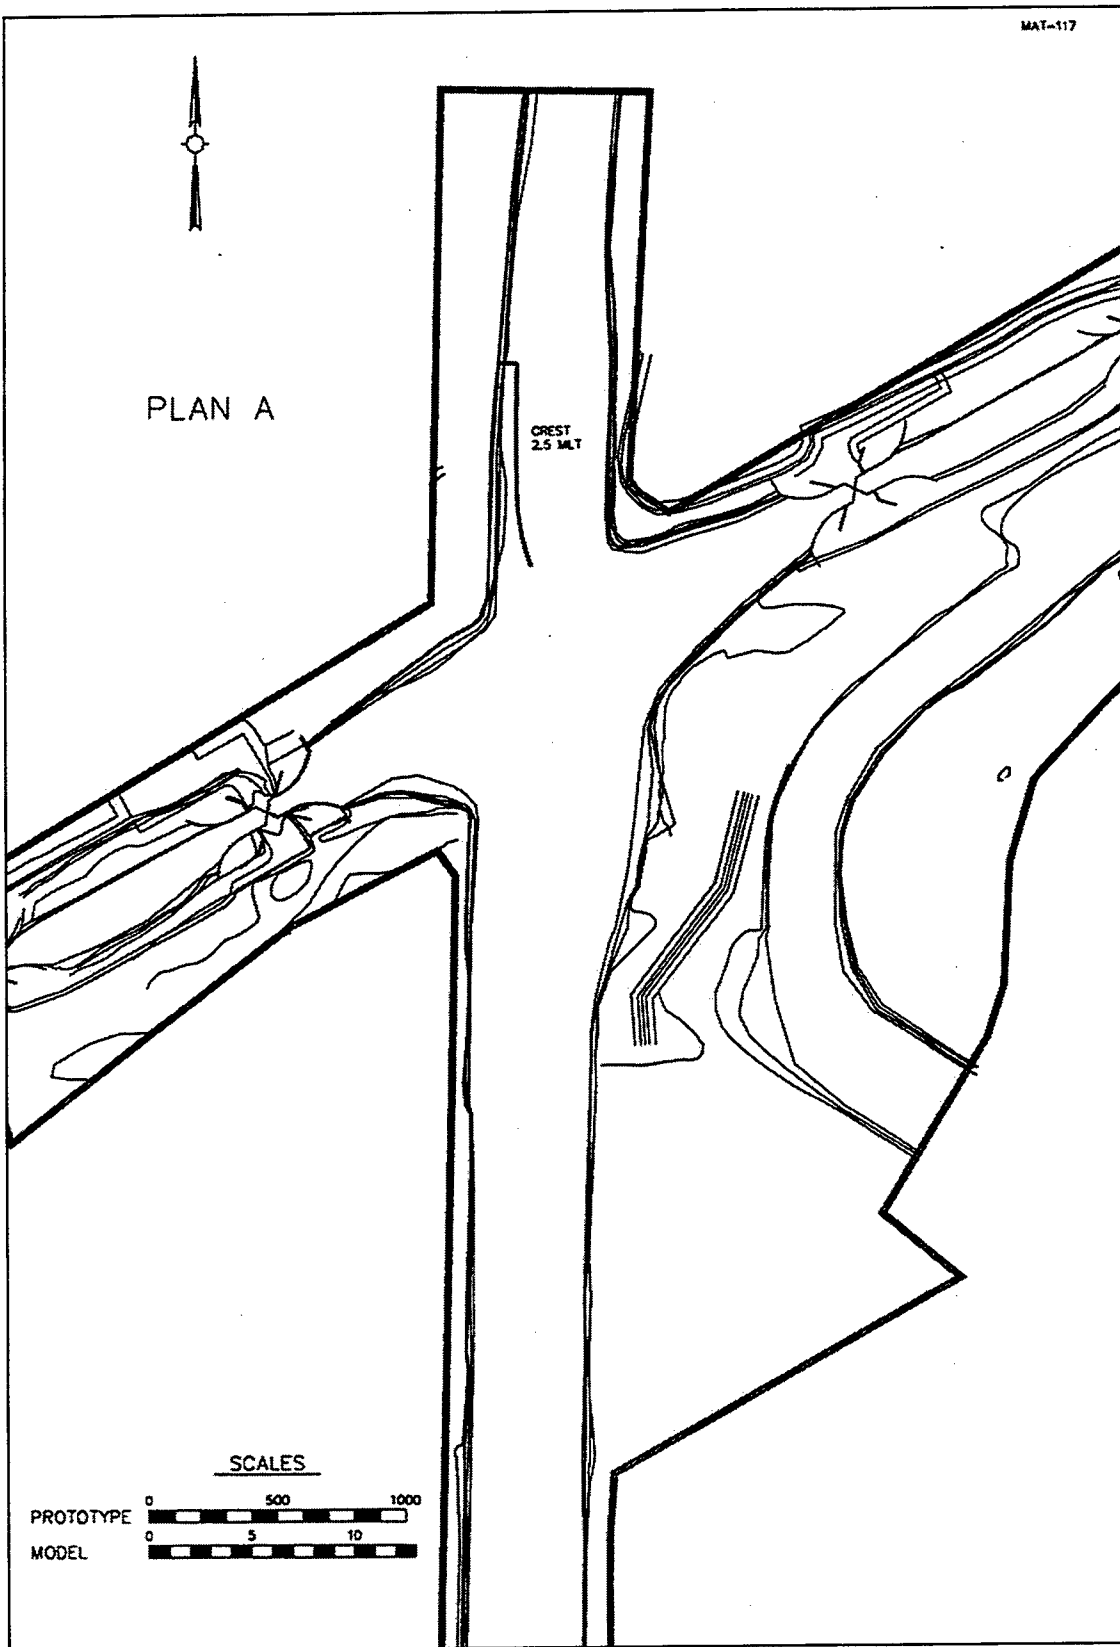
Figure 3. Plan A layout

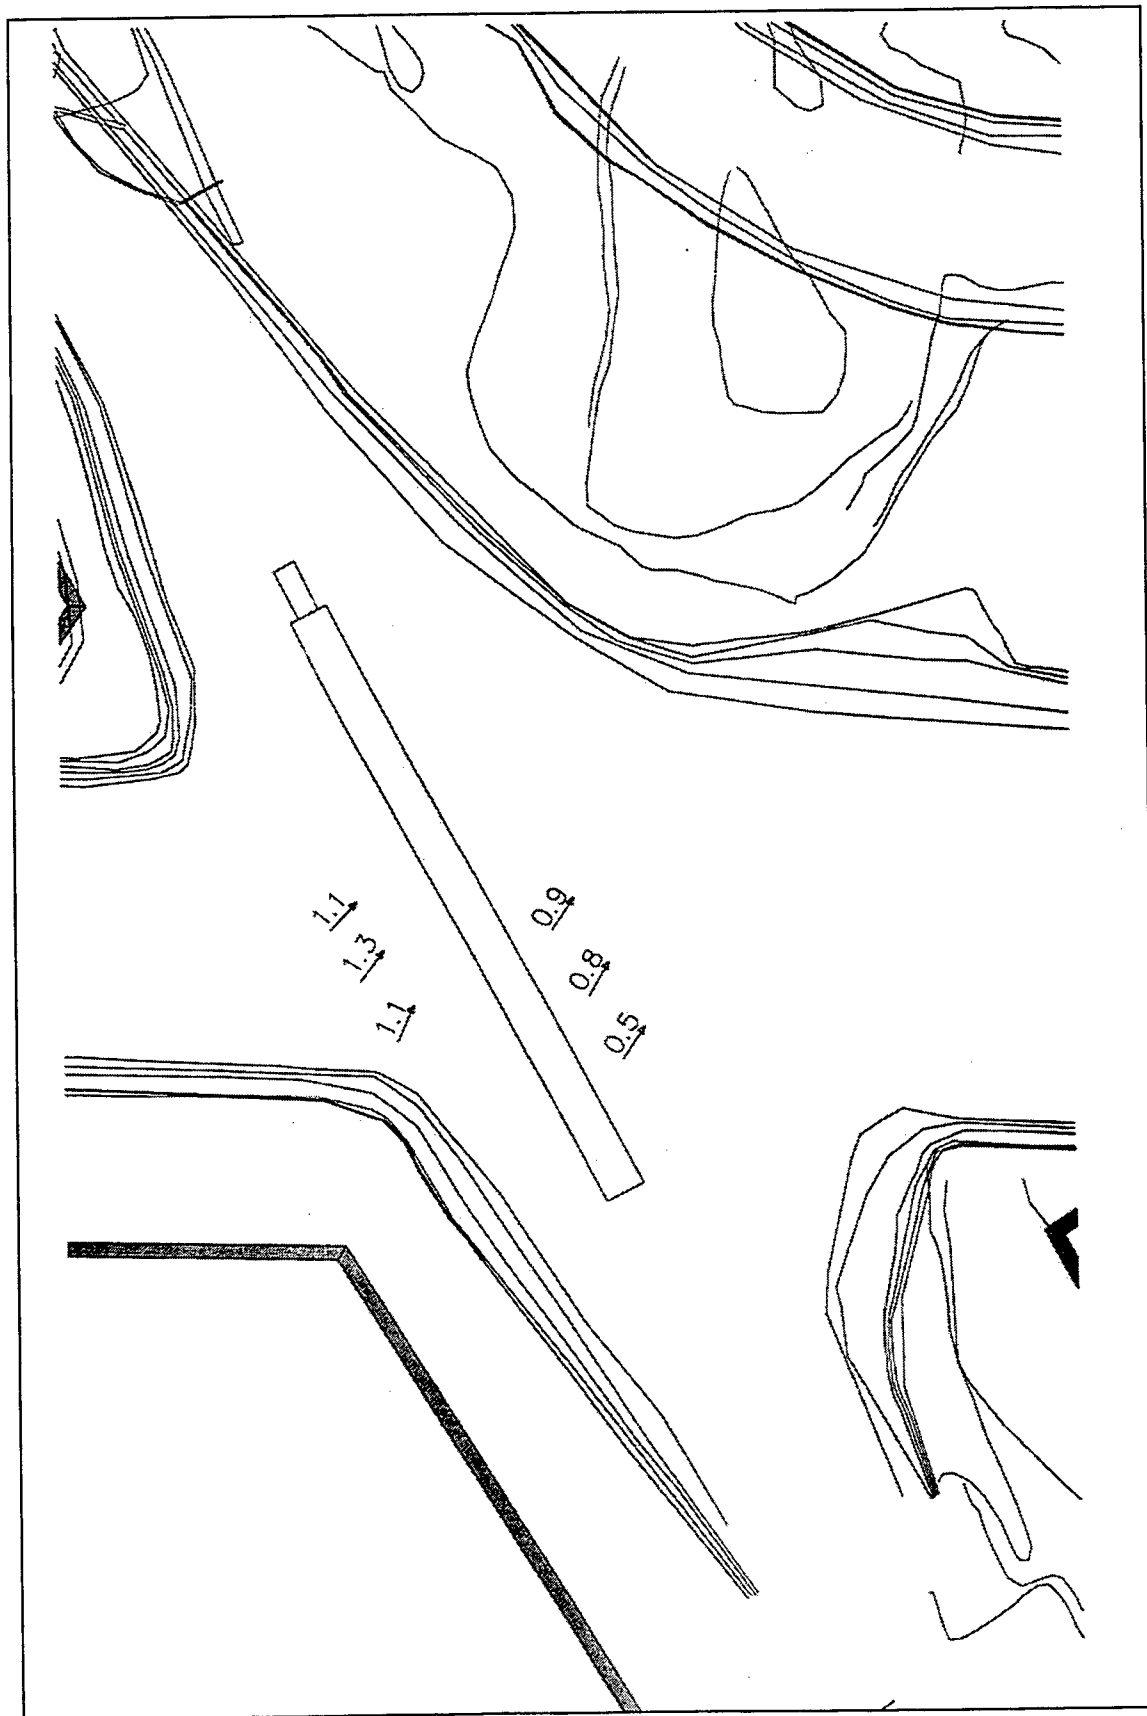
Figure 5. 6,000 cfs flow, no dredging, velocities at 8 ft below water surface (WS) (To convert cubic feet per second to cubic meters per second, multiply by 0.0283) (To convert feet to meters, multiply by 0.3048)

**Velocities in the intersection.** While this plan was in the model, the Galveston District requested that point velocities be taken in the intersection with a loaded, three-barge tow across the intersection with the dredging in place and also with the predredged channel in place. This was done to determine how much the flow was influenced by the channel dredging. To accomplish this, the three-barge tow was tied in place across the intersection where it most fully blocked the flow coming down the Colorado, angled slightly upstream into the flow, and positioned approximately where it would typically be during a transit from east to west. An acoustic Doppler velocity meter was used to collect velocities at stations 30.5 m (100 ft) upstream and downstream of the tow. Velocities were taken on the right and left edges and the center of the dredge cut at depths of 2.4, 4.3, and 6.7 m (8, 14, and 22 ft) below the water surface with flow conditions of 170 and 283 cu m/s (6,000 and 10,000 cfs). After this was completed, the dredged cut was filled with sand and coated with a thin layer of cement to the bed configuration of the 1997 survey. The same information was collected at the same stations, except for velocities at a 6.7-m- (22-ft-) depth, which does not exist with the undredged channel. The velocity vectors indicate the relative angle the velocities were moving. The magnitudes of the velocities are recorded in feet per second (fps). The arrowhead points are the actual position of the velocity measurements.

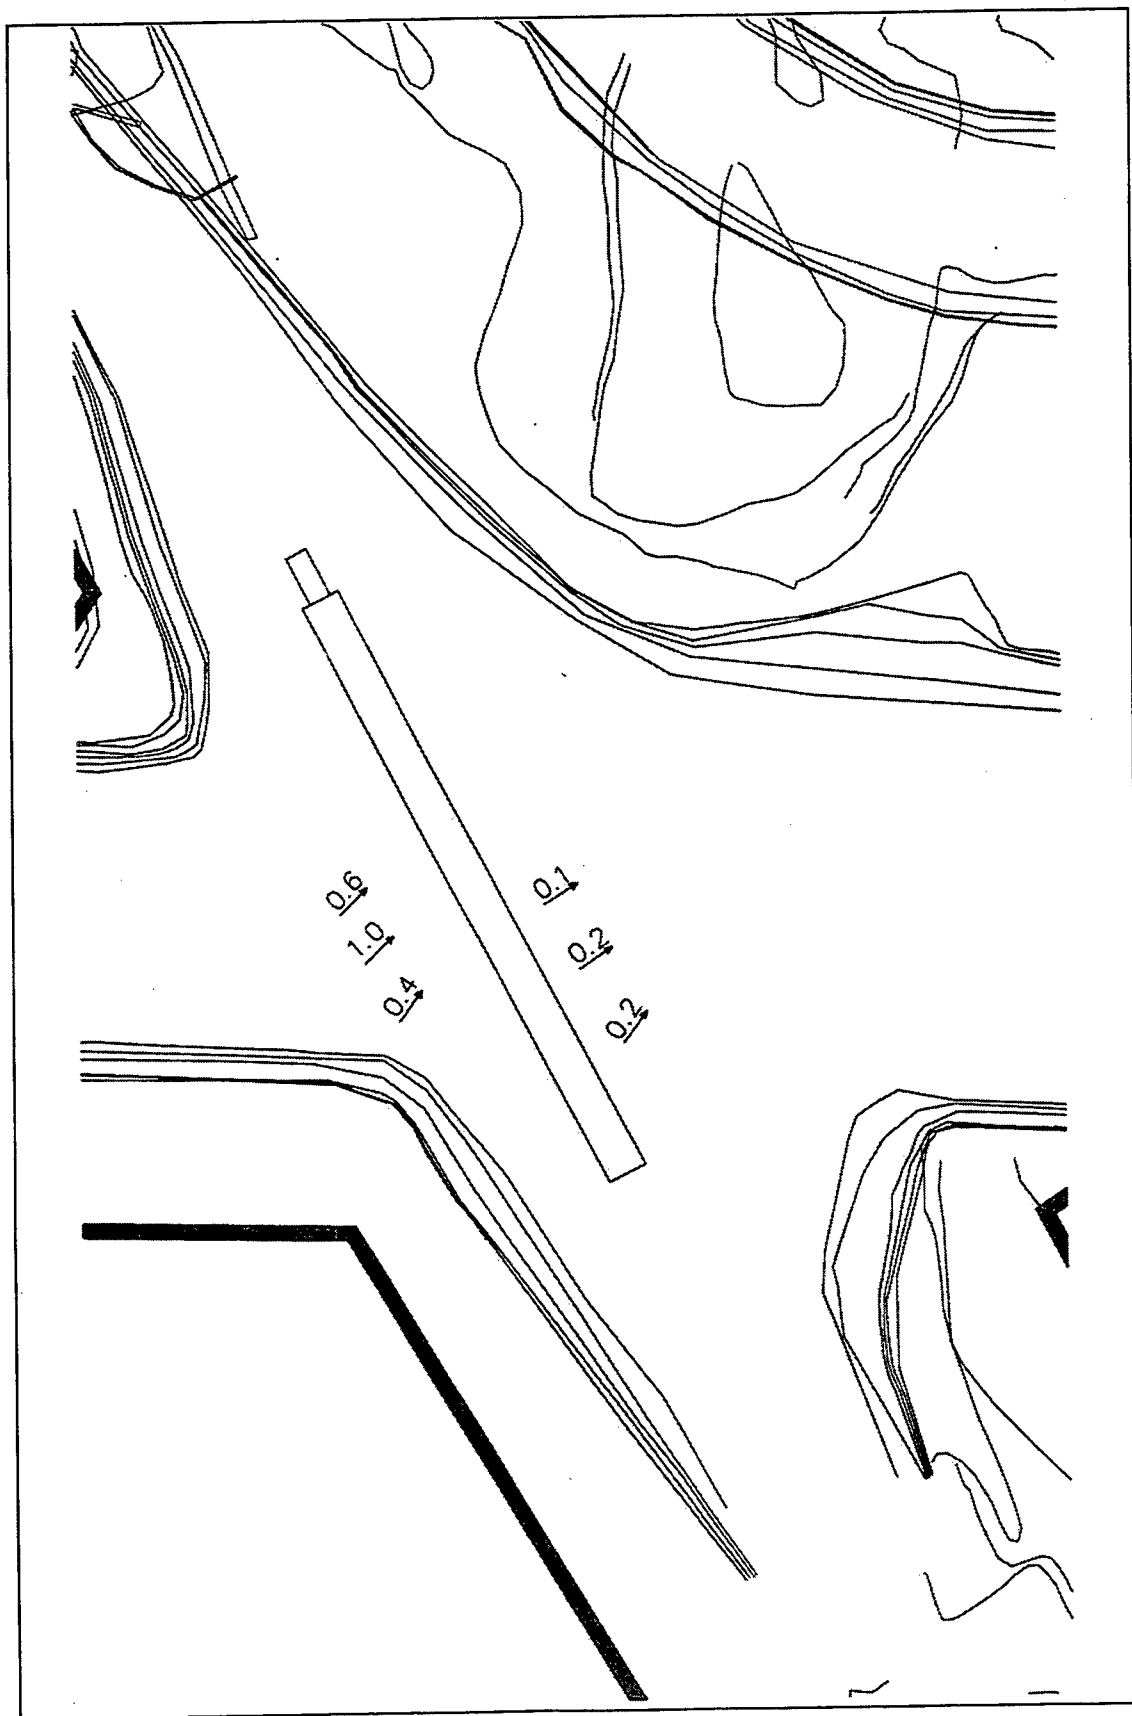
Figure 6. 6,000 cfs flow, no dredging, velocities at 14 ft below WS

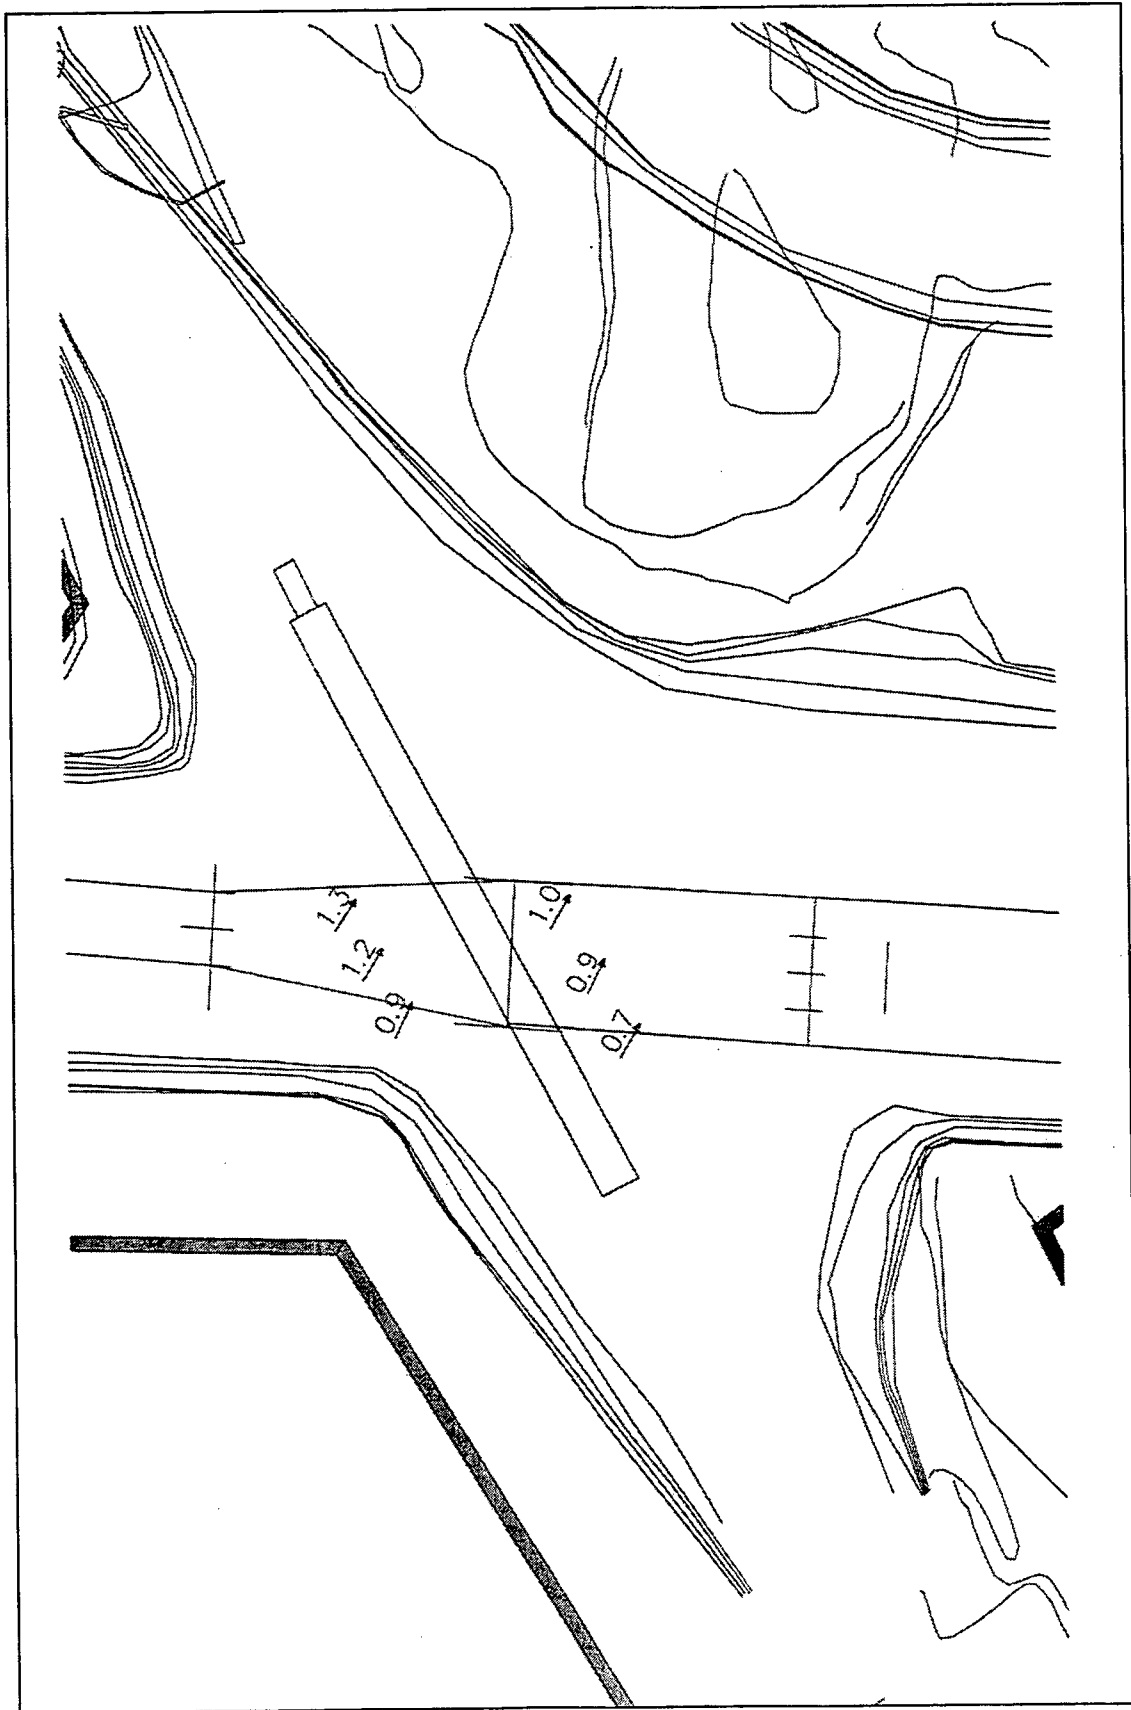
Figure 7. 6,000 cfs flow, dredged channel, velocities at 8 ft below WS

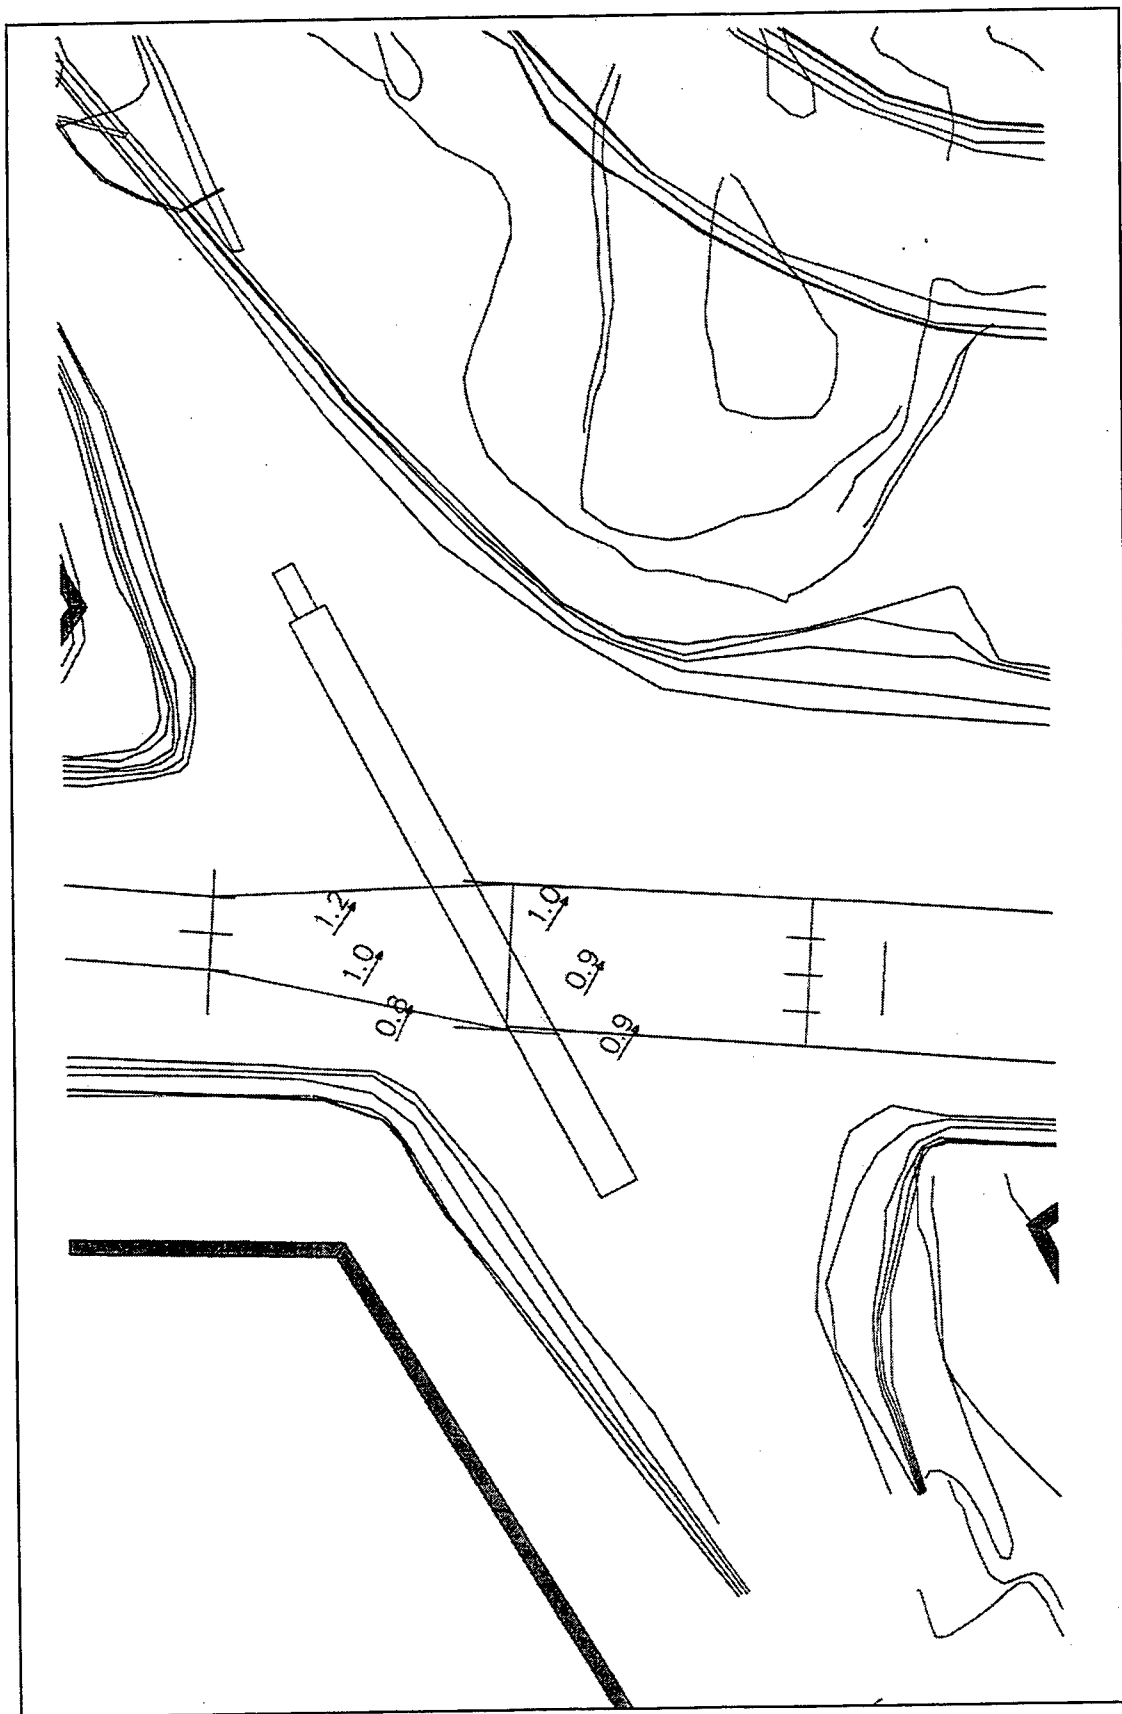
Figure 8. 6,000 cfs flow, dredged channel, velocities at 14 ft below WS

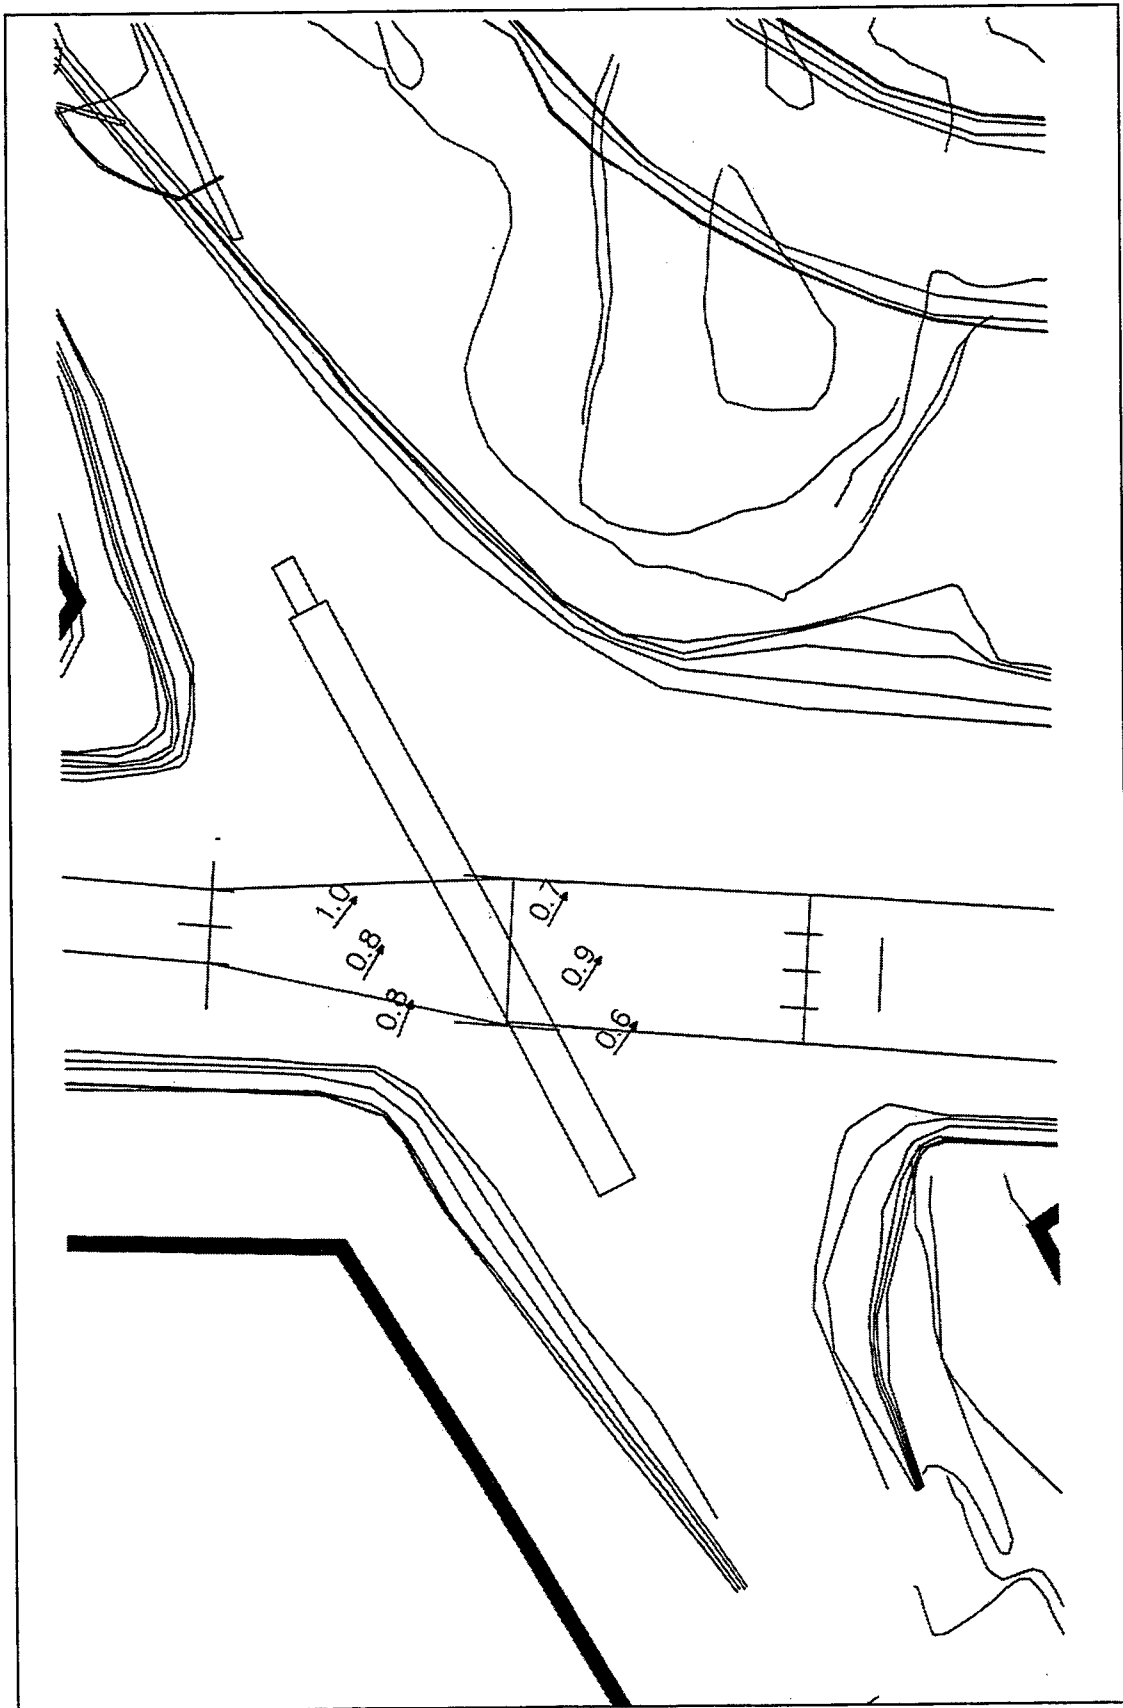
Figure 9. 6,000 cfs flow, dredged channel, velocities at 22 ft below WS

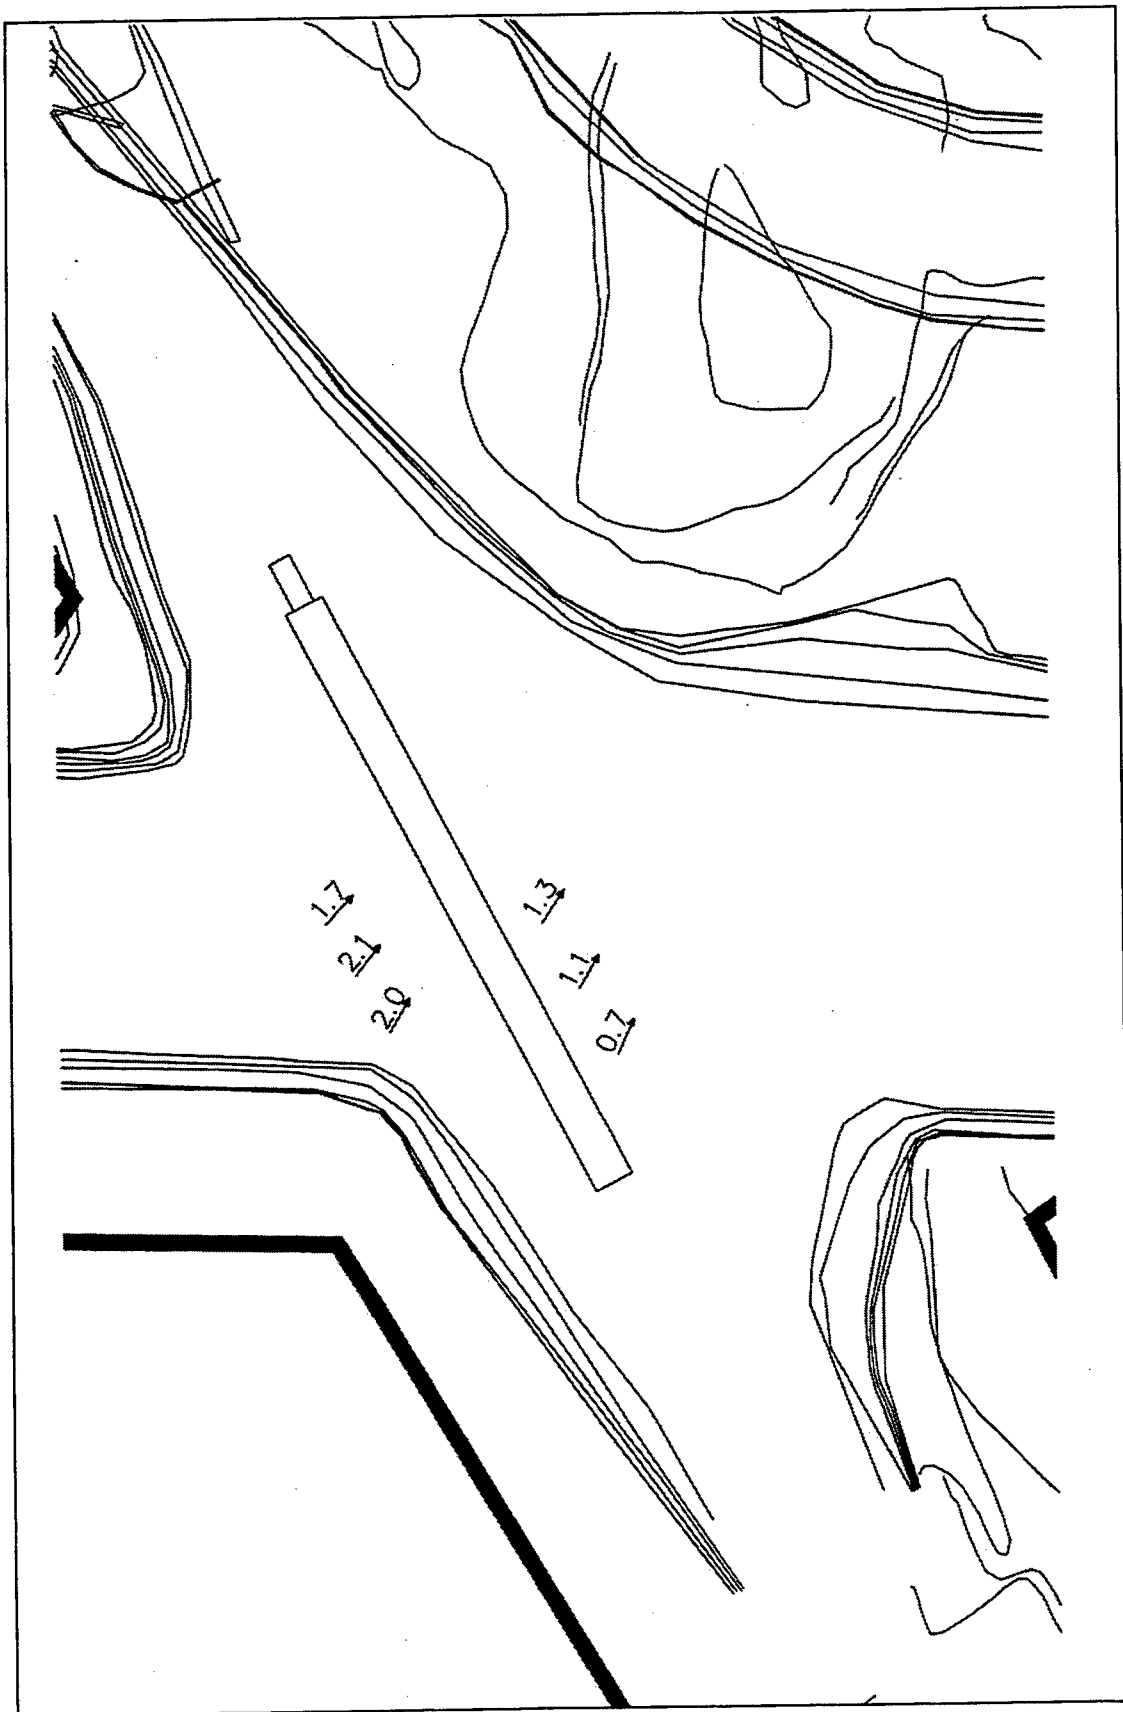
Figure 10. 10,000 cfs flow, no dredging, velocities at 8 ft below WS

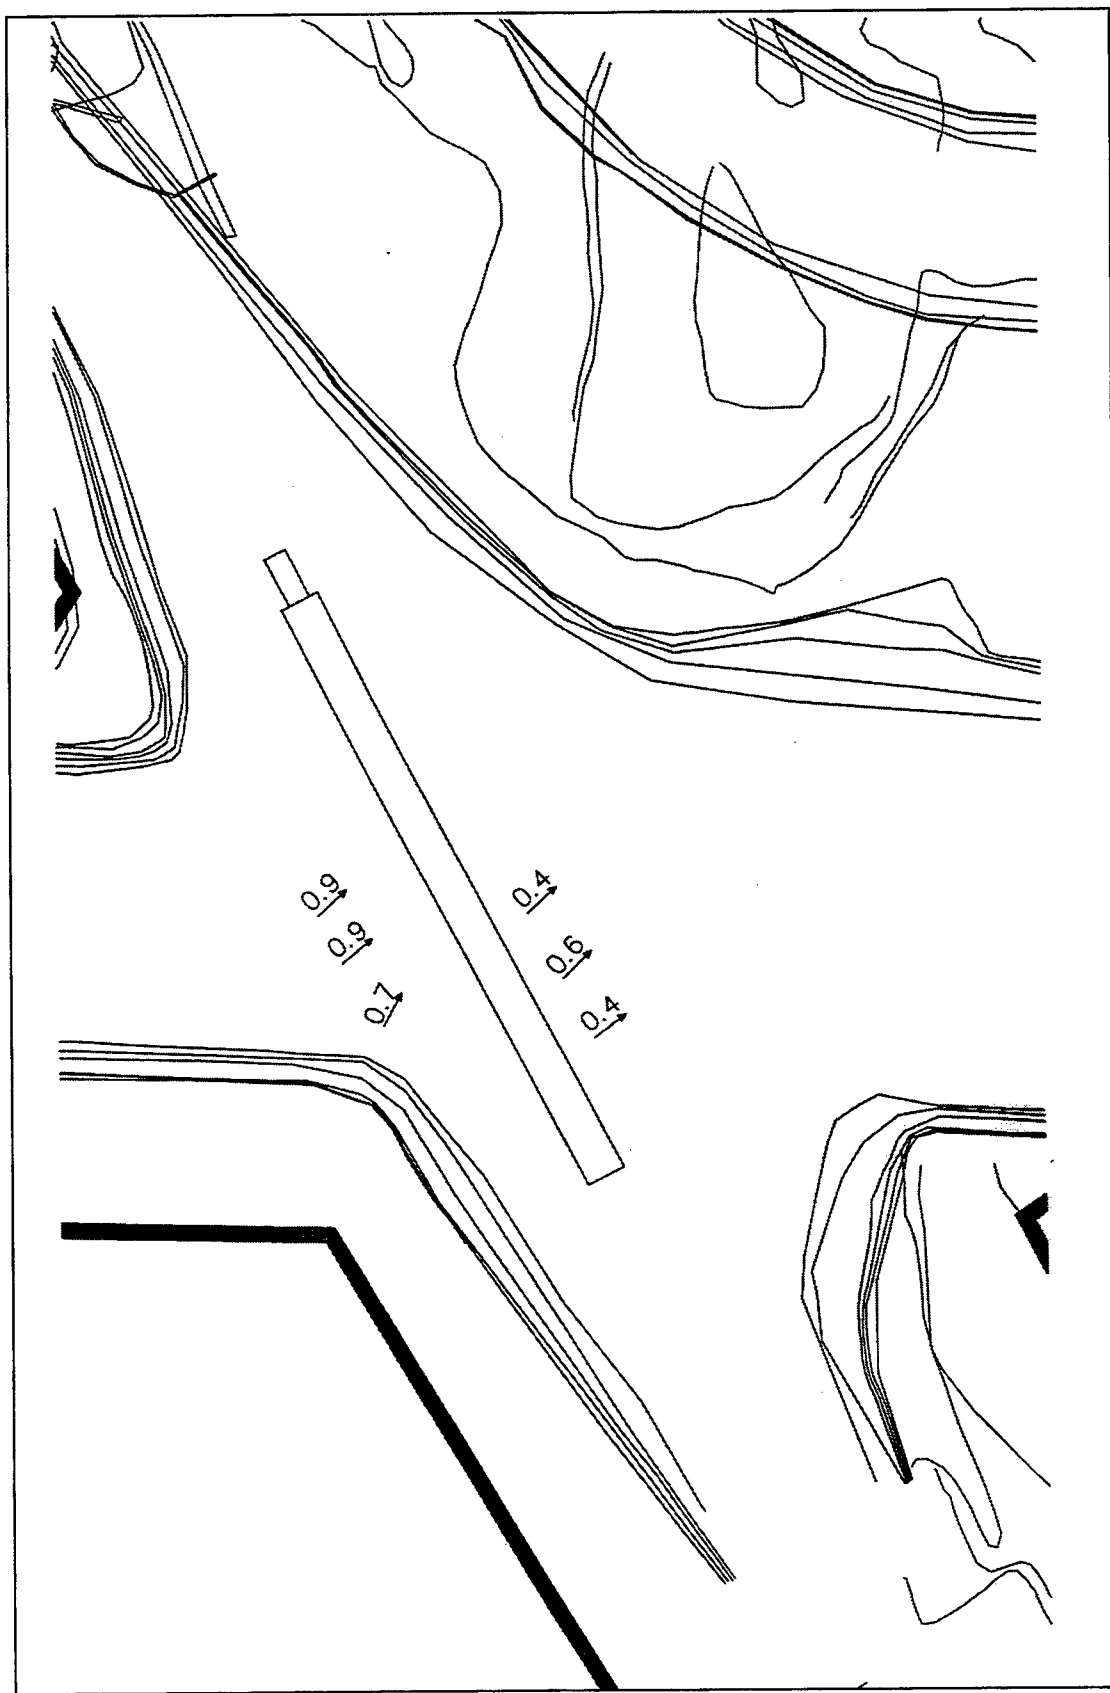
Figure 11. 10,000 cfs flow, no dredging, velocities at 14 ft below WS

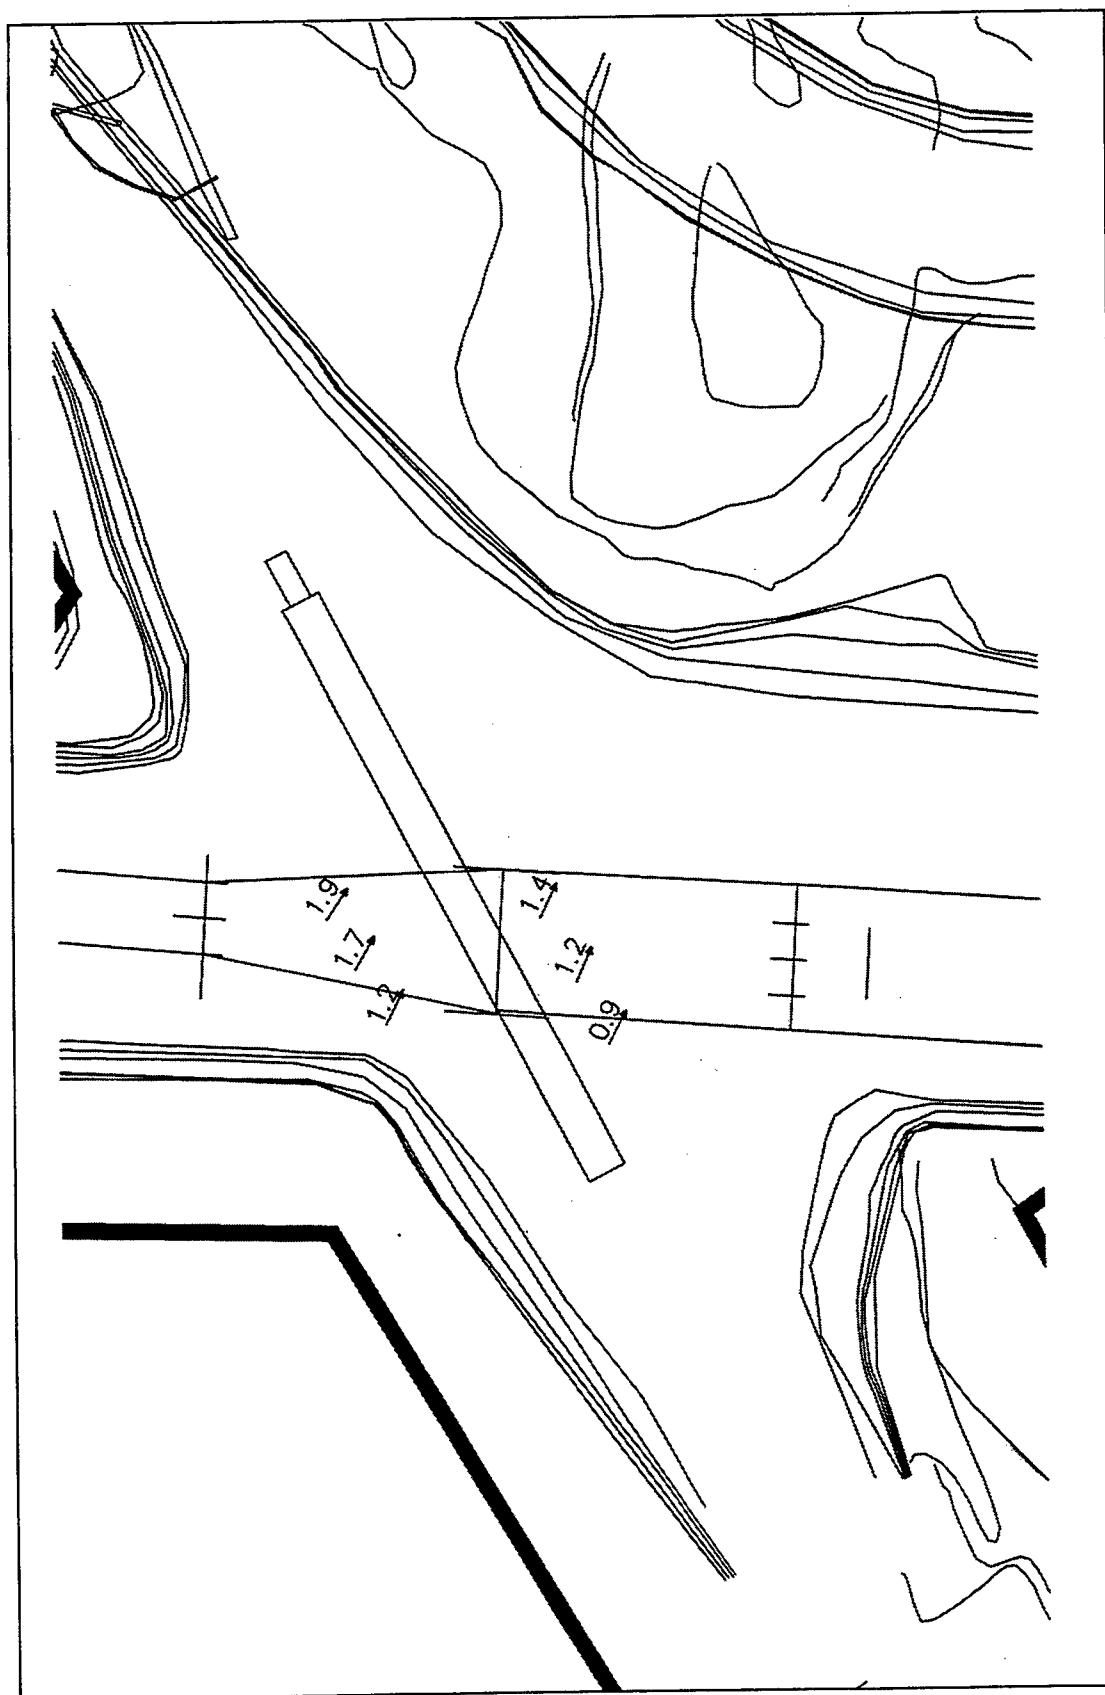
Figure 12. 10,000 cfs flow, dredged channel, velocities at 8 ft below WS

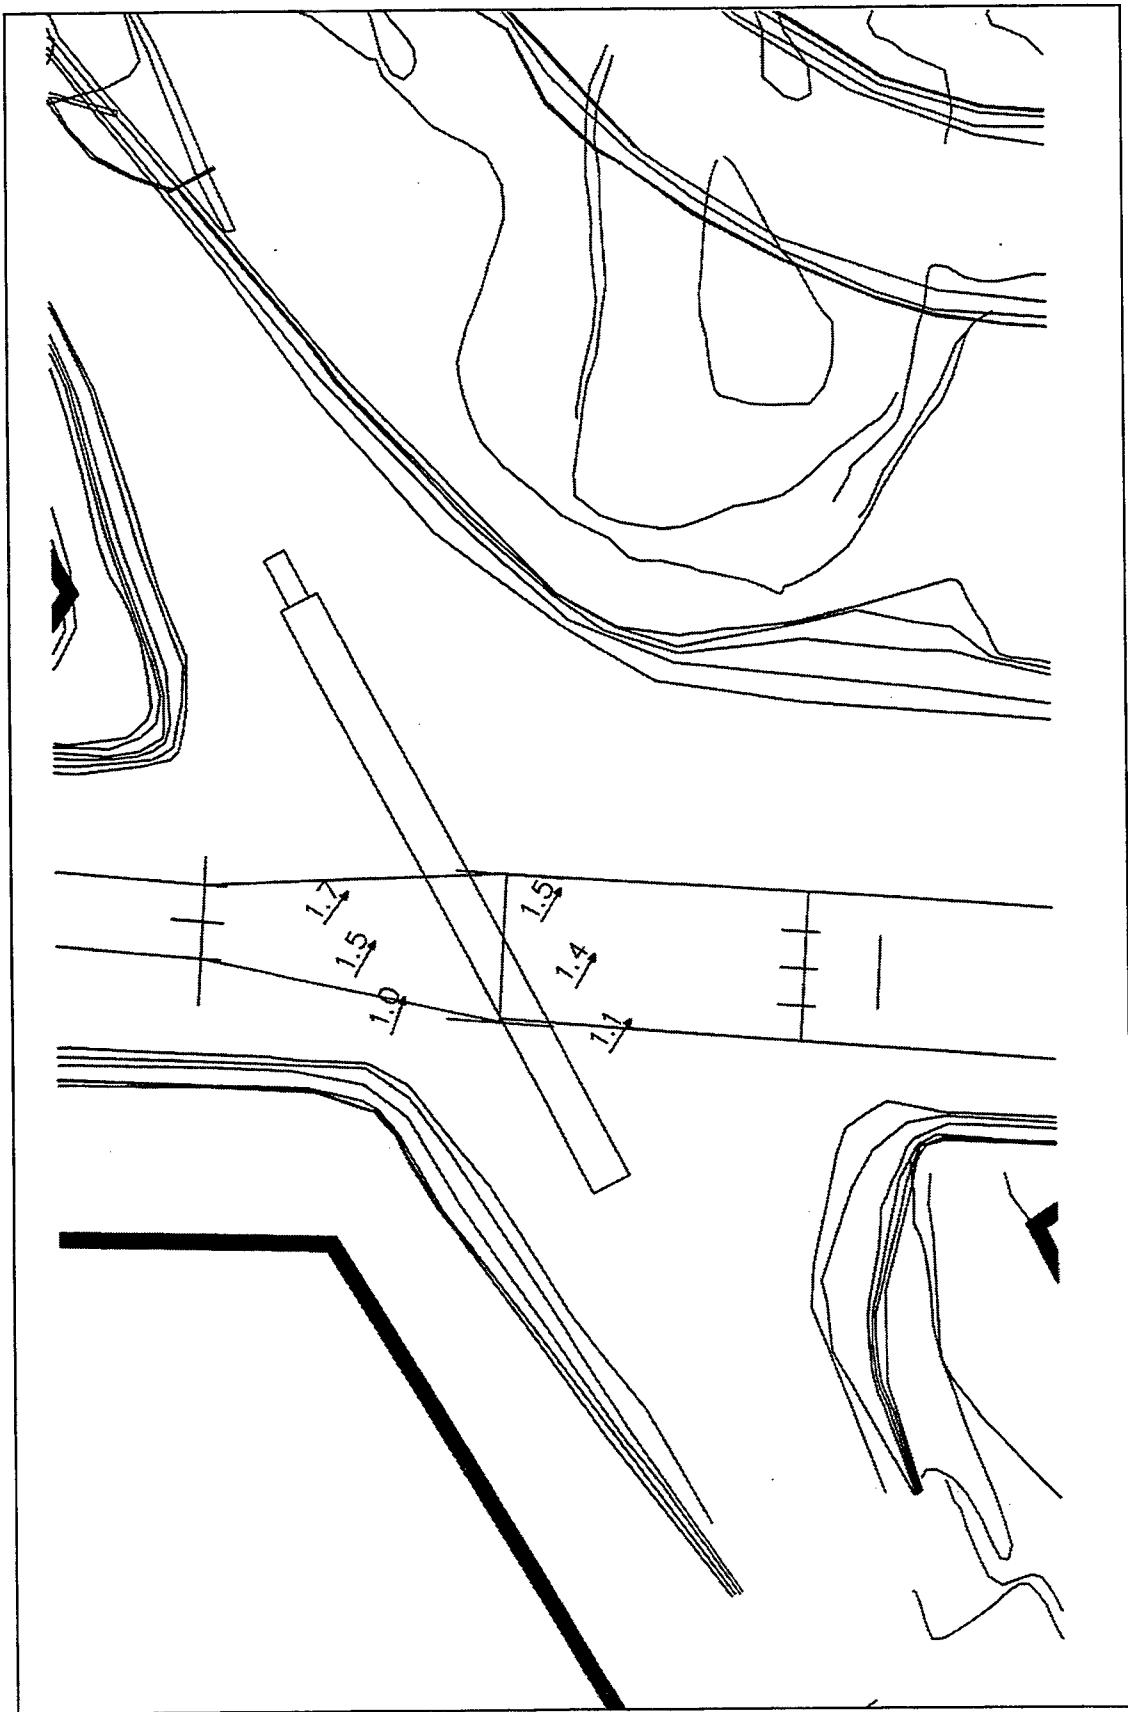
Figure 13. 10,000 cfs flow, dredged channel, velocities at 14 ft below WS
