ERDC/CHL TR-00-26

## **Navigation Study, Colorado Locks, Colorado River, Matagorda, Texas**

# **Navigation Study, Colorado Locks, Colorado River, Matagorda, Texas**

Final report

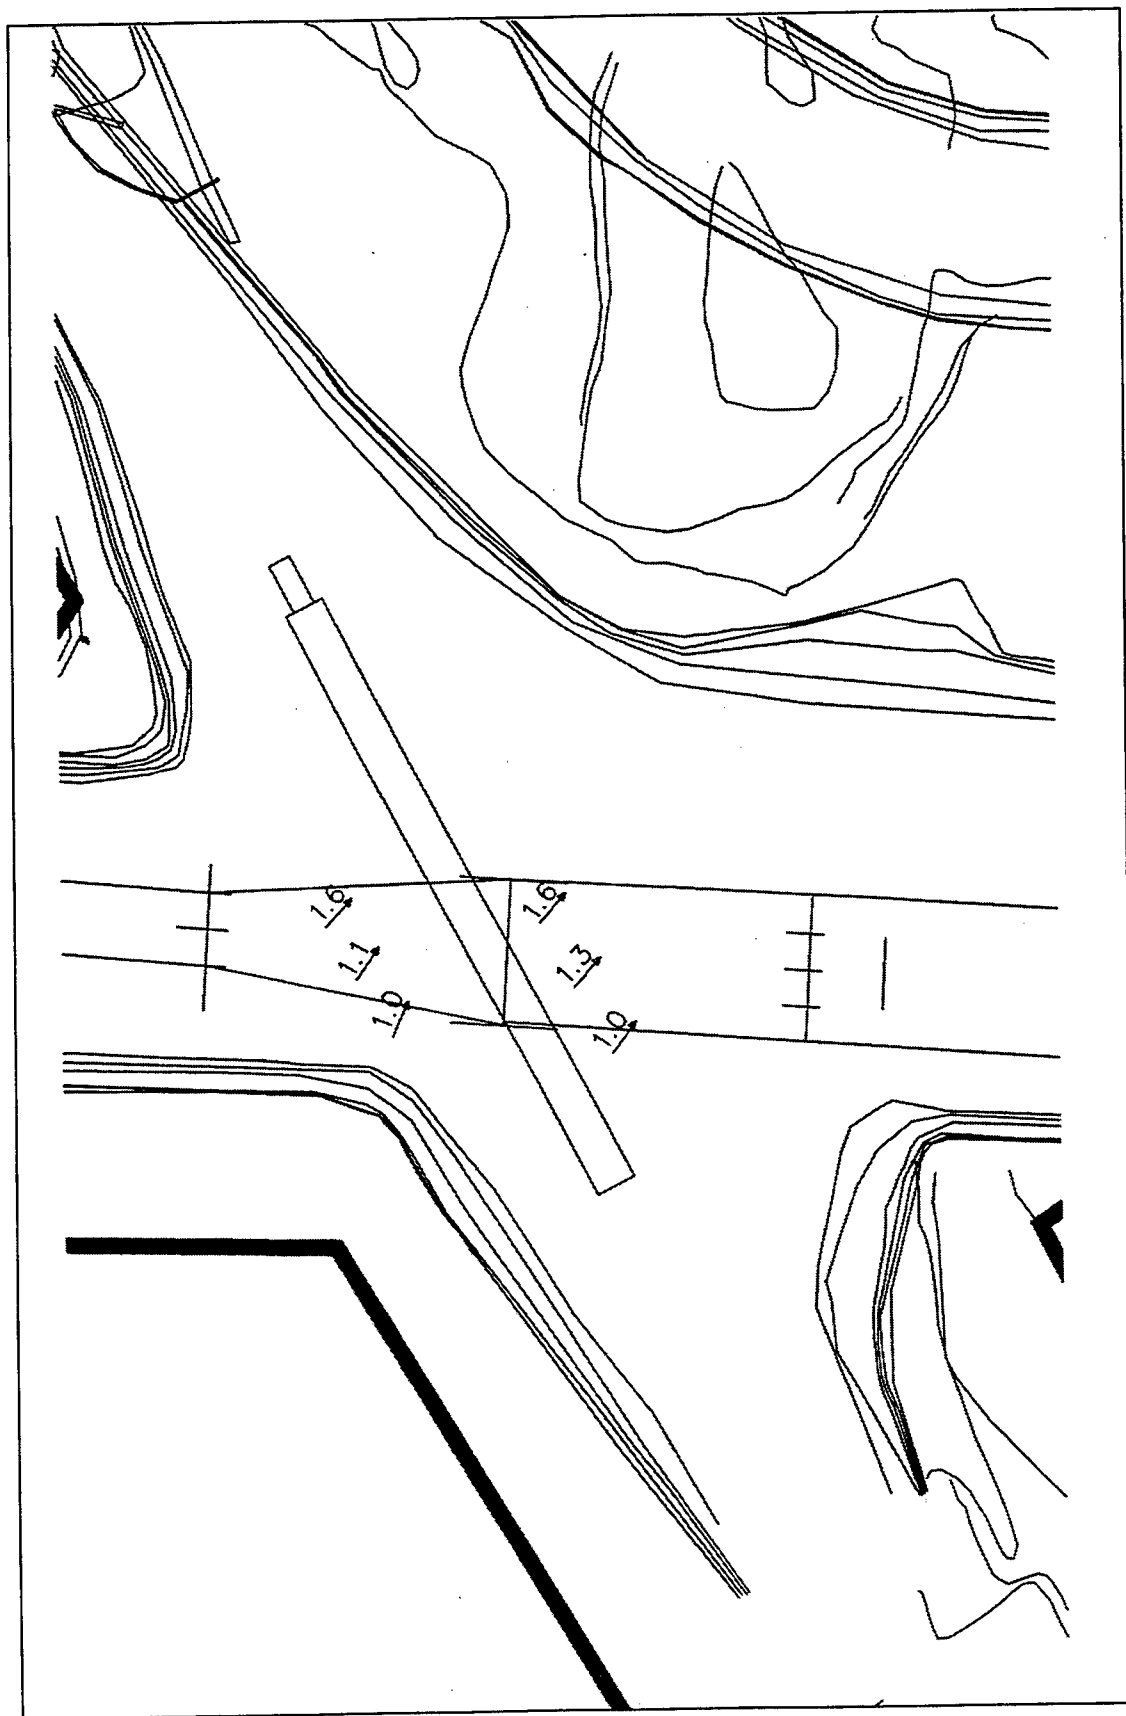
Figure 14. 10,000 cfs flow, dredged channel, velocities at 22 ft below WS

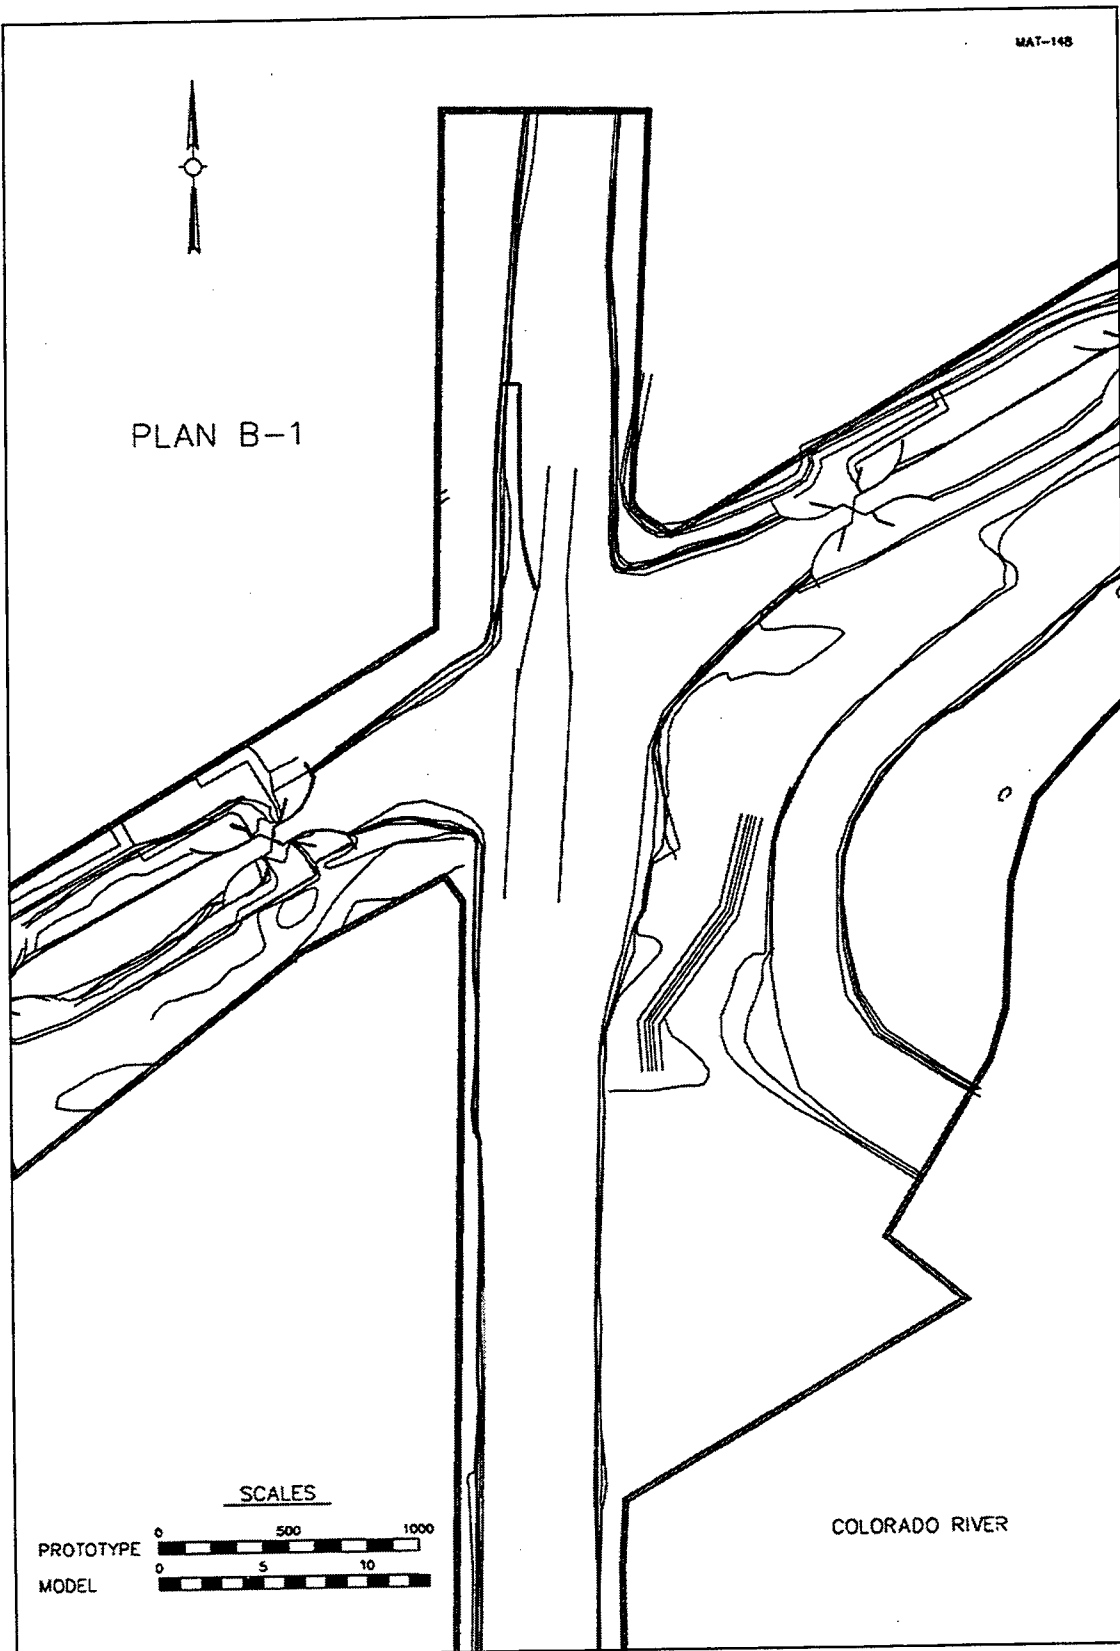
Figure 15. Plan B-1 layout

commonly controlled by the use of contraction works, similar to the L-head dike as evaluated in Plan B. Although this model could not address the effectiveness of this dike in maintenance of the deepened channel in the intersection, it could be used to evaluate how the combination of a training structure and dredging might affect navigation. Plan B-1 (Figure 15) consisted of the dredged channel as used for Plan B and the L-head dike as used for Plan A.

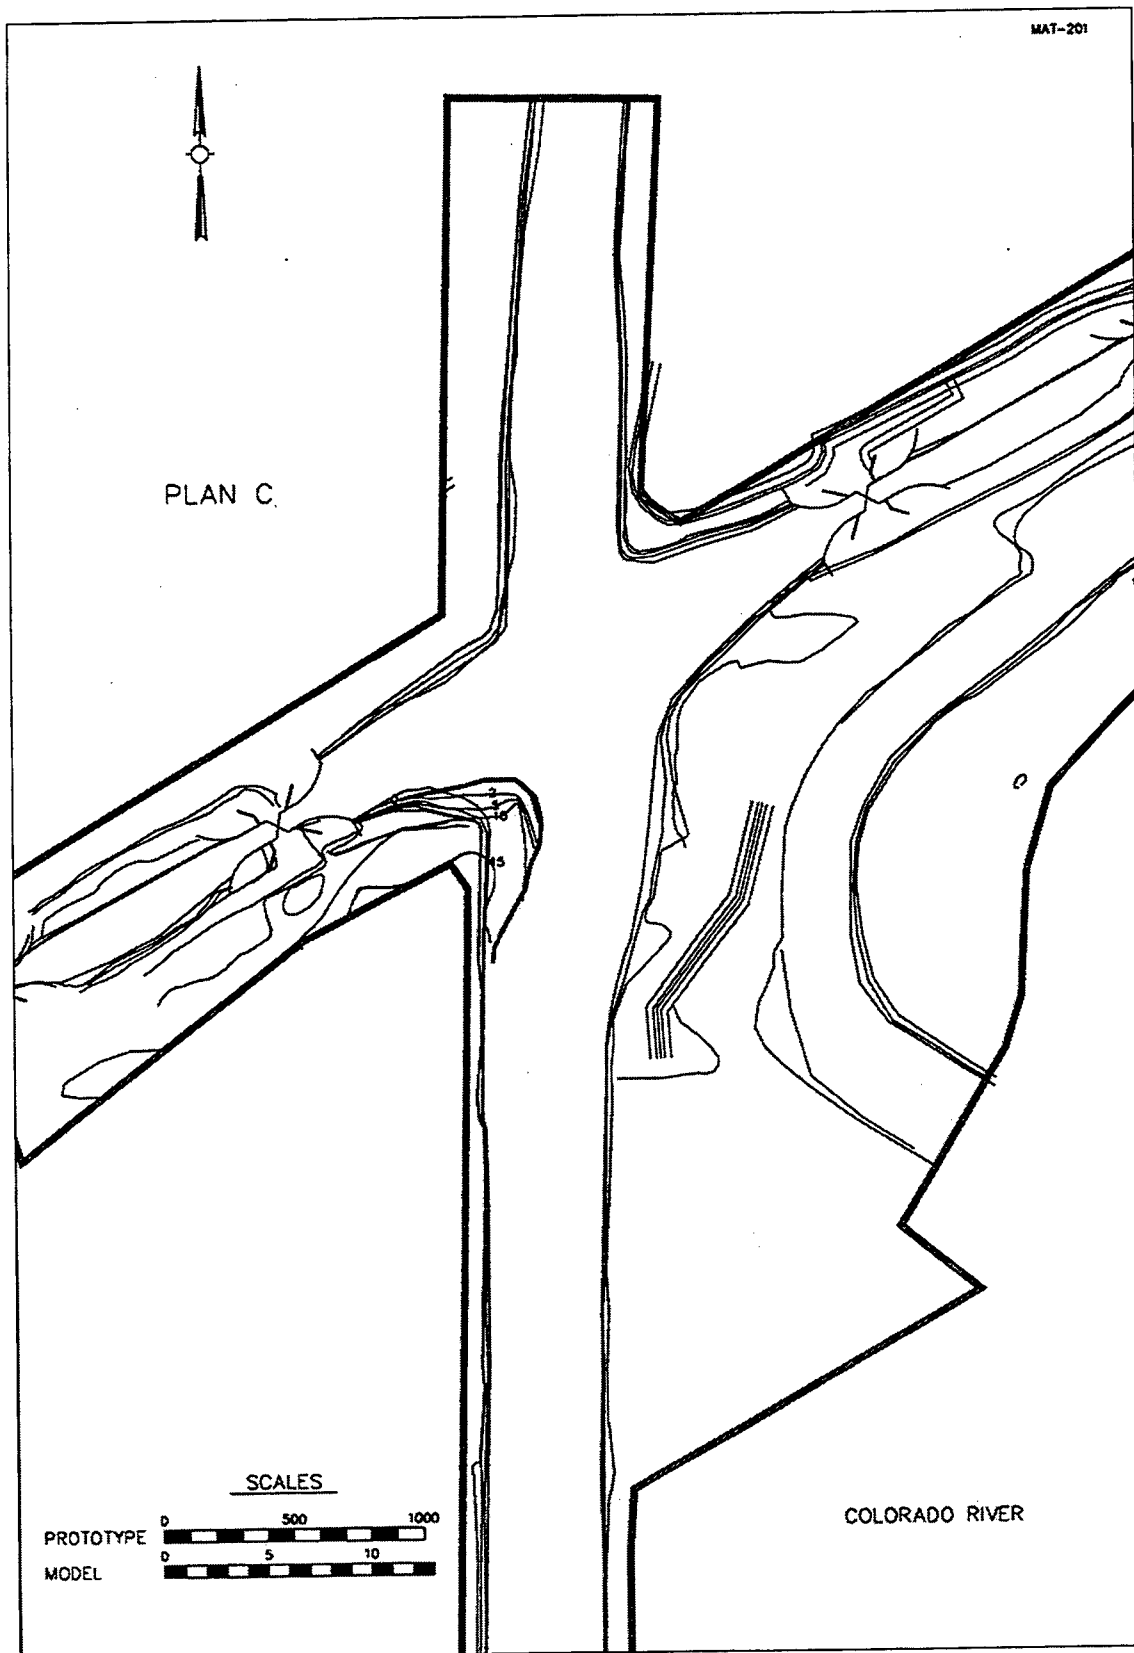
Figure 16. Plan C layout

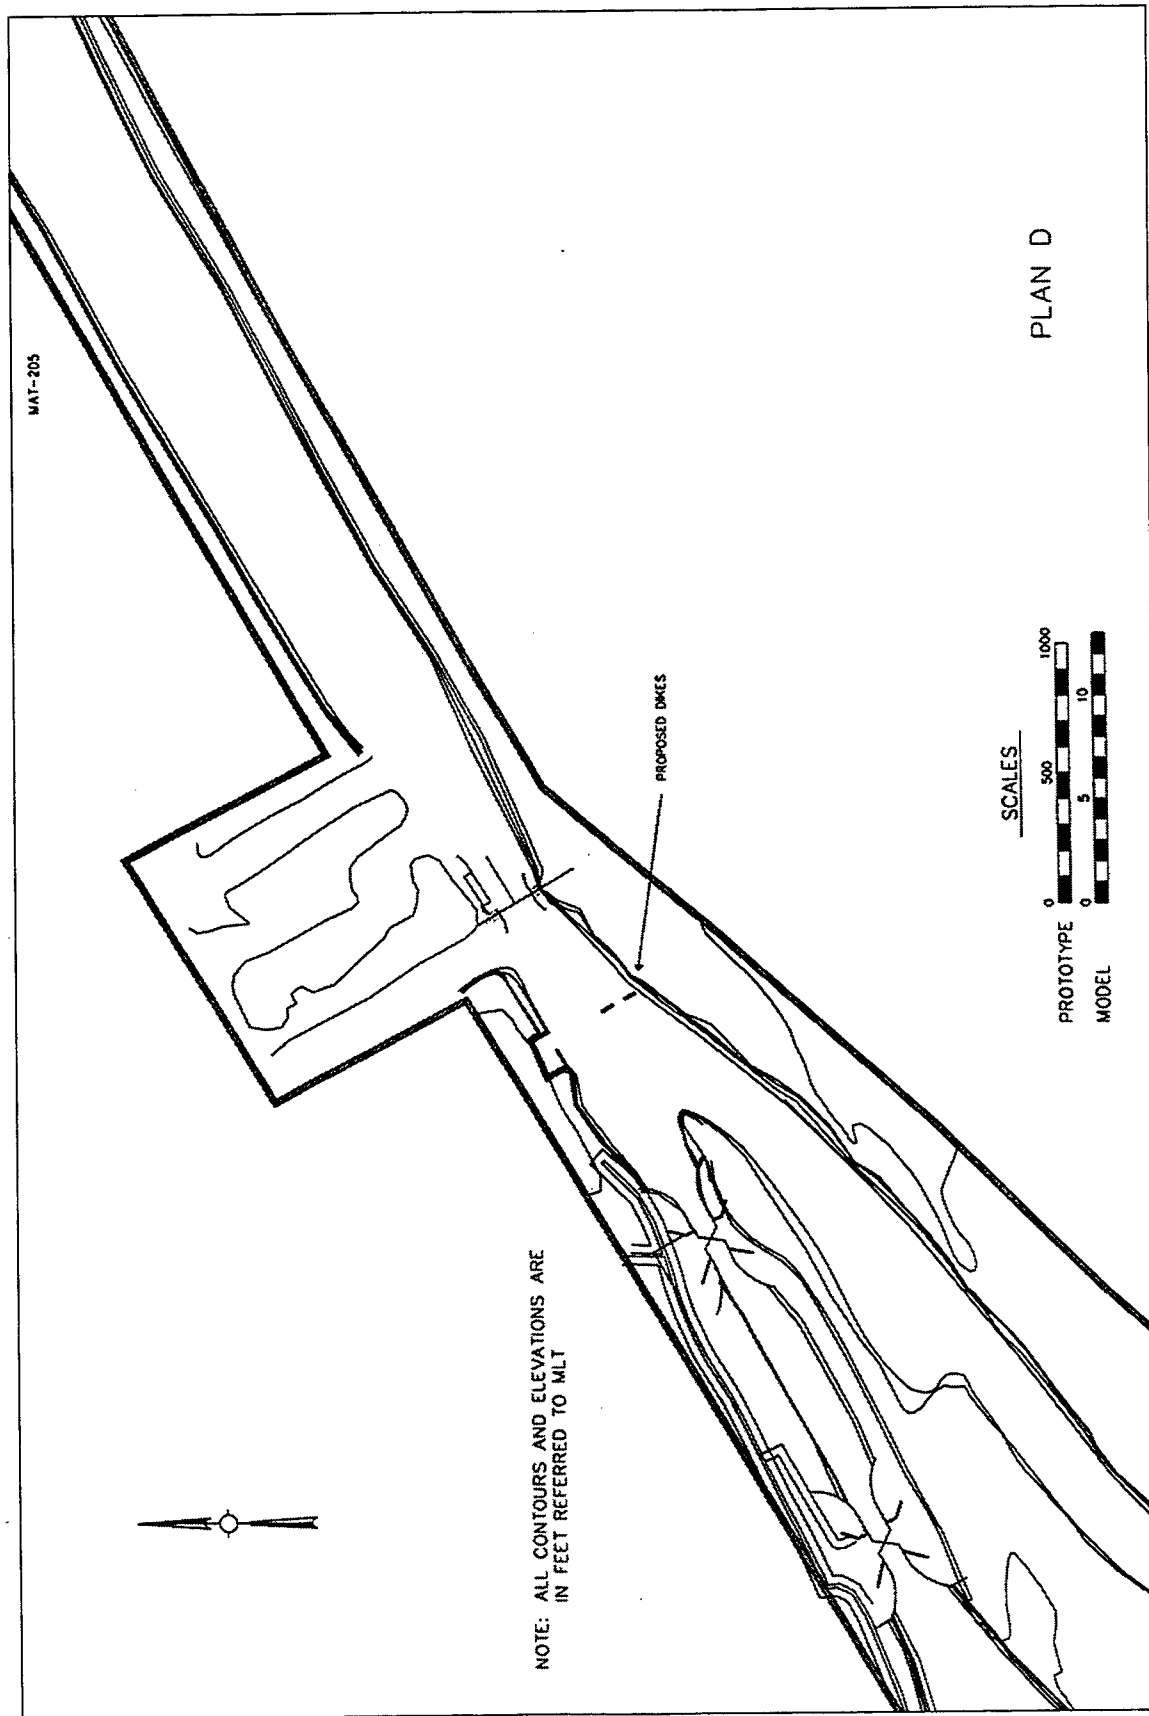
Figure 17. Plan D layout

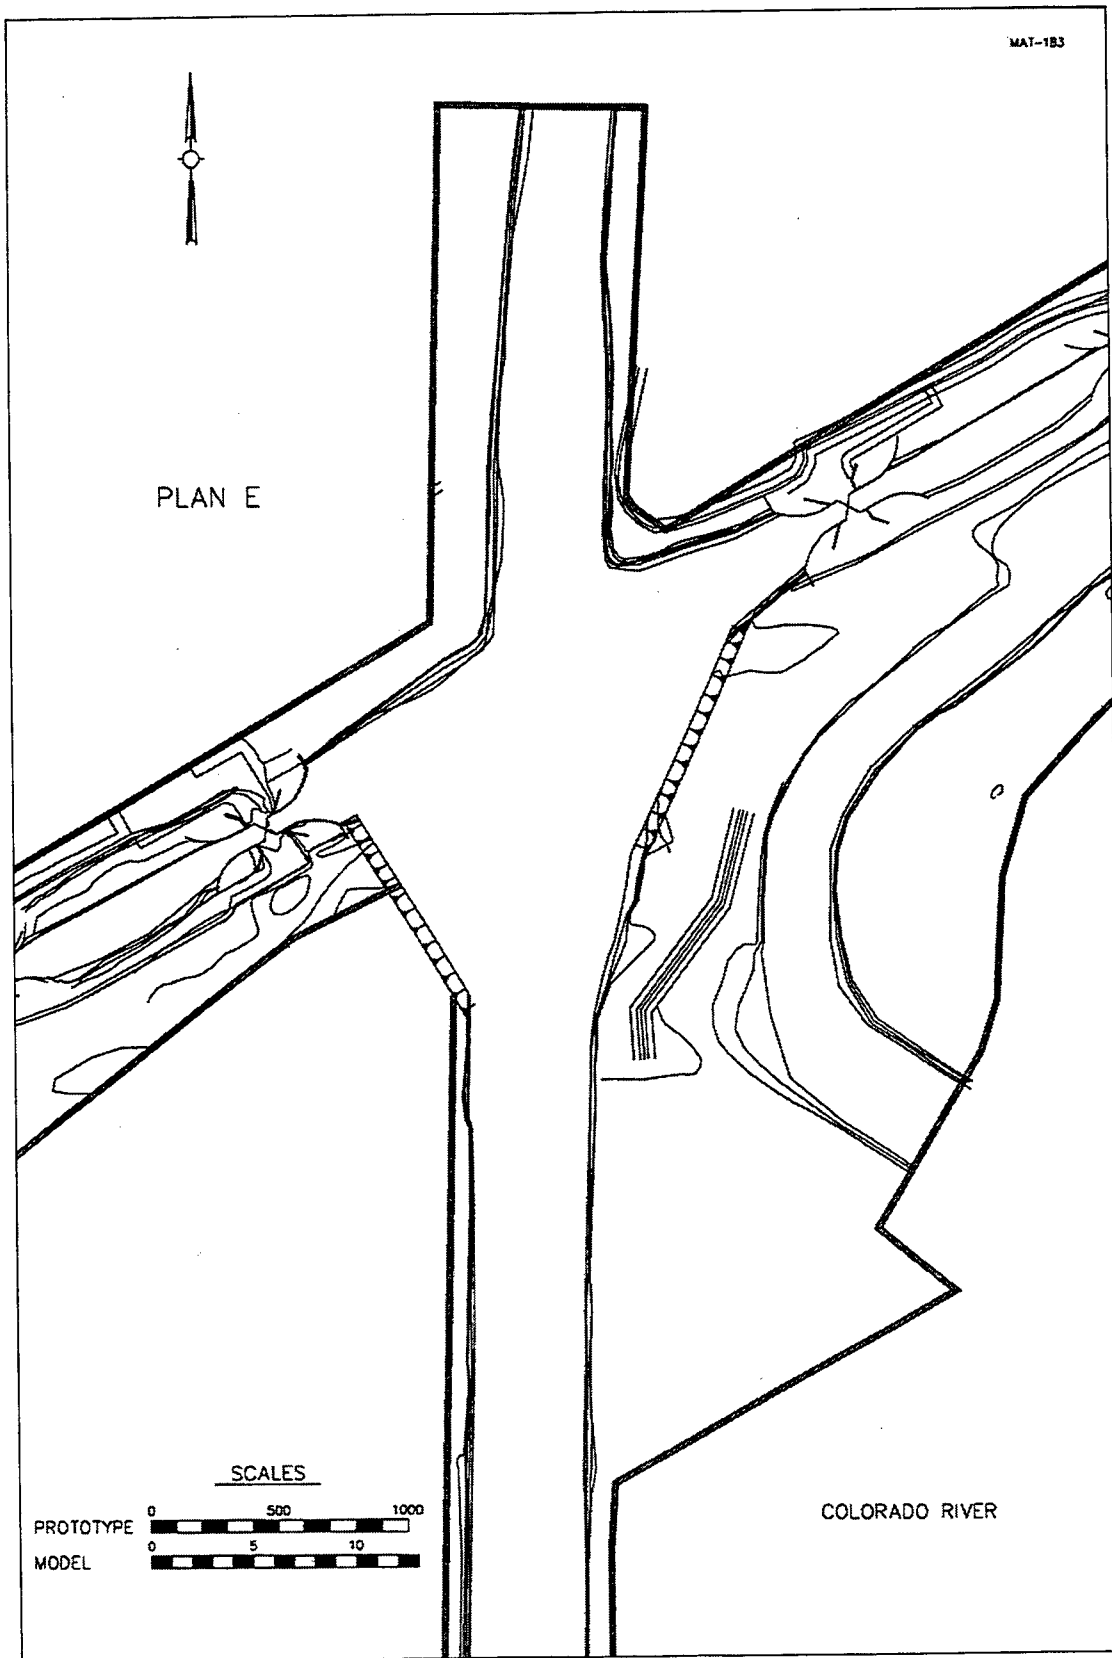
Plan E consisted of the complete removal of the southwest and southeast corners of the Colorado/GIWW intersection (Figure 18). The bank lines were

Figure 18. Plan E layout

placed to an alignment provided by the Galveston District, cut to a slope of 1 on 3, and the depth of the dredged channel was 3.66 m (-12 ft) mlt.

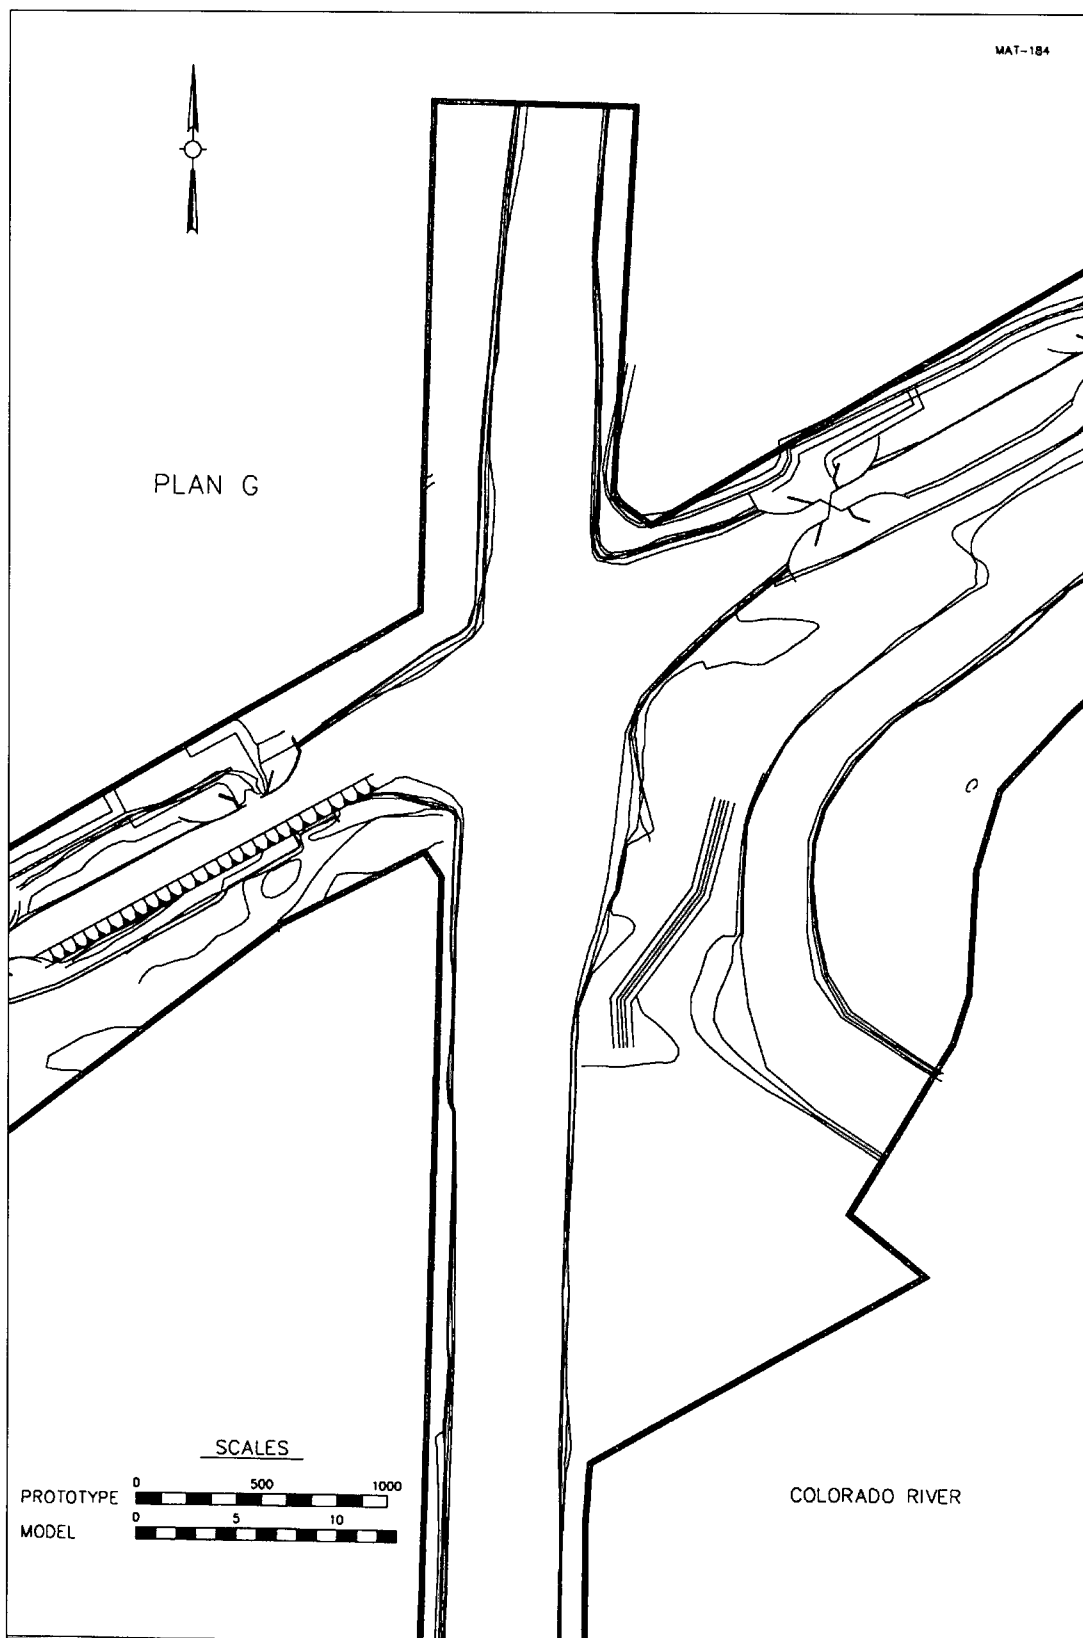
Figure 31. Plan G layout

Plan G (Figure 31) removed the south miter gate and wing wall from the east end of the West Lock, leaving the north gate and wing wall intact. This plan would be similar to the original design from the late 1940s of only single flood control gates in the GIWW on both the east and west side of the Colorado River. At that time, tows could not push through the flood gate against the current and a second set of gates were installed on either side of the Colorado closer to the intersection, forming the now existing East and West Lock. The bottom width of the channel was 38.1 m (125 ft) and an elevation of -15 mlt and the left bank line from the southwest point of the Colorado/GIWW intersection to the west gate of the West Lock was cut on a 1 on 3 slope from -15 mlt to top bank. This made the channel through the West Lock asymmetrical to the center line of the GIWW, but

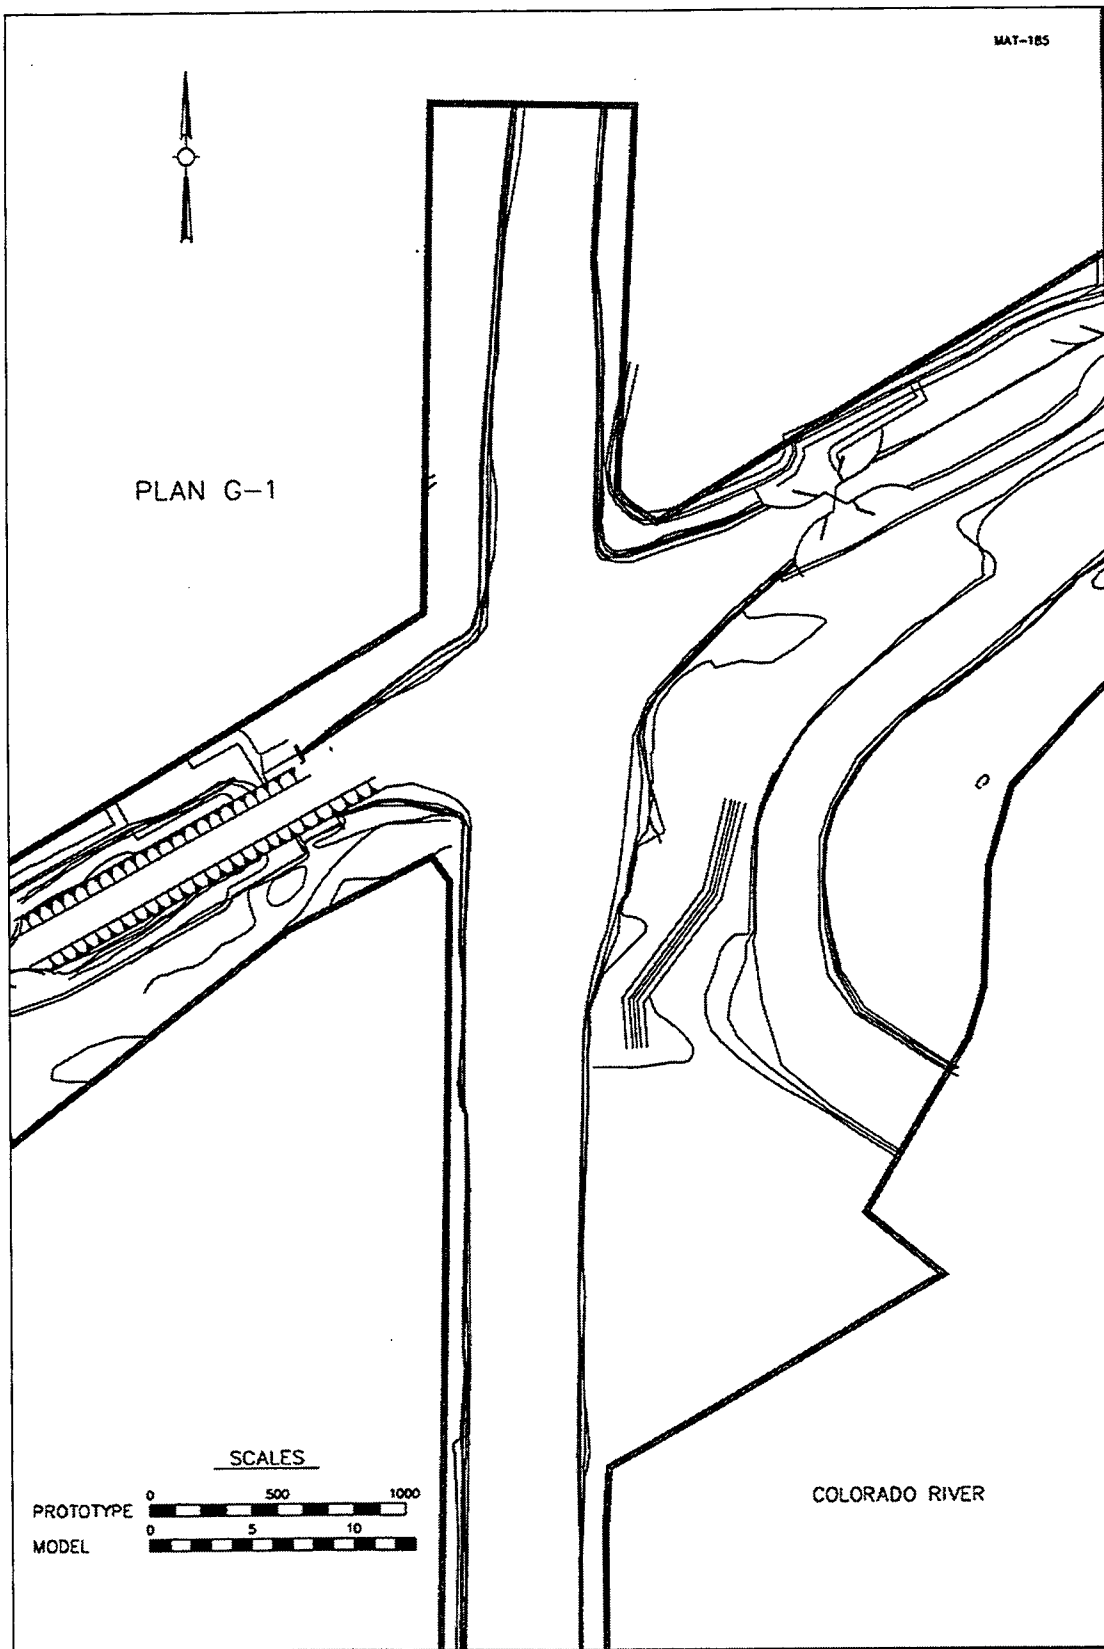
Figure 32. Plan G-2 layout

Plan G-1 (Figure 32) removed both the north and south gates from the east end of the West Lock, removing the gates, lock walls, and wing walls, creating a

symmetrical channel about the GIWW center line. The bottom width of the channel was 38.1 m (125 ft), centered on the GIWW center line, with an elevation of -15 mlt and the left and right bank lines from the northwest and southwest points of the Colorado/GIWW intersection to the west gate of the West Lock was cut on a 1 on 3 slope from -15 mlt to top bank. As with Plan G, no evaluation of how the tow might be affected by flow through the remaining set of miter gates could be performed.

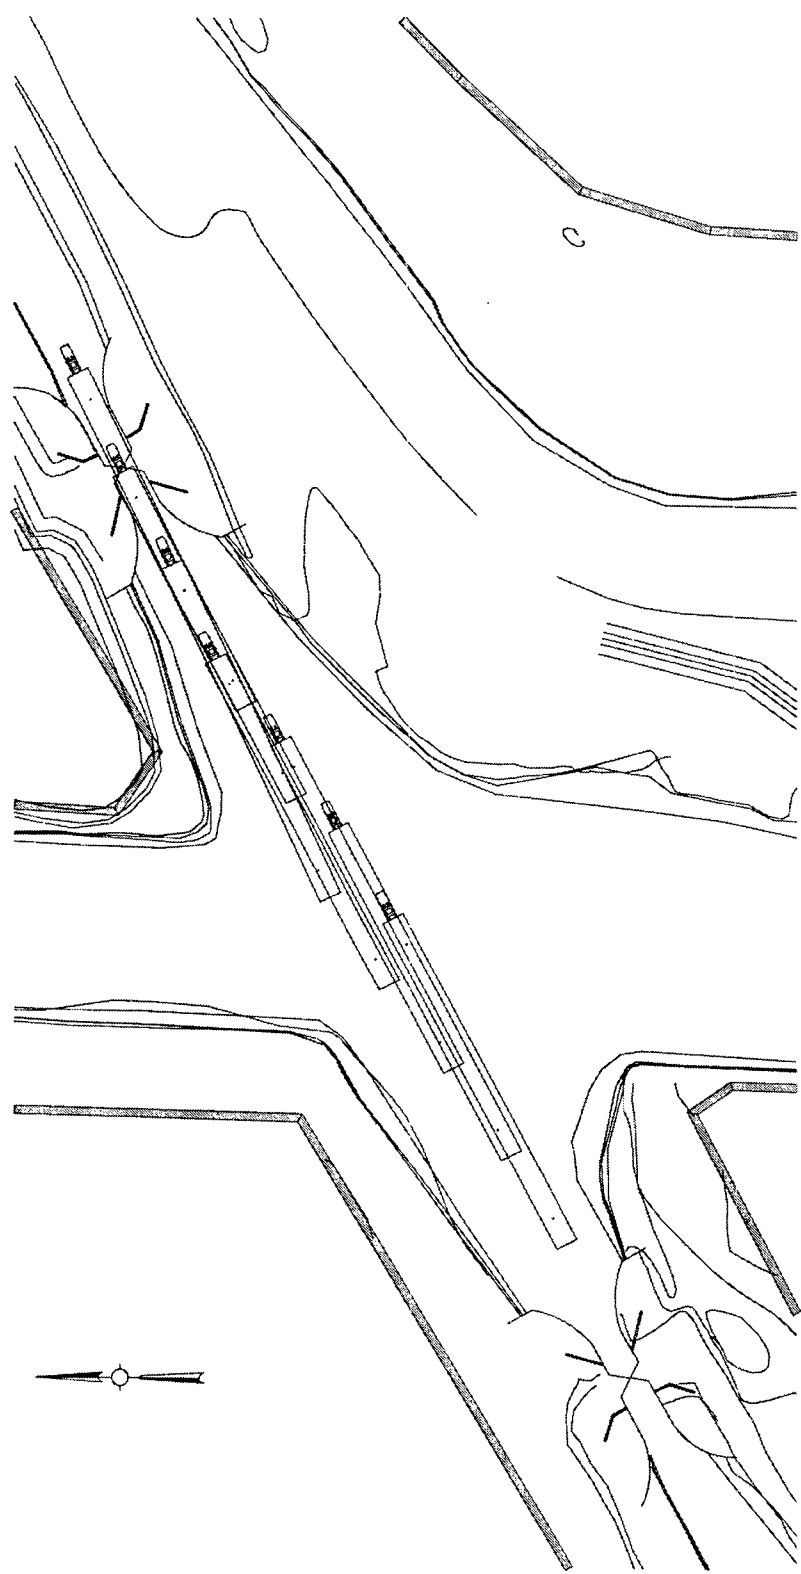
Plate 15

3-BARGE TOW: 3 LONG X 1 WIDE  
54FT WIDE X 885FT LONG  
70FT PUSHER BOAT

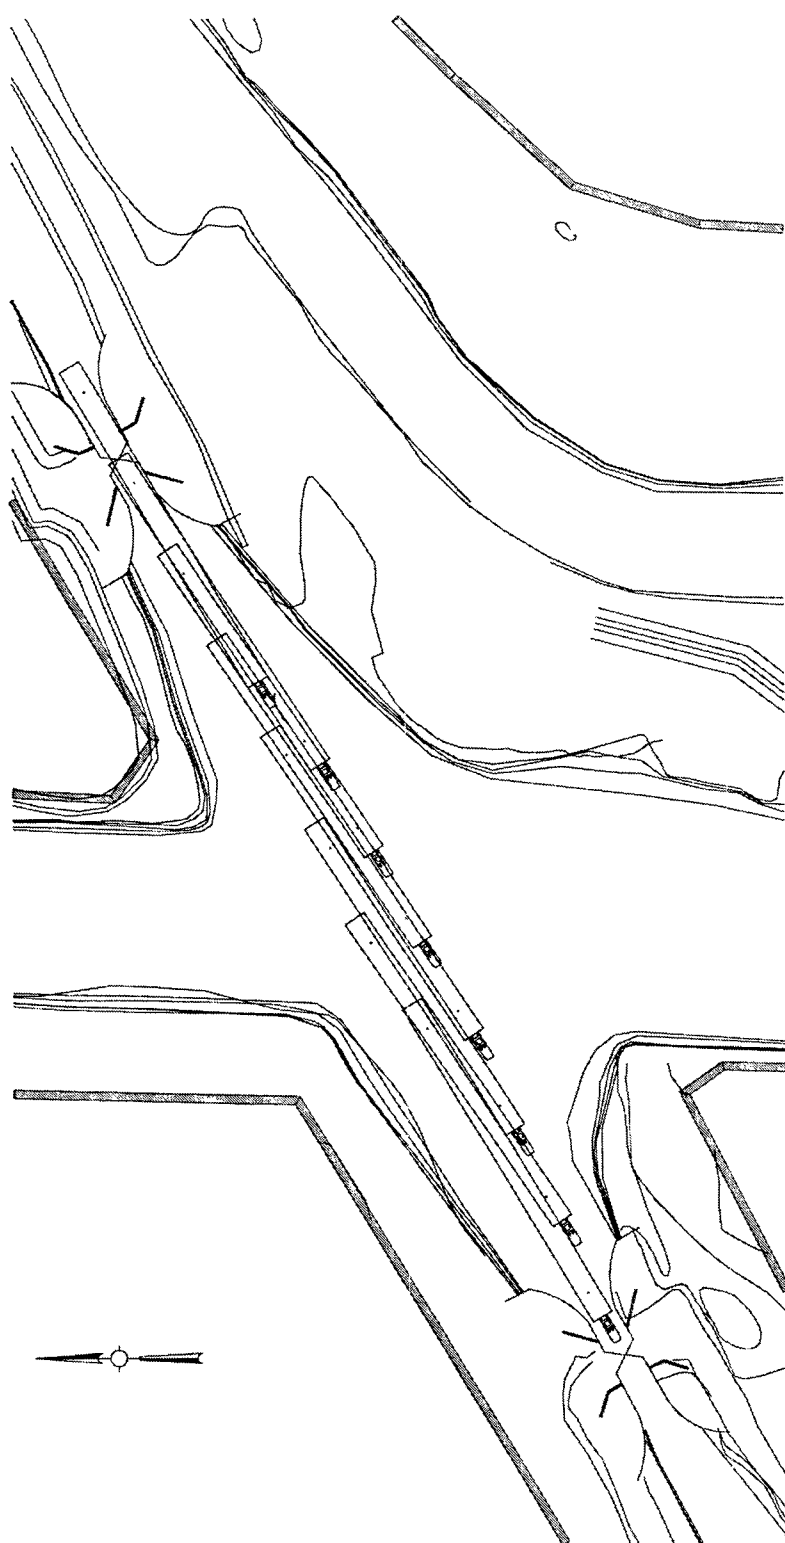
Plate 16.

3-BARGE TOW: 3 LONG X 1 WIDE  
54FT WIDE X 885FT LONG WITH  
70FT PUSHER BOAT

BASE TEST  
DISCHARGE: 6,000 CFS  
STAGE: 2.0 FT

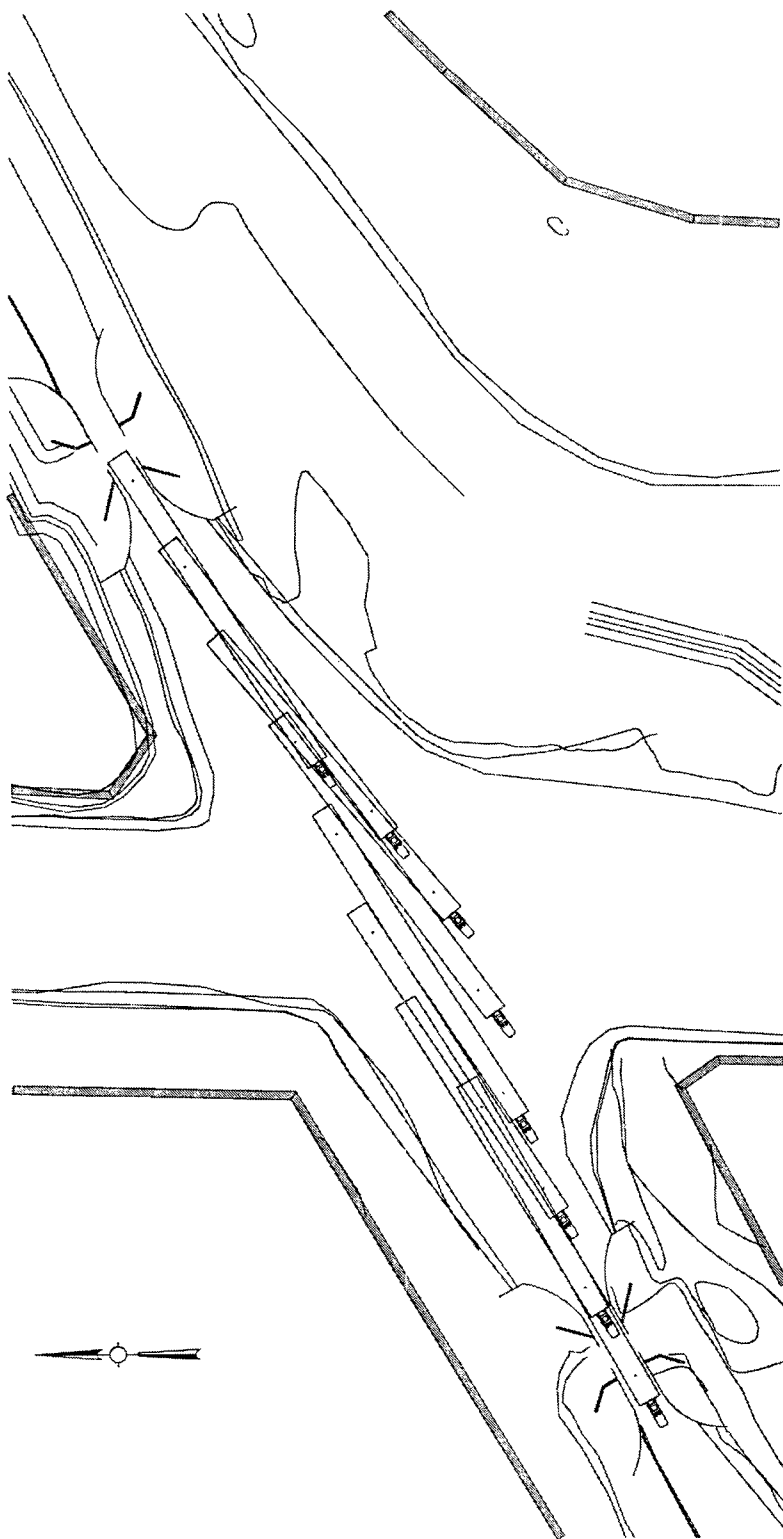
Plate 18

3-BARGE TOW: 3 LONG X 1 WIDE  
54FT WIDE X 885FT LONG WITH  
70FT PUSHER BOAT

BASE TEST  
DISCHARGE: 10,000 CFS  
STAGE: 2.5 FT

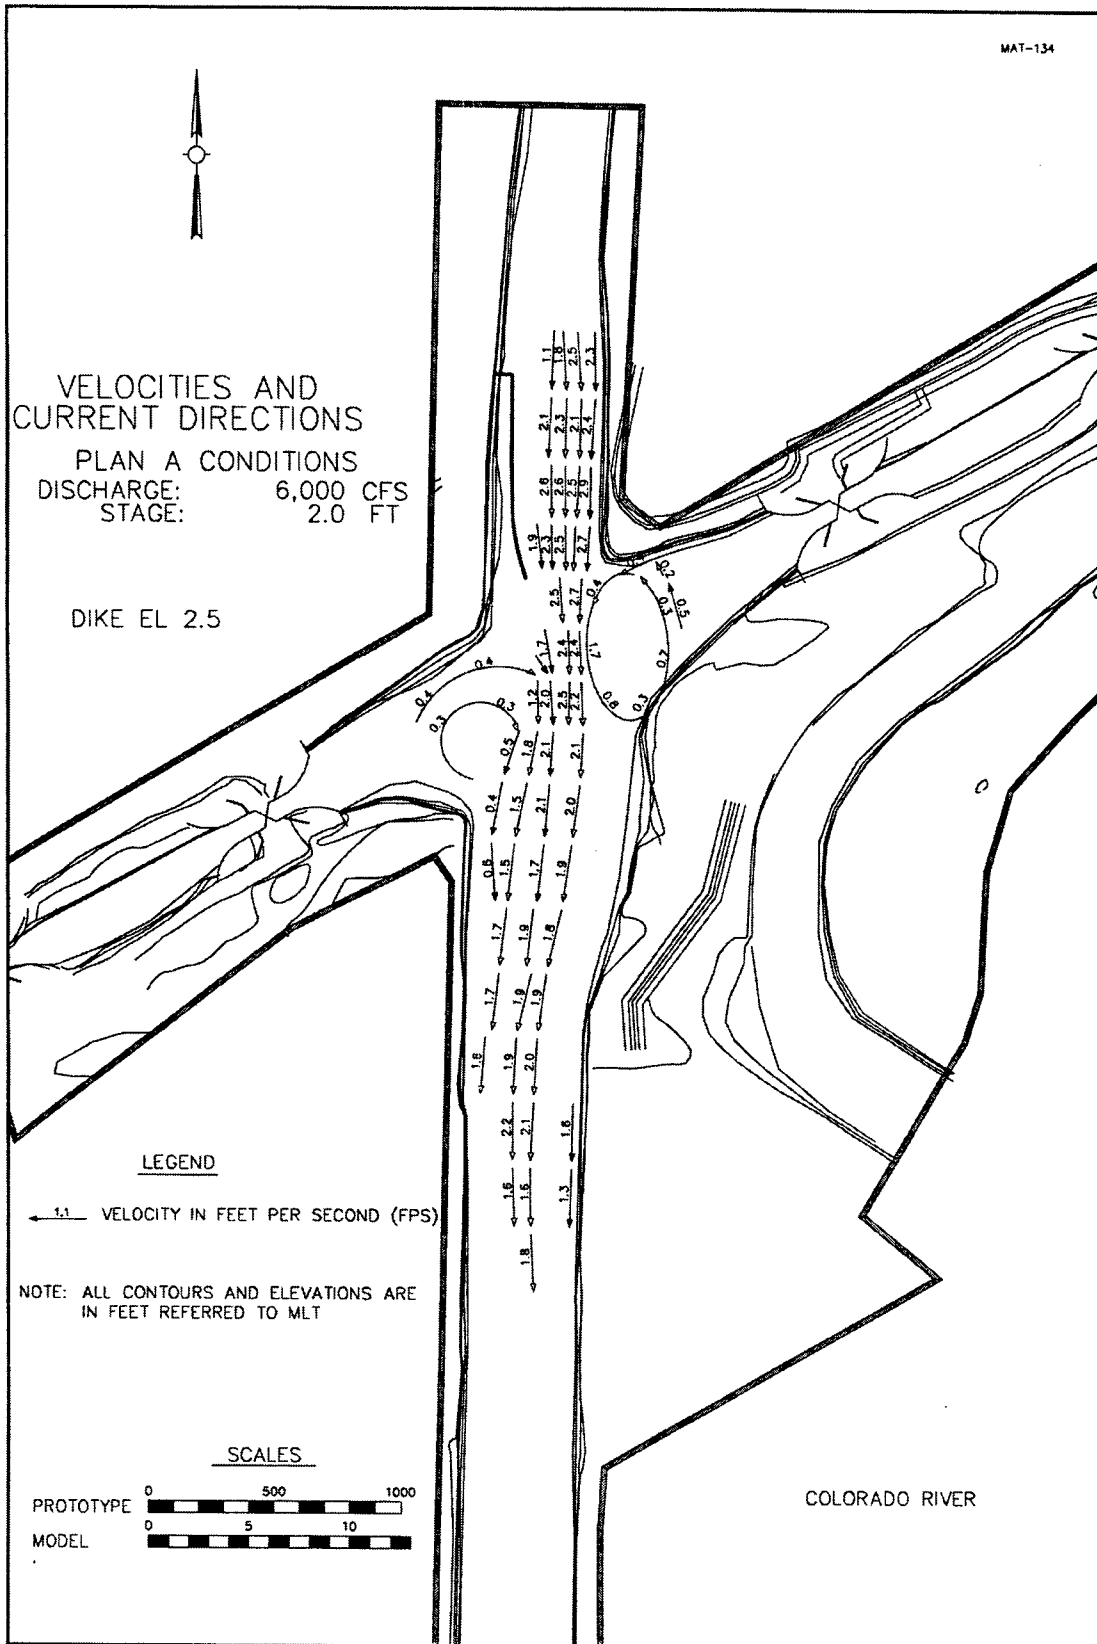
Plate 20

VELOCITIES AND  
CURRENT DIRECTIONS  
PLAN A CONDITIONS

NOTE: ALL CONTOURS AND ELEVATIONS ARE  
IN FEET REFERRED TO MTL

- a. *Plan A. L-head dike.* The training dike as examined for Plan A (Figure 3) appeared to provide moderate improvements to navigation, based on operation of the model tow. This plan was presented to representatives of the towing industry during meetings in September 1998. Based on their observations of transits between the locks with the model tow, they determined that the increase in velocities along the eastern side of the intersection offset any gains in relatively slack water along the western side.

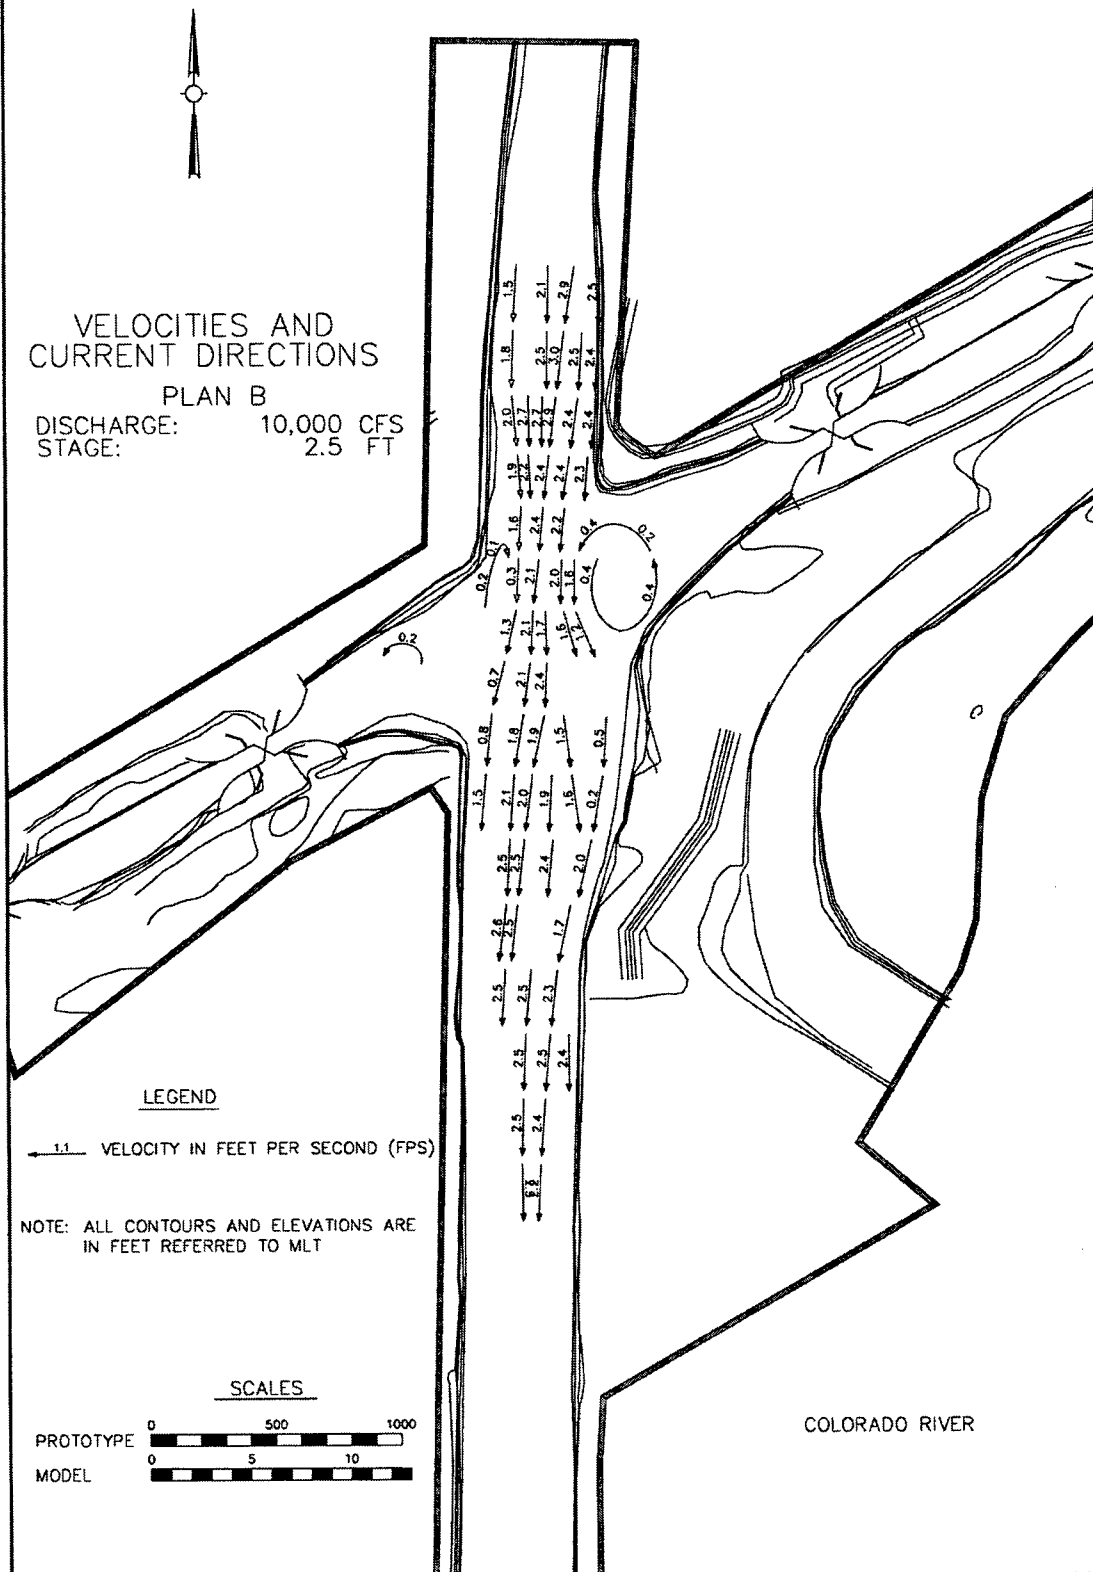
# VELOCITIES AND CURRENT DIRECTIONS

PLAN B

DISCHARGE: 10,000 CFS  
STAGE: 2.5 FT

- b. *Plan B. Dredging intersection.* Dredging of the intersection for Plan B (Figure 4) decreased the effective currents on the crossing tows and provided moderate improvements to navigation. The model examined only the "as dredged" condition. As the intersection shoals, which will likely occur from the heavy sediment load carried by the Colorado River, navigation conditions will return to that of the existing conditions.

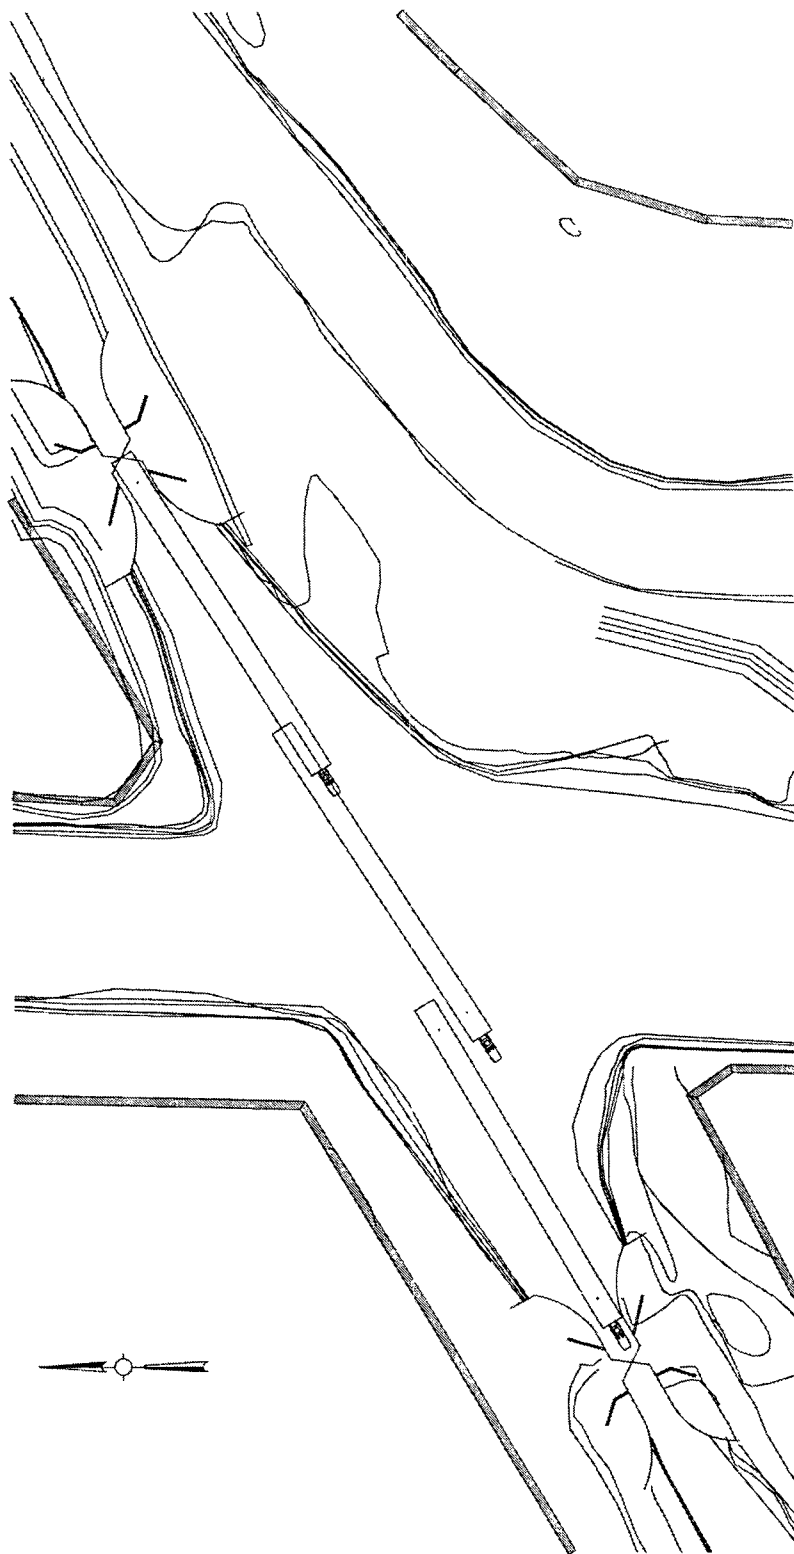
Plate 28

3-BARGE TOW: 3 LONG X 1 WIDE  
54FT WIDE X 885FT LONG WITH  
70FT PUSHER BOAT
