ERDC/CHL TR-00-26

## **Navigation Study, Colorado Locks, Colorado River, Matagorda, Texas**

# **Navigation Study, Colorado Locks, Colorado River, Matagorda, Texas**

Final report

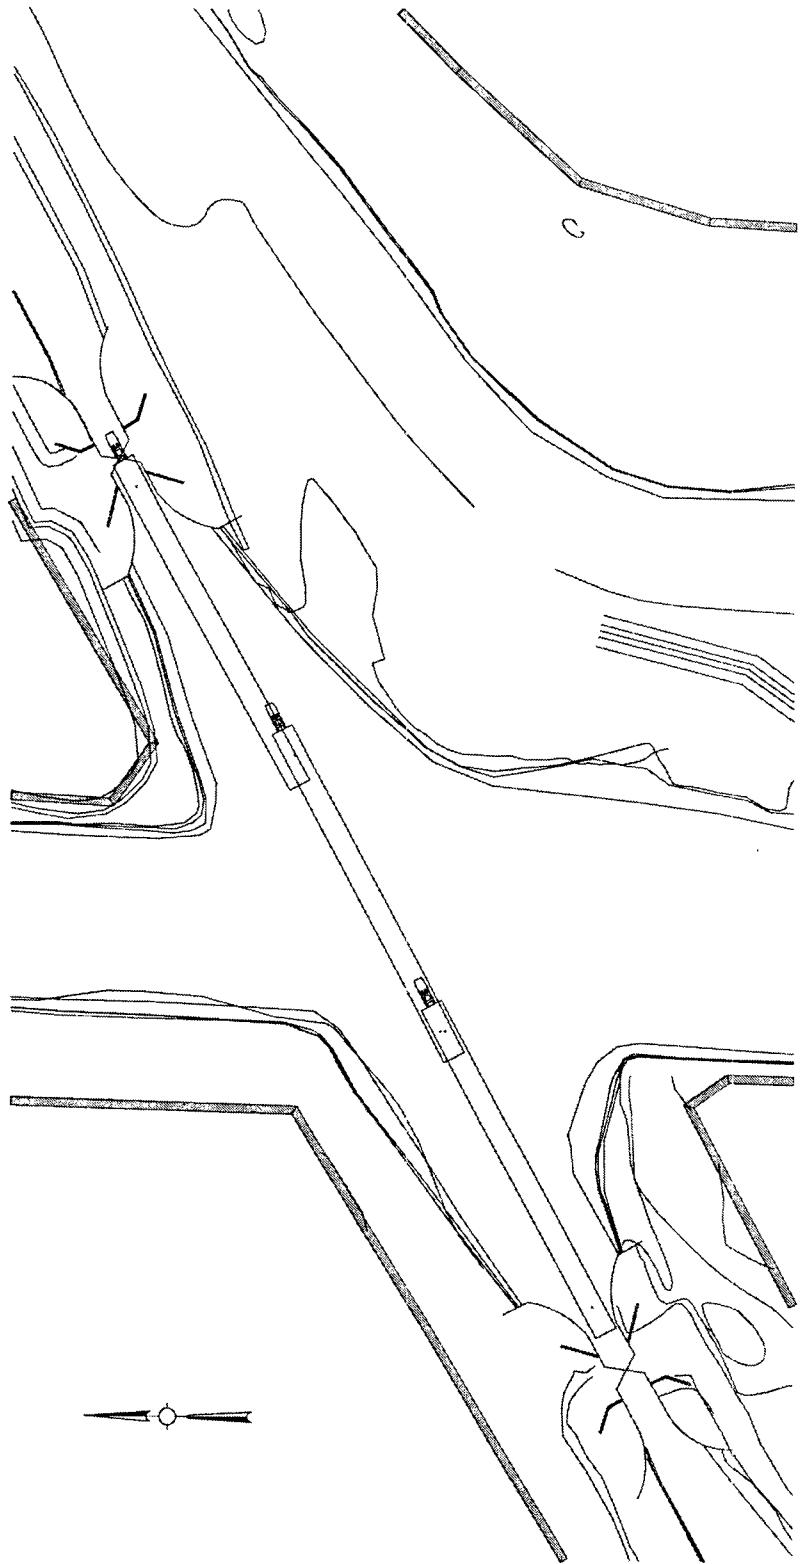
MAT-144

TOW PATHS WESTBOUND  
PLAN B  
DISCHARGE: 10,000 CFS  
STAGE: 2.5 FT

3-BARGE TOW: 3 LONG X 1 WIDE  
54FT WIDE X 885FT LONG  
70FT PUSHER BOAT

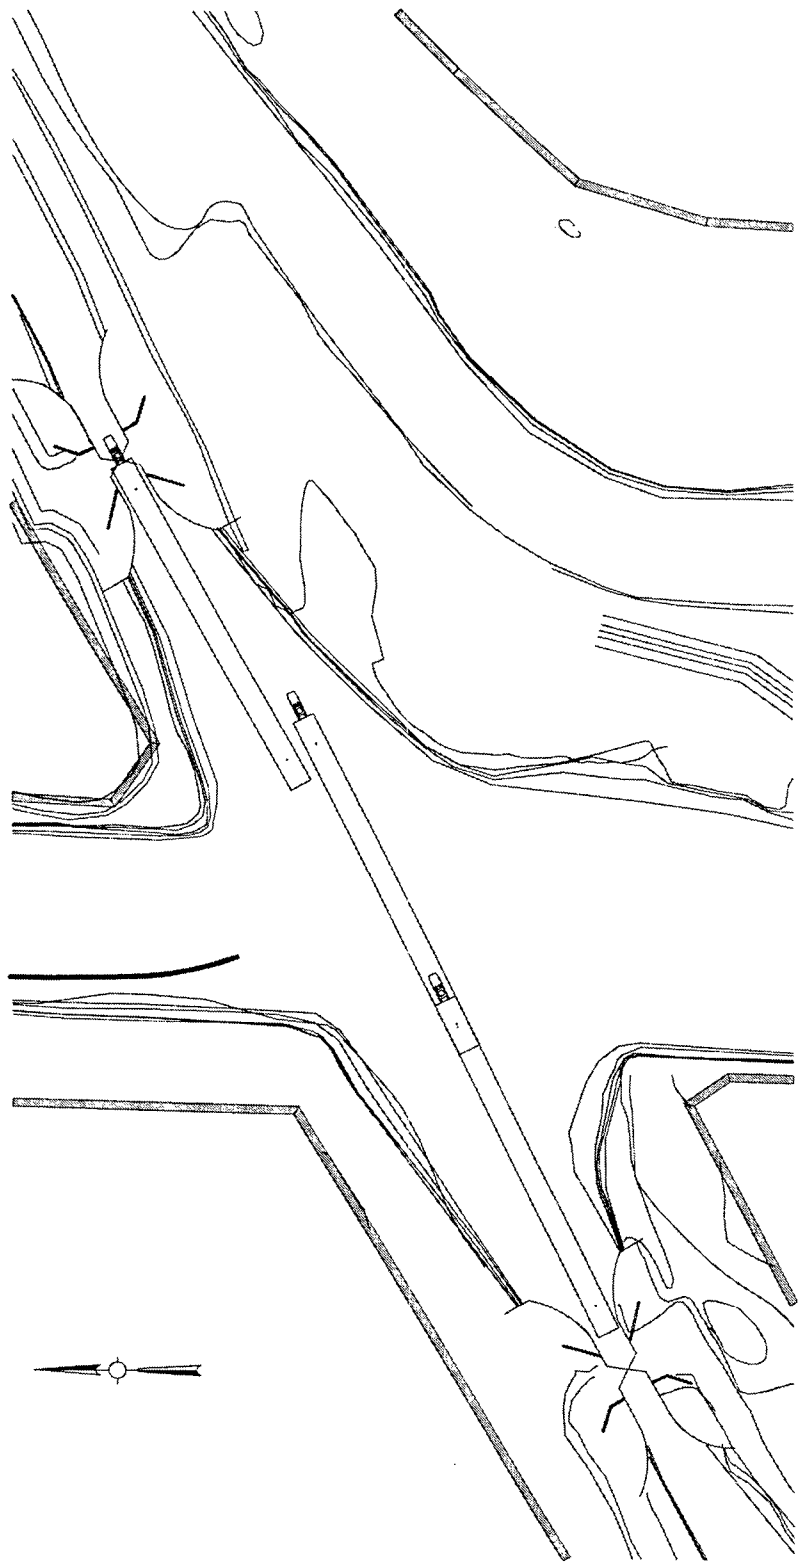
MAT-143

3-BARGE TOW: 3 LONG X 1 WIDE  
54FT WIDE X 885FT LONG  
70FT PUSHER BOAT

TOW PATHS WESTBOUND  
PLAN B-1  
DISCHARGE: 10,000 CFS  
STAGE: 2.5 FT

- c. *Plan B-1. Dredging and L-head dike.* The addition of the dike used for Plan A with the dredging used for Plan B, as done for Plan B-1 (Figure 15), provided navigation conditions slightly better than the existing conditions but not as good as with just the dredging alone. As mentioned previously, the model could not be used to determine how effective the dike would be at reducing shoaling in the intersection, but could be used to determine how such a structure would impact navigation. Also, the model did not reflect any channel bed changes that might have occurred from either shoaling or scouring as the result of the dike and the subsequent current pattern changes that they would cause.

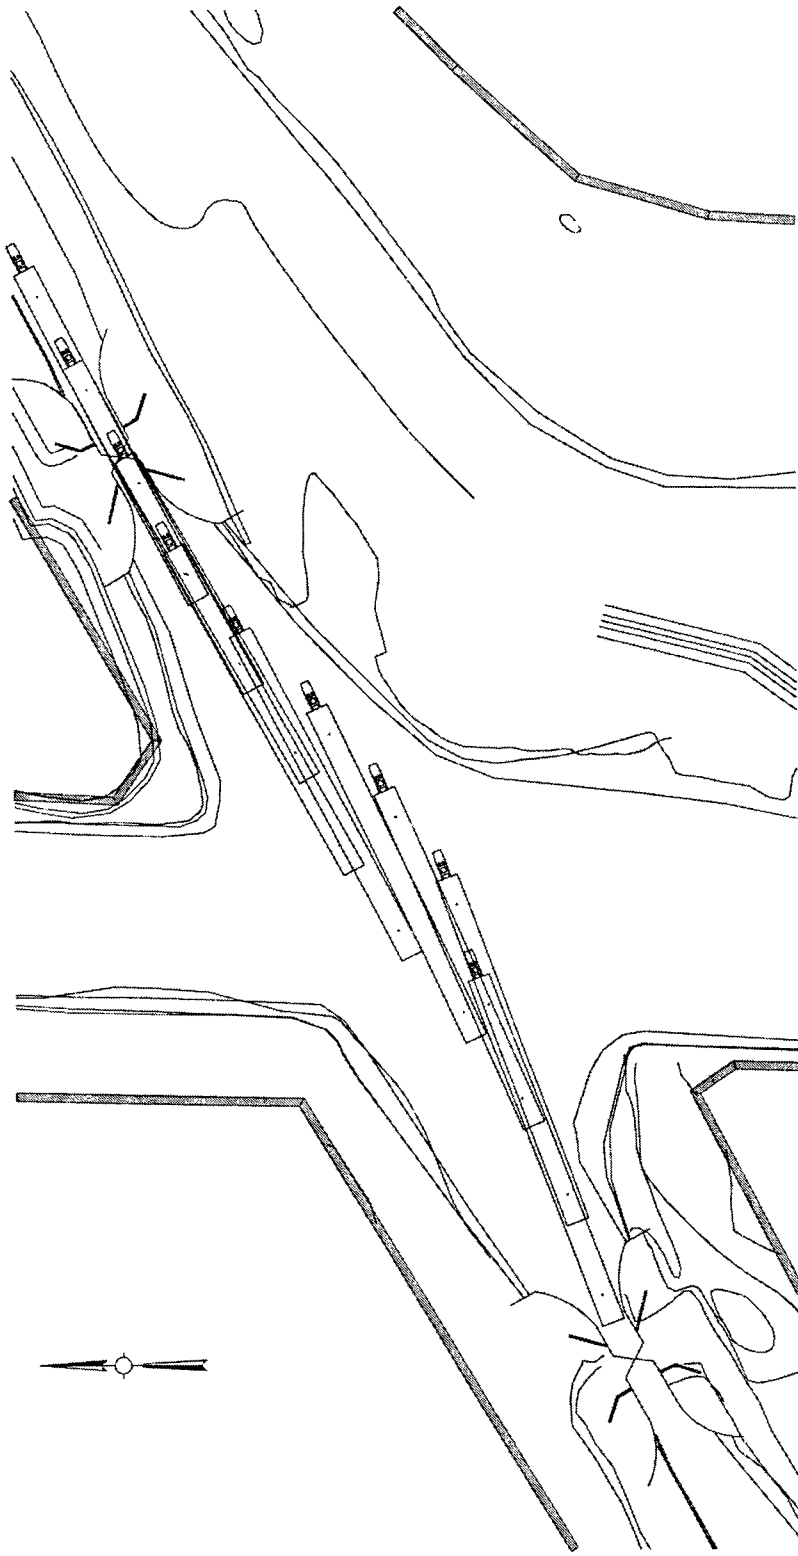
MAT-155

3-BARGE TOW: 3 LONG X 1 WIDE  
54FT WIDE X 885FT LONG WITH  
70FT PUSHER BOAT

TOW PATHS WESTBOUND  
2 FPS THRU WEST LOCK  
DISCHARGE: 10,000 CFS  
STAGE: 2.5 FT

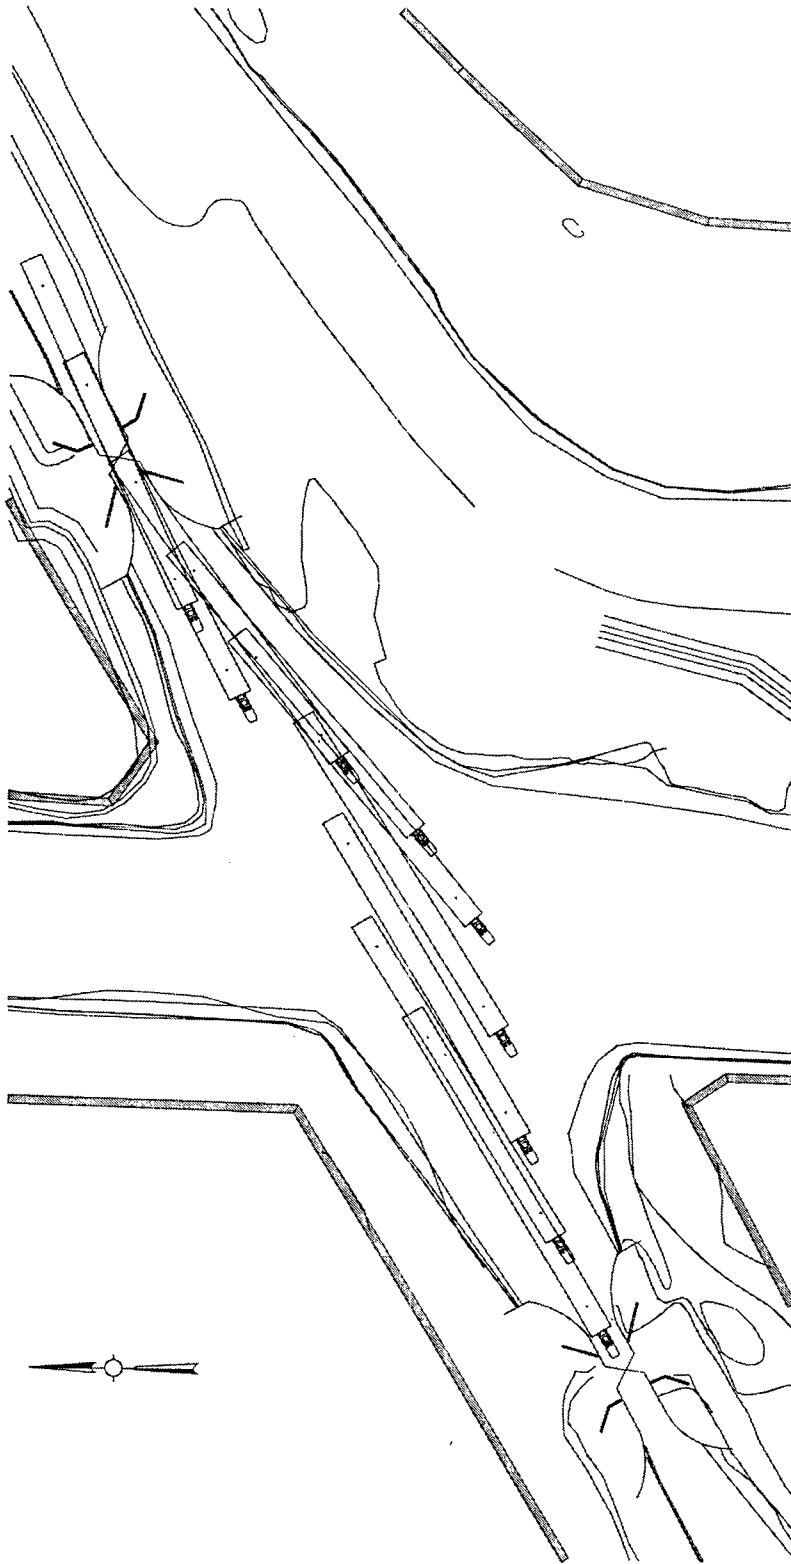
MAT-167

3-BARGE TOW: 3 LONG X 1 WIDE  
54FT WIDE X 885FT LONG WITH  
70FT PUSHER BOAT

TOW PATHS EASTBOUND  
2 FPS THRU WEST LOCK  
DISCHARGE: 10,000 CFS  
STAGE: 2.5 FT

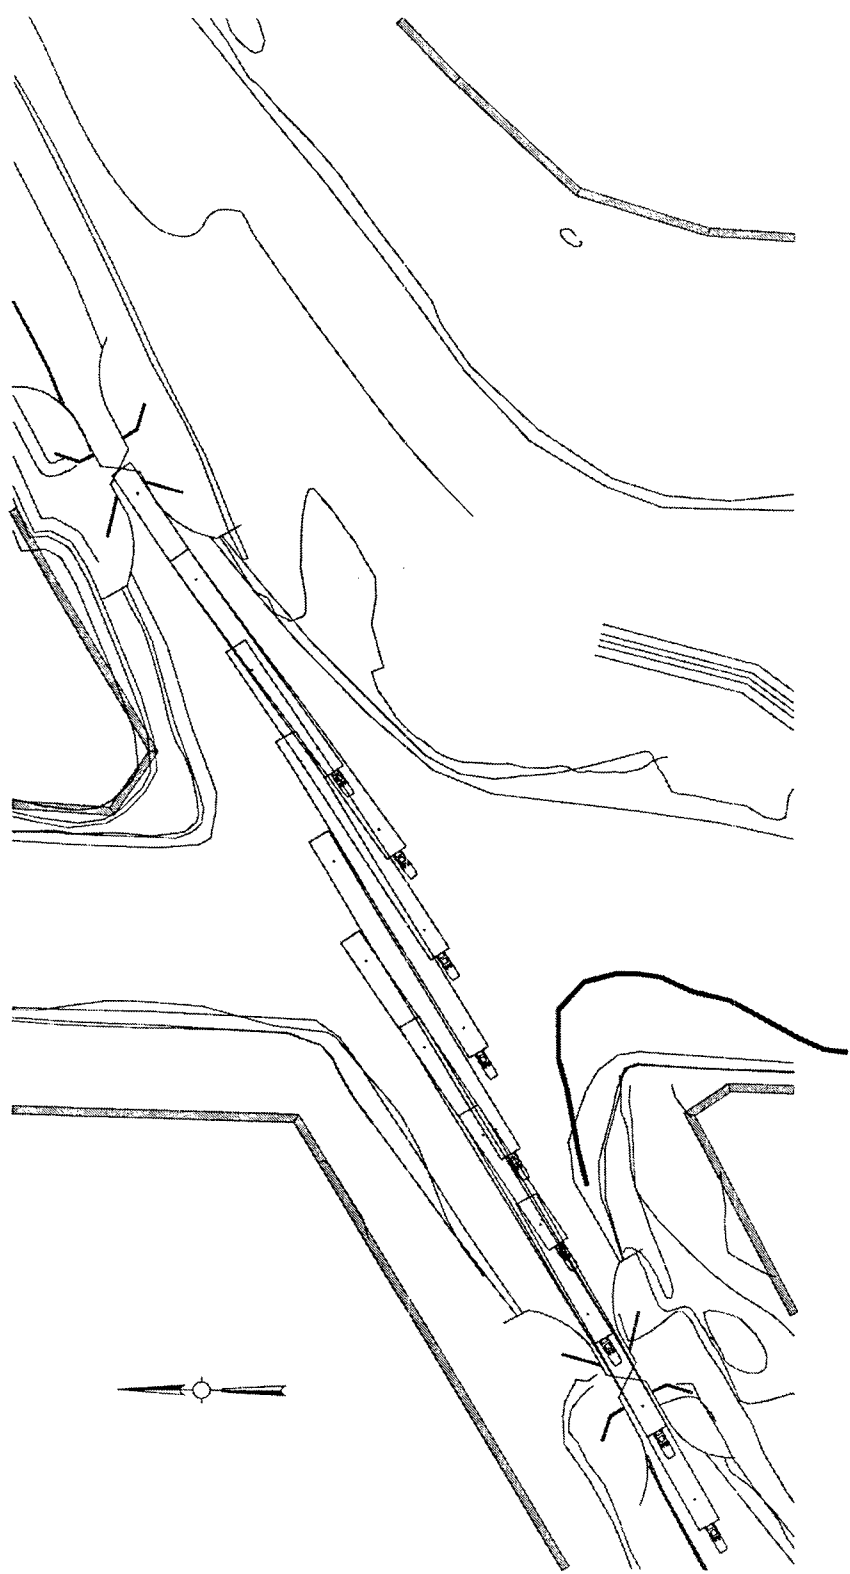
MAT-177

TOW PATHS EASTBOUND  
PLAN C  
DISCHARGE: 10,000 CFS  
STAGE: 2.5 FT

3-BARGE TOW: 3' LONG X 1' WIDE  
54FT WIDE X 885FT LONG WITH  
70FT PUSHER BOAT

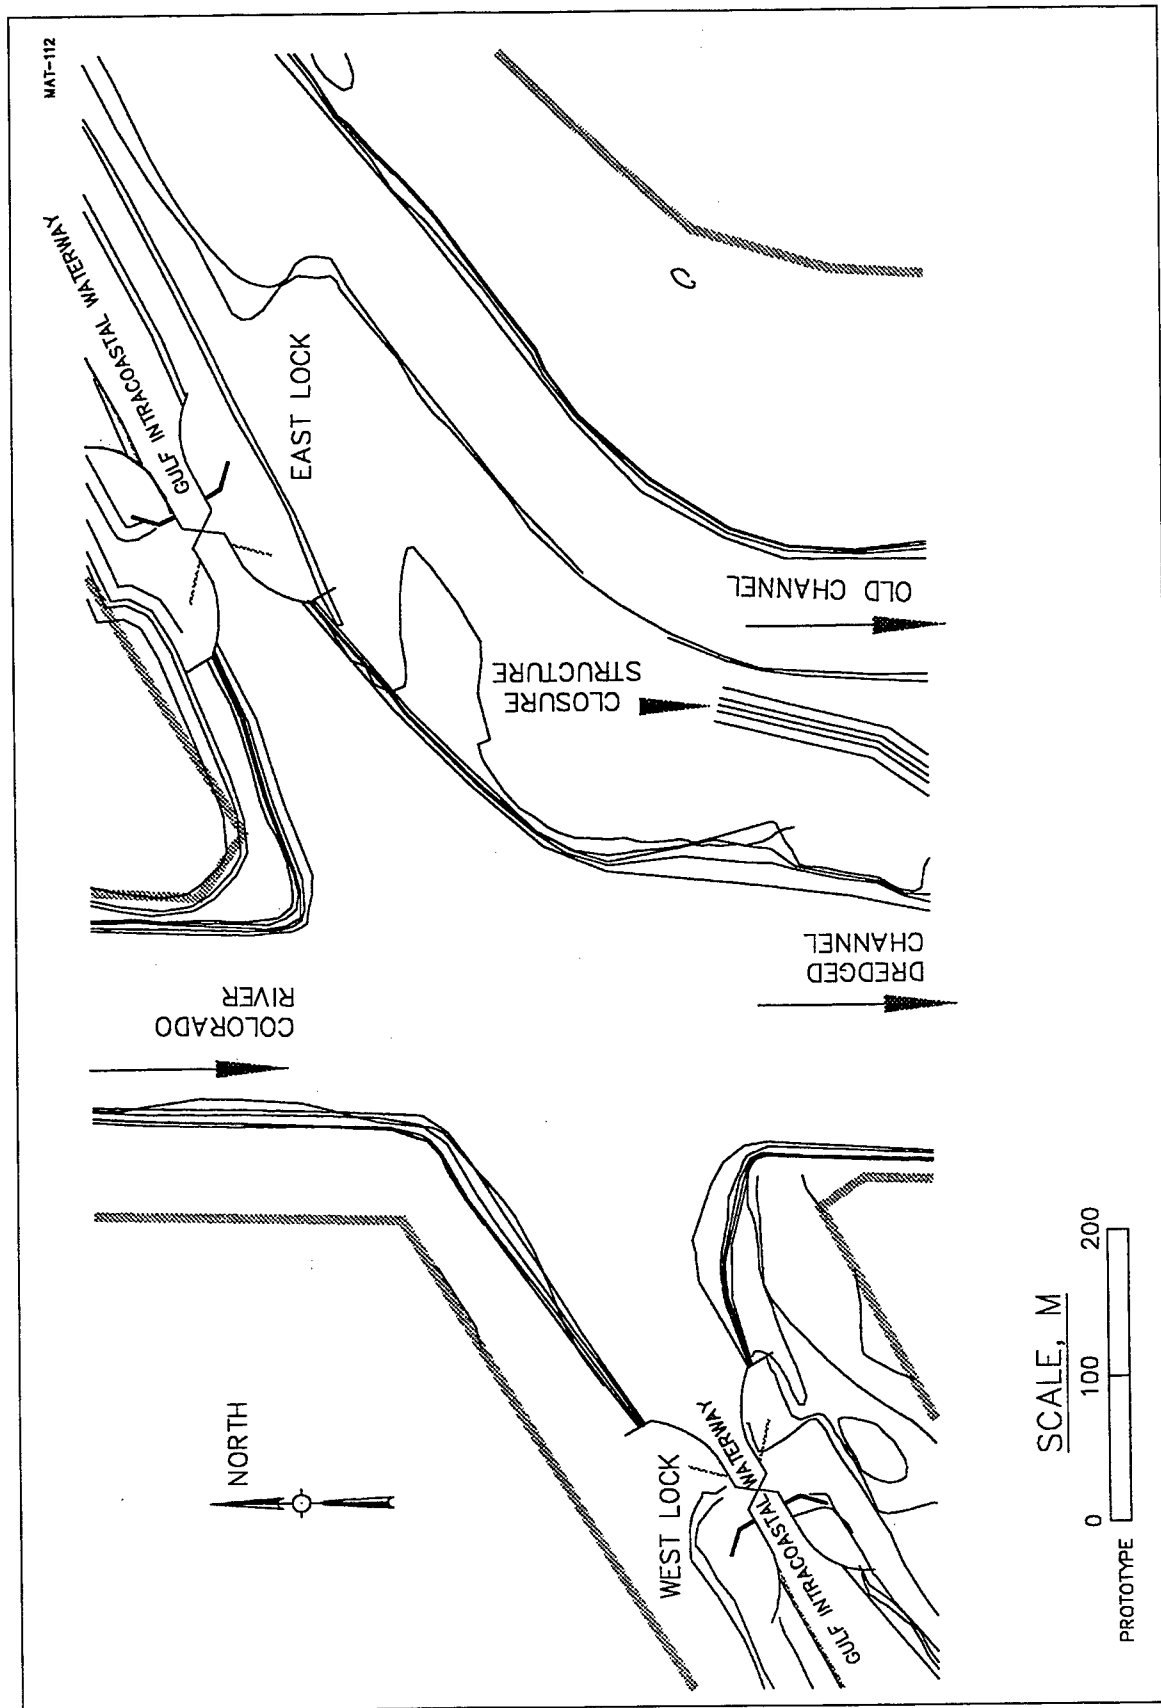
Figure A1. Existing conditions

After diversion of the CR, pilots report increased difficulty crossing the CR. Some pilots attribute some or all of this difficulty to erosion of the SW corner and most agree that the SW corner is less suitable as a landing point. The U.S. Army Engineer District, Galveston, asked the U.S. Army Engineer Research and Development Center to make recommendations to achieve the previously stated objective.

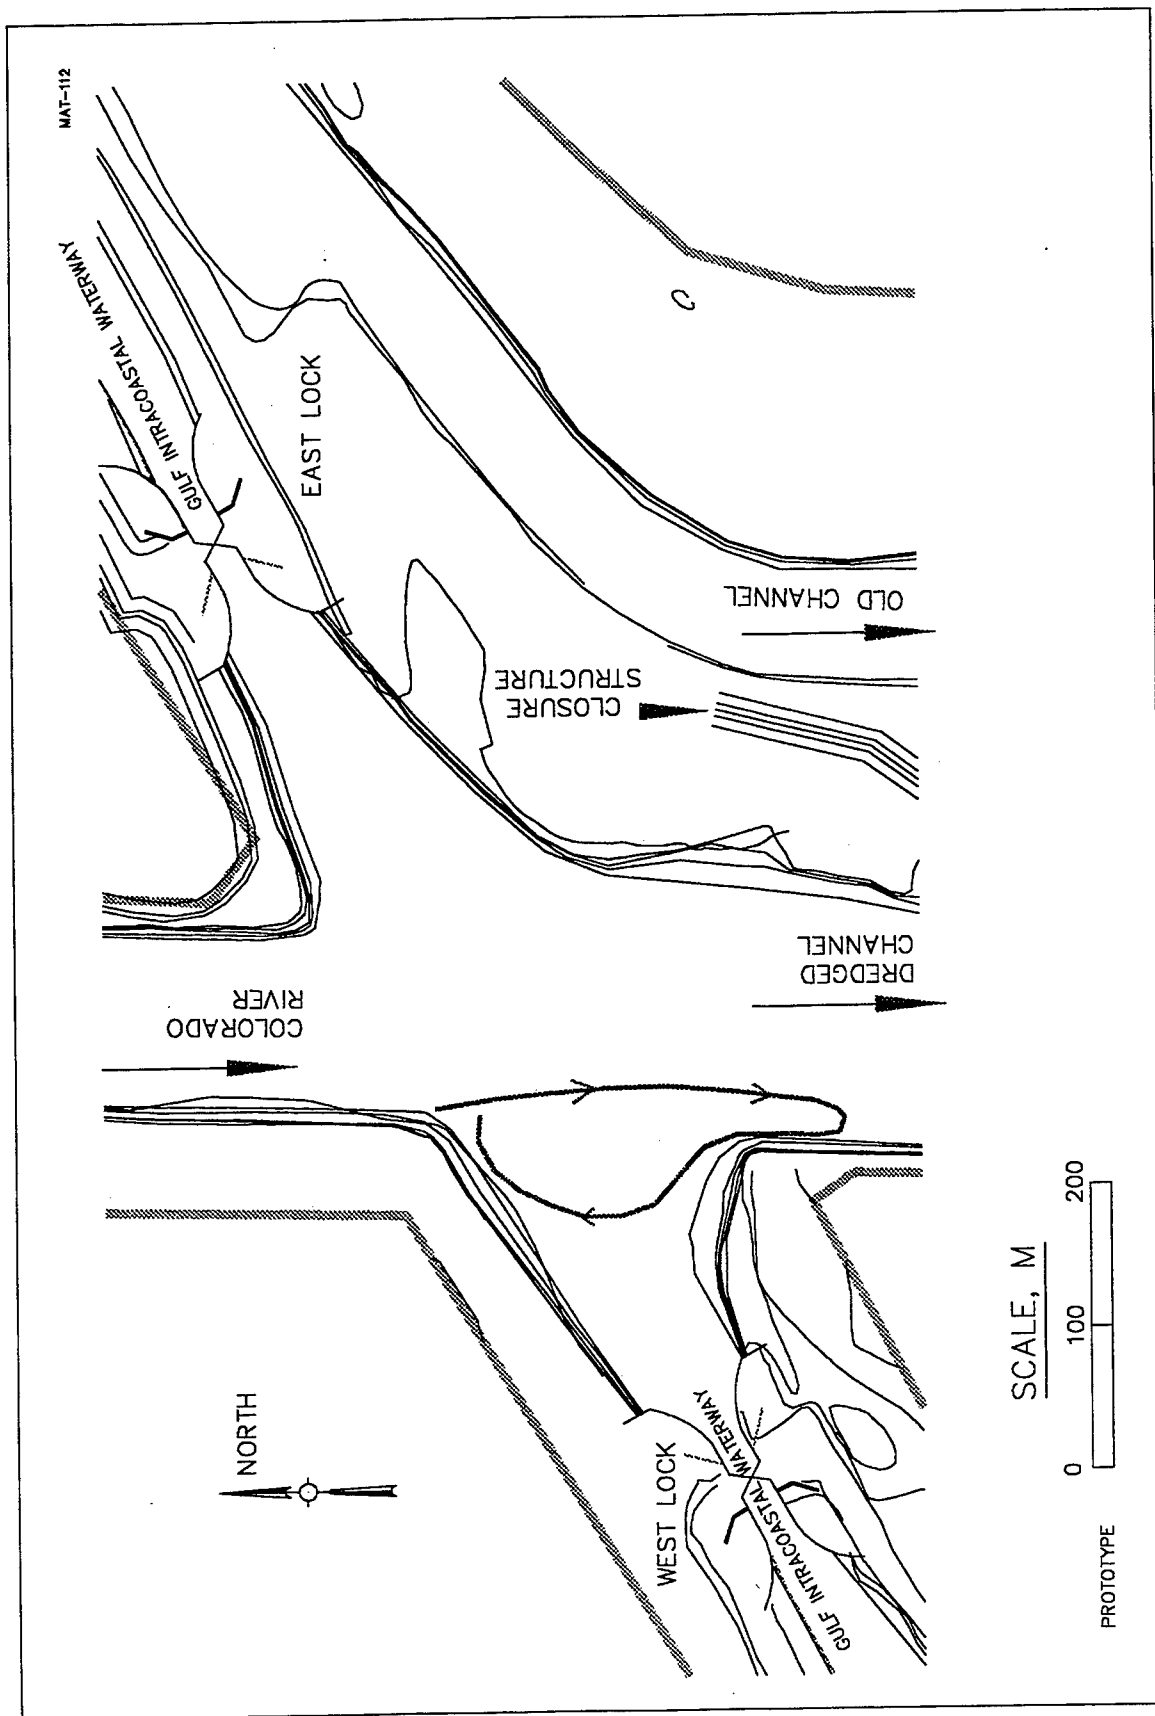
Figure A2. Eddy in West Lock approach

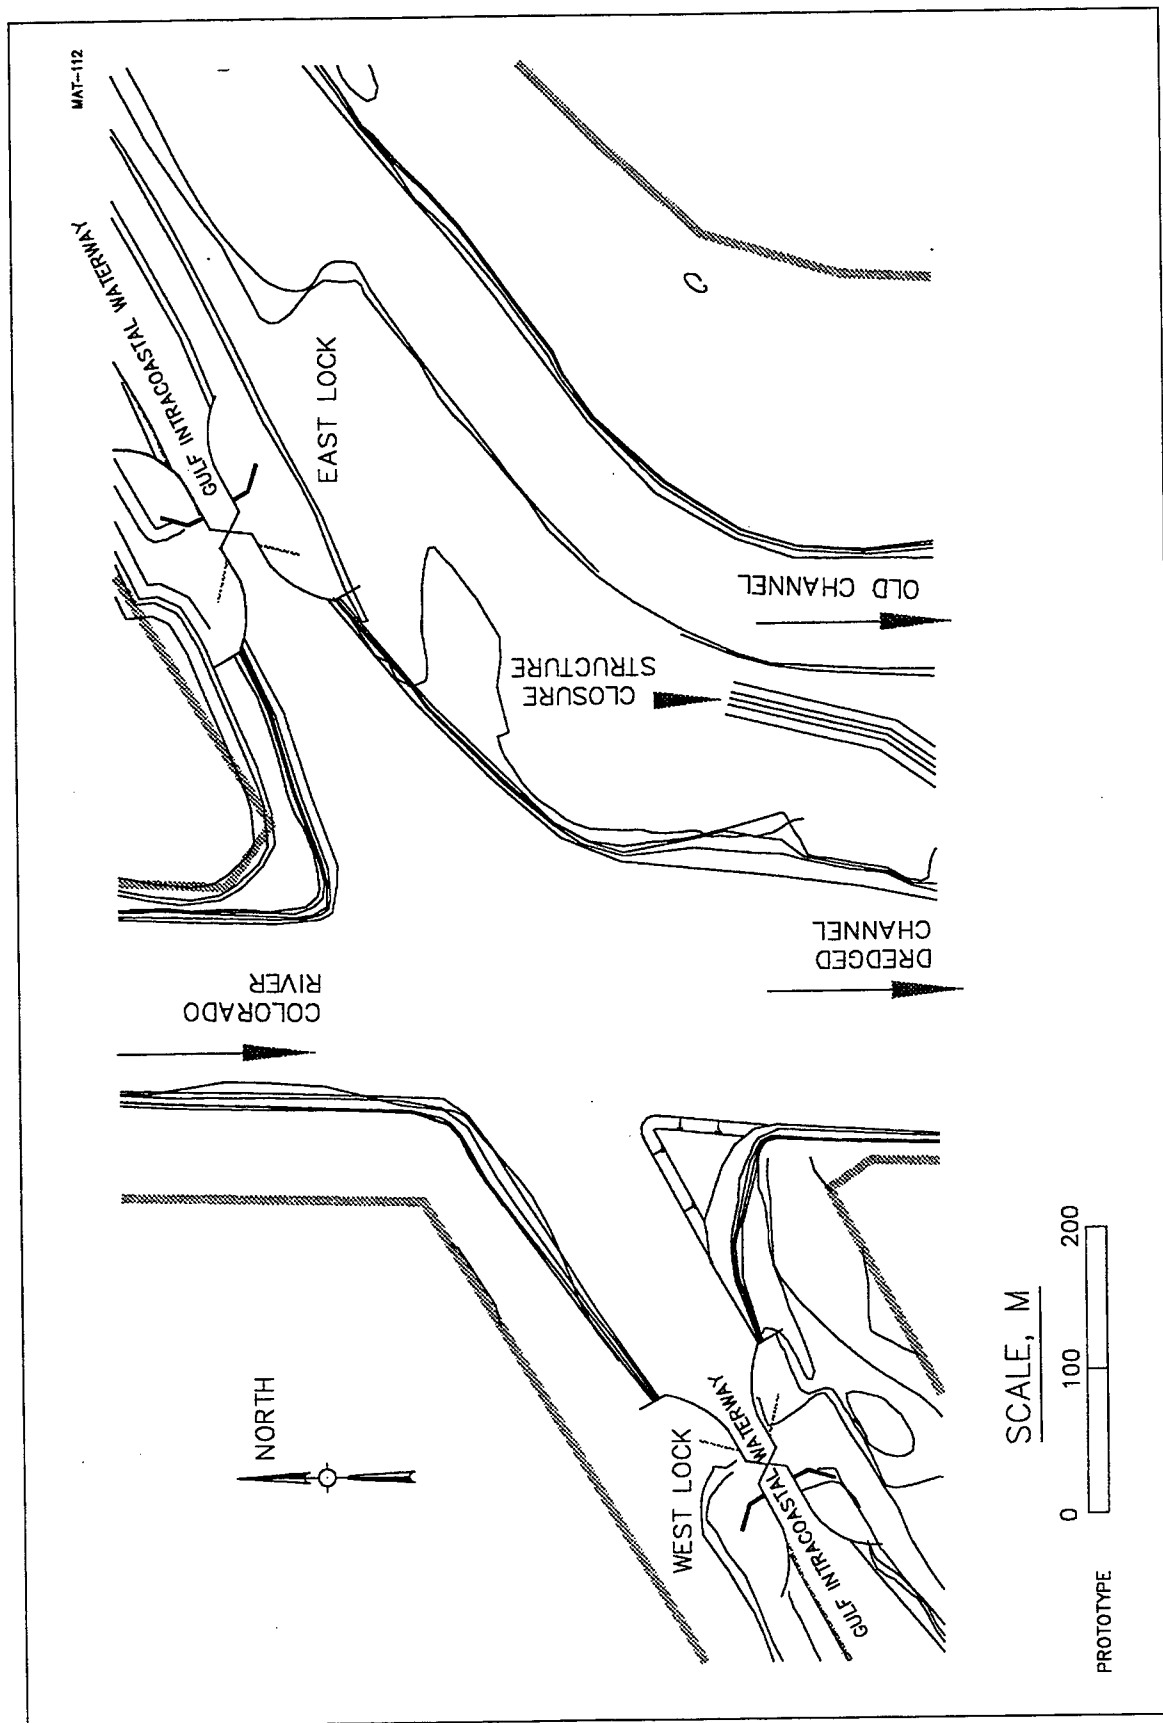
Figure A3. Rebuild point with dredged material

Of the alternatives presented, the option of placing dredged material on the SW corner should be considered before any structural alternatives such as sandbag dikes or fenders. The life of the sandbag dikes and the uncertainty of the fenders being able to withstand extreme tow impact events are the basis for recommending the nonstructural alternative. In addition, any fender scheme will have the tow pinned against the fender by the flow which presents concerns about capsizing to the pilots. Placement of the dredged material rebuilds the corner to about its original shape and may result in improved navigation conditions. If the dredged material is rapidly removed by flow forces or if environmental restrictions prevent its use, the sandbag dike should be considered along with a maintenance plan to periodically add bags to the nose of the structure. If a fender design is considered, it is recommended that the Corps' Marine Design Center in Philadelphia and/or a marine fender consultant be retained and data from the physical navigation model be used to design the structure.

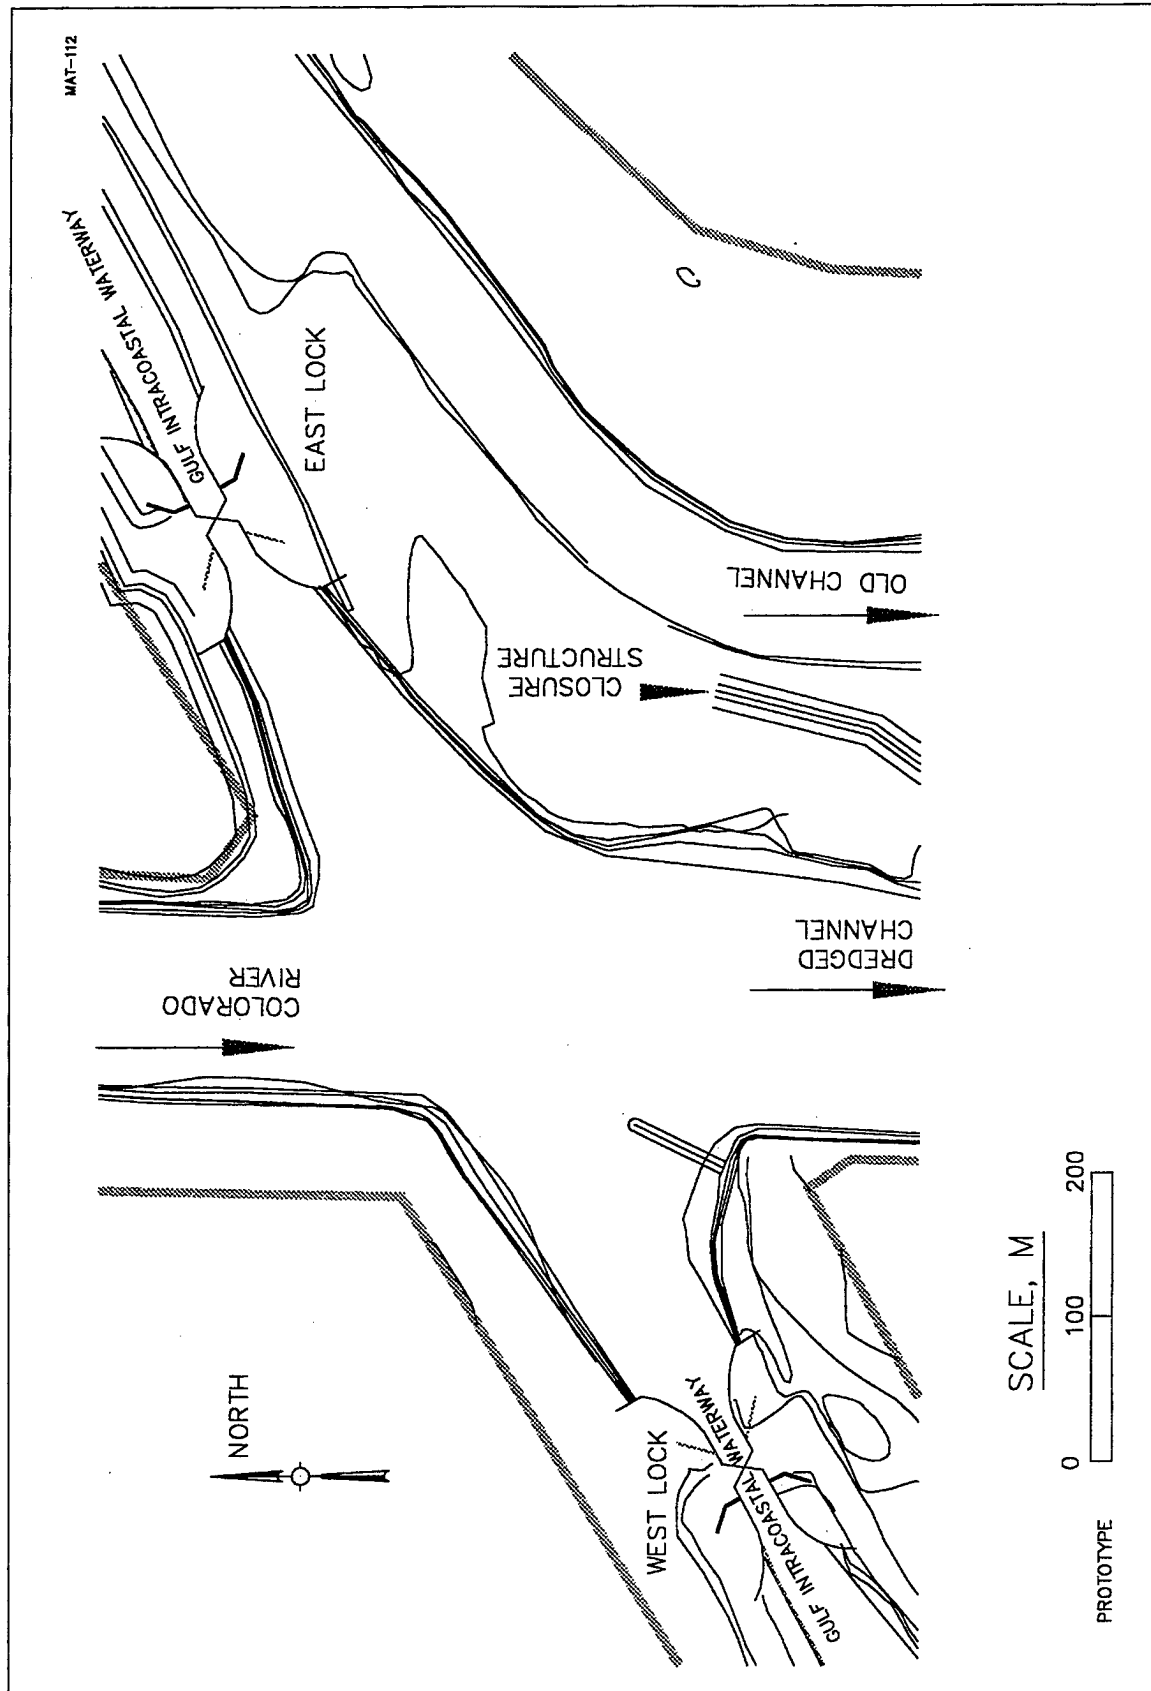
Figure A4. Sandbag dike

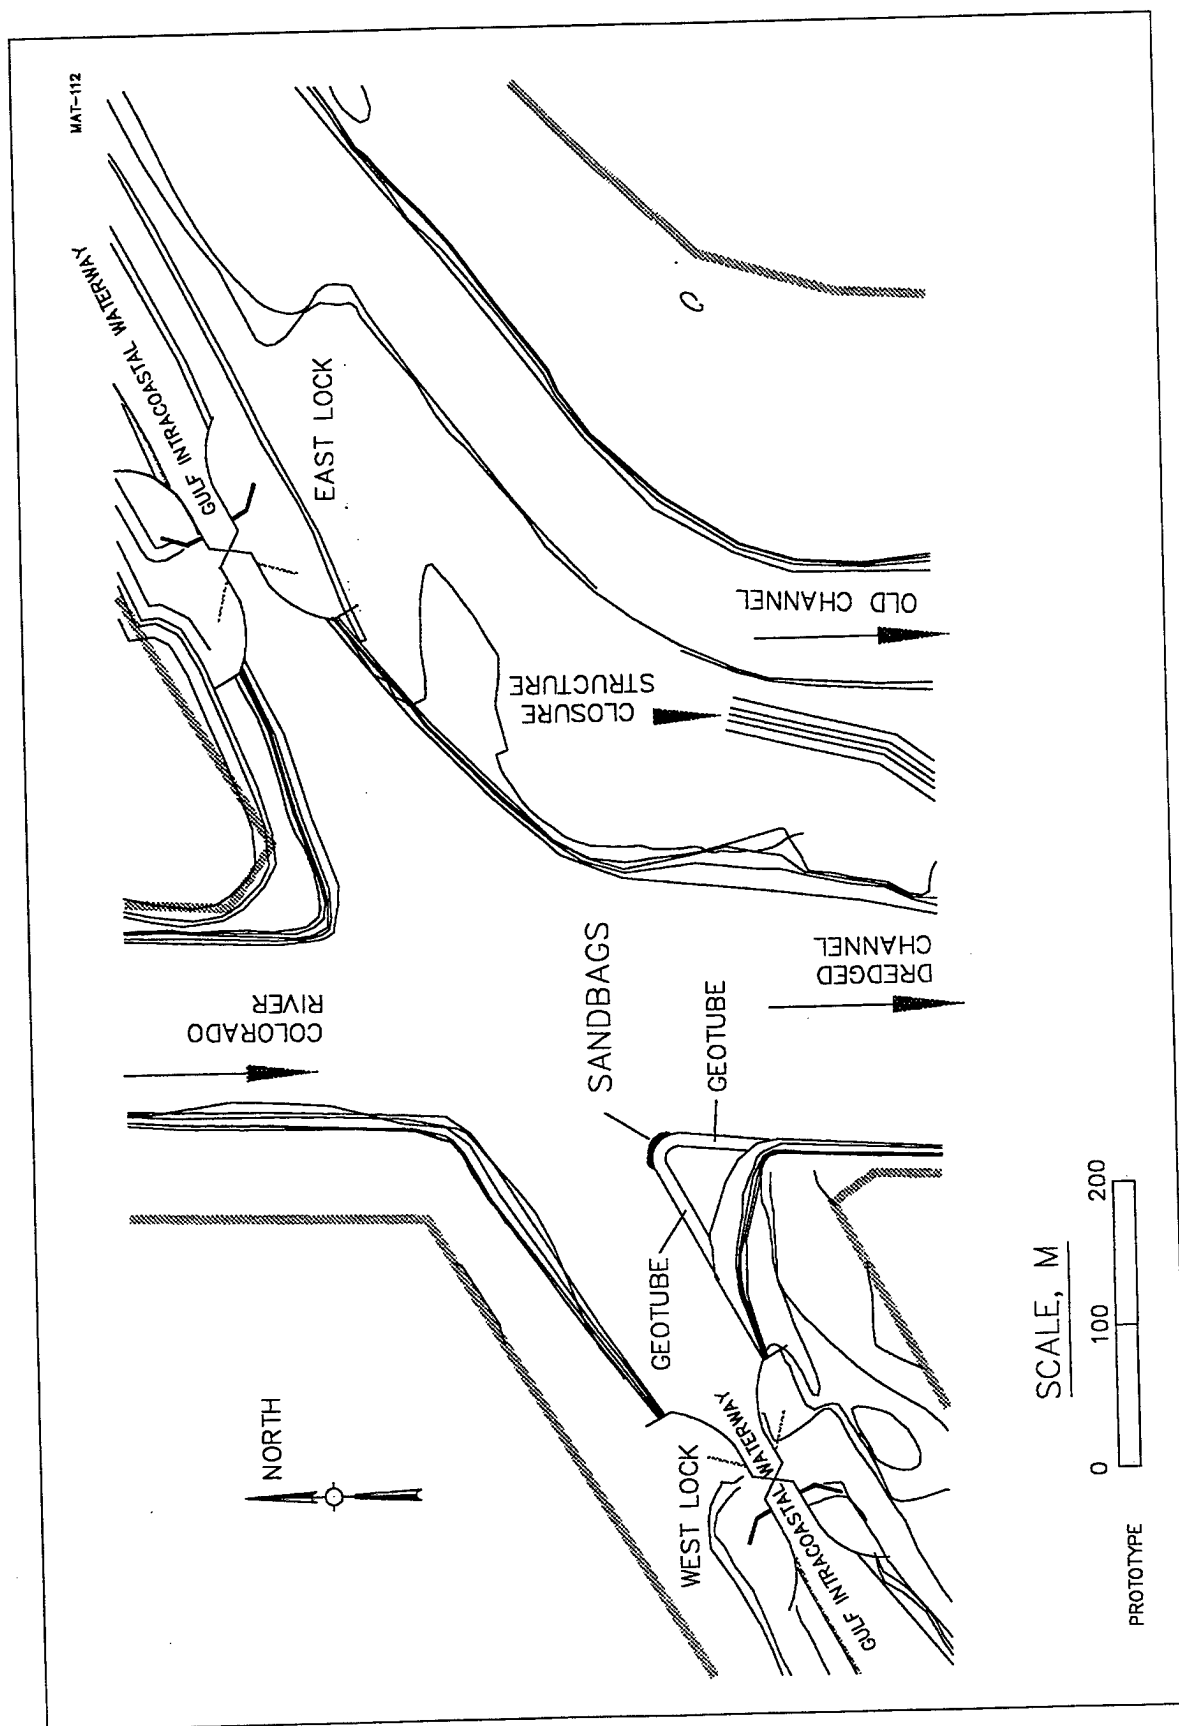
Figure A5. Geotube with sandbags
