**FATIGUE RESPONSE OF THIN STIFFENED  
ALUMINUM CRACKED PANELS REPAIRED  
WITH BONDED COMPOSITE PATCHES**

THESIS

Jason B. Avram, Captain, USAF

**AIR FORCE INSTITUTE OF TECHNOLOGY**

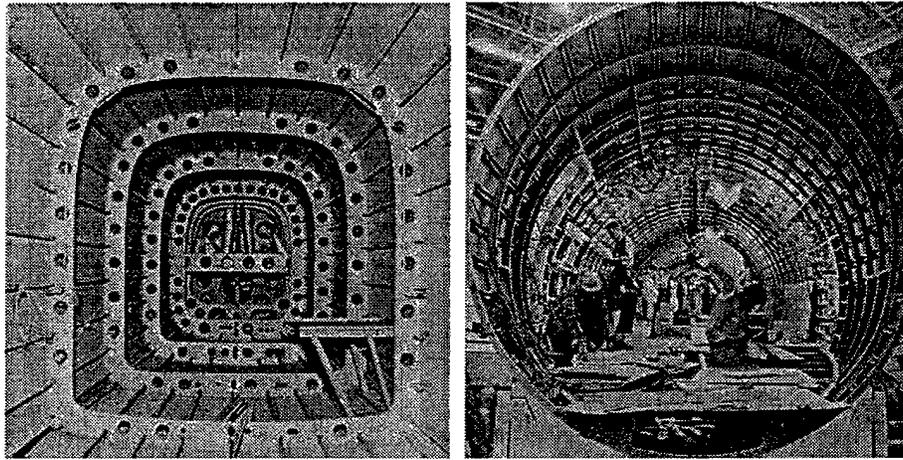
*Figure 1 Stiffened Aircraft Structure*

All of the research done prior was on unstiffened aluminum panels with varying thicknesses. Actual aircraft are not simply aluminum panels, they are stiffened structures. As seen in Figure 1 (12:A20.2), aircraft consist of skin, stringers, webs, and spars. All of this underlying structure stiffens the aluminum panel that makes up the skin and significantly impacts the fatigue characteristics of the aircraft. Performing fatigue

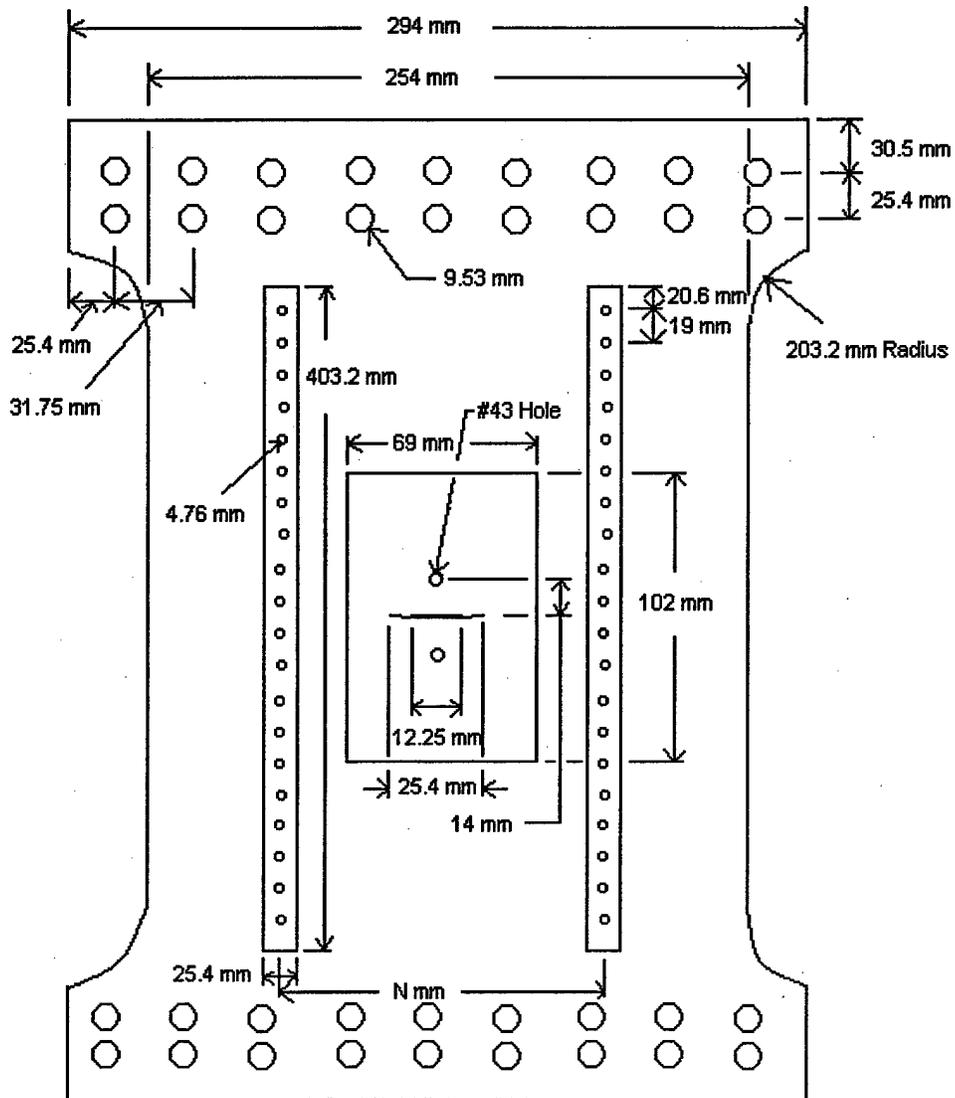
aluminum panel, are shown in Figure 3. The aluminum panels were AL2024-T3 with dimensions of 558.8x254x1.016mm (width given is at crack location). Stiffeners were AL2024-T3 with nominal dimension of 403.225x25.4x1.6mm. The patch used was a 3 ply boron/epoxy laminate with dimensions of 102x69x0.381mm.

**Figure 3 Panel Configuration**  
**( $N = 102$  mm and  $152$  mm)**  
**Aluminum Panel Thickness = 1 mm**  
**Stiffener Thickness = 1.6 mm (stiffeners on both sides of panel)**

Disbond and stiffener configurations are as defined in Figure 2 and Figure 3, respectively, in Chapter 1. Table 12 details the exact testing configuration of each specimen, along with cycles to failure.

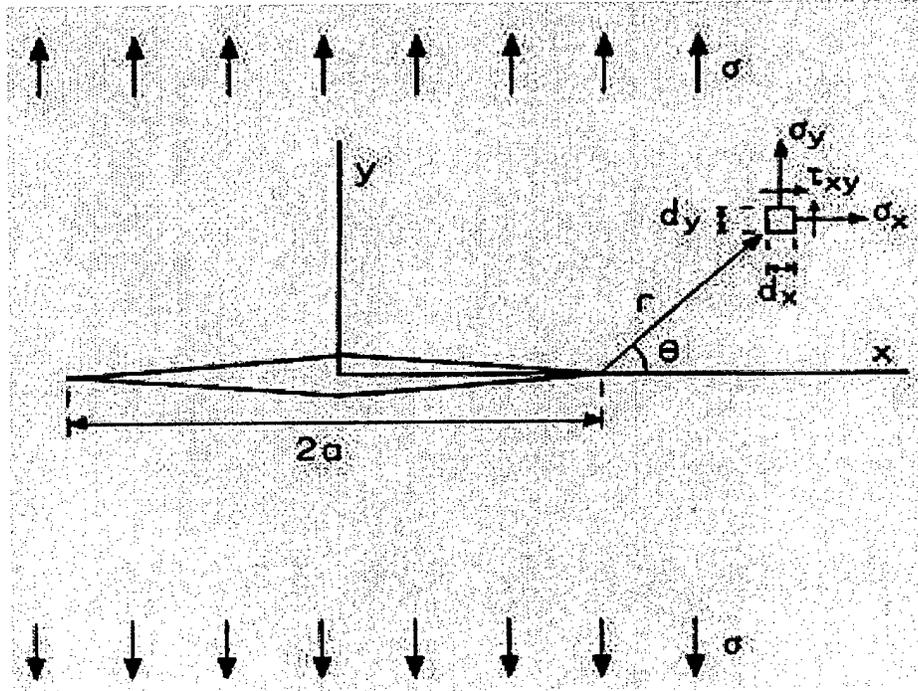
**Figure 4 Crack in an Infinite Plate**

Consider a crack in an infinite plate, Figure 4 (13; 3). The stress intensity factor for an opening mode,  $K_I$ , must first be defined, since it is the driving force for crack growth. The stress intensity factor is the linear elastic fracture mechanics parameter relating remote load, crack size, and structural geometry and may be expressed in the following form (13):

For the crack geometry shown in Figure 4 (center crack in an infinite plate),  $K$  is given by

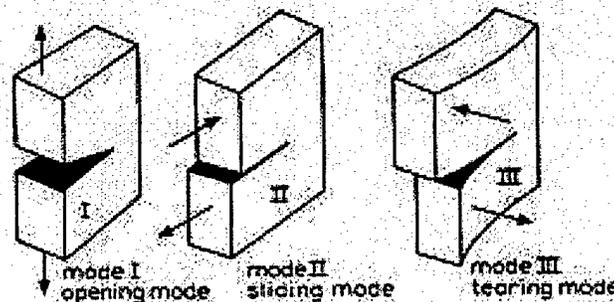
**Figure 5 Crack Loading Modes**

There are three different loading modes that can be applied to cracks. Each one affects the crack in different ways, and therefore creates a different K solution, either  $K_I$ ,  $K_{II}$ , or  $K_{III}$ . Normal stresses create mode I crack opening, which is known as the “opening mode.” “The displacements of the crack surfaces are perpendicular to the plane of the crack (14:8).” Mode II is referred to as the “sliding mode” and is caused by in-plane shear stresses. Crack tip displacements are in the plane of the crack and perpendicular to the crack leading edge. The “tearing mode,” or mode III occurs as a result of out of plane shear. Crack surface displacements are in the plane and parallel to the crack leading edge. Figure 5 (13) illustrates the three different modes of crack loading. Almost all cracks in aircraft skin are the result of mode I loading.

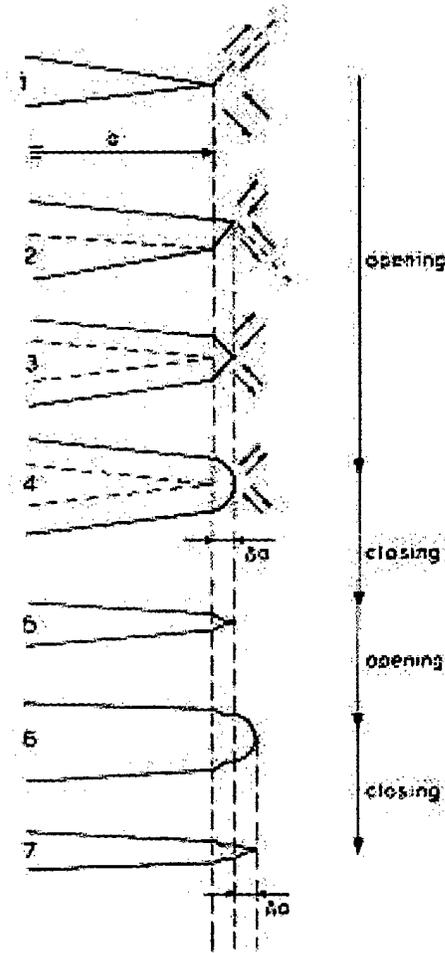
**Figure 6 Fatigue Crack Growth Model**

This relationship shows that the larger the stress intensity factor, the higher the crack growth rate. Therefore reducing the stress intensity factor is the key to accomplishing a successful aircraft repair. Fatiguing of aircraft components, however, directly opposes this task. The longer cracks grow and the smaller the crack tip radius becomes (the crack tip radius is defined as the radius of the circle drawn inside the tip of the crack—the smaller the radius, the sharper the crack tip), the larger the stress intensity factor becomes, which is precisely what the fatigue cracking process produces. This process is shown below in Figure 6. "A sharp crack in a tension field causes a large stress concentration at its tip where slip can occur fairly easily. The material above the crack (stages 1 and 2 in Figure 6) may slip along a favorable slip plane in the direction of maximum shear stress. Due to that slip the crack opens, but it also extends in length. Slip can now occur on another plane (stage 3). Work hardening and increasing stress will

(14:60).” This process, because it increases the crack length and cyclically sharpens the crack tip, creates increasingly larger stress intensity factors. According to the Paris Law, this creates increasing crack growth rates. Minimizing  $K_I$  and slowing down or stopping its growth is the aim of all crack repair techniques.

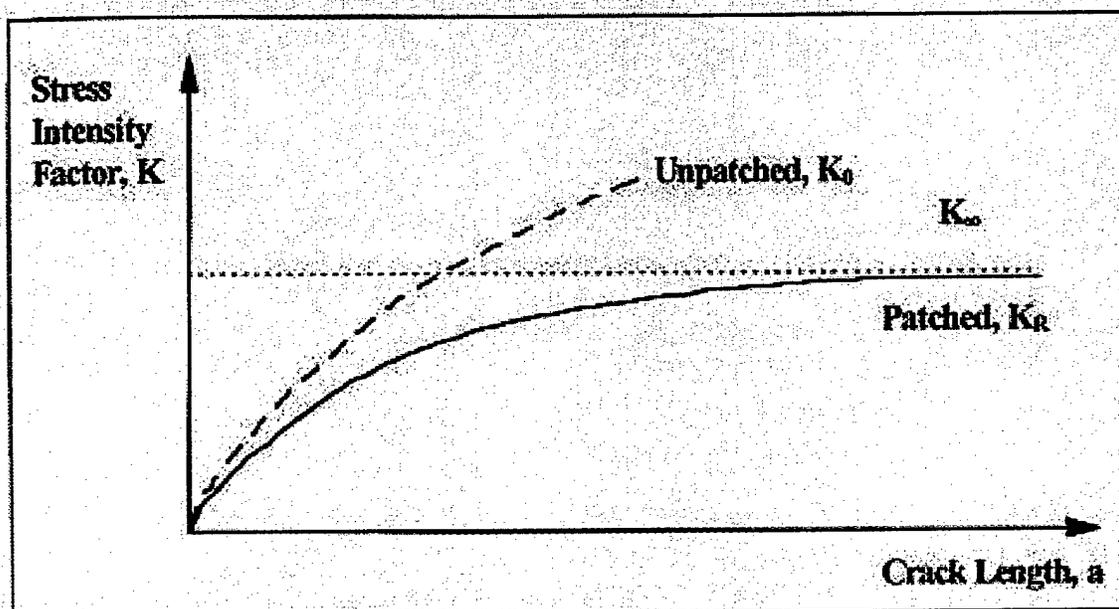
*Figure 7 Reduction in the Stress Intensity Factor with Repair*

providing much more efficient load transfer. A well designed and bonded patch causes the stress intensity at the crack tip to reach a limiting factor,  $K_{\infty}$ , no matter how long the crack length becomes. This is shown schematically in Figure 7 (15; 11). Further, a well designed patch, because it efficiently carries the stress of the aircraft part, significantly reduces the need for short inspection intervals. This can be seen in Figure 8 (16; 11).

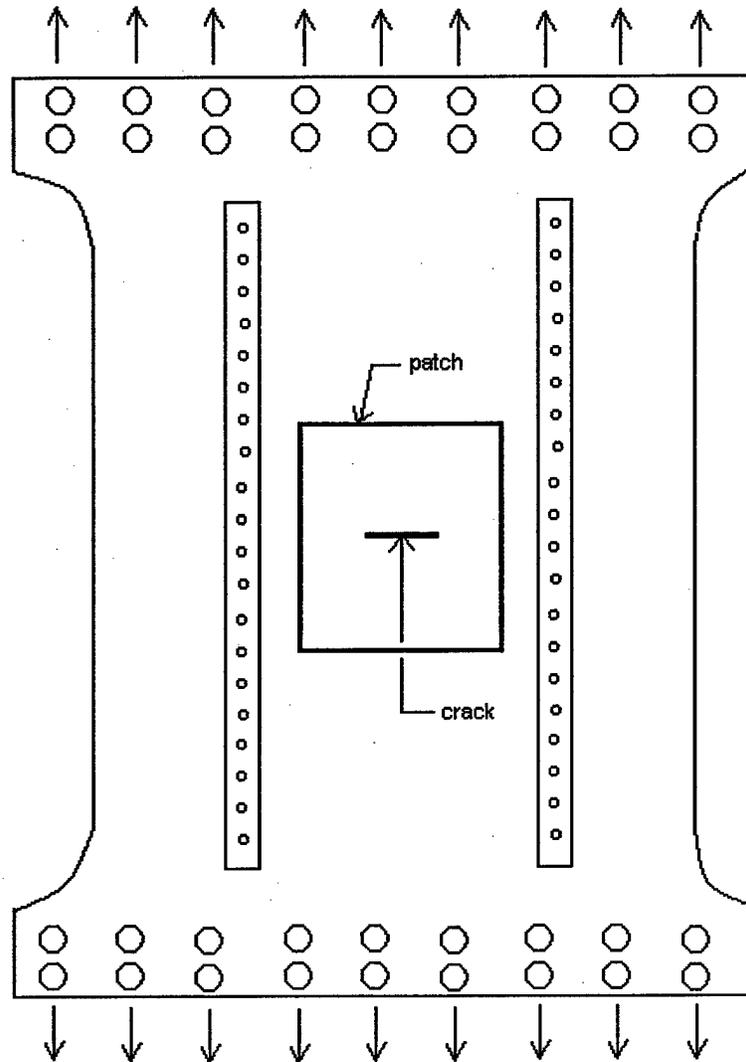
As the above list states, there is a lot of thought and work that goes into designing a composite repair, but the first place to start is in knowing what loads exist in the repair area that the patch will be applied to. This study investigates a patched aluminum panel undergoing mode I loading, as seen in Figure 9.

**Figure 9 Patched Aluminum Panel in Tension**  
*(Panel has a thickness of 1 mm; Stiffeners have a thickness of 1.6 mm)*

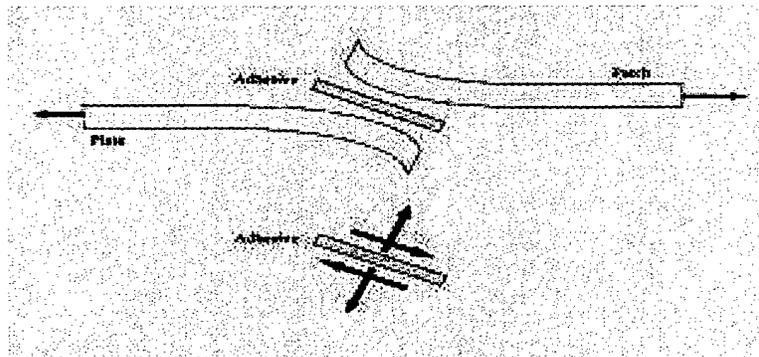
**Figure 10 Bending Caused by Neutral Axis Shift in Single Sided Repair**

Tension on an aluminum panel/patch system creates shear stress in the bondline. Also, because the patch is bonded to the surface of the panel and picks up stress, a neutral axis shift occurs. This neutral axis shift creates normal stresses in the form of out of plane bending that acts at the tips of the patch. This is shown in Figure 10 (3). Normal and shear stresses are the main drivers for patch failure and, when referring to bonded

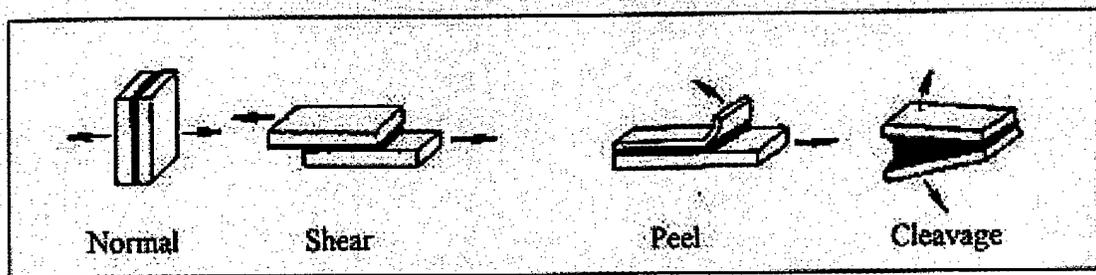
**Figure 11 Loading on Adhesive Bonds**

repairs can lead to possible peel and cleavage stress. These four loading states are shown schematically in Figure 11 (11; 17).

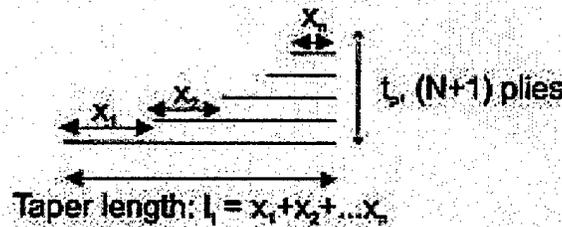
*Figure 13 Taper Length Schematic*

The length of each consecutive step is given by the following equation and is shown schematically in Figure 13 (7).

$$x_2 = \frac{x_1}{2} \text{ and for the following steps: } x_n = \frac{x_{n-1}}{n} \quad (25)$$

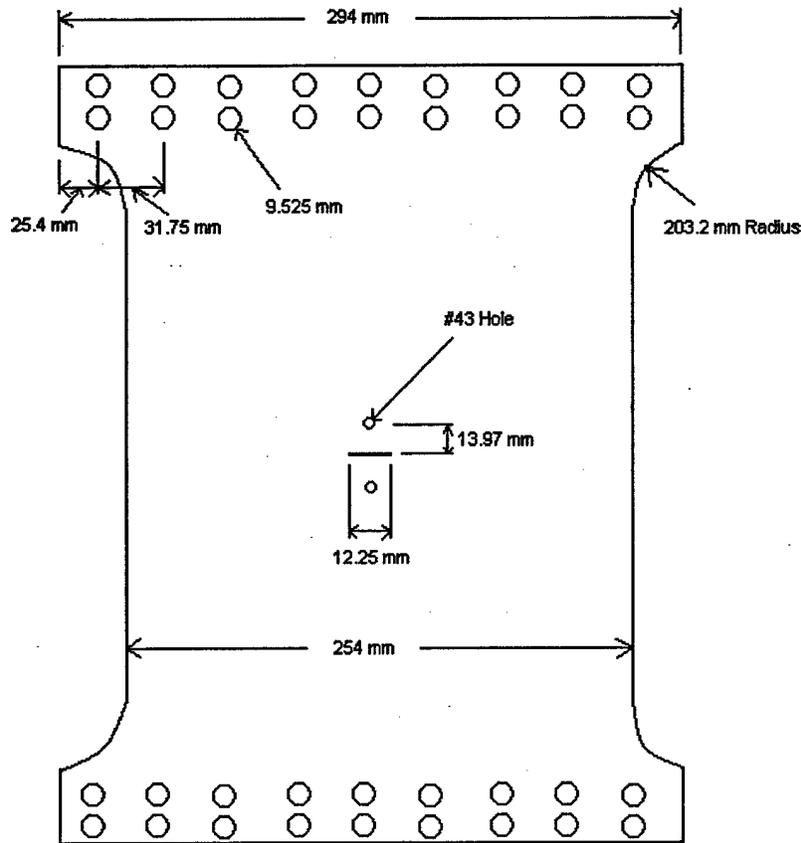
**Figure 14 2024-T3 Aluminum Test Panel**

The aluminum panels were first cut down to a rough dimension of 304.8mm x 558.8mm (12" x 22") with a shear press. They were then sent out to a local machine shop to be milled to the exact dimensions of 304.8 mm x 558.8 mm "dog-boned" down to 254 mm (10"). Because this was the first research investigating the fatigue response of repaired, stiffened panels, dimensions were chosen to closely match dimensions of earlier work focusing on unrepaired, stiffened structures performed by Heinemann (27). The width of the panels is slightly wider to accommodate the two different stiffener spacings investigated. The machine shop also performed the electrical discharge machining (EDM) of the panels to create a 12.7mm (0.5") notch in the center of the panel. A schematic of the completed panel is shown below in Figure 14.

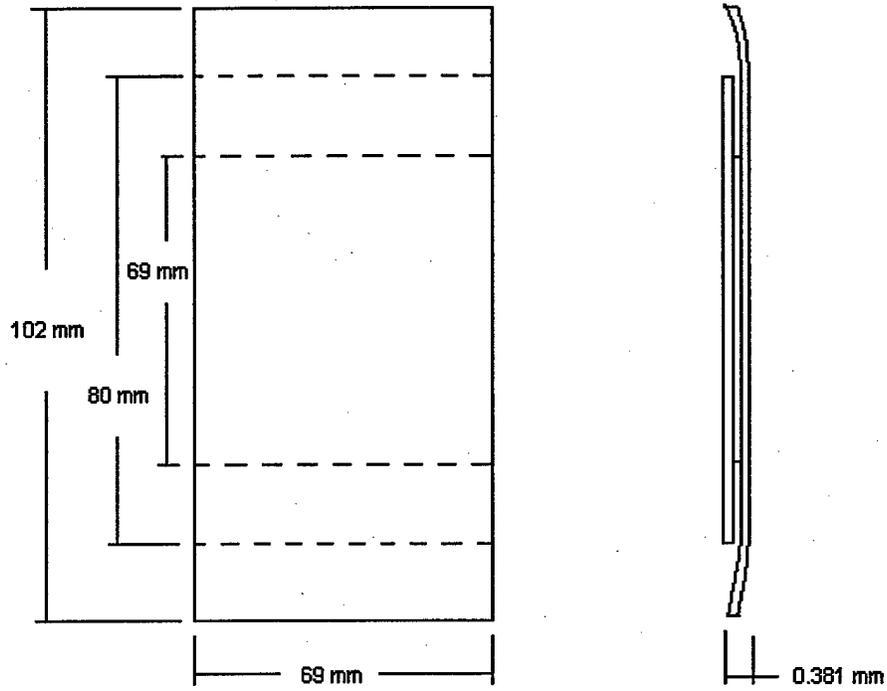
**Figure 17 Boron/Epoxy Patch Lay-up with Cover Ply**

It is common practice to use the largest composite ply as a cover ply over the patch, as it provides good environmental protection. This is what was done for six of the fourteen patches bonded on to panels. The other eight panels had a simple “wedding cake” lay-up configuration, with no cover ply utilized. Both patches consisted of three plies with the same dimensions, so the strength of both patch configurations was equivalent. Schematics of each type of patch are shown below in Figure 17 and Figure 18.

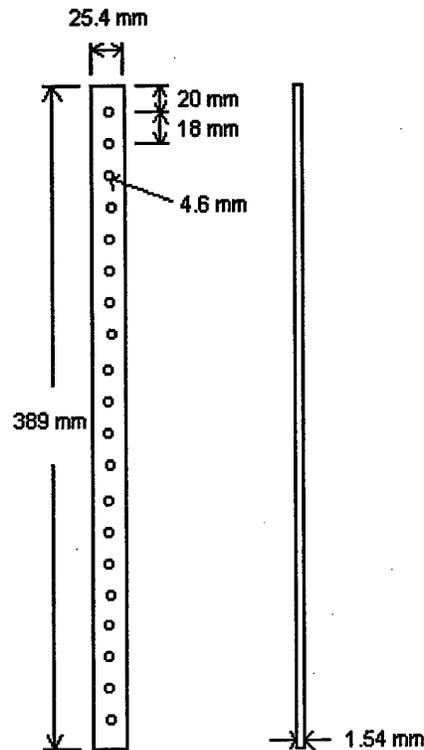
**Figure 21 Aluminum Stiffener**

The stiffeners in this study were bonded to the aluminum panels, as well as riveted. Because of this, certain steps had to be taken to reduce stress concentrations at the stiffener tips. Just like the boron/epoxy patch, the ends of the stiffeners were "tapered" by grinding them down. This was performed to reduce the stress concentrations due to load attraction from the surrounding skin. Also, the ends of the stiffeners were rounded to reduce the stress concentrations at the corners. This process helped to ensure that no fatigue crack initiation would occur in the skin outside of the stiffener tips. A schematic of the stiffeners is shown below in Figure 21.

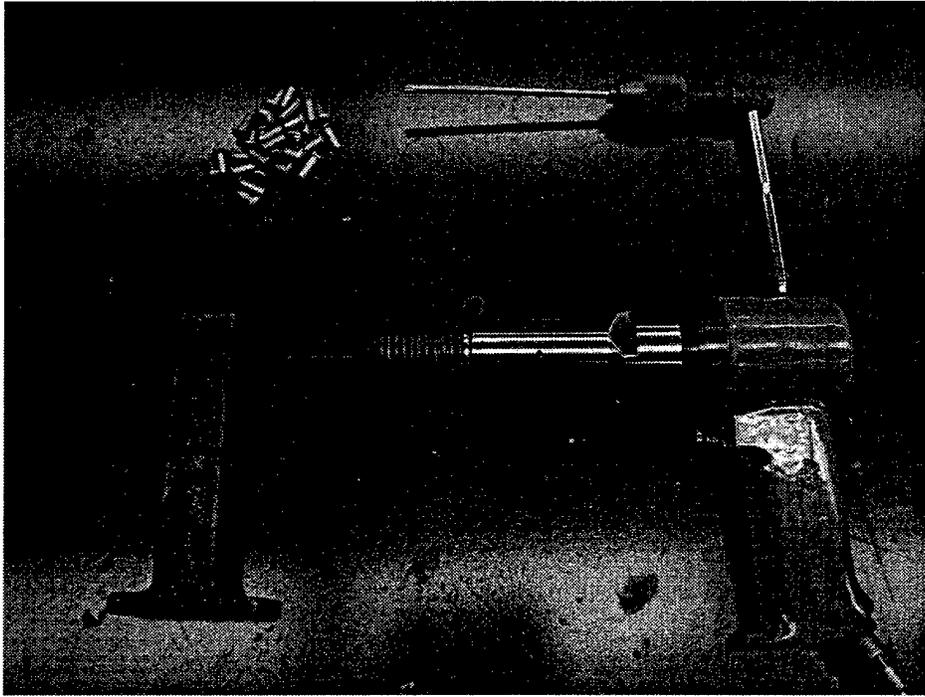
*Figure 22 Riveting Tools*

The stiffeners were attached to the panels using a pneumatic riveting process. All tools needed (rivets, reamer, bucking bar, and pneumatic rivet gun) are shown in Figure 22. The rivet holes in the stiffeners and panels were first "reamed" to 4.85 mm (0.191") to ensure the proper size for the rivets and to reduce the chances of fatigue crack initiation in the holes. This process is shown in Figure 23. Rivets were then inserted into the holes and installed one at a time. This consisted of placing the rivet gun against the head of the rivet and the bucking bar against the butt. As the gun hit the rivet, the bucking bar deformed the butt and the rivet filled the hole. Because the panel tends to expand slightly as it is riveted, it is best to work from the center of the panel out toward the ends to reduce any deformity in the panel. This process is shown in Figure 24, Figure 25, and Figure 26.

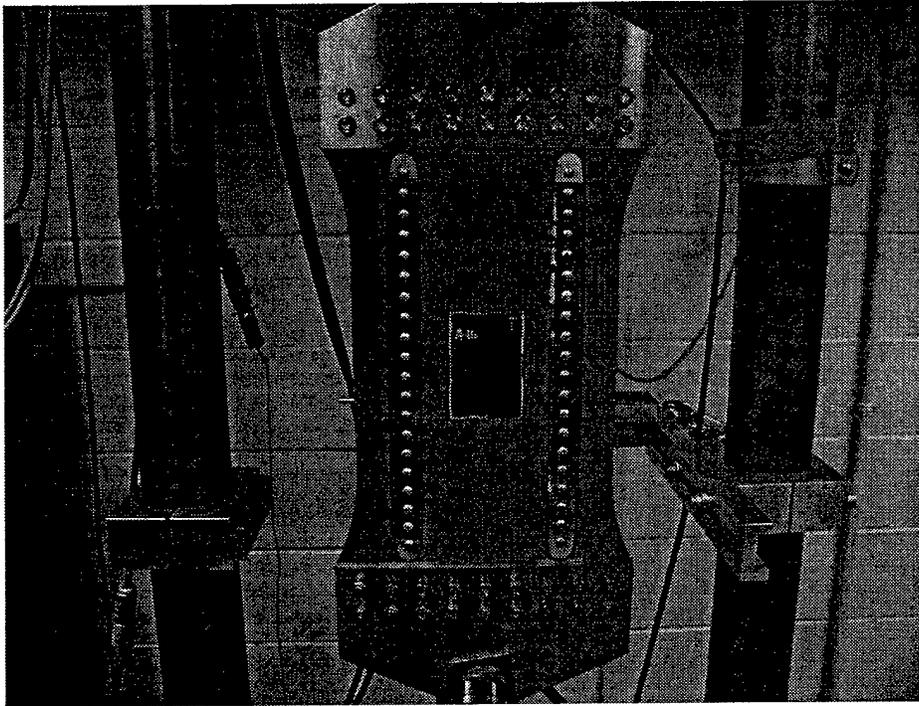
*Figure 27 Completed Panel with Boron/Epoxy Patch and Stiffeners*

Bonding the stiffeners to the aluminum panels was performed by curing the AF-163-2M adhesive in an oven under vacuum. To accomplish this, an envelope vacuum bag was manufactured around the panel. Once the bag was complete with full vacuum applied to the panel, it was inserted into the oven. The cure cycle used was a ramp up to 82.2°C (180°F) at 1.67°C (3°F) per minute. This was held for 30 minutes. During this stage, the panel was under full vacuum, or approximately 25" Hg, until it reached 82.2°C (180°F). When the panel reached 82.2°C (180°F), the vacuum level was reduced to 13" Hg. After the initial cure, the panel was ramped to 121°C (250°F) at 2.22°C (4°F) and held for an additional hour. A completed panel, with boron/epoxy patch and stiffeners applied, is shown below in Figure 27.

Testing was performed in the Air Force Research Laboratory Air Vehicles Fatigue and Fracture Lab Laboratory on MTS tensile machines, as was seen in Figure 27. All fatigue testing was performed at 8 hertz and 120 MPa. Cracks were measured utilizing a “floating” microscope mounted to the MTS machine, as seen in Figure 28. Crack length data, as well as cycles to reach the crack lengths, were immediately stored in a Microsoft Excel 97 spreadsheet. Panels were fatigued until one of three things happened:

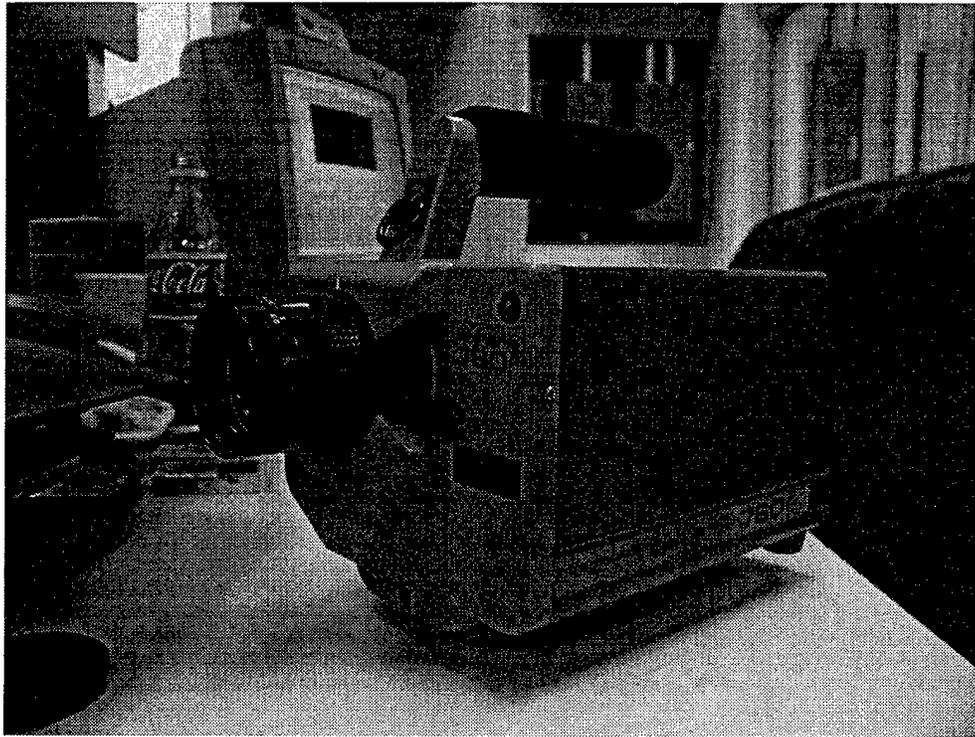
*Figure 29 Inframetrics 760 IR Camera*

Infrared pictures were periodically taken to record changes in delaminations in the adhesive bondline under the patch. This was accomplished with the Inframetric 760 IR camera system. This equipment is shown in Figure 29 and Figure 30. The patch was first heated up with a standard heat gun, shown in Figure 31, and the infrared camera displayed "hot spots" in the bondline. Delaminations remain hot longer because air acts as an insulator between the patch and the metal panel. This keeps the patch from cooling

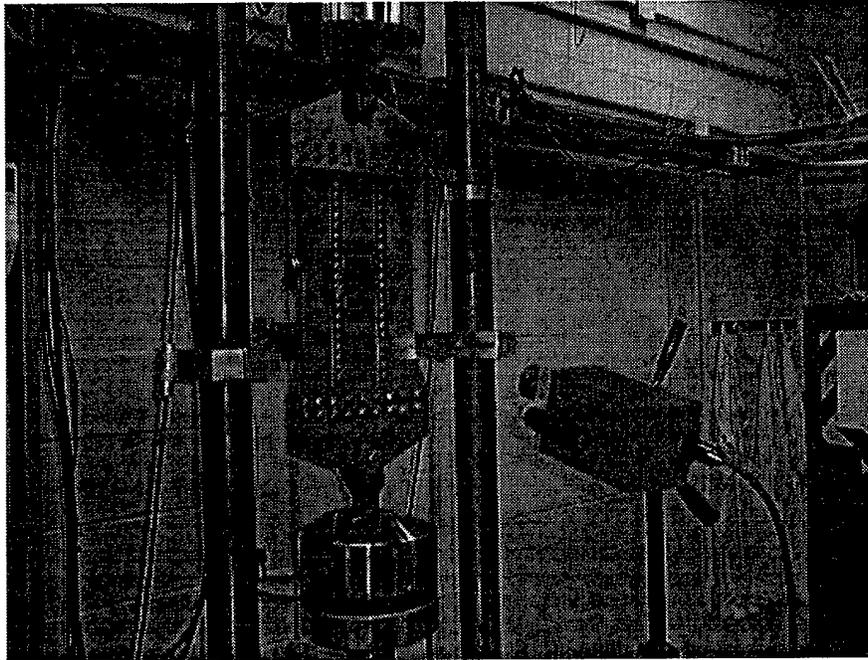
*Figure 32 IR Camera in Operation*

down due to contact with the metal. A picture of the IR camera in operation is shown in Figure 32, and an infrared picture showing disbonds can be seen in Figure 33.

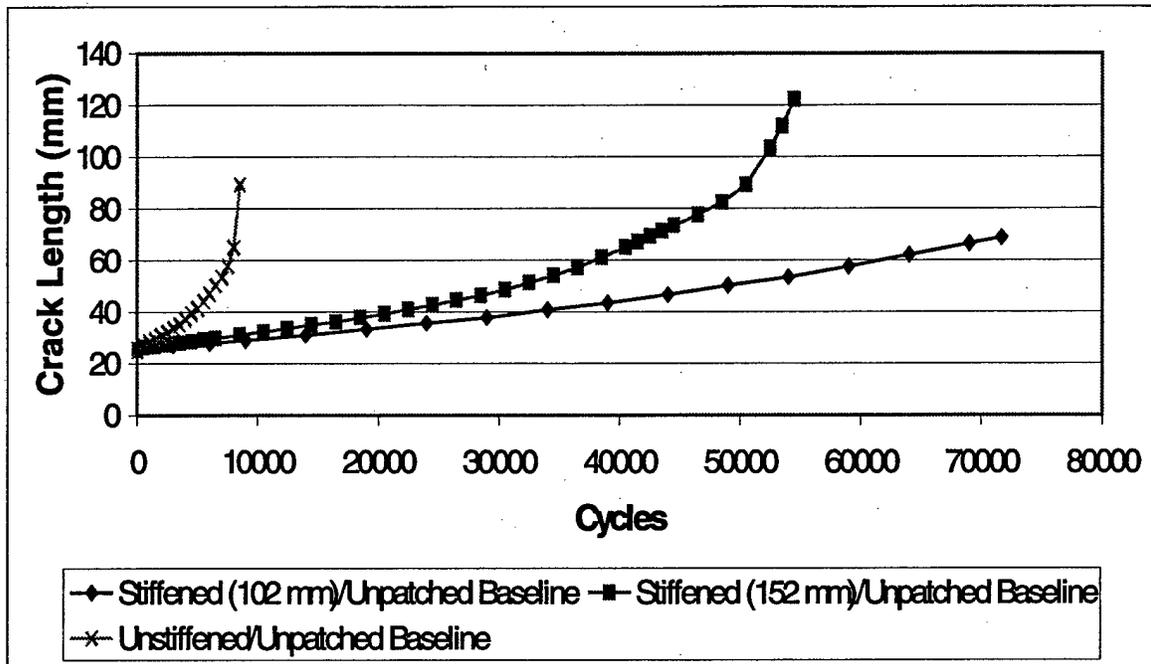
**Figure 34 Stiffener Effect on Unrepaired Panel Fatigue Life**

In order to determine the effect of stiffeners and their spacing on unrepaired panel life, a baseline unrepaired panel (no stiffener/no patch) was compared to baseline unrepaired stiffened panels (102 mm and 152 mm spaced stiffeners with no patch). 152 mm and 102 mm spaced stiffeners were used to simulate stiffener spacing in transport aircraft fuselage and wings, respectively. Table 13 documents the fatigue lives of the three panels, and Figure 34 shows the comparison. The baseline unstiffened panel fatigue life correlates well with Denny's data (11).

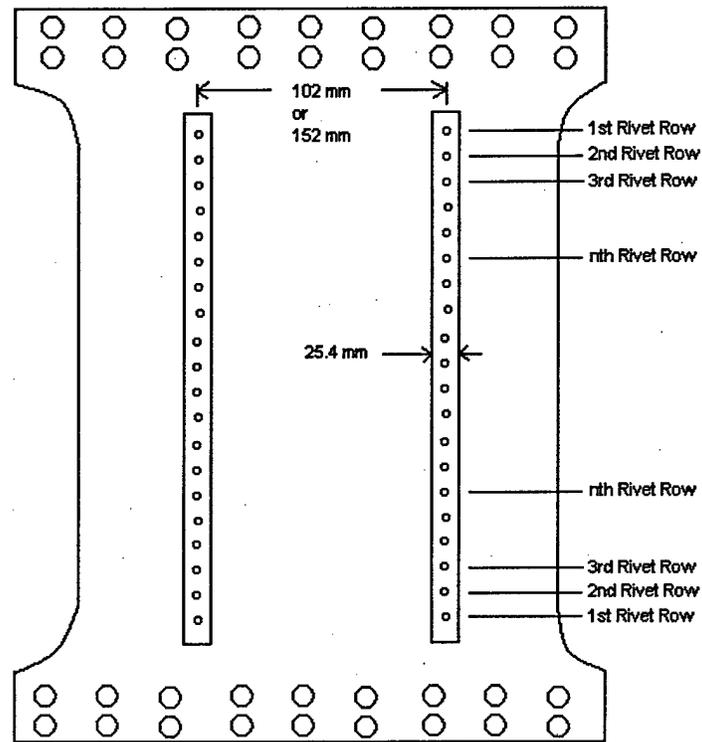
**Figure 35 Rivet Row Illustration**

When dealing with riveted structure, stress is transferred from the panel in decreasing percentage by subsequent rivets (28:24). This is why the crack initiated in the first rivet row. The 152 mm spaced stiffeners did not provide enough crack retardation to drive the failure into the rivet row. This phenomenon of “driving” failure into the rivet row was seen in both cases (152 mm and 102 mm spaced stiffeners) of the repaired panels and will be discussed further in latter sections.

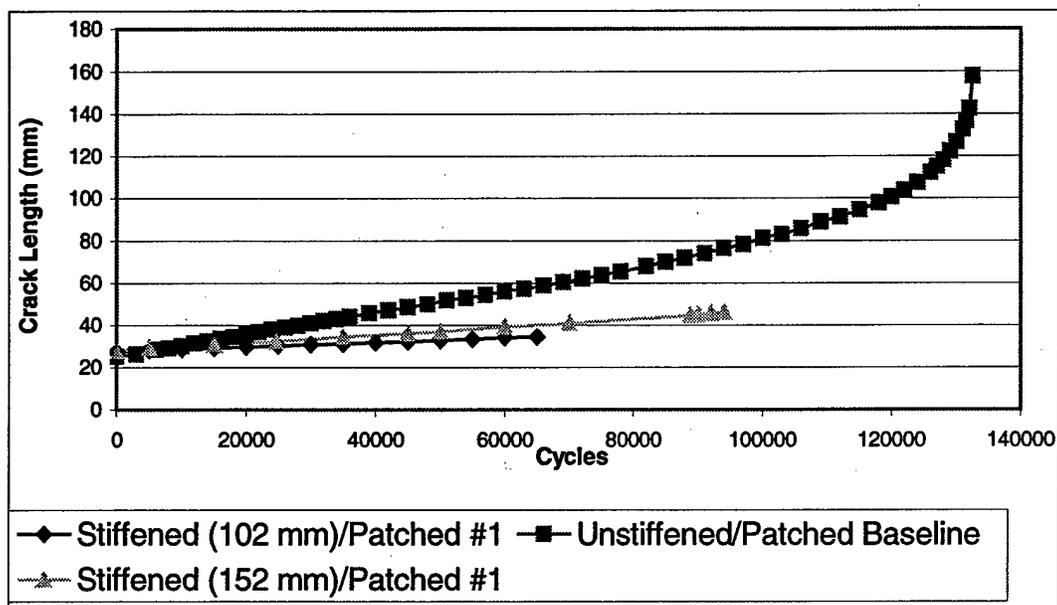
**Figure 37** *Repaired Fatigue Life of Unstiffened and Stiffened Panels*

catastrophic failure. This occurred in both stiffened panel configurations because the patch, combined with the stiffeners, even for the case of 152 mm centered stiffeners, strengthened the repaired area to such an extent that it drove the failure into the rivet row. This can be seen in Figure 37, which compares unstiffened/patched panel fatigue life to that of stiffened/patched panels. The stiffened panels were performing much better than the unstiffened panel before they failed.

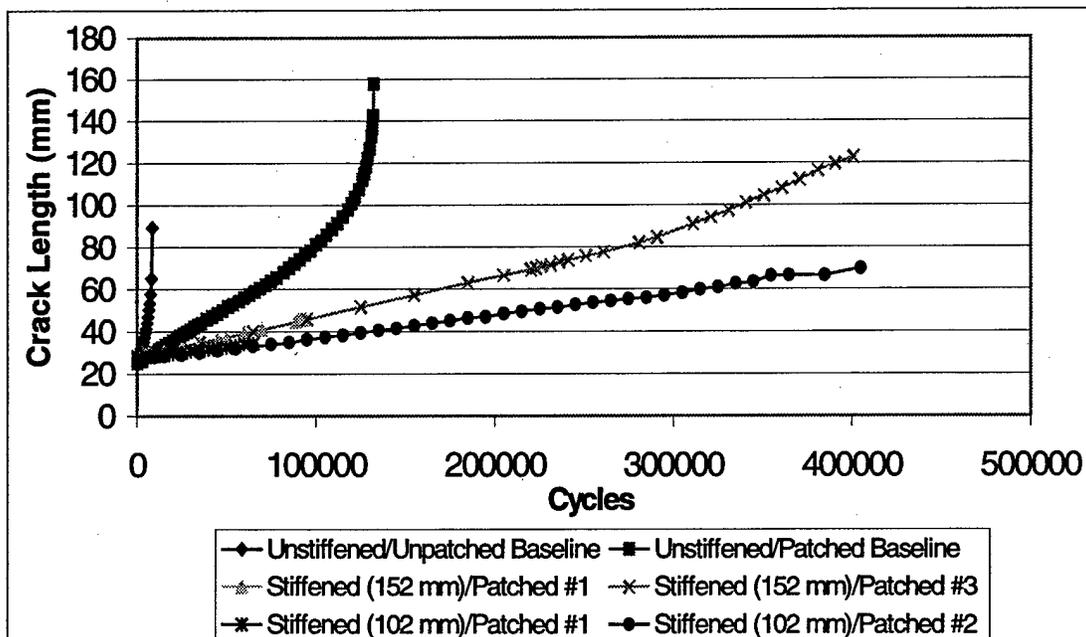
**Figure 38 Repaired Fatigue Life of Bonded/Riveted Stiffened Panels vs. Unstiffened Panels**

To remove this failure mode, along with riveting the stiffeners to the panels, they were bonded as well. This reduced the stress concentration at the rivet holes and drove the failure back into the initial crack underneath the patch. Table 15 presents the fatigue life data of each panel and Figure 38 shows the fatigue lives graphically. Fatigue life data for panels with riveted-only stiffeners (not adhesively bonded) is also included in

Figure 38. Comparing this data to the fatigue lives of panels with riveted and bonded stiffeners shows very good correlation, since the curves for unbonded and bonded stiffeners lie on top of each other. Therefore, it can be concluded that bonding the stiffeners does not change the crack growth behavior of the panel, it only ensures that no crack initiation will occur in the rivet holes. Data for the unstiffened/unrepaired baseline panel is also provided in Figure 38 to show the advantages of repaired panels over unrepaired panels.

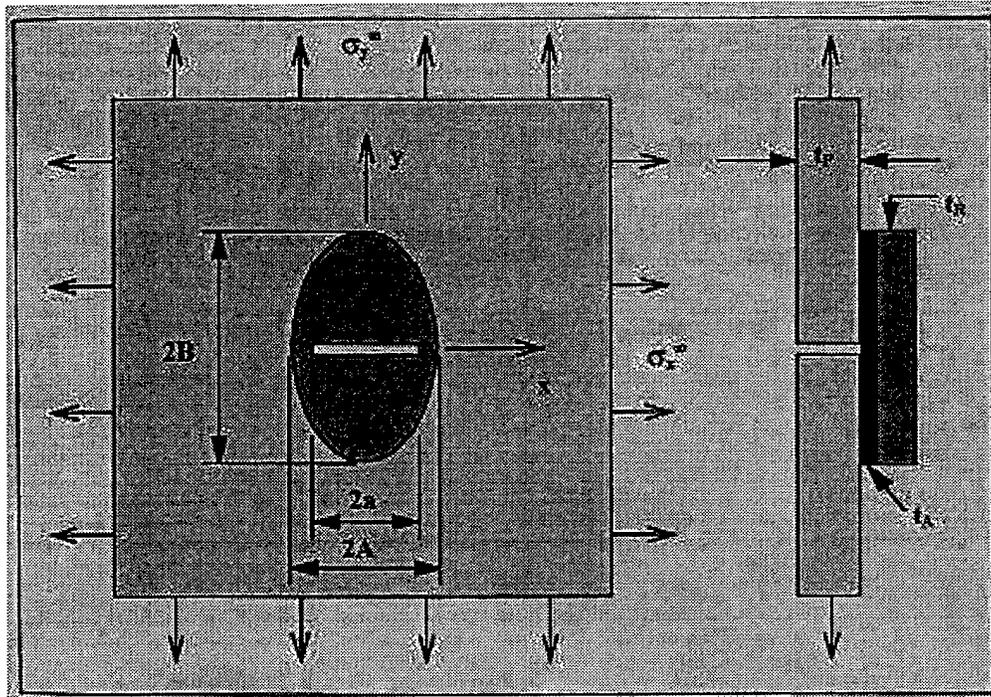
Figure 39 Equivalent Inclusion

The major assumption in Stage I Rose model analysis is that the patch and the plate form a perfect rigid bond which allows no movement between the patch and the plate. The plate and patch are viewed as an *equivalent inclusion* (Figure 39 (17:115)) of higher stiffness than the surrounding plate. To determine the normal stress distribution,  $\sigma_0$ , in the reinforced plate, three calculations must be performed (11):

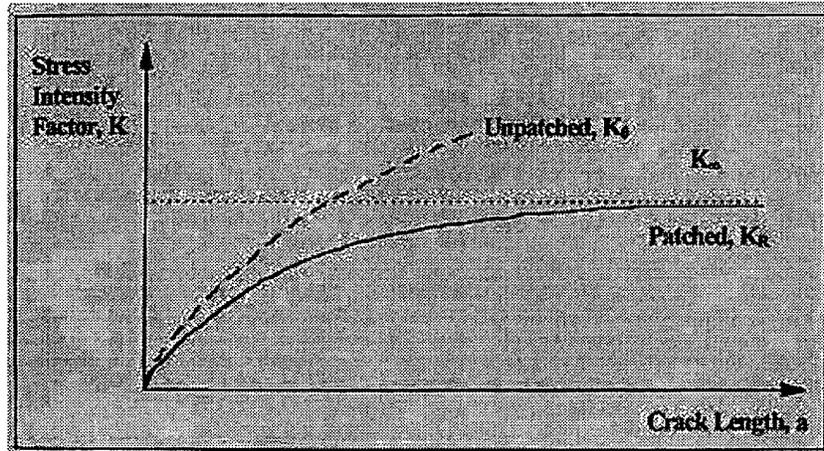
**Figure 40 Reduction in Stress Intensity Factor with Repair**

This stress intensity factor is one upper bound of the repaired stress intensity factor,  $K_R$ . "However, in comparison to an unbounded  $K_0$  with crack length for a nominal center cracked plate,  $K_R$  does not exceed a limiting value of  $K_\infty$  as shown in Figure 40 (11; 15). Rose shows that  $K_\infty = K_0$  at a characteristic crack length,  $\Lambda$  (11)." The equation for  $\Lambda$  is shown below:

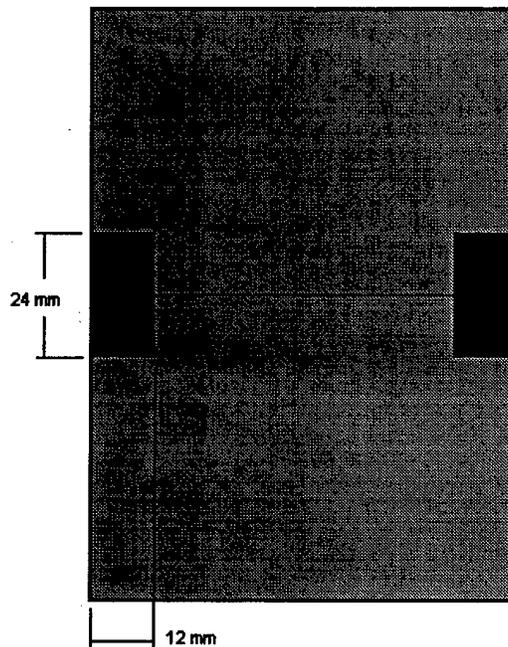
**Figure 41 Schematic of CTD**

Four fatigue panels with CTD's were tested—two with 152 mm spaced stiffeners (panels A-11 and A-12) and two with 102 mm spaced stiffeners (panels A-8 and A-10). Disbonds accounted for approximately 8% of the bondline area of the patch and are shown schematically in Figure 41. The fatigue life data of the disbanded panels, along with the fatigue life data of different baseline panels used for comparison, are shown in Table 17. The data is broken up into two sections—cycles to reach 45 mm of crack length and cycles to reach 69 mm of crack length—for easier comparison. Initial crack propagation occurred under the completely bonded section of the patch, which makes up the first 45 mm of total crack length. The final 24 mm (12 mm for each crack tip) of crack tip propagation underneath the patch occurred in a completely disbanded region of

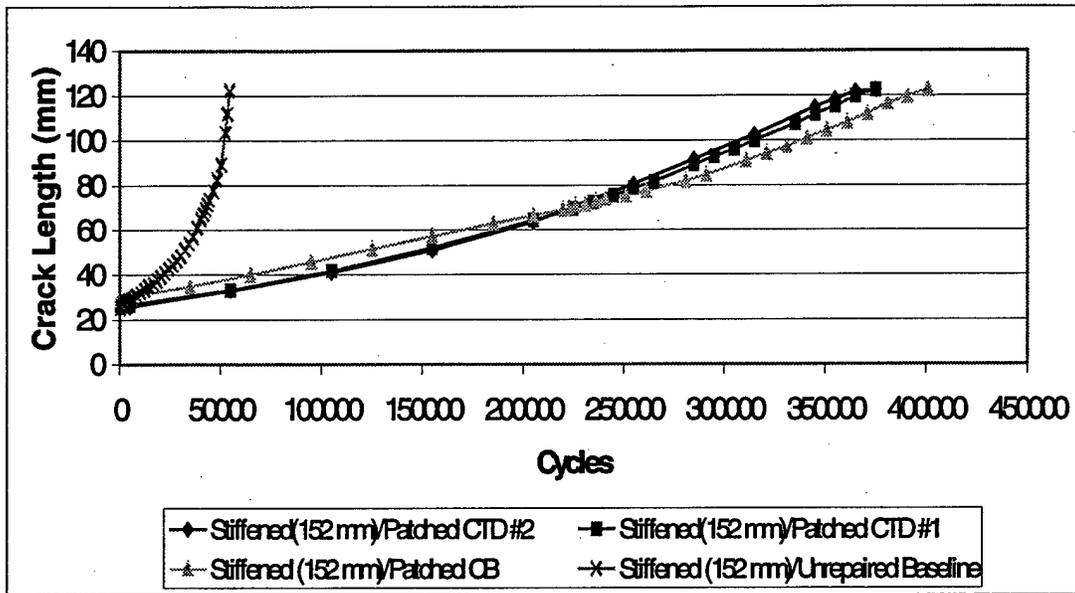
Figure 42 CTD Effects on Fatigue Life of 152 mm Centered Stiffened Panels

the patch. By comparing the data separately, the effect of the disbond can be better understood. The results are shown schematically in Figure 42, Figure 46, and Figure 51. Figure 42 shows the effect of the CTD on panels with 152 mm spaced stiffeners and how the fatigue life of those panels compared to the baseline data. Figure 46 shows the same for panels with 102 mm spaced stiffeners. Figure 51 shows a direct comparison between CTD effects when dealing with 152 mm spaced stiffeners and 102 mm spaced stiffeners.

The overall fatigue life of the repaired panels with 152 mm spaced stiffeners with CTD's decreased slightly when compared to the perfectly bonded case, as seen in Figure 42. By comparing the data within the two regions defined in Table 17 ( $2a = 45$  mm and  $2a = 69$  mm), the panels with CTD's present actually initially performed slightly better than the completely bonded baseline panel—about 10%. Once the crack tips reached the disbonds, crack propagation increased slightly. Within the disbonded region spanning a 45 mm total crack length and a 69 mm total crack length (the width of the patch), the CTD panels had 29% faster average crack propagation rate than the completely bonded panels. While the completely bonded panel maintained linear crack growth underneath the patch (Figure 42), the CTD panels show a slight curve upward, indicating that the disbond does adversely affect crack growth rates. This data supports

Three fatigue panels with FWD's were tested—one with 152 mm spaced stiffeners (panel A-13) and two with 102 mm spaced stiffeners (panels A-14 and A-17). Since good correlation was already found between fatigue tests with the same configuration, such as panels A-11 and A-12 with CTD's (Figure 42), two specimens were not tested for every test case. This was done to preserve the number of specimens used so that more disbond configurations could be tested. The full-width disbond took up approximately 12% of the bondline area and is shown in Figure 52. The fatigue life data of the FWD specimens, along with the fatigue life data of different baseline panels used for comparison, is shown in Table 21. The data is broken up into two sections—crack growth between the end of the precrack and the edge of the patch and crack growth between the edge of the patch and the edge of the stiffener. Initial crack propagation was under a completely disbanded patch, which had a width of 69 mm. Once the crack extended beyond the width of the patch, the crack propagation rate changed as the crack tips approached the stiffener edges, which were approximately 122.3 mm apart in the case of 152 mm spaced stiffeners. The data is separated to make comparisons of the data involving panels with 152 mm spaced stiffeners easier. Panels with 102 mm spaced stiffeners do not have substantial crack growth between the edge of the patch and the stiffener, since the stiffeners are located in close proximity to the patch edges. By comparing the data separately, the effect of the disbond can be better understood.

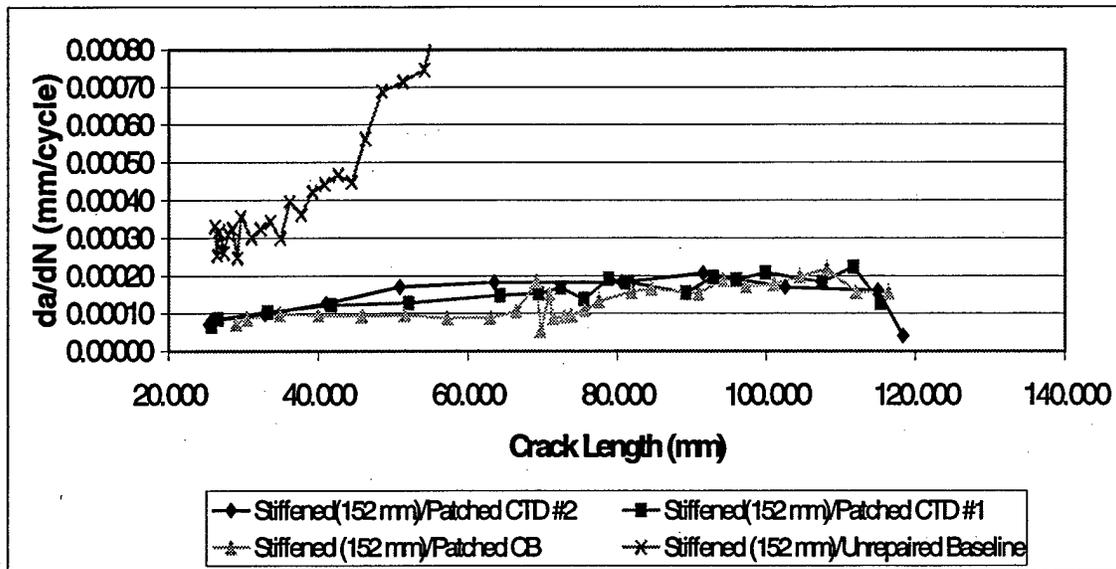
**Figure 43 Crack Growth per Cycle for 152 mm Spaced Stiffener Panel**

Baker's (32) observation that disbonds in front of the crack tip have little or no effect on crack tip propagation. It is only when disbonds appear in the crack tip wake that they make a difference. From the edge of the patch out to the stiffeners, the CTD panels' average crack growth rate was approximately 18% faster than that of the completely bonded repaired patch and the overall fatigue life of the repaired panels containing CTD's was approximately 7% shorter. Table 18 shows the crack growth per cycle ( $da/dN$ ) for each of the three panels broken out by region and Figure 43 shows the same data in graphical form. The figure shows that the CTD panels had a consistently higher crack propagation rate than the CB panel. All three panel's crack propagation rates decreased as the crack tips approached the stiffeners. Figure 43 also displays the crack propagation rate of the baseline unrepaired panel with 152 mm spaced stiffeners for comparison. The benefits of bonded composite repairs can easily be seen in the reduced crack propagation rates.

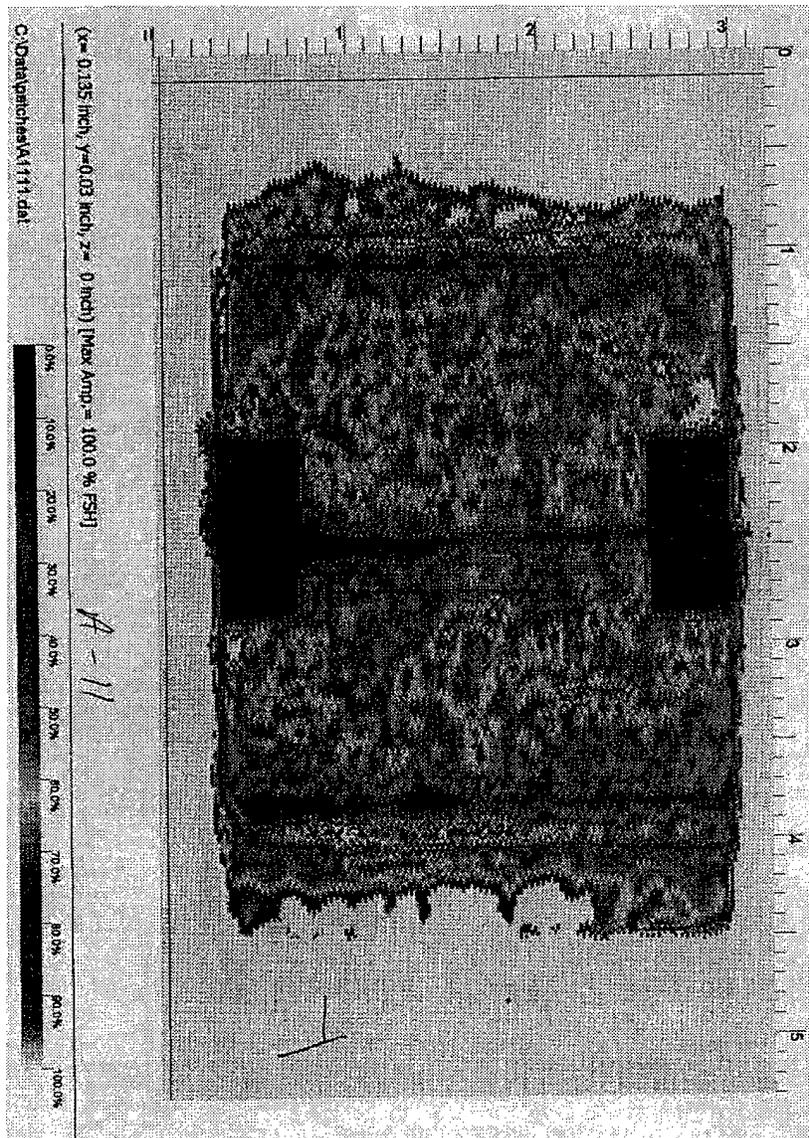
**Figure 45 End-of-Life C-Scan of Panel A-11 with CTD**

The testing showed excellent correlation, since both panels with CTD's present, panels A-11 and A-12, had fatigue life curves that fell right on top of each other. While there was a minor reduction in fatigue life with the disbond present, the repaired structure still performed considerably better than the unrepaired structure. Panels A-11 and A-12, even with disbonds present, had a fatigue life on average of 688% longer than the unrepaired stiffened panel. This result supports the idea that bonded repairs are very durable. Also, by comparing infrared (IR) pictures of the repair (Figure 44) taken at different cycle counts during testing with a C-SCAN of the repair (Figure 45) performed after failure, no substantial disbond growth occurred over the life of the repair. The figures, especially the end-of-life C-SCAN, do show that there was minimal disbonding around the crack, but the initial intentional disbonds did not grow larger. The three IR pictures were taken at 5,009, 205,007, and 345,006 cycles and corresponded to 26.581 mm (1.046 inches), 64.364 mm (2.534 inches), and 111.646 mm (4.396 inches). The C-

SCAN was taken after 375,010 cycles, corresponding to a crack length of 122.339 mm  
(4.816 inches).

The data from both stiffener configurations supports Baker's (32) previous findings that disbonds in the wake of crack tips have more of an effect on crack tip propagation than disbonds in front of the tip. Also, Figure 44, Figure 45, Figure 49, and Figure 50 support Hart-Smith's (33) observations that adhesive bondlines are relatively damage tolerant and pre-existing intentional disbonds will not grow.

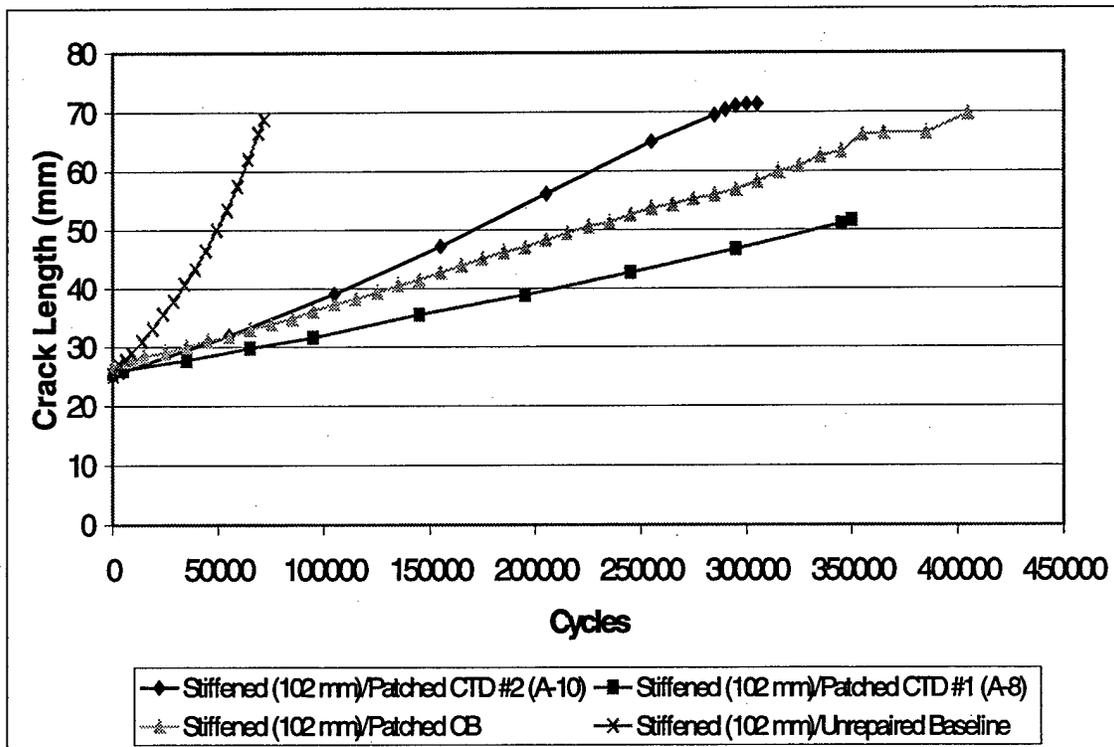
Figure 46 Effects of CTD on 102 mm Spaced Stiffened Panels

This testing showed the same trends as that of A-11 and A-12 for one of the panels, A-10, but showed an entirely different result for the other panel, A-8. The fatigue life of the repaired 102 mm spaced stiffener panel, A-10, decreased by approximately 16% when compared to the perfectly bonded case. However, the fatigue life of panel A-8 showed an increase of almost 43% when compared to the perfectly bonded panel. The fatigue life curves of each panel, along with the perfectly bonded case and unrepaired case, are shown in Figure 46.

The overall fatigue life of panel A-10 decreased slightly when compared to the perfectly bonded case, as seen in Figure 46. By comparing the data within the two regions defined in Table 17 ( $2a = 45$  mm and  $2a = 69$  mm), a better picture of the result of the disbond can be seen. Table 19 shows the crack growth per cycle ( $da/dN$ ) for the two panels broken out by crack length and Figure 48 shows the same data in graphical form. From the end of the precrack out to the beginning of the disbond, the CTD panel had a 32% faster crack propagation rate than the completely bonded panel. Within the area of the disbond, the CTD panel had a 62% faster crack propagation rate than the completely bonded panel. The difference in crack propagation rates between the two cases is almost twice as much within the disbond, further supporting Baker's (32) observations. Figure 48 shows that panel A-10 had a consistently higher crack propagation rate than the completely bonded case. Crack propagation rate versus crack length is also provided for the unrepaired baseline panel with 102 mm spaced stiffeners for comparison in Figure 48. The oscillation in the curve is due to the extremely small
