**FATIGUE RESPONSE OF THIN STIFFENED  
ALUMINUM CRACKED PANELS REPAIRED  
WITH BONDED COMPOSITE PATCHES**

THESIS

Jason B. Avram, Captain, USAF

**AIR FORCE INSTITUTE OF TECHNOLOGY**

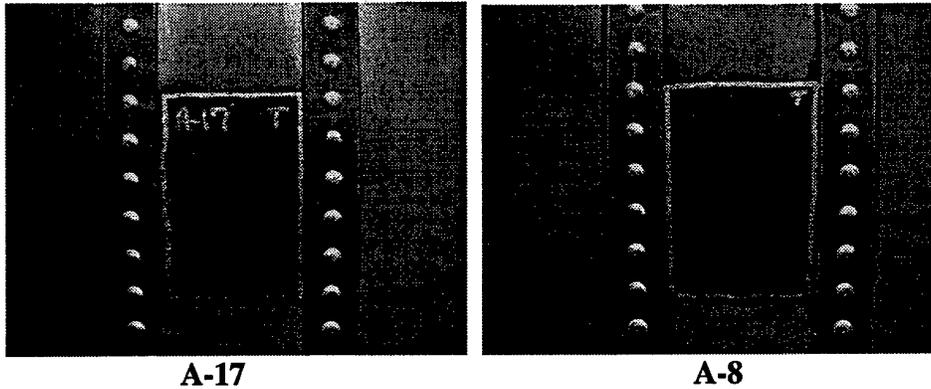
*Figure 47 "Pooling" of Adhesive in Panel A-8*

The only difference between the two CTD panels was in the way the patches were bonded on. In panel A-10, like in the preceding panels, the patch was first bonded on, followed by a separate cure cycle for the stiffeners. In order to save time, since the cure cycle was the same, the patch and stiffeners for panel A-8 were bonded at the same time in a vacuum bag. Because of the close proximity of the stiffeners to the patch, the adhesive pooled together and hardened, causing an increase in stiffness, as seen in Figure 47. This is the reason for the increased fatigue life of panel A-8. This argument is strengthened by the fact that the same experiment was done in the case of panels A-11 and A-12. A-11 was manufactured with two cure steps, while A-12's patch and stiffeners were cured at the same time in a vacuum bag. Because the stiffeners were positioned further from the patch, the adhesive did not pool together and there was no added stiffness in the panel. As a result, the two panels, even though they were manufactured using slightly different processes, performed almost identically, as seen in Figure 42. Therefore, performing the repair in two steps, as opposed to one step, did not change the patch properties or the material properties of the repair system in any way. Performing a one step cure simply provided a means for increased stiffness of the system in the case of the 102 mm spaced stiffeners due to the mixing of adhesive between patch and stiffener. Panel A-10 provided realistic data for the case of panels with 102 mm spaced stiffeners, while panel A-8 provided skewed data.

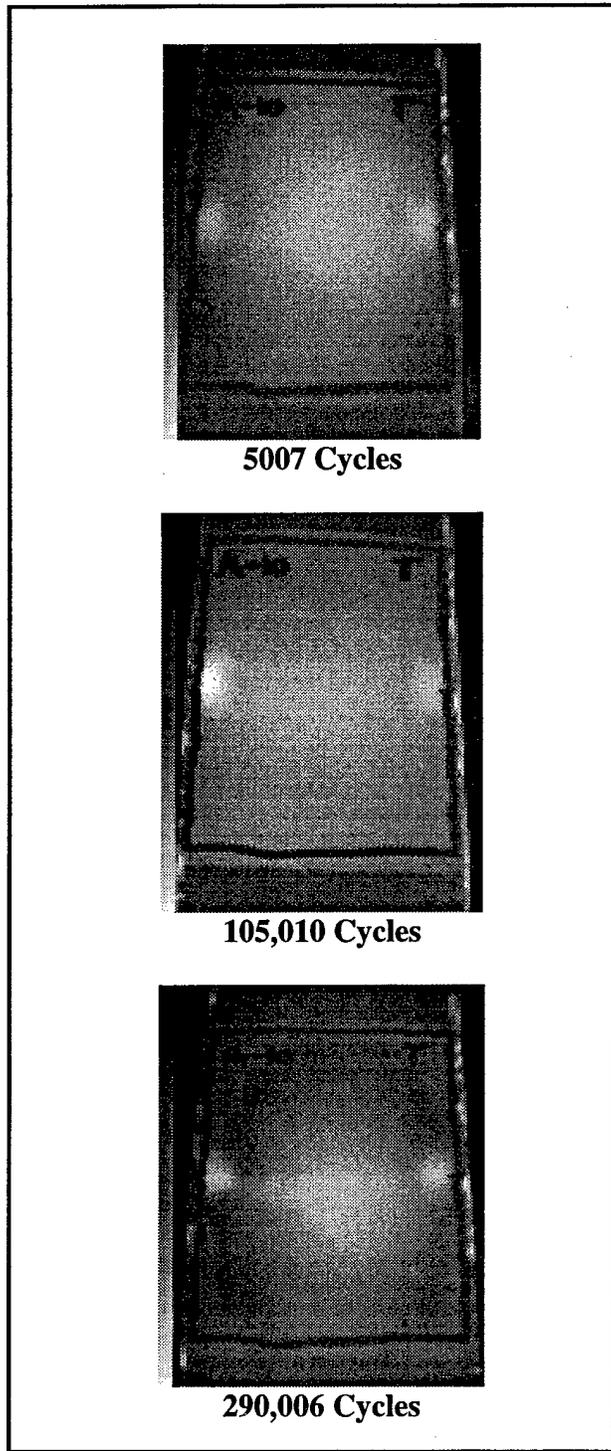
*Figure 49 Infrared Pictures of Panel A-10 with CTD*

unrepaired/102 mm stiffened panel. IR pictures of the repair taken during testing, when compared to a C-scan of the repair taken after testing was completed, show no substantial disbond growth during the life of the patch. The IR pictures of panel A-10 are shown in Figure 49 and the C-SCAN is shown in Figure 50. The three IR pictures were taken at 5,007, 105,010, and 290,006 cycles and corresponded to 25.883 mm (1.019 inches), 39.091 mm (1.539 inches), and 70.358 mm (2.77 inches). The C-SCAN was taken after 305,007 cycles, corresponding to a crack length of 71.336 mm (2.809 inches).

The data from both stiffener configurations supports Baker's (32) previous findings that disbonds in the wake of crack tips have more of an effect on crack tip propagation than disbonds in front of the tip. Also, Figure 44, Figure 45, Figure 49, and Figure 50 support Hart-Smith's (33) observations that adhesive bondlines are relatively damage tolerant and pre-existing intentional disbonds will not grow.

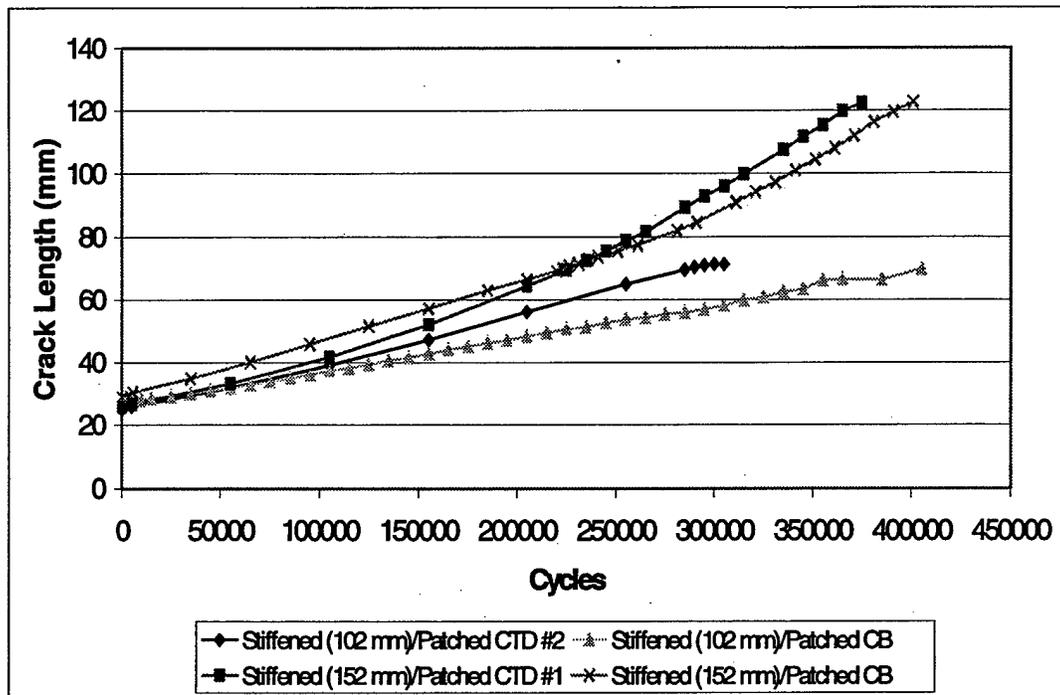
Figure 51 Fatigue Life Trend of Stiffened Panels with CTD

Both configurations of stiffened panels, the 152 mm spaced stiffeners and the 102 mm spaced stiffeners, behaved approximately the same with the CTD's present. Both showed slight decreases in fatigue life when compared to the perfectly bonded panels utilizing the same stiffener configuration. Figure 51 provides a direct comparison between fatigue life trends of the two different stiffener configurations when CTD's were present. From the figure, it appears that the CTD affects the panel with 102 mm spaced stiffeners more severely. Table 20 lists the effect the CTD had on the two different panel stiffener configurations. It shows the percentage of crack propagation rate increase by section when compared to the baseline panels. Looking at the data, it does appear that the disbonds affected the panel with 102 mm spaced stiffeners more severely. While this may be true to a certain extent, the fact that the crack length vs. cycles curve (a vs. N) for the 102 mm spaced stiffeners is not as severely sloped as that of the 152 mm spaced stiffeners makes any crack propagation increases appear worse for this case. For instance, when dealing with crack length versus cycles in the case of 102 mm spaced stiffeners, it took the completely bonded baseline panel approximately 11,188 cycles (interpolated) to grow from a total crack length of 50 mm to one of 51 mm. It took the baseline panel with 152 mm spaced stiffeners only 5,249 cycles to grow the same distance, or less than half the time. This phenomenon "harshens" the affect of the CTD on panels with 102 mm spaced stiffeners, when in fact the effect on both types of stiffener configurations is very comparable.

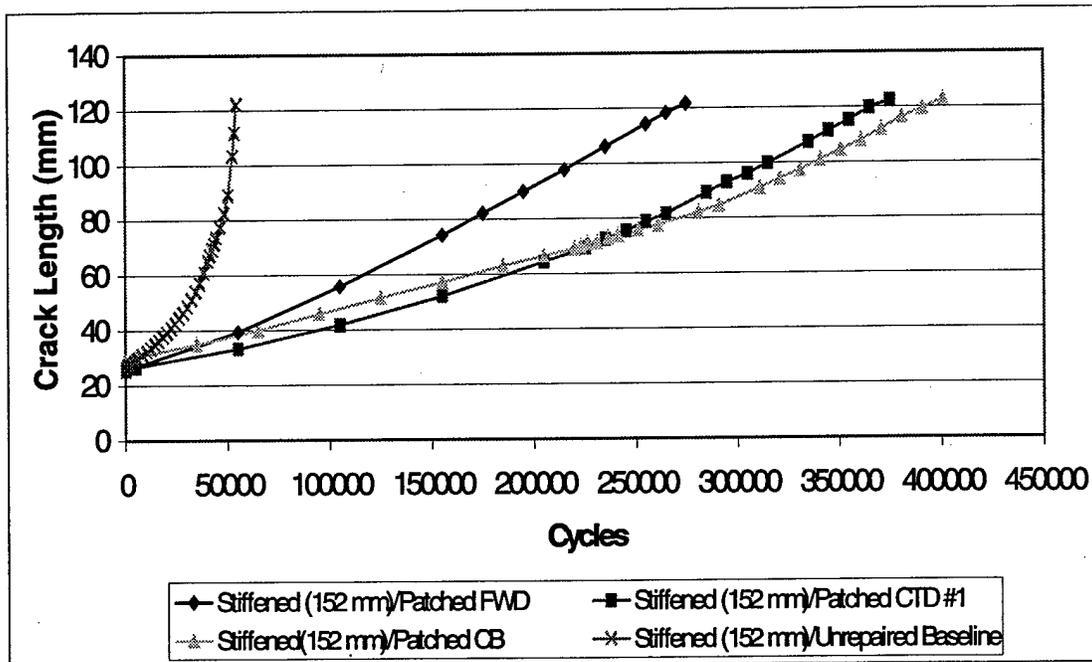
Figure 53 Effects of FWD on 152 mm Spaced Stiffened Panels

Results of the testing are shown schematically in Figure 53, Figure 57, and Figure 62. Figure 53 shows the effect of the FWD on panels with 152 mm spaced stiffeners and

how the fatigue life of those panels compared to the baseline data. Figure 57 shows the same for panels with 102 mm spaced stiffeners. Figure 62 shows a direct comparison between FWD effects when dealing with 152 mm spaced stiffeners and 102 mm spaced stiffeners.

The overall fatigue life of the repaired panel with 152 mm spaced stiffeners and an intentional FWD defect decreased substantially when compared to the perfectly bonded case, as seen in Figure 53. By comparing the data within the two regions of the panel defined in Table 21 ( $2a = 69$  mm and  $2a = 122.3$  mm), it can be seen that the FWD panel did far worse than the perfectly bonded panel *and* the CTD panels. Table 22 lists  $da/dN$  data for the set of panels with 152 mm spaced stiffeners including the completely bonded baseline repair, two CTD repairs, and the FWD repair. Looking only at the area under the patch, the FWD panel had a crack tip propagation rate over 70% faster than the baseline panel and over 56% faster than either of the CTD panels. Under the patch is where the most difference should be seen, but even outside of the patch, the FWD panel did worse than the other two repair cases, with crack growth rates 32% greater than the baseline panel and over 12% greater than the CTD panels. This data supports Denny's

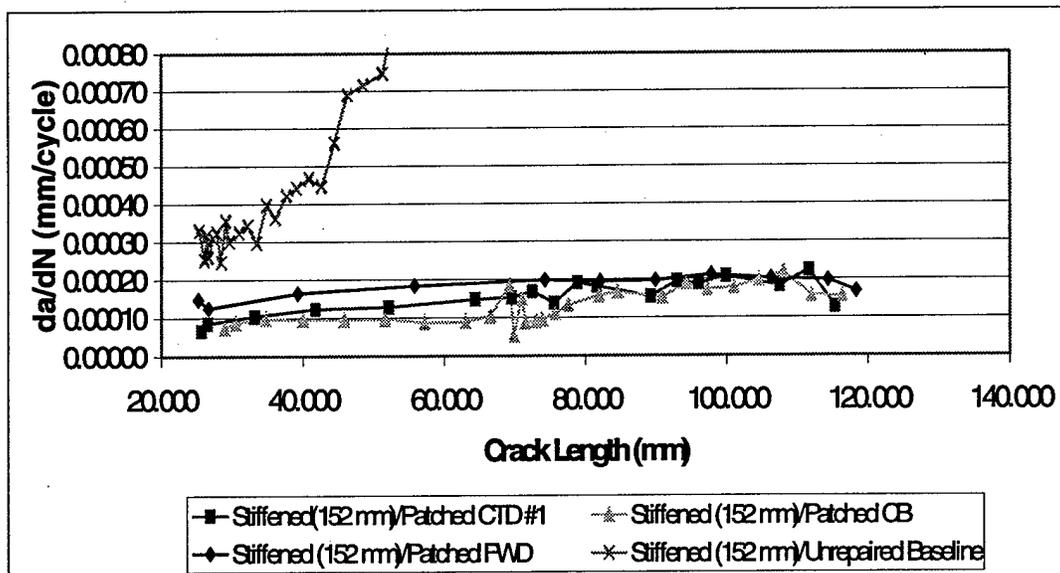
**Figure 54 Comparison of Crack Growth Rates for 152 mm Spaced Stiffener Panels**

(11) earlier observations that larger disbonds in more intimate contact with the crack will cause more adverse affects to fatigue life. Figure 54 shows the crack growth rate comparison between the perfectly bonded, CTD, and FWD panels with 152 mm spaced stiffeners. The FWD panel has the highest consistent crack propagation rate of the three disbond configurations and has a very constant  $da/dN$  with respect to crack length. The CTD panel, on the other hand, has a  $da/dN$  versus crack length curve that increases once the tips reach the disbond. Figure 54 also shows the crack propagation rate versus crack length curve for the unrepaired baseline panel with 152 mm spaced stiffeners for comparison.

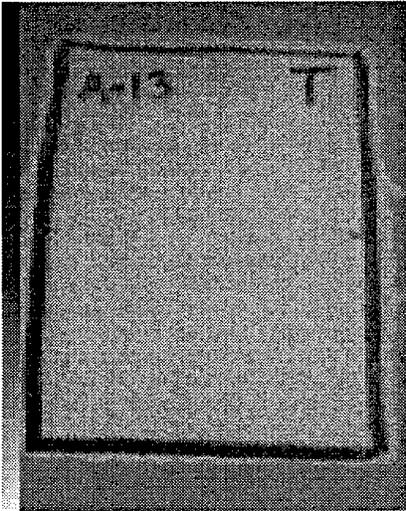
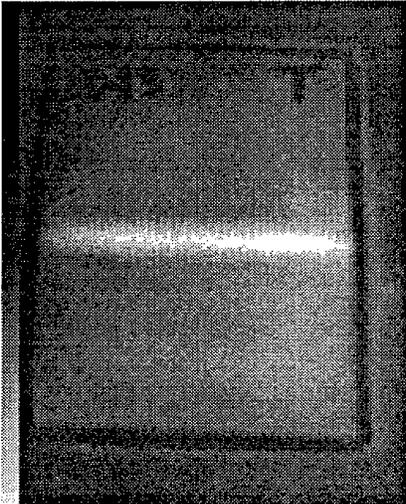
**5,007 cycles**

**155,007 cycles**

*Figure 55 Infrared Pictures of Panel A-13 with FWD*

by comparing IR pictures of the repair (Figure 55) taken at different cycle counts during testing with a C-SCAN of the repair (Figure 56) performed after failure, no substantial disbond growth occurred over the life of the repair. The two IR pictures were taken at 5,007 and 155,007 cycles and corresponded to 26.746 mm (1.053 inches) and 74.193 mm (2.921 inches). The C-SCAN was taken after 275,007 cycles and corresponded to a crack length of 121.704 mm (4.791 inches).

reached 45 mm in length, however, panels with CTD's present experienced a severe increase in crack propagation rate, where as panels with FWD's maintained constant crack growth rates, or less severe increases in crack growth rate for the case of panel A-13. Also, comparisons between Figure 55, Figure 56, Figure 60, and Figure 61 support Hart-Smith's (33) observations that adhesive bondlines are relatively damage tolerant and pre-existing intentional disbonds will not grow.

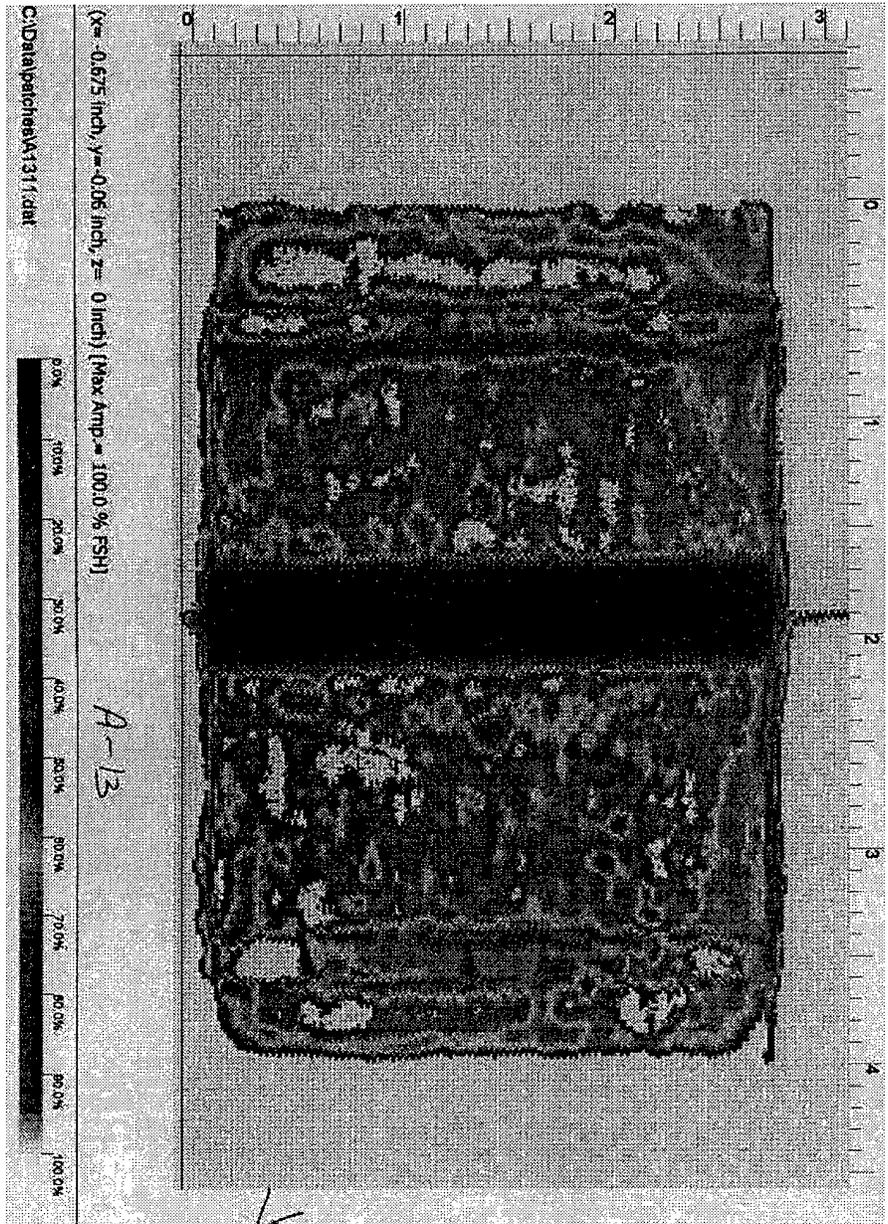
**Figure 56 End-of-Life C-SCAN of Panel A-13 with FWD**

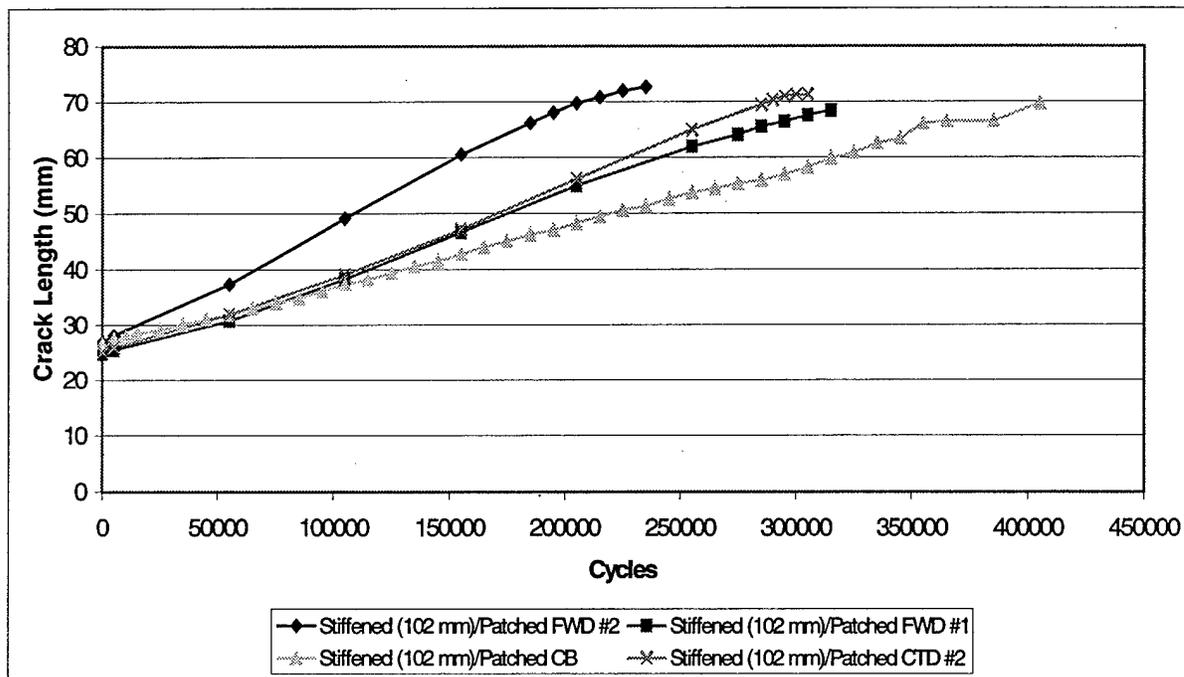
*Figure 57 Effects of FWD on 102 mm Spaced Stiffened Panels*

Data from the testing of FWD panels with 102 mm spaced stiffeners (panels A-14 and A-17) showed identical trends as data from the FWD panel with 152 mm spaced stiffeners, but the data from the two FWD panels did not correlate very well with each other. Figure 57 shows fatigue life data for the completely bonded, CTD, and both FWD repair configurations for panels with 102 mm spaced stiffeners. Both panels had substantial fatigue life reduction when compared to the completely bonded panel, A-5, and both FWD panels also had fairly linear  $a$  vs.  $N$  curves. However, while panel A-17 had an overall fatigue life reduction of 50% compared to the completely bonded panel, A-14 only had a reduction of 20%. Table 23 lists  $da/dN$  data for all four panels in different areas under the patch. Both FWD panels had very linear crack growth rates at all areas under the patch. This differed from panels with the CTD repair configuration. As the crack grew through the CTD repair configuration, it first encountered a perfectly bonded repair, followed by complete disbonding of the repair. With both the FWD and completely bonded repair configurations, the propagation environment did not change as the crack grew—it was always either completely bonded or completely disbonded. For this reason, panels with either completely bonded repairs or with FWD's present should always have linear crack propagation curves. Figure 58 shows the crack growth rate comparison between the perfectly bonded, CTD, and FWD panels with 102 mm spaced stiffeners. The FWD panel has the highest consistent crack propagation rate of the three disbond configurations and has a very constant  $da/dN$  with respect to crack length. The CTD panel has the next highest  $da/dN$  in comparison to the completely bonded panel.

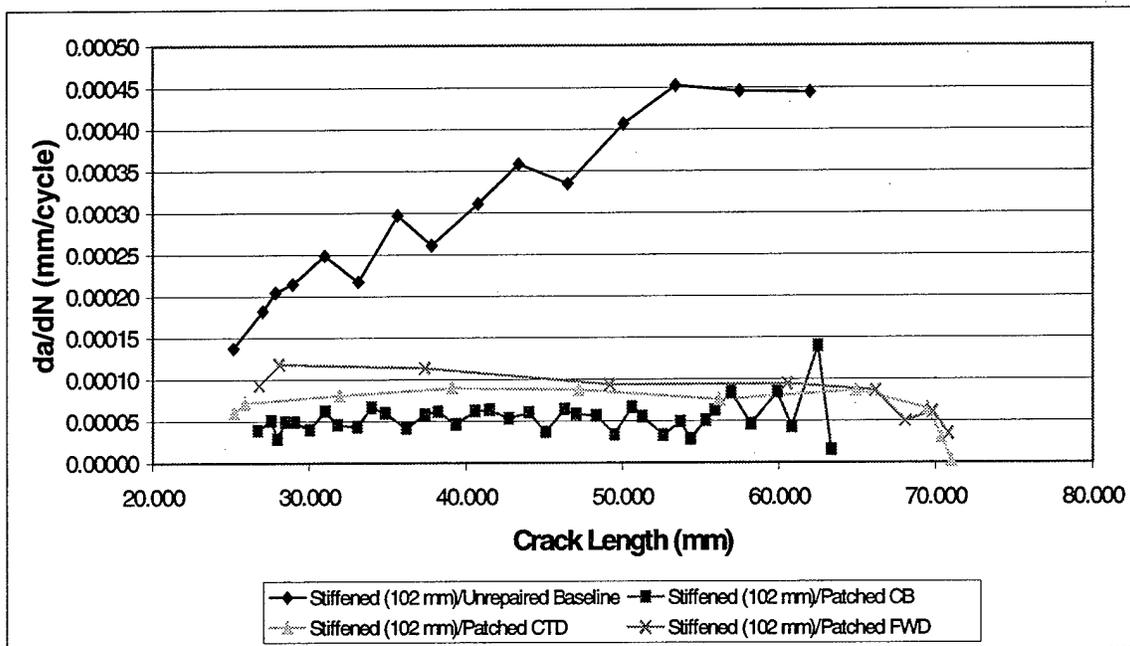
**Figure 58 Comparison of Crack Growth Rates for 102 mm Spaced Stiffener Panels**

Figure 58 also shows the crack propagation rate versus crack length curve for the unrepaired baseline panel with 102 mm spaced stiffeners for comparison.

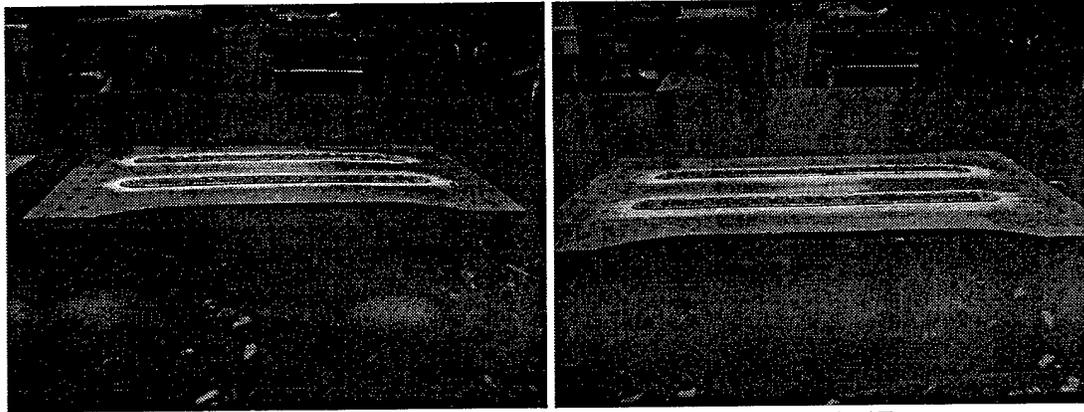
**Panel A-14**

**Panel A-17**

*Figure 59 Panel Curvature Differences Between A-14 and A-17*

life data. There are a few reasons, however, that, when combined together, could account for the approximately 53% difference in fatigue lives between the two panels. Firstly, all crack lengths were measured with a microscope and human eye, so operator error plays some role. Secondly, the hand-riveting process is not scientific. The pressure on the aluminum panel is not necessarily exactly the same from rivet to rivet and panel to panel. This can lead to different residual stresses between panels, possibly contributing to differences in the fatigue life data. Lastly, panel A-14 visibly had more curvature, and hence residual stresses, than panel A-17, as seen in Figure 59. It makes sense that A-14 performed better in tensile fatigue, since the panel had more residual compressive stresses than panel A-17. This is due in part to possible differences in stresses due to riveting. Also, during the riveting process, the pneumatic rivet gun head slipped off the rivet and slammed into the panel, leaving a large dent that had to be worked out. Because of a lack of panels, A-14 was still used. This was most likely the main cause for the difference in fatigue life of the two panels, so panel A-17 produced the most accurate data.

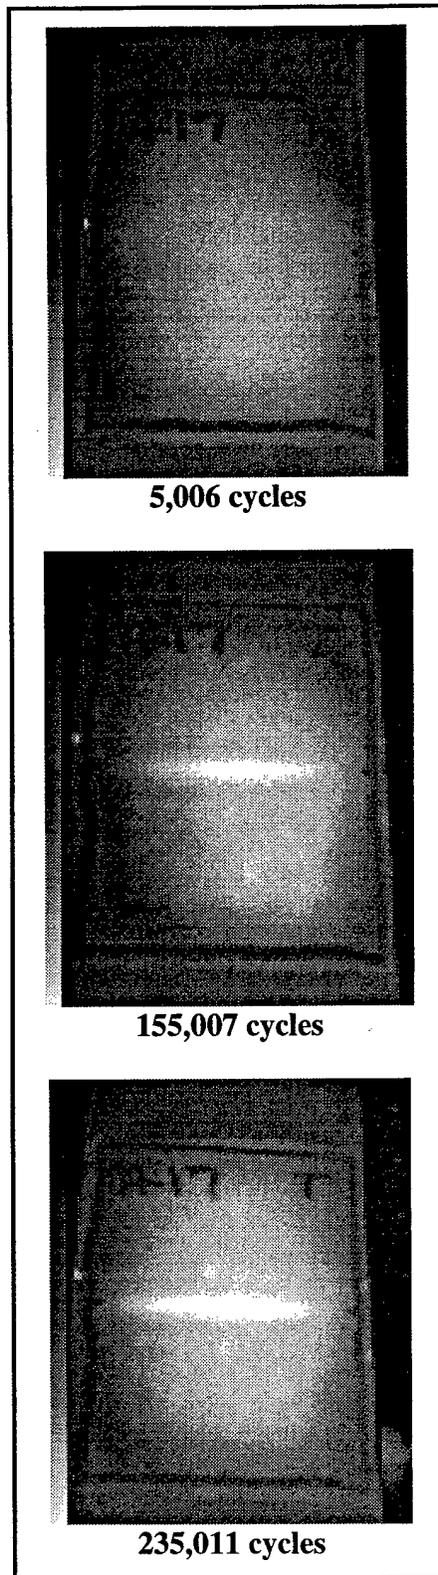
*Figure 60 Infrared Pictures of Panel A-17 with FWD*

While there was a decrease in fatigue life of FWD panels when compared to the baseline completely bonded repair, A-17 still performed much better than the unrepaired specimen, with a 280% longer fatigue life. Also, comparing IR pictures of the repair taken at different stages during cycling with a C-SCAN of the repair taken after cycling was completed, the bonded repair proved very durable as the intentional FWD did not grow. The infrared pictures are shown in Figure 60, and the C-SCAN is shown in Figure 61. The three IR pictures were taken at 5,006, 155,007, and 235,011 cycles corresponding to crack lengths of 28.08 mm (1.106 inches), 60.528 mm (2.383 inches), and 72.708 mm (2.863 inches). The C-SCAN was taken after 235,011 cycles corresponding to a crack length of 72.707 mm (2.863 inches).

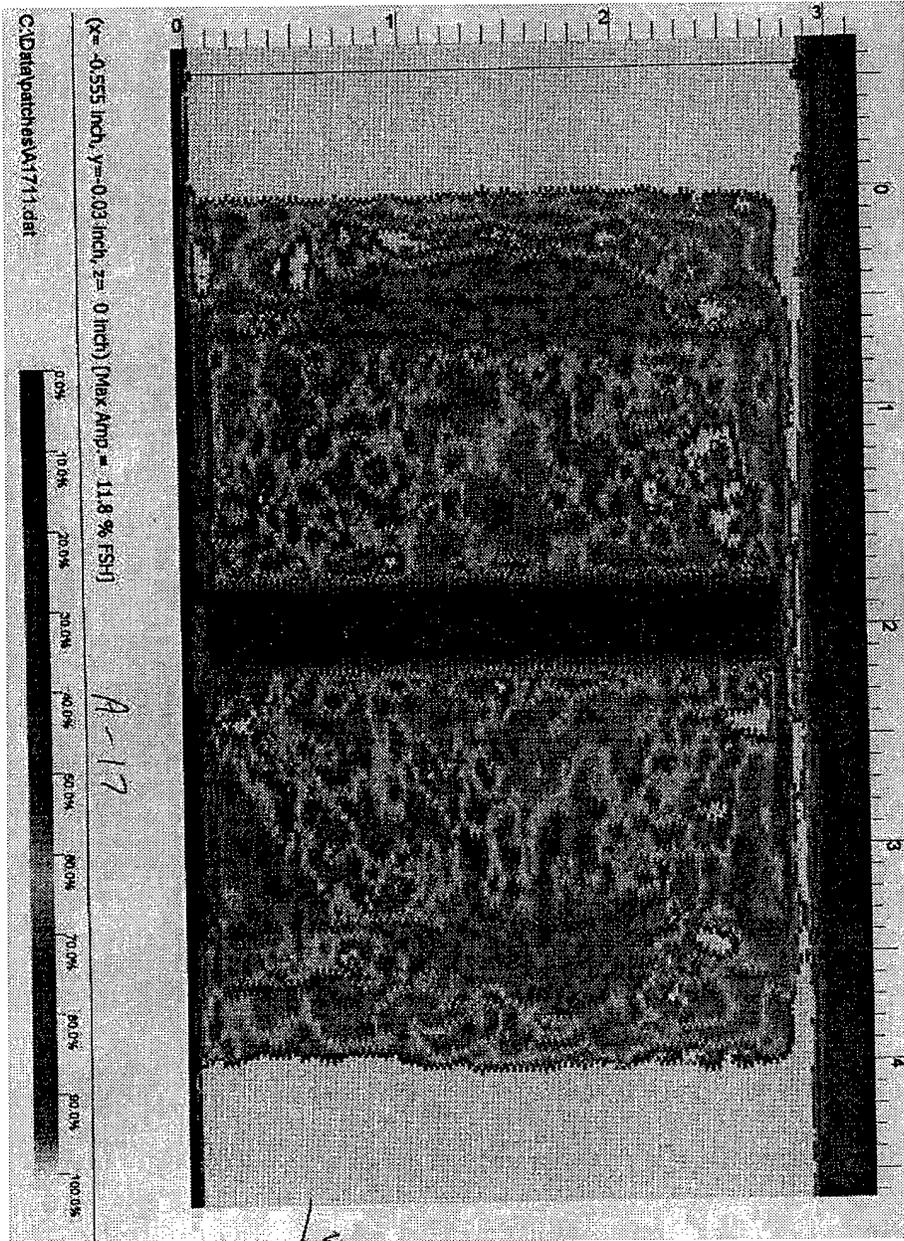
**Figure 61 End-Of-Life C-SCAN of Panel A-17 with FWD**

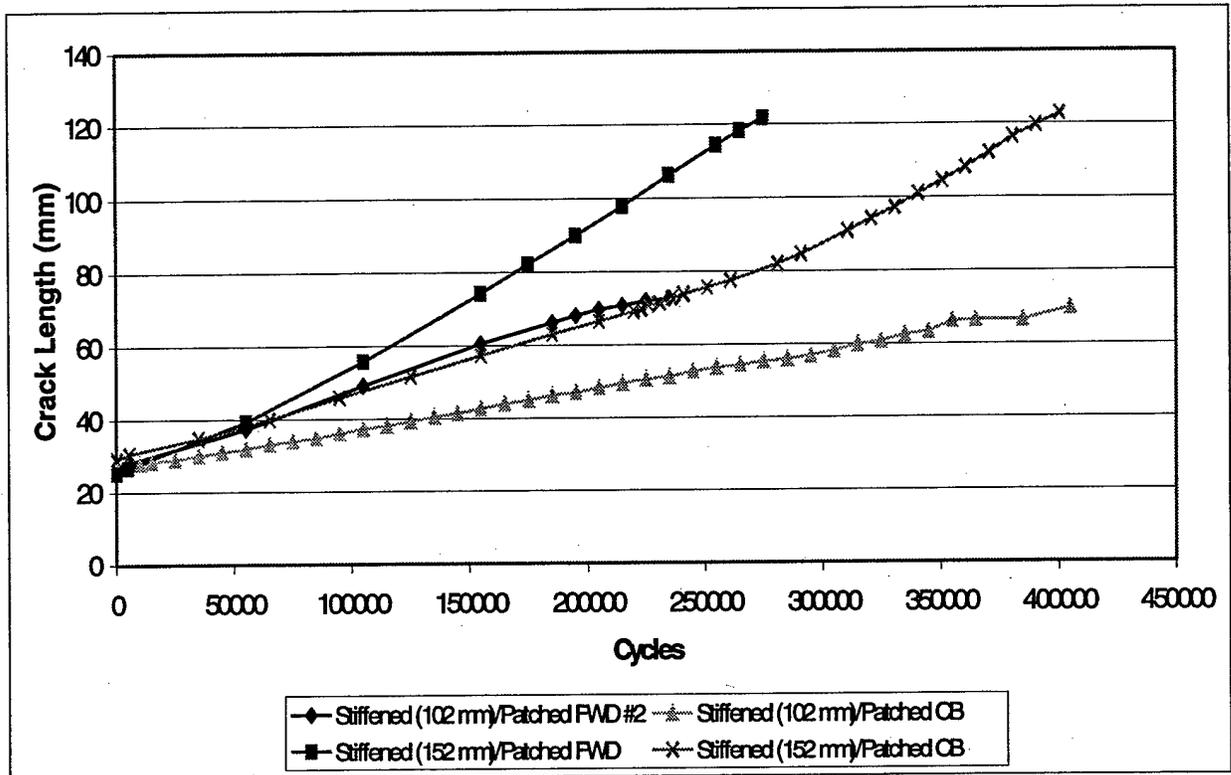
Figure 62 Fatigue Life Trend of Stiffened Panels with FWD

Both configurations of stiffened panels, the 152 mm spaced stiffeners and 102 mm spaced stiffeners, behaved approximately the same with FWD's present. For simplicity, since possible problems with panel A-14 were already brought to light, panel A-17 will be the only FWD panel with 102 mm spaced stiffeners discussed and compared to the 152 mm spaced stiffener configuration in this section. Both configurations showed considerable decreases in fatigue life, more than the CTD configuration, when compared to the perfectly bonded panels, which was expected. Figure 62 provides a direct comparison between fatigue life trends of the two different stiffener configurations. From the figure, both stiffener configurations appear to have been affected approximately the same with the disbonds present. Table 24 lists the effect the FWD had on the two different panel stiffener configurations. It shows the percentage of crack propagation increase for both stiffener configurations when compared to the completely bonded panels. Both configurations experienced a large impact on fatigue life due to the disbond, but, as with the CTD panels, the 102 mm spaced stiffener panel experienced a larger effect. As explained before, while this may be the case to some extent, panels with 152 mm spaced stiffeners have crack propagation rate curves more severely sloped than panels with 102 mm spaced stiffeners. This causes the detrimental effects of the disbonds to seem less severe for that configuration.

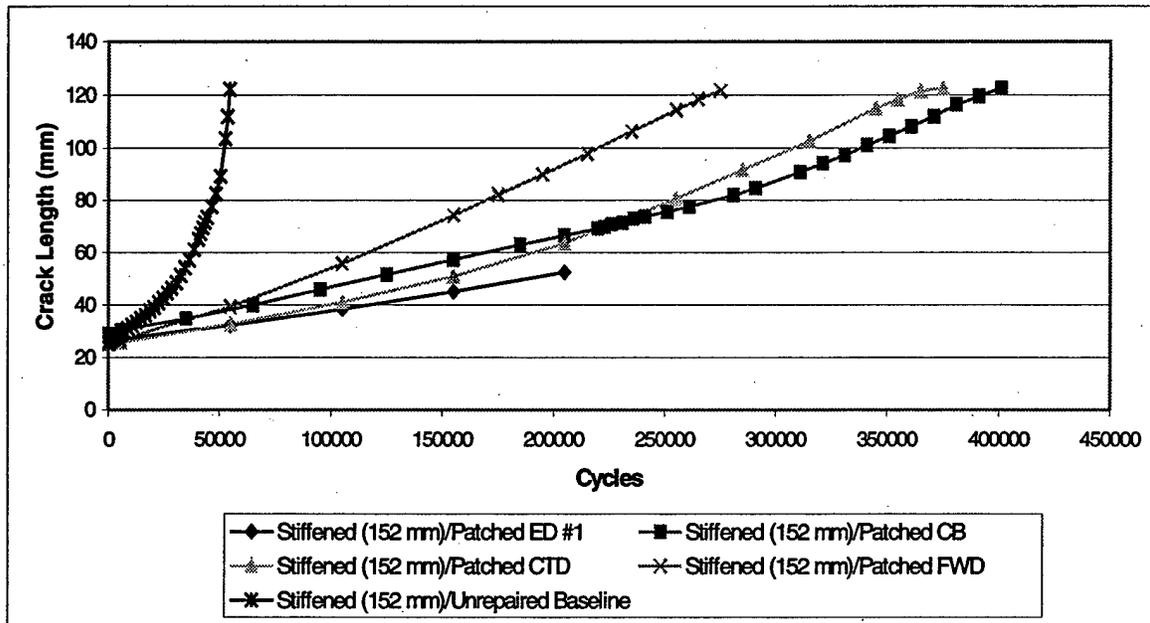
**Figure 65 ED Effects on Fatigue Life of 152 mm Centered Stiffened Panels**

crack propagation occurred within the realm of a completely bonded patch, since the disbond was intentionally placed away from the crack. The results are shown schematically in Figure 65, Figure 69, and Figure 73. Figure 65 shows the effect of the ED on panels with 152 mm spaced stiffeners and how the fatigue life of those panels compared to the baseline data. Figure 69 shows the same for panels with 102 mm spaced stiffeners. Figure 73 shows a direct comparison between ED effects when dealing with 152 mm spaced stiffeners and 102 mm spaced stiffeners.

The overall fatigue life of the repaired panels with 152 mm spaced stiffeners showed relatively no difference between the completely bonded patch and one with ED's present, as seen in Figure 65. By comparing crack propagation data in Table 27, not only is there no increase in  $da/dN$  with an ED present, the rate decreased by approximately 30%. Figure 66 provides a graphical representation of the crack propagation rate versus crack length. According to the inclusion analogy (29; 30), the composite patch and skin act together as a region of higher stress. If the length of this higher stress region decreases, as it essentially does when ED's are present, the region attracts less load from the surrounding skin (11). This decrease in attracted load results in a reduced patch and skin stress around the crack, and hence a reduced repaired stress intensity factor,  $K_r$ . This reduced  $K_r$  results in the crack tips experiencing less stress, leading to a slightly slower crack propagation rate. ED's present in the repair appear to cause no significant reduction in repair life when compared to the completely bonded repair baseline. This is

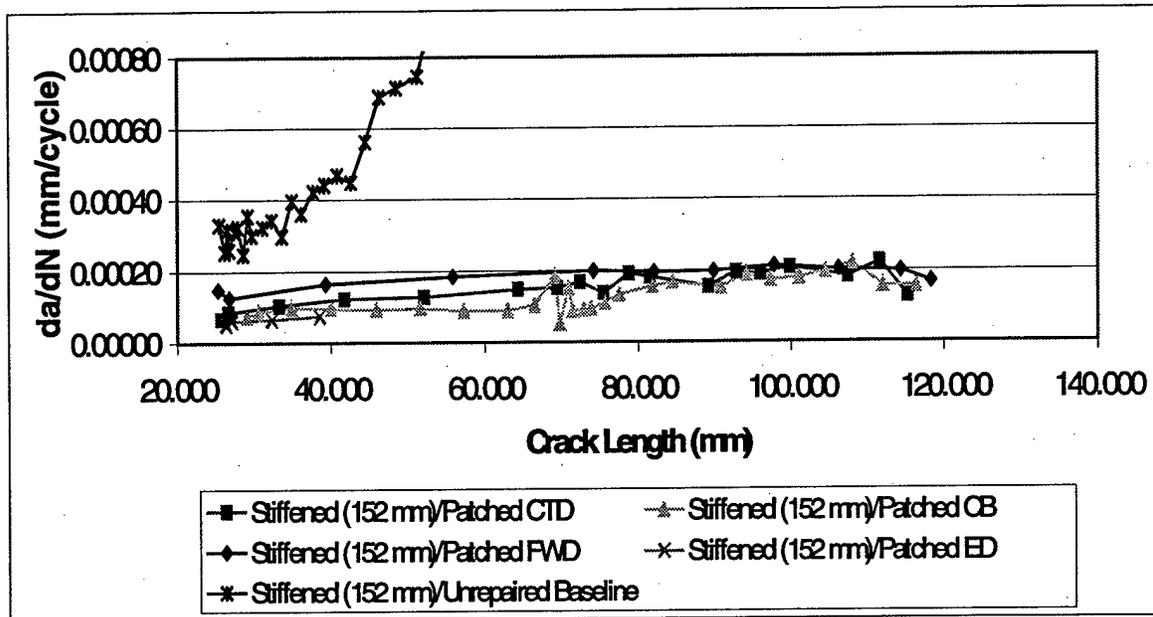
**Figure 66 Comparison of Crack Growth Rates for 152 mm Spaced Stiffener Panels**

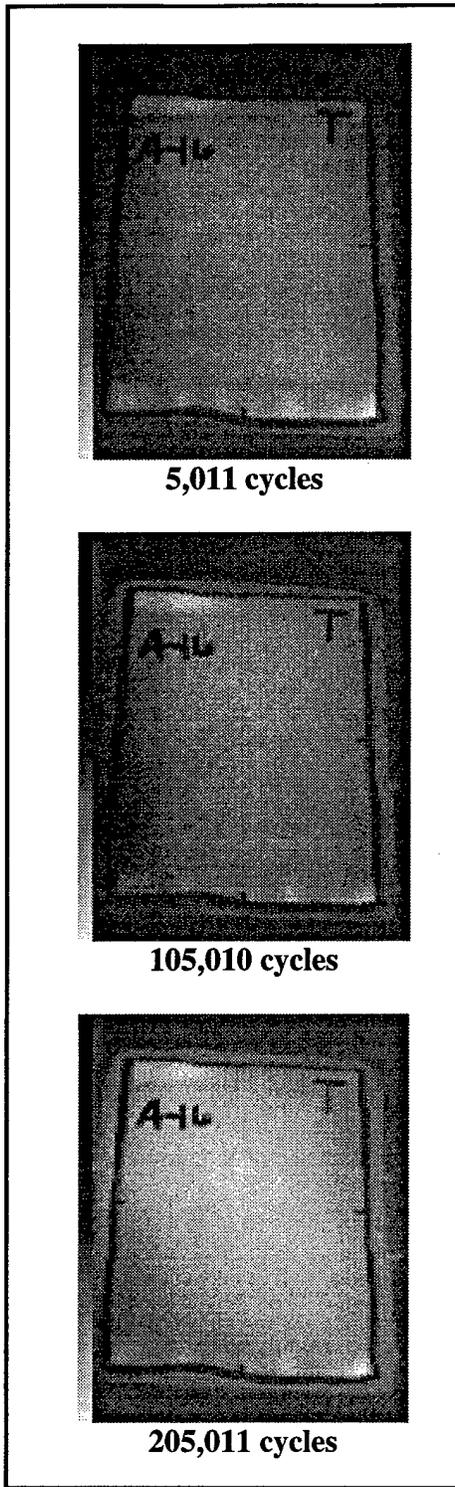
*Figure 67 Infrared Pictures of Panel A-16 with ED*

Panels with ED's present proved to be just as durable under tensile fatigue as the other disbond cases. This can be seen by comparing IR pictures of the repair taken at different stages during cycling with a C-SCAN of the repair taken after cycling was completed. The infrared pictures are shown in Figure 67 and the C-SCAN is shown in Figure 68. The three IR pictures were taken at 5,011, 105,010, and 205,011 cycles corresponding to crack lengths of 27.102 mm (1.067 inches), 38.532 mm (1.517 inches), and 52.476 mm (2.066 inches). The C-SCAN was taken after 212,816 cycles corresponding to a crack length of over 52.476 mm (2.066 inches). Comparison of the pictures with the C-SCAN show that the end disbonds did not grow larger over time in the constant amplitude cyclic fatigue environment.

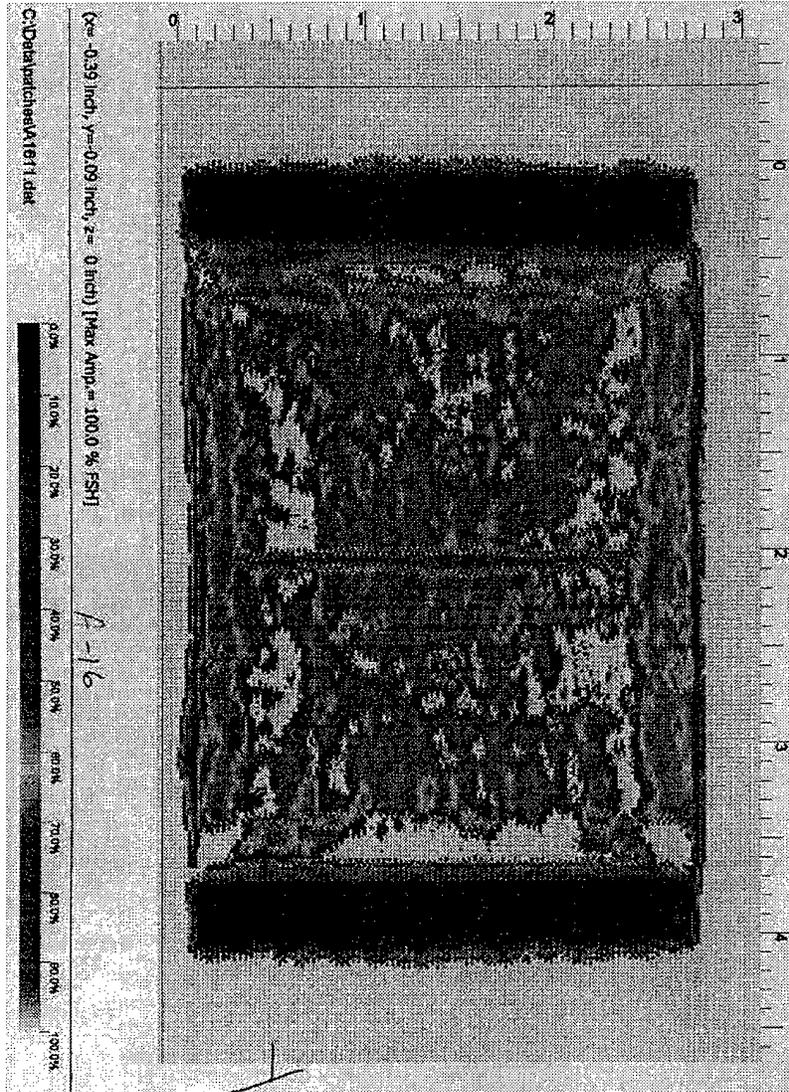
Figure 68 End-of-Life C-SCAN of Panel A-16 with ED

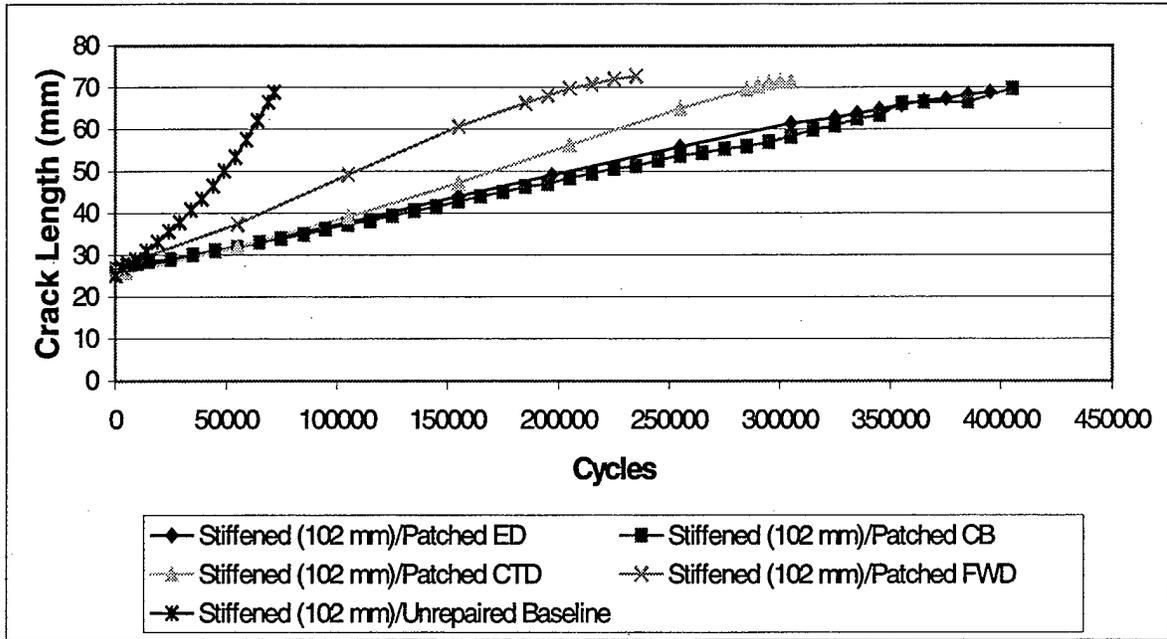
*Figure 69 Effects of ED on 102 mm Spaced Stiffened Panels*

Data from the testing of ED panels with 102 mm spaced stiffeners (panel A-15) showed a similar trend as did data from the ED panel with 152 mm spaced stiffeners. Figure 69 shows fatigue life data for the completely bonded, CTD, FWD, and ED repair configurations, as well as the unrepaired baseline configuration, for panels with 102 mm spaced stiffeners. The a vs. N curve for the ED configuration is almost identical to that of the completely bonded case. By comparing crack propagation data in Table 28, panel A-15 with ED's present has approximately the same crack propagation rate as panel A-5, which has a perfect bond. This end result is what was expected and reinforces Baker's (32) findings that disbonds have more of an effect on crack propagation rate and fatigue life when they have more intimate contact with the crack/damage. Figure 70 provides a graphical representation of the crack propagation rate versus crack length data.

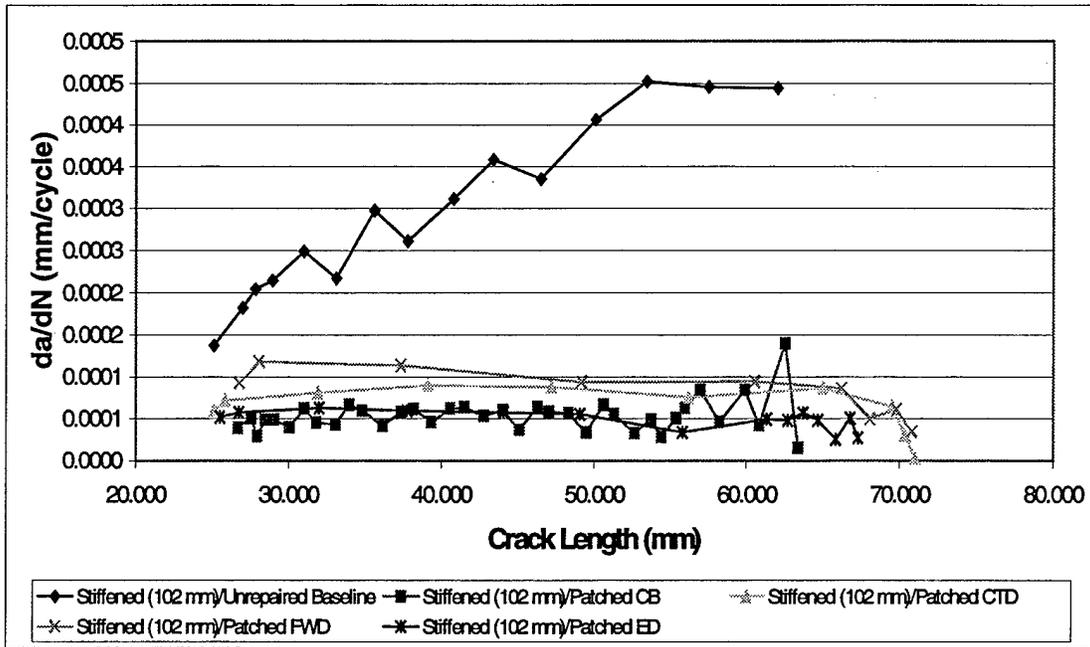
**Figure 70 Comparison of Crack Growth Rates for 102 mm Spaced Stiffener Panels**

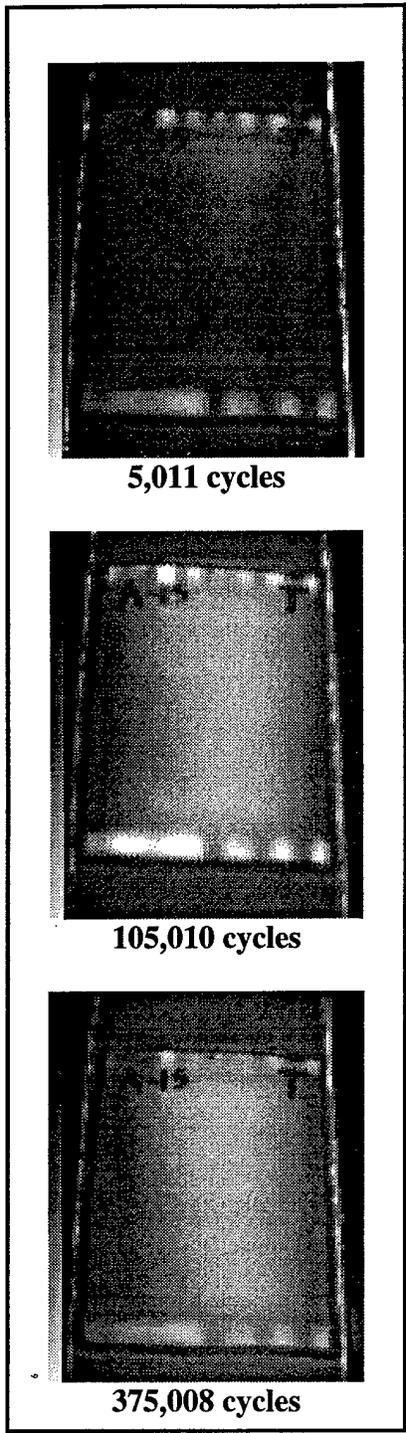
*Figure 71 Infrared Pictures of Panel A-15 with ED's*

Repaired panels with ED's present and 102 mm spaced stiffeners were as durable as the 152 mm spaced stiffener case. Comparing IR pictures of the repair taken at different stages during cycling with a C-SCAN of the repair taken after cycling was completed, it can be seen that no disbond growth occurred. The infrared pictures are shown in Figure 71 and the C-SCAN is shown in Figure 72. The three IR pictures were taken at 5,011, 105,010, and 375,008 cycles corresponding to crack lengths of 26.772 mm (1.054 inches), 37.757 mm (1.486 inches), and 67.259 mm (2.648 inches). The C-SCAN was taken after 395,000 cycles corresponding to a crack length of 68.821 mm (2.709 inches).

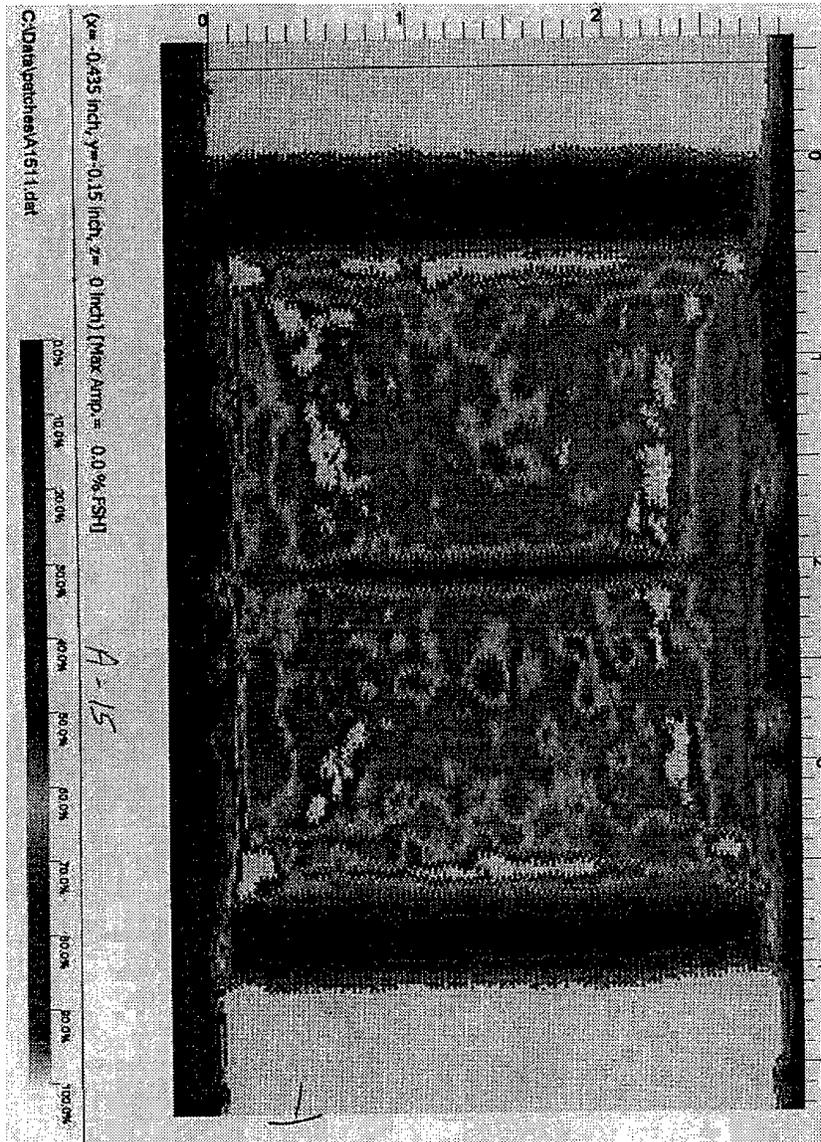
*Figure 72 End-of-Life C-SCAN of Panel A-15 with ED's*

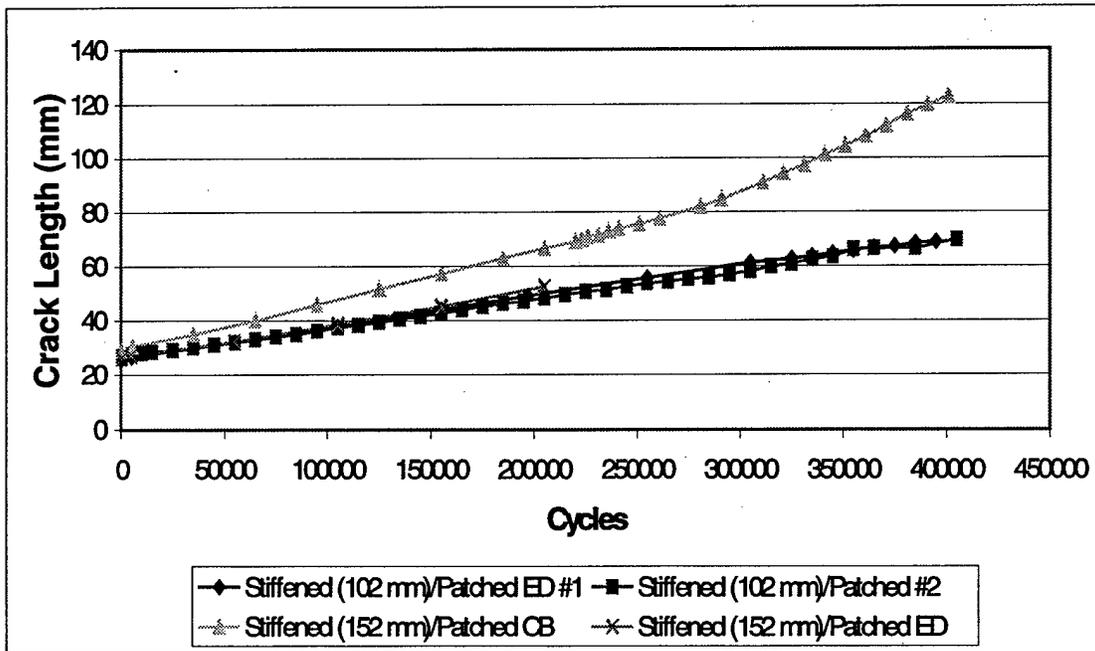
Figure 73 Fatigue Life Trend of Stiffened Panels with ED
