Review of F-111 Structural Materials

DSTO-TR-1118

ABSTRACT

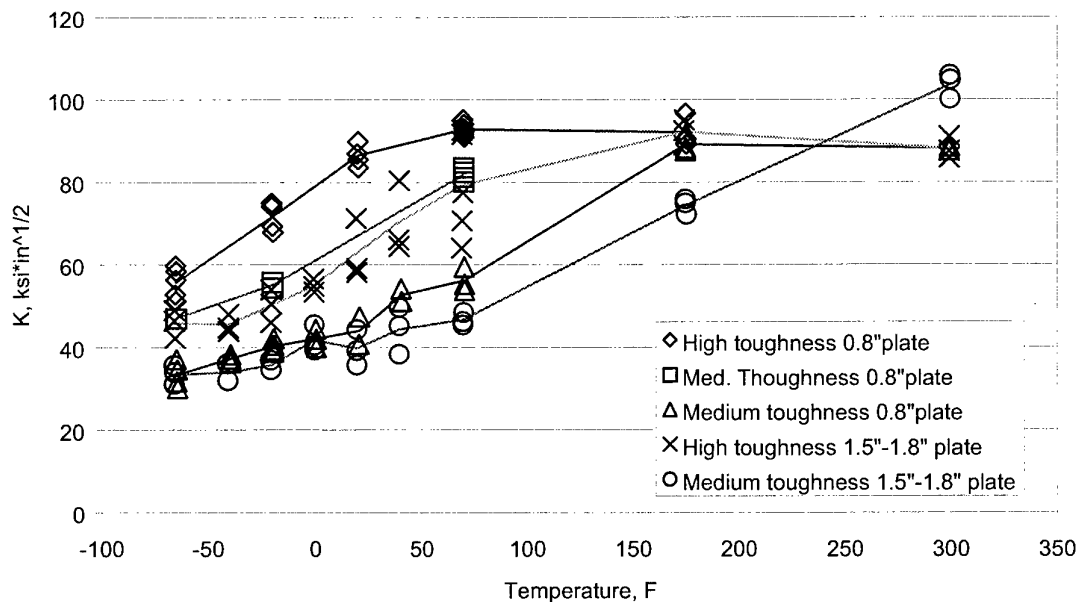
Figure 2. Variation in fracture toughness with test temperature for plates of medium and high toughness at two different thicknesses [Feddersen et al. 1972].

Feddersen et al. (1972) also studied the effect of test temperature on the fracture toughness. The toughness generally increases with temperature up to 38-66°C (100-150°F) for high toughness plate and forgings, from where it levels off. In low toughness plate, the toughness becomes constant at temperature >66°C (150°F), and in low toughness forgings the levelling off was not observed at all up to 149°C (300°F) (the maximum test temperature reported). The effect of temperature on toughness of plates of various fracture toughness is illustrated in Figure 2. Additional data on the variation in toughness with temperature may be found in Feddersen's report. The decrease in fracture toughness with decreasing temperature was also utilised in the Cold Proof Load Test, where the critical fracture toughness is reached at smaller crack sizes than would be required in normal service, therefore ensuring that surviving cracks are innocuous.

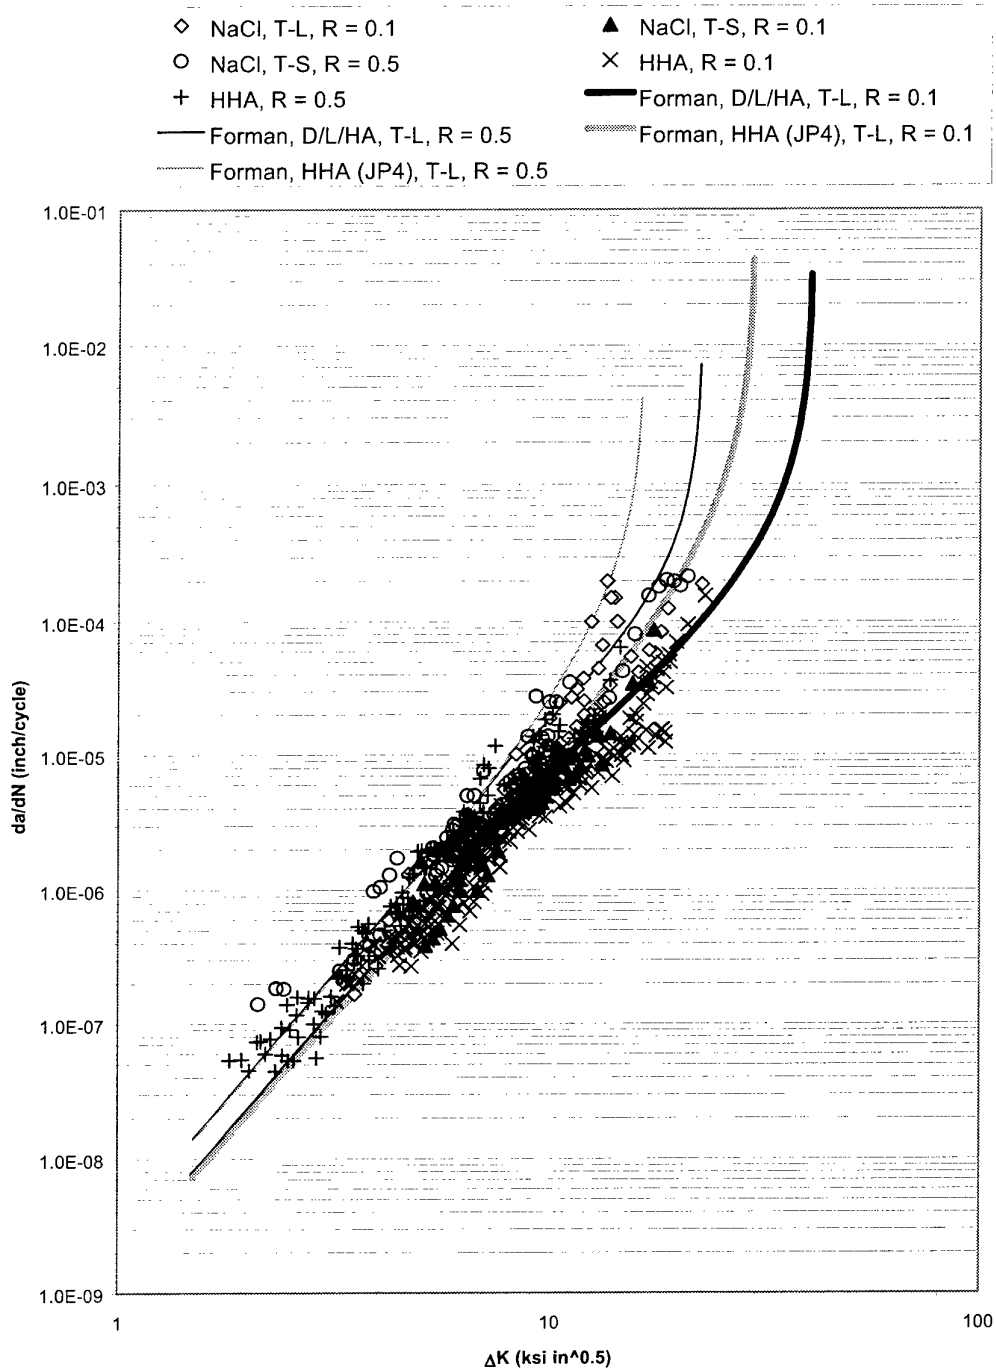
Figure 24. FCG data for 2024-T851 in humid air and NaCl [Krupp et al. 1974] shown with Forman curve fits [Ball and Doerfler 1996].

Figures 23, and 25-26 all show the tight families of data for a variety of environments studied by several aerospace companies, including Lockheed, McDonnell Douglas, and Rockwell. Figure 24 gives an idea of where the Lockheed Forman curves fall compared to the data from which they were derived.

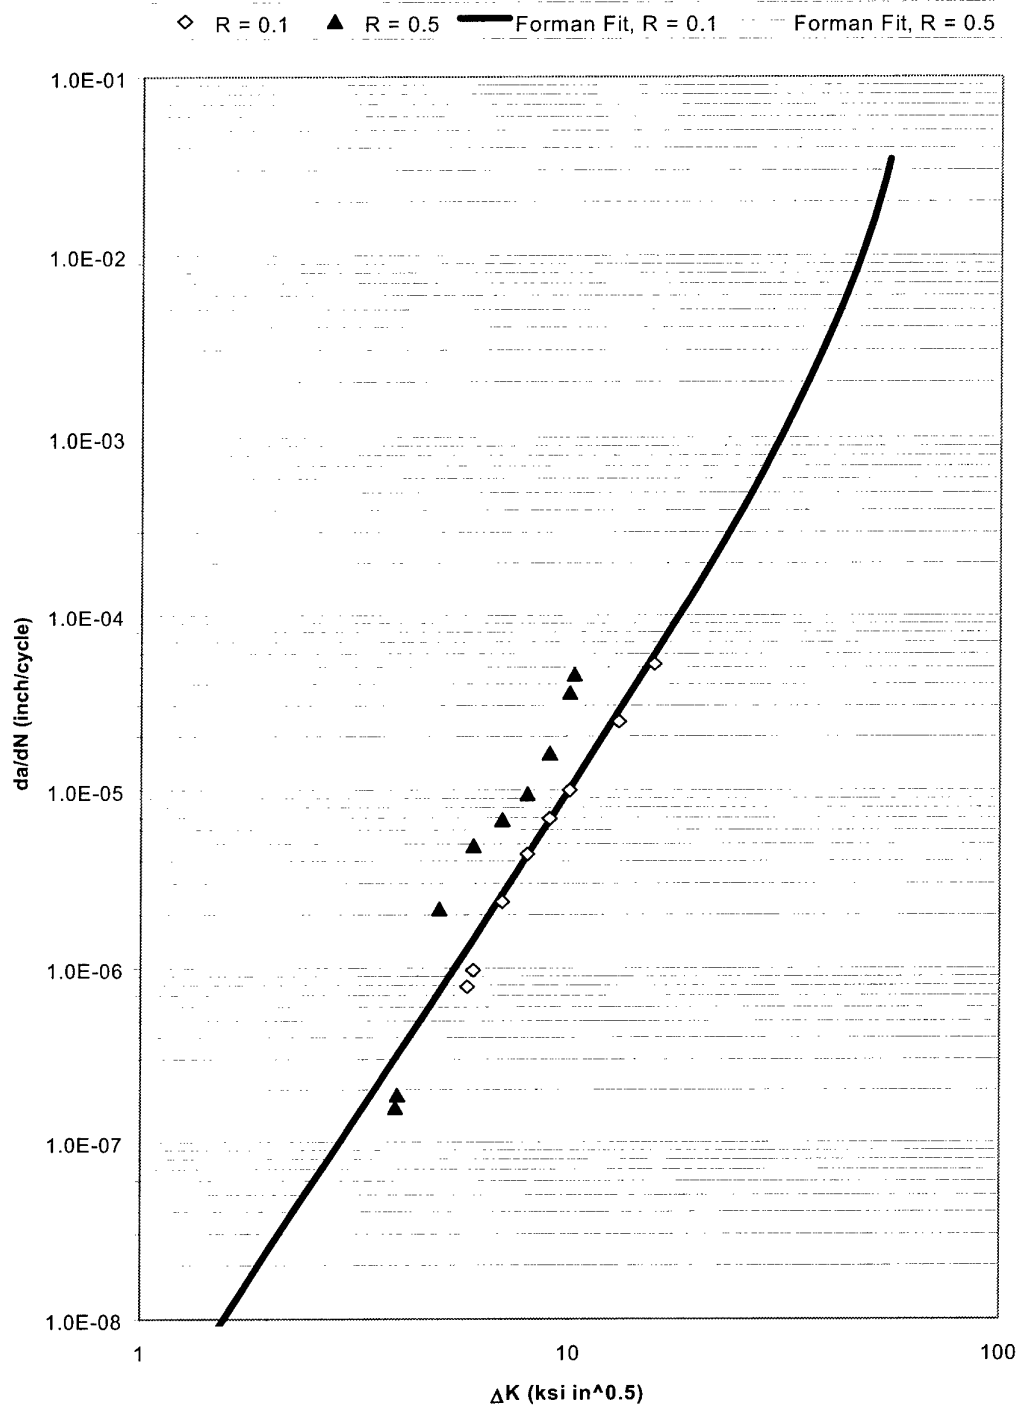
Figure 27. Original data fit used for Lockheed DADTA on F-111 [Ball and Doerfler 1996].

7075-T6 is probably one of the most widely researched aluminium alloys in the aerospace industry, so only a handful of data are presented here to illustrate the key points. The first plot (Fig. 27) shows the basic Damage Tolerance Design Handbook data used by Lockheed to generate the Forman curves for two different stress ratios at $R = 0.1$ and $R = 0.5$. The solid lines represent the Forman curves from Ball and Doerfler (1996).
