Investigation of Fiber-Reinforced Polymer for Seismic Rehabilitation of Concrete Structural Frames With Unreinforced Masonry Infill

Ghassan K. Al-Chaar, Justin B. Berman,
and Steven C. Sweeney

May 2003

ERDC/CERL TR-03-10

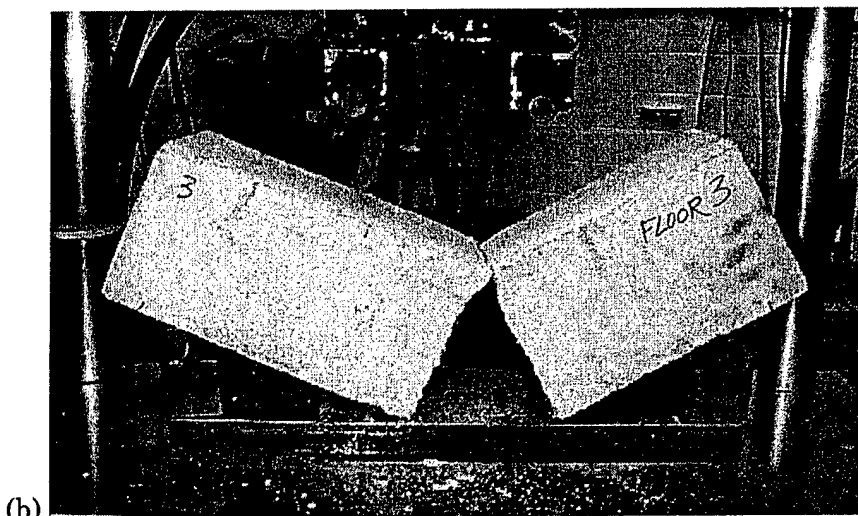
Figure 3.13. Concrete flexural specimen for 4-point bending test (a) before test and (b) after test.

The concrete modulus of rupture was determined according to ASTM C78-94. All specimens failed within the center third of the beam. Before and after photos of one of these test specimens are shown in Figure 3.13. A summary of concrete flexural strength is presented in Table 3.7.

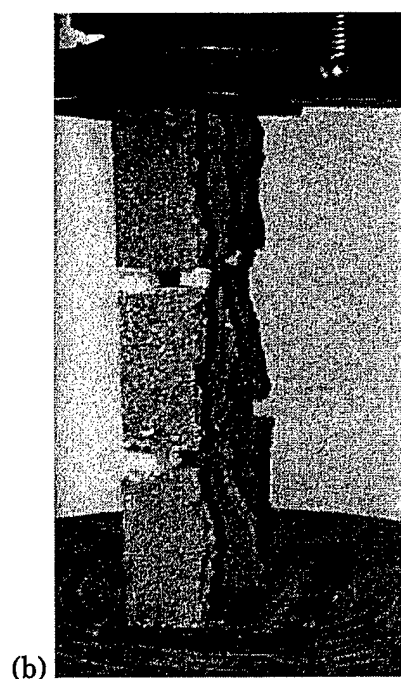
**Figure 3.20. Compression test setup and failure mode for masonry prisms.**

Prisms for each floor were constructed and tested according to ASTM C1314-00. The age, compressive strength, and modulus of elasticity for each floor for each model are summarized in Table 3.10. Compressive strength was calculated using a net area of 10.5 sq in. The modulus of elasticity was calculated as $E_m = 750 f_m$. All specimens failed from a single tensile crack that propagated down the center of the prism, which was oriented in the longitudinal direction of the CMU. Pictures of the test setup and mode of failure for the masonry prism are shown in Figure 3.20.

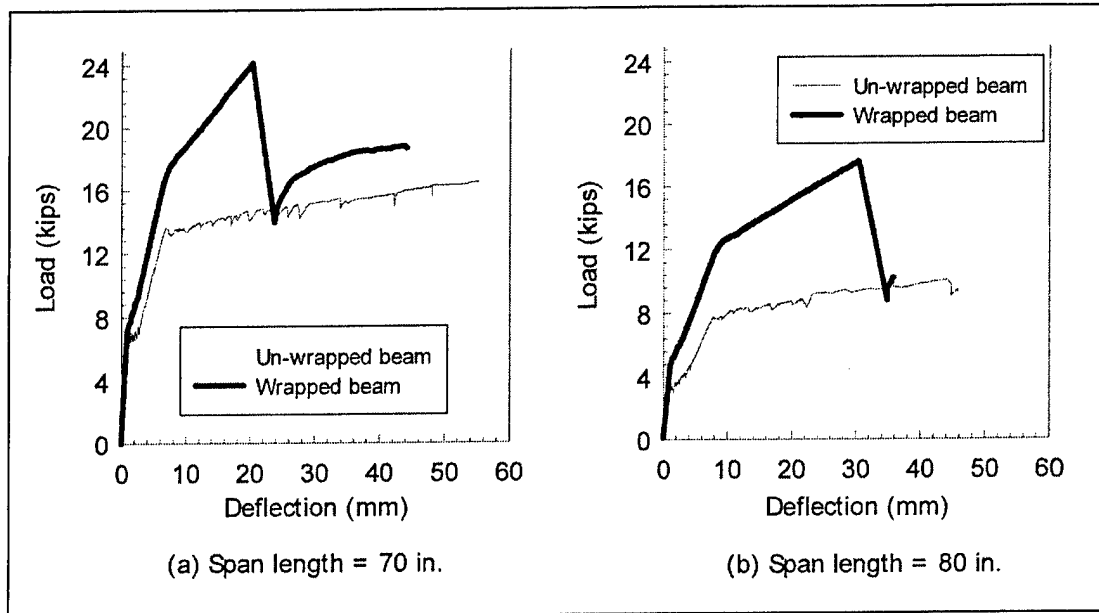
Figure 4.7. Load/displacement response of wrapped and unwrapped beams.

The observed results were analyzed and compared. The load/displacement response of CFRP-wrapped and unwrapped beams are shown in Figure 4.7. For the wrapped specimens, the increase in ultimate load was 75% for beams with shear span-to-depth ratio (a/d) of 2.7, and 45% increase for those with a/d ratio of 1.8. Failure occurred due to tension in the flexural zone of the concrete, and there was tensile failure in the CFRP laminate after the concrete was crushed under the loading points.

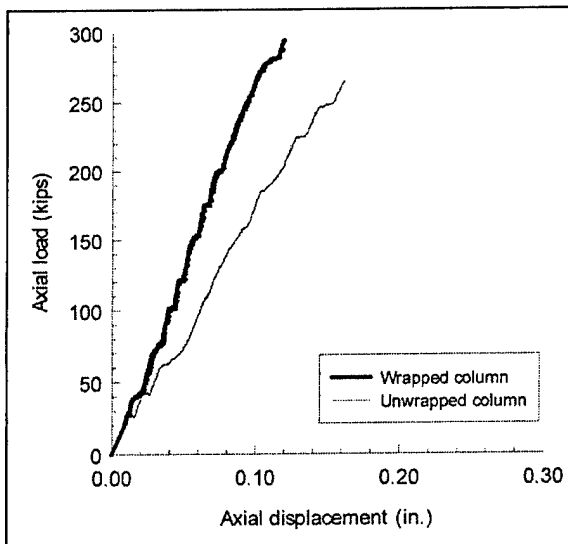
Figure 4.8. Axial load/displacement response of wrapped and unwrapped columns.

The comparison of the test results for wrapped and unwrapped columns is shown in Figure 4.8. The confinement due to the wrapping of CFRP sheets was clearly manifested. The ultimate load for the wrapped column was 12% higher than for the unwrapped column with only one thin layer of CFRP applied. By comparison, the CFRP made a significantly greater strength contribution to the wrapped compressive test cylinder specimens, which registered a 50 percent compressive strength increase over the unwrapped specimen. This higher performance is attributed to

the fact that a circular cross section member wrapped with CFRP fails with less stress concentration on the CFRP fibers, and therefore it can resist a greater load than a CFRP-wrapped rectangular cross section.

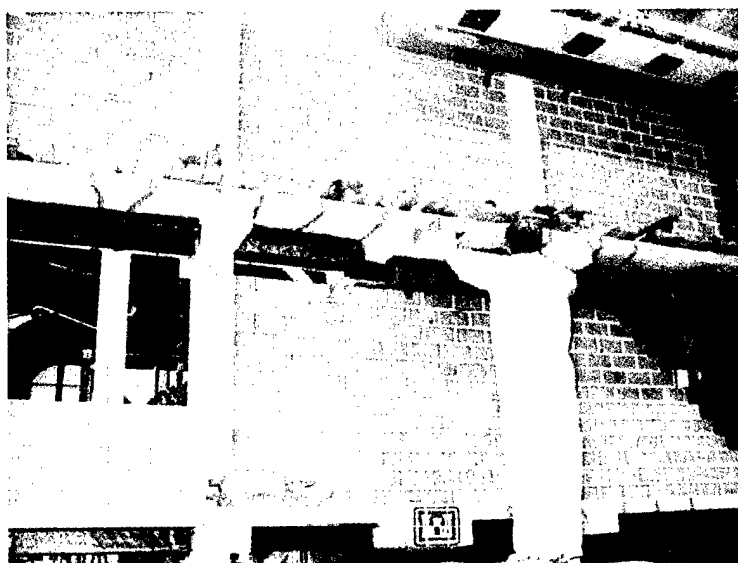
Figure 6.4. Photograph of stories two and three of the rehabilitated frame.

Figure 6.4 shows a photograph of a portion of the rehabilitated frame. The CFRP appears black and spans the lower portion of the beams, and the gray bands on the beams are the J-51 epoxy sealant. The J-56 injection epoxy is clear and not visible in the photograph.
