1. REPORT DATE (DD-MM-YYYY) 04-06-2003		2. REPORT TYPE Technical Viewgraph Presentation		3. DATES COVERED (From - To)	
4. TITLE AND SUBTITLE Usage of Multi-Axis Fiber Grating Strain Sensors to Support Nondestructive Evaluation of Composite Pressure Vessels and Adhesive Bond Lines				5a. CONTRACT NUMBER F04611-02-C-0007	
				5b. GRANT NUMBER	
				5c. PROGRAM ELEMENT NUMBER

Usage of Multi-Axis Fiber Grating Strain Sensors to Support Nondestructive Evaluation of Composite Parts and Adhesive Bond Lines

The 4th International Workshop on
Structural Health Monitoring
Stanford University

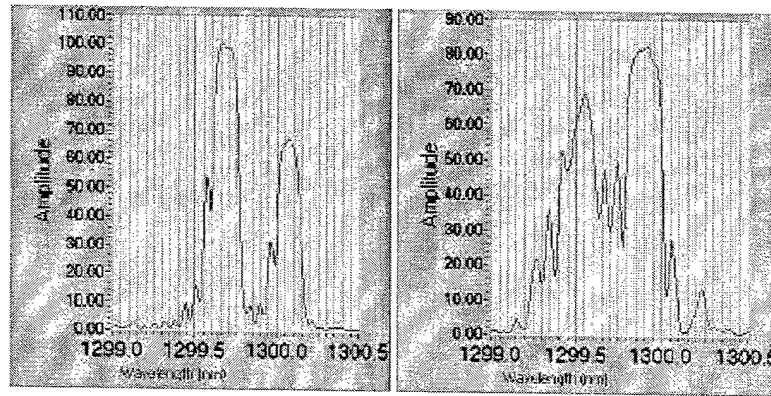
(a) (b)
Figure 5. Aligned dual-axis fiber grating strain sensor placed bare into the pressure vessel near the area of the cut tow damage site (a) before cure and (b) after cure.

Figure 5 shows the spectral profile of the dual-axis fiber grating strain sensor placed near the area of the cut tow damage site in the pressure vessel. In this case, prepreg tow alignment elements were placed on either side of the fiber grating but not over it, so the dual-axis fiber grating was integrated directly into the composite article. Before cure and completion of the pressure vessel, the two spectral peaks corresponding to the two transverse axes of the dual-axis fiber grating strain sensor are undistorted by transverse strain gradients. The short wavelength peak is aligned in the plane of the cylinder while the long wavelength peak is orthogonal to it. After cure significant transverse strain gradients appear on the short wavelength peak corresponding to transverse strain gradients in the plane of the cylinder in the direction of the cut tow. Of the six dual-axis fiber grating strain sensors placed in the part this was the only one exhibiting this type of behavior.

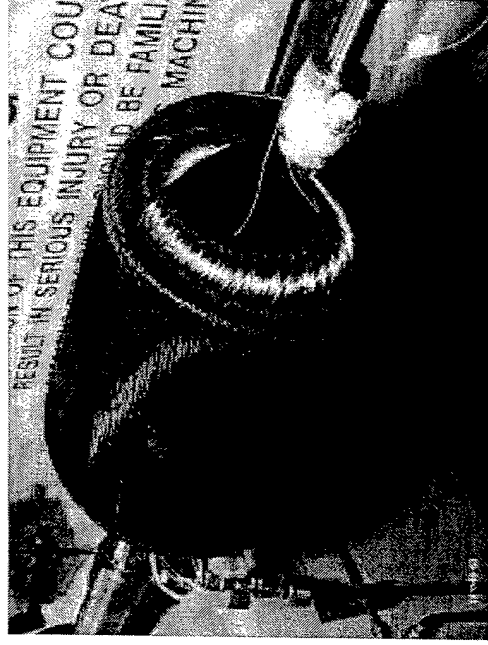
Casing with Embedded Fiber Grating Strain Sensors
