1. REPORT DATE (DD-MM-YYYY) 04-06-2003		2. REPORT TYPE Technical Presentation		3. DATES COVERED (From - To)	
4. TITLE AND SUBTITLE Usage of Fiber Grating Strain Sensors for Diagnostics of Composite Pressure Vessels				5a. CONTRACT NUMBER F04611-02-C-0007	
				5b. GRANT NUMBER	
				5c. PROGRAM ELEMENT NUMBER

USAGE OF FIBER GRATING STRAIN SENSORS
FOR DIAGNOSTICS OF COMPOSITE PRESSURE VESSELS

16th International Conference on Optical Fiber
Sensors (OFS-16)
October 13-17, 2003
Nara, Japan

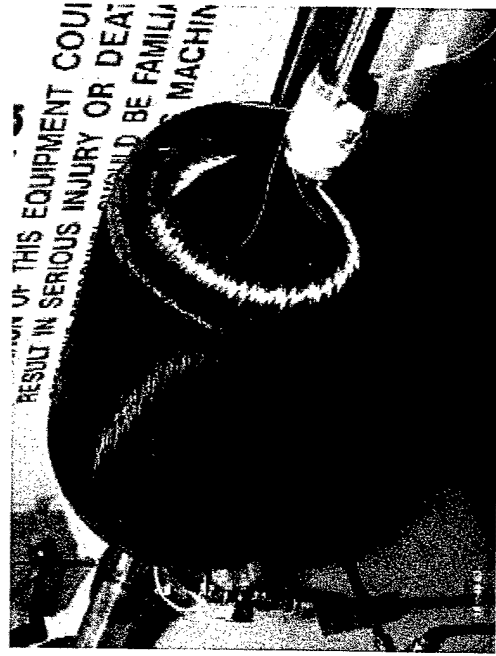
Casing with Embedded Fiber Grating Strain Sensors

Parameter	Characteristics
Composite	T700/UF3369
Liner	Approx. 12" dia. & 20" length Cross linked Polyethylene 5.7 lbs.
Winding Plan: Wind directly over plastic liner	Made by Roto Molding of Utah 3 Helical layers (0.0705 in. thick) 2 to boss -10 deg. X 1stepped back one bandwidth -16 deg. Xsb 7 hoop plies (0.0823 in. thick) 4 tows/band 5 lbs/tow tension
Winding Sequence	X O O O Xsb O O O X O

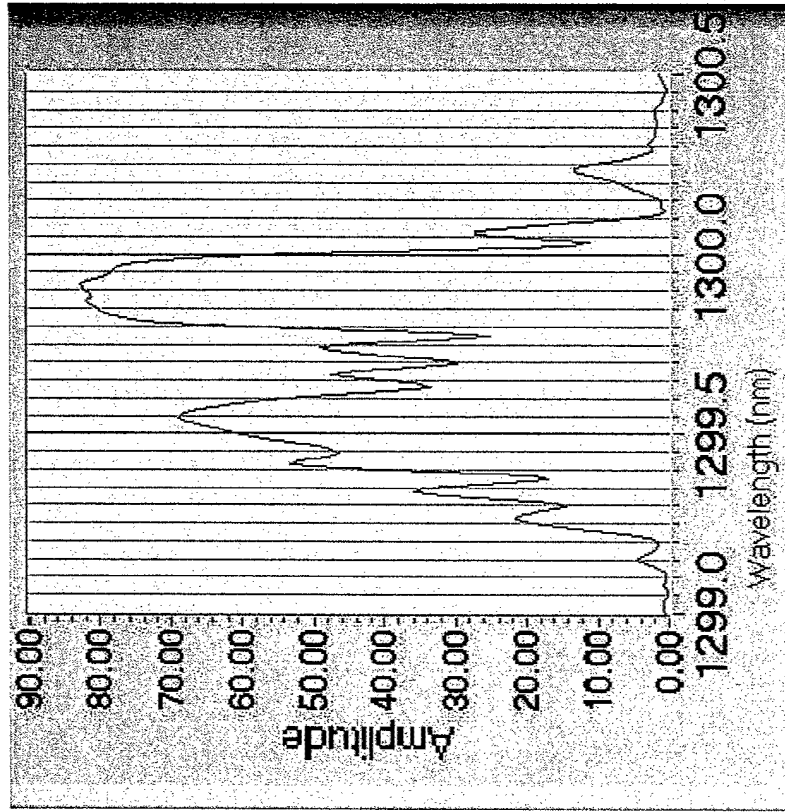
Spectral Profile of Sensor #8 (a) before and (b) after curing process

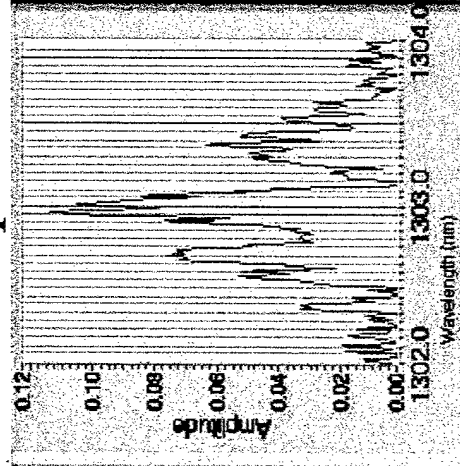
Sequence of Spectral Profiles from Sensor 2 Near Teflon Tape Damage Site during 1st pressure cycle

0 psi

666 psi

1000 psi

333 psi

Return to 0 psi

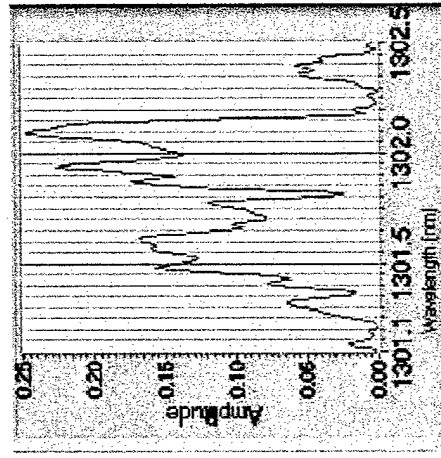
Spectral Profiles of Sensor 8 After Impact 2 Near Cut Tow Area During 3rd Pressure Cycle

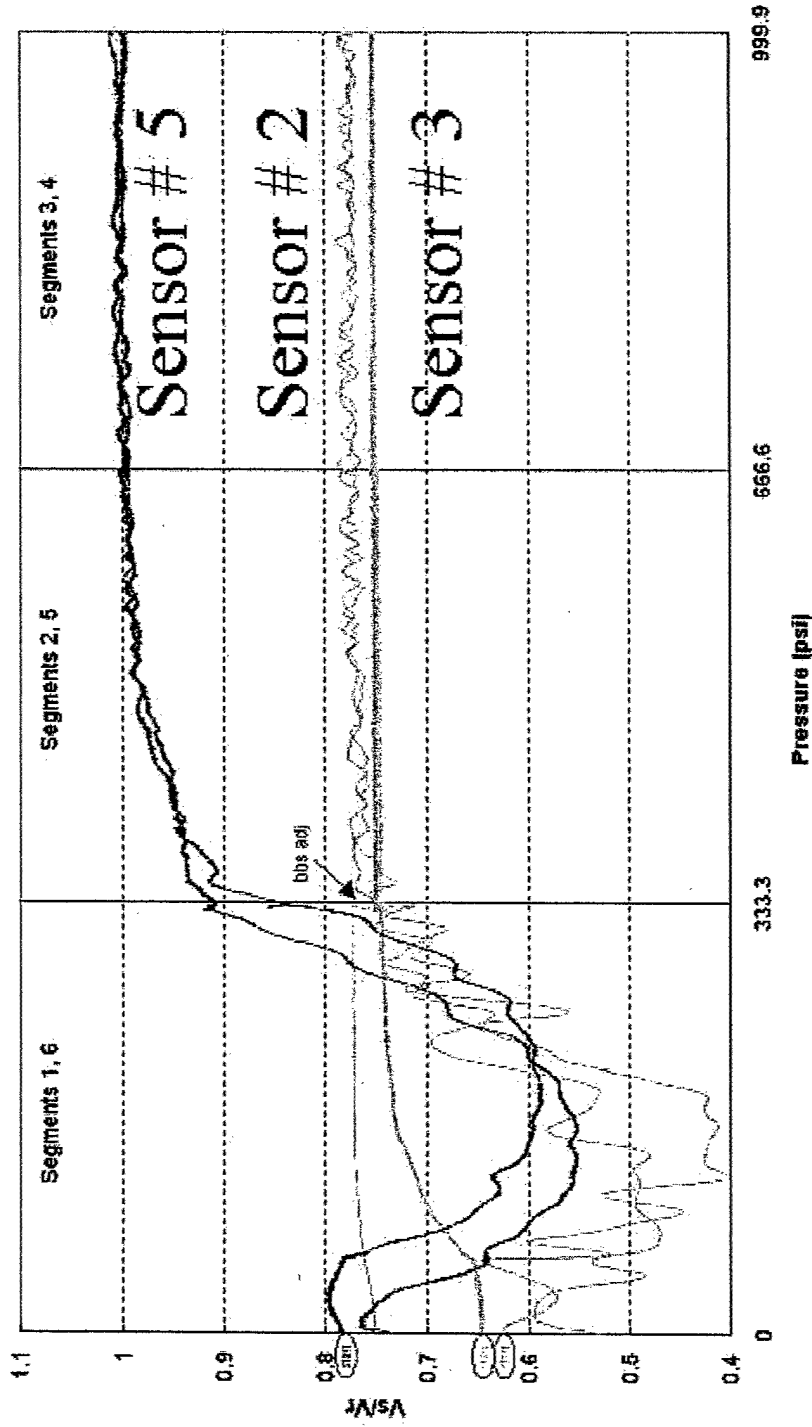
Strain Measurements Made During 1st Pressure Cycle

Sensor 2: deepest embedded layer, near Teflon tape flaw
 Sensor 3: opposite side of tank, in same layer as sensor 2
 Sensor 5: middle embedded layer in same area as sensor 2
