# Aircraft Carrier Flight and Hangar Deck Fire Protection: History and Current Status

**NAVAL AIR WARFARE CENTER WEAPONS DIVISION  
CHINA LAKE, CA 93555-6100**

## **NAWCWD Technical Publication 8516**

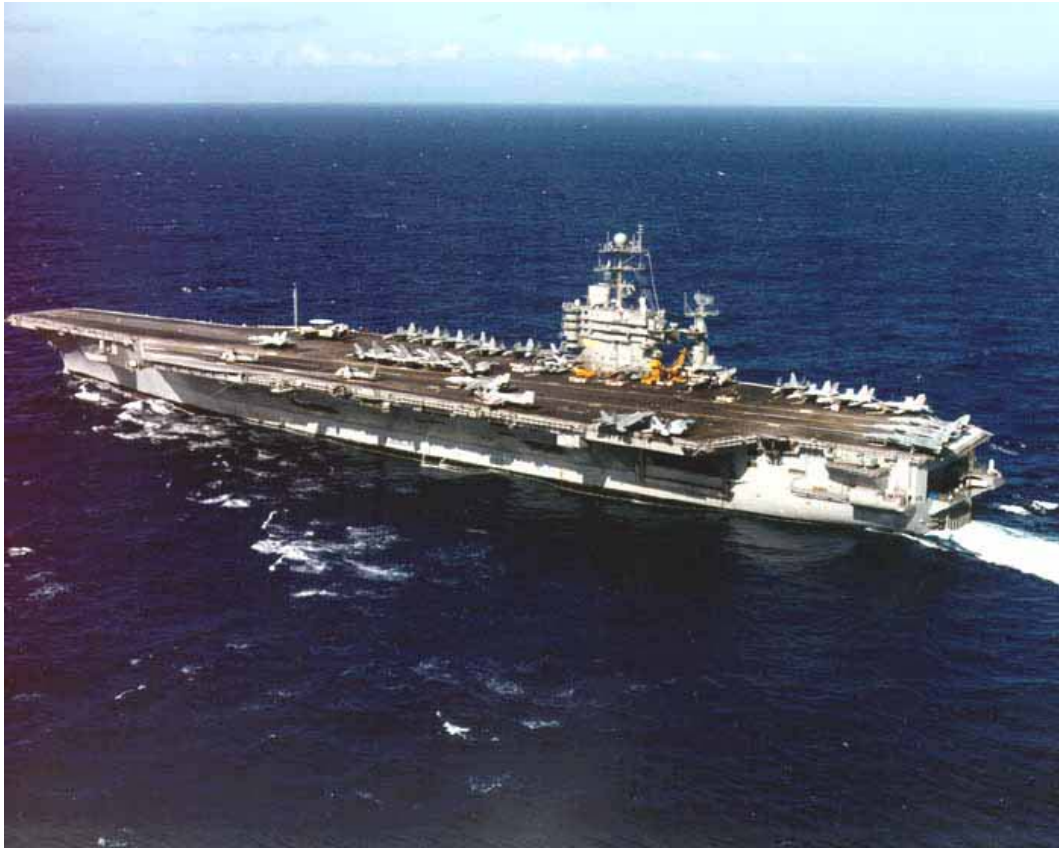
FIGURE 6. *Nimitz*-Class Carrier.

Figure 6 is a photograph of the newest aircraft carrier, the CVN-75, which is the USS *Harry S Truman*. The ship's overall length is almost 1100 feet, and the maximum width of the flight deck is 255 feet. That is actually significant from a firefighting standpoint because hoses for firefighting are stored in the catwalks on both the port and starboard side, and hoses have to be stretched across that maximum width. We learned years ago that we needed to provide additional hose on the reels or the racks that serve the maximum width of the flight deck. The beam of the ship at the water line is almost 135 feet, and the flight deck occupies about 4½ acres. Admittedly, that sounds like a lot of real estate, but when you are loaded with aircraft and involved in trying to conduct launching and recovery operations, then the flight deck can get very crowded in spite of the 4½ acres.

The full load displacement for a *Nimitz*-class carrier is almost 100,000 tons and there are approximately 6,000 people on the ship, split fairly evenly between ship's company and the deployed airwing. The height of the flight deck above the waterline is about 60 feet, which means to abandon ship from the flight deck requires a considerable fall into the water. In fact, during the flight deck fire on the *Forrestal* in 1967, several people did go overboard and in most cases they survived. We discuss that incident subsequently. A couple of other statistics: the height from the keel to the top of the mast is about equivalent to a 20-story building, roughly 200 feet. The ship has two nuclear reactors and two anchors, each anchor weighing about 30 tons.

Several things come in groups of four. There are four shafts driven by the propulsion plant, four propellers, four aircraft elevators and four catapults—two on the front of the bow and two on the angle deck. Also four cross-deck pendants constitute the arresting gear.

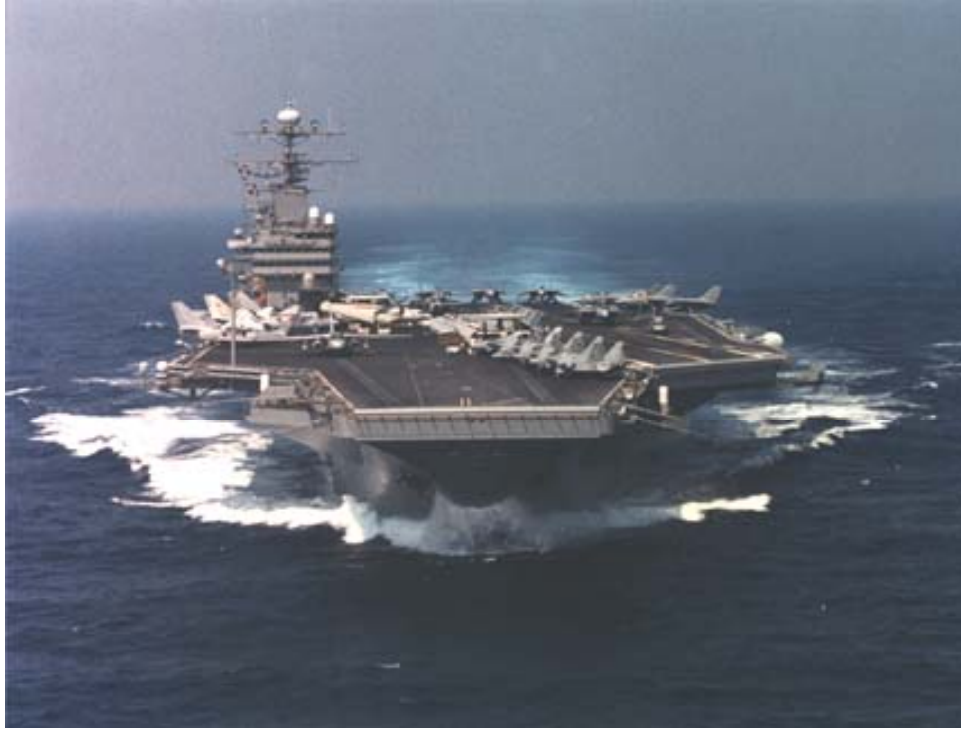
FIGURE 7. View of Bow.

Figure 7 is a picture looking directly on the bow. The width of the bow is about 80 feet. The angle deck to the right is about 800 feet long. The two bow catapults are visible and to the right would be the two waist catapults, although they are hard to see in this photograph. The white cylinders on each side of the bow are two of the CIWS Phalanx 20-mm self-protection guns. The ship will have three or four of those, depending on the year of construction. Each of the two NATO Sea Sparrow Launchers has eight missile-launch tubes. For electric power generation, eight ship service turbo generators have about 8 MW each.

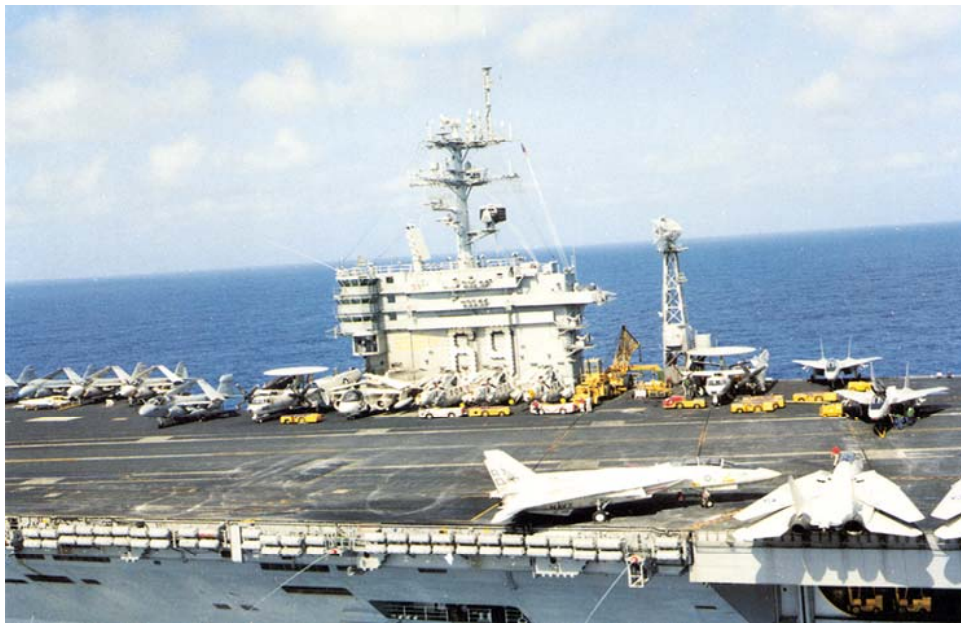
FIGURE 8. View of Island.

Figure 8 shows the island structure. Each one of those pieces of yellow gear, as they are called, represents support equipment provided by NAVAIR to support air operations. Other equipment includes a crash crane known as “tilley,” a forklift, tow tractors, and jet engine starting units. The white vehicles are the special flight-deck fire trucks.

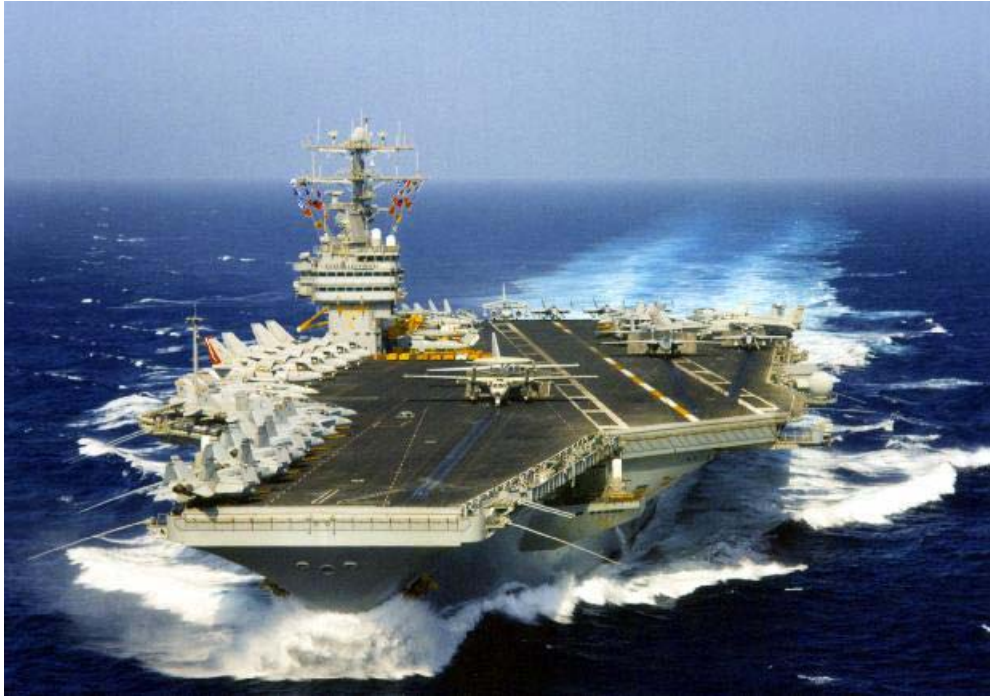
FIGURE 9. Angle Deck.

Figure 9 is another view of the angle deck. The advent of the angle deck years ago made a great contribution to fight deck safety because aircraft could be stored on the bow. An aircraft could attempt to land on the angle, and if he was unable to engage the arresting gear he could safely fly around for another attempt without the fear of crashing into the aircraft on the bow. We

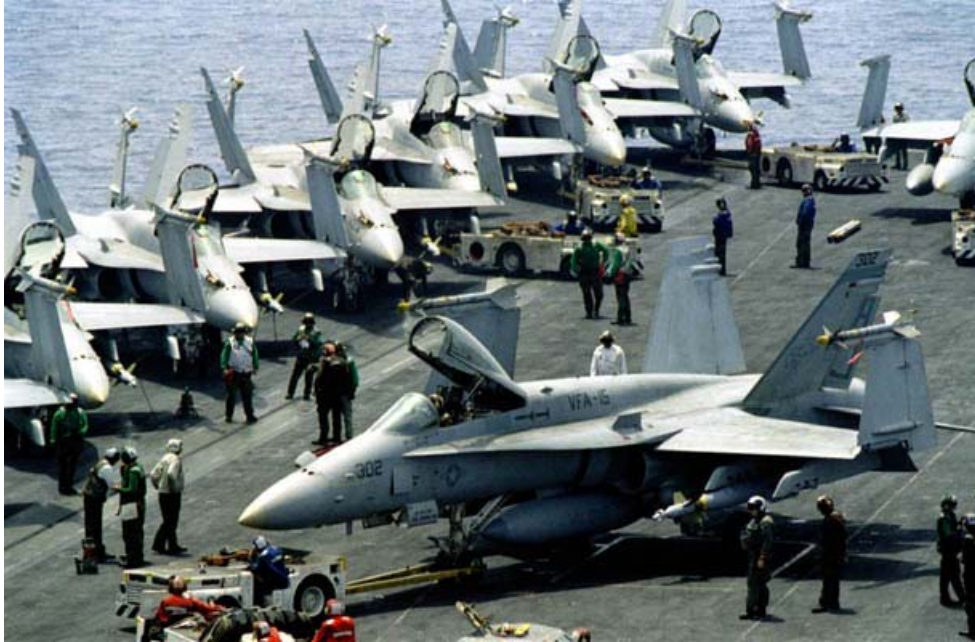
FIGURE 10. Parking on Bow.

Figure 10 shows how closely packed aircraft can be when they are parked. All Navy aircraft have the ability to fold their wing tips to get a tighter stacking pattern on the flight deck. Typically a carrier can have approximately 80 aircraft, both fixed wing and helicopters. F-14 Tomcats, F/A-18 Hornets, EA6B Prowlers provide electronic countermeasures, while anti-submarine warfare would probably be handled by S-3 Vikings. The E-2C Hawkeyes provide early warning, and the transport of people and logistics are handled by the C-2 Greyhounds. Helicopters are primarily the SH-60s.

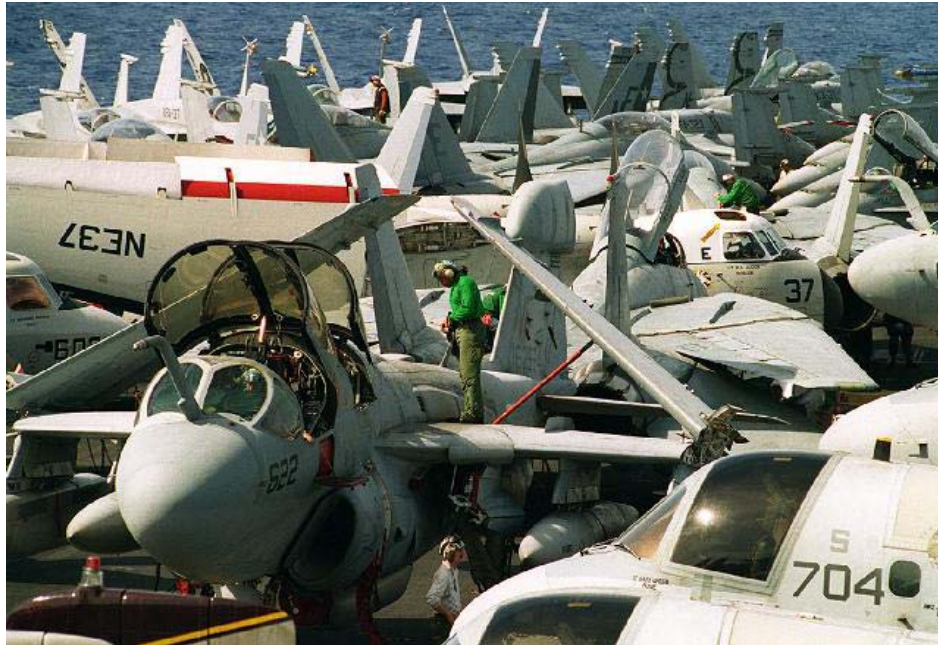
FIGURE 12. Aircraft Tightly Packed.

Figure 12 illustrates the tight packing of aircraft and the resulting congestion. Of course that does make it difficult for firefighting; hose teams have difficulty getting into the center of the pack. It is especially difficult for the little fire truck to get in there, though they try to leave a firelane to facilitate access.

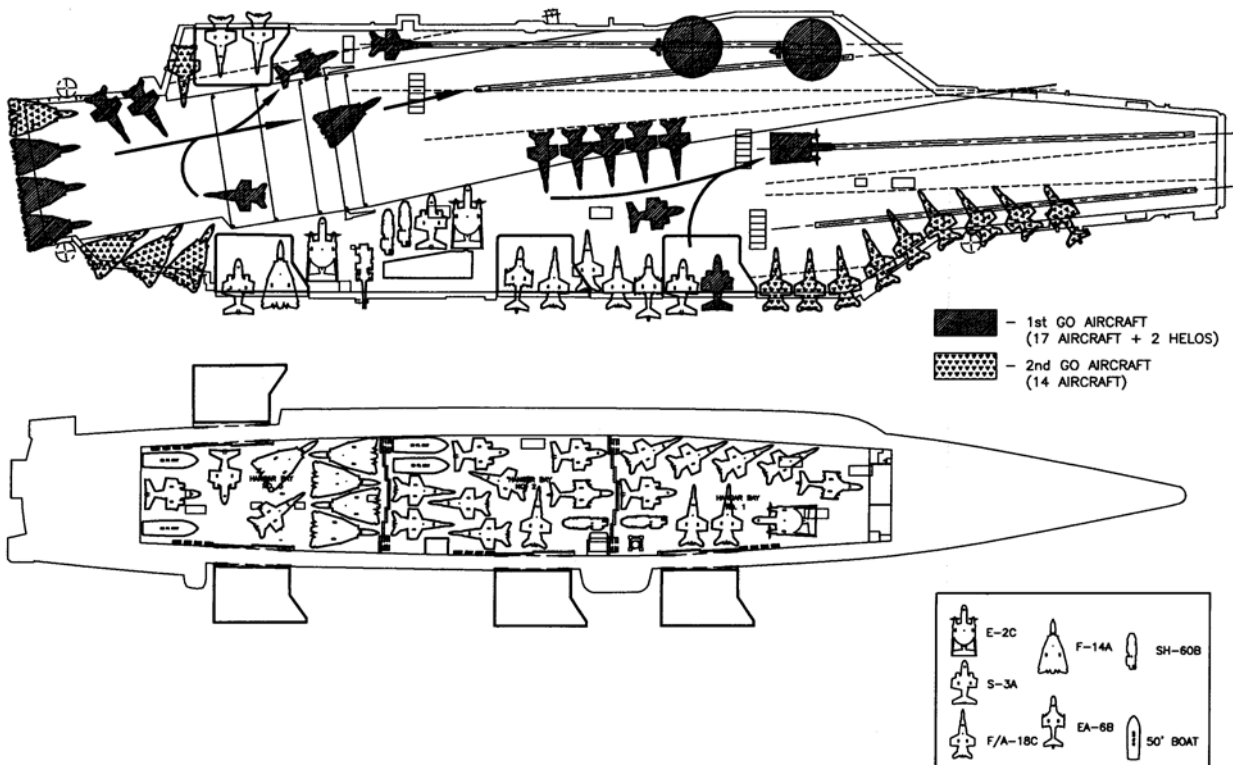
FIGURE 14. Pre-Launch Spotting Pattern.

Figure 13 shows a catapult shot off the No. 2 catapult on the bow at the same time aircraft are parked on the starboard side. Parking patterns are designated as are aircraft movement paths, depending on where you are in your cyclic operations, in launch or recovery. Figure 14 shows how aircraft would typically be parked and maneuvered for the first or second launch of the day. Aircraft are parked on the starboard side to feed catapult 1 and 2. The little arrows show how the aircraft is moved up to either No. 1 or No. 2 catapults and aircraft parked aft are moved forward to be shot off the waist catapults.

The bottom part of this figure shows the parking pattern on the hangar bay. There are four aircraft elevators. No. 1 aircraft elevator comes down on the starboard side of hangar bay 1, elevator No. 2 comes down on the starboard side of hangar bay 2, and elevators 3 and 4 come down on both the port and starboard side of hangar bay No. 3. You can see the three hangar bays with the division doors that separate the hangar bays. The division doors came about really as a result of the Kamikaze attacks in World War II as an attempt to limit the maximum fire area. These are very thick steel doors and the object is to try to confine an incident to the bay of origin.

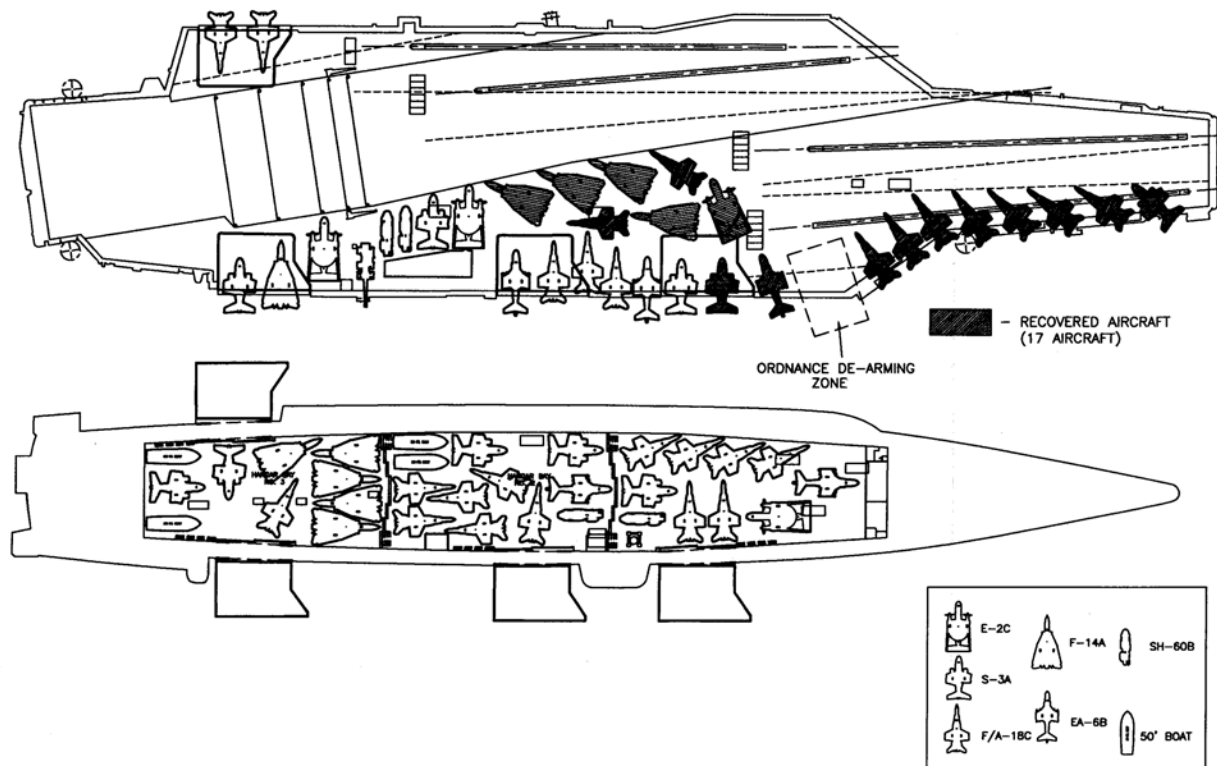
FIGURE 15. Second Recovery Spotting Pattern.

Figure 15 shows a typical parking pattern for recovery of aircraft. The difference here is that all the aircraft have to be parked outboard of the foul line that defines the angle deck so that the angle deck is left clear for recovery. Out of necessity, aircraft are parked very close to that foul line. One of our flight deck accidents in 1981 occurred when this parking pattern was in place. In fact, the incident occurred later on in the recovery when they began to stow aircraft up on the port side of the bow. Figure 16 illustrates the spotting arrangement in effect at the time of the *Nimitz* crash.

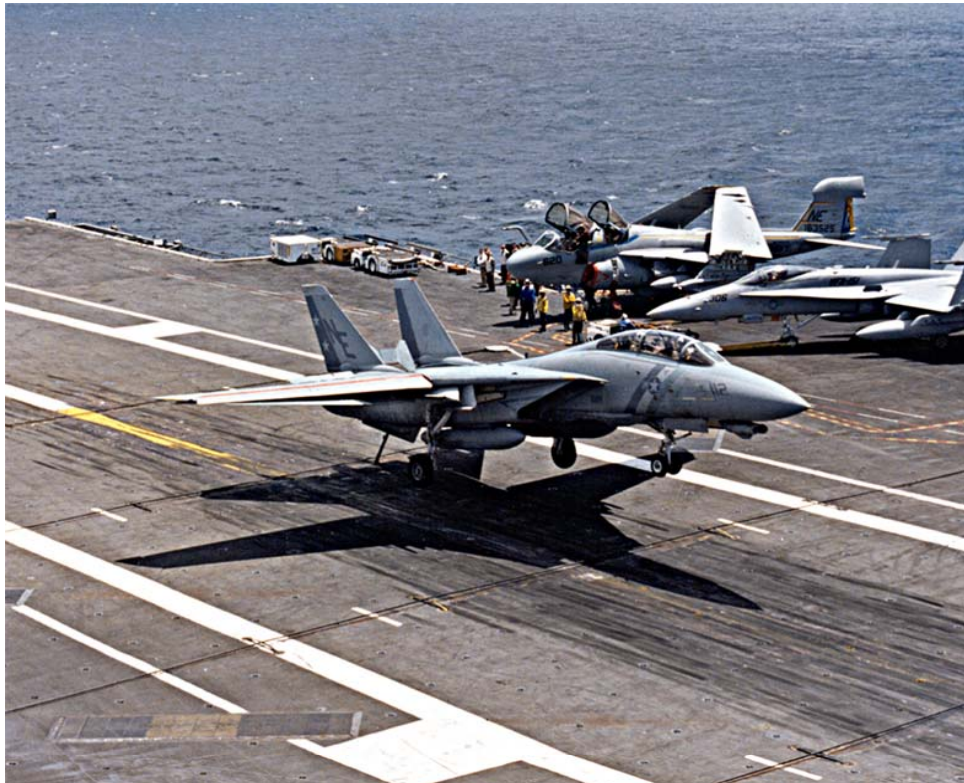
FIGURE 17. Arrested Landing.

Figure 17 shows a typical arrested landing where the tail hook of the aircraft catches one of the four cross deck pendants. In a situation where a pilot is injured, there is damage to the aircraft, or the aircraft is low on fuel so it may not have enough fuel to go around again should he fail to catch the crossdeck pendants, a barricade consisting of nylon webbing is stretched across a couple of steel pylons (Figure 18). This is erected for a "must-catch" situation. Some manual evolution is involved in this but during drills they usually try to get it up in a couple minutes. Figure 19 illustrates how it works. The airplane comes in and is trapped by the nylon webbing. Usually a little damage occurs to the airplane, but most of the aircraft is salvaged and the pilot is saved. Figure 20 is a photograph of an actual arrested landing using the barricade.

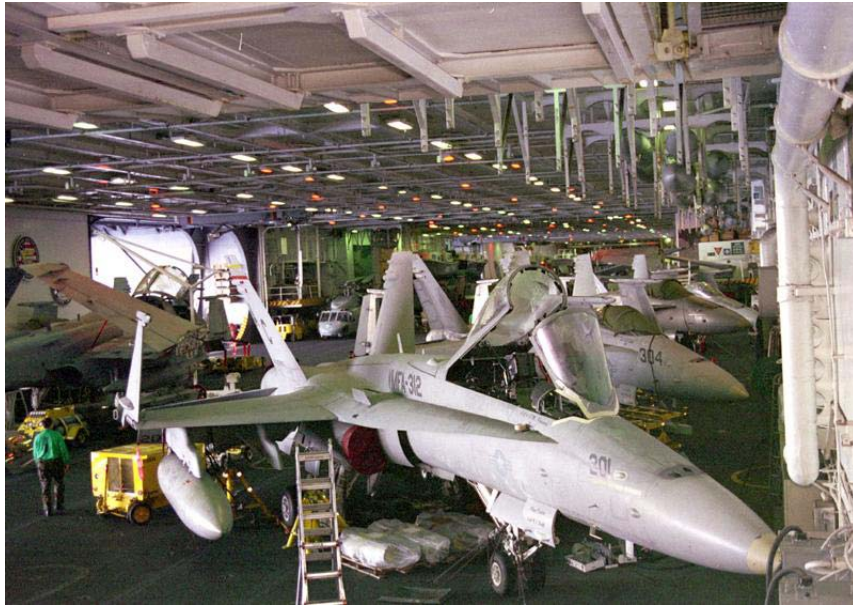
FIGURE 21. Aircraft on Hangar Deck.

The hangar bay can be very congested (Figure 21). During checkout or maintenance evolutions, airplanes often have their cockpits open when they are on the hangar bay. That is significant relative to the overhead sprinkling system. The hangar bay is protected by an overhead aqueous film-forming foam (AFFF) sprinkler system that discharges a solution consisting of 94% seawater. Seawater in a cockpit certainly does a lot of damage, so we have to be careful to design a fire-protection system for the hangar bay that is not prone to accidental or inadvertent trip. Should that system go off when there is no fire much damage could occur.

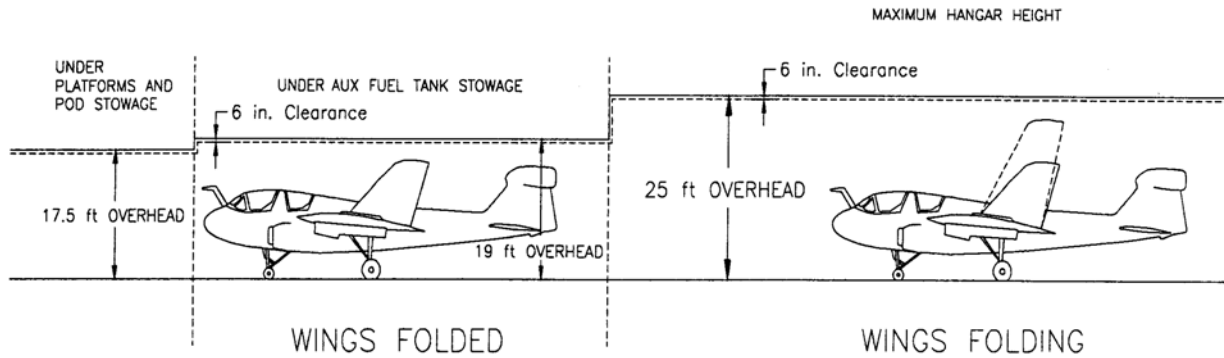
FIGURE 23. Hangar Overhead Clearance.

Figure 22 is another photograph in the hangar bay and you can see the open cockpits. The ceiling height in the hangar varies, but most of it has about a 25-foot overhead (Figure 23). An area forward is used to store auxiliary fuel tanks at the overhead, which reduces the clearance to

about 19 feet. All the way forward in hangar bay 1 some platforms and pod storage reduce the overhead clearance to about 18 feet. This overhead clearance is considerably less than in an aircraft hangar at a naval air station ashore. The division doors separating the hangar deck into three distinct bays are about 76 feet wide and are very heavy. They can be opened and closed from the Conflag Stations. From a Conflag Station, the operator can also open and close elevator doors, and activate the overhead AFFF sprinkling the AFFF flooding system in the weapons elevators. A Conflag Station is in each hangar bay and has to be manned at all times if an aircraft is in the hangar bay.

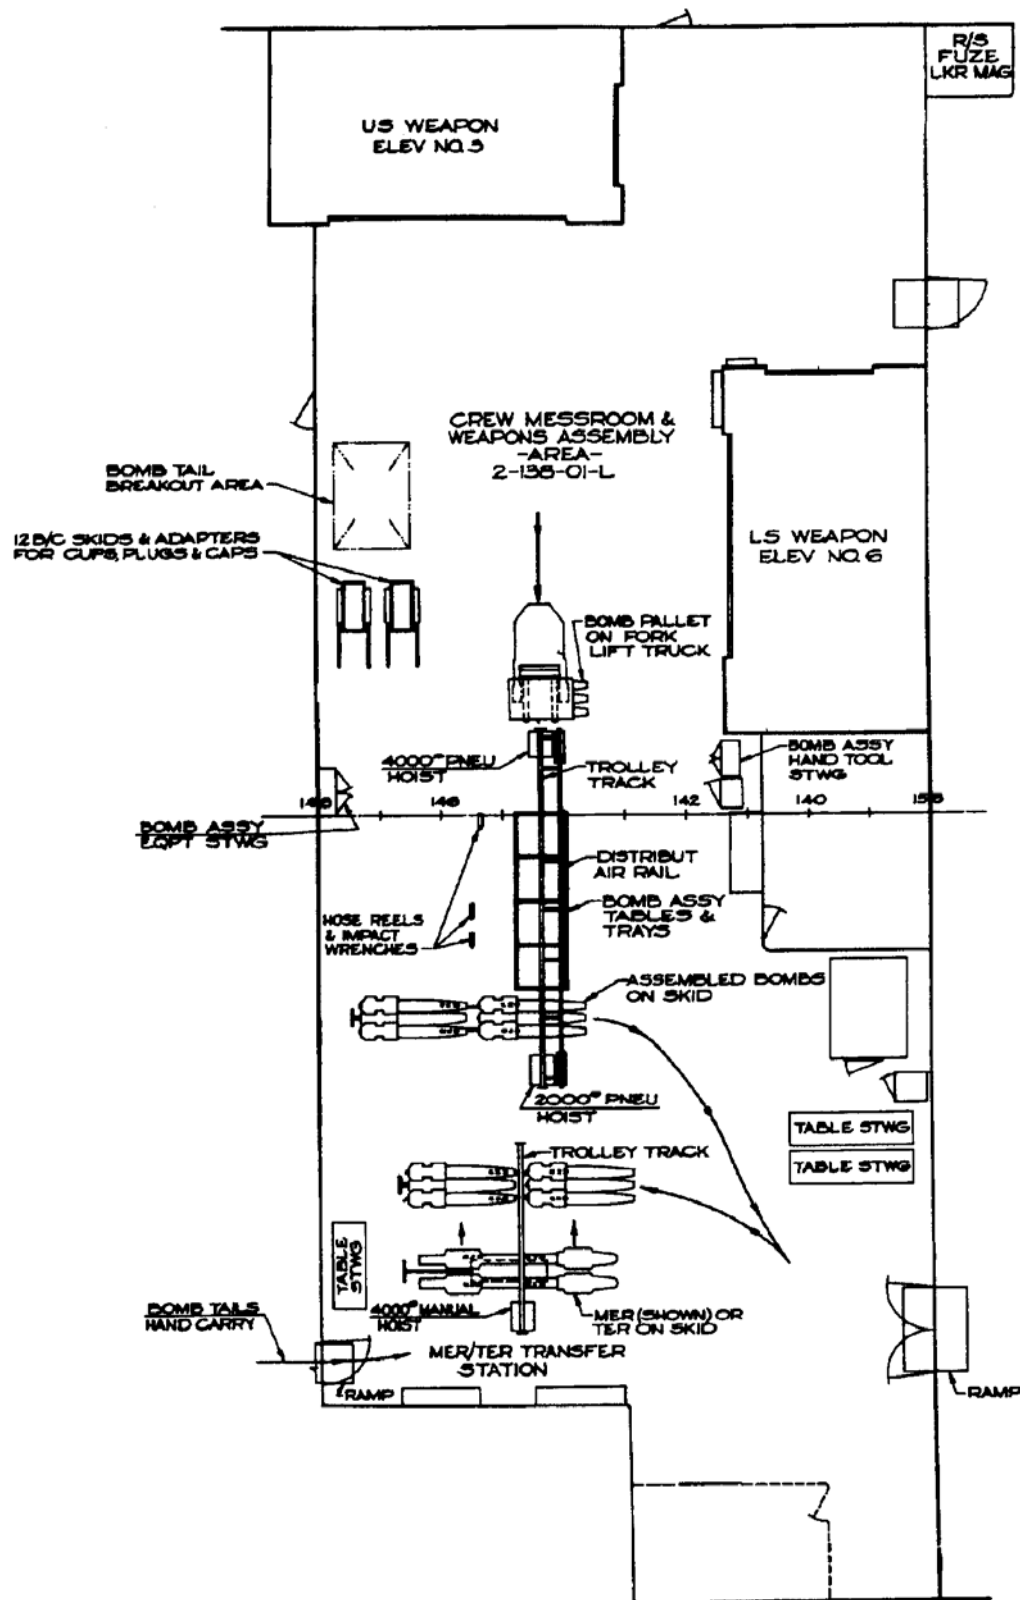
FIGURE 28. Weapons Assembly Area—Second Deck.

Weapons assembly can be done on the second deck in the crew mess room, which also doubles as a weapons-assembly area (Figure 28). Here you can see a sketch of that area. Ordnance is brought up the lower-stage weapons elevator into this area to put on items such as bomb fins. Then the ordnance would be moved over to the upper-stage weapons elevator where it could be raised to the flight deck. Weapons can be raised from the hangar deck to the flight deck using the aircraft elevators. A number of studies are underway to increase weapons-movement efficiency. One of several proposals is to have a weapons elevator that would actually be slanted so it could go outboard of the hangar bay (Figure 29). A new weapons-handling area would be added on a sponson on the 03 level. A second elevator would be used to move the

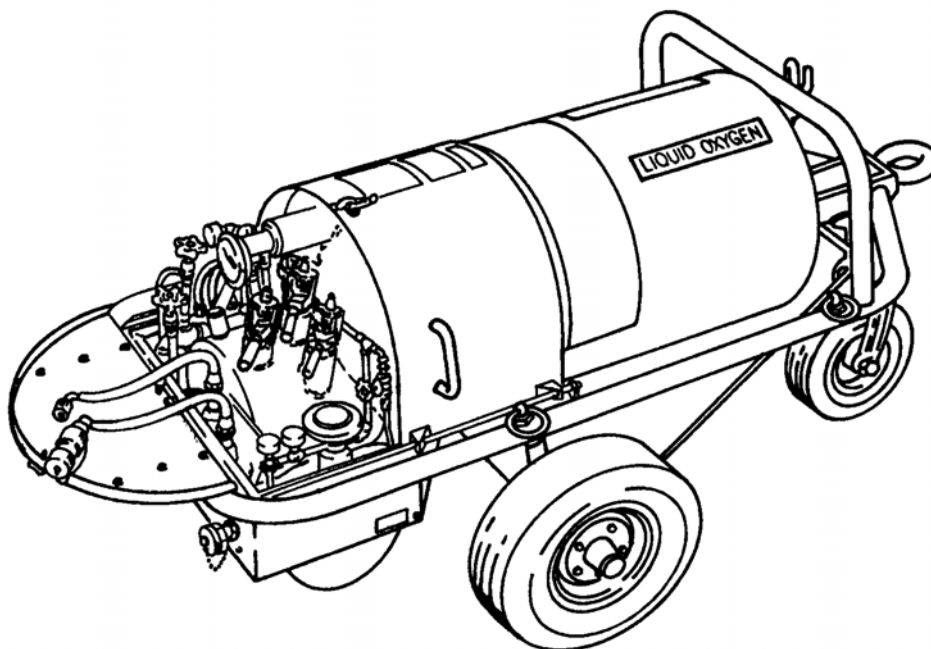
LIQUID OXYGEN STORAGE TANK , TMU 70/M

The Liquid Oxygen Storage Tank, TMU 70/M, is a completely self-contained unit comprised of three (3) major components: a 50- gallon DEWAR storage tank, a 15- liter DEWAR transfer tank, and a system of transfer lines and control valves. The three (3) components are permanently mounted on a portable 3- wheel trailer equipped with a manually operated parking brake system and retractable caster wheel. The storage and transfer tanks are equipped with liquid level and pressure gages, and pressure relief devices. The primary purpose of this equipment is the servicing of aircraft liquid oxygen converters. It is used only for the storage of liquid oxygen conforming to Type II Specification MIL-O-27210. The transfer lines carry the liquid oxygen from the storage tank to the transfer tank and then to the converter. The transfer lines also carry the vented oxygen gas from the converter back to the storage tank. The closed loop of the transfer lines contains the vented oxygen gas to avoid venting large volumes of gas during converter filling operations. The interconnecting liquid and return gas lines are

vacuum jacketed transfer lines wherever practical. These lines are of minimum length to reduce cool-down and heat leak losses.

FIGURE 41. Liquid Oxygen Cart.

Figure 41 shows one of the miscellaneous hazards—a liquid oxygen storage tank (Reference 4). Table 2 illustrates how many JP-5 fueling stations are around the flight and hangar decks. The hangar deck would be used only in a special case. Most of the fueling and defueling is done on the flight deck. Anywhere from 14 to 18 JP-5 fueling stations are on the flight deck. Also about six or seven fueling stations are located on the hangar deck.

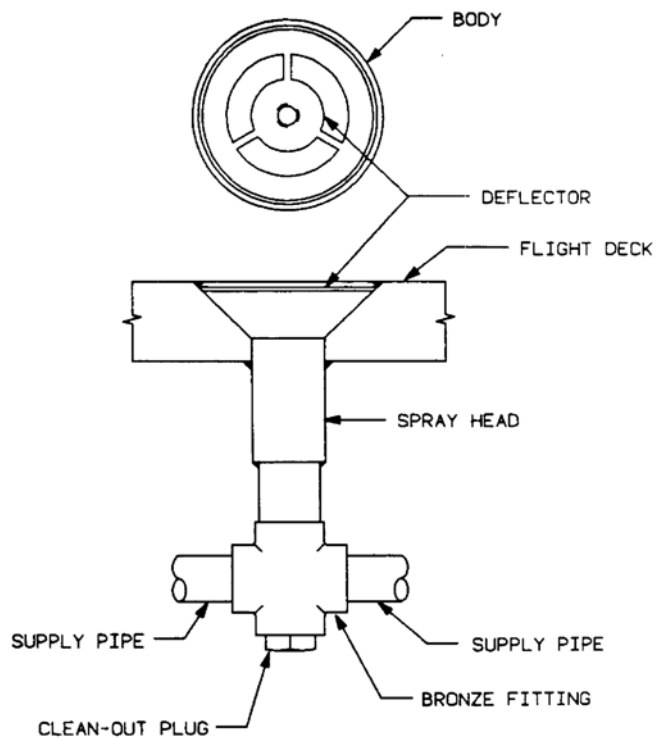
FIGURE 55. Clean-Out Fitting.

NOTE - NO CLEANOUT FITTINGS SHALL BE INSTALLED IN SPACES CONTAINING ELECTRONIC EQUIPMENT. IN SUCH CASES THE CLEANOUT FITTINGS SHALL BE PROVIDED IN AN ADJACENT SPACE OUTSIDE OF THE ELECTRONICS AREA IF PRACTICABLE.

Underneath most of the nozzles, clean-out plugs have been added to enable a plugged nozzle to be cleaned from below (Figure 55). Now that most ships put on covers when they go into port, the need for the clean-outs has been considerably reduced. Covers should be in place when the nonskid is being removed or applied. In Figure 56, to the lower left, the deck-edge nozzles are discharging above the coaming to provide protection near the edge of the deck. Figure 57 is another view of the nozzles shooting above the gutter onto the flight deck.

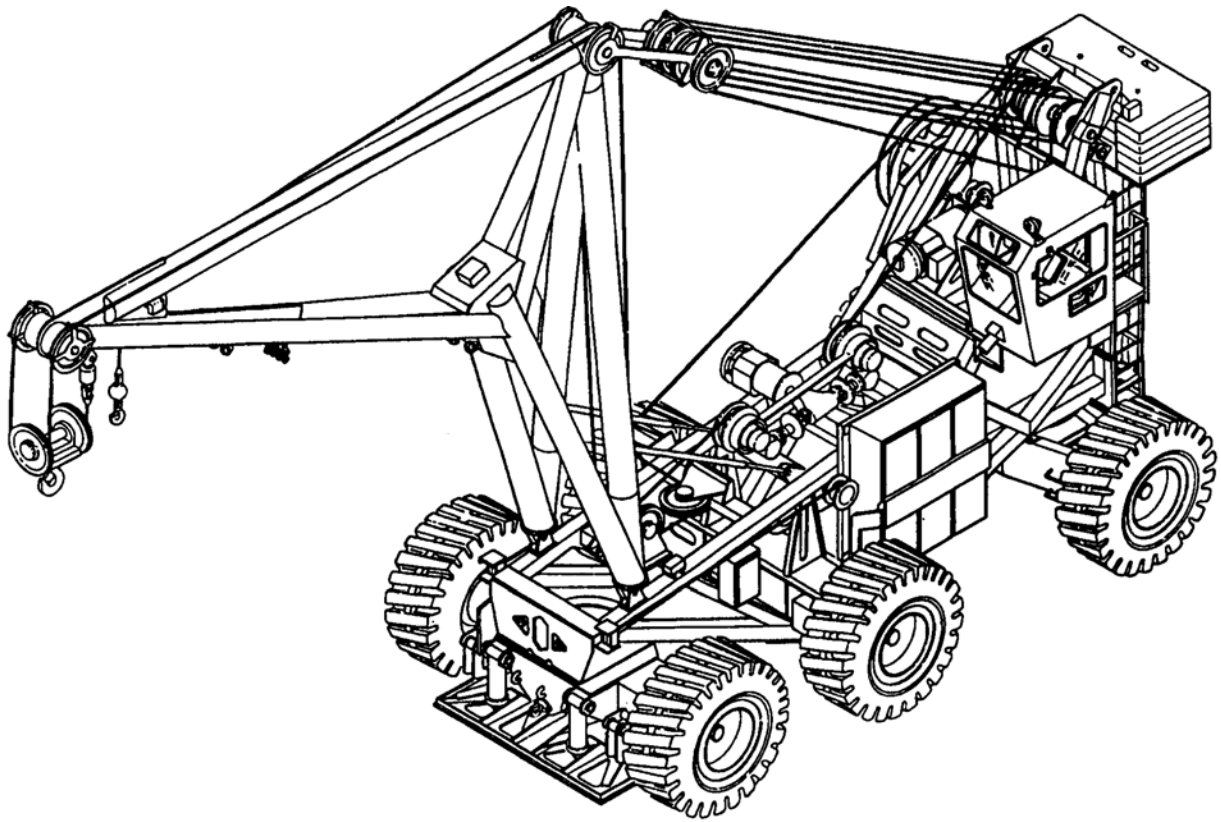
FIGURE 65. Aircraft Crash/Salvage Crane.

*AIRCRAFT SALVAGE CRANE, A/S32A-35*

The A/S32A-35 Aircraft Salvage Crane is a self-propelled, 4-wheel drive, diesel-electric-powered vehicle mounted on pneumatic rubber tires. The crane can lift crashed or damaged aircraft from various locations and attitudes and move the load on a rolling and pitching ship to a designated safe parking area on the flight deck. The crane is capable of operating in inclement weather and is designed for stowage on the flight deck.

Characteristics	
Lifting capacity	<u>DYNAMIC</u> - 65,000 lb @ 25-ft outreach and 25-ft min. hook height <u>STATIC</u> - 75,000 lb @ 25-ft outreach and 25-ft min. hook height <u>ANCHORED</u> - 120,000 lb @ 25-ft outreach
Weight	132,500 lb
Hoist speed (rated load)	20 fpm
Height	32 ft (approximate with boom parallel to flight deck)
Width	15 ft 2 in.
Length (less boom)	34 ft
Overall length (boom parallel to flight deck)	59 ft

Figure 65 shows some of the other yellow gear that can be used in a flight-deck crash. The "Tilley," the crash crane that can be used to lift or move disabled aircraft is shown in Figure 66. A crash dolly is shown in Figure 67. All carriers will have a crash forklift (Figure 68). Most of them configure a man basket on the forklift. If a fire occurs in a jet engine that is high above the deck, like a high engine on a helicopter, they can put a man in the basket, lift him up, hand him an extinguisher or hose-line, and he can put out the fire.

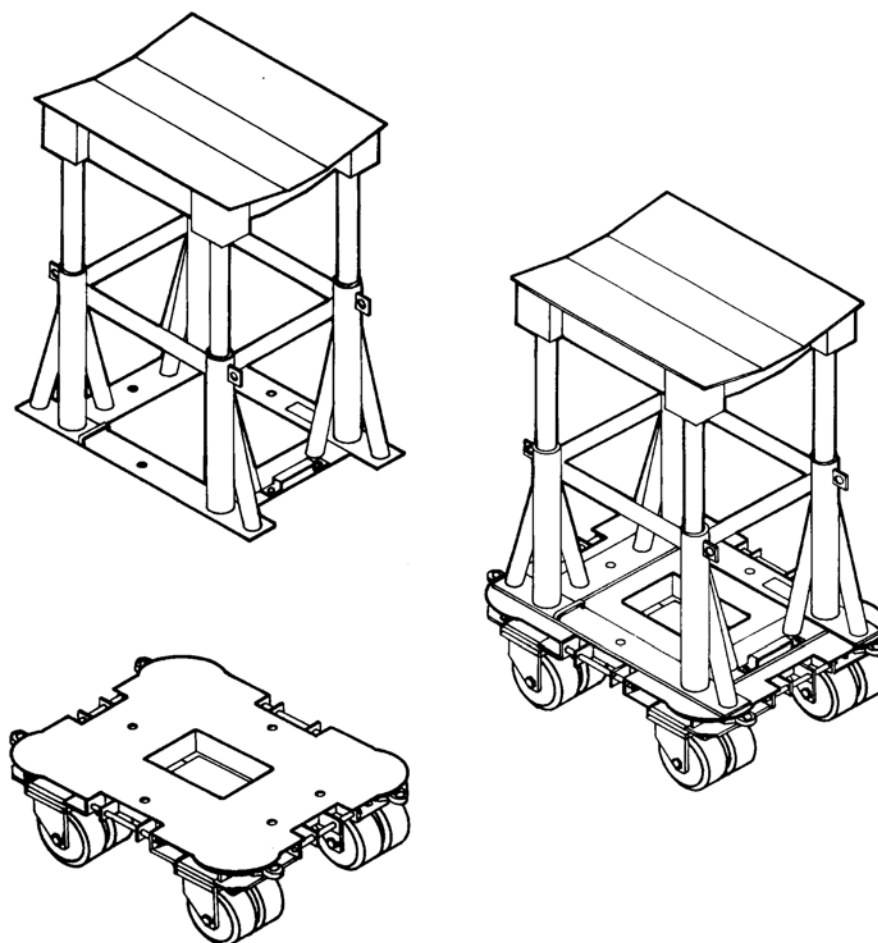
FIGURE 67. Aircraft Crash Dolly.

*AIRCRAFT CRASH DOLLY AND ADAPTER AHU-24/E*

Four (4) Aircraft Crash Dollies and two (2) Adapters are provided on all aircraft carriers to move heavy aircraft components and to aid in moving crashed or immobile aircraft. Each dolly is capable of supporting a 32,000- pound load. The crash dolly may be configured many different ways in order to meet the demands of each salvage operation.

PN: DOLLY-1359AS201-1  
ADAPTERS:  
CONCAVE-1359AS251-1  
FLAT-1359AS302-1

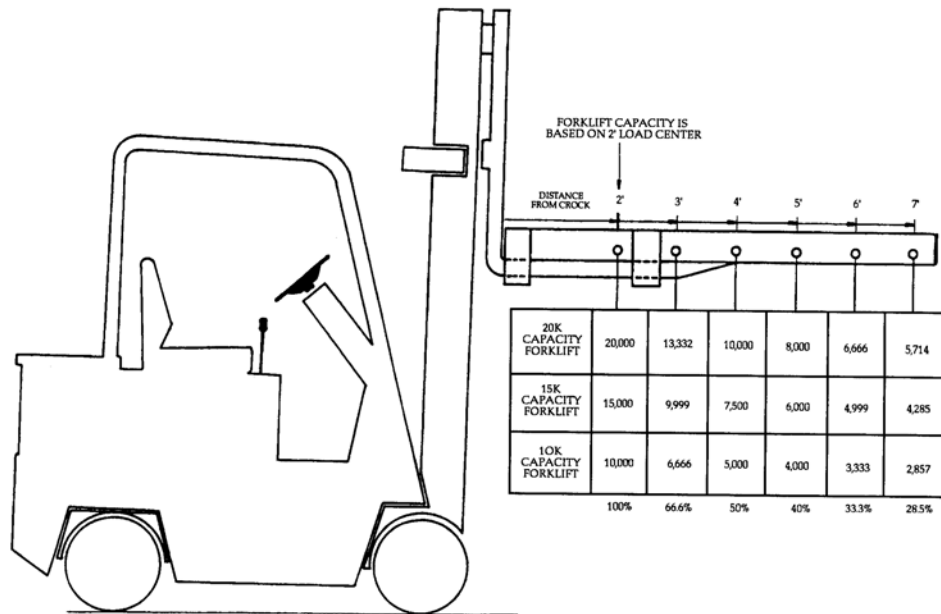
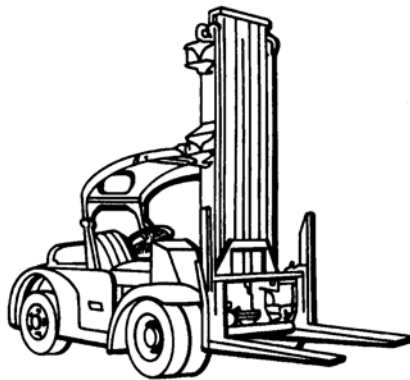
FIGURE 68. Crash Forklift.

CRASH FORKLIFT , NF-20

The Crash Forklift is used to partially lift aircraft in certain situations. It is highly maneuverable and most useful in those salvage operations that involve the damage or collapse of one (1) landing gear. It is diesel powered and equipped with pneumatic tires. Forklifts are rated to a maximum safe lifting capacity. The rated weight should never be exceeded. The crash forklift normally used for CV salvage operations has a maximum safe lifting capacity of 20,000 pounds at 24- inch load centers. Occasionally, a 15,000- pound capacity forklift may be used on CV or amphibious aviation ships. Lifting capacity decreases as the load moves outward from the heel of the forks. See the table above.

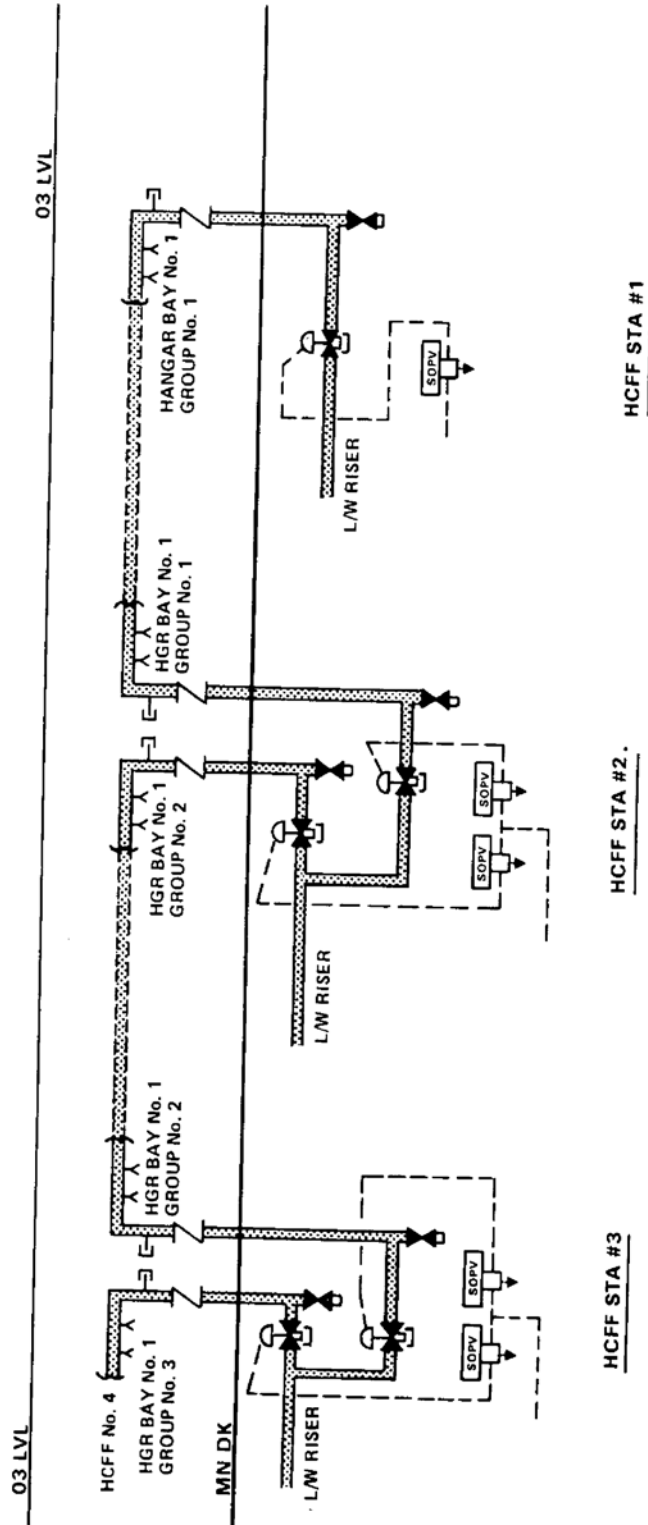
FIGURE 78. Hangar Sprinklers Dual Supply.

# "HANGAR BAY LOOP" 2-SPD SYSTEM

As shown in Figure 78, every hangar bay sprinkling group is fed from two separate stations; one on the port side and one on the starboard side. If you were postulating a hit in the hangar bay as part of a LFT&E analysis and considering that the hangar bay sprinkling group may be damaged from the detonation, one important consideration would be whether that damage occurs above or below the check valve installed in the riser in each supply line. A check valve is on each side so that if one proportioning station should be out of commission, you would not pump AFFF from the other side back into that station. If you had a break below that check valve, you would still be able to supply that group from the other side. The flow would be reduced, but you would still be able to distribute AFFF into that area of the hangar bay. If the break occurred above the check valve, the situation would be different because the supply from both sides would be going through the break. Very little would be going through the sprinkler systems, which could be a factor in doing LFT&E analysis on a hangar bay hit.
