**NAVAL
POSTGRADUATE
SCHOOL**

THESIS

**EXPERIMENTAL STUDY OF COMPOSITES AND
METAL-WIRE JOINTS**

MASTER OF SCIENCE IN MECHANICAL ENGINEERING

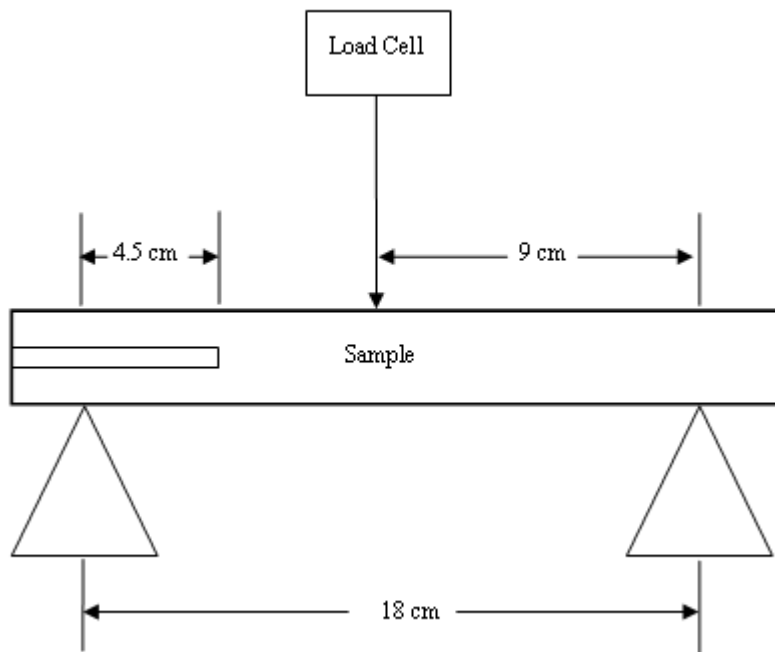
Figure 23. Dimensioned Test Setup

Each sample was tested for Mode II interlaminar toughness by placing it in a three point bending stand. The distance from the crack tip to the support on the right side was 4.5 cm and the distance between the two supports was 18 cm. The load was applied at the center between the two supports. For these samples Instron 4570 held the center support stationary with the load cell and moved the two lower supports up into the stationary support connected to the load cell. Figure 23 shows a fully dimensioned test setup. Digital image correlation software was simultaneously used and recorded deformation fields on the surface near the crack tip.

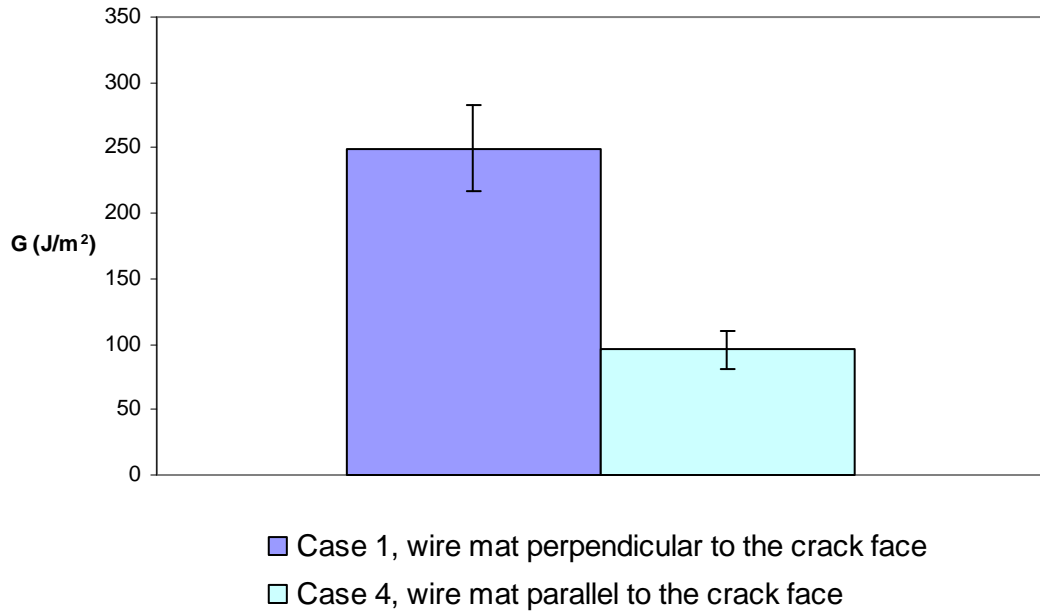
Figure 32. Average Fracture Toughness Cases 1 and 4 with one Standard Deviation

Comparison of Case 1 with metal wire mat of 0 degree to Case 4 with metal wire mat of 90 degree layer proved the wire mat of 90 degree layer is the weakest configuration as shown in Figure 32, even though both had wire to wire contact at the crack initiation site. This was further supported by viewing and comparing Cases 2 and 3, both of which had a 1 inch gap between the crack face and the crack initiation point.

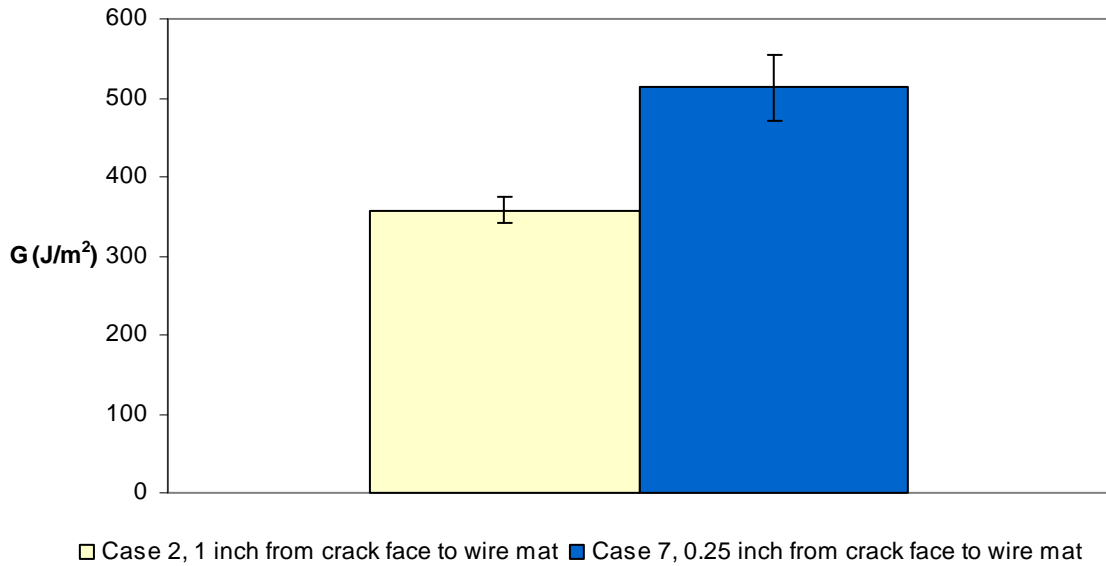
Figure 33. Average Fracture Toughness Cases 2 and 7 with one Standard Deviation

Figure 33 compares Cases 2 and 7, both with 0 degree metal wire orientation, which varied by the distance between the crack tip and metal wire mat. Case 7 proved to be stronger due to the increased stiffness of the imbedded wire mat. Furthermore Case 2 with 0 degree layer face wire mat had a higher interlaminar fracture toughness than Case 3 which had the weaker 90 degree wire mat layer configuration with the same distance from the crack to the wire mat, Figure 34. In general the lower interlaminar fracture toughness was produced by the greater distance between the crack face and metal wire mat and the lowest was produced by the greatest distance between the crack face and the wire mat with a 90 degree orientation, Case 3.

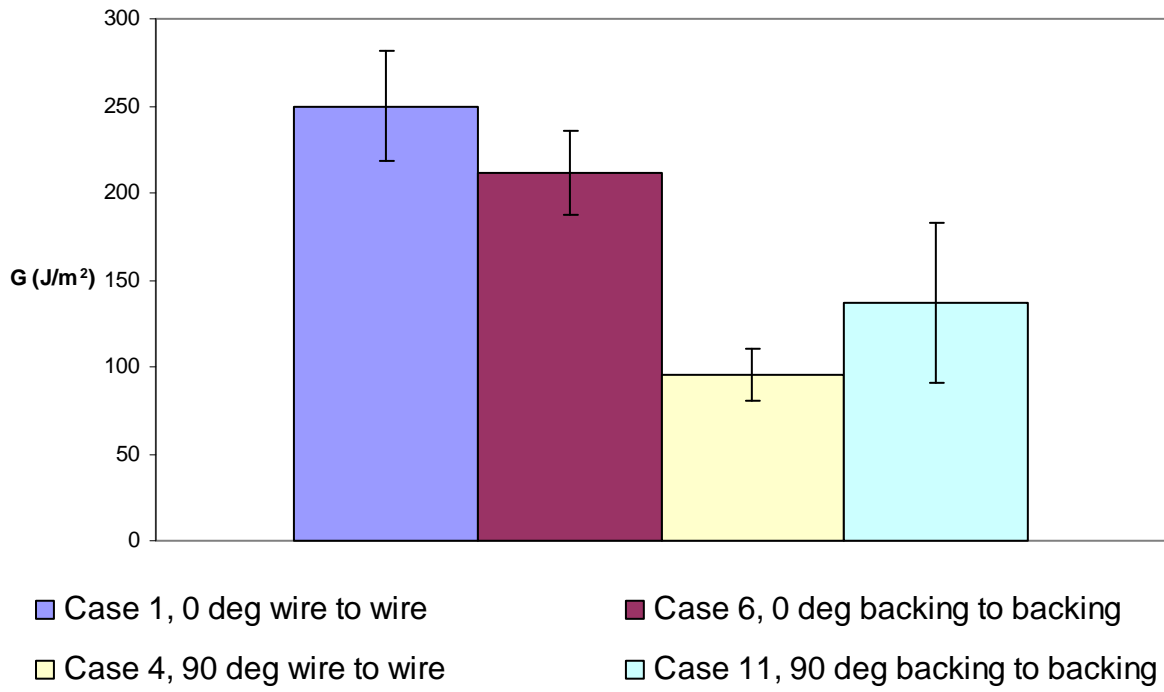
Figure 35. Comparison between Cases 1, 4, 6 and 11

Comparing Cases 1 and 6 (0 degree orientation) and 4 and 11 (90 degree orientation), Figure 35, showed the fibrous backing has little effect on the fracture toughness. It also restates the conclusion the 90 degree wire mat orientation had a lower fracture toughness when compared to the 0 degree orientation.
