1. REPORT DATE (DD-MM-YYYY) 04142009		2. REPORT DATE 04142009		3. DATES COVERED: (From - To) 23052006 - 14092008	
4. TITLE AND SUBTITLE Fatigue Testing of Maglev-Hybrid Box Beam				5a. CONTRACT NUMBER NA	
				5b. GRANT NUMBER N00014-06-1-0872	
				5c. PROGRAM ELEMENT NUMBER

ONR Final report

This report summarizes the results from the ONR project "Fatigue Testing of Maglev-Hybrid Box Beam". The project concerned fatigue testing and numerical evaluation of a steel / composite hybrid girder. The girder was previously built under collaboration between Maglev Inc. and Lehigh University. The girder was instrumented with strain gages and LVDT's to monitor strains and deflections. A test setup with bottom supports and towers for mounting two or three hydraulic actuators was installed in the ATLSS test lab. The girder was fatigue tested for over 300,000 cycles at loads up to 120% of design load. There was extensive cracking in the steel structure, but only minor damage in the composite panels towards the very end of the test. No damage in the adhesive joints was found. All items included in the proposal were fully addressed. Reports have been prepared for publication in scientific journal

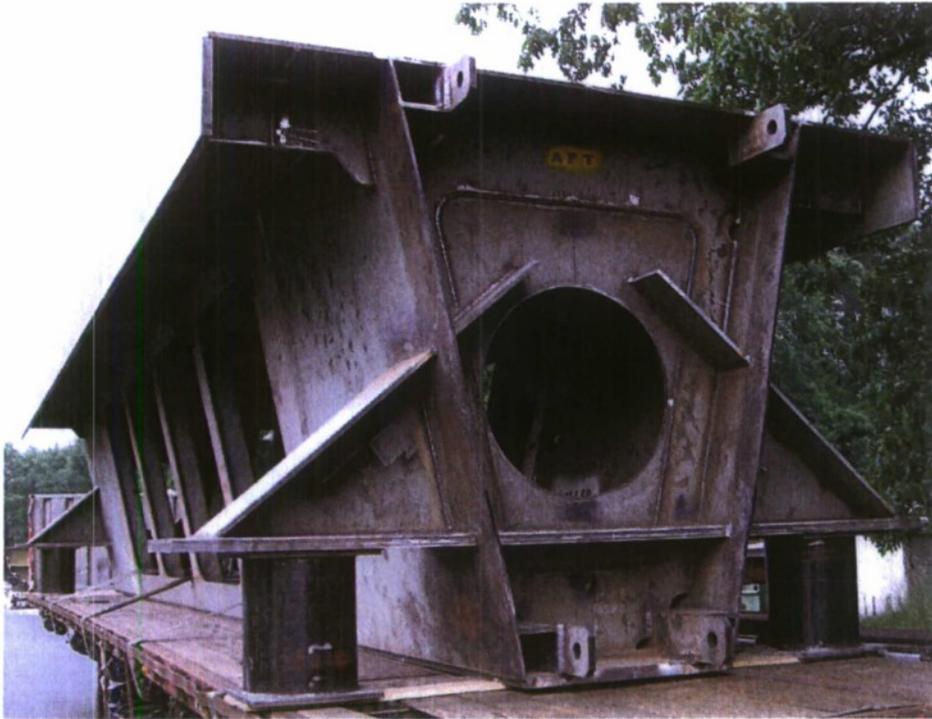
Fig. 1. Steel part of the steel/composite hybrid girder.

The objective of the study was to fatigue test the steel/composite hybrid girder shown in Figs. 1-2. The eight stainless steel "window openings" were closed out with vacuum infused glass fiber skin / foam core sandwich panels. The panels were bonded to the steel frame with an epoxy paste adhesive. No mechanical fasteners were used. Six of the eight panels were conventional sandwich panels with a uniform core thickness up to near the edges, where the core tapered off and the two skins joined. The last two panels had deeply corrugated inner skins and flat outer skins. The corrugated panels were lighter and presumably stronger than the conventional ones. The two different panel configurations are shown in Fig. 3.
