Final Report for AOARD-07-4052  
Enhancement of POD for structural health monitoring of bonded repaired structures

**Abstract:** This paper discusses the scattering of stress waves by defects in representative aircraft structures with multi-layered construction and geometry variation. The approaches for determining and enhancing the probability of detection of non-surface penetrating defects in such structures as well as minimising the contributions of multi-layered construction and geometry variation to false indications are presented. The results demonstrate the importance of selecting the appropriate frequency and location of the sensor in monitoring subsurface defects on these structures. The findings suggested that a computer solution of the problem may be required to determine the optimal combination of frequency and sensor location. This study suggests the possibility of incorporating structural health monitoring into the design of future structures which will constitute a significant leap in the current knowledge base of structural health monitoring.

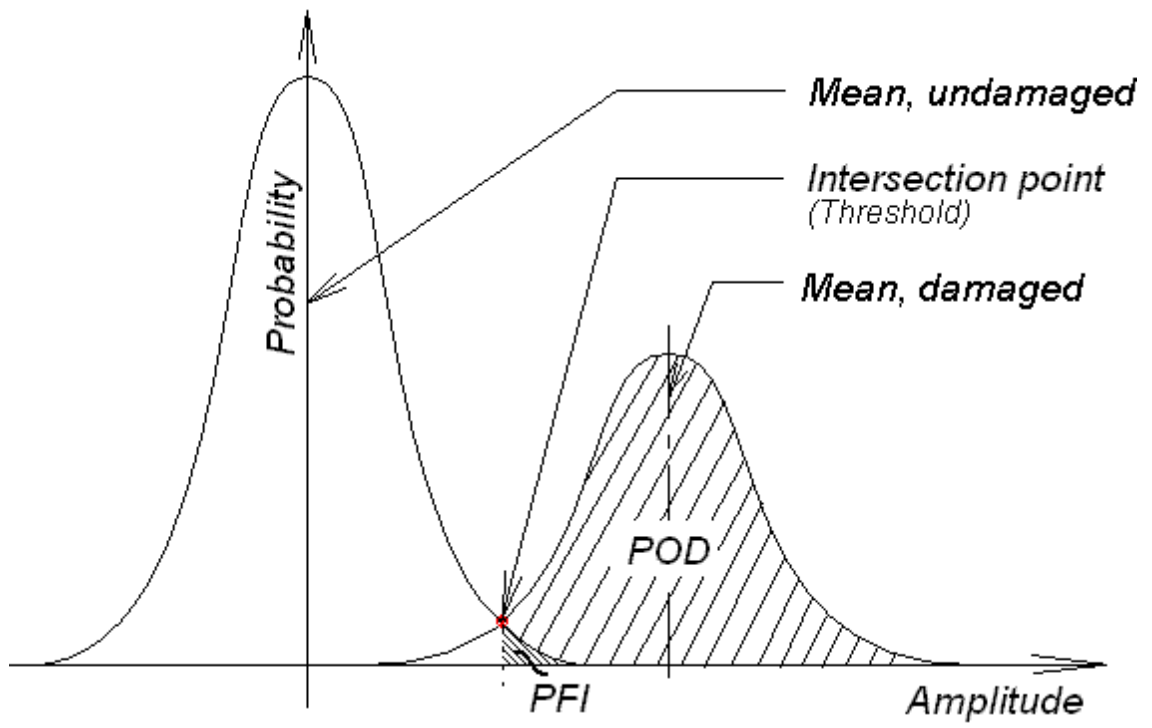
Figure 6 Sample probability distribution for undamaged- and damaged-case signals

where  $T$  is the threshold, or the intersection point in Figure 6.

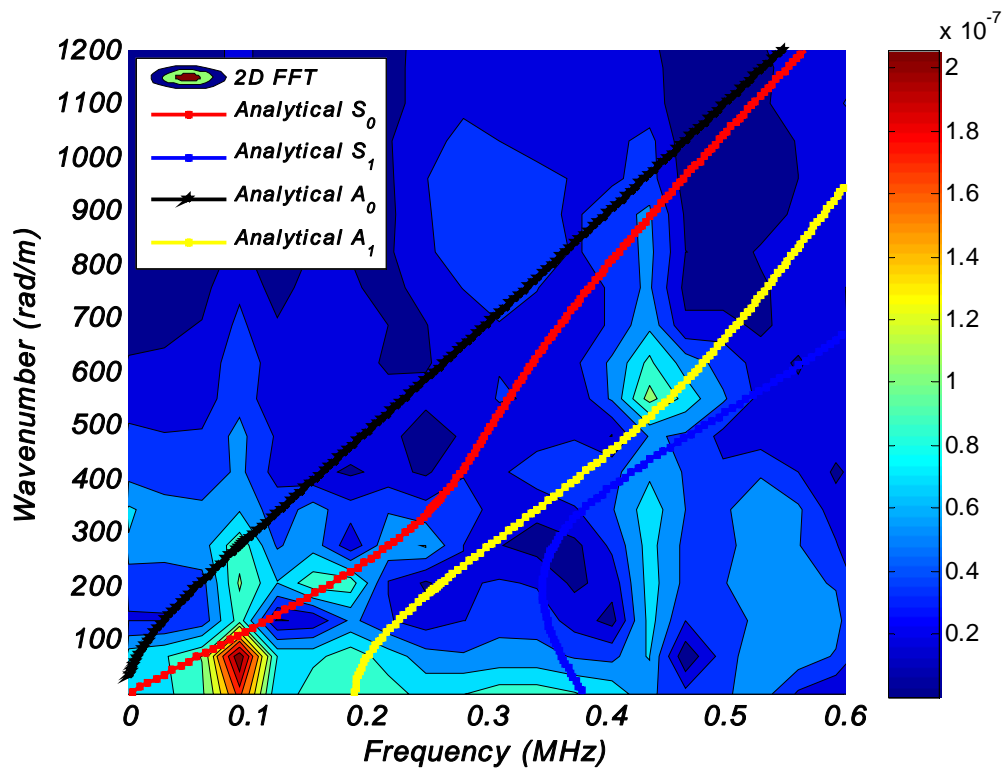
Figure 7 Two-dimensional fast Fourier transform (2D FFT) for an undamaged flat plate

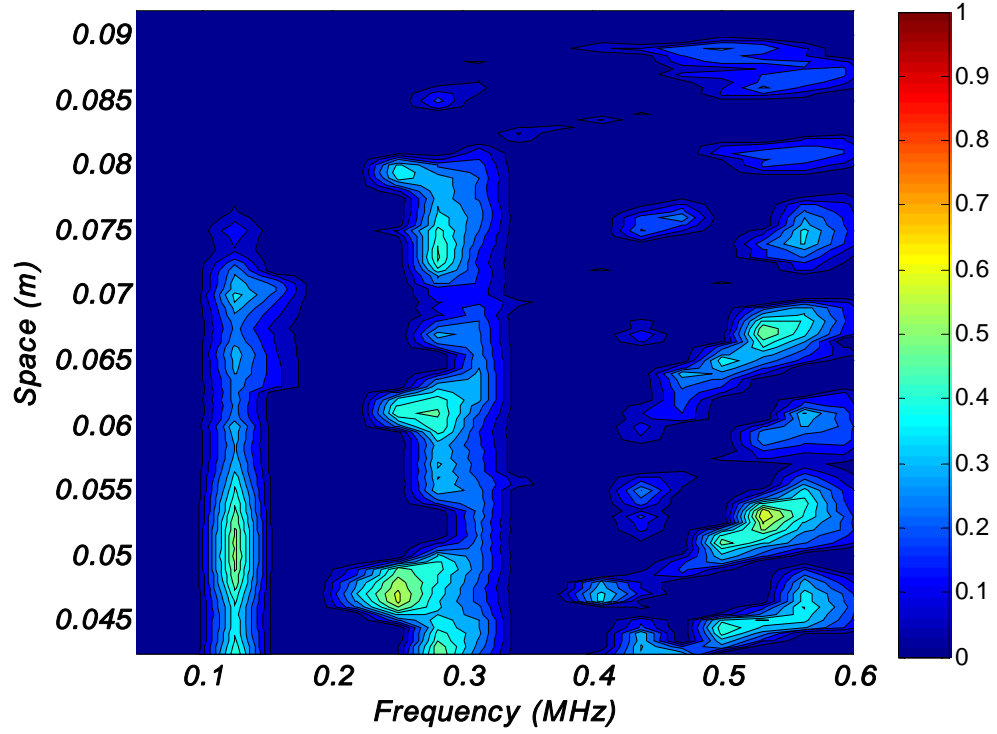
Figure 10 POD for 33% defect flat plate

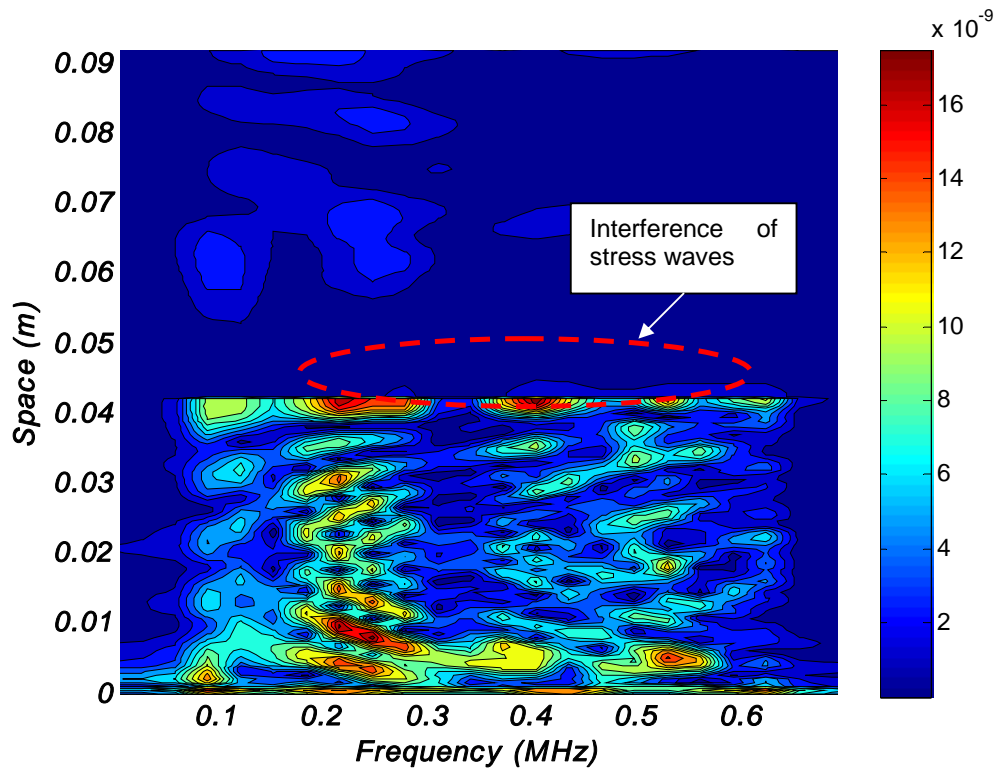
Figure 13 Temporal - spatial characteristics for surface penetrating defect, flat plate

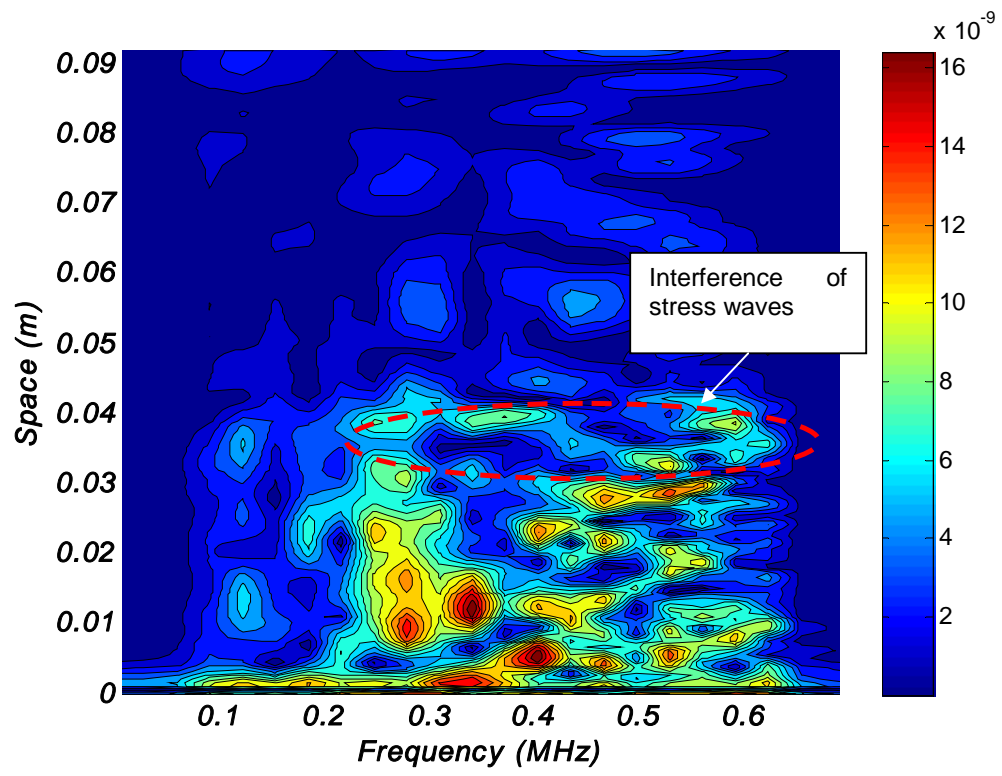
Figure 18 Temporal - spatial characteristics for 67% defect geometry variation case

Figure 18 shows the results obtained with a sub-surface defect that is 67% of the plate thickness. The POD calculated is shown in Figure 19. This figure suggests that the choice of frequency has not changed from that in Figure 17. Figure 20 shows the results obtained with a defect that has penetrated the surface. The POD calculated is shown in Figure 21 and the choice of frequency has not altered.

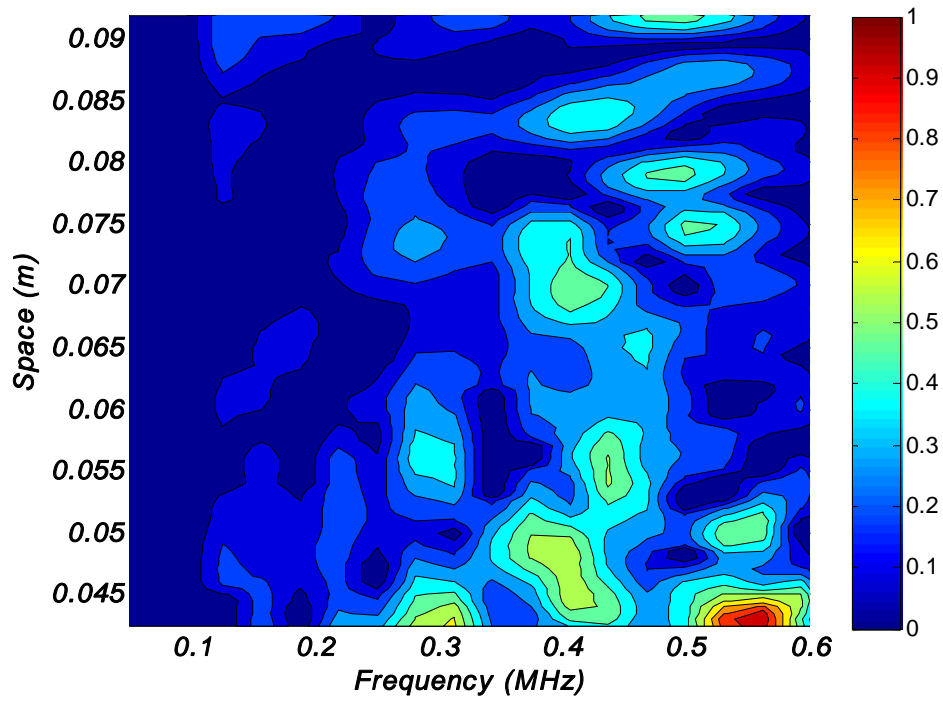
Figure 21 POD for surface-penetrating defect geometry variation case
