**FATIGUE BEHAVIOR OF AN ADVANCED SiC/SiC COMPOSITE
AT ELEVATED TEMPERATURE IN AIR AND IN STEAM**

THESIS

Devon T. Christensen, Captain, USAF

AFIT/GAE/ENY/09-D02

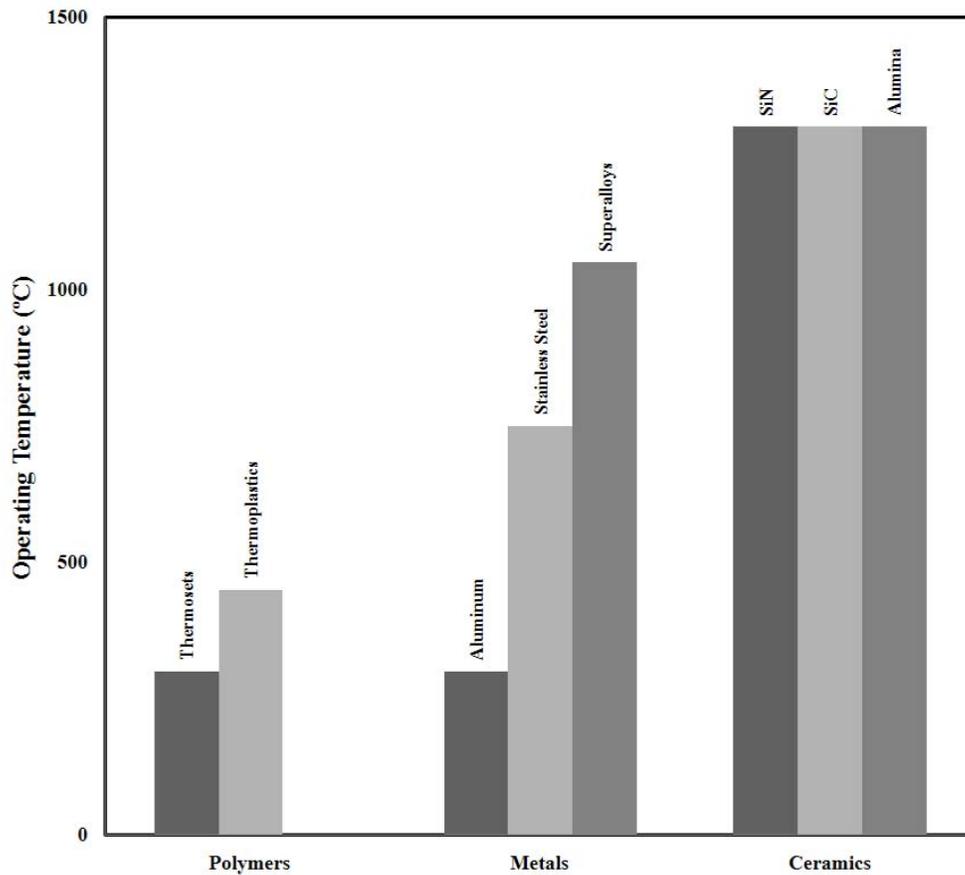
Figure 1: Comparison of Material Operating Temperatures.

The use of advanced composites as primary materials in modern aircraft began in the 1970's. However, their use in propulsion technology lagged, requiring the development of composite materials capable of withstanding the extreme temperature and pressure environments of a jet turbine engine. Predominantly, only high strength steel alloys, Titanium alloys, or metal superalloys such as those based on Nickel or Cobalt were capable of maintaining their structural integrity in these operating conditions, and their performance was still severely temperature-limited. Figure 1 outlines the operating temperatures of the main classes of materials.

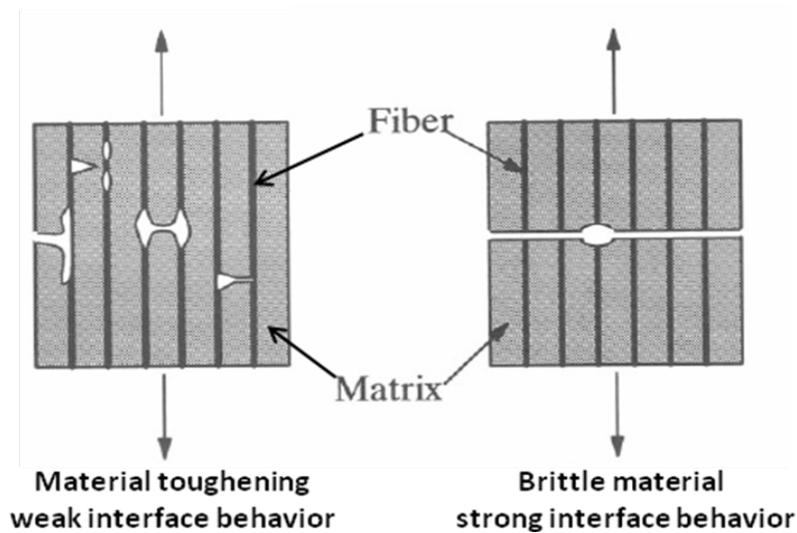
Figure 2: Fracture damage comparison between CMCs with weak versus strong interface bonds.

the matrix and the reinforcing fibers. If the fiber-matrix bond is too strong, any matrix cracks will continue to grow through the fiber as in monolithic ceramics. However, weak fiber-matrix interaction allows damage energy to be dispersed through the material via fiber-matrix debonding, crack deflection, fiber bridging, or fiber pull out [2:460; 3:4-5]. Since most CMC use very similar materials as matrix and reinforcement the fiber-matrix bond is naturally quite strong, therefore several types of interphase material (i.e. fiber coatings) are used to create a weak fiber-matrix interface.

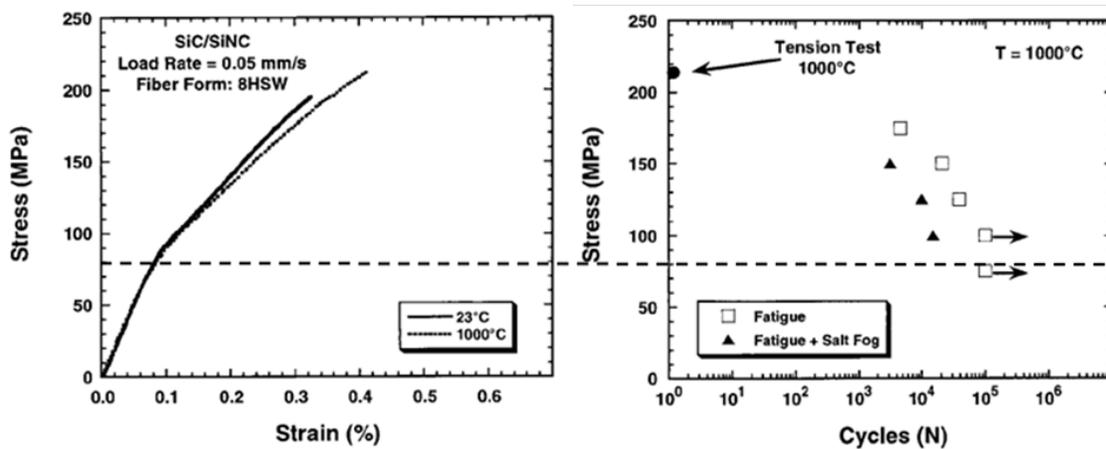
Figure 3: Room and high temperature tensile behavior vs. high temperature fatigue behavior of a Nicalon/SiNC CMC in an oxidizing environment as reported by Zawada [24: 1284, 1286]. The dashed line corresponds to the proportional limit.

Zawada and co-workers at the Air Force Research Laboratory extended Mizuno’s work by investigating the behavior of three Nicalon fiber containing composites at 1000°C subjected to fatigue at 1.0 Hz in oxidizing environments of steam and salt fog [24: 1282-1291]. The composites tested by Zawada et al. were produced using a polymer infiltration and pyrolysis (PIP) process. Unlike the CVI process, PIP involves infusing the fiber pre-forms with a polymer then pyrolyzing the material, to convert the polymer to a ceramic matrix. Zawada et al. followed Mizuno’s procedure of first performing tensile tests to establish baseline material properties, then performing cyclic fatigue. Zawada et al. employed a temperature chamber with steam generating capability and performed periods of cyclic fatigue followed by periods of exposure to the oxidizing environment. Figure 3 below summarizes Zawada’s finding with Nicalon/SiNC.

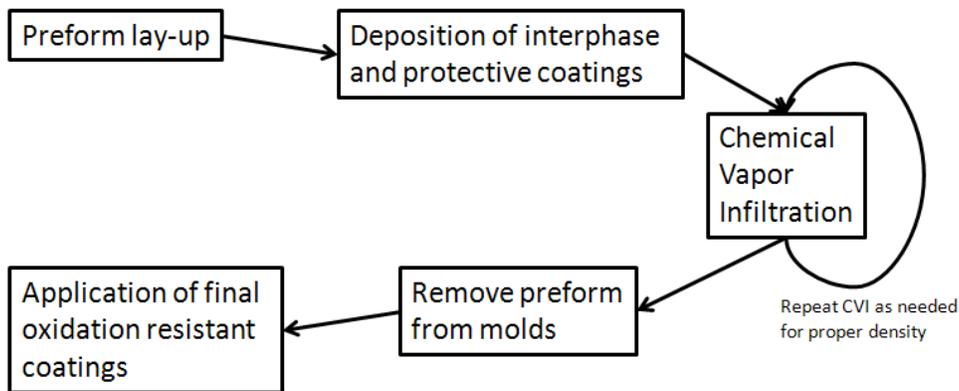
Figure 4: Chemical Vapor Infiltration process.

Production of the Hi-Nicalon/BN/SiC material for this study used the Chemical Vapor Infiltration (CVI) method, outlined below.

To obtain SiC via CVI, manufacturer place a porous reinforcement material in an autoclave in which the chemical methyltrichlorosilane (CH_3SiCl_3) is decomposed with Hydrogen (H_2) at temperatures between 1000 °C – 1350 °C. The reaction is as follows:

The resulting solid SiC infiltrates and densifies the porous areas of the reinforcement while the resultant gaseous HCl is vented. To increase the melting and working temperatures of the final SiC matrix, the CVI processing temperature is increased [2:482-484; 3:122-123].

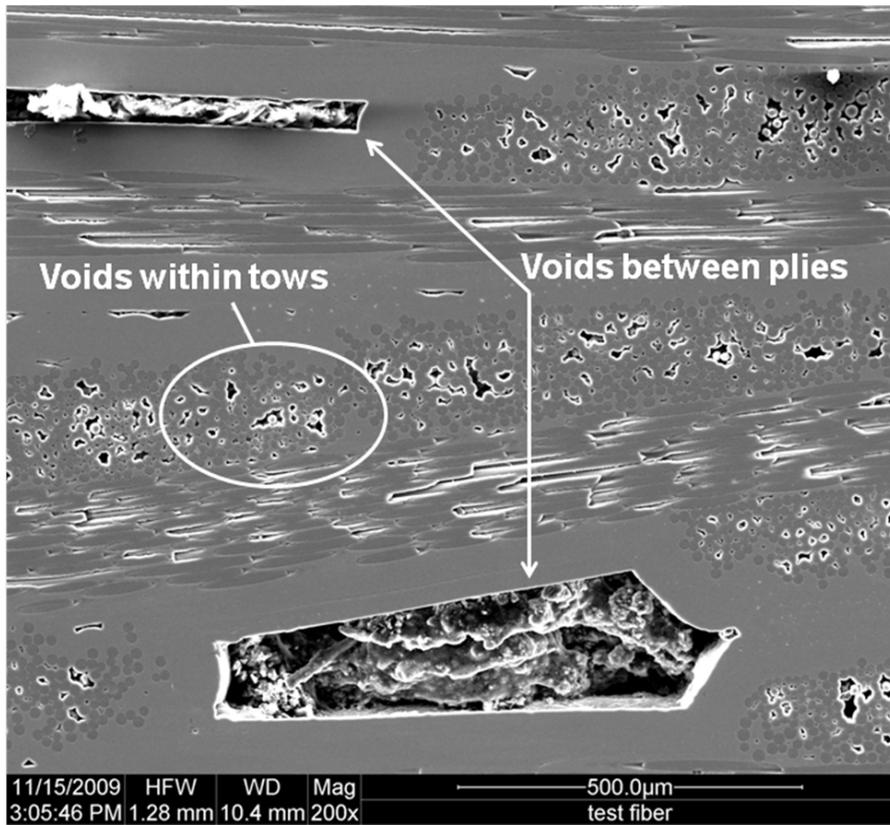
Figure 5: SEM micrograph of polished, as-processed Hi-Nicalon/BN/SiC specimen showing a) voids between plies and b) voids within tows.

The major drawback to CVI processing of matrix material is porosity. As the reaction starts, SiC deposits preferentially at the first surfaces encountered, often sealing off deeper portions of the reinforcement material forming voids [2:483]. This void porosity has three modes, within the fiber bundles, between the layers, and as conjoined holes through fiber layers. The first two modes account for over 95% of the porosity in CVI produced materials [3:123]. Hyper-Therm reported 8.8-10.2% porosity in the parent Hi-Nicalon/BN/SiC panels, which is seen in the following microstructure image.

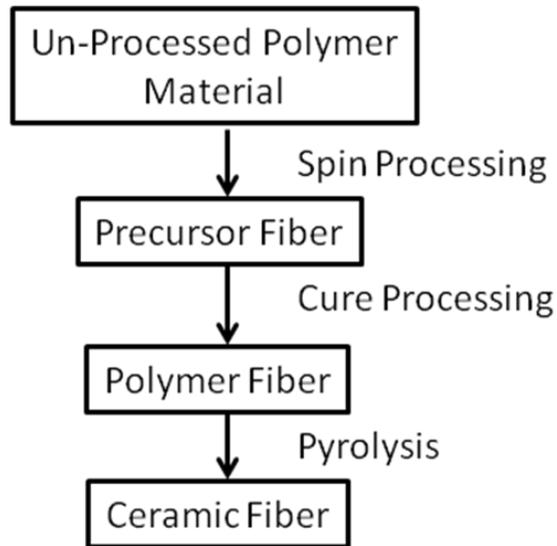
Figure 6: Flow diagram for making ceramic fibers from a polymeric precursor.

In the 1970's, work began on alternate production methods for SiC fibers, ultimately leading to the polymer pyrolysis process for producing Nicalon fibers. Polymer Pyrolysis is a multi-step process consisting of synthesizing a spinnable polymer, spinning a precursor fiber, crosslinking the fiber through curing so it won't melt during pyrolysis, then pyrolyzing the fiber into a ceramic. Since there was no substrate core, this process produced fibers of solid Nicalon. These fibers had higher operating temperatures than the SiC fiber produced via the CVD process. Also, the Nicalon fibers produced by the PIP had smaller diameters than earlier fibers, giving them a tighter bend radius thus making it easier to form then into smaller, more compact shapes. The flow diagram of this process is shown in Figure 6.

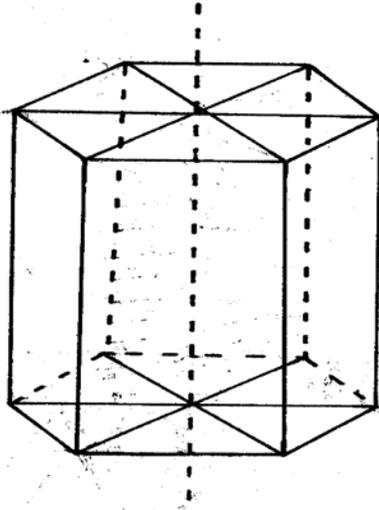
Figure 7: Hexagonal close-packed α -BN crystal structure.

The second advantage of BN is its crystalline structure. Through careful control of the BN CVD process, the interphase layer will be of α -BN, which has a hexagonal, layered structure.

This hexagonal structure easily undergoes cleavage under loading making it a mechanical lubricant [3:37]. Hexagonal BN is sometime referred to as White Graphite. This lubricating effect weakens the bond between the Hi-Nicalon fibers and the SiC matrix, producing the toughness desired in the final CMC.

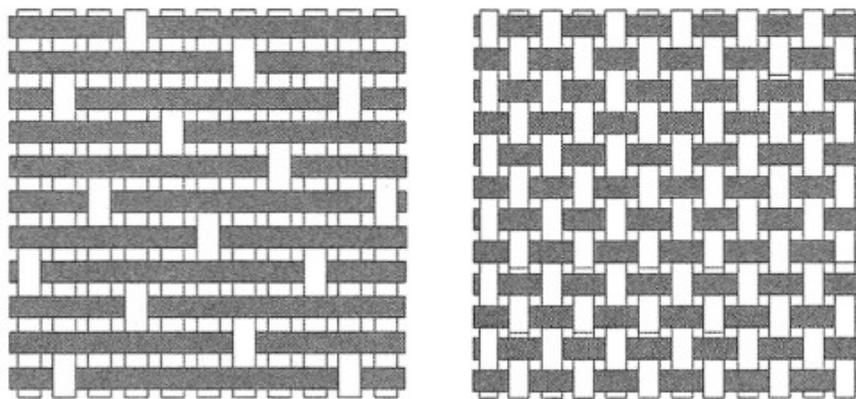
Figure 8: Comparison of eight-harness-satin (8HS) to plain weave.

The preform fabric was woven in an eight-harness-satin (8HS) weave (8HSW). Woven fabrics contain warp, lengthwise bundles of fibers, and weft, transverse bundles of fiber. As seen in the weave comparison below, in an 8HS weave, each warp interlaces with the eighth weft. Each $[0^0/90^0]$ weave pattern will have a slight variation in strength arising from the different number of warp/weft overlays. In production, however, the main factor in choosing a weave pattern is the fabric formability. Weaves with higher harness-satin counts are usually more flexible and can form parts with tighter corner radii than plane or twill weaves. For the Hi-Nicalon/BN/SiC CMC this is not an issue since the parent panels are flat and the test specimens were loaded along one axis only.

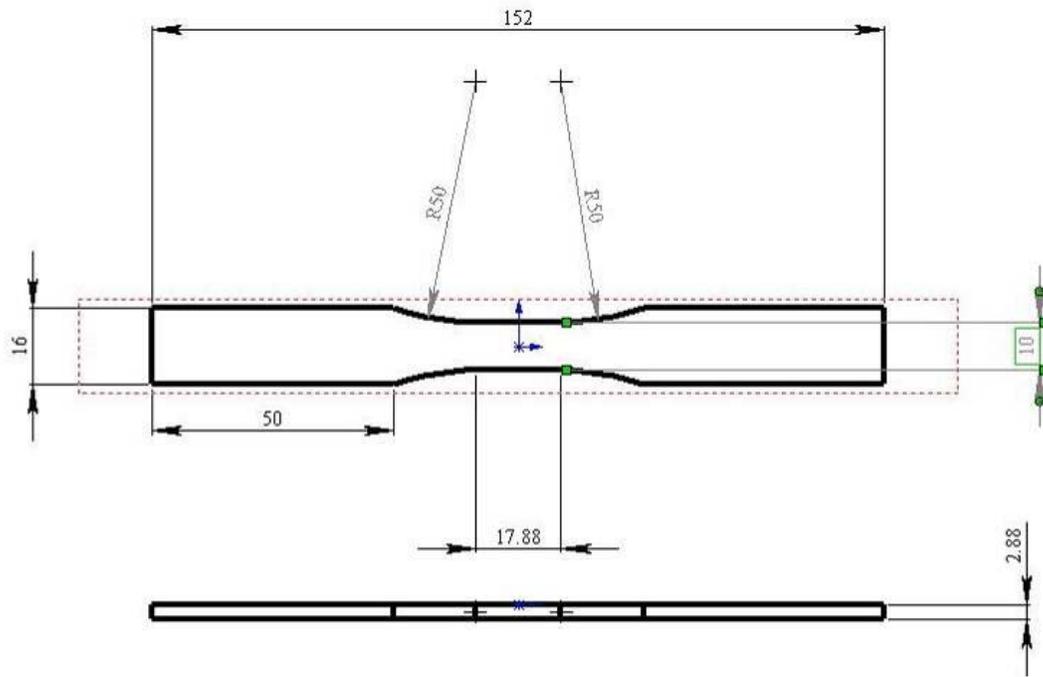
Figure 9: Test specimen. Dimensions in mm.

Bomas Machine Specialties, Inc. used diamond grinding to “cut” the parent panels into standard AFIT tensile test specimens according to the specifications shown in Figure 9. To prevent fraying of the test specimen edges during machining, the parent material was sandwiched between pieces of sacrificial material. Following machining, the test specimens were returned to the manufacturer for a seal coating through an additional SiC CVI treatment. Prior to testing, fiberglass tabs were glued onto both sides of each end of the test specimens to protect the ends from being crushed by the hydraulic grips of the test machine. Throughout machining, sealing, and testing, strict documentation and control ensured traceability of each test specimen back to its parent panel. A specimen ready for testing is shown in Figure 10.

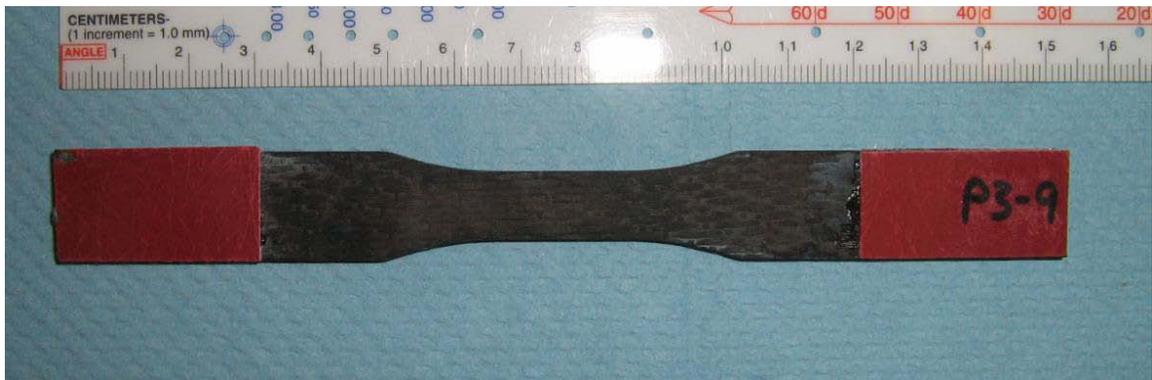
Figure 10: Hi-Nicalon/BN/SiC test specimen.

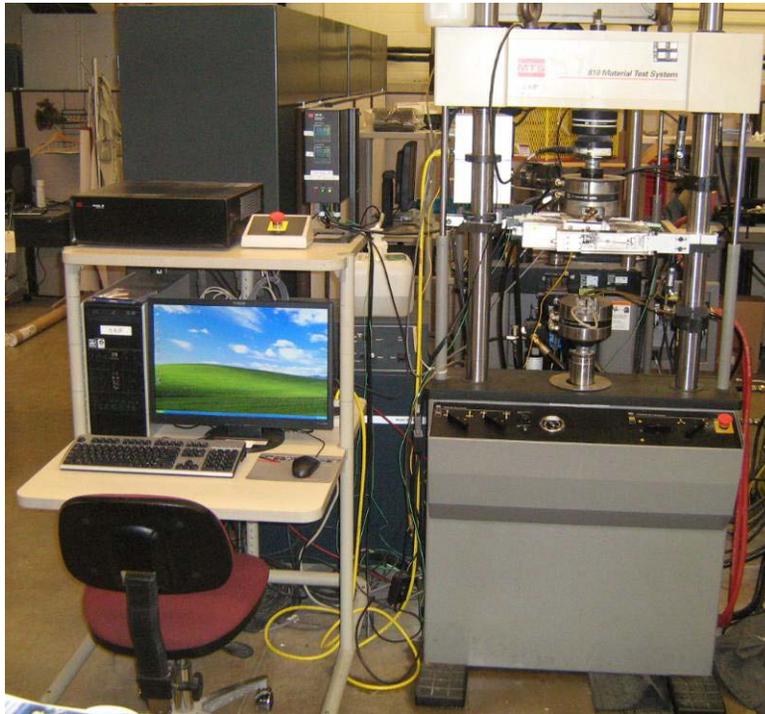
Figure 11: MTS 5 kip vertical servo hydraulic test stand.

Testing of the Hi-Nicalon/BN/SiC employed several pieces of equipment in AFIT's mechanical testing laboratory. The primary testing machine was the Material Test Systems (MTS) vertical servo hydraulic test stand with a 25 kN (5.5 kip) load cell, hereafter referred to as the 5 kip machine. Test specimens were mounted into the 5 kip machine via MTS 647 hydraulic, water cooled, wedge grips. Grip pressure was set to 8 MPa. This grip pressure was high enough to prevent slipping during the tests yet low enough not to crush the specimens. Machine alignment was maintained with an MTS 609 alignment fixture. Figure 11 shows the 5 kip machine.

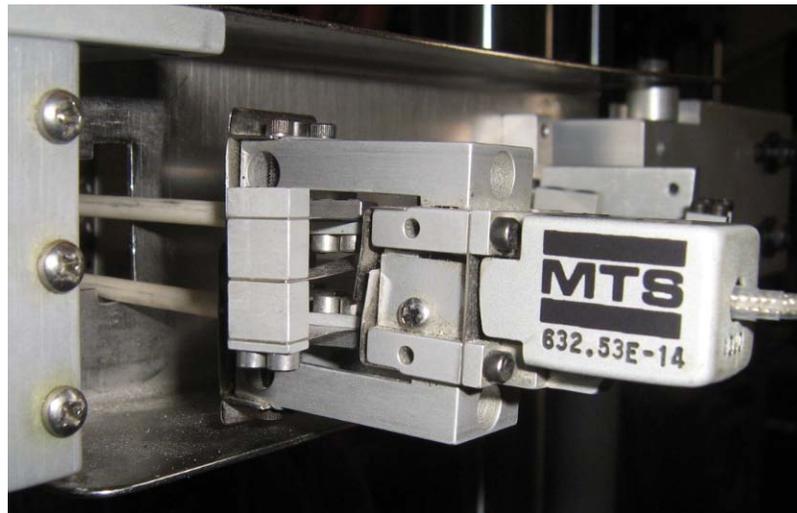
Figure 12: MTS uniaxial low contact force, high temperature extensometer.

An MTS Model 632.53 E-14 uniaxial low contact force, high temperature extensometer was employed for strain measurement. The gauge section of the extensometer was 12.7mm. The extensometer is shown in Figure 12.

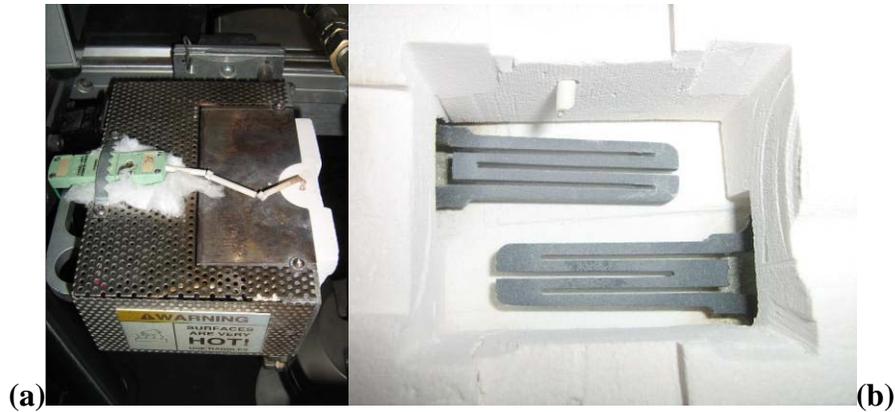
Figure 13: AMTECO Hot Rail Furnace (a) exterior and (b) interior.

Tests were performed at 1200 °C in laboratory air and in steam environments. An AMTECO Hot Rail two zone furnace system, shown in Figure 13, and an MTS 409 temperature controller were used for elevated temperature testing.

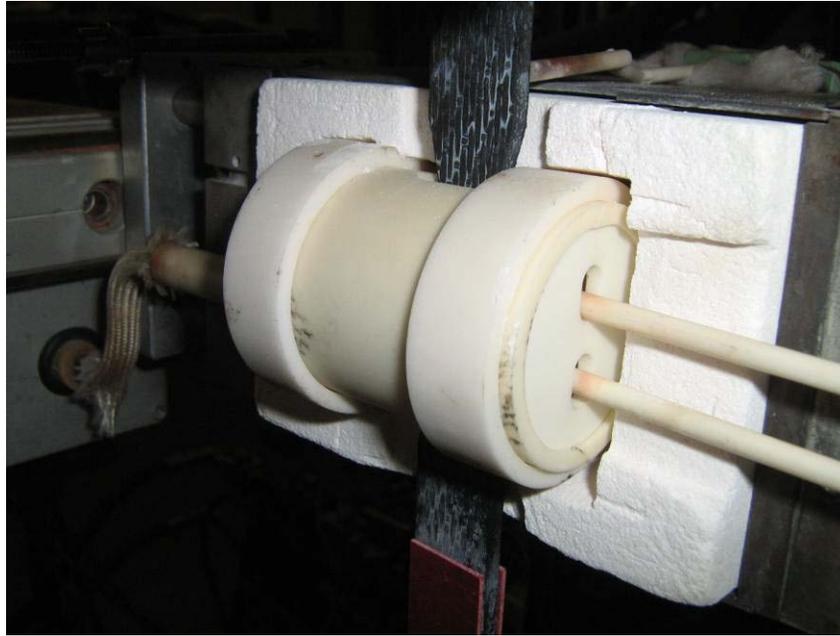
Figure 14: Test specimen mounted in Alumina susceptor.

Tests in steam employed an alumina susceptor (a tube with end caps), which fits inside the furnace. The specimen gage section fits inside the susceptor with the grips ends of the specimens passing through slots in the susceptor. Steam was generated by an AMTECO Steam Generator and introduced into the susceptor in a continuous stream with a slightly positive pressure creating a near 100% steam environment inside the susceptor (Figure 14). Cooling water held at 15°C by a NESLAB Coolflow Model HX-75 refrigerated re-circulator and pumped through the wedge grips protected them from the heat of the furnace during testing.

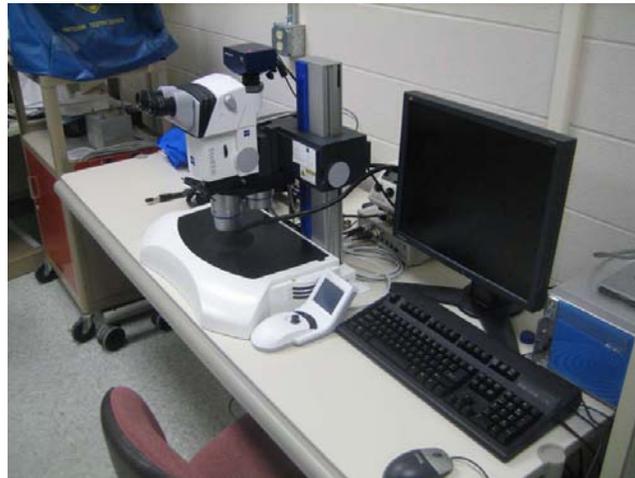
Figure 15: Zeiss Stemi SV II optical microscope with a Zeiss AxioCam HRc digital camera.

After testing, the failed samples were examined under 1) a Zeiss Stemi SV II optical microscope equipped with a Zeiss AxioCam HRc digital camera (Figure 15)

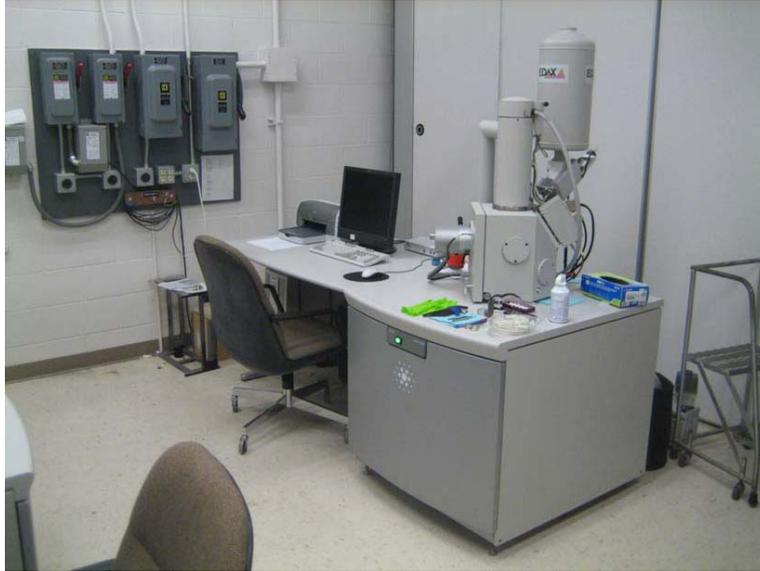
Figure 16: Quanta 200 Scanning Electron Microscope.

And 2) the Quanta 200 scanning electron microscope (Figure 16).

The failed specimens were cut ~4mm behind the fracture surface, and then the fracture surface was mounted on a metallic SEM sample tab. Viewing these specimens at progressively tighter magnifications allowed analysis and characterization of the fracture surface.

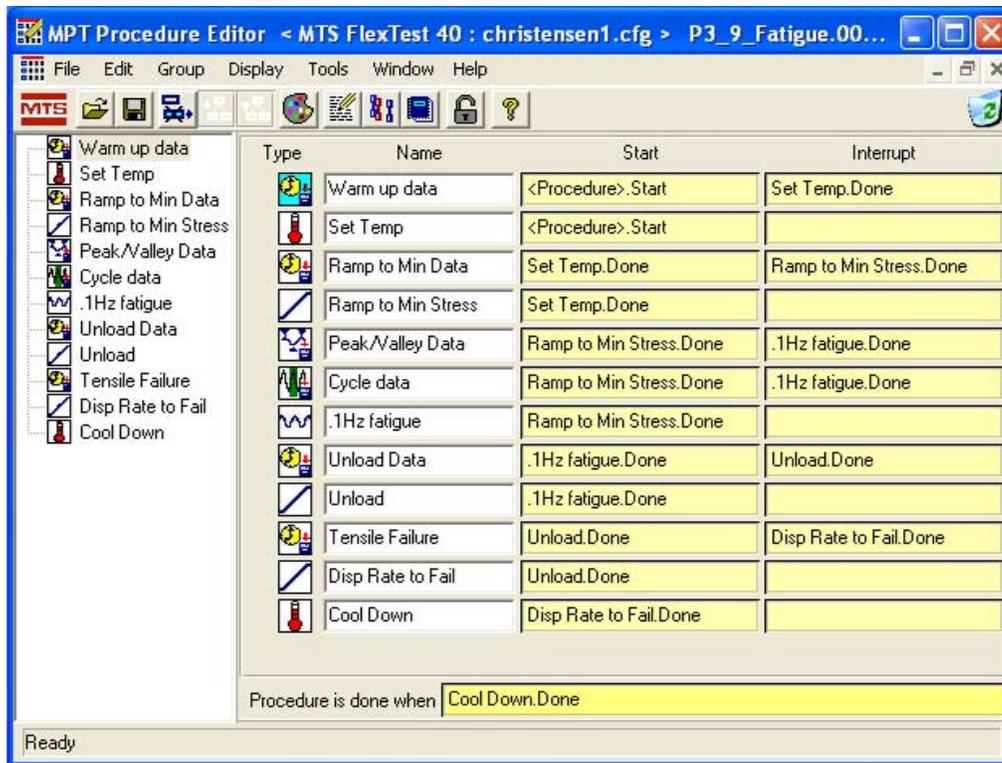
Figure 17: MTS FlexTest 40 fatigue test procedure.

Tension-tension fatigue tests with an R ratio (ratio of minimum stress to maximum stress) of 0.1 were conducted in load control at frequencies of 0.1 Hz, 1.0 Hz, and 10 Hz in both laboratory air and in steam environments. Fatigue run-out was defined as 10^5 cycles at 0.1 Hz and as 2×10^5 cycles at 1.0 Hz and 10 Hz. In all tests, the specimen was heated under a zero load command at a rate of $1\text{ }^{\circ}\text{C}/\text{sec}$ to $1200\text{ }^{\circ}\text{C}$, then the specimens tested in air were held at $1200\text{ }^{\circ}\text{C}$ for 20 minutes and the specimens tested in steam were held at $1200\text{ }^{\circ}\text{C}$ for 25 minutes. Before the cyclic loading began, the load was raised to the minimum stress level in 20 seconds. Once this minimum load level was reached the specimen was subjected to cyclic loading. Data collected during the test included strain, load, load command, displacement, cycle number, temperature and time. “Peak and valley” data were taken for every cycle. Full cycle data was taken for the following cycles: i) cycles 1 to 25, ii) every tenth cycle between cycles 30 and 100, iii) every 100^{th} cycle between cycles 100 and 1000, iv) every 1000^{th} cycle between cycles 1000 and 10000, and v) every 10000^{th} cycle between cycles 10000 and run-out. Figure 17 shows a typical test procedure.

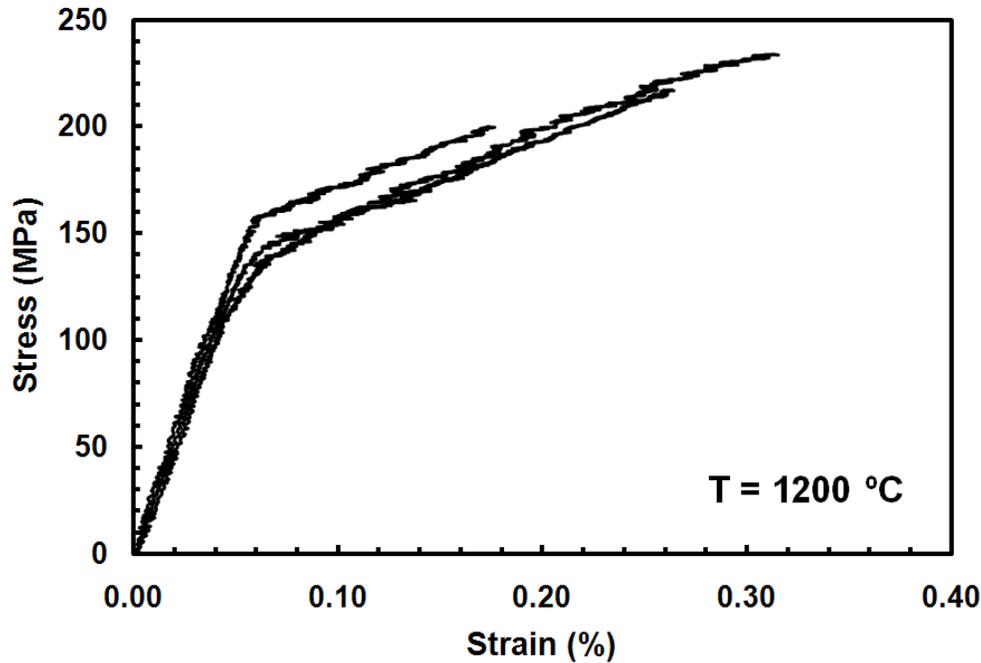
Figure 18: Tensile stress-strain curves for Hi-Nicalon/BN/SiC ceramic composite at 1200 °C in air.

Three specimens, one from each panel, were subjected to tensile tests to failure at 1200 °C. Test results are summarized in Table 6. The tensile stress–strain behavior is shown in Figure 18. The average ultimate tensile strength (UTS) was 217.0 MPa, the average elastic modulus was 246.5 GPa, and the average strain to failure was 0.25 %. The stress-strain curves are nearly linear up to the proportional limit. The average proportional limit was 110 MPa, which is ~ 55 % of the average UTS. At the proportional limit, the nonlinear behavior caused by matrix cracking occurs over a short strain range. After the “knee” in the stress-strain curve, the non-linear behavior appears to terminate, the stress-strain behavior becomes nearly linear and remains almost linear to failure.

It is seen in Figure 18 that the three specimens produced qualitatively similar stress-strain behavior. The minor differences in tensile properties produced by different specimens are within expected specimen-to-specimen and panel-to-panel scatter. However, statistically significant variations in tensile properties could not be determined because of the limited number of specimens.

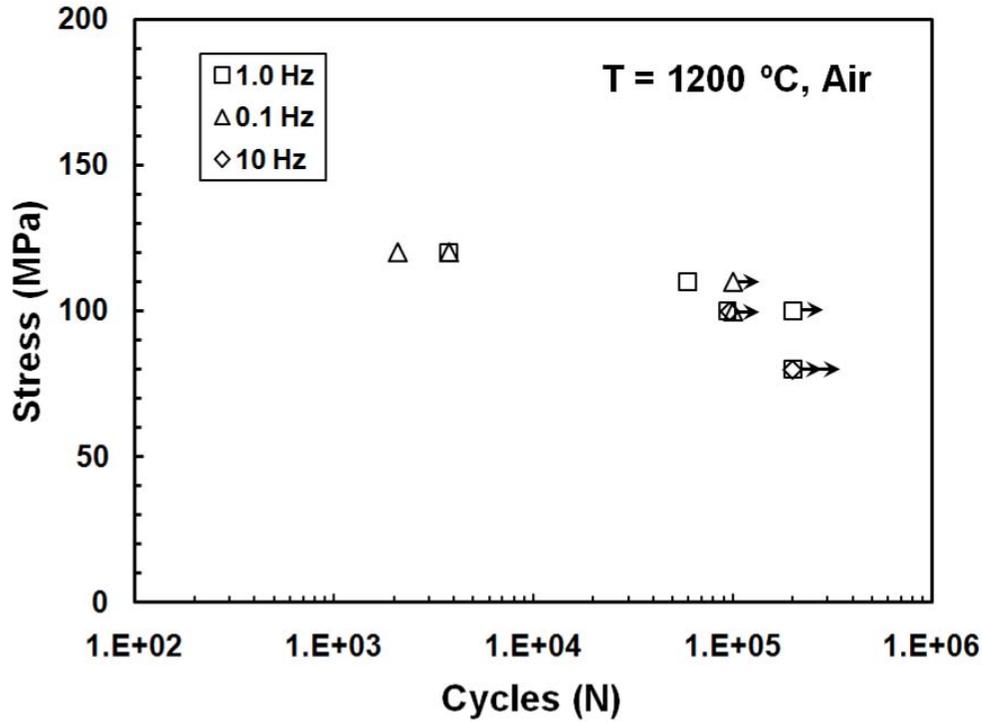
Figure 19: Fatigue stress vs. cycles to failure results (S-N curves) for Hi-Nicalon/BN/SiC ceramic composite at 1200 °C in laboratory air. Arrow indicates that failure of specimen did not occur when the test was terminated.

Tension-tension fatigue tests were conducted at frequencies of 0.1 Hz, 1.0 Hz and 10 Hz at 1200 °C in laboratory air. Fatigue run-out was set to 2×10^5 cycles for the frequencies of 1.0 and 10 Hz and to 10^5 cycles for the frequency of 0.1 Hz. These run-out conditions approximate the number of loading cycles expected in aerospace applications at 1200 °C. Results are summarized in Table 7. Results are also presented in Figure 19 as the stress vs. cycles to failure curves (i.e. S-N curves) for the three frequencies.

Results in Table 7 and Figure 19 reveal that increasing the fatigue frequency by an order of magnitude resulted in decreasing fatigue limit. While the fatigue limit was 110 MPa for the frequency of 0.1 Hz, the fatigue limit for 1.0 Hz was a lower 100 MPa. For the frequency of 10

Hz the fatigue limit further decreased to 80 MPa. These fatigue limits are based on the run-out conditions specified above. It is recognized that a more rigorous run-out condition could have resulted in lower fatigue limits. Note that the fatigue limits produced at 1.0 Hz and 10 Hz are below the average proportional limit obtained in tensile tests. This indicates that at 1.0 Hz and 10 Hz the fatigue limit is less than the stress of matrix cracking. The fatigue limit obtained at 0.1 Hz is at a level equal to the stress of matrix cracking.

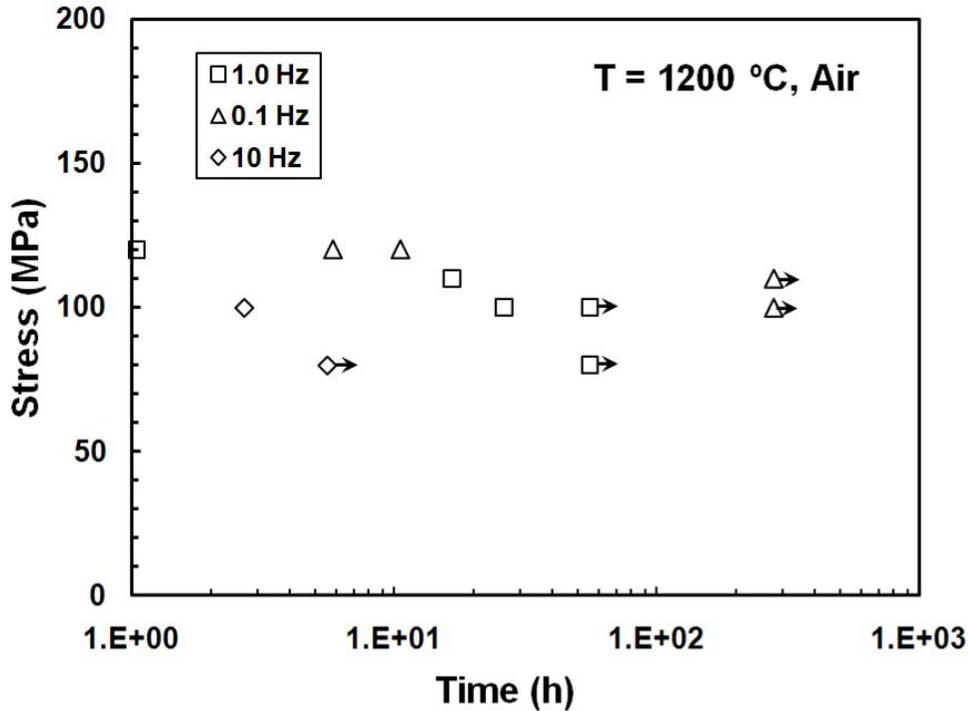
Figure 20: Fatigue stress vs. time to failure for Hi-Nicalon/BN/SiC ceramic composite at 1200 °C in laboratory air. Arrow indicates that failure of specimen did not occur when the test was terminated.

The fatigue data in Figure 19 can also be plotted as a function of time to failure (see Fig. 20). The results in Figure 20 and data in Table 7 show that, for a given stress level (consider, for example, 100 MPa), time to failure decreases with increasing frequency.

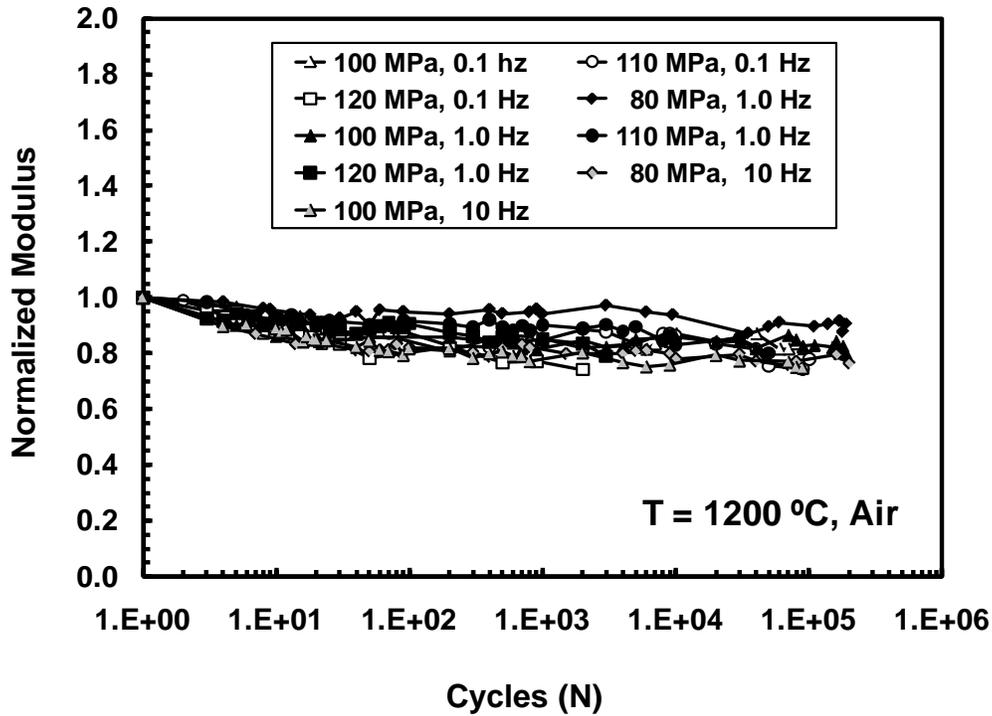
Figure 21: Normalized modulus vs. fatigue cycles for Hi-Nicalon/BN/SiC ceramic composite at 1200 °C in laboratory air.

Of importance in cyclic fatigue is the reduction in stiffness (hysteresis modulus determined from the maximum and minimum stress-strain data points during a load cycle), which reflects the damage development during fatigue cycling. Modulus evolution with fatigue cycles is shown in Figure 21, where normalized modulus (i.e. modulus normalized by the modulus obtained in the first cycle) is plotted vs. fatigue cycles. It is noteworthy that although some tests achieved run-out, a decrease in normalized modulus with cycling was still observed. Contrary to expectations, modulus loss remained relatively independent of the fatigue stress level for all fatigue frequencies. Furthermore, the loading frequency also appears to have little effect on the modulus change with cycles. At 0.1 Hz the normalized modulus decreased by 22% in the 100 MPa test and by 26% in the 120 MPa test. At 1.0 Hz the normalized modulus decreased by

21% in the 80 MPa test and by 20% in the 120 MPa test. At 10 Hz the normalized modulus decreased by 24% in the 80 MPa test and by 25% in the 100 MPa test. The modulus loss of 22% observed in the 100 MPa test at 0.1 Hz is not significantly different from the 25% modulus loss noted in the 100 MPa test at 10 Hz.

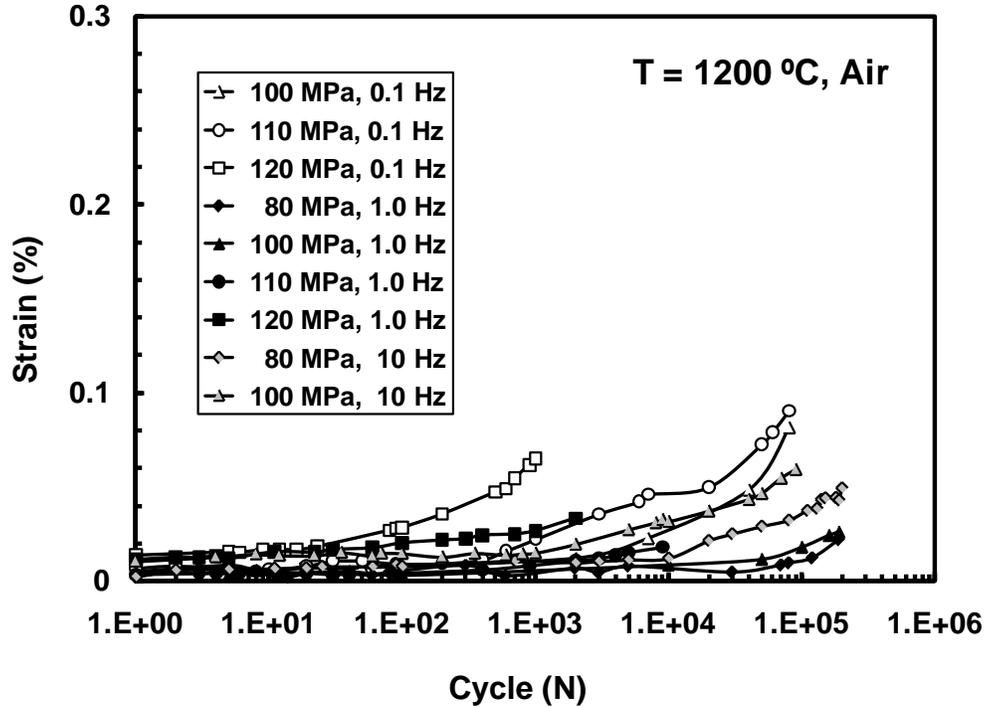
Figure 22: Maximum strain vs. fatigue cycles for Hi-Nicalon/BN/SiC ceramic composite at 1200 °C in laboratory air.

Maximum cyclic strains as functions of fatigue cycles are presented in Figure 22. It is seen that at 1200 °C in air continual strain accumulation with cycling occurs until failure or run-out. The loading frequency does not appear to have a profound effect on the rate of strain accumulation or on the accumulated strains. All strains accumulated in fatigue tests conducted at 1200 °C in air are below 0.1%.

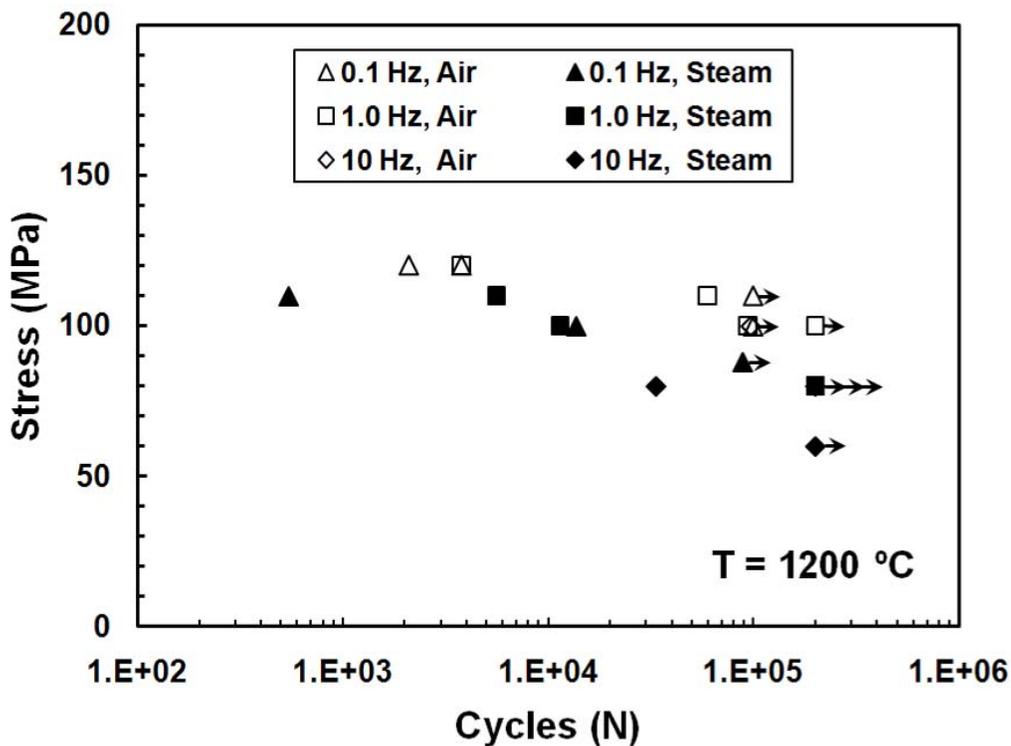
Figure 23: Fatigue stress vs. cycles to failure results (S-N curves) for Hi-Nicalon/BN/SiC ceramic composite at 1200 °C in laboratory air and in steam environment. Arrow indicates that failure of specimen did not occur when the test was terminated.

Tension-tension fatigue tests were conducted at frequencies of 0.1 Hz, 1.0 Hz and 10 Hz at 1200 °C in steam environment. Fatigue run-out was set to 2×10^5 cycles for the frequencies of 1.0 Hz and 10 Hz and to 10^5 cycles for the frequency of 0.1 Hz. Results are summarized in Table 8. Results are also presented in Figure 23 as the stress vs. cycles to failure curves (i.e. S-N curves) for the three frequencies. Results obtained in laboratory air are included in Table 8 and in Figure 23 for comparison.

Results in Table 8 and Figure 23 show that at all fatigue frequencies investigated the presence of steam causes severe degradation in fatigue performance. For the frequency of 0.1 Hz the reduction in cyclic life due to the presence of steam was 86% in the 100 MPa test and 99% in the 110 MPa test. While the fatigue limit at 0.1 Hz in air was 110 MPa, the fatigue limit in steam was below 90 MPa. At 1.0 Hz the cyclic lifetimes were reduced by >90% in tests with the maximum stress of 100 and 110 MPa. The fatigue limit obtained at 1.0 Hz in steam was only 80 MPa, noticeably lower than the fatigue limit of 100 MPa produced in air. At 10 Hz the cyclic

lifetime in the 80 MPa test was reduced by 83% due to the presence of steam. Furthermore, the fatigue limit at 10 Hz was reduced from 80 MPa to 60 MPa due to steam.

The effect of fatigue frequency on the fatigue performance in steam was no more pronounced than that observed in laboratory air. In steam, an increase in fatigue frequency by an order of magnitude also resulted in decreasing fatigue limit. At 1200 °C in steam, as the fatigue frequency increased from 0.1 Hz to 1.0 Hz, the fatigue limit decreased from ~90 MPa to 80 MPa. Likewise, as the fatigue frequency increased from 1.0 Hz to 10 Hz, the fatigue limit decreased from 80 MPa to 60 MPa.

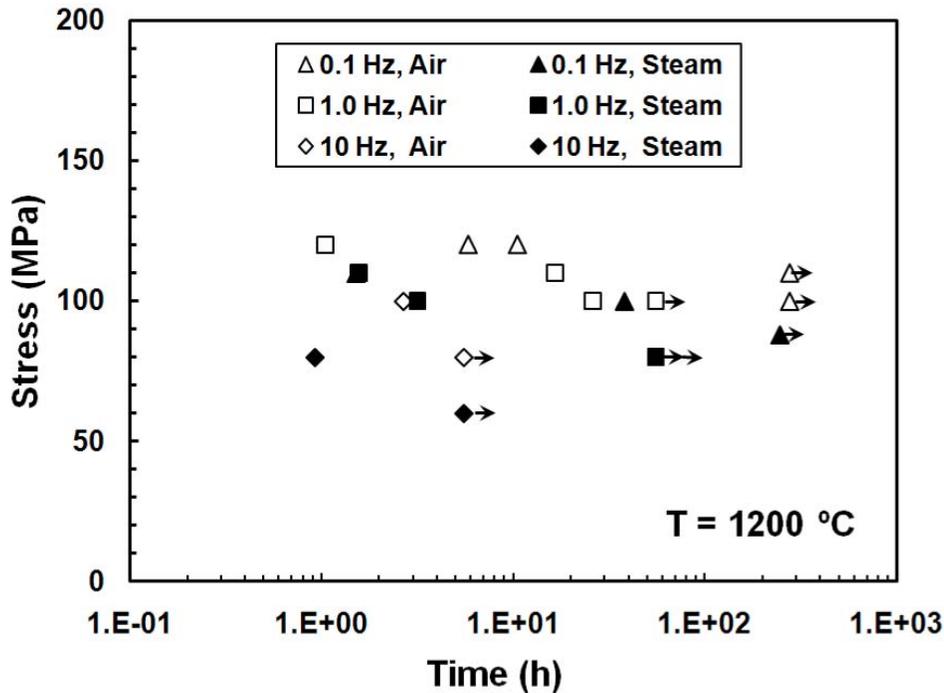
Figure 24: Fatigue stress vs. time to failure for Hi-Nicalon/BN/SiC ceramic composite at 1200 °C in laboratory air. Arrow indicates that failure of specimen did not occur when the test was terminated.

The fatigue data in Figure 23 obtained in steam were also plotted as a function of time to failure in Figure 24. The results in Figure 24 and data in Table 8 show that in steam, for a given stress level, time to failure decreases with increasing frequency.

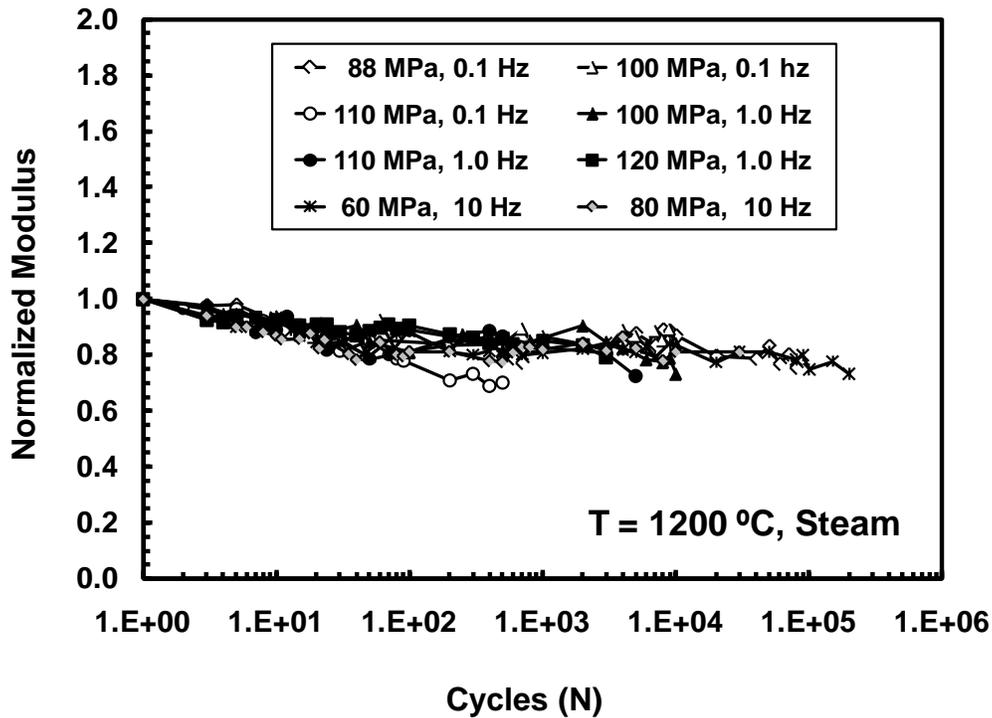
Figure 25: Normalized modulus vs. fatigue cycles for Hi-Nicalon/BN/SiC ceramic composite at 1200 °C in steam.

Change in hysteresis modulus (determined from the maximum and minimum stress-strain data points during a load cycle) with fatigue cycling at 1200 °C in steam was evaluated. Results are presented in Figure 25, where normalized modulus (i.e. modulus normalized by the modulus obtained in the first cycle) is plotted vs. fatigue cycles. A decrease in normalized modulus with cycling was observed in all tests conducted in steam. Changes in normalized modulus are somewhat more pronounced in steam. While at 1200 °C in air the modulus loss was limited to 26%, in steam modulus loss of 30% was observed in the 110 MPa test at 0.1 Hz. As in air environment, in steam the modulus change with cycles appears to be relatively independent of

the loading frequency. At 0.1 Hz in steam the normalized modulus decreased by 25% in the 88 MPa test and by 30% in the 110 MPa test. At 1.0 Hz in steam the normalized modulus decreased by 27% in the 100 MPa test and by 28% in the 110 MPa test. At 10 Hz in steam the normalized modulus decreased by 27% in the 60 MPa test and by 20% in the 80 MPa test. The modulus loss of 30% noted in the 110 MPa test at 0.1 Hz is close to the modulus loss of 28% recorded in the 110 MPa test at 1.0 Hz.

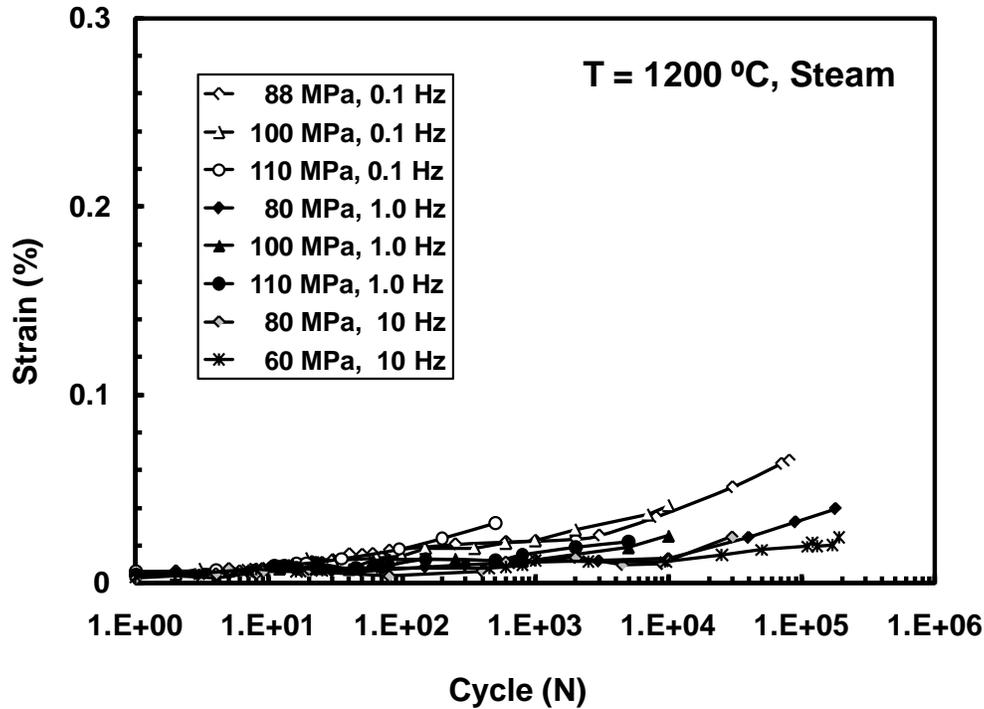
Figure 26: Maximum strain vs. fatigue cycles for Hi-Nicalon/BN/SiC ceramic composite at 1200 °C in steam.

Maximum cyclic strains produced at 1200 °C in steam are presented as functions of fatigue cycles in Figure 26. It is seen that the strains accumulated in steam are somewhat lower than those accumulated in air at the same fatigue stress and loading frequency. In steam, the largest strain (0.06%) was accumulated in the 88 MPa test conducted at 0.1 Hz. In air, the largest strain (0.09%) was accumulated in the 110 MPa test conducted at 0.1 Hz. Typically, lower strain accumulation with fatigue cycles indicates that less damage has occurred, and that it is mostly limited to some additional matrix cracking. However, lower strains accumulated in steam generally correspond to shorter fatigue lifetimes. As in air, in steam the loading frequency does not have a strong effect on the rate of strain accumulation or on the accumulated strains.

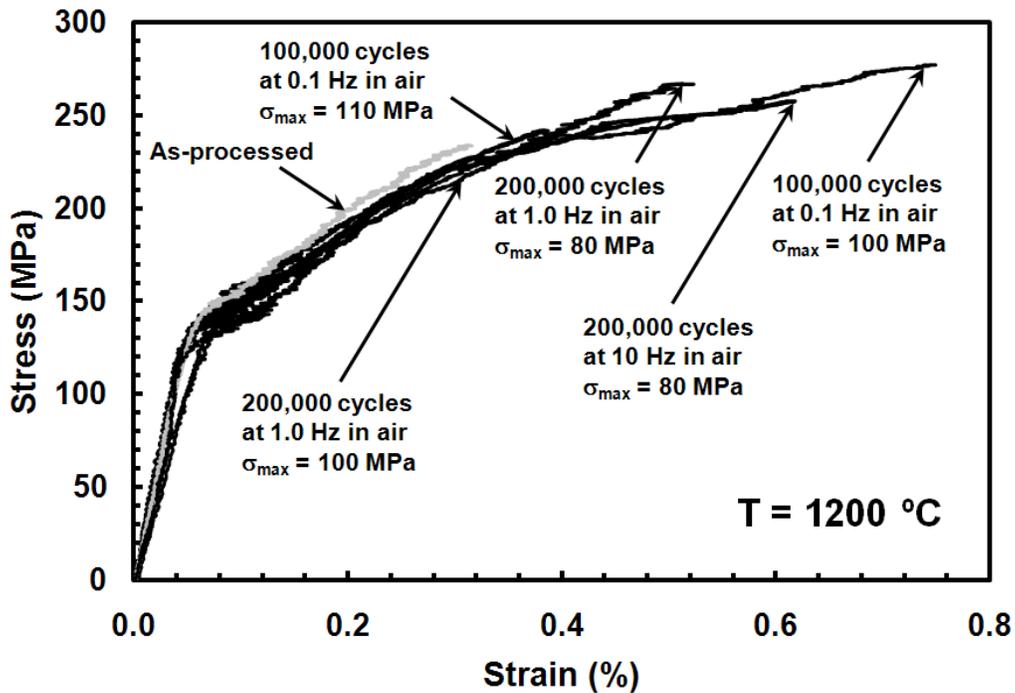
Figure 27: Stress-Strain response of Hi-Nicalon/BN/SiC specimens fatigued in air at 1200 °C then subjected to a monotonic tensile test to failure in laboratory air at 1200 °C at a displacement rate of 0.05mm/s.

The tensile stress-strain curves produced by pre-fatigued specimens are compared to the tensile stress-strain curves obtained for the as-processed composite in Figures 27 and 28. The stress-strain curves obtained for the pre-fatigued specimens are qualitatively similar to those produced by the as-processed composite.

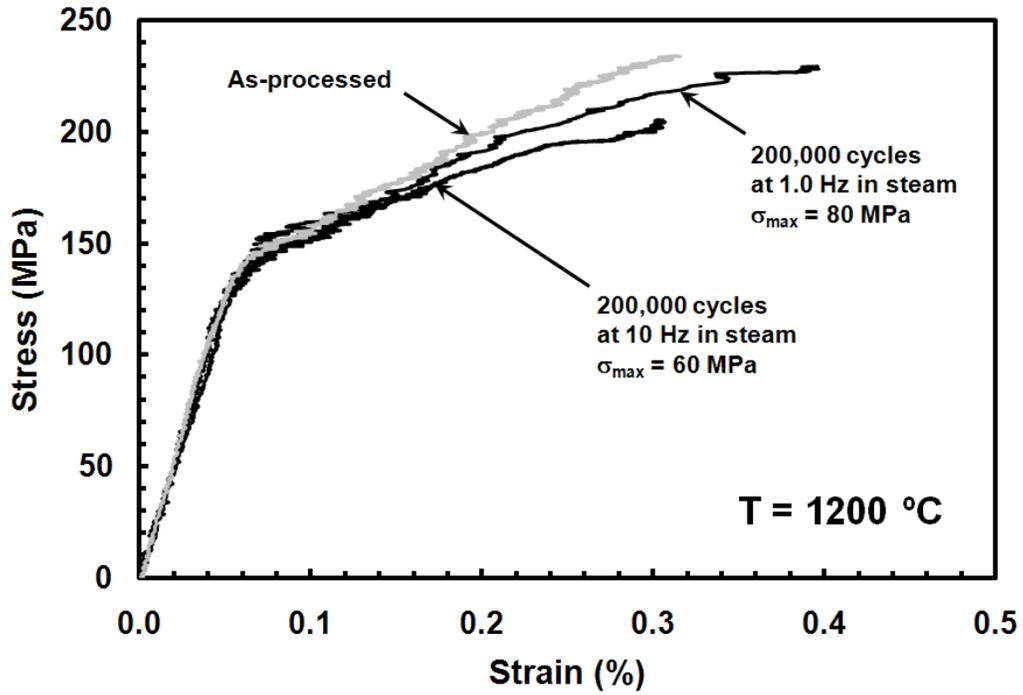
Figure 28: Stress-Strain response of Hi-Nicalon/BN/SiC specimens fatigued in steam at 1200 °C then subjected to a monotonic tensile test to failure in laboratory air at 1200 °C at a displacement rate of 0.05mm/s.
