**FATIGUE BEHAVIOR OF AN ADVANCED SiC/SiC COMPOSITE
AT ELEVATED TEMPERATURE IN AIR AND IN STEAM**

THESIS

Devon T. Christensen, Captain, USAF

AFIT/GAE/ENY/09-D02

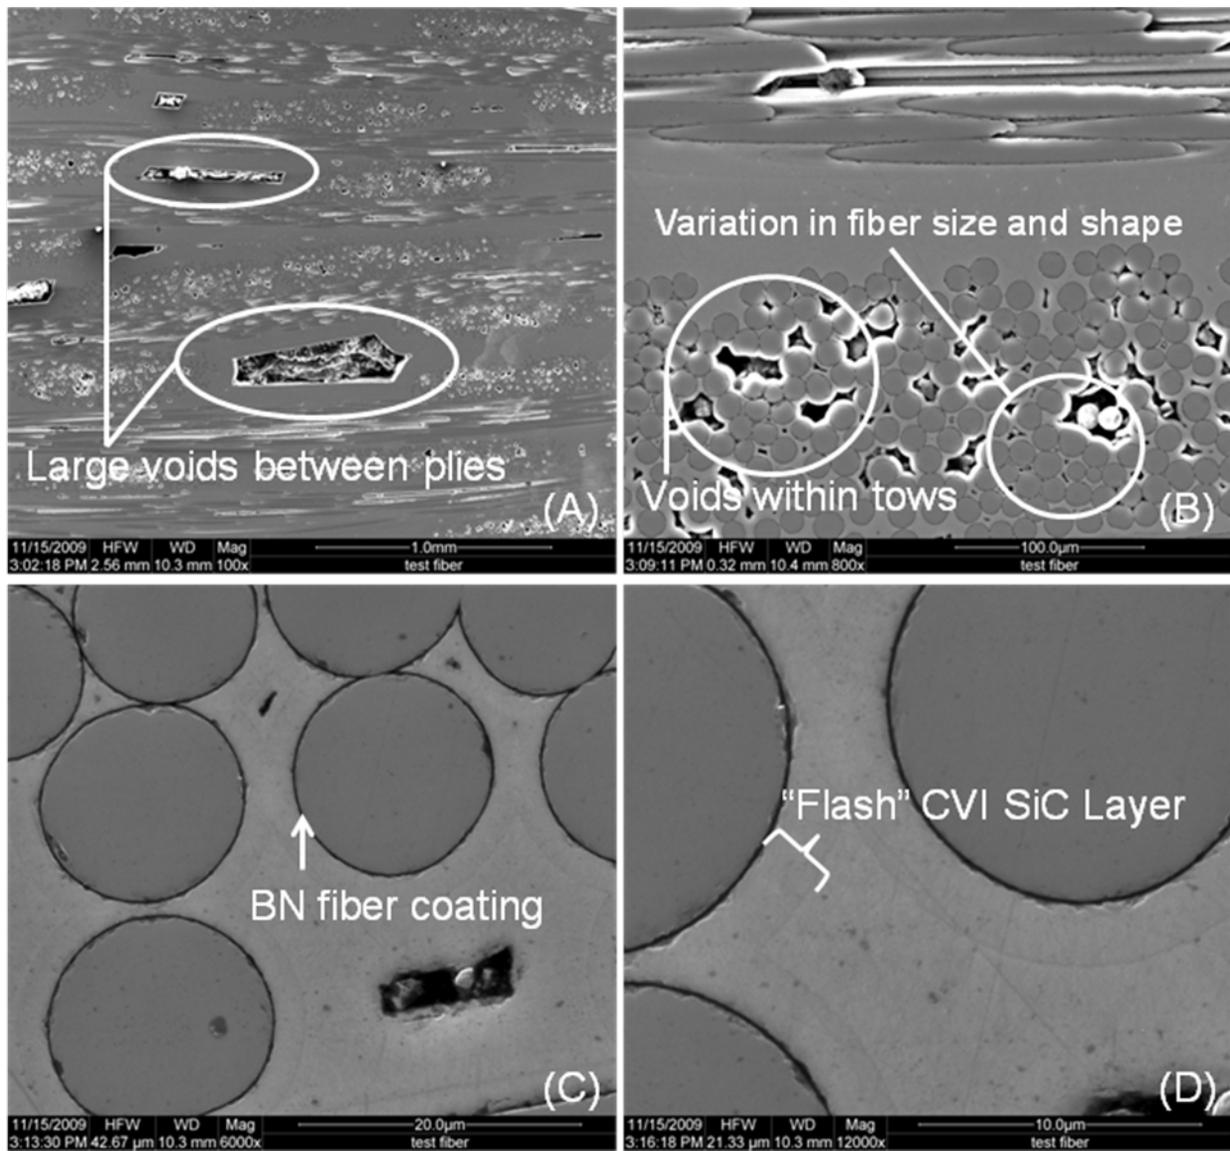
Figure 29: SEM micrographs of the as-processed material from Panel 1 showing A) voids between plies, B) voids within tows of the 8HS weave, C) the BN fiber coating and D) the “flash” CVI SiC layer.

Sections of material from the three composite panels were mounted and polished for viewing under the SEM. As seen in Figures 29-31, similar microstructural features were present in all three parent panels. First, large voids were observed between adjacent plies (see Figure 29 (A)). Next, Figure 29 (B) shows smaller voids within the fiber tows of the woven fabric. Also seen in figure 29 B are the various fiber shapes and sizes. Since the BN fiber coating is quite soft and reacts with water, which was the base of the polishing fluids, it is most likely not present at the surface of these specimens; however, the space occupied by the BN layer is clearly visible and of uniform thickness, Figure 29 (C). Finally, a multi-step manufacturing technique produces a “flash” layer of SiC around the fibers, Figure 29 (D). Despite the difference in appearance, this “flash” layer is the same material and has the same properties as the rest of the SiC matrix densified by the CVI process.

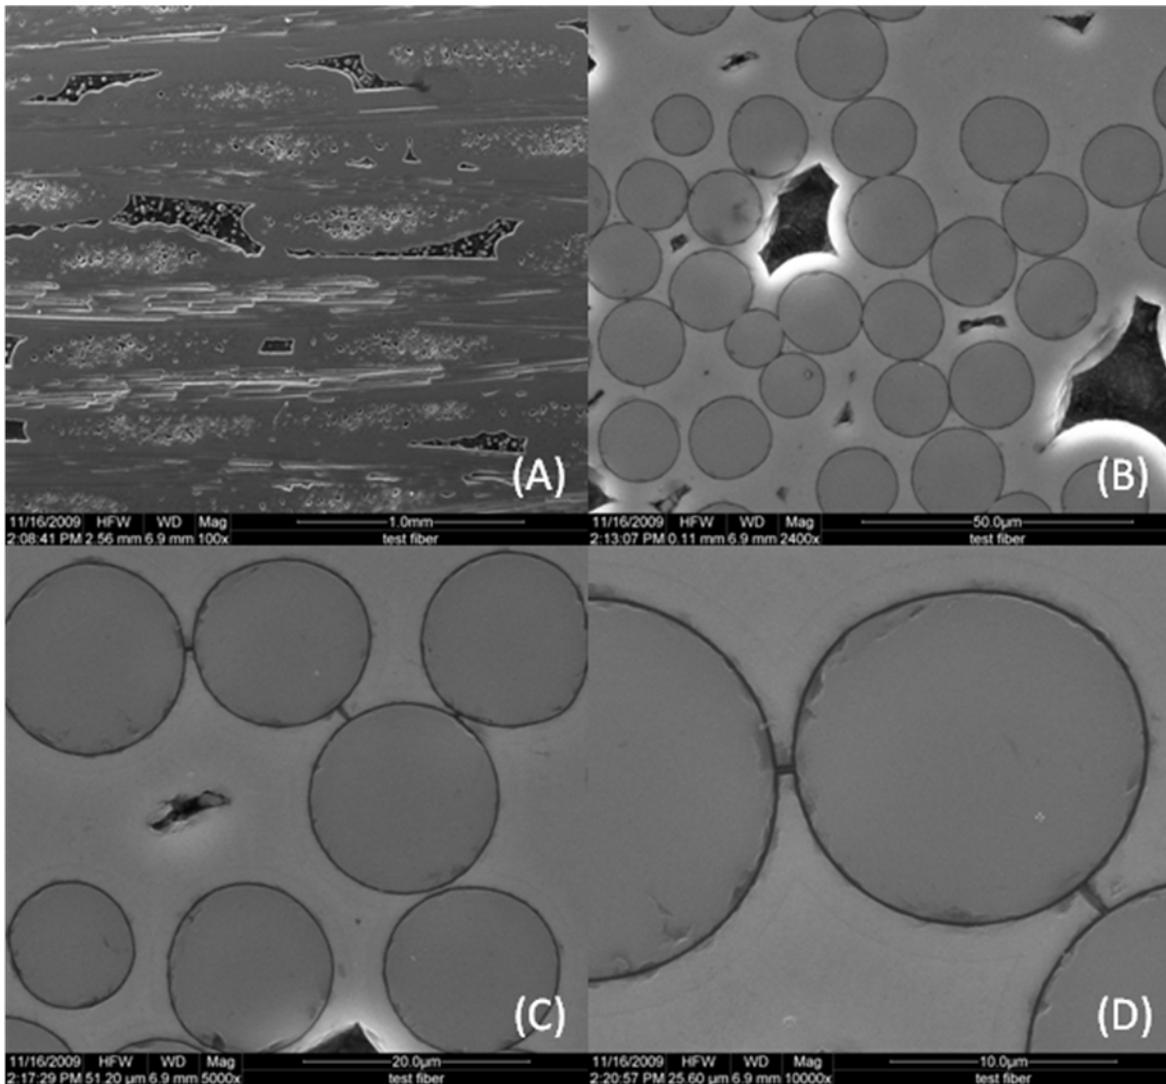
Figure 30: SEM micrographs of the as-processed material from Panel 2 at various magnifications showing similar microstructural features as those observed in Panel 1.

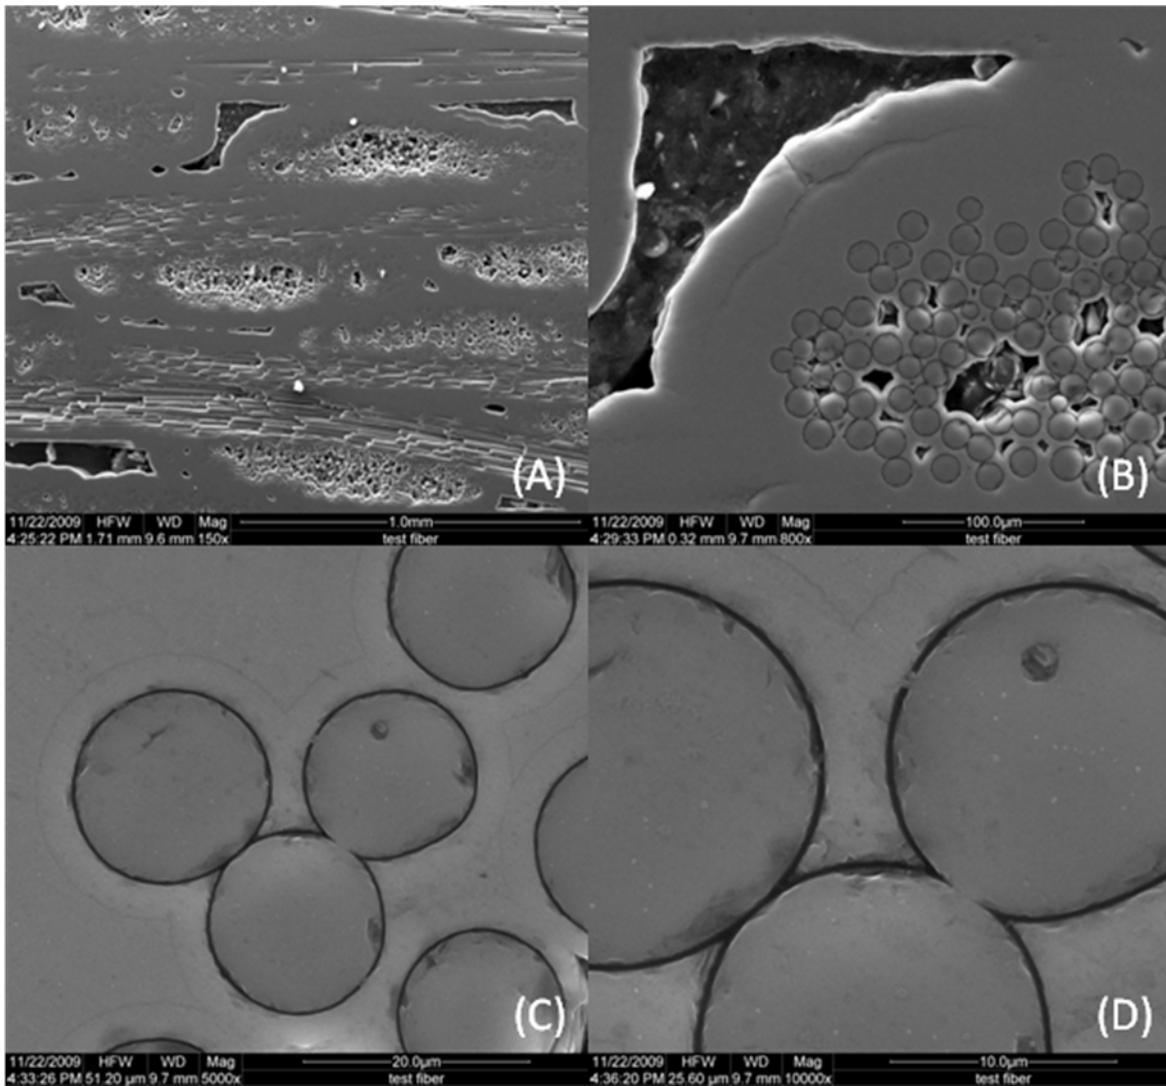
Figure 31: SEM micrographs of virgin material from Panel 3 at various magnifications showing similar microstructural features as those observed in Panel 1.

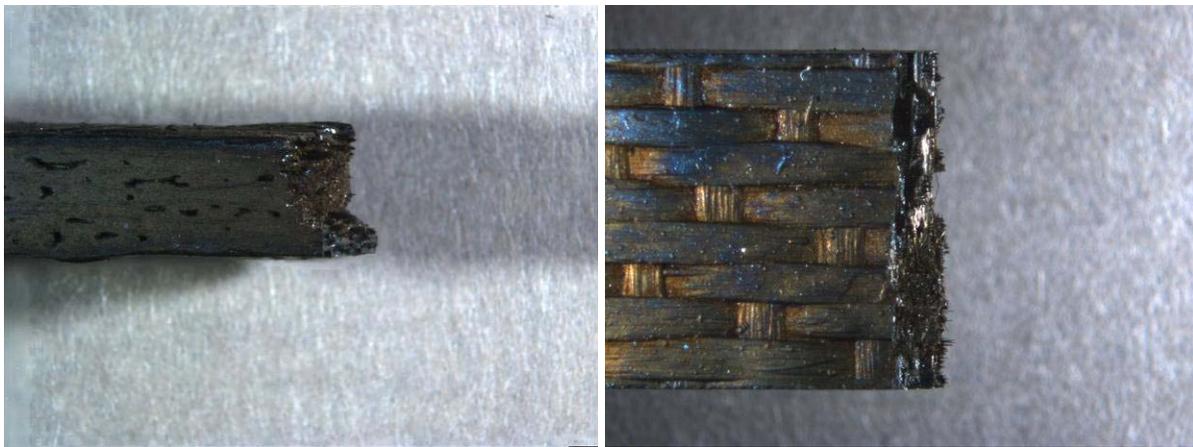
Figure 32: Optical Micrographs of the fracture surfaces produced in tensile test to failure conducted at 0.05mm/sec at 1200 °C in air on specimen P1-3.

To characterize the failure behavior of the Hi-Nicalon/BN/SiC test material, the failed specimens were examined using both a Zeiss optical microscope and a Quanta scanning electron microscope. Figures 32-34 show the optical micrographs of the specimens failed in monotonic tension. It is interesting to note that in these cases little or no fiber pull-out was observed. The fracture surfaces are nearly perpendicular to the 0^0 tows, as seen in Figure 32. The side views of these specimens show no signs of ply delamination.

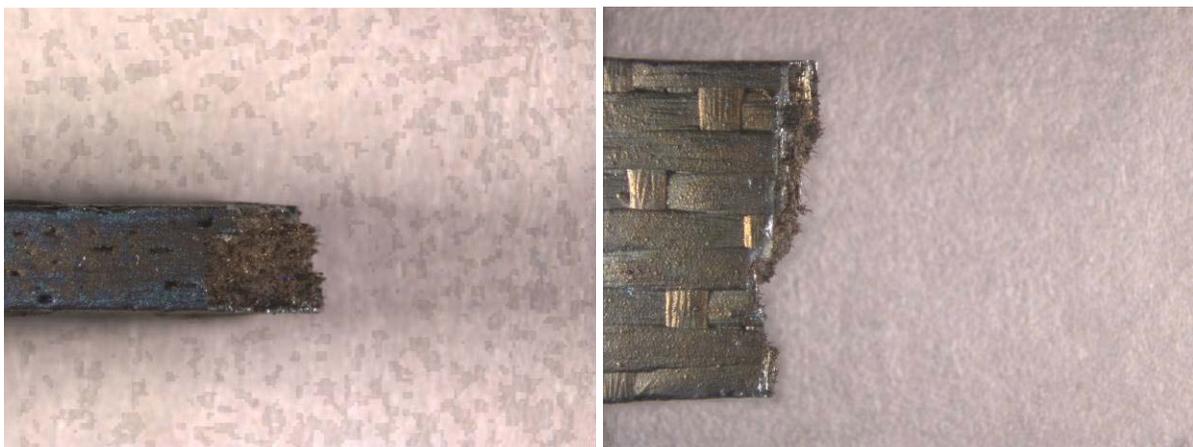
Figure 33: Optical Micrographs of the fracture surfaces produced in tensile test to failure conducted at 0.05mm/sec at 1200 °C in air on specimen P2-4.

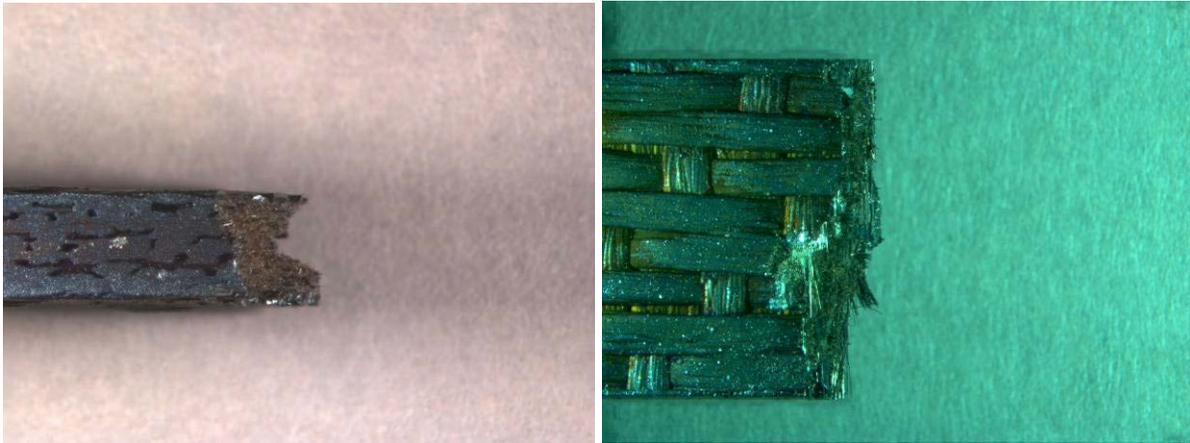
Figure 34: Optical Micrographs of the fracture surfaces produced in tensile test to failure conducted at 0.05mm/sec at 1200 °C in air on specimen P3-1.

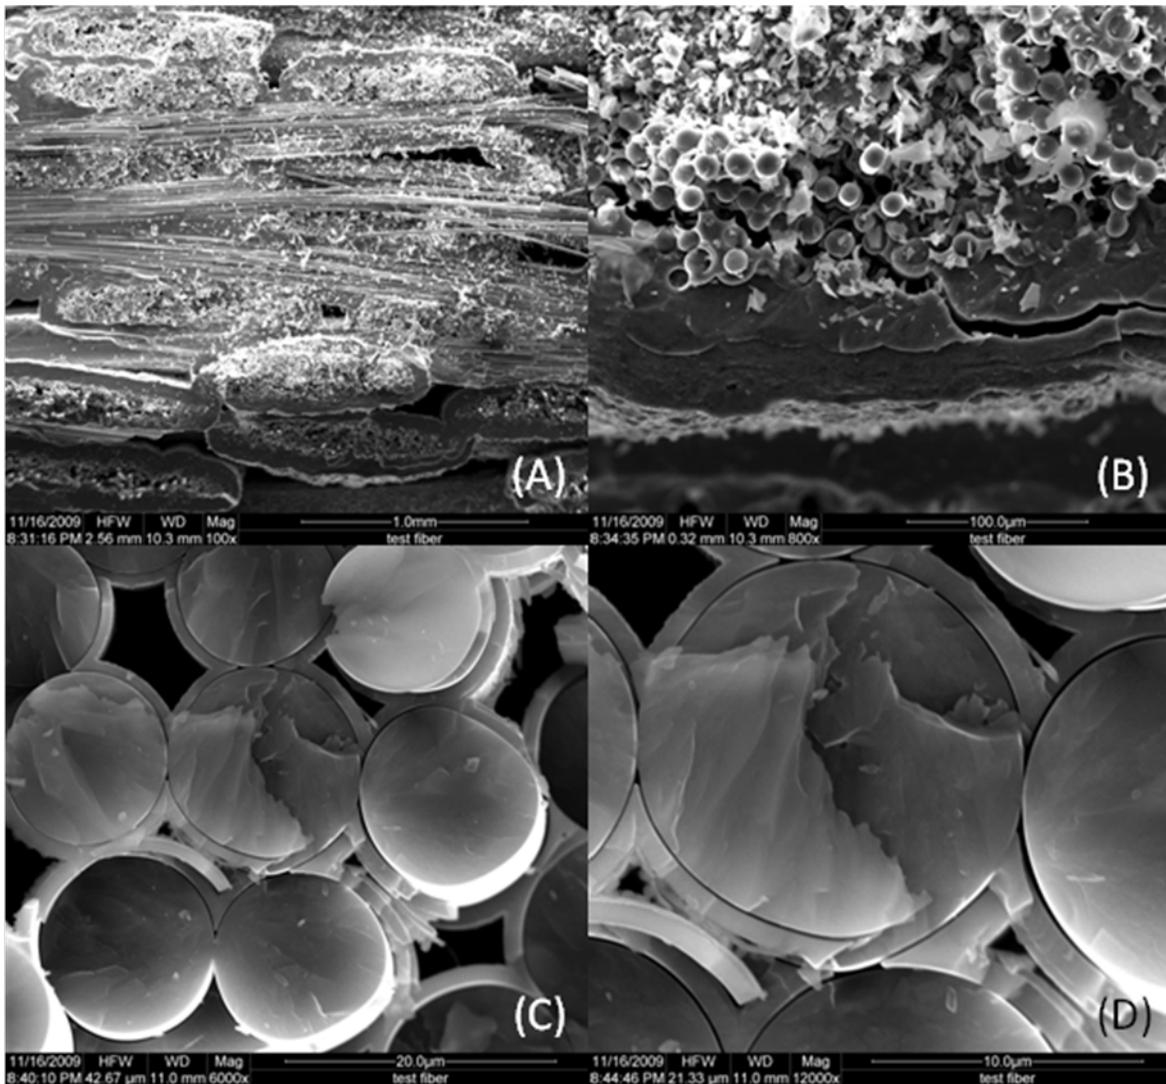
Figure 35: SEM micrographs of fracture surfaces produced in tensile test to failure conducted at 0.05mm/sec at 1200 °C in air on specimen P1-3.

The SEM micrographs of the fracture surface of the three specimens failed in tensile tests also reveal several interesting features. The BN coating appears to be intact indicating that no degradation by oxidation took place. This was expected due to the short duration of the tests. While there is evidence of crack deflection around fibers, as seen in Figure 35 B, cracks also propagated between the “flash” SiC layer and the bulk SiC matrix material, which can be seen in Figures 36 C and D.

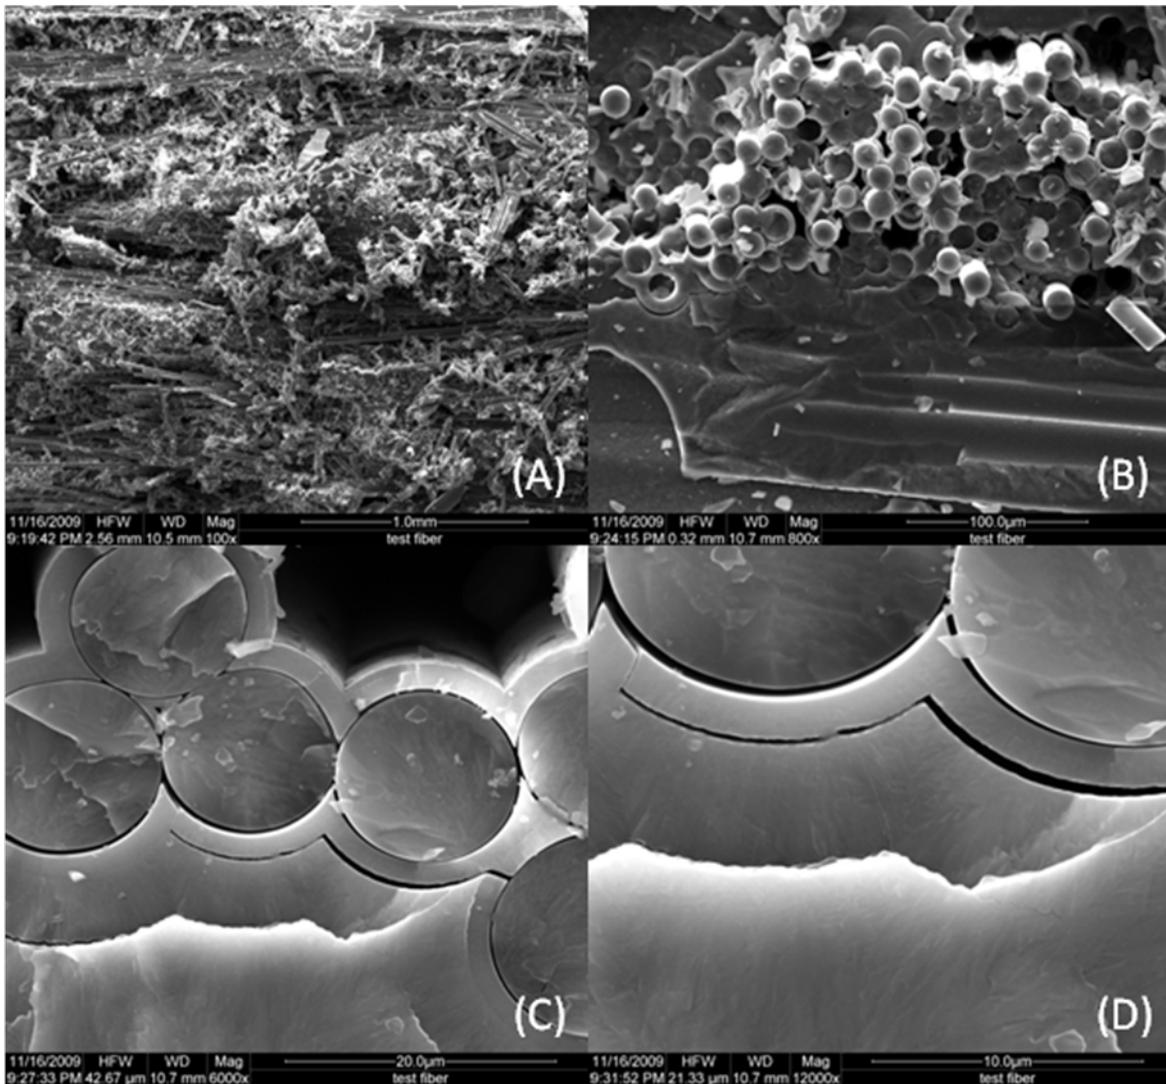
Figure 36: SEM micrographs of fracture surfaces produced in tensile test to failure conducted at 0.05mm/sec at 1200 °C in air on specimen P2-4.

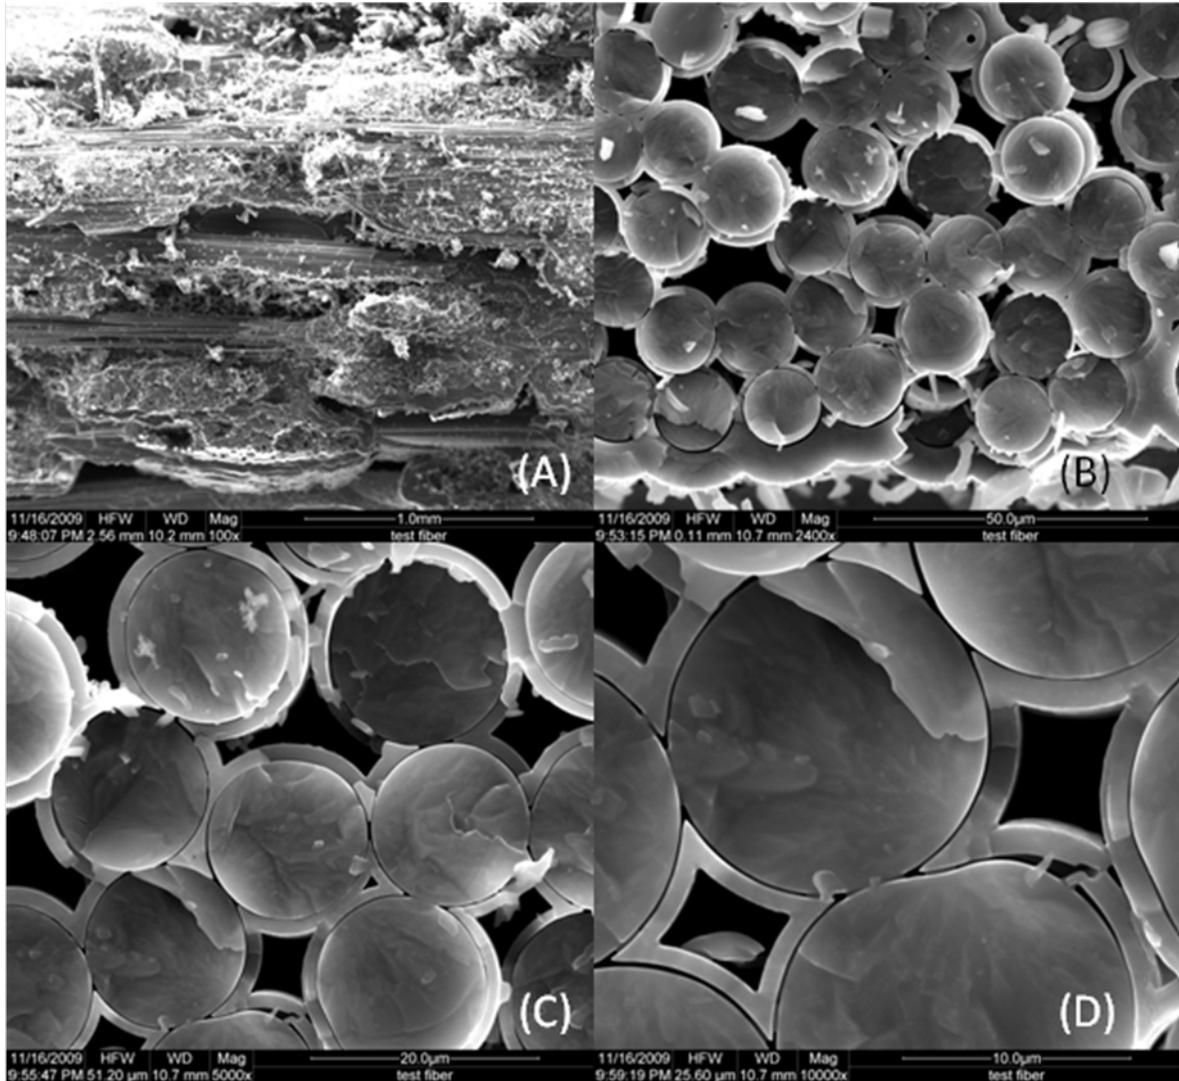
Figure 37: SEM micrographs of fracture surfaces produced in tensile test to failure conducted at 0.05mm/sec at 1200 °C in air on specimen P3-1.

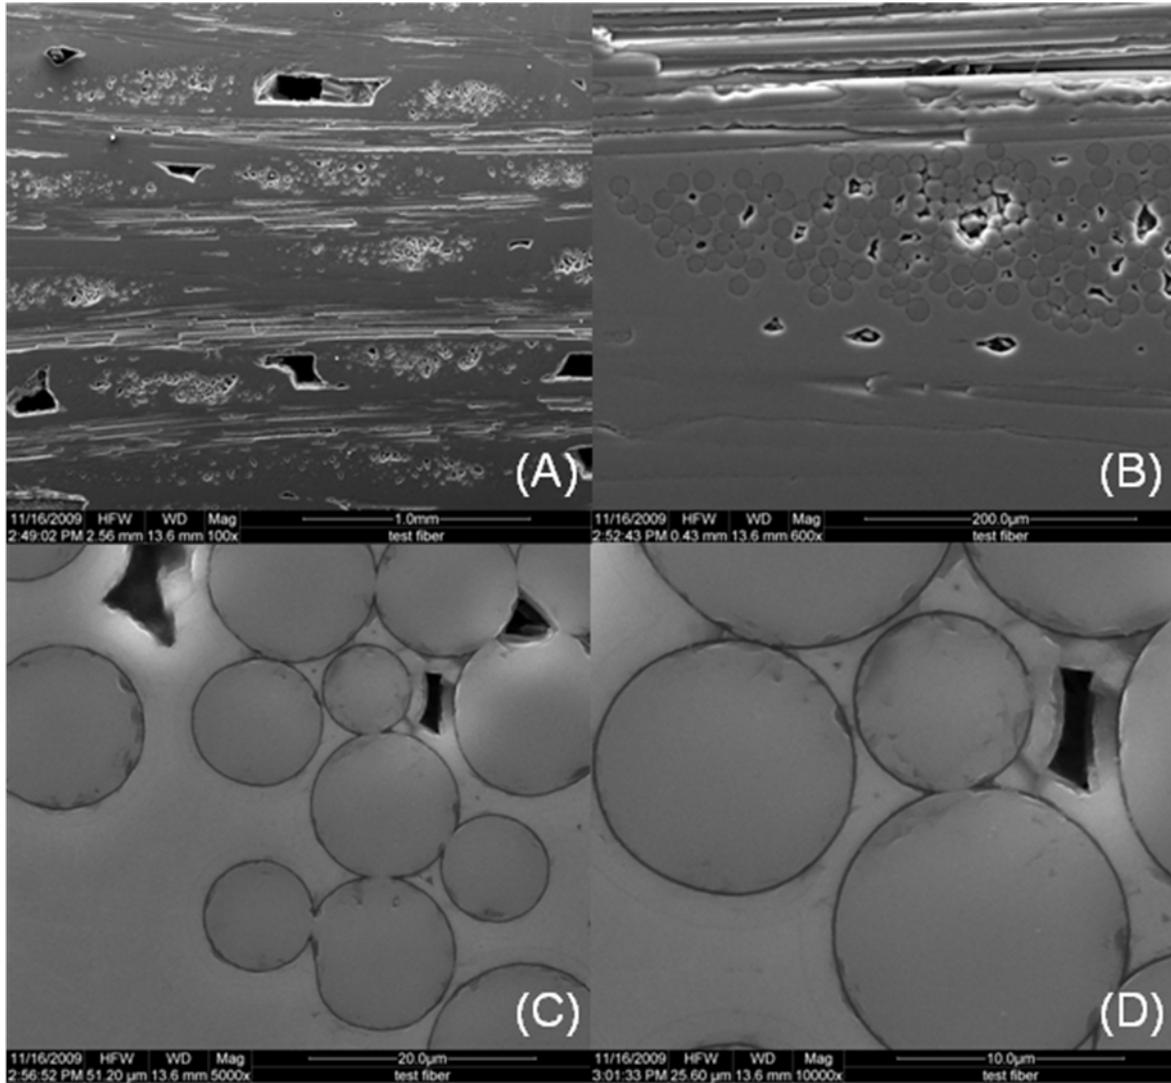
Figure 38: SEM micrographs of polished section from specimen P1-3 failed in tensile test.

Analysis of the polished surfaces of these specimens further supports the conclusion that the BN fiber coating was not damaged during the tensile test to failure. Micrographs in Figures 38-40 show the fiber coating remains smooth and uniform in all specimens failed in monotonic tension. There was no apparent damage to the 90° fibers. Figures 40 (B) and (C) show what appears to be cracks propagating between fibers; however, closer examination of the micrograph

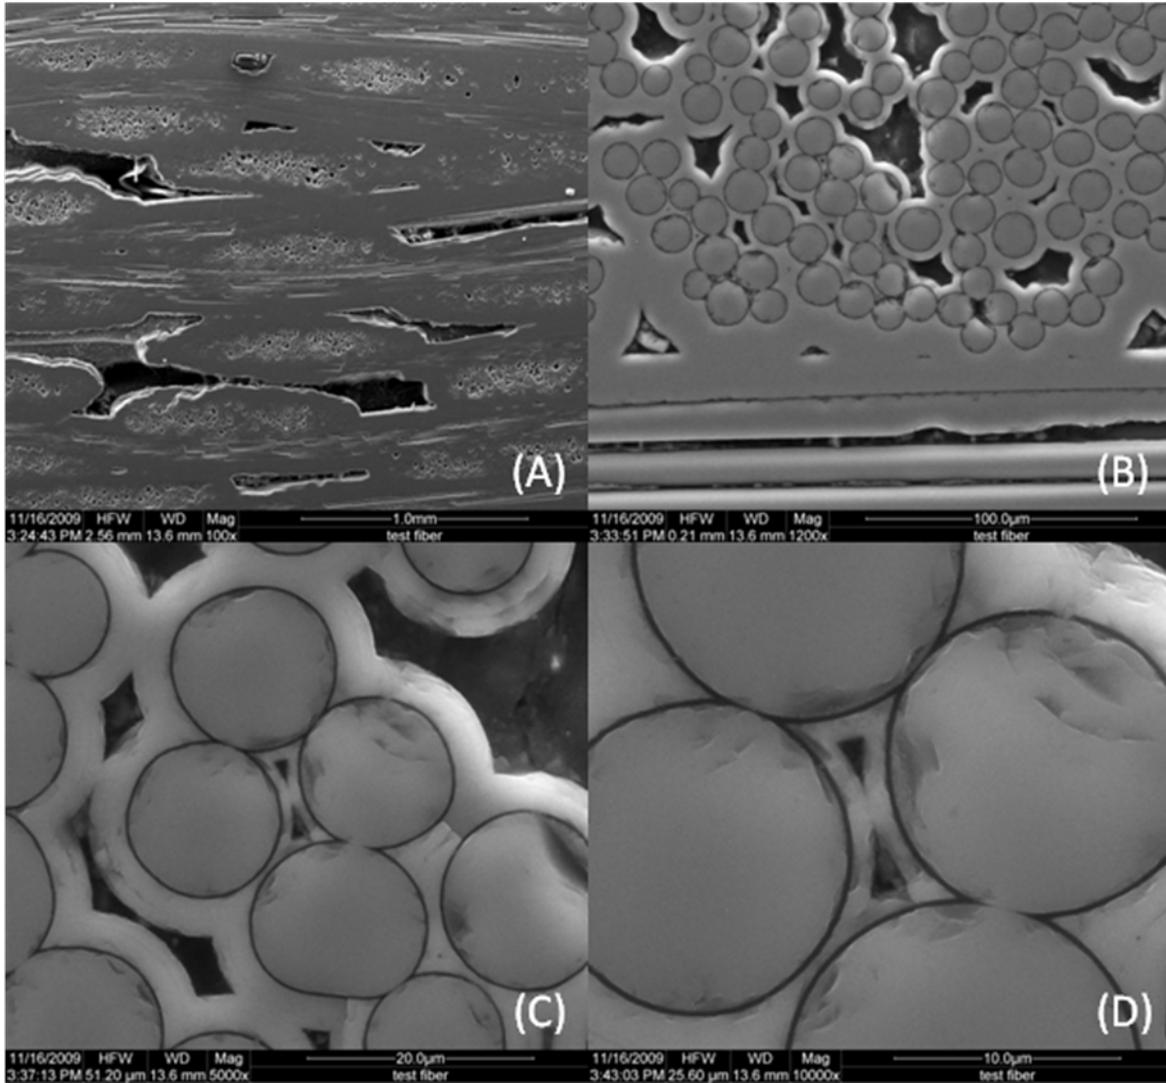
Figure 39: SEM micrographs of polished section from specimen P2-4 failed in tensile test.

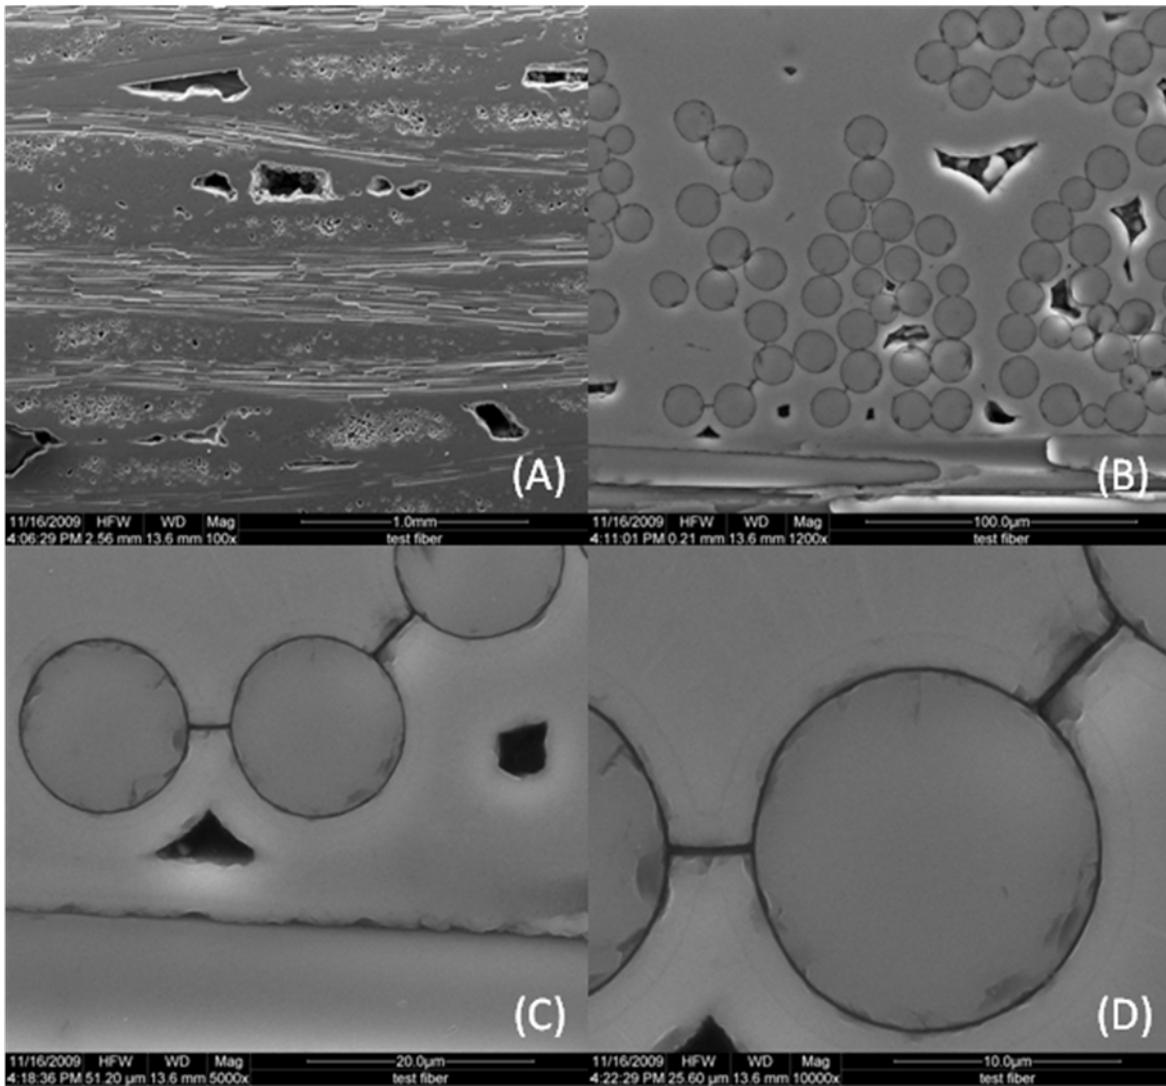
Figure 40: SEM micrographs of polished section from specimen P3-1 failed in tensile test.

in Figure 40 (D) suggests this is most likely a BN bridge between fibers, or a gap in the SiC matrix between adjacent fibers, both of which would have formed during processing.

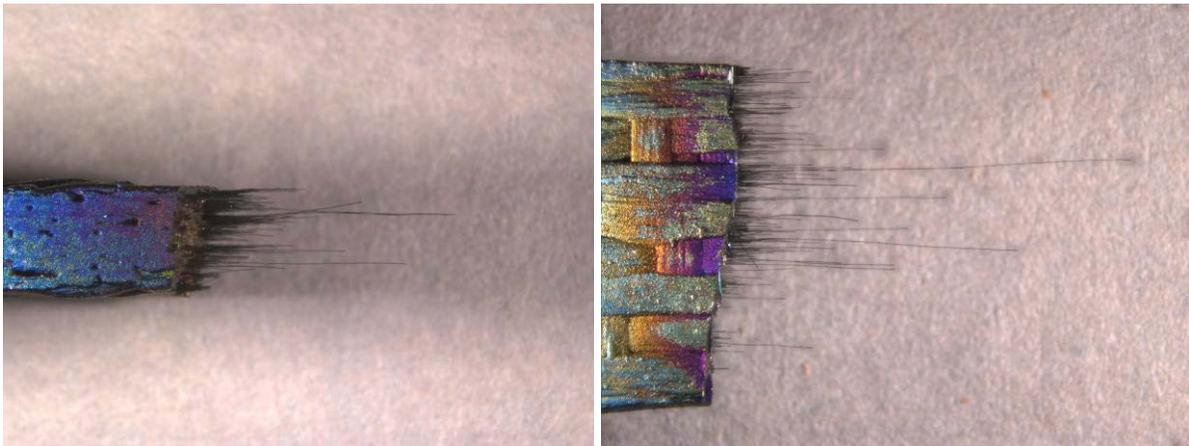
Figure 41: Optical micrographs of specimen P2-6 tested in fatigue at 0.1 Hz in air at 1200 °C. $\sigma_{max} = 120$ MPa, $N_f = 3780$, $t_f = 10.5$ h.

Figures 41-44 show the optical micrographs of specimens P2-6 and P2-7 which were subjected to fatigue at 0.1 Hz in air and specimens P3-9 and P3-7 which were subjected to fatigue at 0.1 Hz in steam. It is interesting to note that fiber pull-out occurred in specimen P2-6, which was tested with the high fatigue stress in air and produced short time to failure. Fiber pull out is also observed for specimen P3-7 which was tested with the low fatigue stress and achieved fatigue run-out in steam.

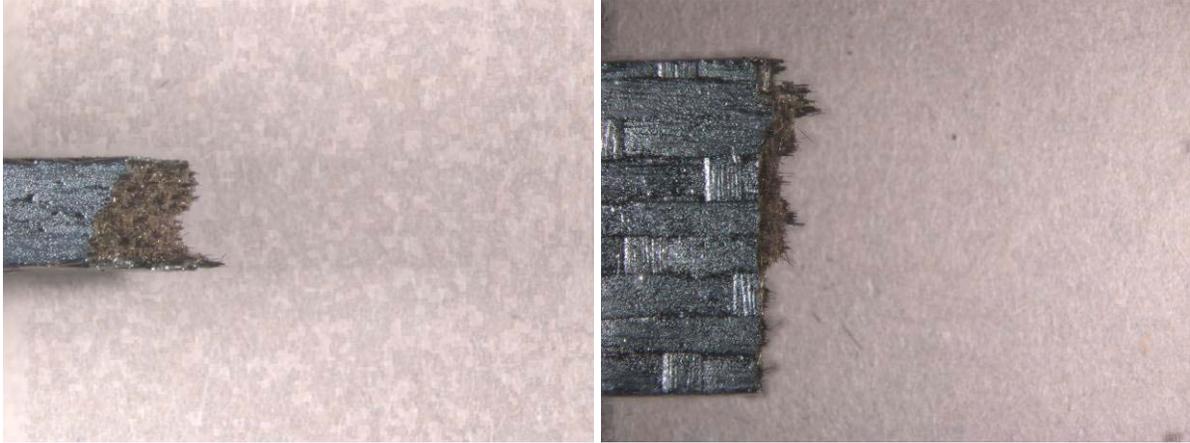
Figure 42: Optical micrographs of specimen P2-7 tested in fatigue at 0.1 Hz in air at 1200 °C. $\sigma_{\max} = 100$ MPa, $N_f = 100,000$, $t_f = 277.78$ h.

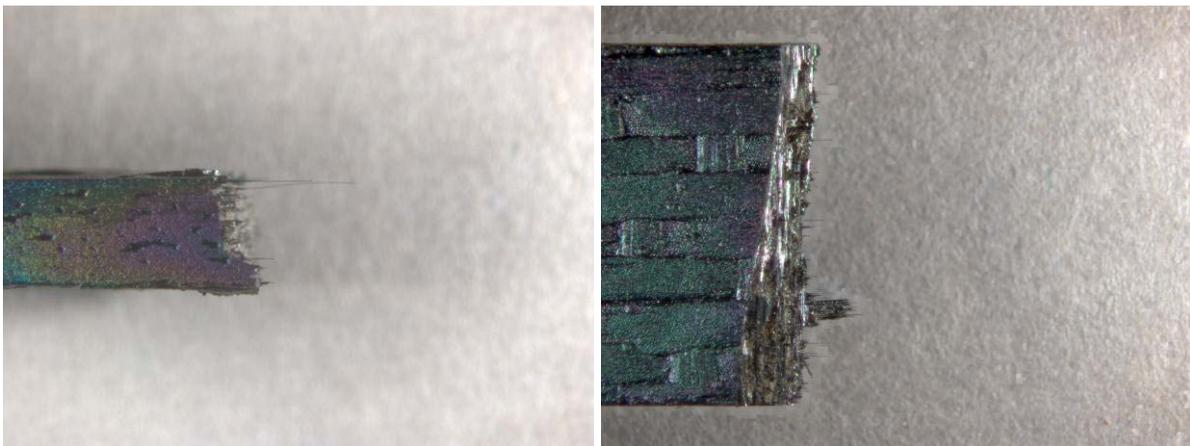
Figure 43: Optical micrographs of specimen P3-9 tested in fatigue at 0.1 Hz in steam at 1200 °C. $\sigma_{\max} = 110$ MPa, $N_f = 548$, $t_f = 1.52$ h.

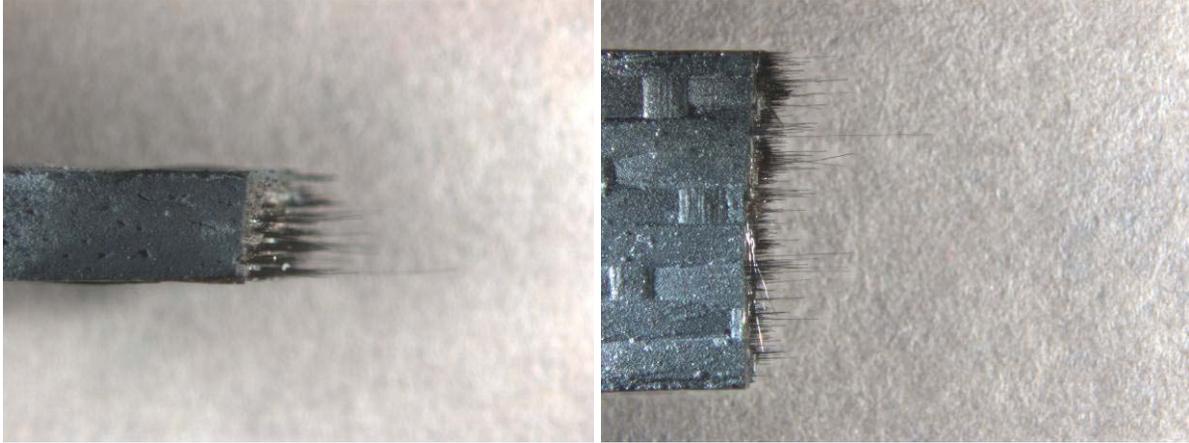
Figure 44: Optical micrographs of specimen P3-7 tested in fatigue at 0.1 Hz in steam at 1200 °C. $\sigma_{max} = 88$ MPa, $N_f = 88,575$, $t_f = 246.04$ h.

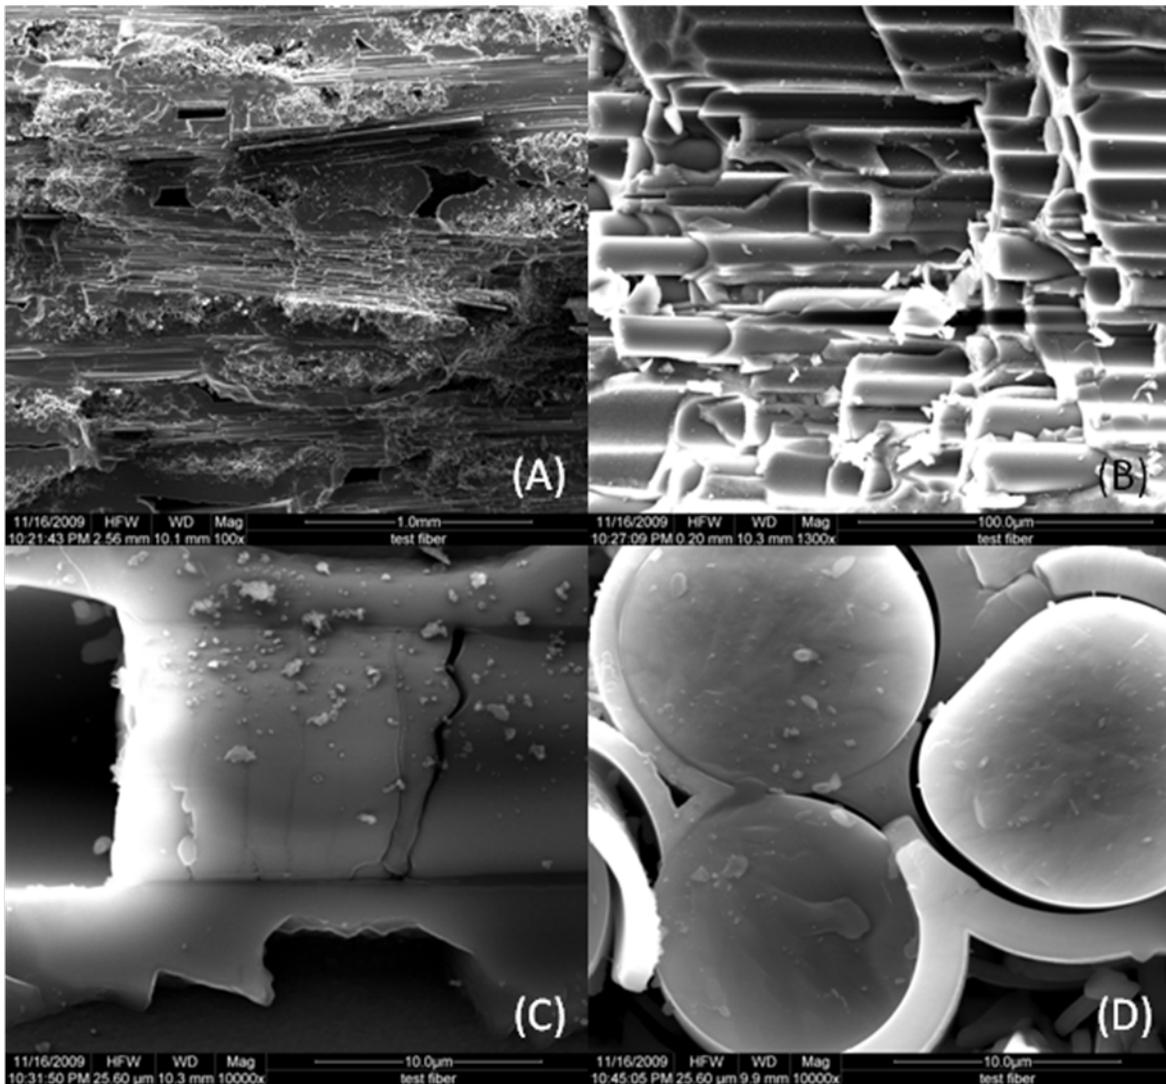
Figure 45: SEM micrographs of fracture surface of specimen P2-6 tested in fatigue at 0.1 Hz in air at 1200 °C. $\sigma_{max} = 120$ MPa, $N_f = 3780$, $t_f = 10.5$ h.

The SEM micrographs of the specimens P2-6 and P2-7 tested in fatigue at 0.1 Hz in air are shown in Figures 45 and 46. The SEM micrographs of the specimens P3-9 and P3-7 tested in fatigue at 0.1 Hz in steam are shown in figures 47 and 48. Figures 45 (B) and (C) show damage occurring in the 90° fibers. Figure 46 B shows a matrix crack originating at the sharp corner of a void. Such voids produce stress concentrations. Several notable features are seen on the fracture surfaces of the specimens tested in steam. Figure 47 (C) shows oxidation of the fracture surface. The fracture edges are rounded and the fracture surfaces of the fibers are smoothed. Small, nearly round glassy deposits, a common result of oxidation, are also observed. However, while some regions of the fracture surface show evidence of oxidation, other regions of the fracture surface, such as that in Figure 47 (B) and 47 (D), show sharp fracture surfaces of the fibers and the presence of BN fiber coatings. The regions showing no evidence of oxidative degeneration were the last to fail.

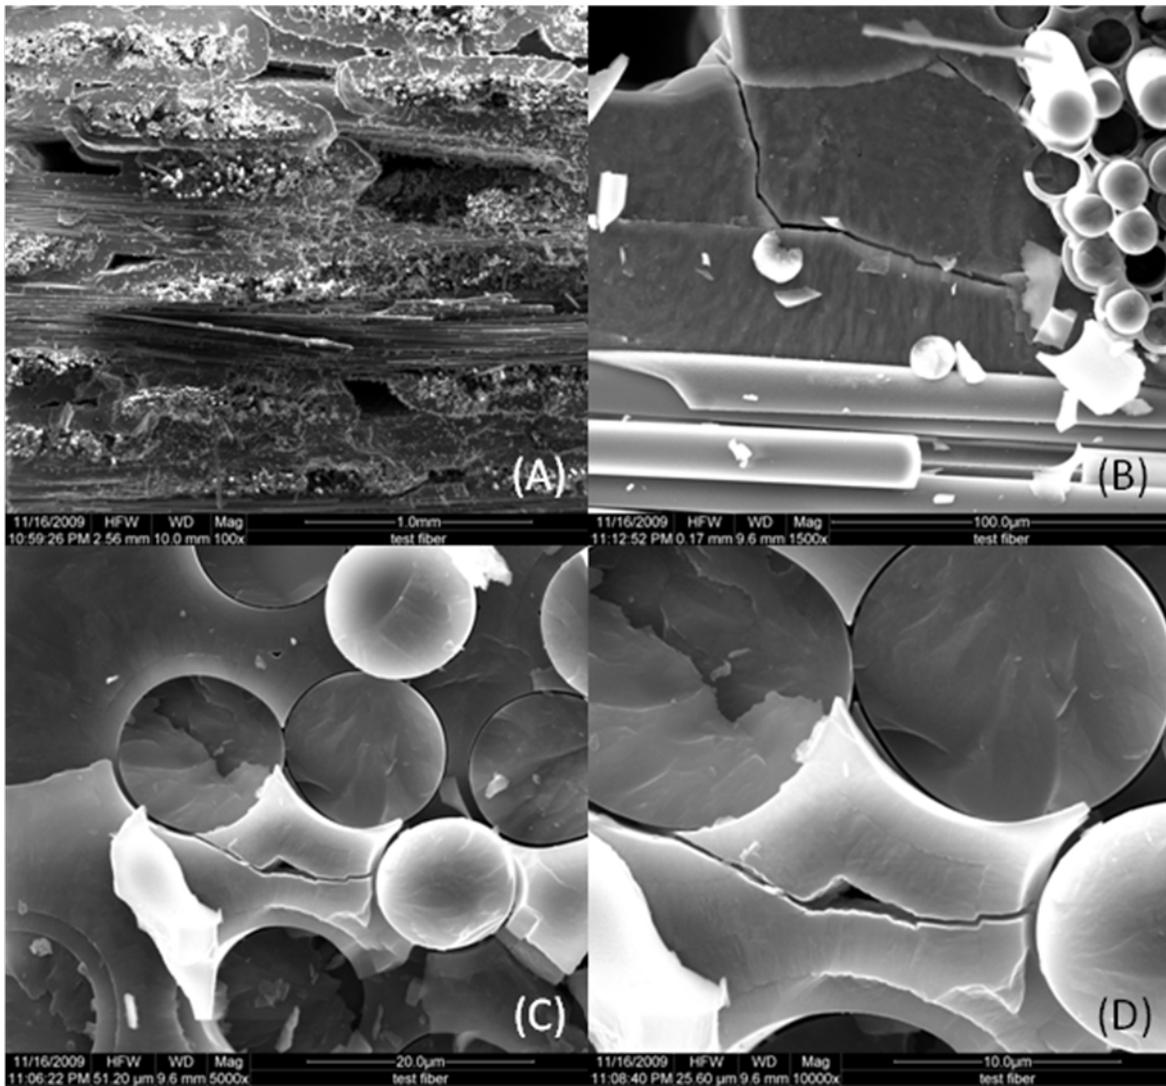
Figure 46: SEM micrographs of fracture surface of specimen P2-7 tested in fatigue at 0.1 Hz in air at 1200 °C. $\sigma_{max} = 100$ MPa, $N_f = 100,000$, $t_f = 277.78$ h.

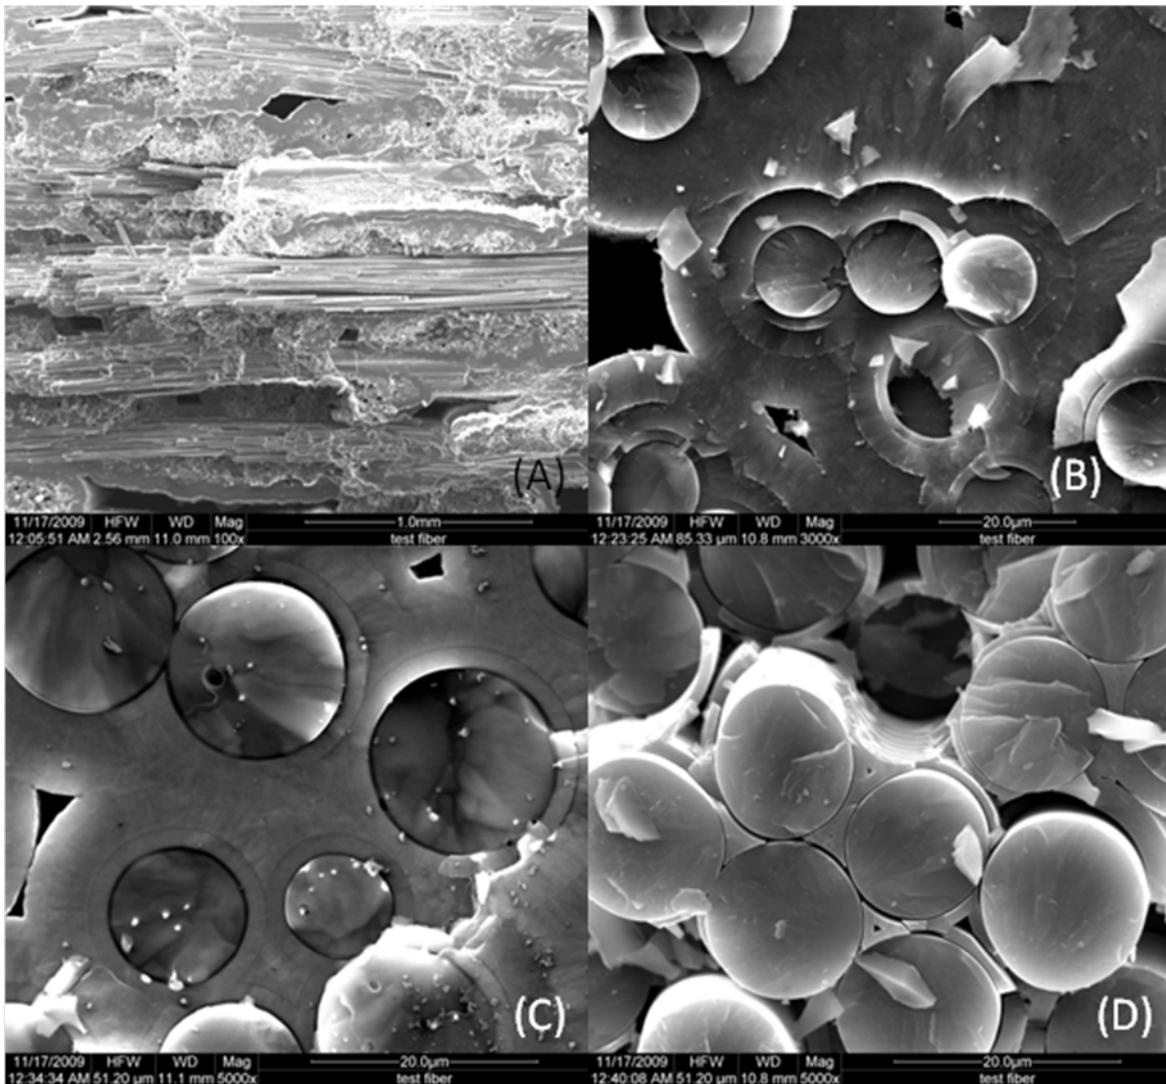
Figure 47: SEM micrographs of fracture surface of specimen P3-9 tested in fatigue at 0.1 Hz in steam at 1200 °C. $\sigma_{max} = 110$ MPa, $N_f = 548$, $t_f = 1.52$ h.

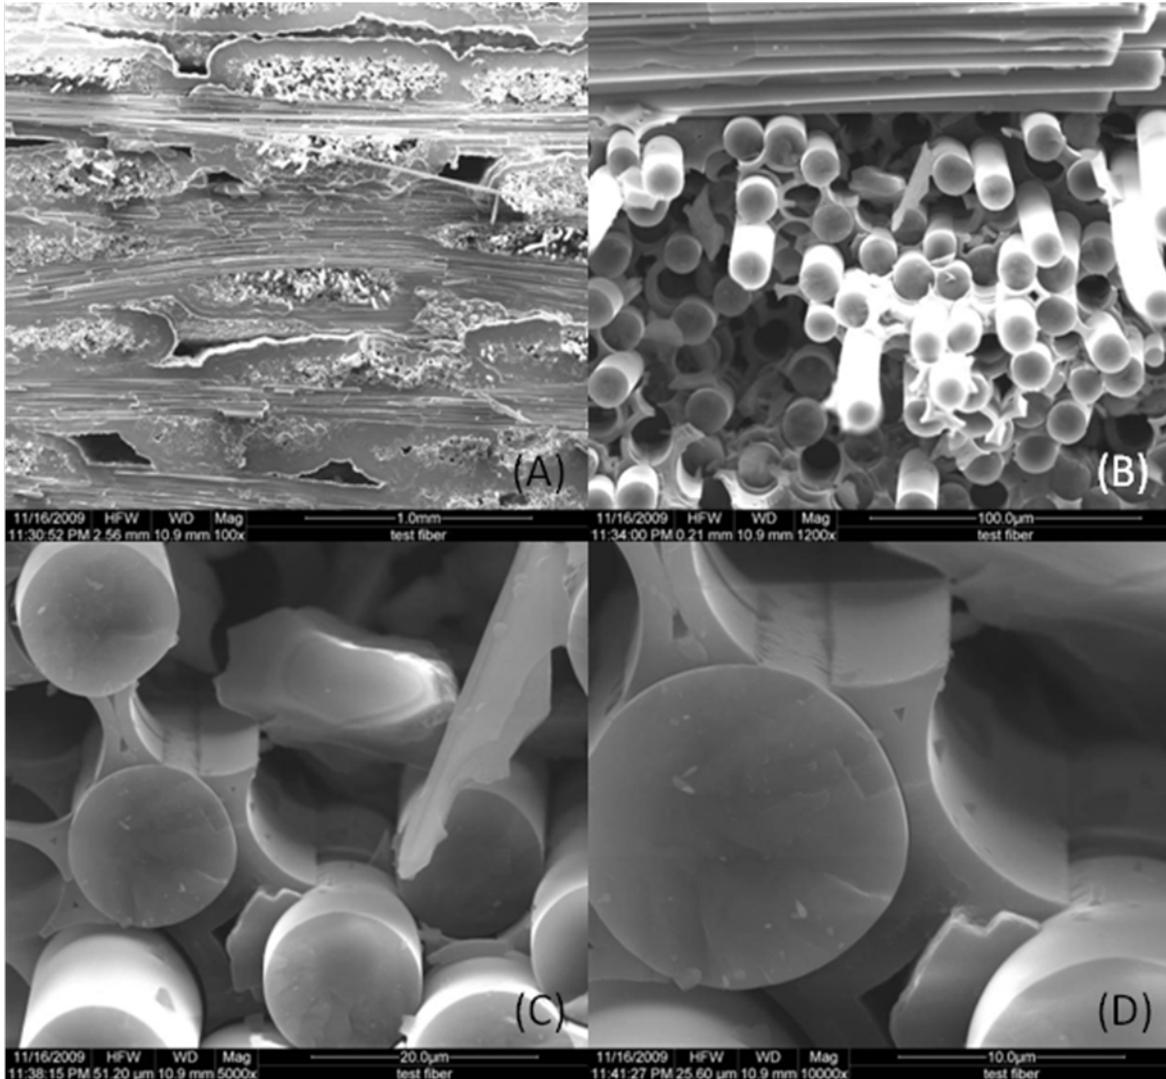
Figure 48: SEM micrographs of fracture surface of specimen P3-7 tested in fatigue at 0.1 Hz in steam at 1200 °C. $\sigma_{max} = 88$ MPa, $N_f = 88,575$, $t_f = 246.04$ h.

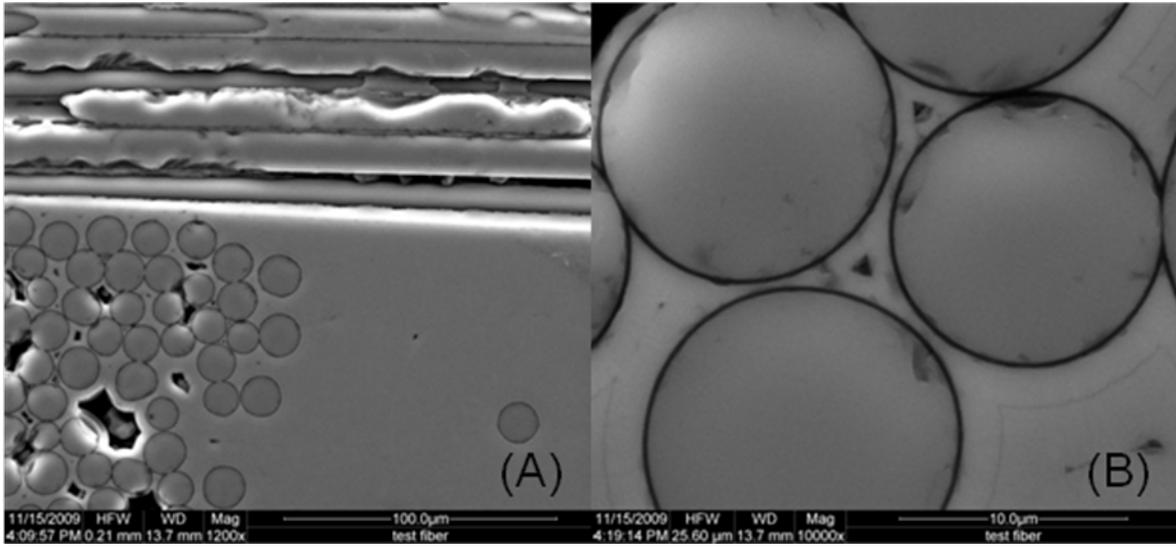
Figure 49: SEM micrographs of polished surface of specimen P2-6 tested in fatigue at 0.1 Hz in air at 1200 °C. $\sigma_{max} = 120$ MPa, $N_f = 3780$, $t_f = 10.5$ h.

The polished sections from specimens P2-6 and P2-7 subjected to fatigue at 0.1 Hz in air are shown in Figures 49 and 50. Figure 49 shows no apparent matrix damage. Conversely, Figure 50 (A) shows matrix cracks originating at voids. Figure 50 (B) shows a matrix crack damaging a 0° fiber. However, other areas of specimen P2-7 do not show matrix damage or fiber damaged as seen in Figures 50 (C) and 50 (D).
