**FATIGUE BEHAVIOR OF AN ADVANCED SiC/SiC COMPOSITE
AT ELEVATED TEMPERATURE IN AIR AND IN STEAM**

THESIS

Devon T. Christensen, Captain, USAF

AFIT/GAE/ENY/09-D02

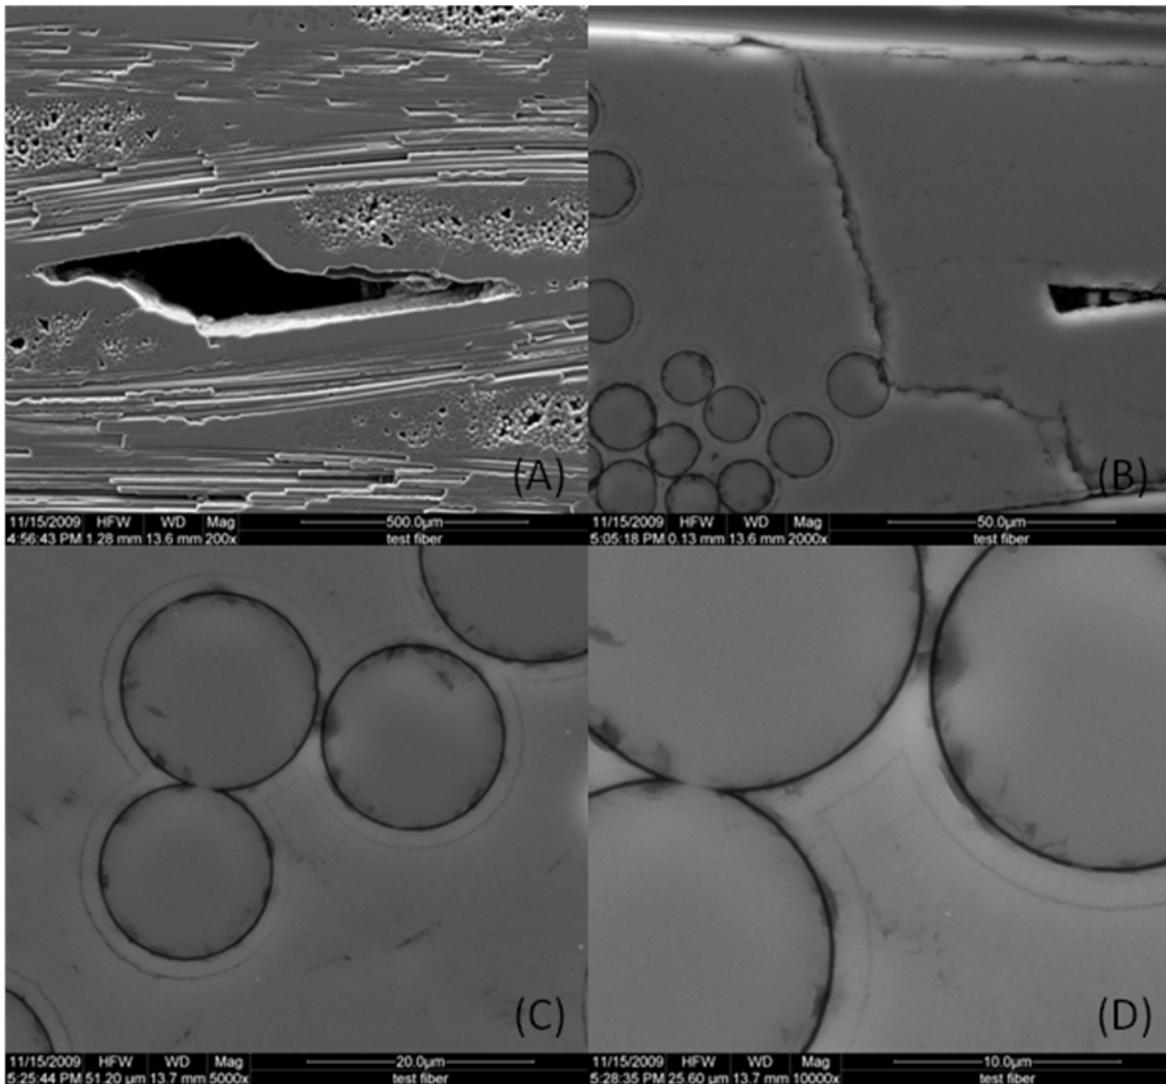
Figure 50: SEM micrographs of polished surface of specimen P2-7 tested in fatigue at 0.1 Hz in air at 1200 °C. $\sigma_{max} = 100$ MPa, $N_f = 100,000$, $t_f = 277.78$ h.

The polished sections from specimens P2-6 and P2-7 subjected to fatigue at 0.1 Hz in air are shown in Figures 49 and 50. Figure 49 shows no apparent matrix damage. Conversely, Figure 50 (A) shows matrix cracks originating at voids. Figure 50 (B) shows a matrix crack damaging a 0° fiber. However, other areas of specimen P2-7 do not show matrix damage or fiber damaged as seen in Figures 50 (C) and 50 (D).

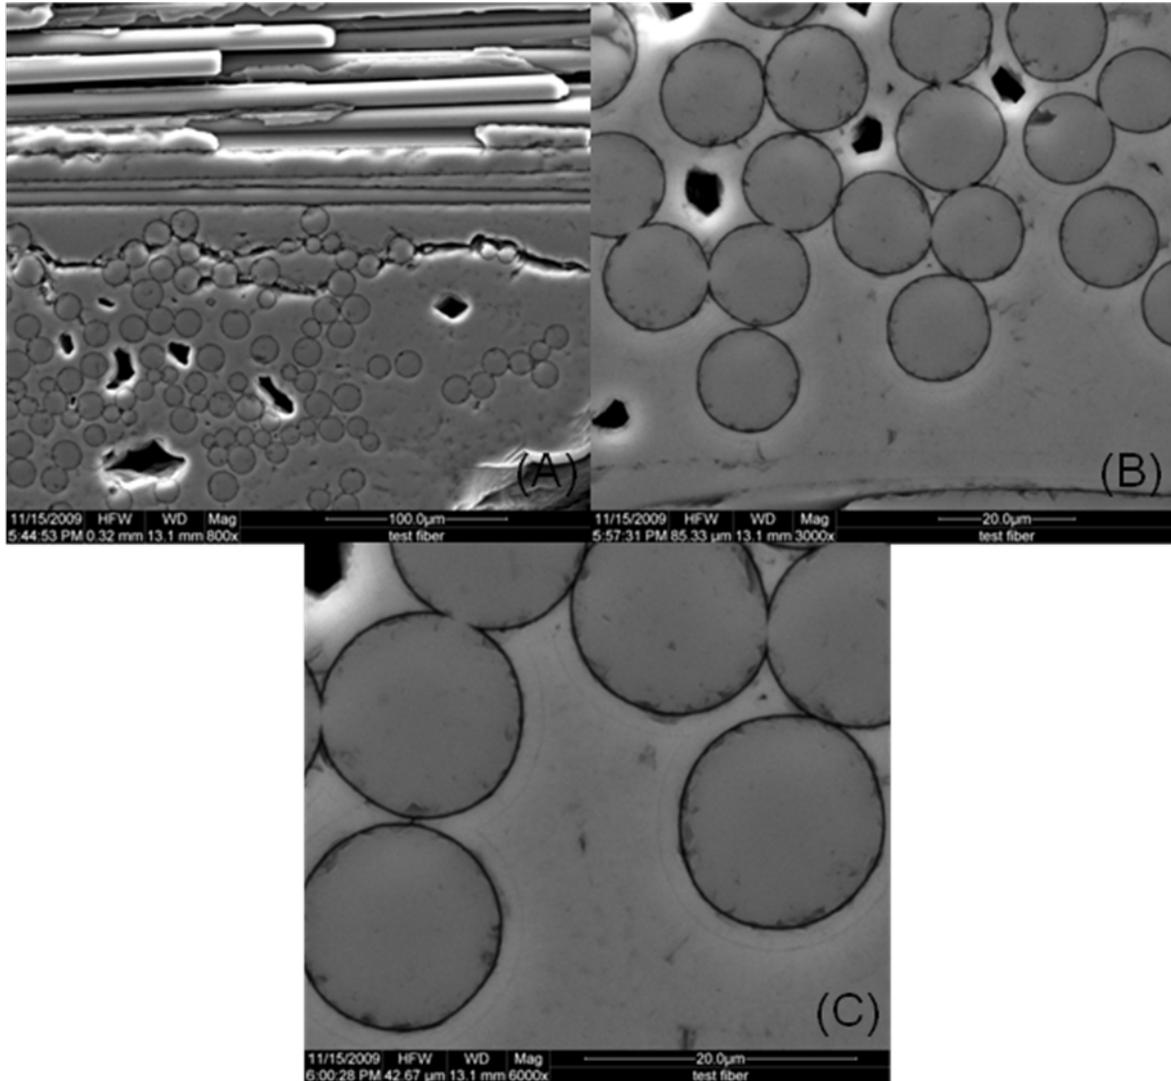
Figure 51: SEM micrographs of polished surface of specimen P3-9 tested in fatigue at 0.1 Hz in steam at 1200 °C. $\sigma_{max} = 110$ MPa, $N_f = 548$, $t_f = 1.52$ h.

The SEM micrographs of the polished section of specimens P3-9 and P3-7 subjected to fatigue at 0.1 Hz in steam are shown in Figures 51 and 52. Micrographs of both specimens show significant matrix cracking with cracks propagating between 0° fibers as seen in Figure 51 (A), or along the “flash” SiC layer/SiC matrix interface as seen in Figure 52 (B).

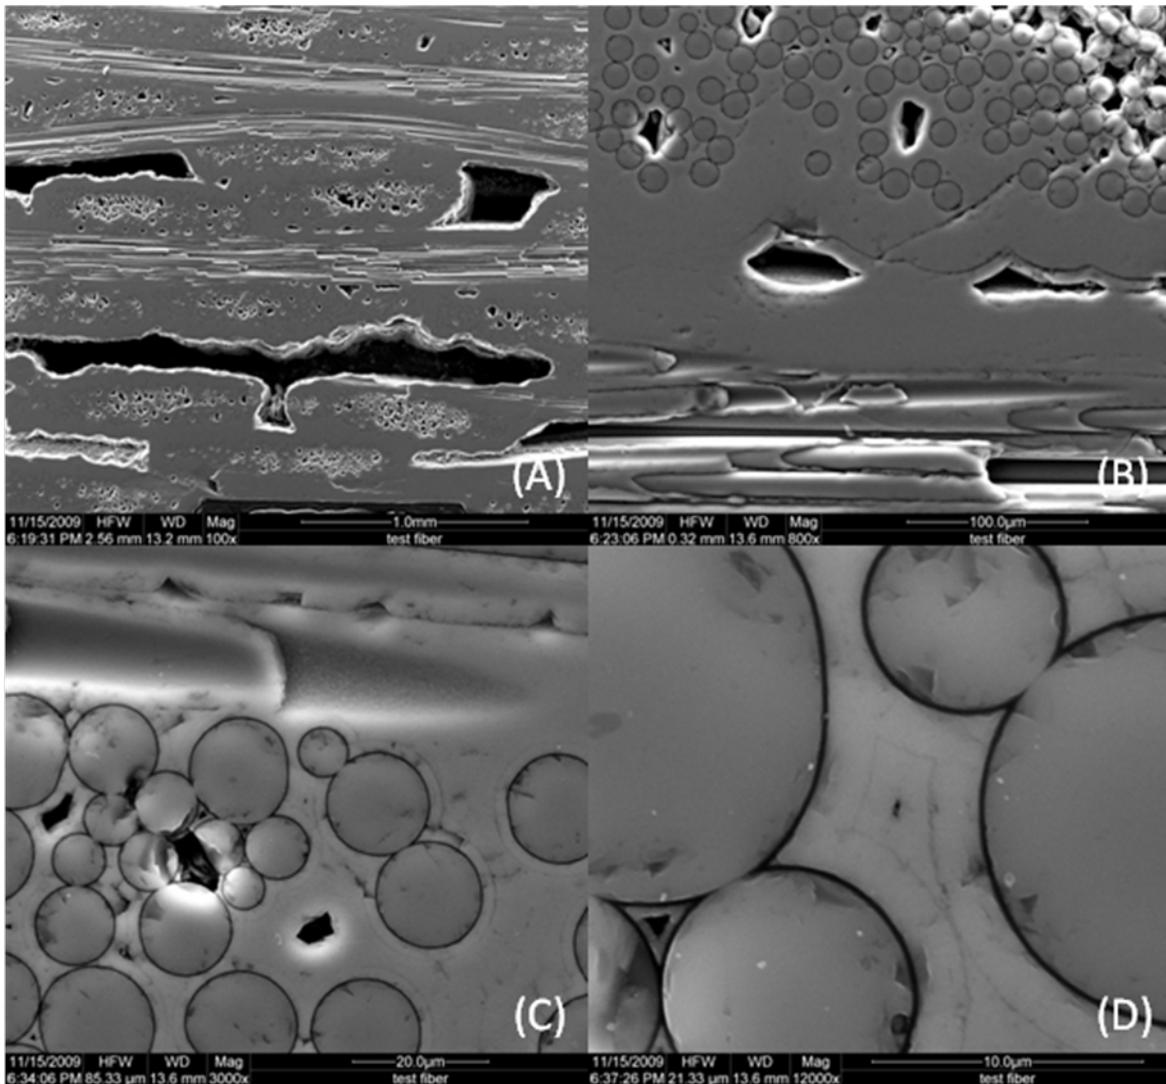
Figure 52: SEM micrographs of polished surface of specimen P3-7 tested in fatigue at 0.1 Hz in steam at 1200 °C. $\sigma_{max} = 88$ MPa, $N_f = 88,575$, $t_f = 246.04$ h.

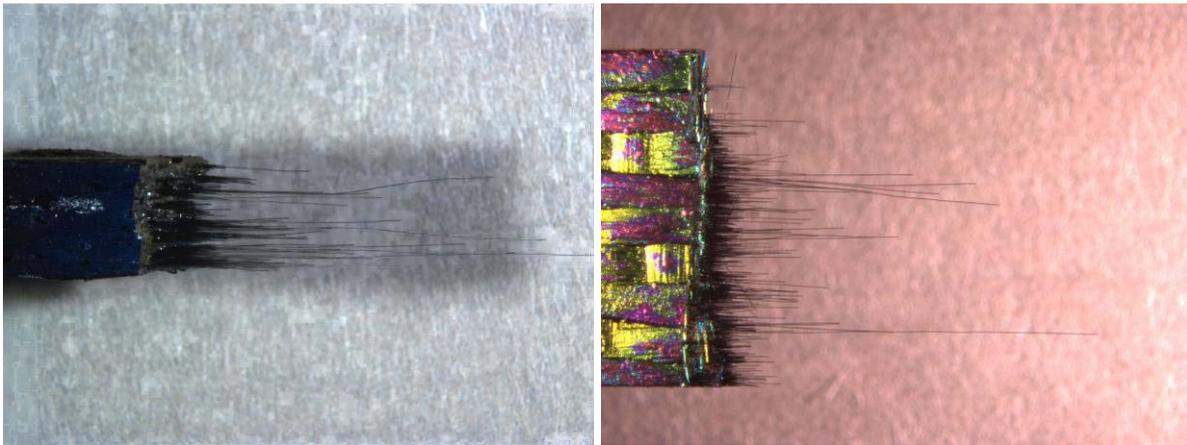
Figure 53: Optical micrographs of specimen P1-4 tested in fatigue at 1.0 Hz in air at 1200 °C. $\sigma_{max} = 120$ MPa, $N_f = 3766$, $t_f = 1.05$ h.

Figures 53-56 show the optical micrographs of the fracture surfaces produced in fatigue tests conducted at 1.0 Hz in air and in steam. Micrographs Figures 53-56 show no delamination between plies irrespective of the fatigue stress level or test environment. With the exception of specimen P1-4 tested in air with a fatigue stress of 120 MPa, none of the specimens tested at 1.0 Hz exhibited significant fiber pull-out.

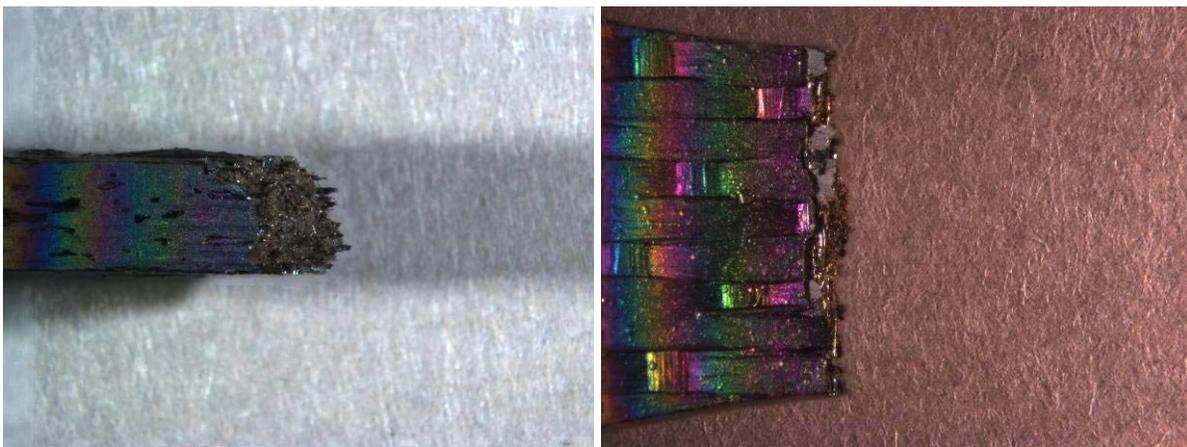
Figure 54: Optical micrographs of specimen P1-5 tested in fatigue at 1.0 Hz in air at 1200 °C. $\sigma_{max} = 80$ MPa, $N_f = 200,000$, $t_f = 55.56$ h.

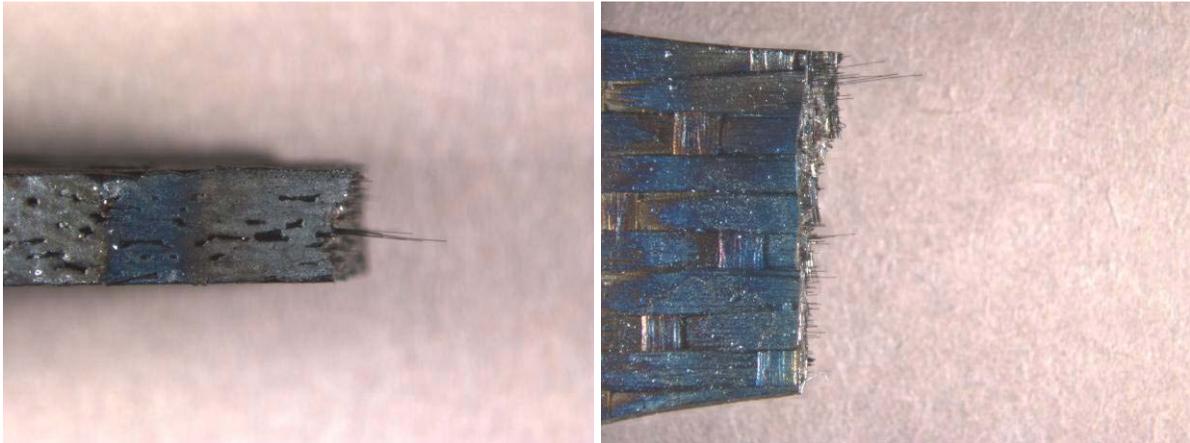
Figure 55: Optical micrographs of specimen P1-9 tested in fatigue at 1.0 Hz in steam at 1200 °C. $\sigma_{max} = 110$ MPa, $N_f = 5620$, $t_f = 1.56$ h.

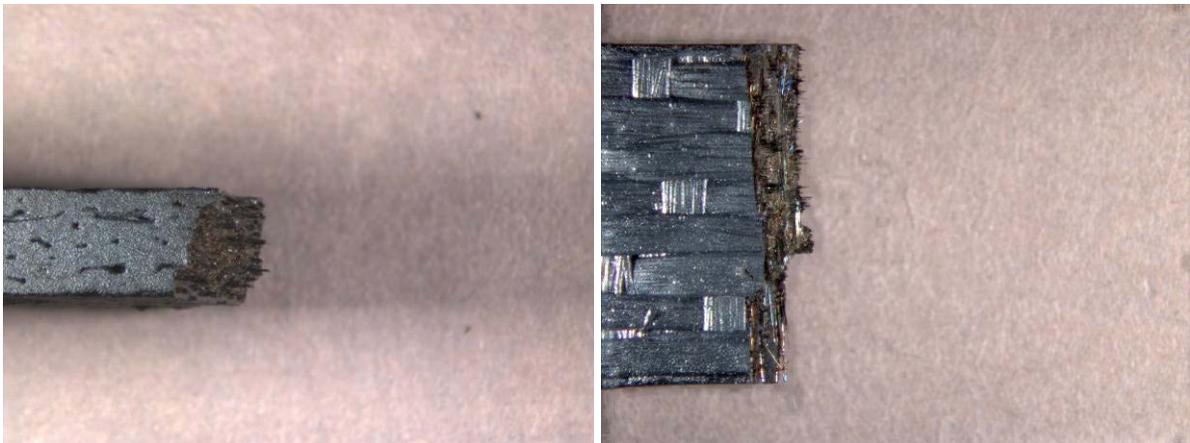
Figure 56: Optical micrographs of specimen P3-2 tested in fatigue at 1.0 Hz in steam at 1200 °C. $\sigma_{max} = 80$ MPa, $N_f = 200,000$, $t_f = 55.56$ h.

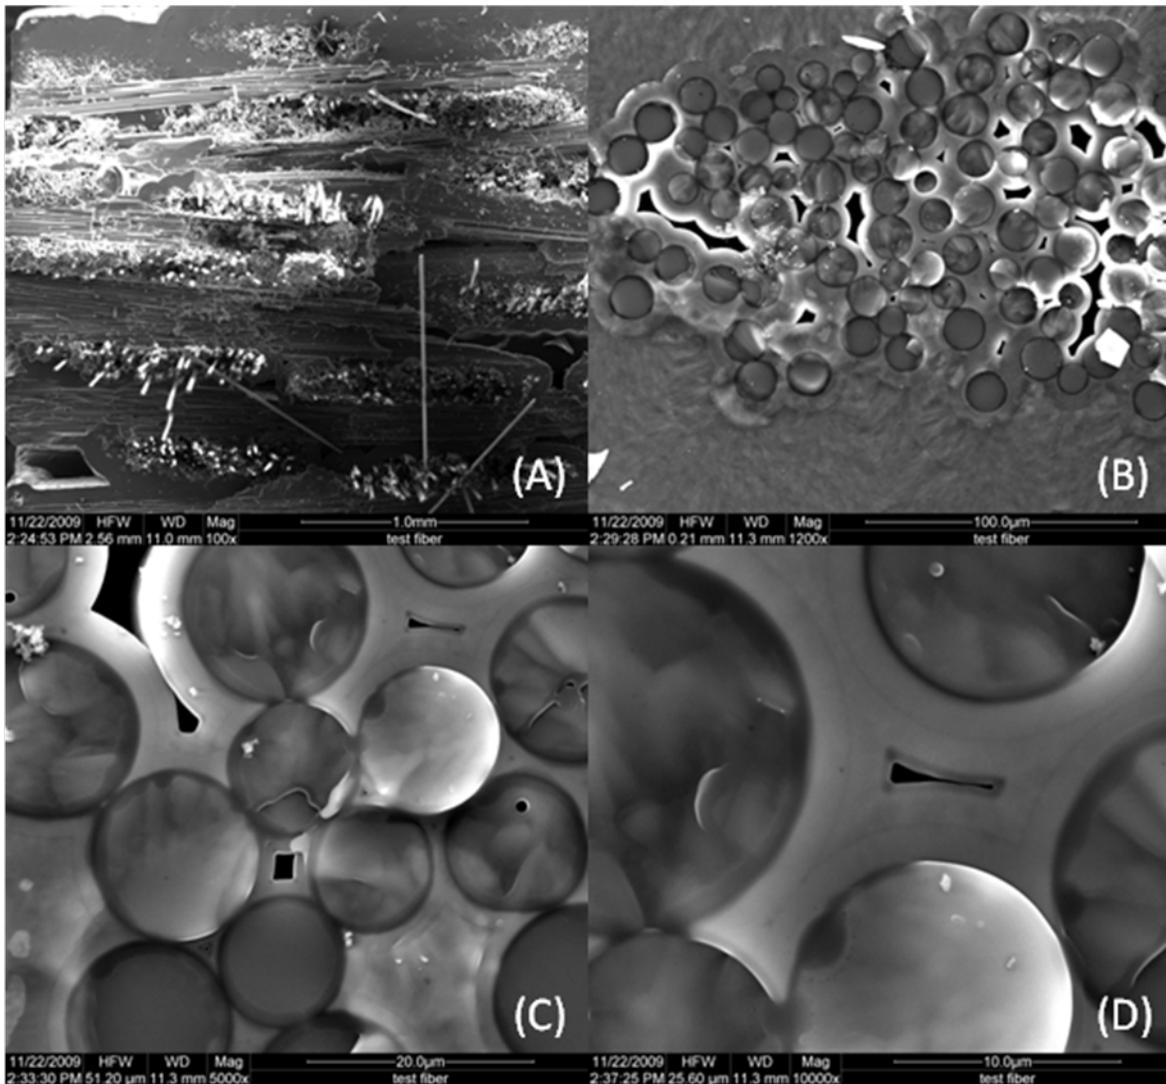
Figure 57: SEM micrographs of the fracture surface of specimen P1-4 tested in fatigue at 1.0 Hz in air at 1200 °C. $\sigma_{max} = 120$ MPa, $N_f = 3766$, $t_f = 1.05$ h.

Figures 57 and 58 show the SEM micrographs of the fracture surfaces of specimen P1-4 and figure 59 shows specimen P1-5 tested in fatigue at 1.0 Hz in air. Areas near the edge of the fracture surface of specimen P1-4 tested in air show the glassy, smoothed over topography caused by oxidation. Although the fracture surface of the specimen P1-4, which failed after 1.05 h, showed evidence of oxidation, the fracture surface of specimen P1-5, which achieved fatigue

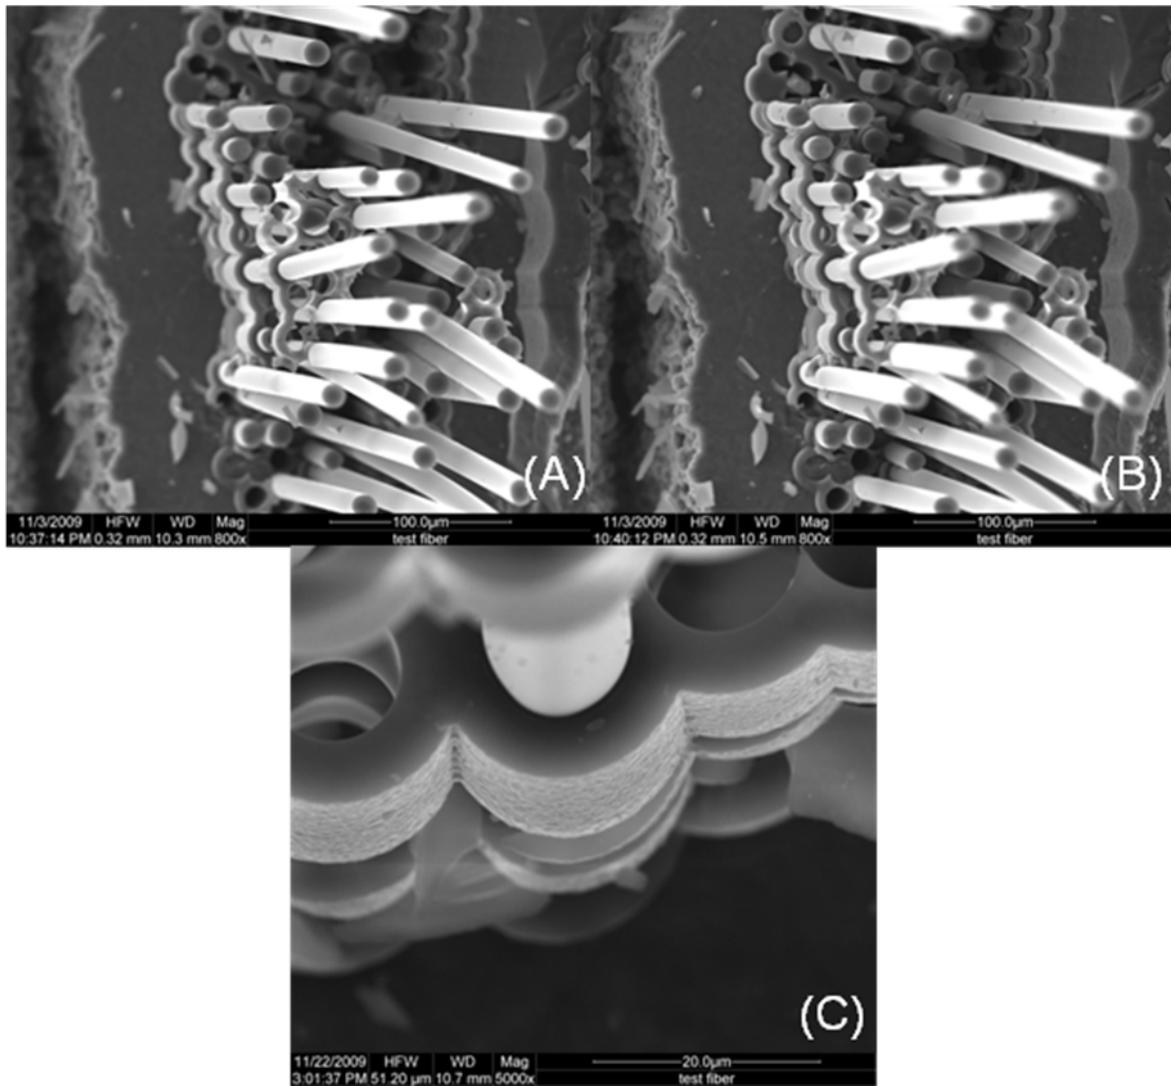
Figure 58: SEM micrographs of the fracture surface of specimen P1-4 showing “islands” of matrix material pulled out along with the 0° fibers.

Another unusual failure mode is seen in Figure 58. This view of the fracture surface of specimen P1-4 shows what appears to be “islands” of matrix material pulled out along with the 0° fibers. A possible explanation is that matrix microcracks perpendicular to those fibers coalesced allowing these plates of matrix material to form and cleave off intact.

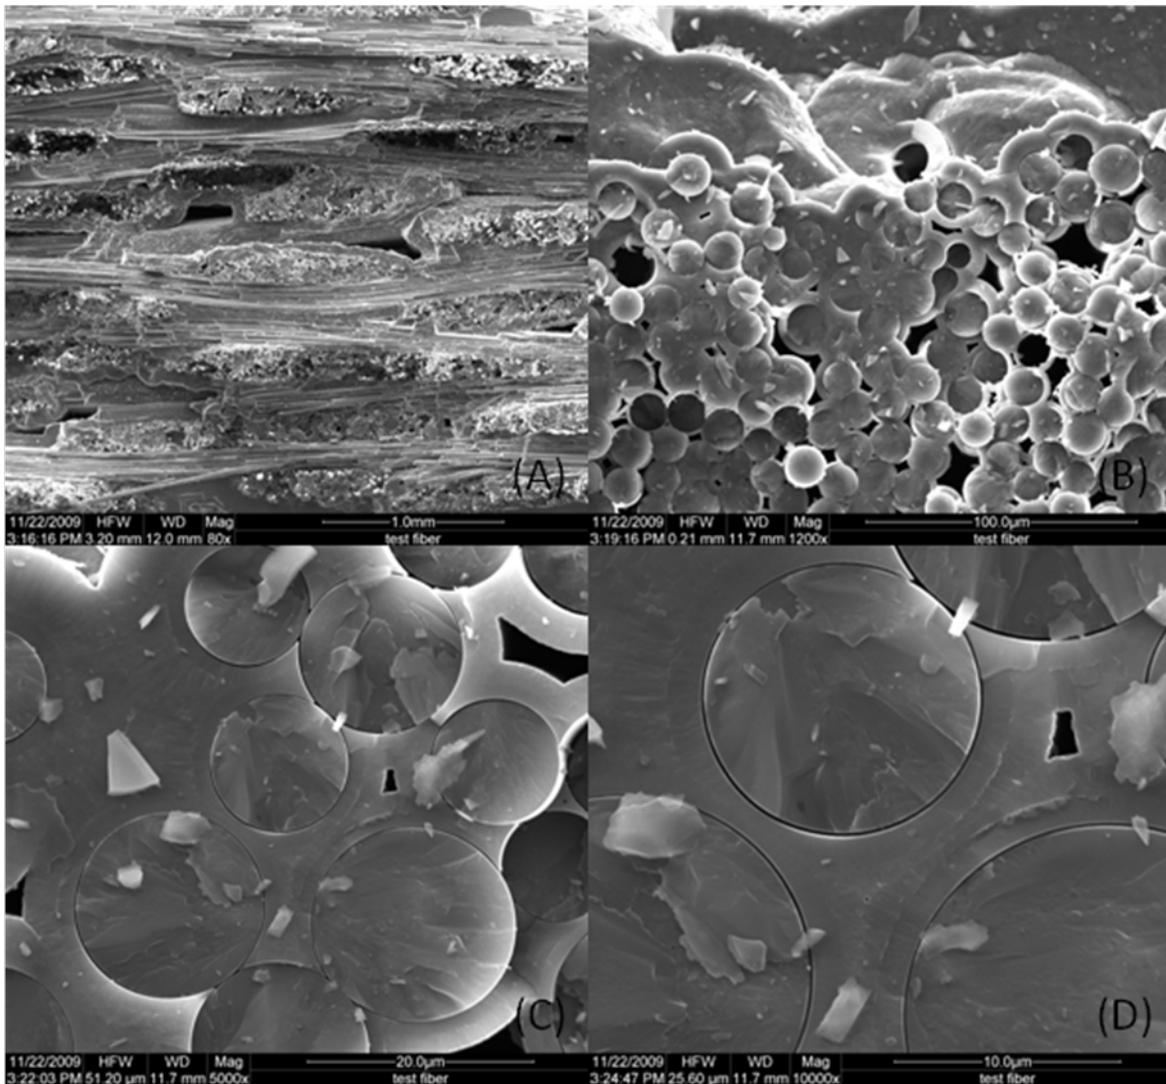
Figure 59: SEM micrographs of the fracture surface of specimen P1-5 tested in fatigue at 1.0 Hz in air at 1200 °C. $\sigma_{max} = 80$ MPa, $N_f = 200,000$, $t_f = 55.56$ h.

run-out, revealed no signs of oxidative degradation. As was the case with the fracture surfaces obtained in fatigue tests in air, the fracture surfaces produced in steam showed evidence of oxidation near the edges. The oxidative damage was much less evident in the center where matrix cracks had not propagated.

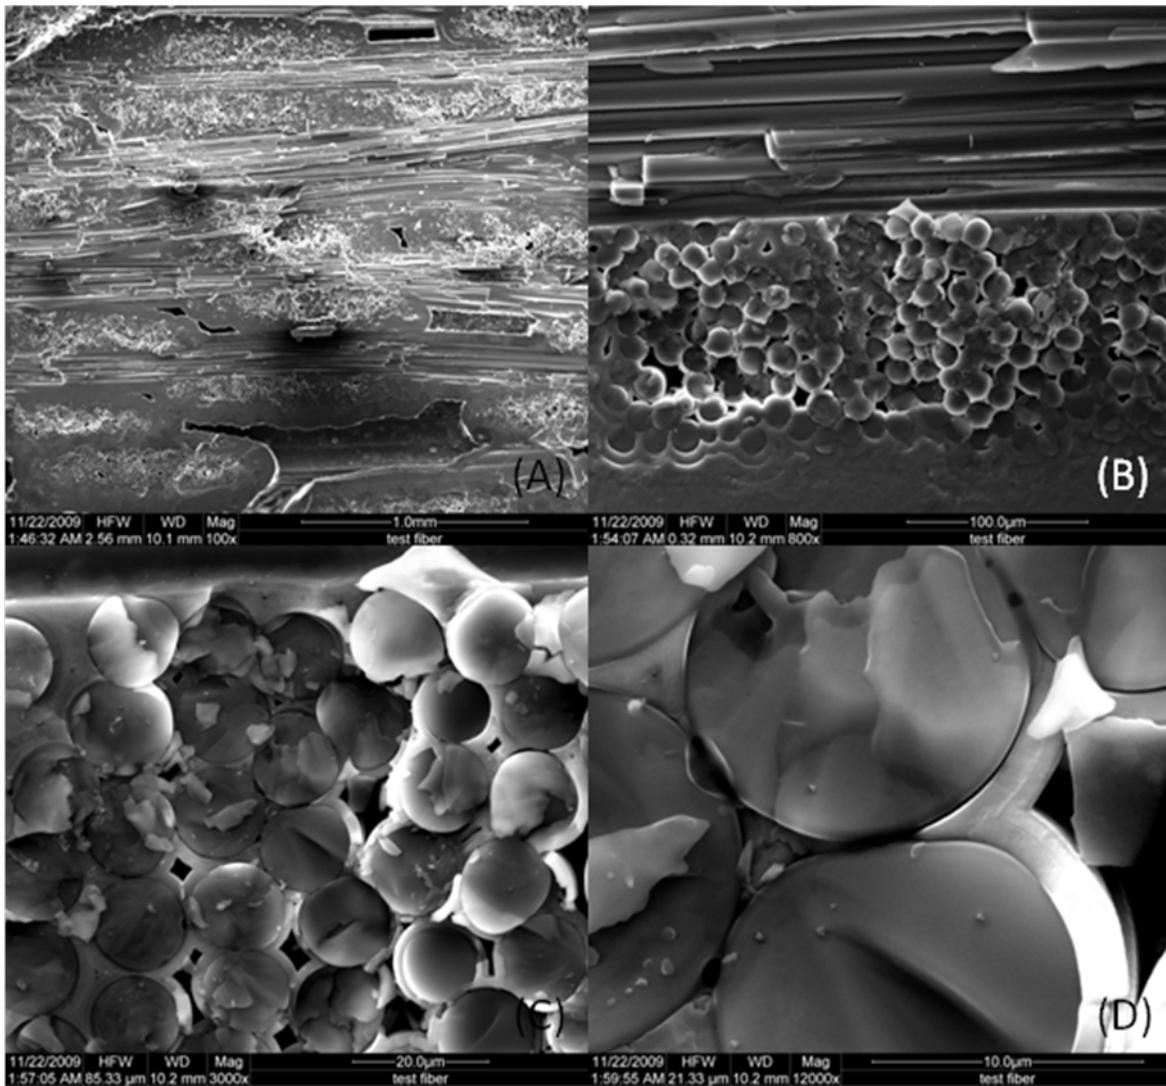
Figure 60: SEM micrographs of the fracture surface of specimen P1-9 tested in fatigue at 1.0 Hz in steam at 1200 °C. $\sigma_{max} = 110$ MPa, $N_f = 5620$, $t_f = 1.56$ h.

Figures 60 and 61 show the SEM micrographs of the fracture surfaces of specimens P1-9 and P3-2, respectively. These specimens were tested in fatigue at 1.0 Hz in steam. Both specimens had fracture surfaces with rugged, brittle-fracture areas, and smooth areas which exhibited oxidative damage. In figure 60, the oxidative damage appears more severe than on the fracture surfaces after the 1.0 Hz tests conducted in air. Otherwise, similar fracture behavior was observed in both environments.

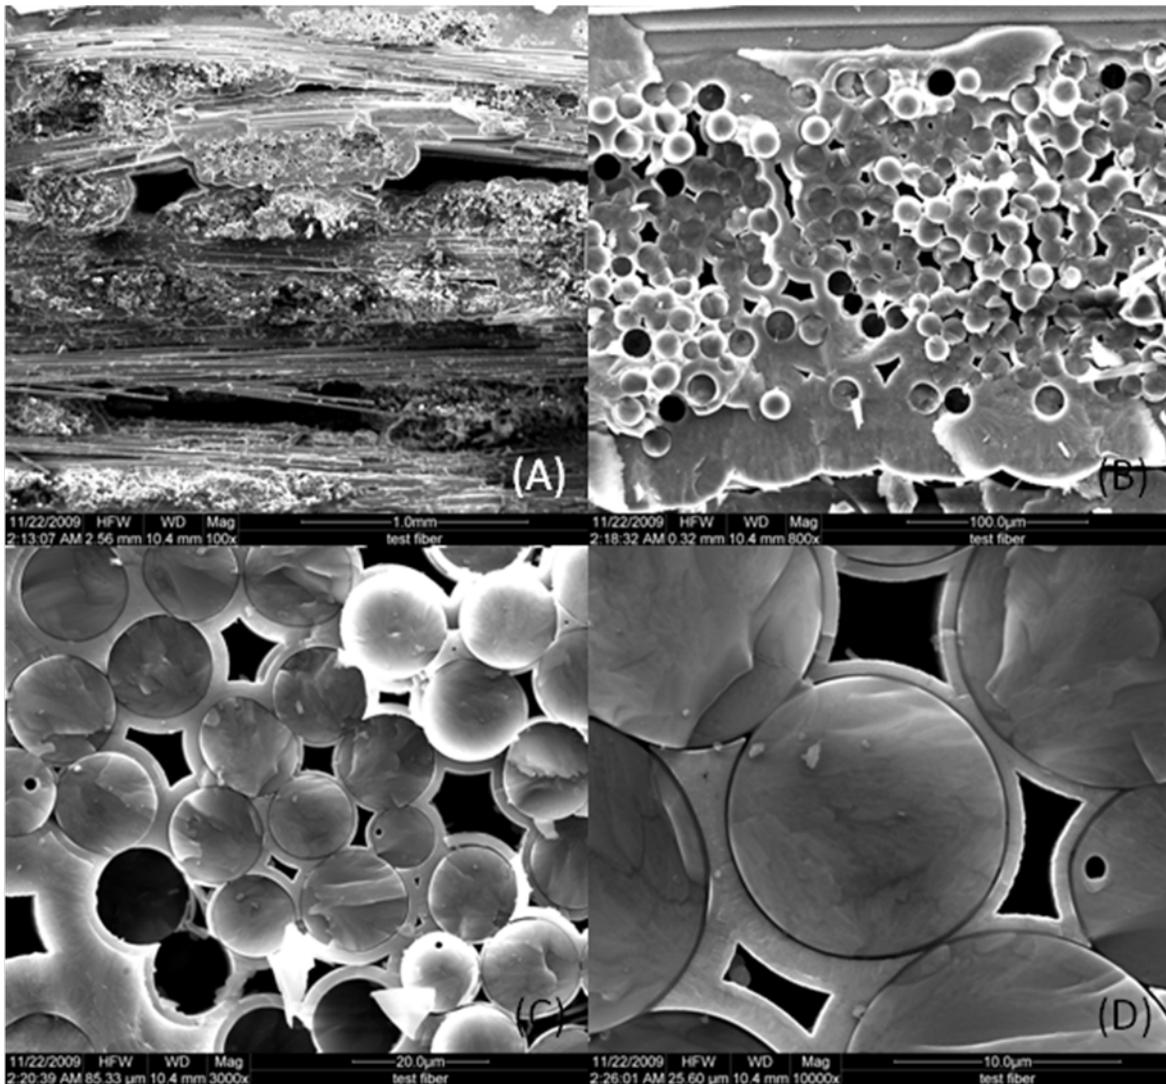
Figure 61: SEM micrographs of the fracture surface of specimen P3-2 tested in fatigue at 1.0 Hz in steam at 1200 °C. $\sigma_{max} = 80$ MPa, $N_f = 200,000$, $t_f = 55.56$ h.

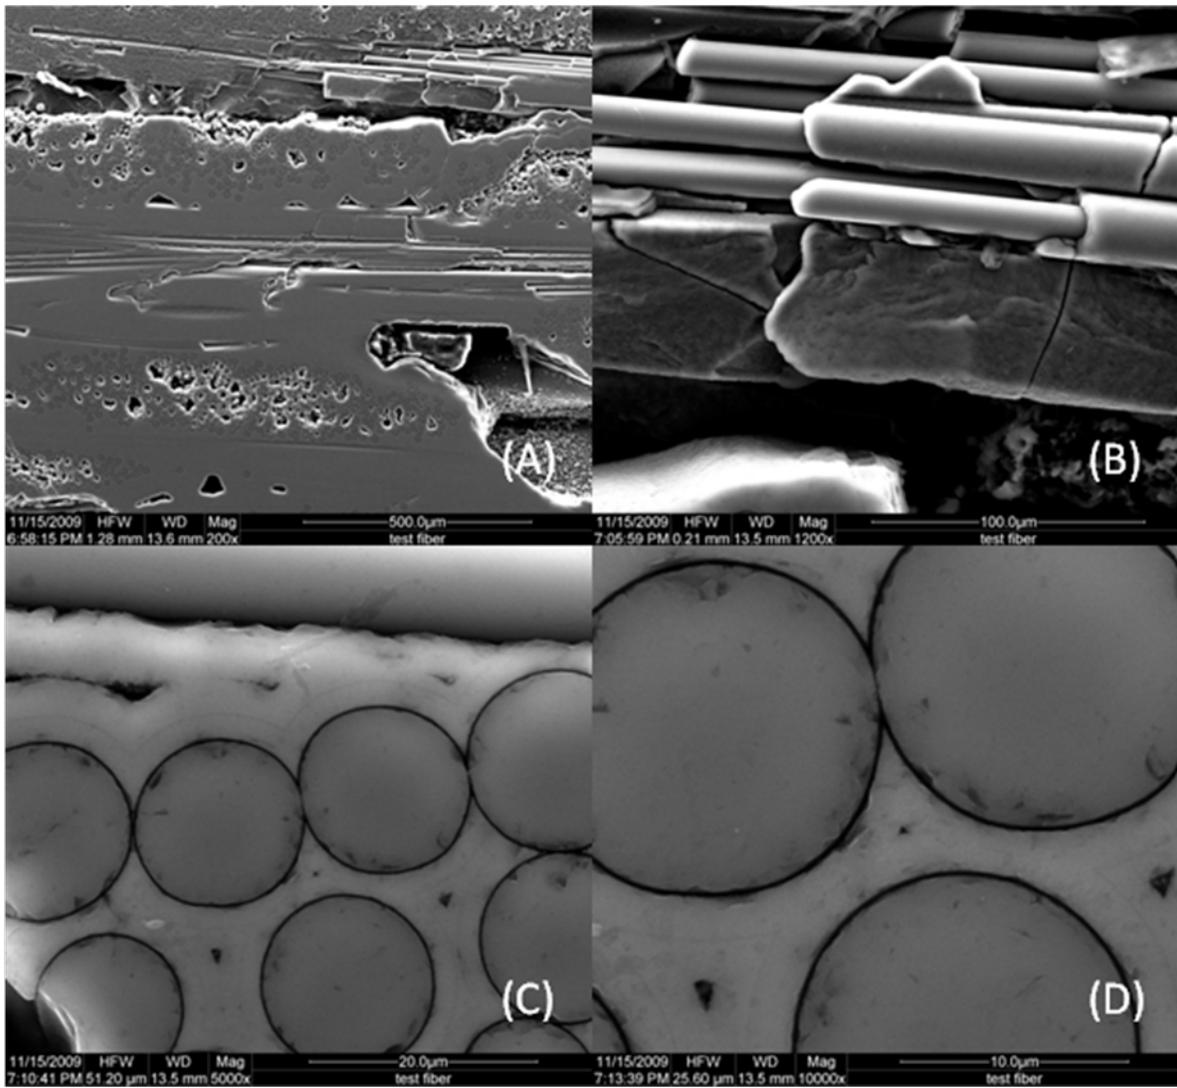
Figure 62: SEM micrographs of the polished surface of specimen P1-4 tested in fatigue at 1.0 Hz in air at 1200 °C. $\sigma_{max} = 120$ MPa, $N_f = 3766$, $t_f = 1.05$ h.

SEM micrographs of the polished sections of specimens tested in fatigue at 1.0 Hz are shown in Figures 62-65. In Figure 62 (B) a matrix crack is seen growing and causing the failure of a 90° fiber. Matrix cracks are seen forming at the sharp corners of voids, then propagating along the “flash” SiC layer/SiC matrix interface (see Figure 63 B). Figure 63 D, however, shows cracks growing through the matrix and stopping at the “flash” SiC layer.

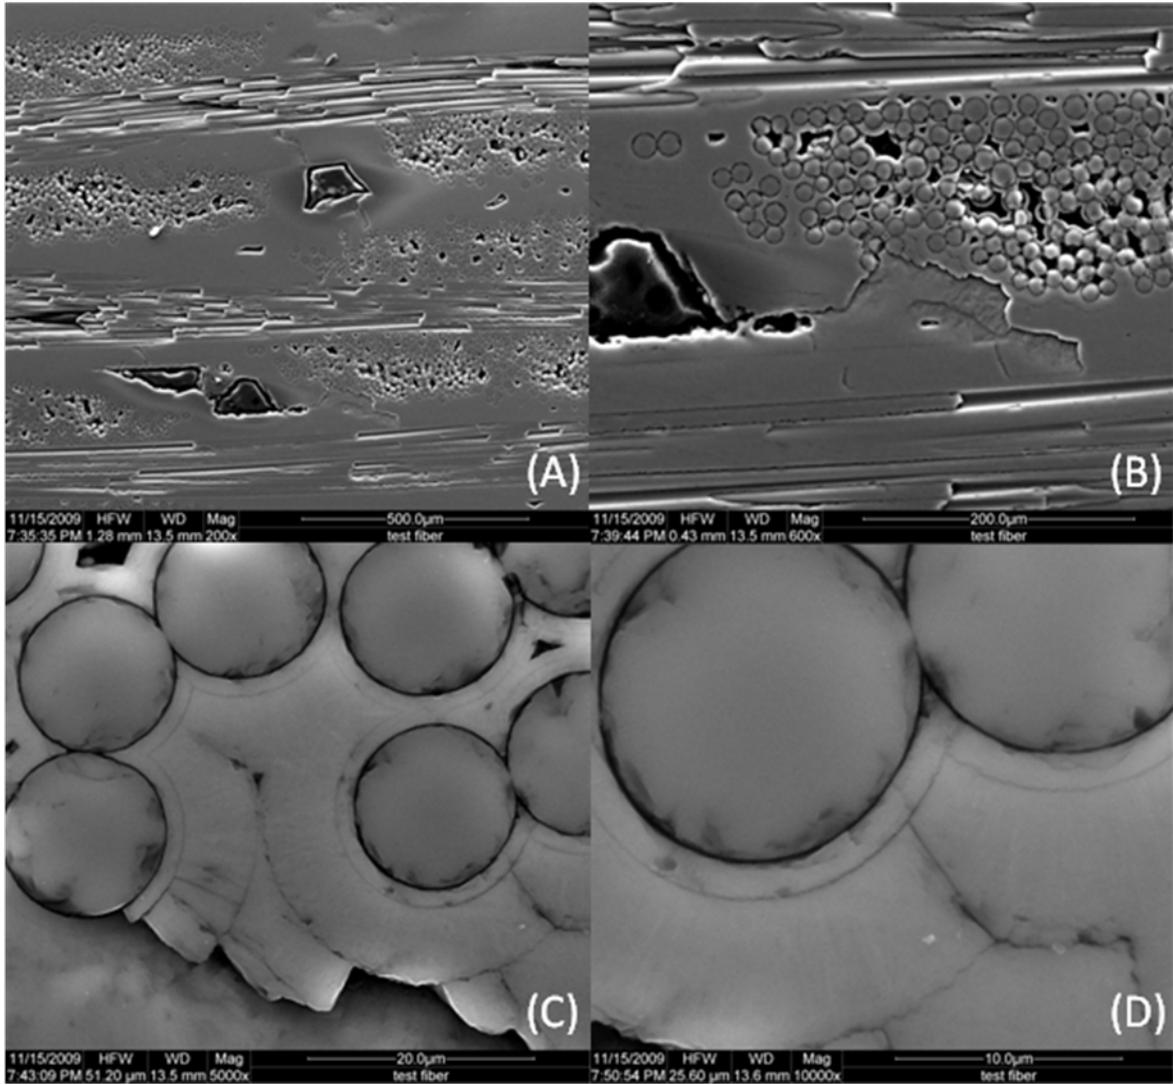
Figure 63: SEM micrographs of the polished surface of specimen P1-5 tested in fatigue at 1.0 Hz in air at 1200 °C. $\sigma_{max} = 80$ MPa, $N_f = 200,000$, $t_f = 55.56$ h.

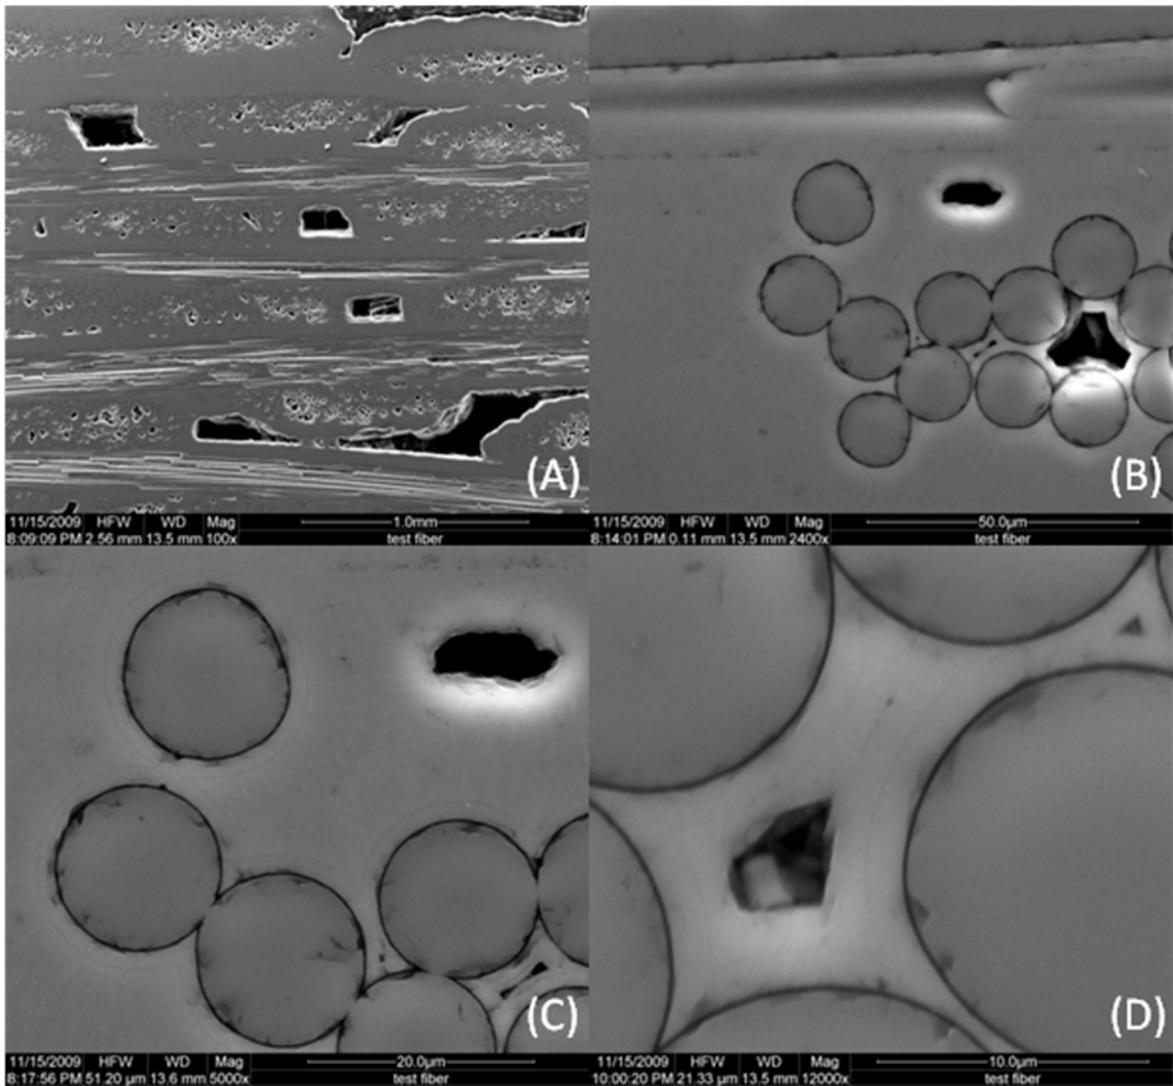
Figure 64: SEM micrographs of the polished surface of specimen P1-9 tested in fatigue at 1.0 Hz in steam at 1200 °C. $\sigma_{max} = 110$ MPa, $N_f = 5620$, $t_f = 1.56$ h.

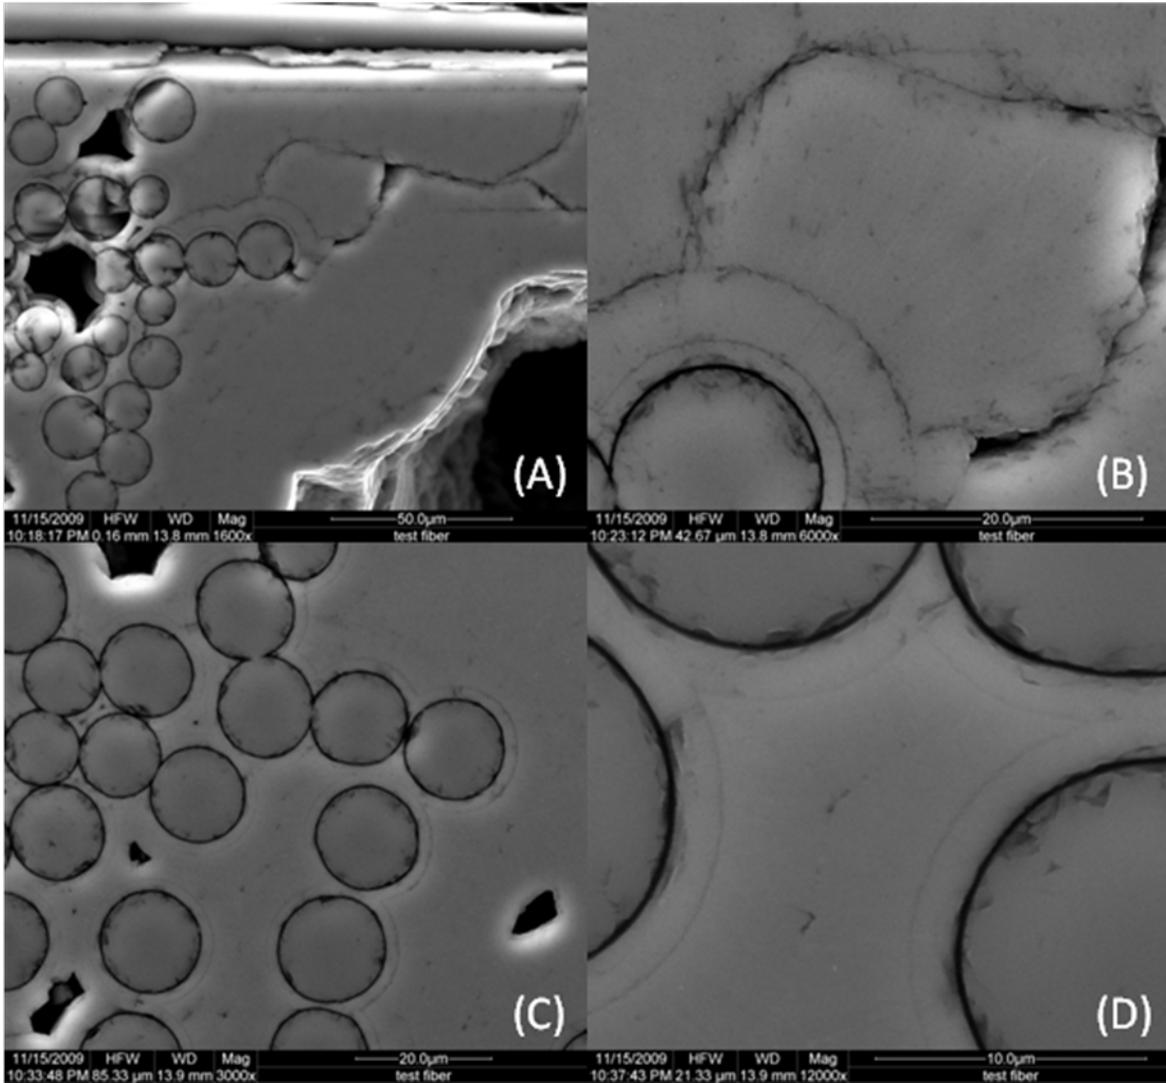
Figure 65: SEM micrographs of the polished surface of specimen P3-2 tested in fatigue at 1.0 Hz in air at 1200 °C. $\sigma_{max} = 80$ MPa, $N_f = 200,000$, $t_f = 55.56$ h.

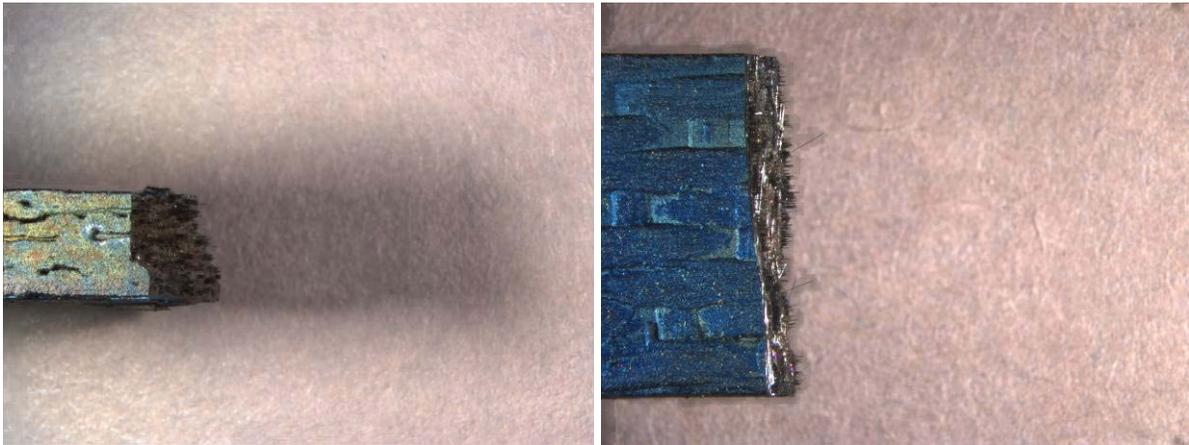
Figure 66: Optical micrographs of specimen P3-3 tested in fatigue at 10 Hz in air at 1200 °C. $\sigma_{max} = 100$ MPa, $N_f = 96,721$, $t_f = 2.69$ h.

Figures 66-69 show the optical micrographs of the fracture surfaces of specimens P3-3 and P2-5 which were tested in fatigue at 10 Hz in air and the optical micrographs of the fracture surfaces of specimens P3-4 and P3-6 which were tested in fatigue at 10 Hz in steam. None of the specimens tested at 10 Hz produced fiber pull-out. As in the case of specimens failed in fatigue at 0.1 Hz and 1 Hz, no delamination between the plies of the composite was observed.

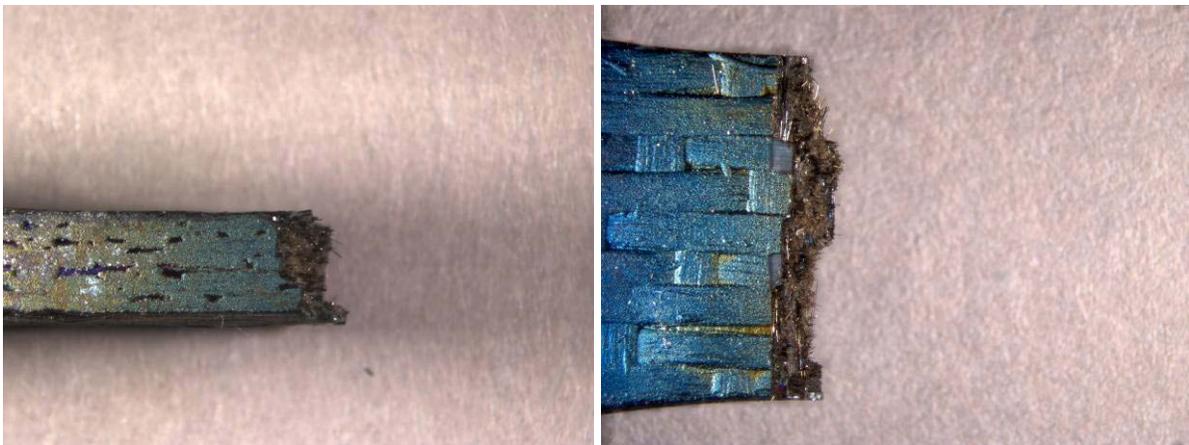
Figure 67: Optical micrographs of specimen P2-5 tested in fatigue at 10 Hz in air at 1200 °C. $\sigma_{max} = 80$ MPa, $N_f = 200,000$, $t_f = 5.561$ h.

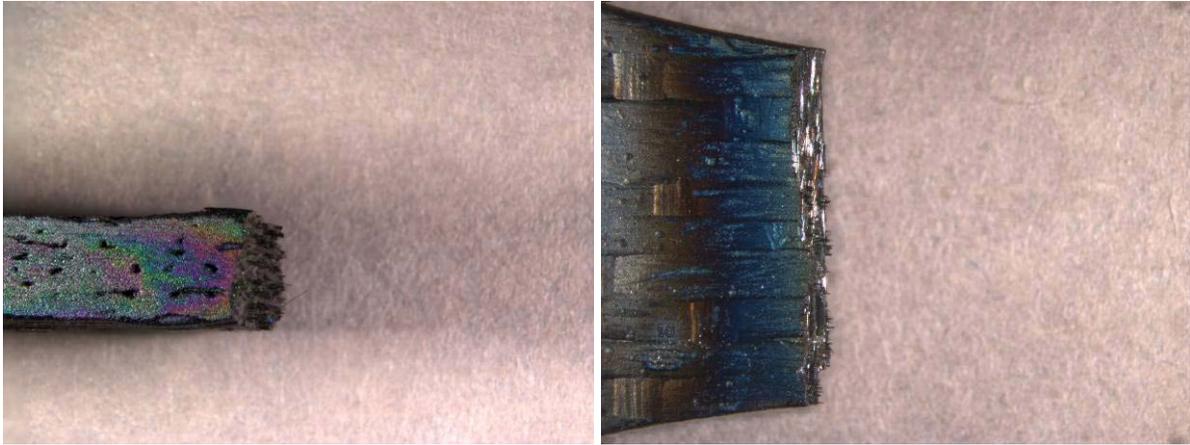
Figure 68: Optical micrographs of specimen P3-4 tested in fatigue at 10 Hz in steam at 1200 °C. $\sigma_{\max} = 80$ MPa, $N_f = 3,451$, $t_f = 0.93$ h.

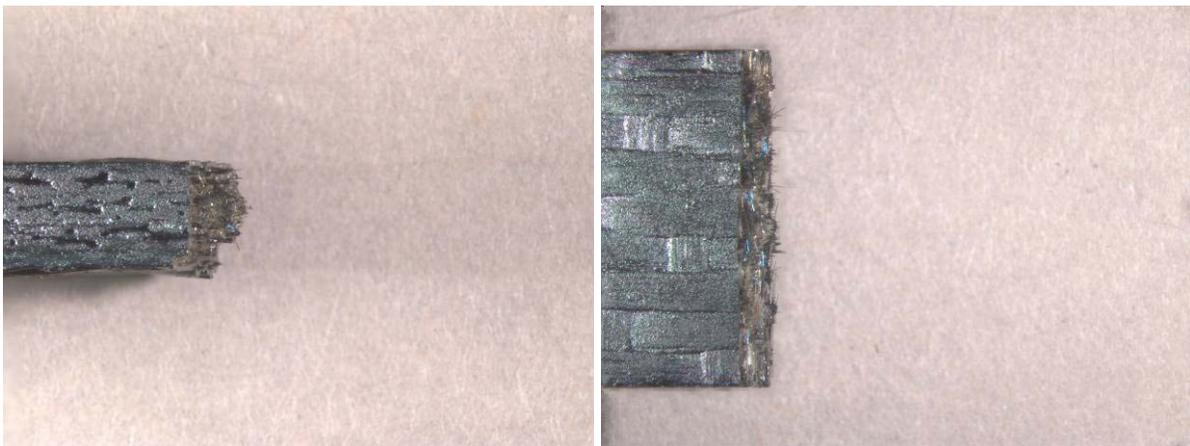
Figure 69: Optical micrographs of specimen P3-6 tested in fatigue at 0.1 Hz in steam at 1200 °C. $\sigma_{\max} = 60$ MPa, $N_f = 200,000$, $t_f = 5.56$ h.

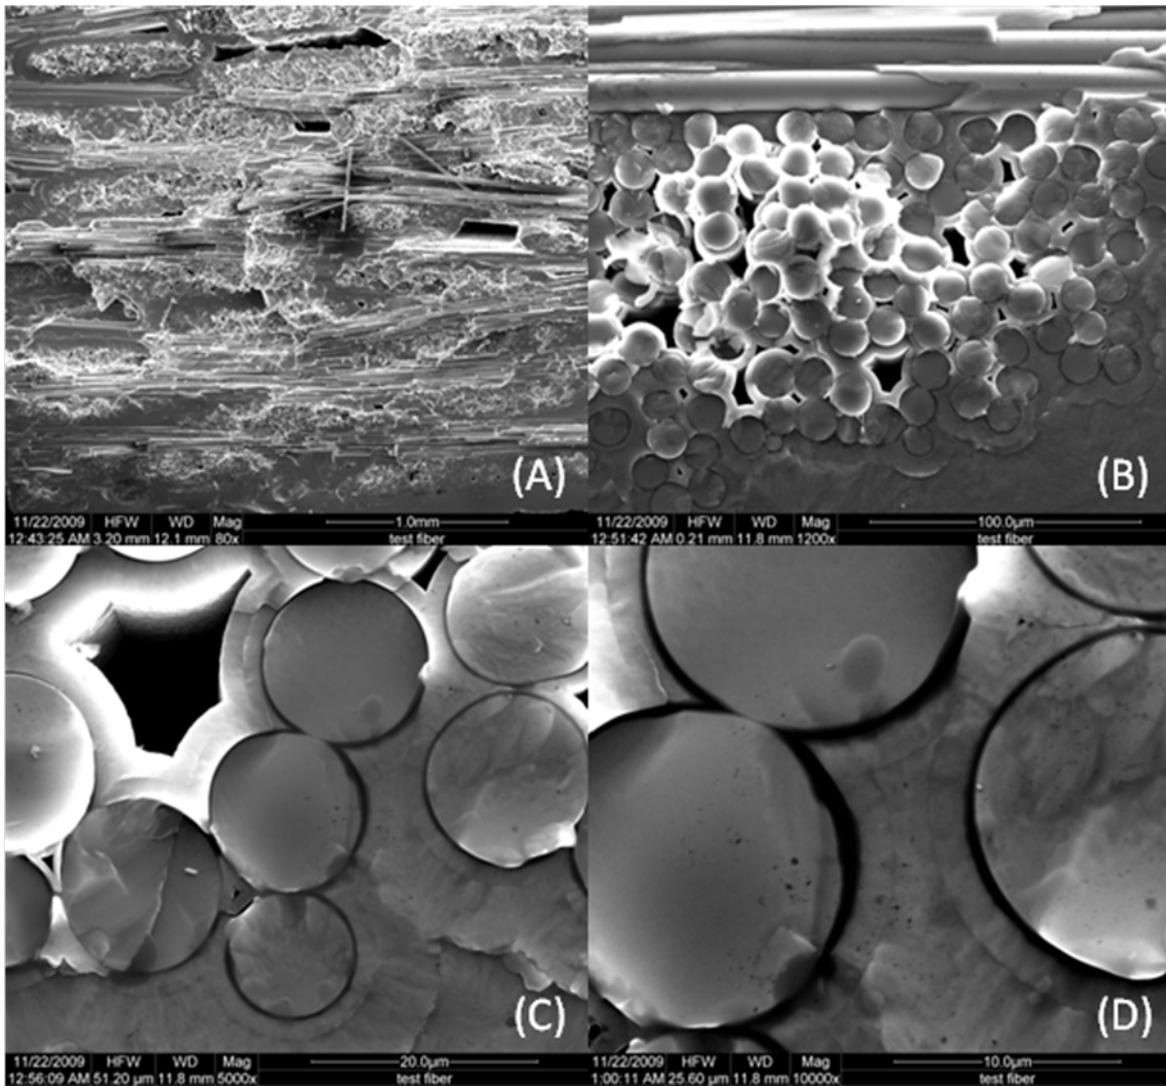
Figure 70: SEM micrographs of the fracture surface of specimen P3-3 tested in fatigue at 10 Hz in air at 1200 °C. $\sigma_{max} = 100$ MPa, $N_f = 96,721$, $t_f = 2.69$ h.

The micrographs of the fracture surfaces produced in the 10 Hz tests display features not seen in the fracture surfaces produced in the 0.1 Hz or 1 Hz tests. SEM micrographs in Figure 70 (D) show what appear to be small, dark spots on the face of the fiber. Near these spots, the gap left by the BN fiber coating, which is normally very smooth and of even thickness, is rough and irregular. It is possible that the higher fatigue rate caused the fibers to slide across the

interface and abrade the adjacent matrix. This abrasion could have deformed the edges of the interface and at the same time produced matrix dust which settled on the fracture surface.
