**FATIGUE BEHAVIOR OF AN ADVANCED SiC/SiC COMPOSITE
AT ELEVATED TEMPERATURE IN AIR AND IN STEAM**

THESIS

Devon T. Christensen, Captain, USAF

AFIT/GAE/ENY/09-D02

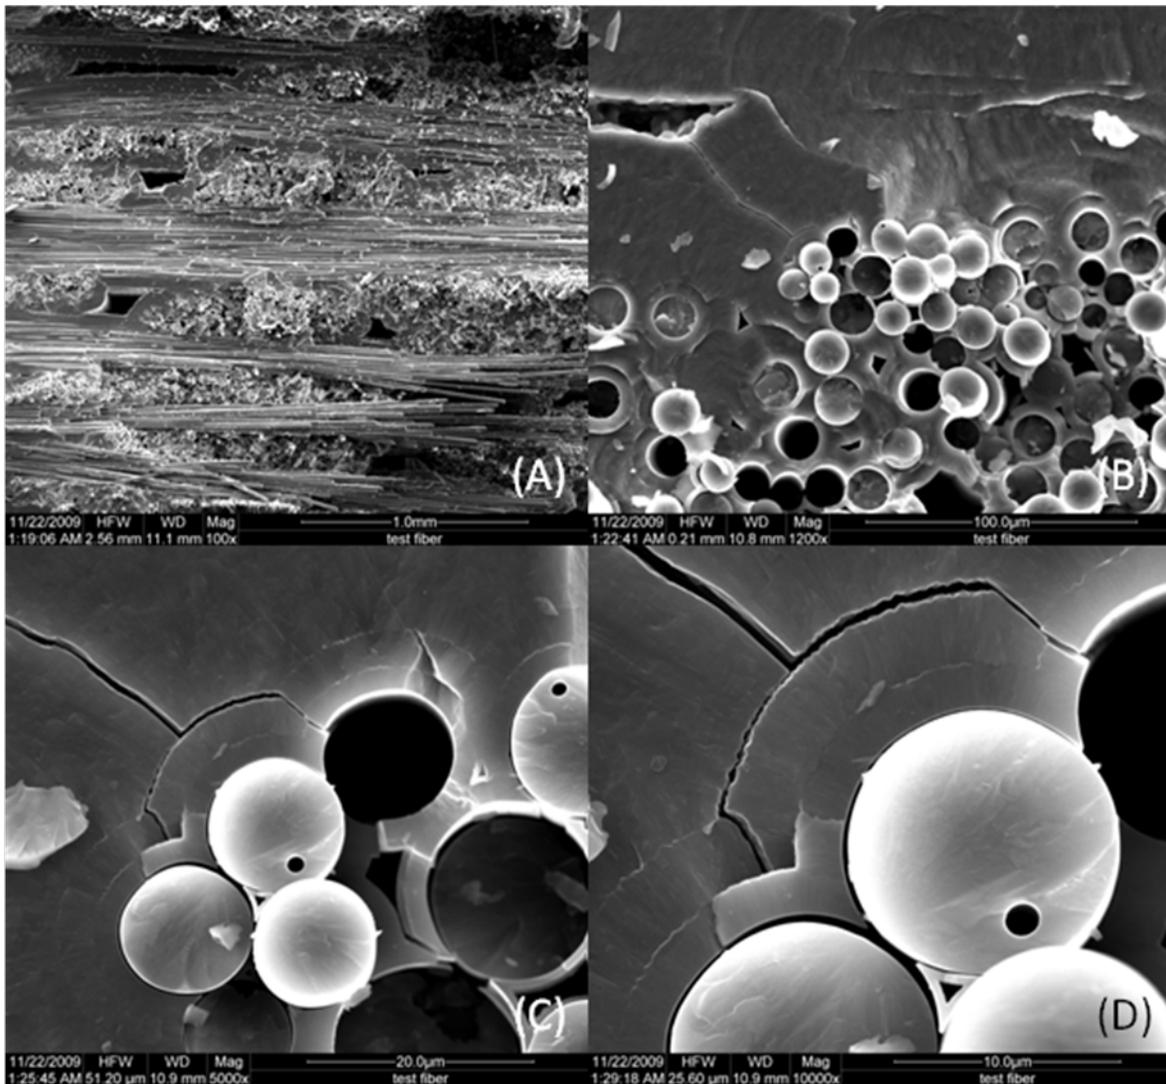
Figure 71: SEM micrographs of the fracture surface of specimen P2-5 tested in fatigue at 10 Hz in air at 1200 °C. $\sigma_{max} = 80$ MPa, $N_f = 200,000$, $t_f = 5.56$ h.

In Figure 71 (C) and (D), a matrix crack is seen growing towards the “flash” SiC layer/SiC matrix boundary, then deflecting a short distance along the boundary in both directions, finally propagating through the “flash” SiC layer and bridging directly along the fiber. The holes inside individual fibers are also visible in these images.

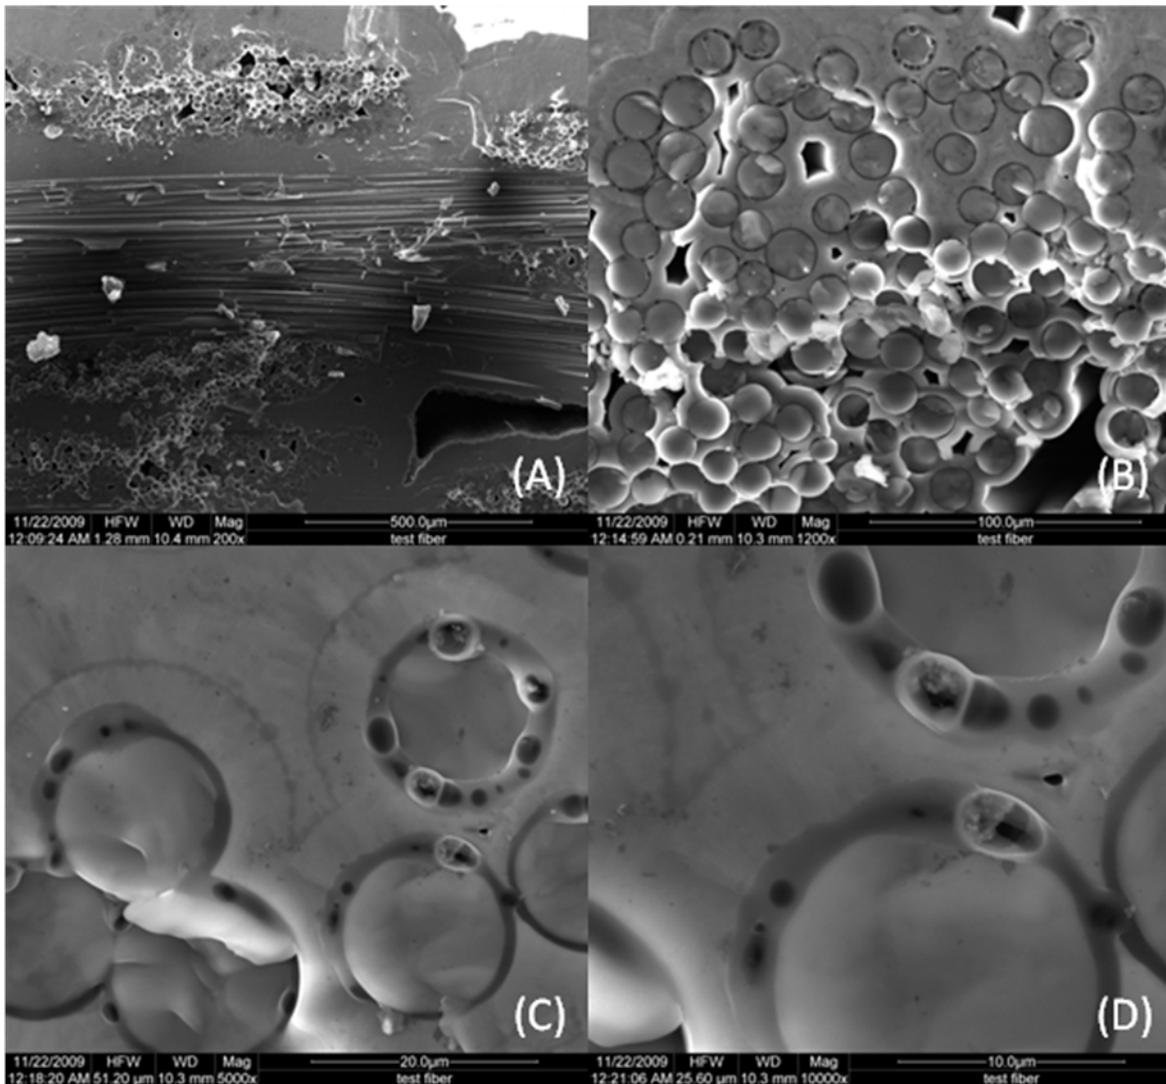
Figure 72: SEM micrographs of the fracture surface of specimen P3-4 tested in fatigue at 10 Hz in steam at 1200 °C. $\sigma_{max} = 80$ MPa, $N_f = 33,451$, $t_f = 0.93$ h.

When viewing the micrographs of the specimens tested in steam even more changes became apparent. In Figure 72 (C) and (D), severe degradation of the BN fiber coating is seen. Glassy bubbles have formed along the BN fiber coating at the fracture surface.

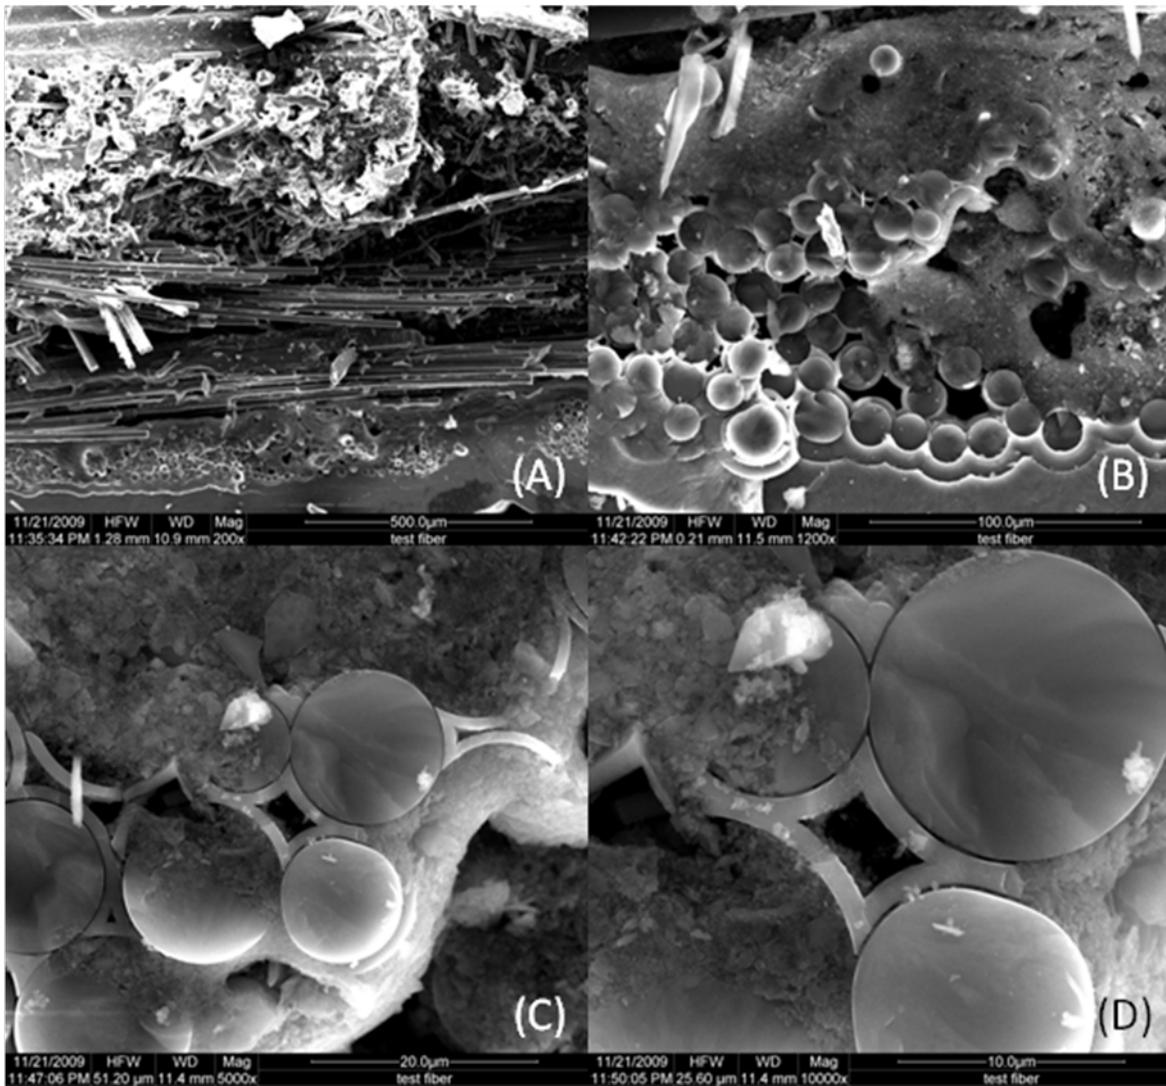
Figure 73: SEM micrographs of the fracture surface of specimen P3-6 tested in fatigue at 10 Hz in steam at 1200 °C. $\sigma_{max} = 60$ MPa, $N_f = 200,000$, $t_f = 5.56$ h.

A closer look at the transition zone between the oxidized region and the brittle fracture zone in the interior of the specimen reveals material which has sloughed off the surrounding areas and flowed onto the fracture surfaces of the 0^0 fibers (seen in Figure 73 (C)). Additionally, it is seen in the lower right hand corner of Figure 73 (D) the “flash” SiC layer between the two fibers has cracked and is sloughing off. This sloughing may be the result of multiple brittle fractures and comminution of the ceramic constituents of the overall composite.

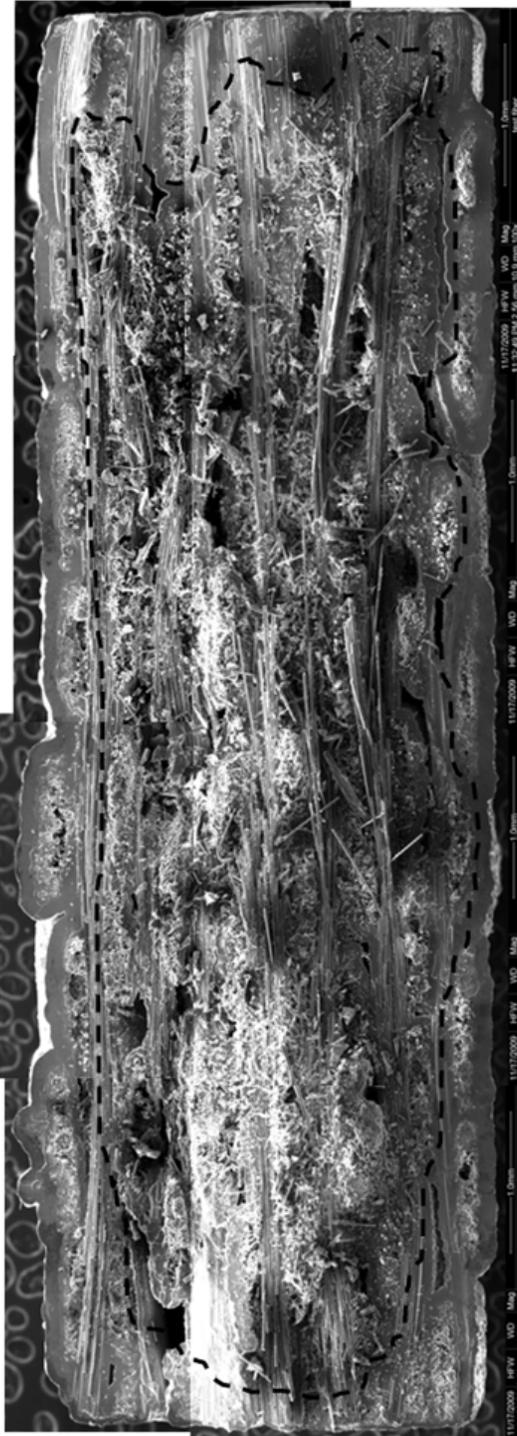
Figure 74: Compiled SEM micrographs of total P3-6 fracture surface after failure during 10 Hz fatigue testing at 1200 °C in steam with $\sigma_{max} = 60$ MPa. Environmental intrusion zone indicated by dotted line.

Figure 74 shows an overall view of the fracture surface of P3-6 which achieved fatigue run-out of 2×10^5 cycles in steam. The depth of the environmental intrusion is approximated by the dashed line. Overall fracture surface micrographs for the remaining specimens are included in Appendix A.

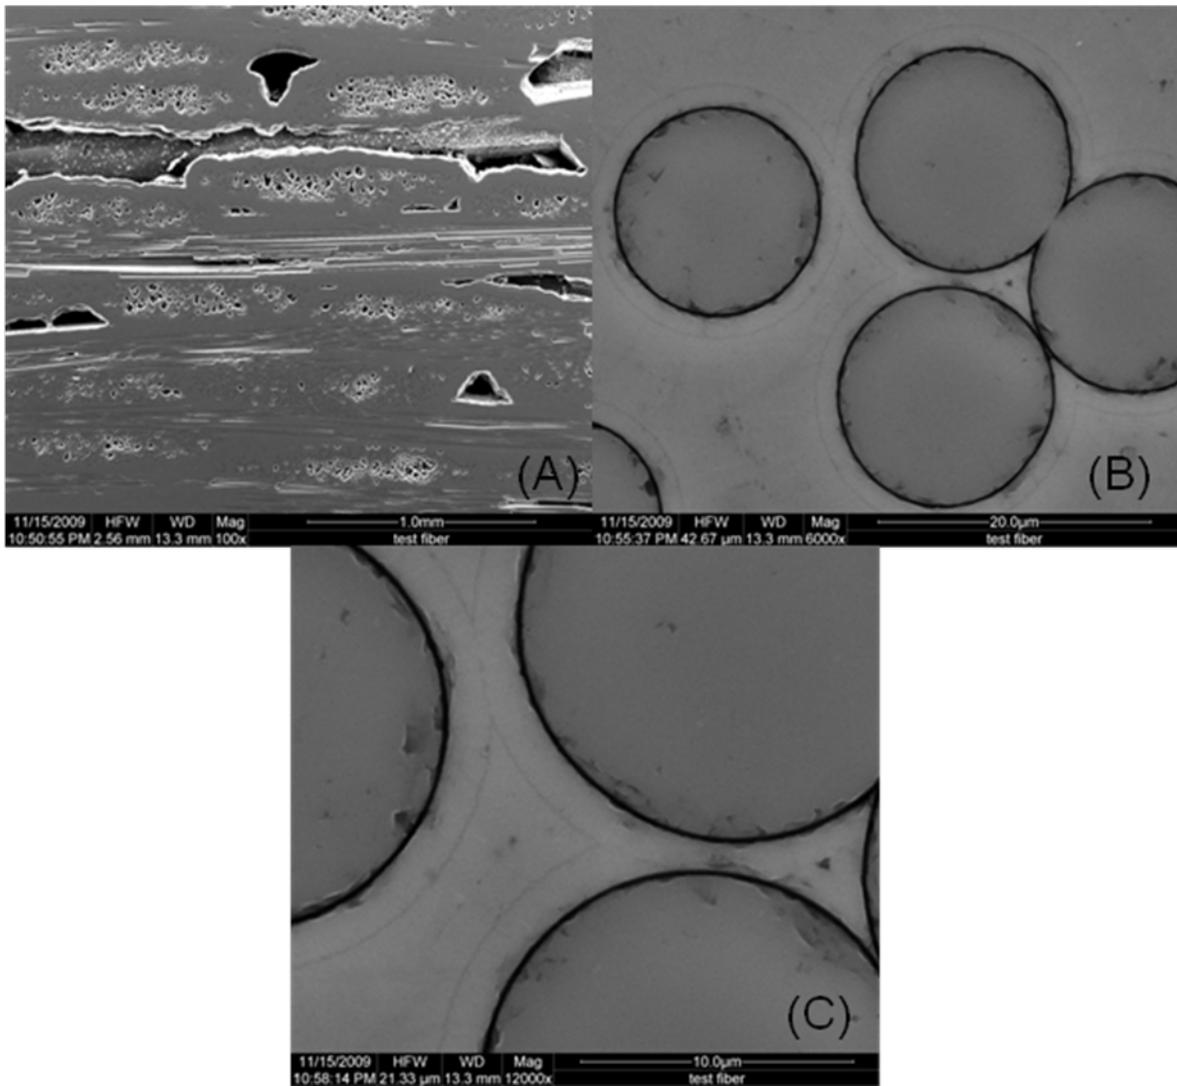
Figure 75: SEM micrographs of the polished surface of specimen P3-3 tested in fatigue at 10 Hz in air at 1200 °C. $\sigma_{max} = 100$ MPa, $N_f = 96,721$, $t_f = 2.69$ h.

Unfortunately, the SEM micrographs of the polished sections of the specimens tested in fatigue at 10 Hz, Figures 75-78, do not offer additional insight. The images of the polished sections look very similar to those of the as-processed material and of the specimens tested at 0.1 Hz and 1.0 Hz.

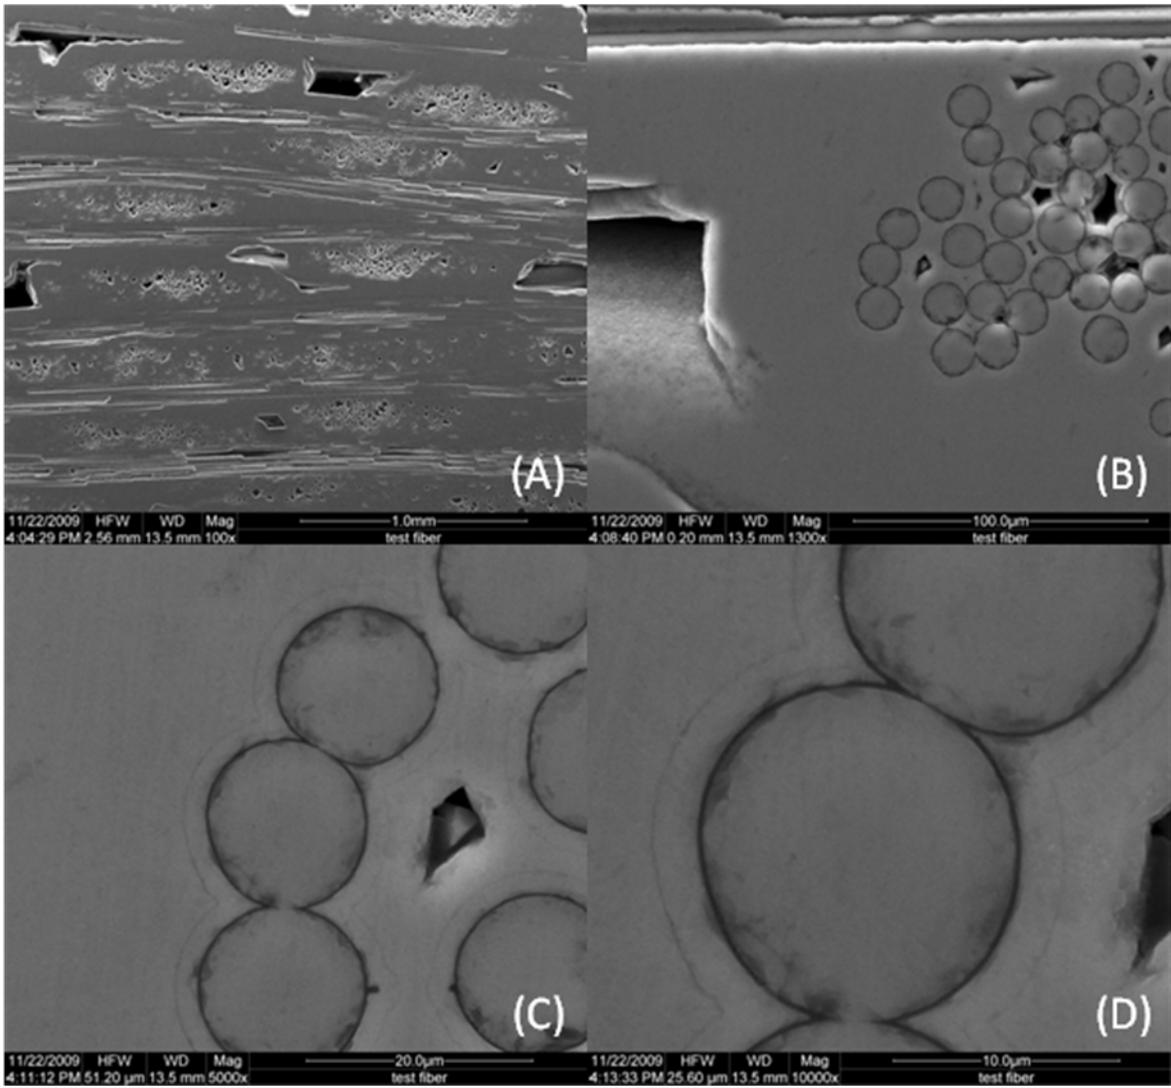
Figure 76: SEM micrographs of the polished surface of specimen P2-5 tested in fatigue at 10 Hz in air at 1200 °C. $\sigma_{max} = 80$ MPa, $N_f = 200,000$, $t_f = 5.56$ h.

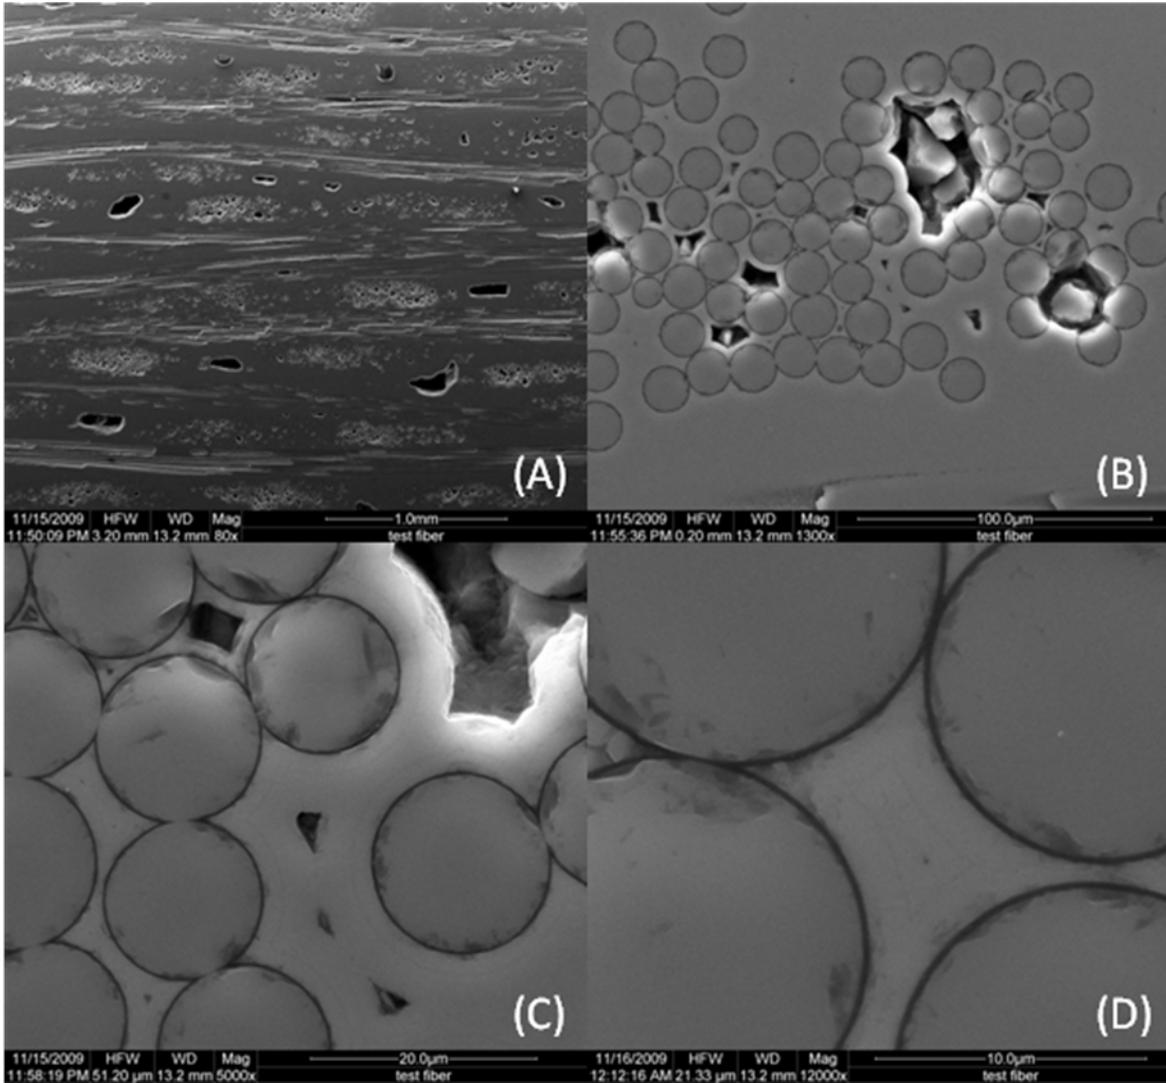
Figure 77: SEM micrographs of the fracture surface of specimen P3-4 tested in fatigue at 10 Hz in steam at 1200 °C. $\sigma_{max} = 80$ MPa, $N_f = 33,451$, $t_f = 0.93$ h.

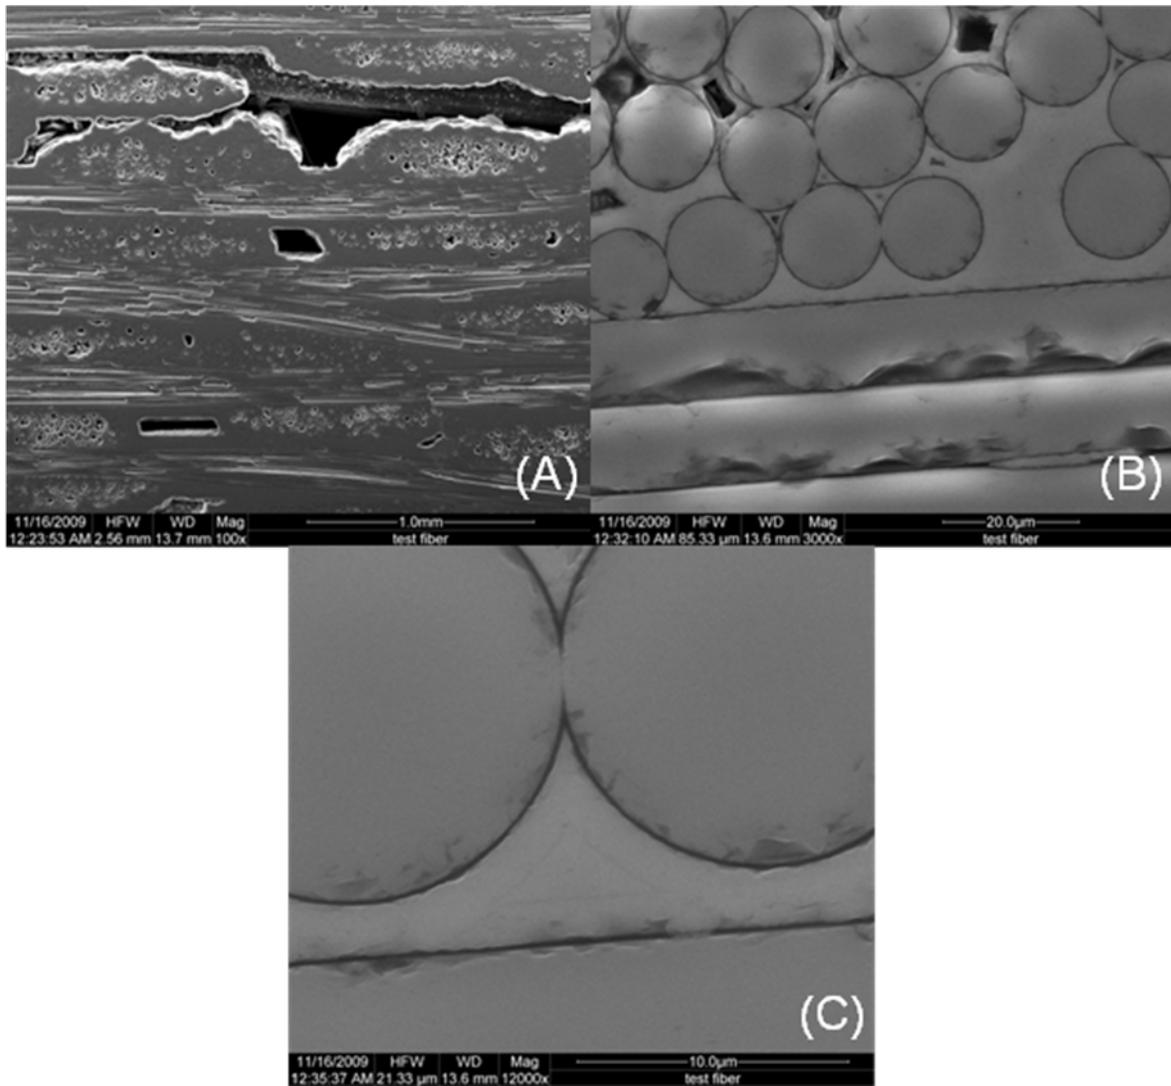
Figure 78: SEM micrographs of the fracture surface of specimen P3-6 tested in fatigue at 10 Hz in steam at 1200 °C. $\sigma_{max} = 60$ MPa, $N_f = 200,000$, $t_f = 5.56$ h.

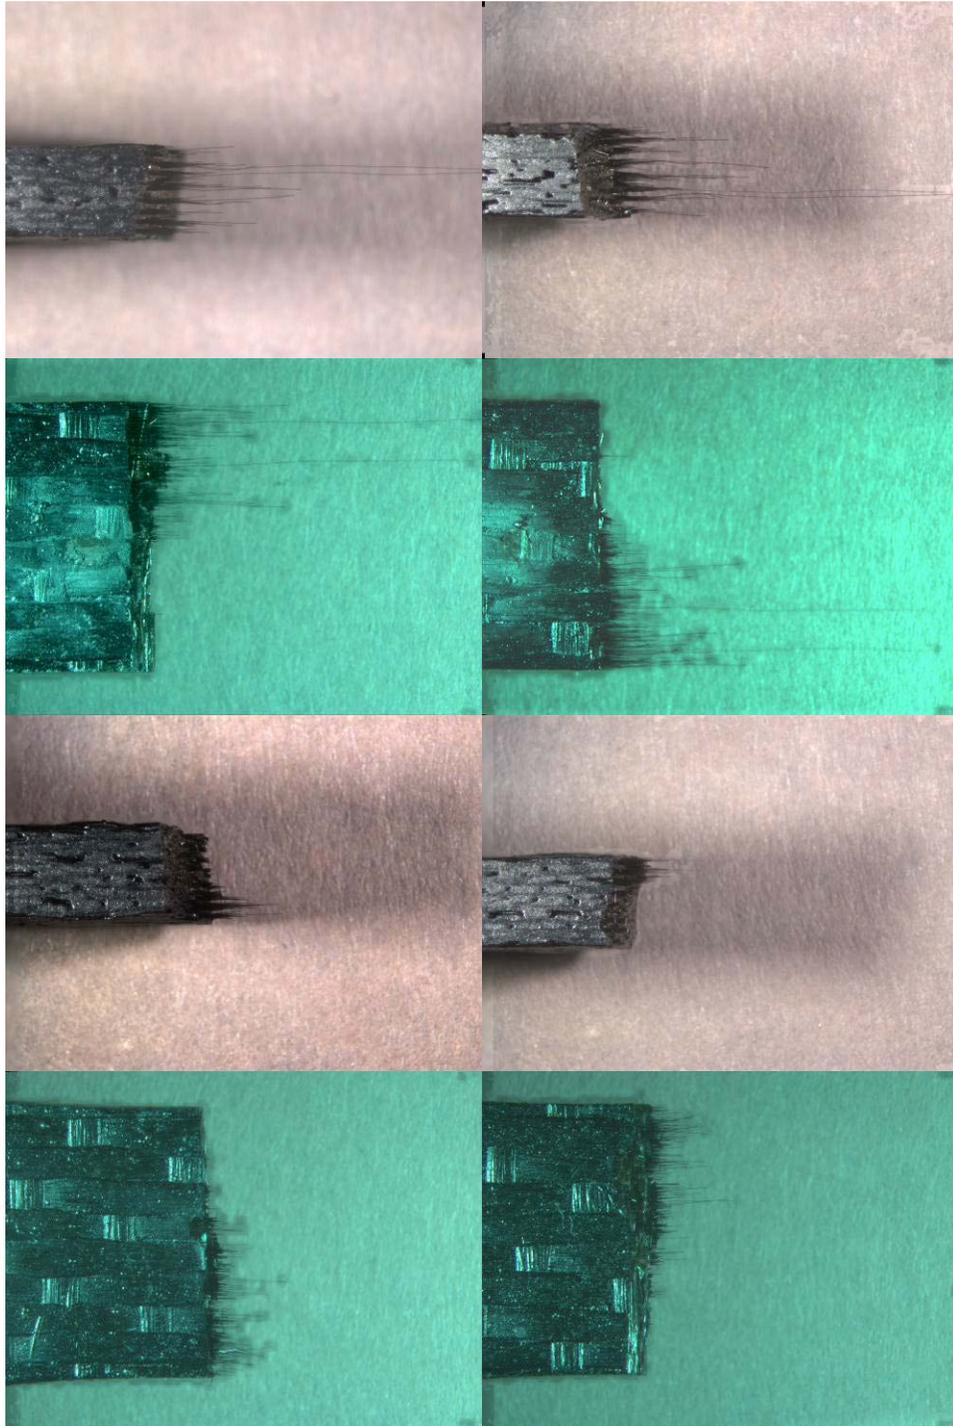
Figure 79: Optical micrographs of specimen P1-1 tested in fatigue at 1.0 Hz in steam at 1200 °C. $\sigma_{max} = 100$ MPa, $N_f = 11,447$, $t_f = 3.18$ h.

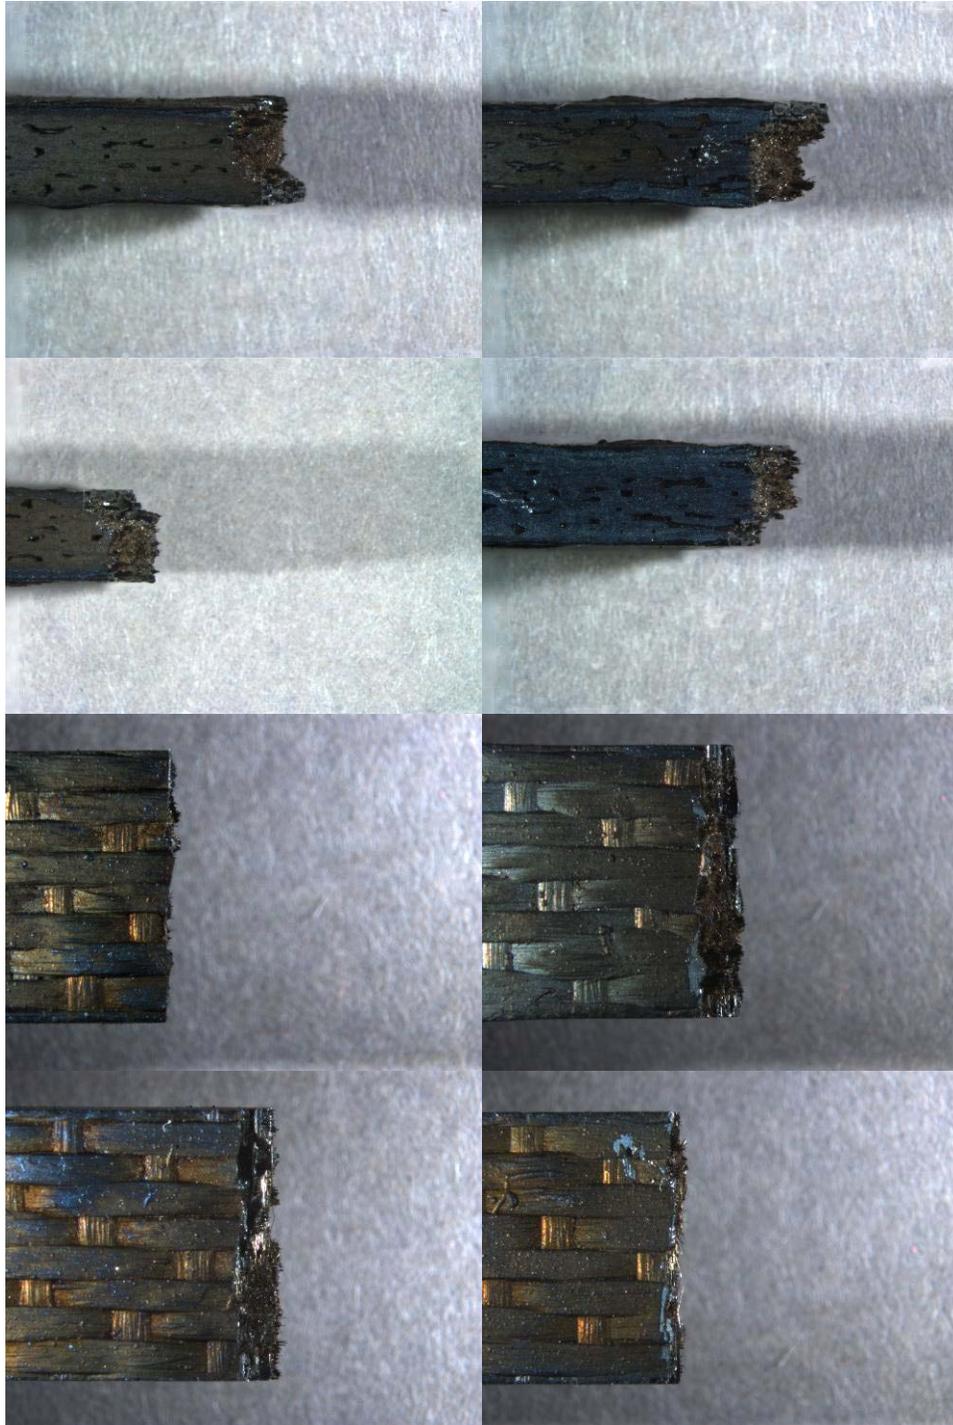
Figure 80: Optical Micrographs of the fracture surfaces produced in tensile test to failure conducted at 0.05mm/sec at 1200 °C in air on specimen P1-3.

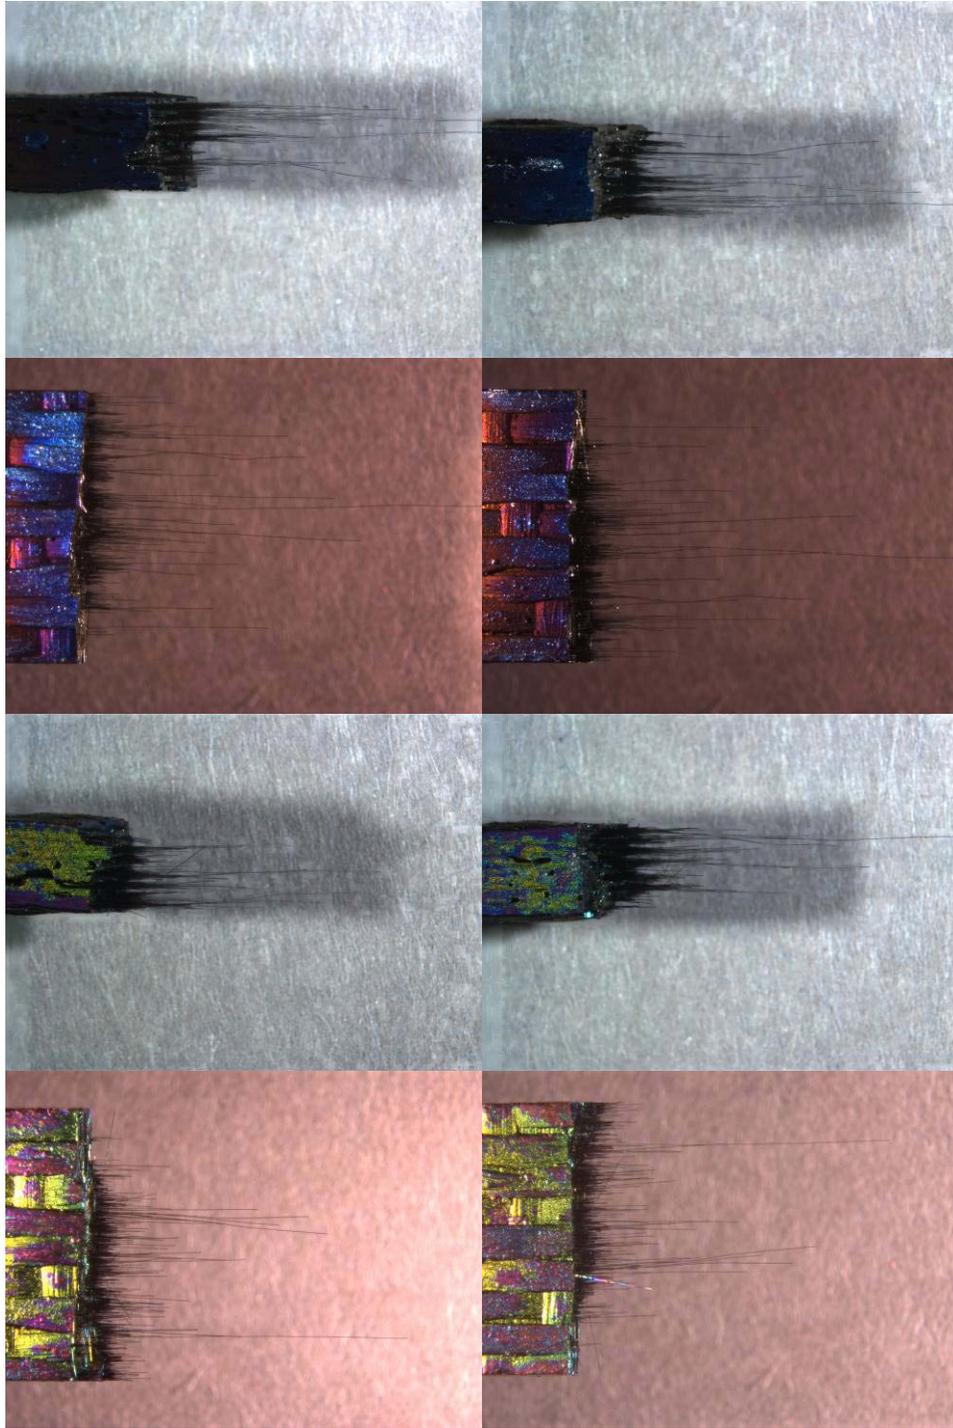
Figure 81: Optical micrographs of specimen P1-4 tested in fatigue at 1.0 Hz in air at 1200 °C. $\sigma_{max} = 120$ MPa, $N_f = 3766$, $t_f = 1.05$ h.

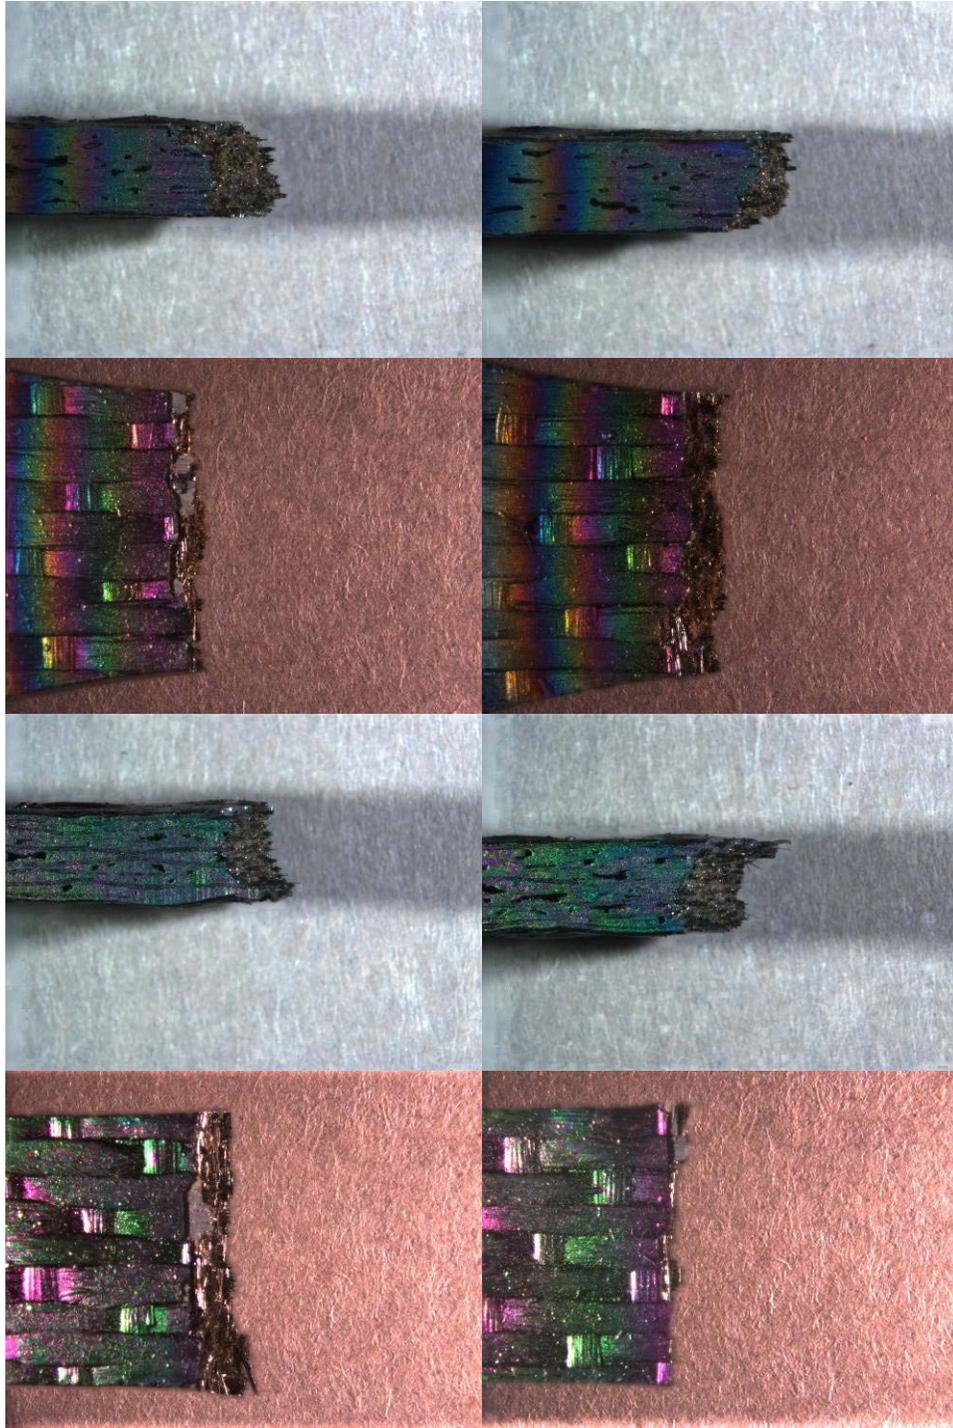
Figure 82: Optical micrographs of specimen P1-5 tested in fatigue at 1.0 Hz in air at 1200 °C. $\sigma_{max} = 80$ MPa, $N_f = 200,000$, $t_f = 55.56$ h.

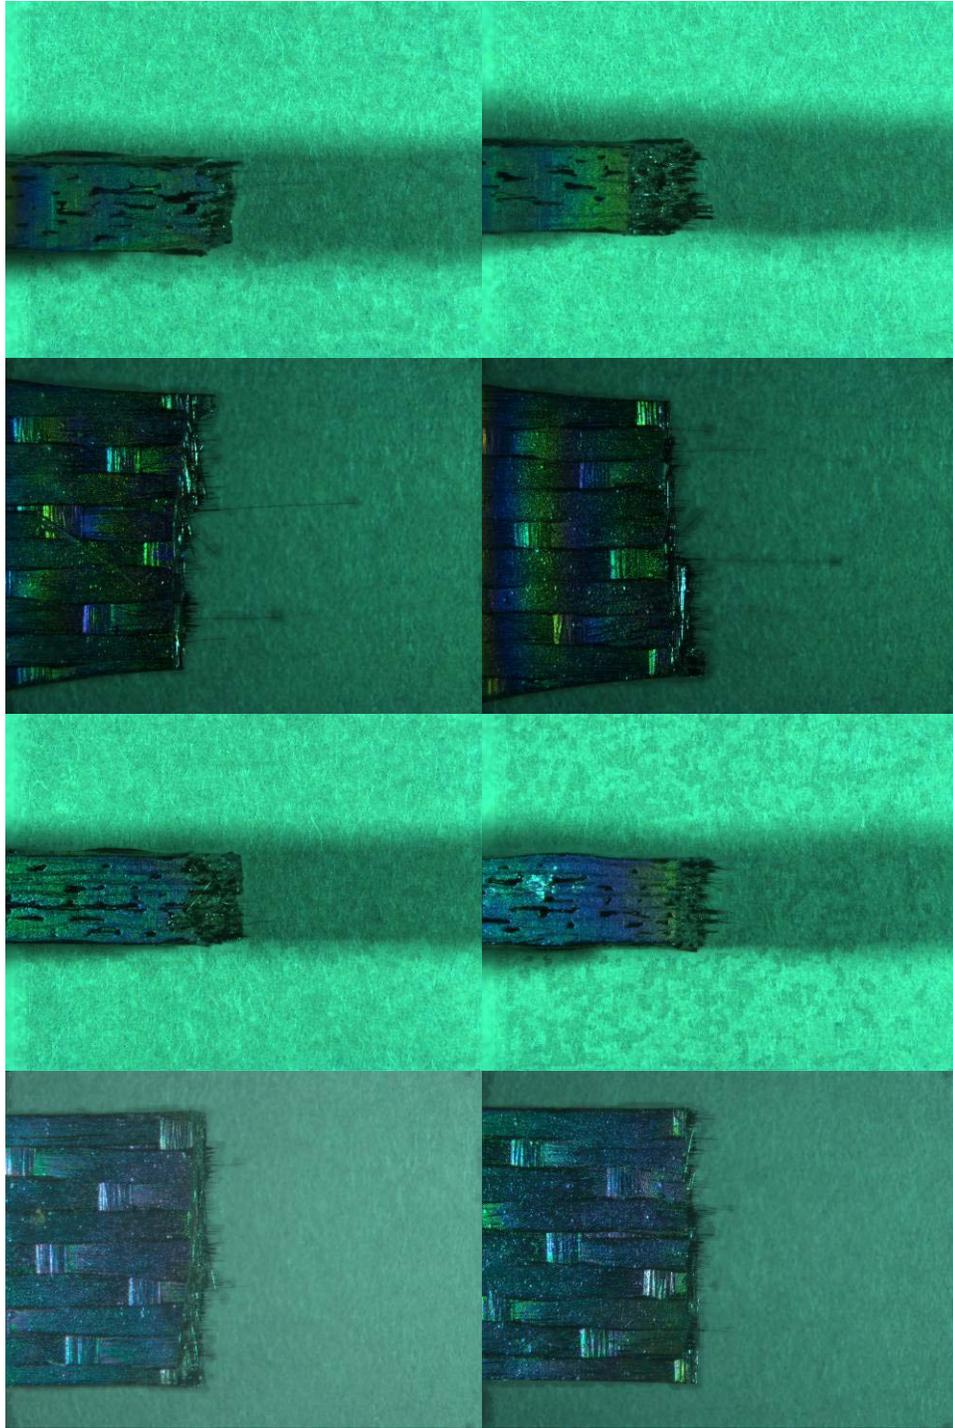
Figure 83: Optical micrographs of specimen P1-6 tested in fatigue at 1.0 Hz in air at 1200 °C. $\sigma_{max} = 100$ MPa, $N_f = 94,022$, $t_f = 26.12$ h.

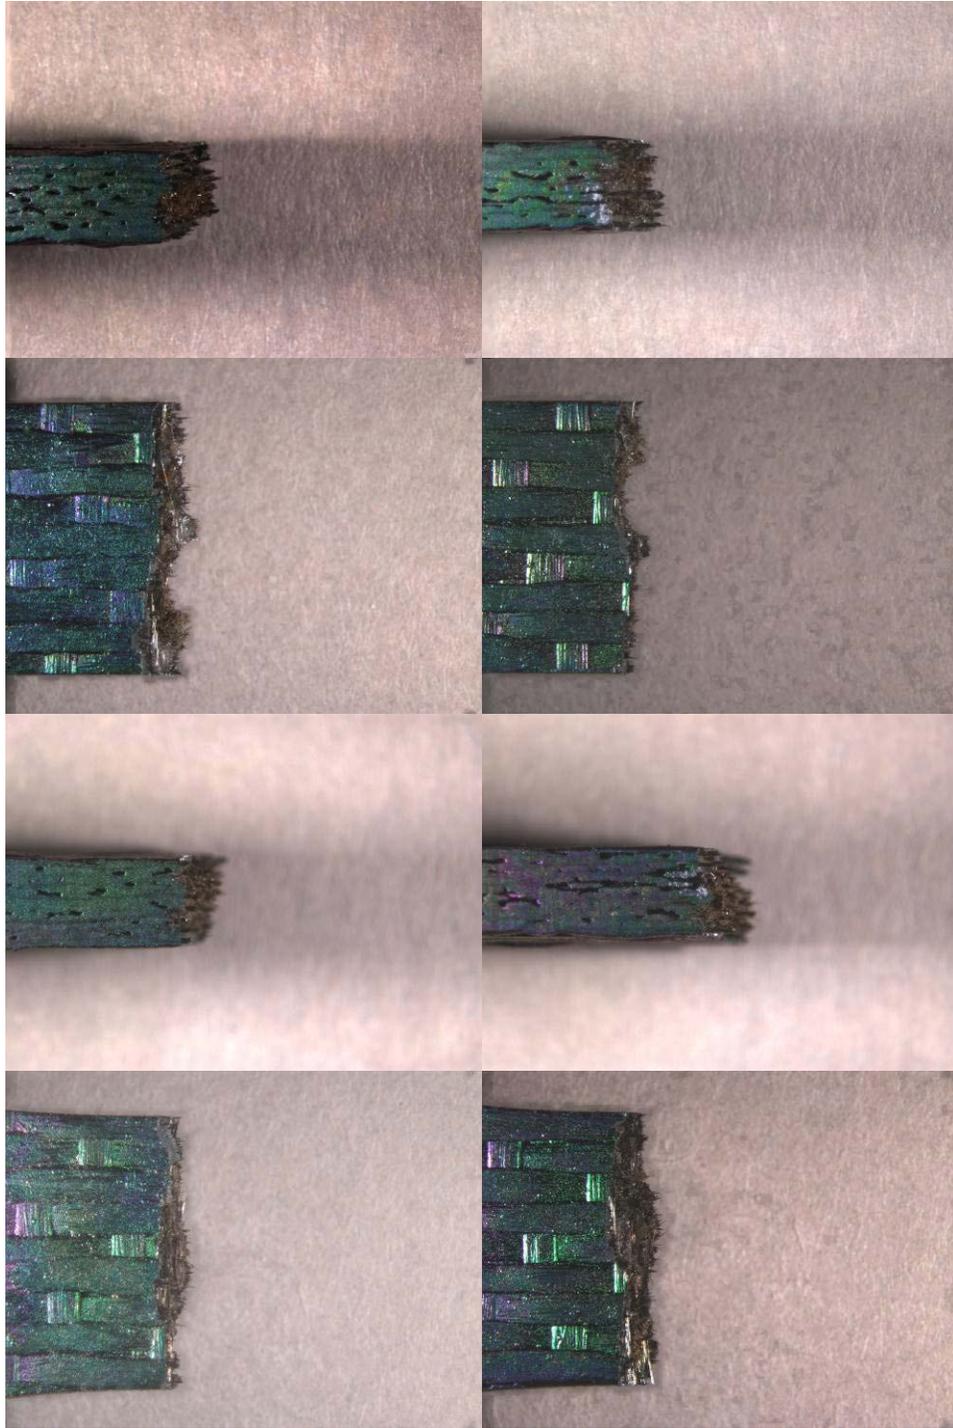
Figure 84: Optical micrographs of specimen P1-7 tested in fatigue at 1.0 Hz in air at 1200 °C. $\sigma_{max} = 100$ MPa, $N_f = 200,000$, $t_f = 55.56$ h.

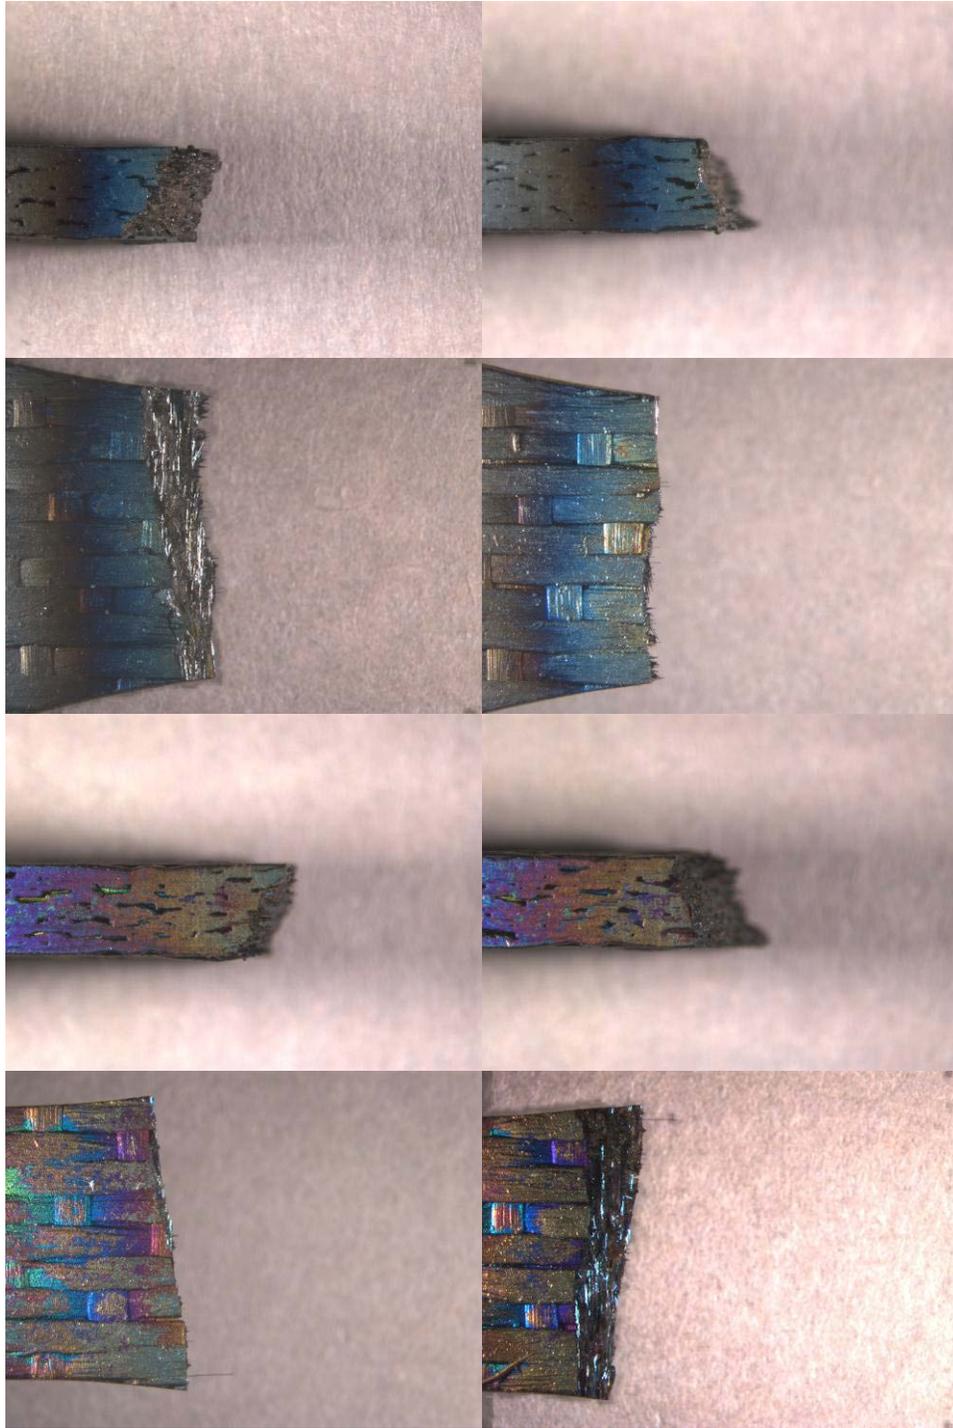
Figure 85: Optical micrographs of specimen P1-8 tested in fatigue at 1.0 Hz in air at 1200 °C. $\sigma_{\max} = 110$ MPa, $N_f = 59,641$ $t_f = 16.57$ h.

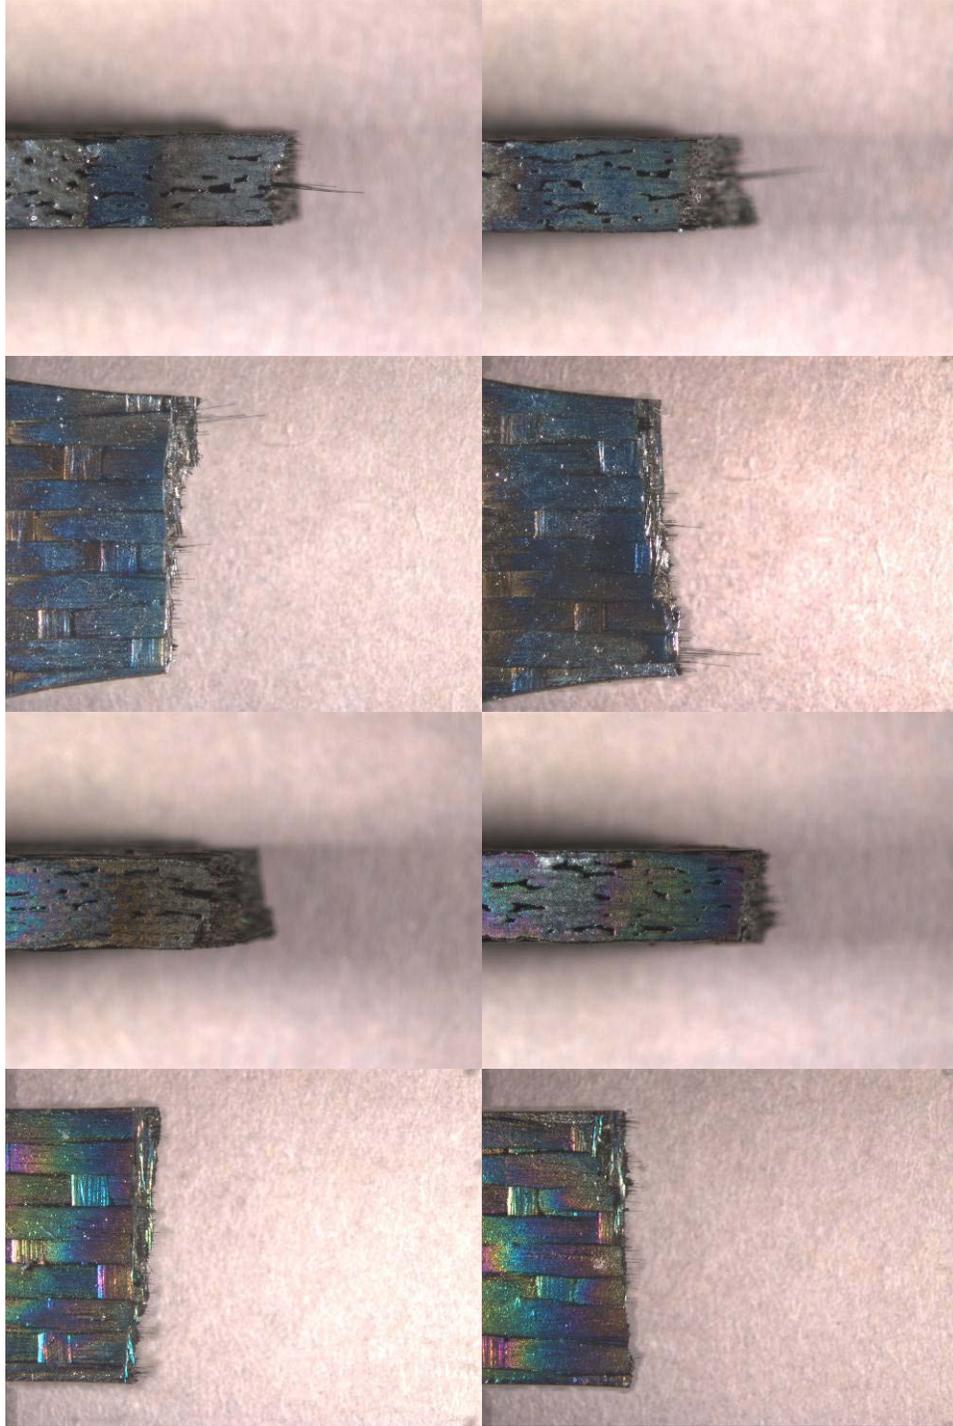
Figure 86: Optical micrographs of specimen P1-9 tested in fatigue at 1.0 Hz in steam at 1200 °C. $\sigma_{max} = 110$ MPa, $N_f = 5620$, $t_f = 1.56$ h.

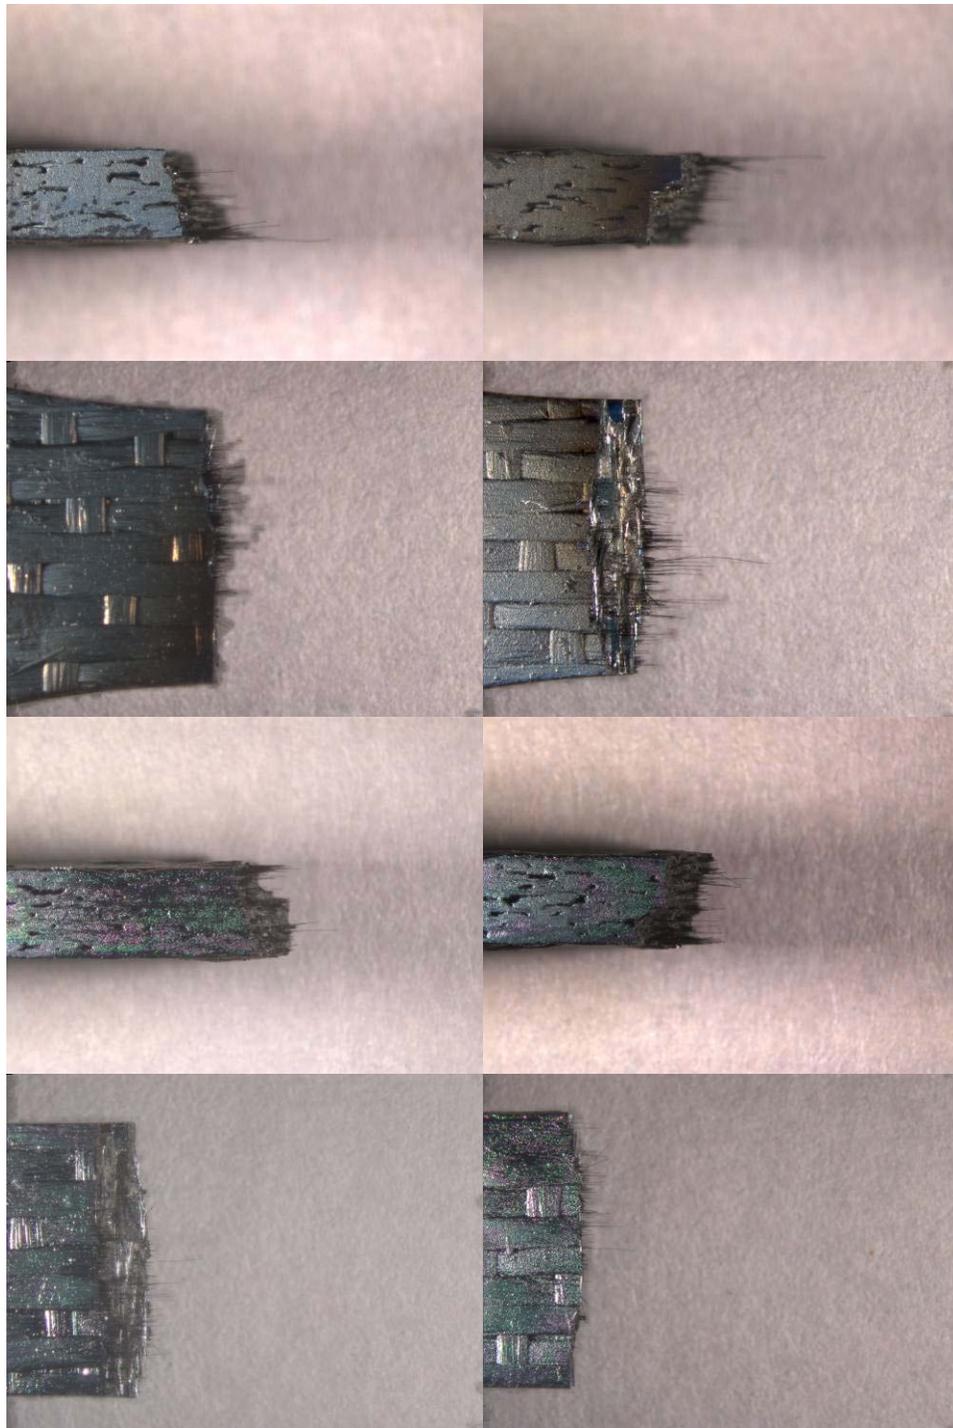
Figure 87: Optical micrographs of specimen P2-1 tested in fatigue at 1.0 Hz in steam at 1200 °C. $\sigma_{max} = 100$ MPa, $N_f = 1128$, $t_f = 0.31$ h.
