**FATIGUE BEHAVIOR OF AN ADVANCED SiC/SiC COMPOSITE
AT ELEVATED TEMPERATURE IN AIR AND IN STEAM**

THESIS

Devon T. Christensen, Captain, USAF

AFIT/GAE/ENY/09-D02

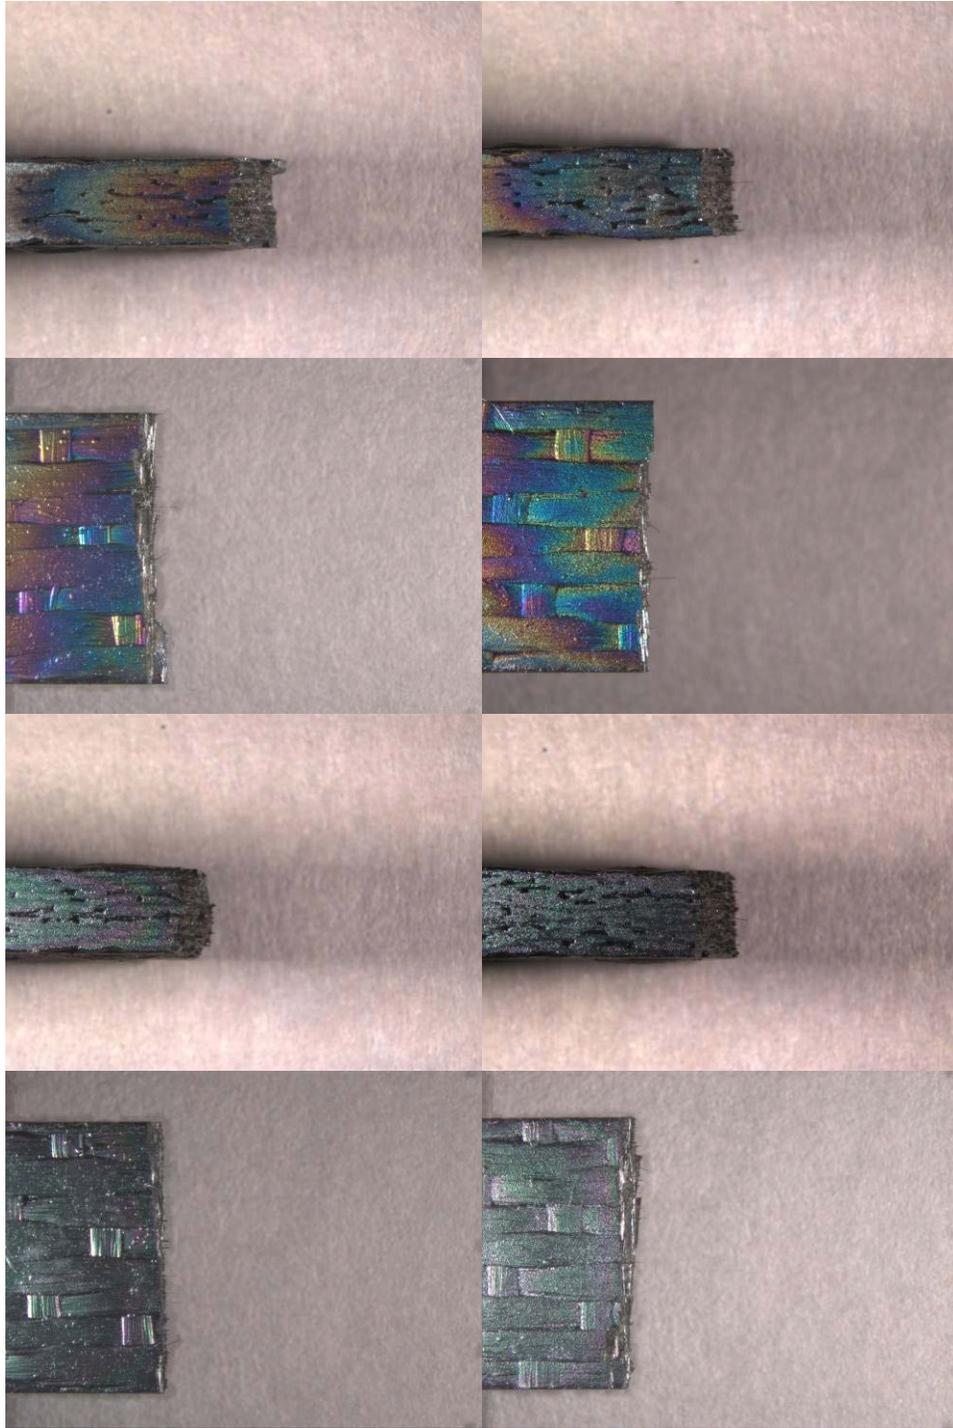
Figure 88: Optical micrographs of specimen P2-3 tested in fatigue at 1.0 Hz in steam at 1200 °C. $\sigma_{max} = 100$ MPa, $N_f = 1650$, $t_f = 0.46$ h.

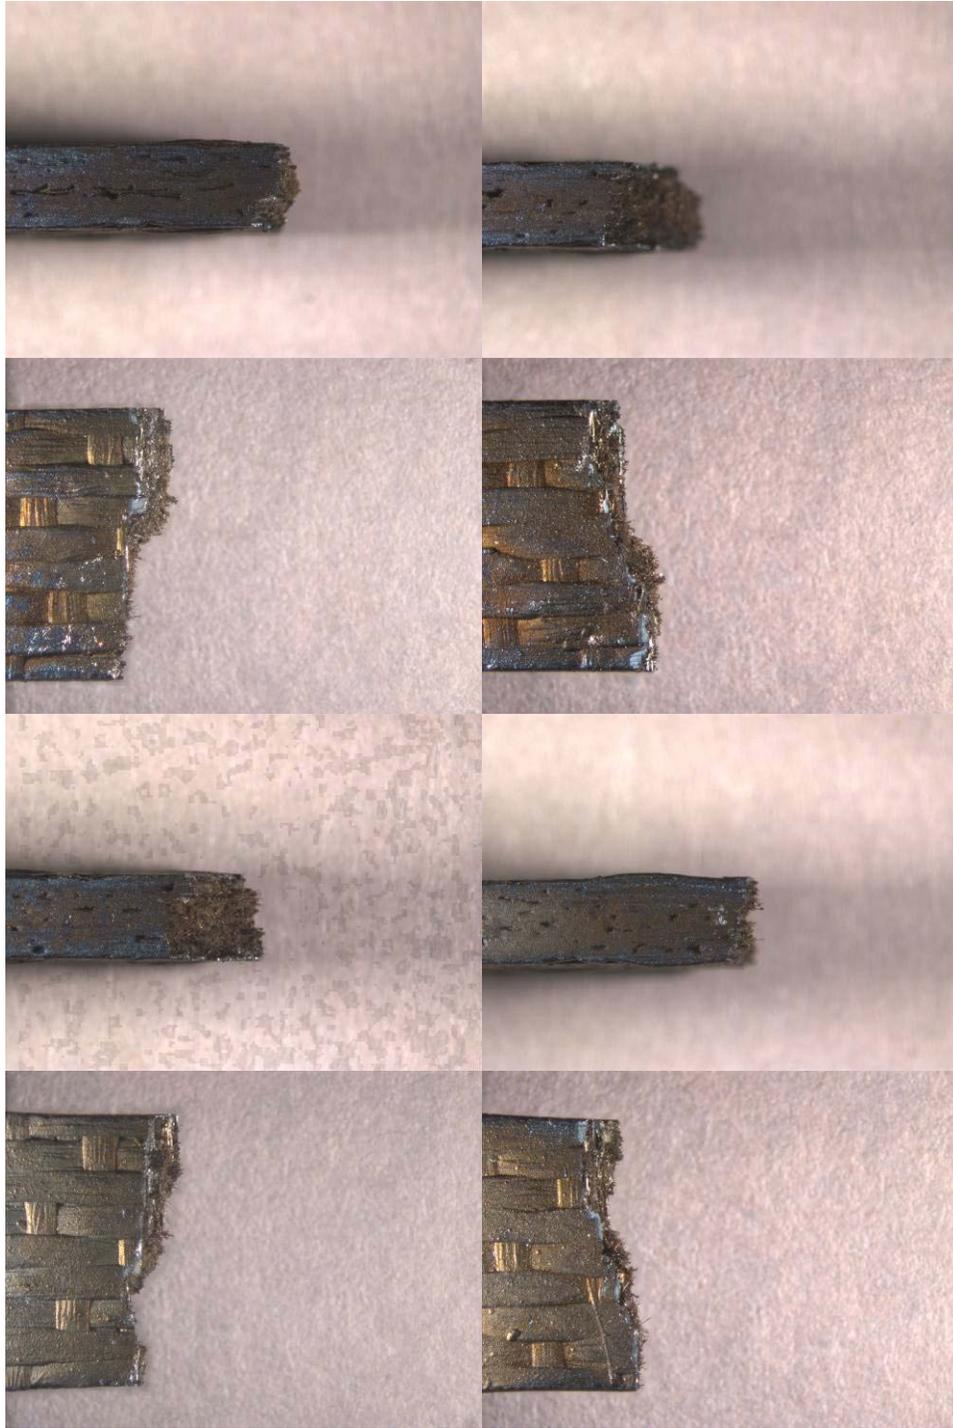
Figure 89: Optical Micrographs of the fracture surfaces produced in tensile test to failure conducted at 0.05mm/sec at 1200 °C in air on specimen P2-4.

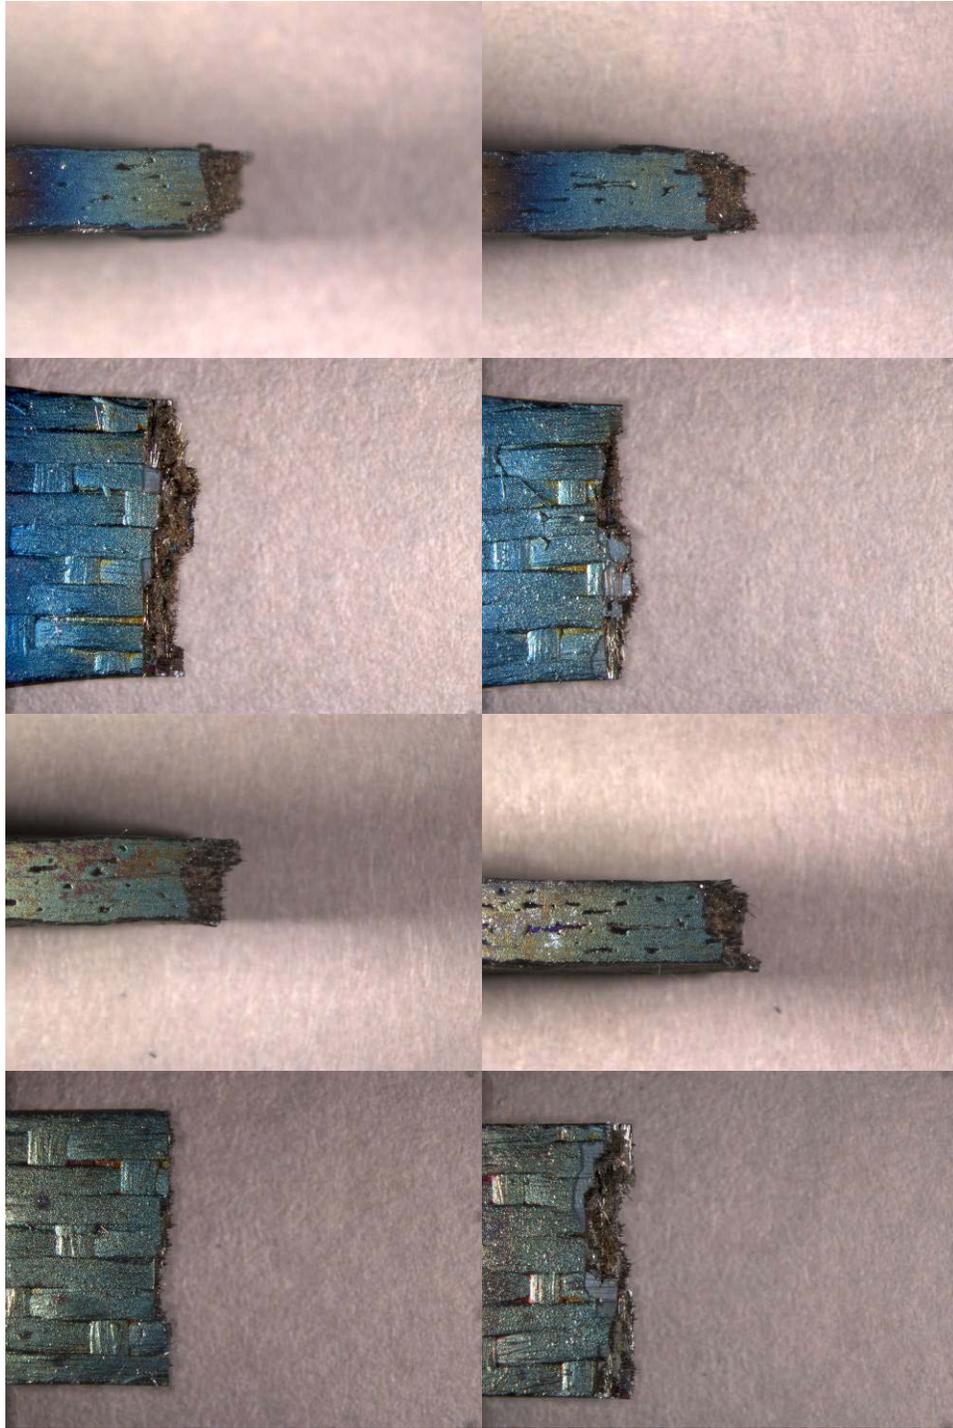
Figure 90: Optical micrographs of specimen P2-5 tested in fatigue at 10 Hz in air at 1200 °C. $\sigma_{max} = 80$ MPa, $N_f = 200,000$, $t_f = 5.56$ h.

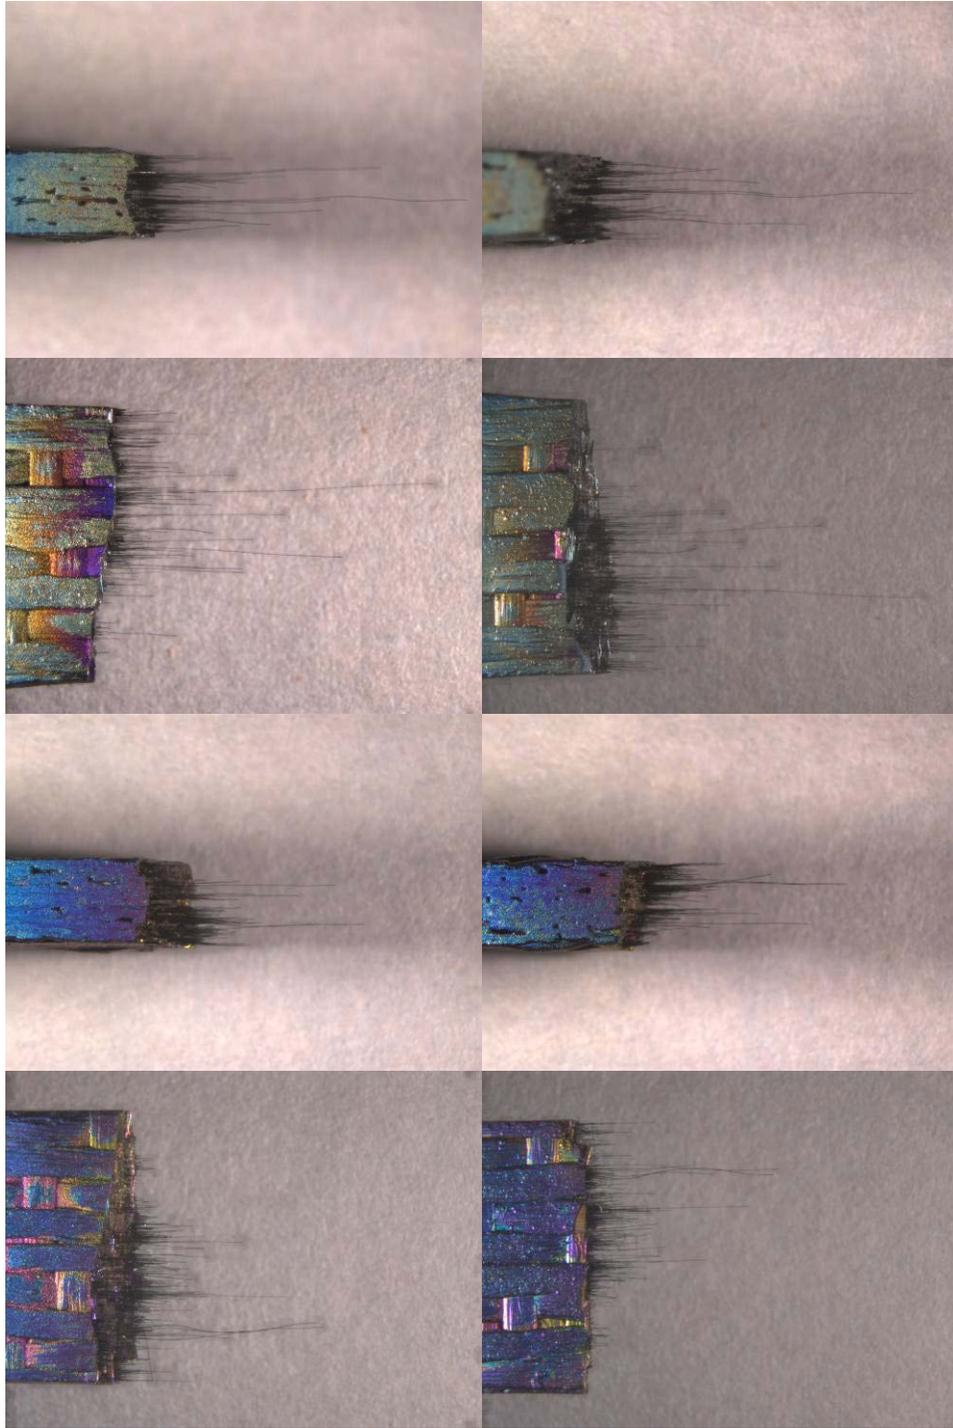
Figure 91: Optical micrographs of specimen P2-6 tested in fatigue at 0.1 Hz in air at 1200 °C. $\sigma_{max} = 120$ MPa, $N_f = 3780$, $t_f = 10.5$ h.

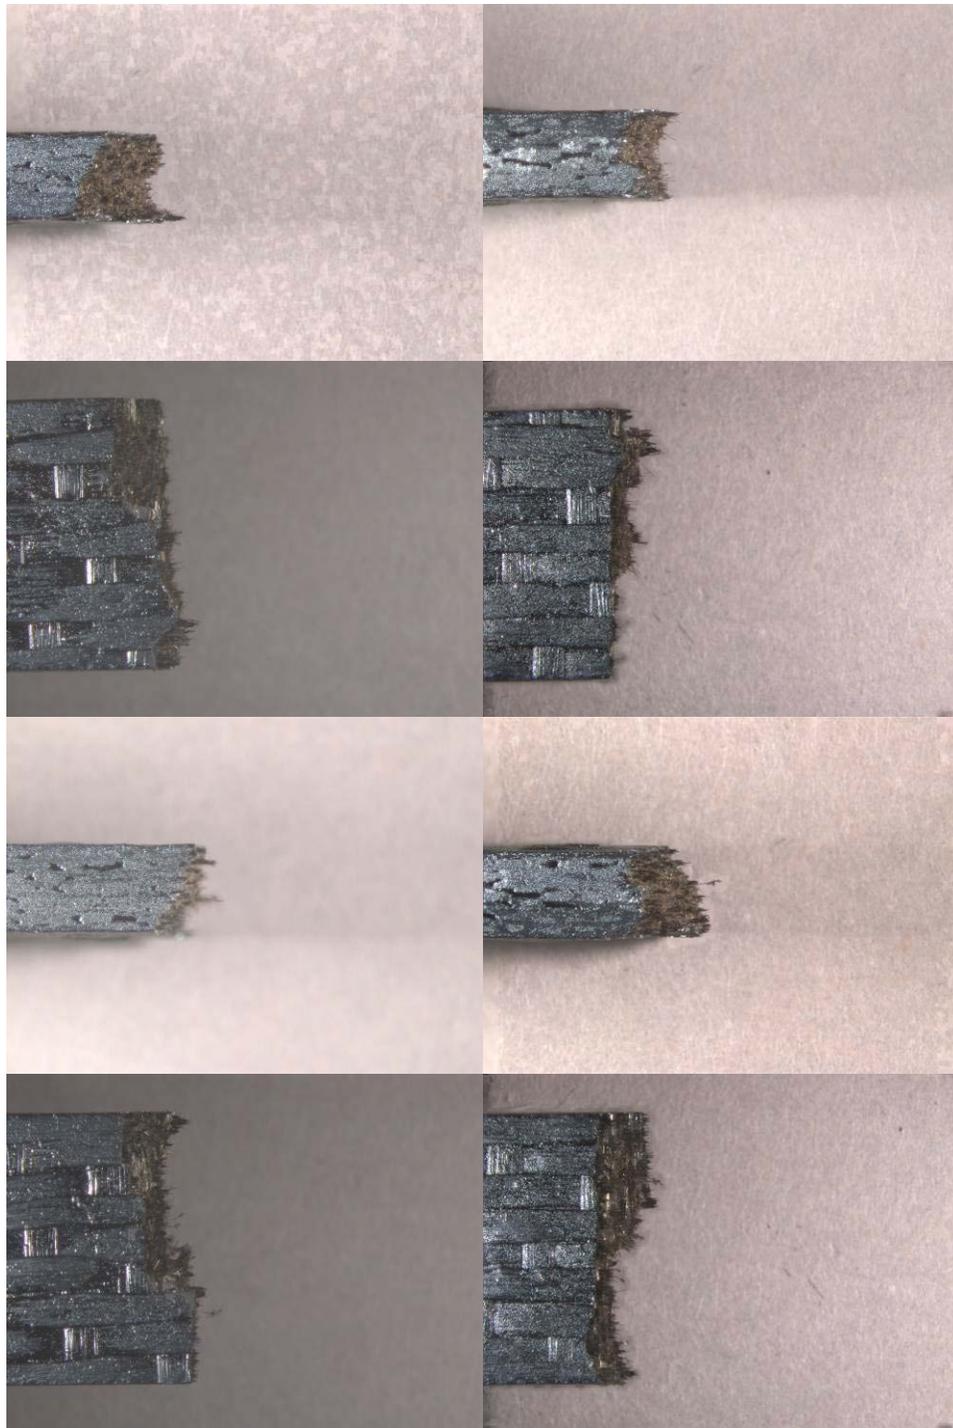
Figure 92: Optical micrographs of specimen P2-7 tested in fatigue at 0.1 Hz in air at 1200 °C. $\sigma_{max} = 100$ MPa, $N_f = 100,000$, $t_f = 277.78$ h.

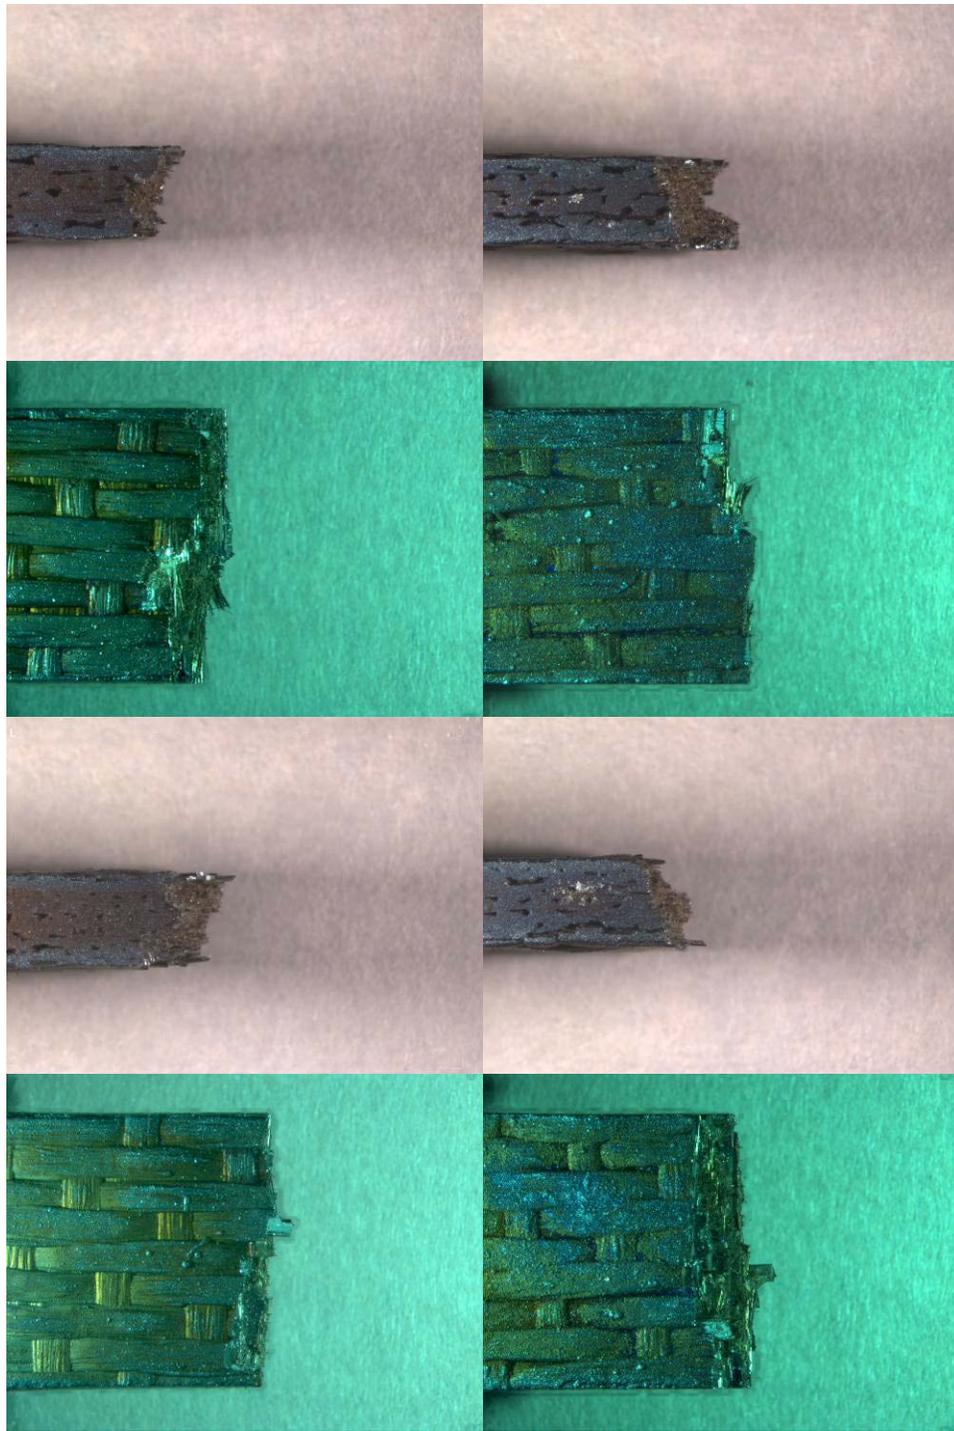
Figure 93: Optical Micrographs of the fracture surfaces produced in tensile test to failure conducted at 0.05mm/sec at 1200 °C in air on specimen P3-1.

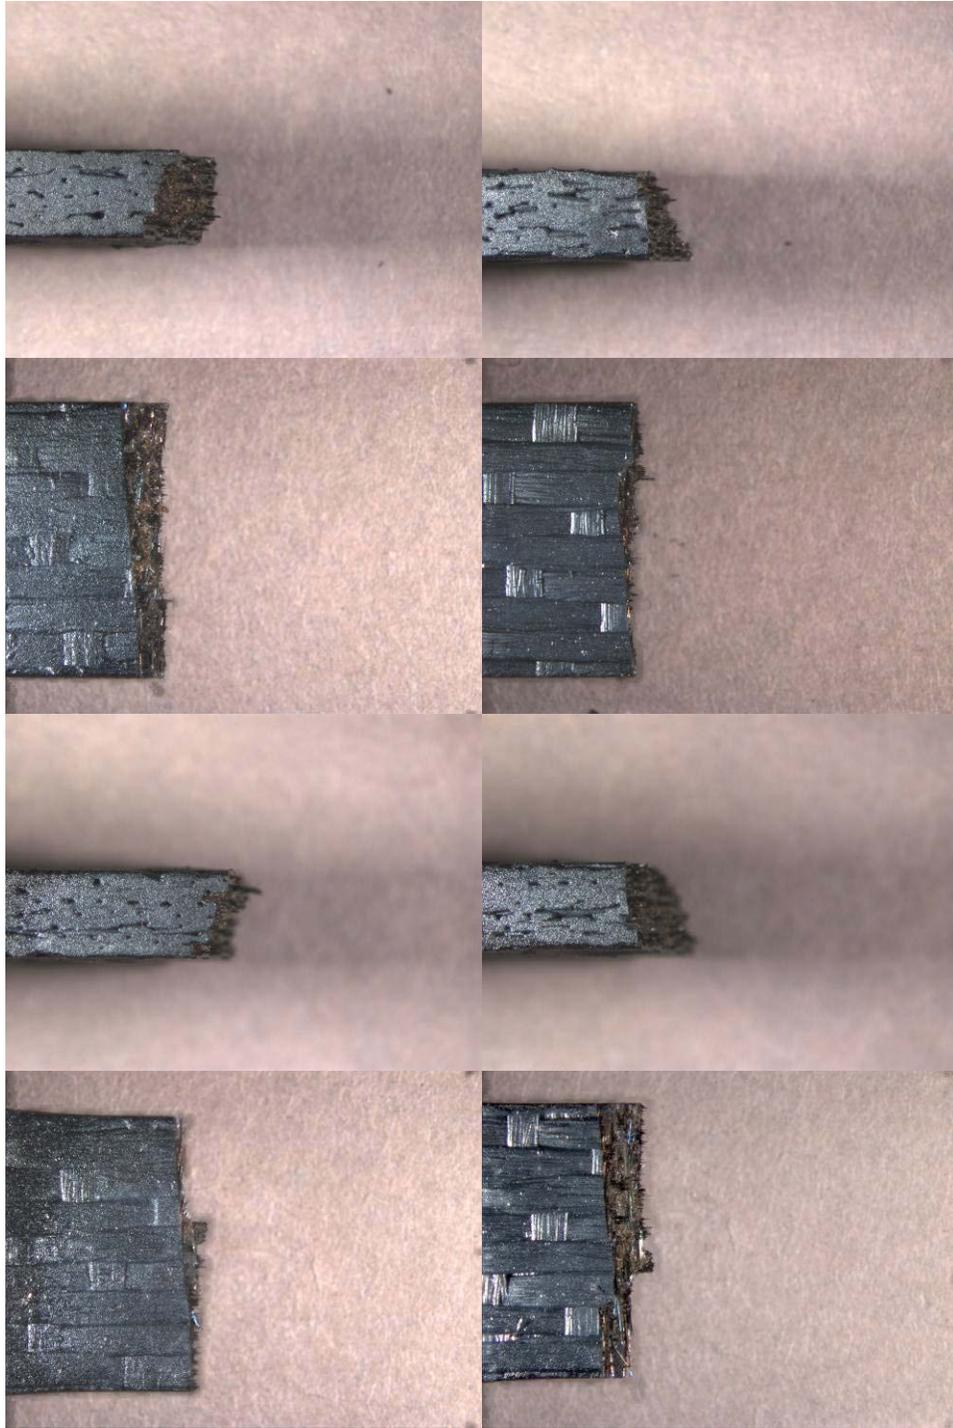
Figure 94: Optical micrographs of specimen P3-2 tested in fatigue at 1.0 Hz in steam at 1200 °C. $\sigma_{max} = 80$ MPa, $N_f = 200,000$, $t_f = 55.56$ h.

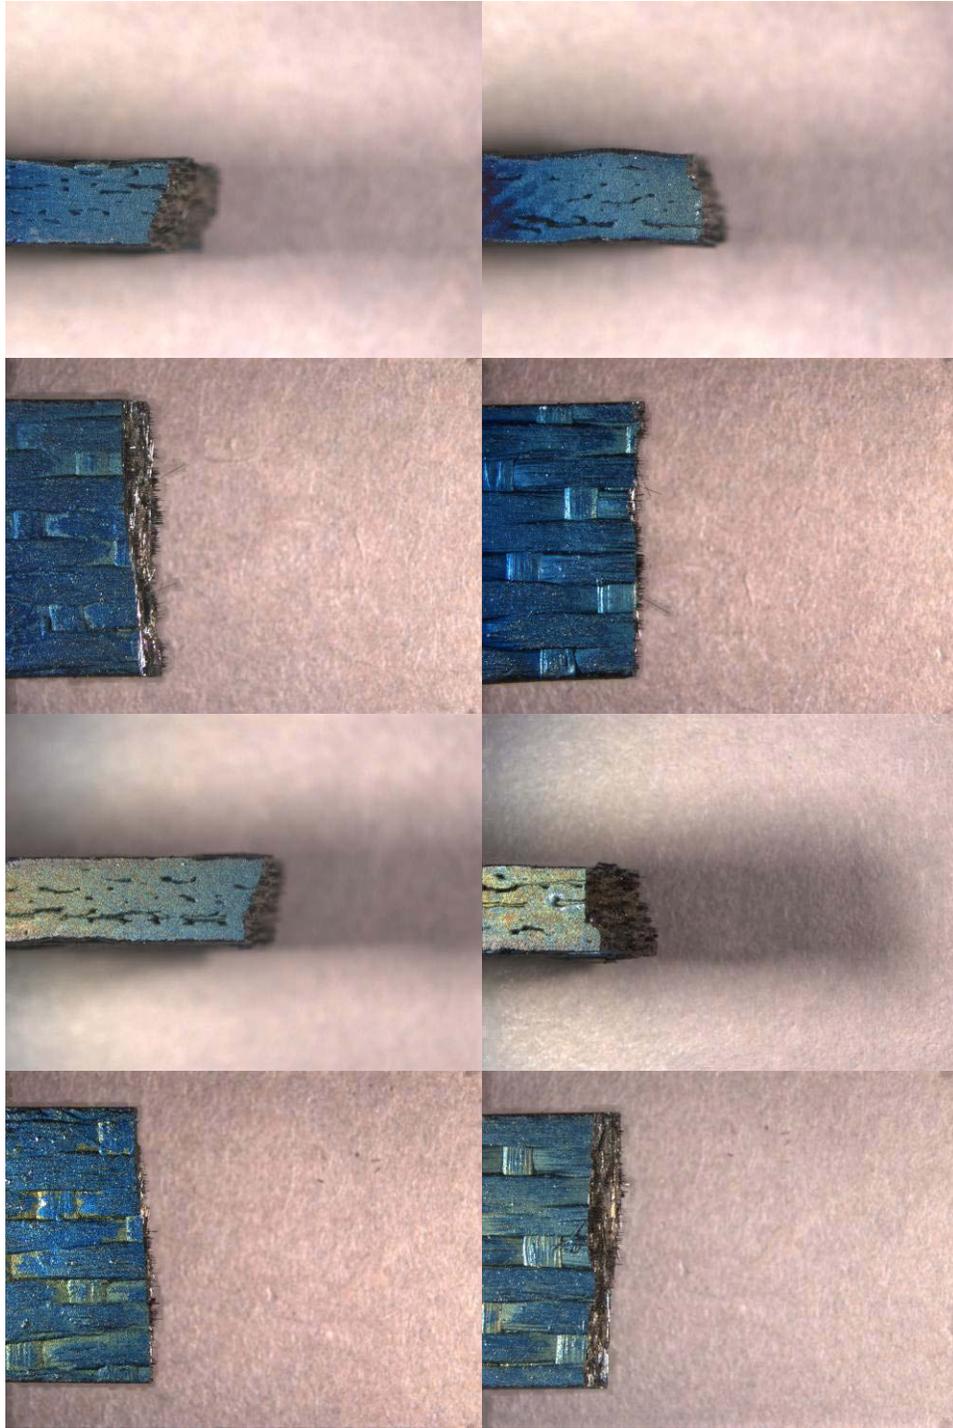
Figure 95: Optical micrographs of specimen P3-3 tested in fatigue at 10 Hz in air at 1200 °C. $\sigma_{max} = 100$ MPa, $N_f = 96,721$, $t_f = 2.69$ h.

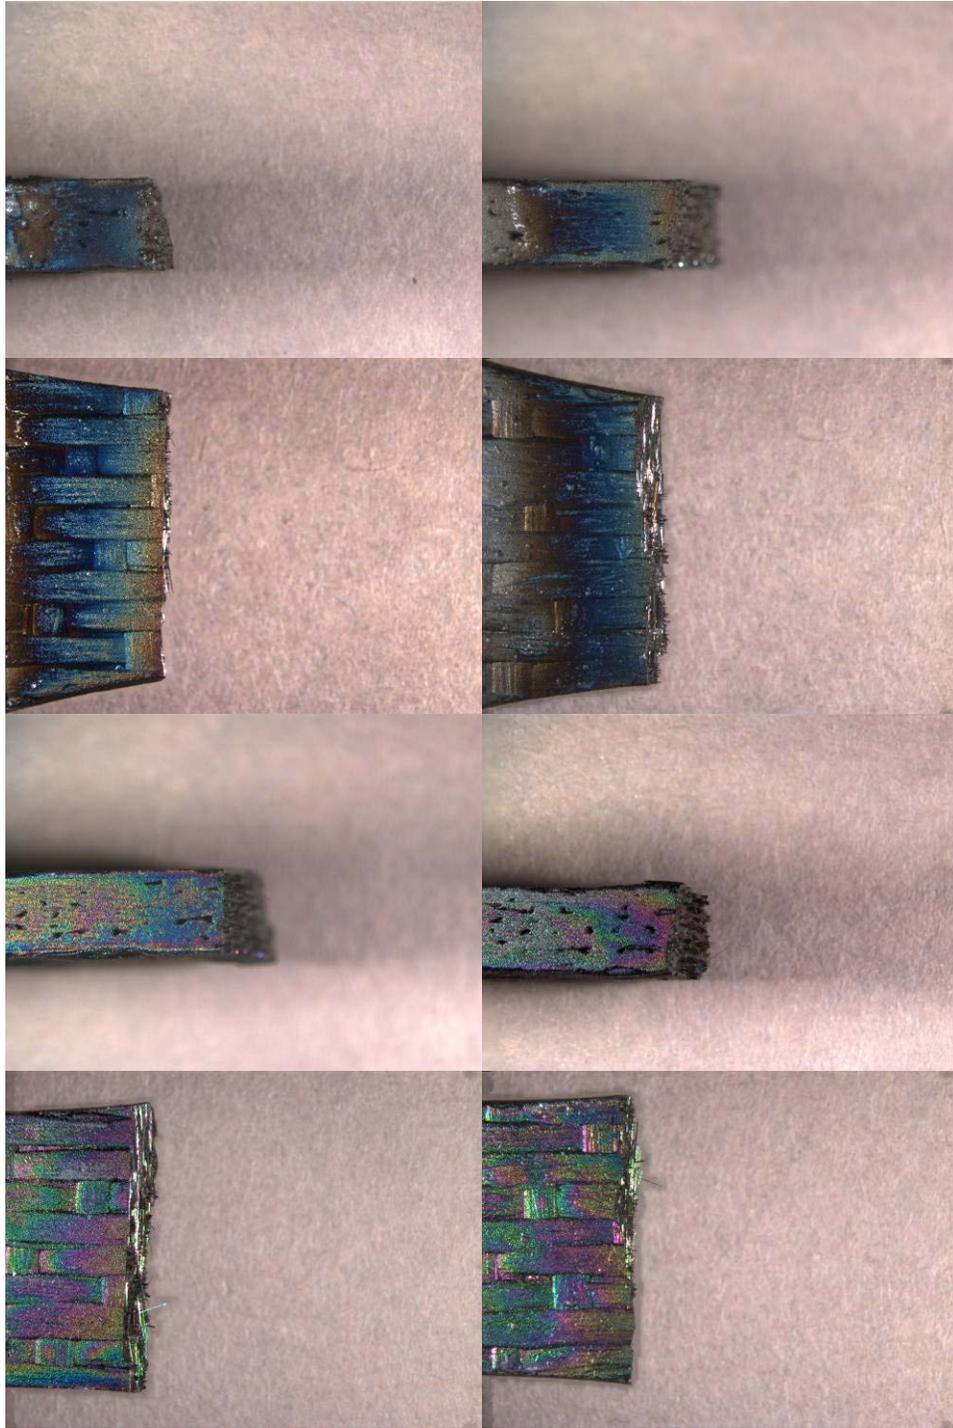
Figure 96: Optical micrographs of specimen P3-4 tested in fatigue at 10 Hz in steam at 1200 °C. $\sigma_{max} = 80$ MPa, $N_f = 33,451$, $t_f = 0.93$ h.

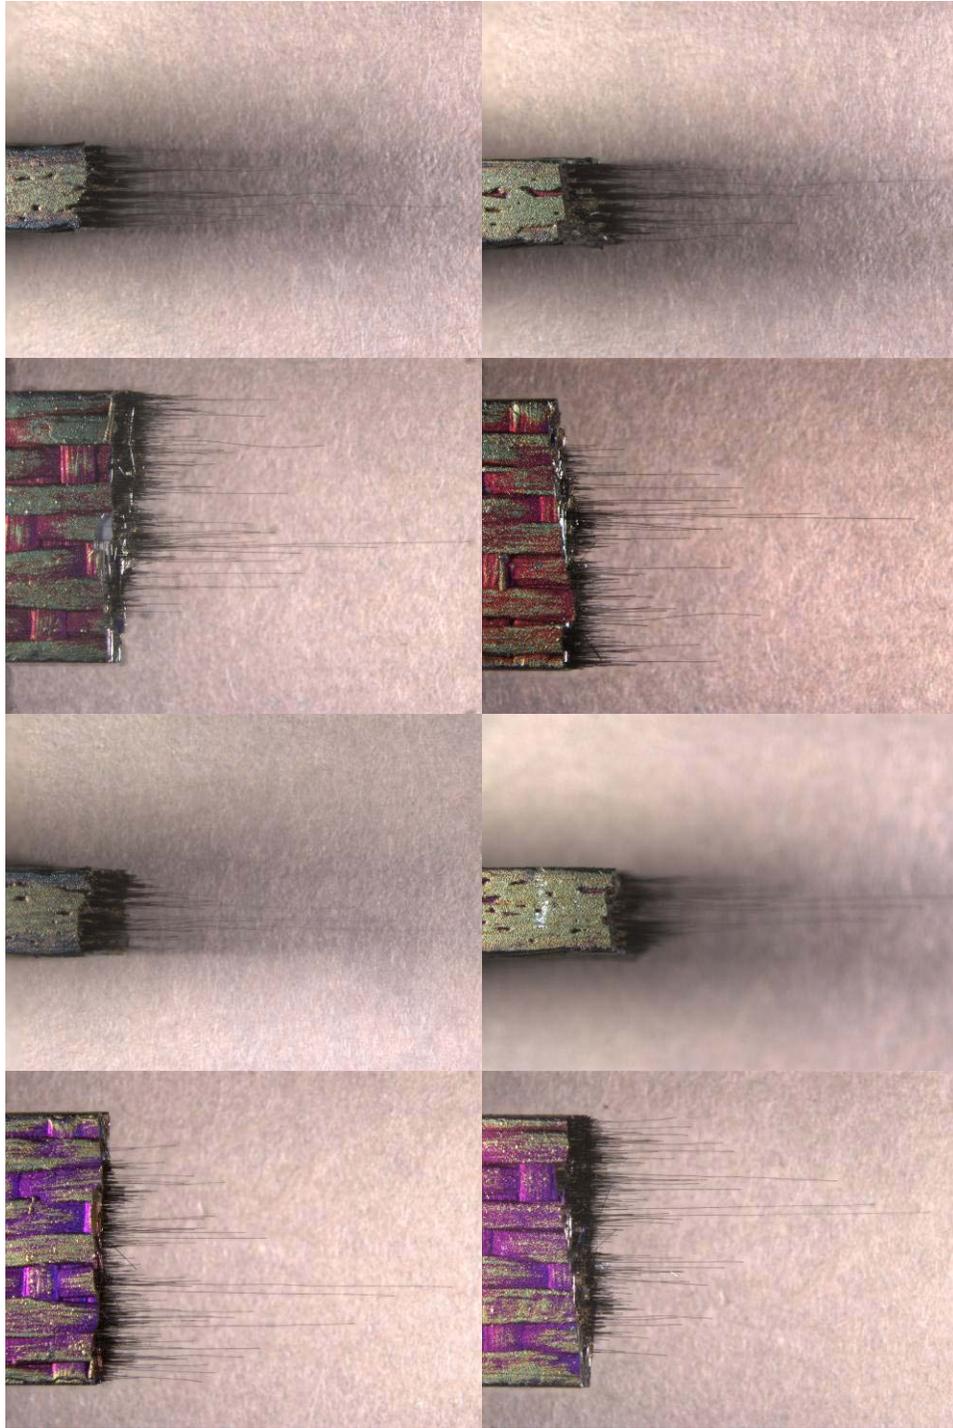
Figure 97: Optical micrographs of specimen P3-5 tested in fatigue at 0.1 Hz in air at 1200 °C. $\sigma_{max} = 120$ MPa, $N_f = 2092$, $t_f = 5.81$ h.

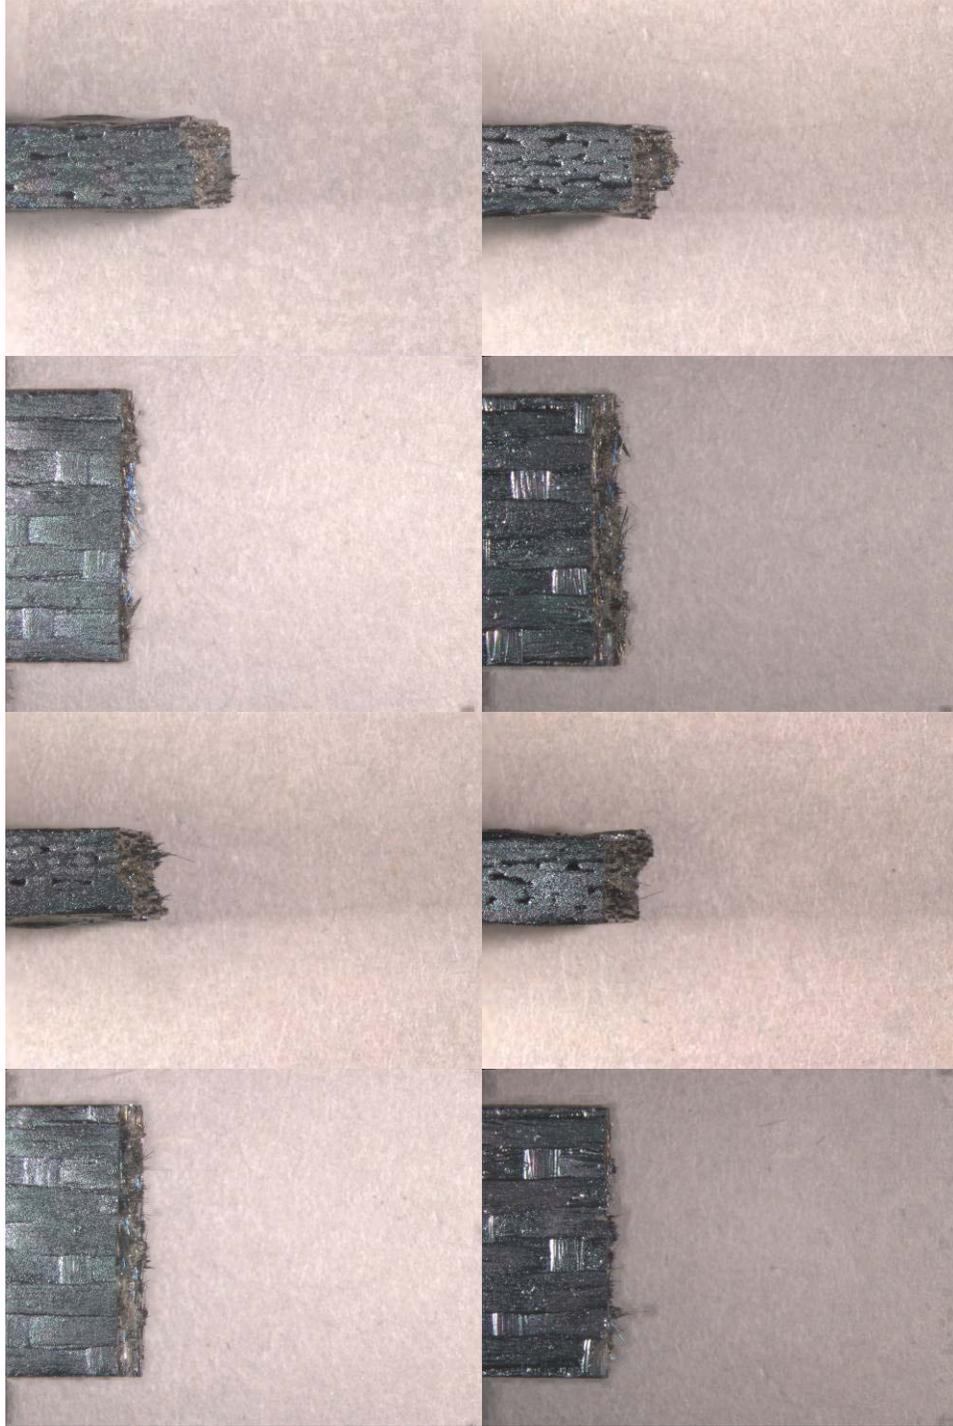
Figure 98: Optical micrographs of specimen P3-6 tested in fatigue at 10 Hz in steam at 1200 °C. $\sigma_{max} = 60$ MPa, $N_f = 200,000$, $t_f = 5.56$ h.

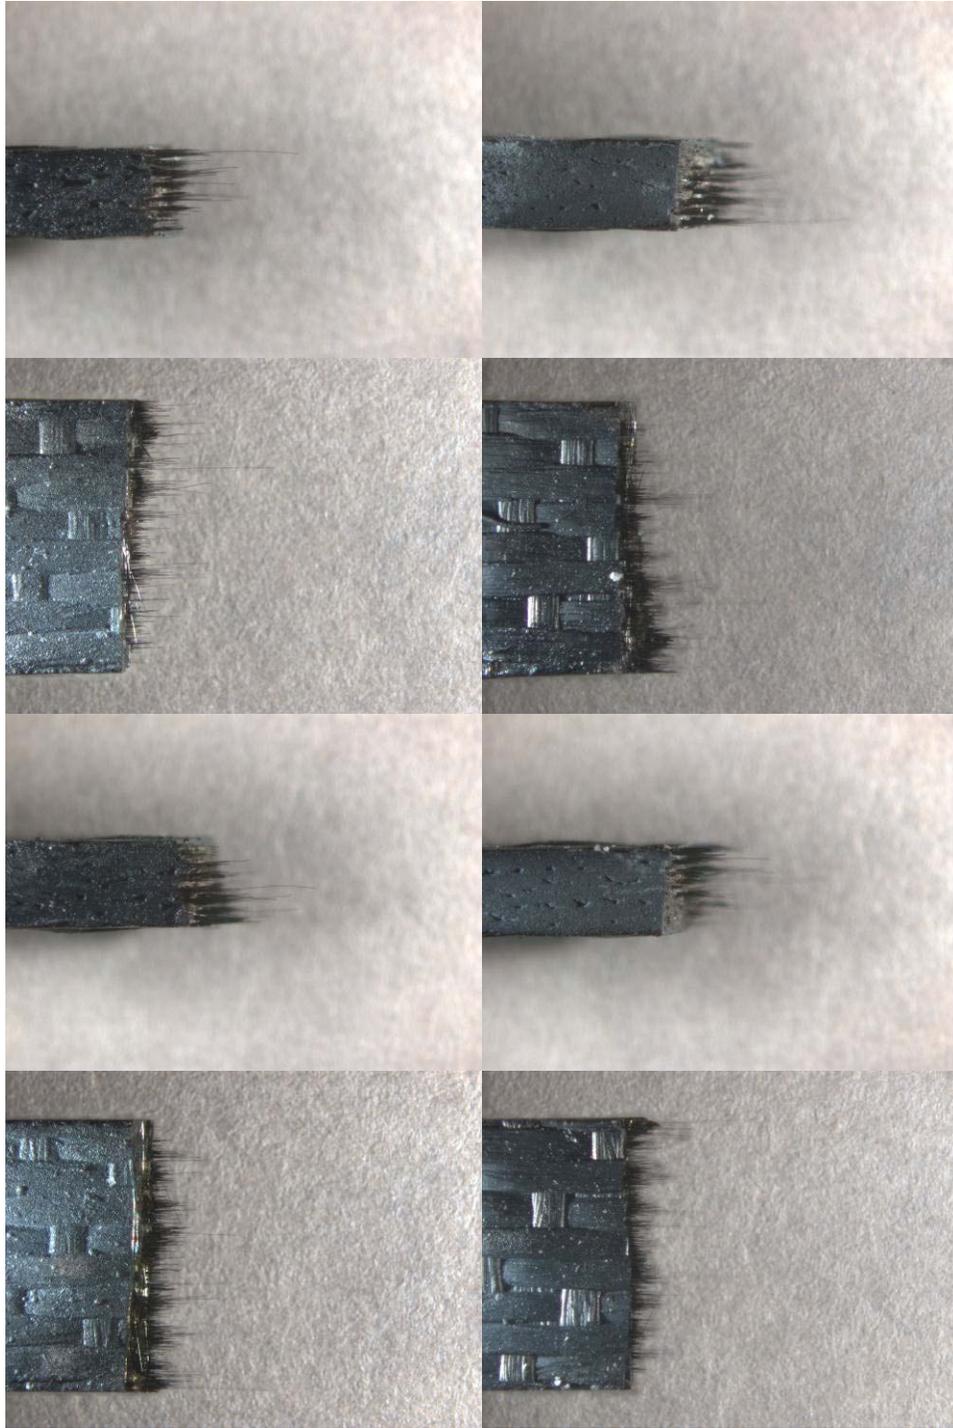
Figure 99: Optical micrographs of specimen P3-7 tested in fatigue at 0.1 Hz in steam at 1200 °C. $\sigma_{\max} = 88$ MPa, $N_f = 88,575$, $t_f = 246.04$ h.

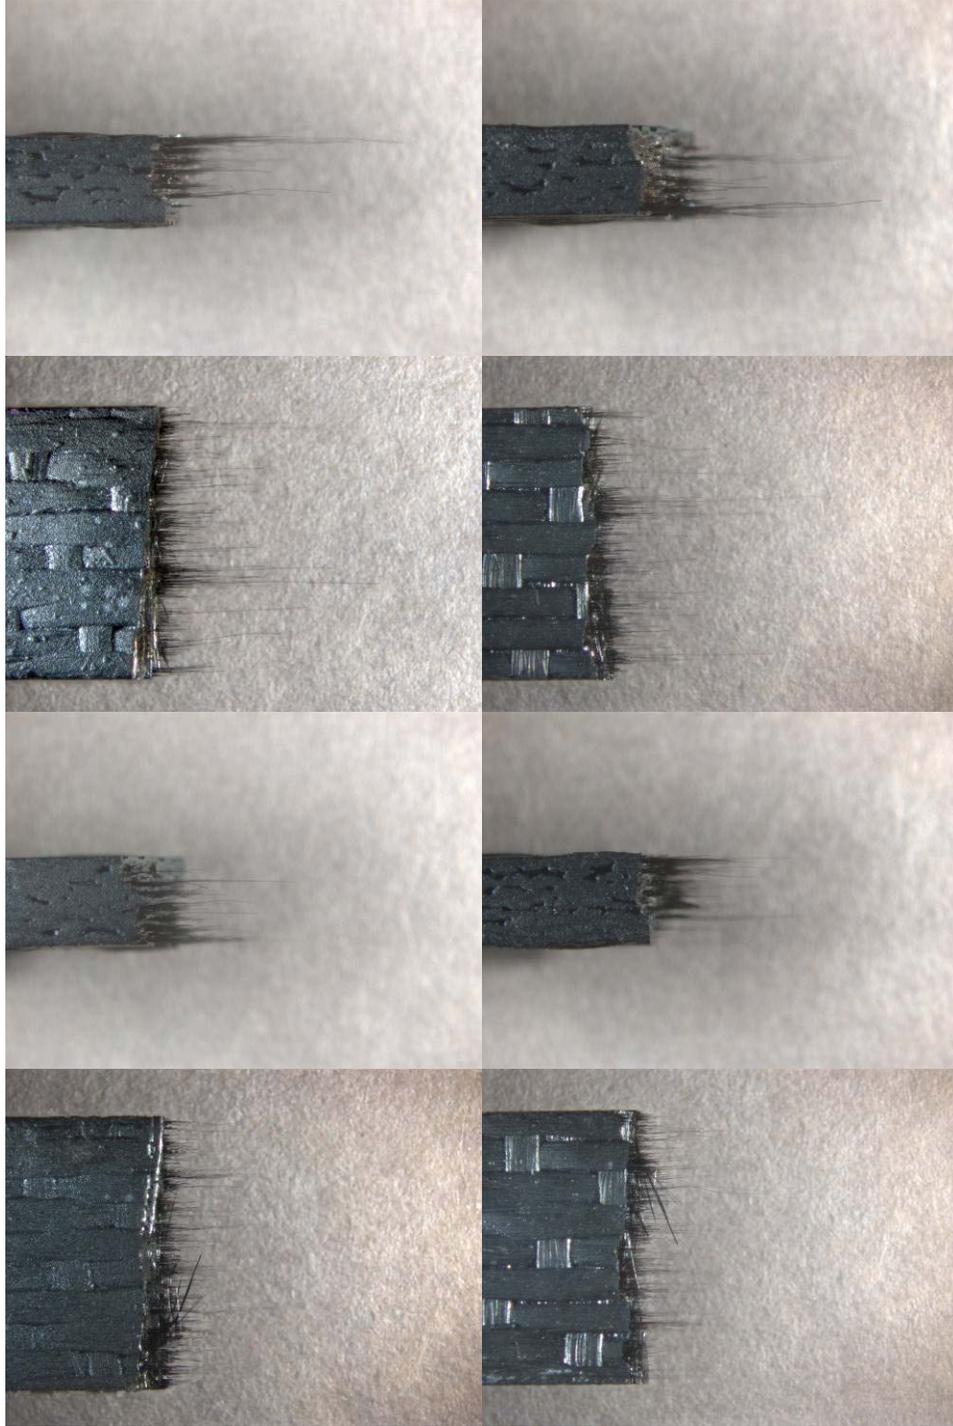
Figure 100: Optical micrographs of specimen P3-8 tested in fatigue at 0.1 Hz in steam at 1200 °C. $\sigma_{max} = 100$ MPa, $N_f = 13,726$, $t_f = 38.12$ h.

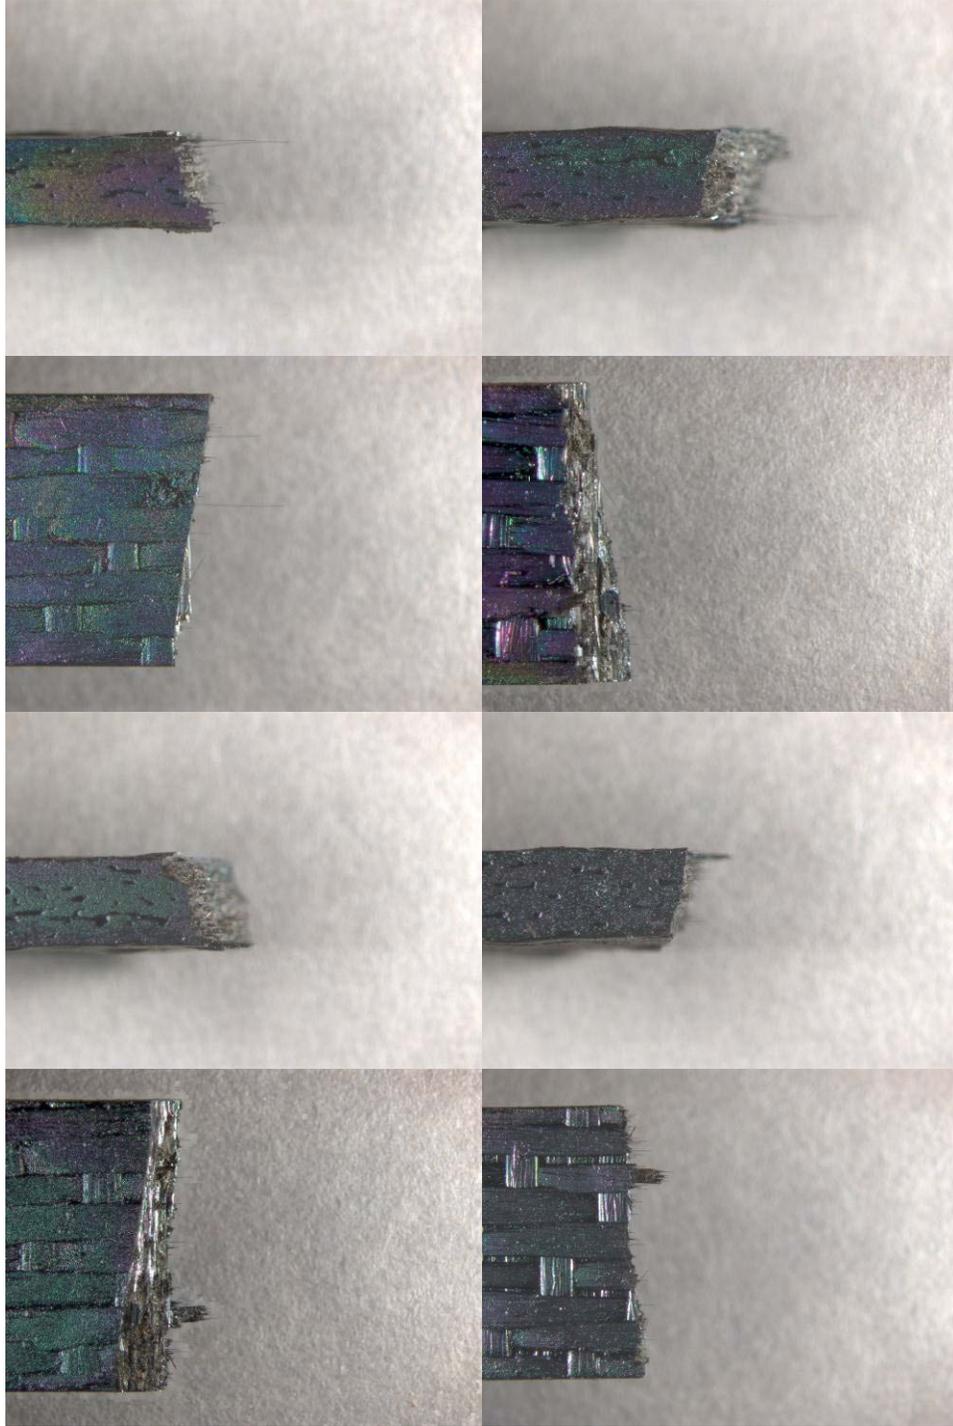
Figure 101: Optical micrographs of specimen P3-9 tested in fatigue at 0.1 Hz in steam at 1200 °C. $\sigma_{max} = 110$ MPa, $N_f = 548$, $t_f = 1.52$ h.

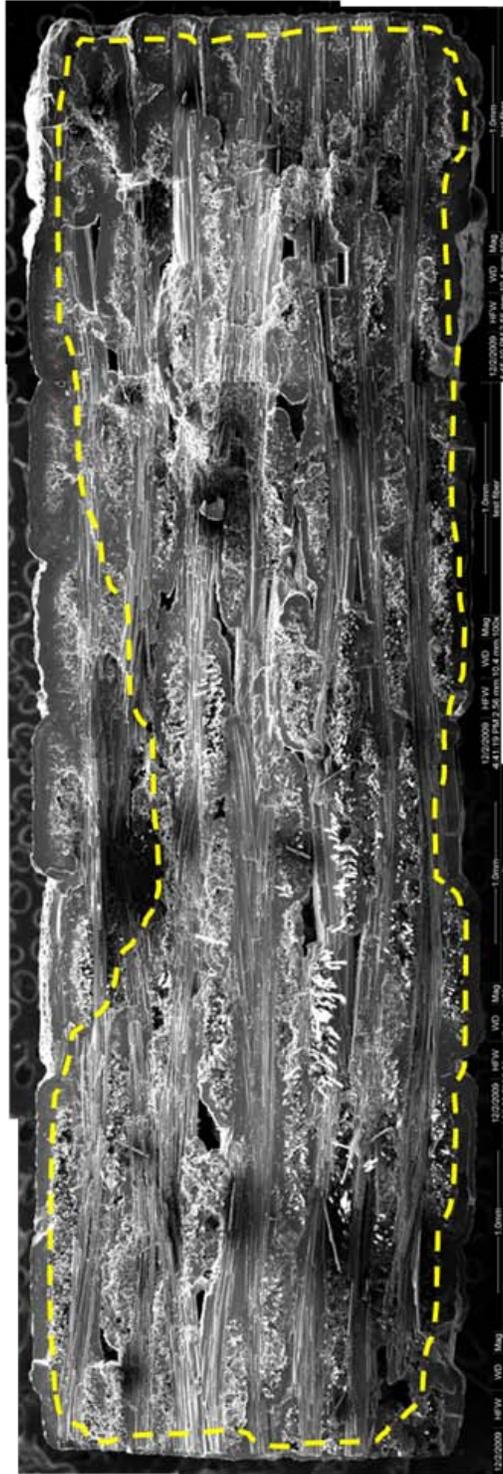
Figure 102: Compiled SEM micrographs of total P2-6 fracture surface after failing during 0.1 Hz fatigue testing at 1200 °C in air with $\sigma_{max} = 120$ MPa. Environmental intrusion zone indicated by dotted line.

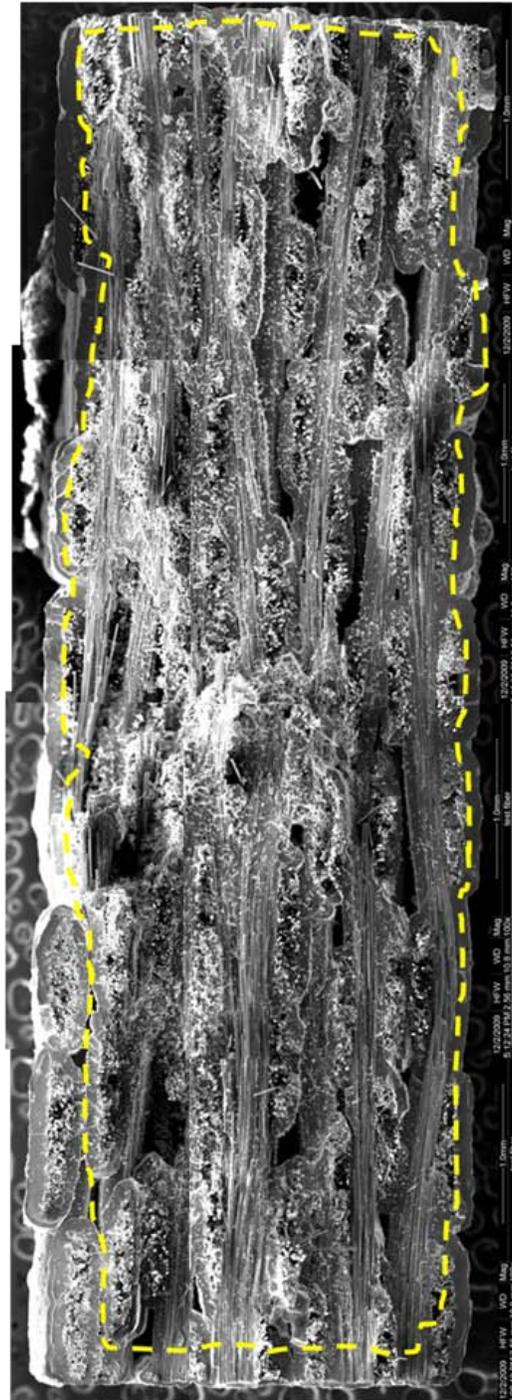
Figure 103: Compiled SEM micrographs of total P2-7 fracture surface after failing during 0.1 Hz fatigue testing at 1200 °C in air with $\sigma_{max} = 100$ MPa. Environmental intrusion zone indicated by dotted line.

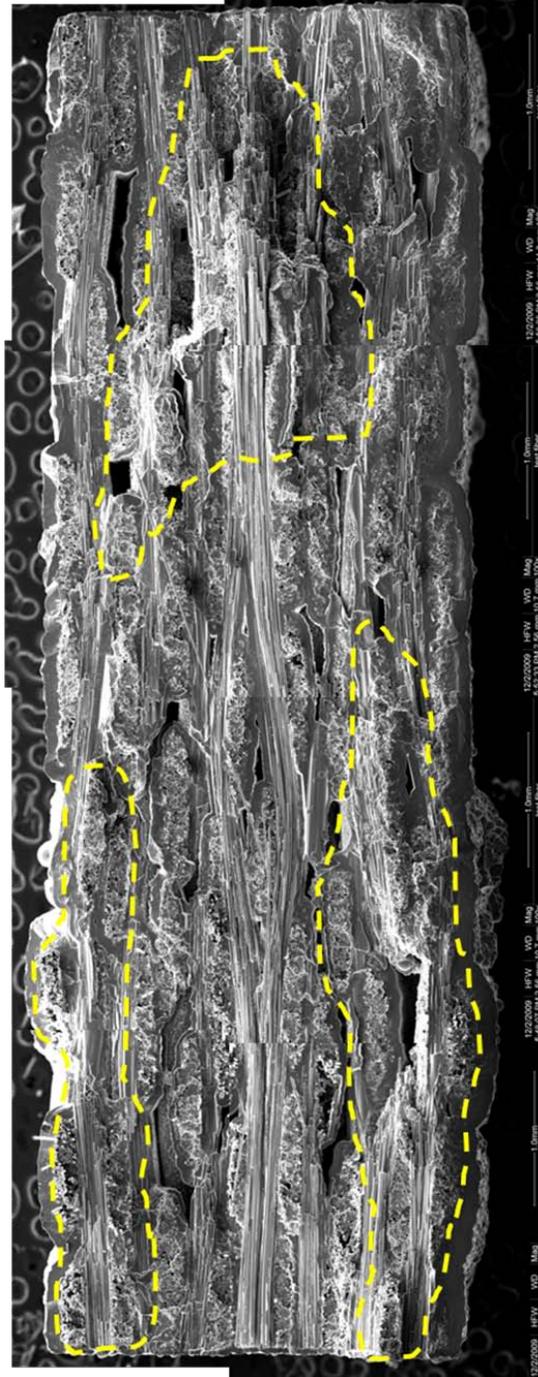
Figure 104: Compiled SEM micrographs of total P3-9 fracture surface after failing during 0.1 Hz fatigue testing at 1200 °C in steam with $\sigma_{max} = 110$ MPa. Environmental intrusion zone indicated by dotted line.

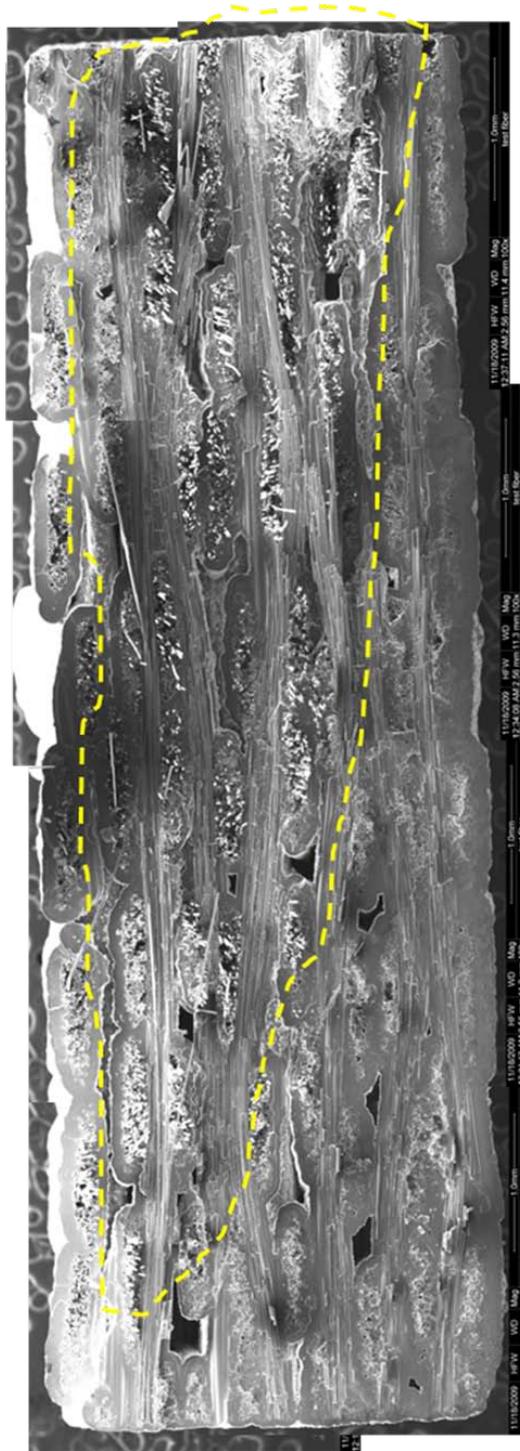
Figure 105: Compiled SEM micrographs of total P3-7 fracture surface after failing during 0.1 Hz fatigue testing at 1200 °C in steam with $\sigma_{max} = 88$ MPa. Environmental intrusion zone indicated by dotted line.
