**FATIGUE BEHAVIOR OF AN ADVANCED SiC/SiC COMPOSITE
AT ELEVATED TEMPERATURE IN AIR AND IN STEAM**

THESIS

Devon T. Christensen, Captain, USAF

AFIT/GAE/ENY/09-D02

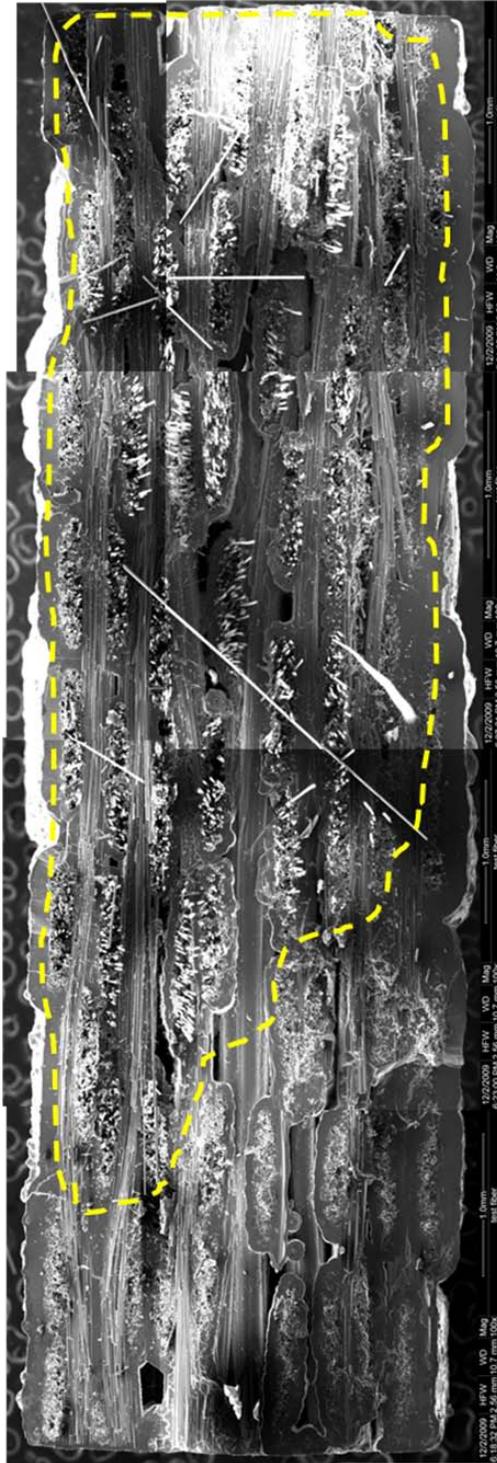
Figure 106: Compiled SEM micrographs of total P1-4 fracture surface after failing during 1.0 Hz fatigue testing at 1200 °C in air with $\sigma_{max} = 120$ MPa. Environmental intrusion zone indicated by dotted line.

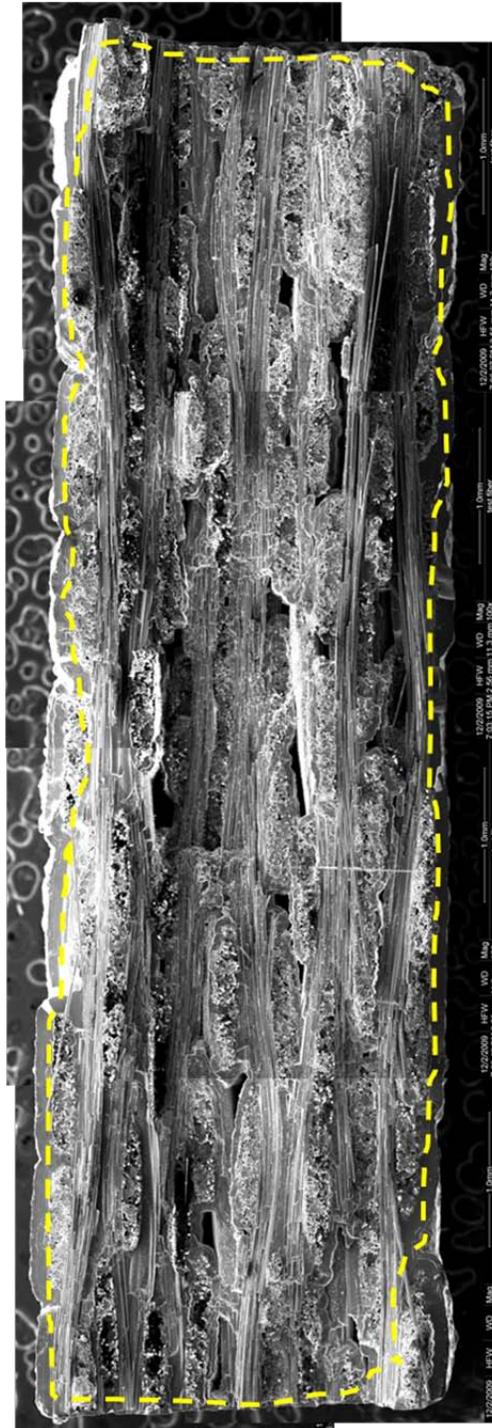
Figure 107: Compiled SEM micrographs of total P1-5 fracture surface after failing during 1.0 Hz fatigue testing at 1200 °C in air with $\sigma_{max} = 80$ MPa. Environmental intrusion zone indicated by dotted line.

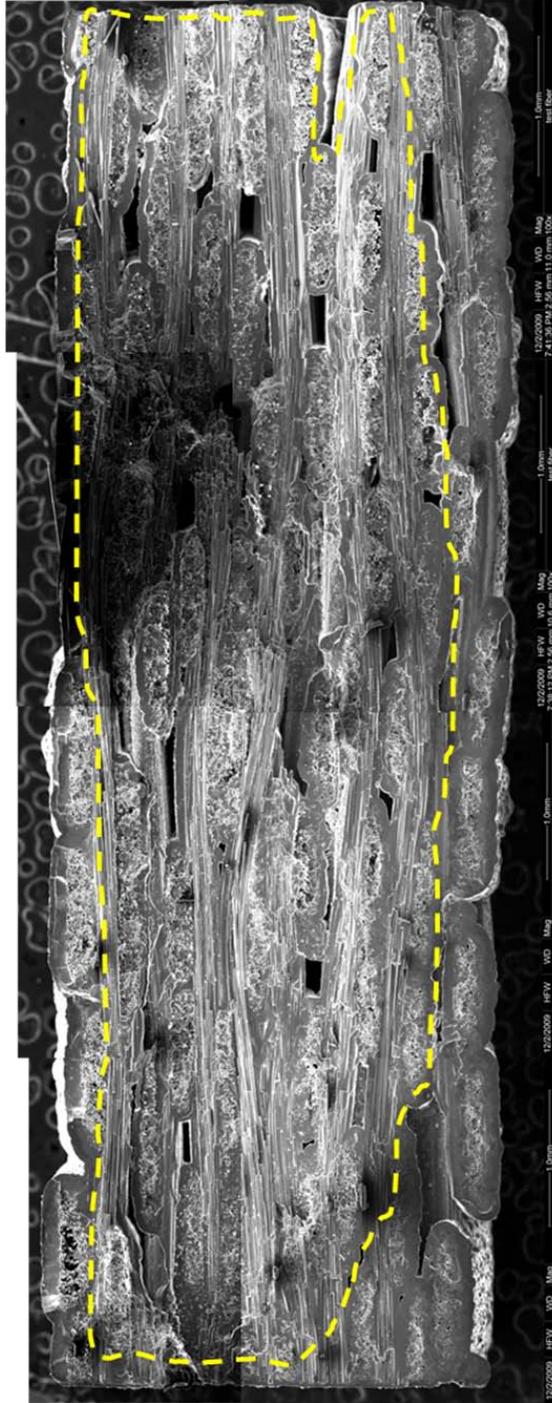
Figure 108: Compiled SEM micrographs of total P1-9 fracture surface after failing during 1.0 Hz fatigue testing at 1200 °C in steam with $\sigma_{max} = 100$ MPa. Environmental intrusion zone indicated by dotted line.

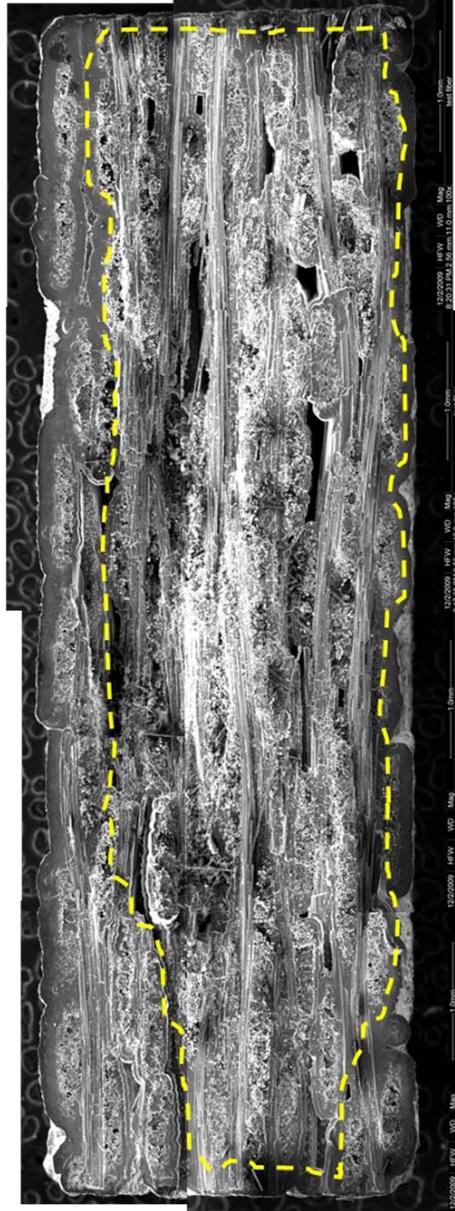
Figure 109: Compiled SEM micrographs of total P3-2 fracture surface after failing during 1.0 Hz fatigue testing at 1200 °C in steam with $\sigma_{max} = 80$ MPa. Environmental intrusion zone indicated by dotted line.

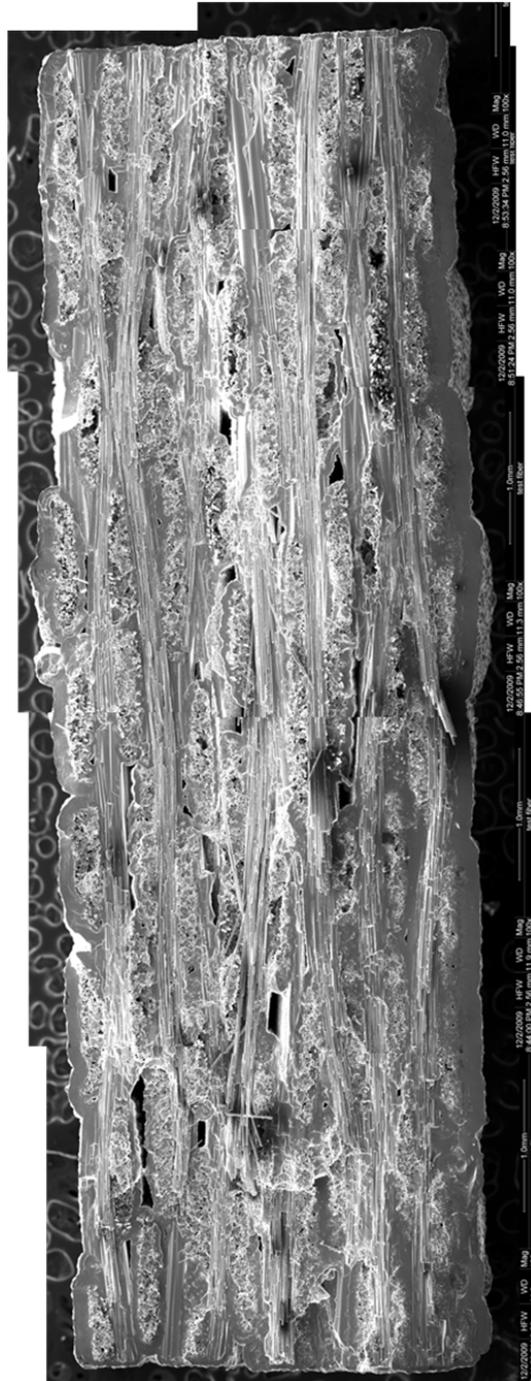
Figure 110: Compiled SEM micrographs of total P3-3 fracture surface after failing during 10 Hz fatigue testing at 1200 °C in air with $\sigma_{max} = 100$ MPa. Environmental intrusion zone unidentifiable due to short time to failure.

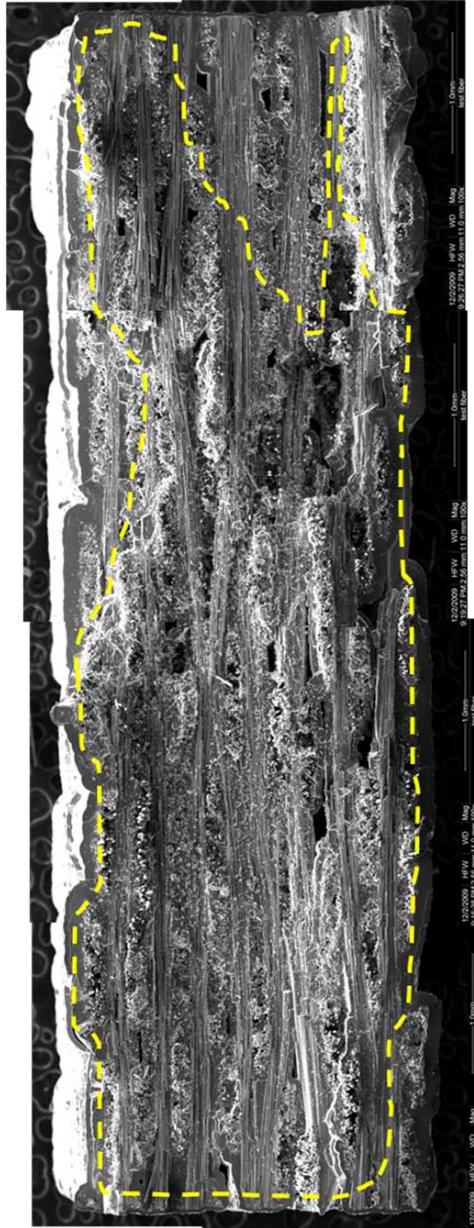
Figure 111: Compiled SEM micrographs of total P2-5 fracture surface after failing during 10 Hz fatigue testing at 1200 °C in air with $\sigma_{max} = 80$ MPa. Environmental intrusion zone indicated by dotted line.

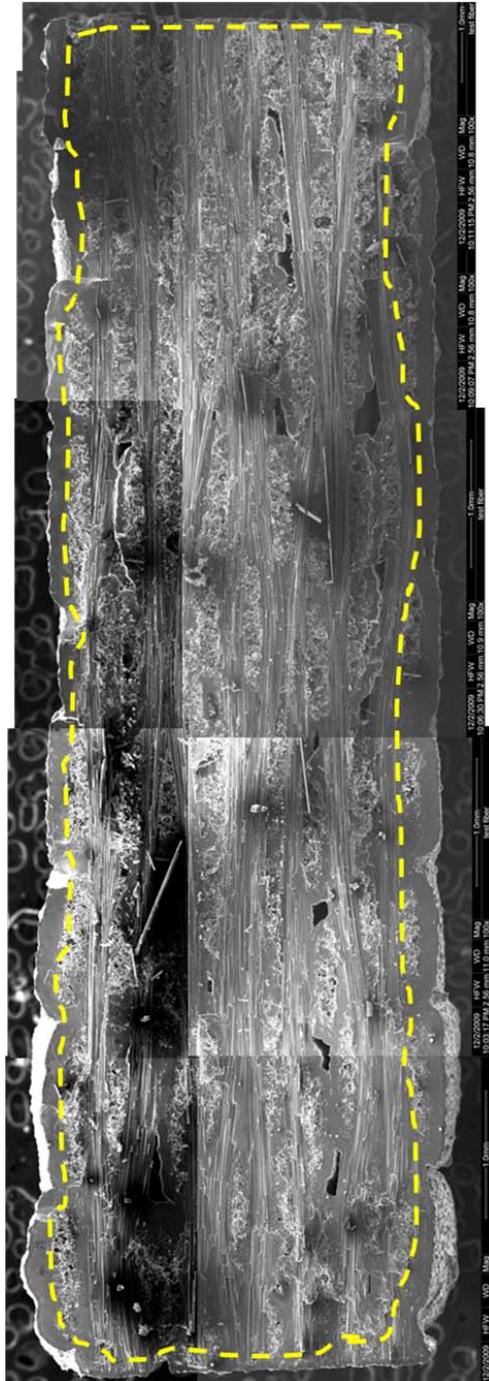
Figure 112: Compiled SEM micrographs of total P3-4 fracture surface after failing during 10 Hz fatigue testing at 1200 °C in steam with $\sigma_{max} = 80$ MPa. Environmental intrusion zone indicated by dotted line.
