Membrane and Flashing Condition Indexes for Modified Bitumen Roofs

Inspection and Distress Manual

David M. Bailey

March 2010

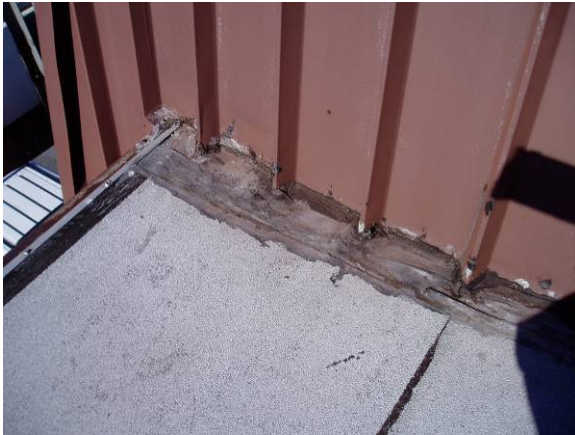
BF-H-4: No base flashing is present.

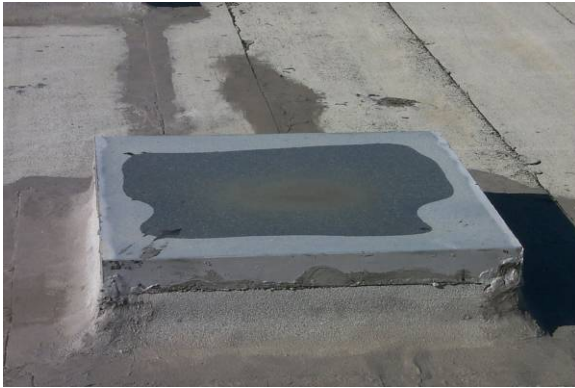
MC-L-2: Metal coping cap is deformed and allows water to pond on the top.

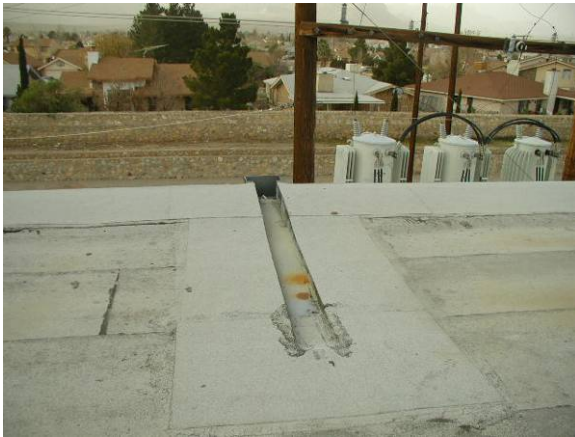
EM-M-6: Entire length of interior gutter is rated medium severity at minimum due to the maintenance problems.

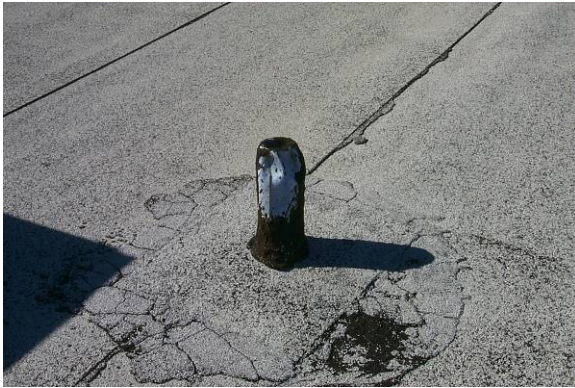
FP-L-1: Flashing sleeve is deformed.

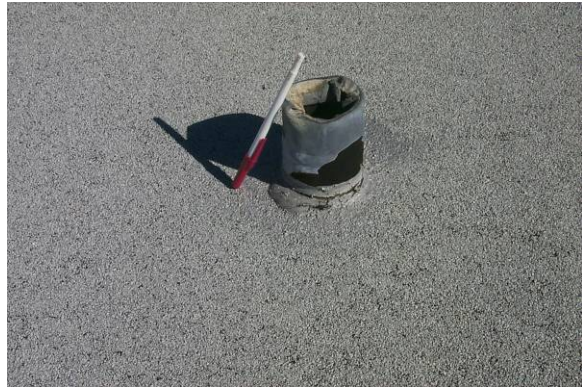
FP-L-2: Opening in the penetration or flashing is less than 6 in. above the roof surface.

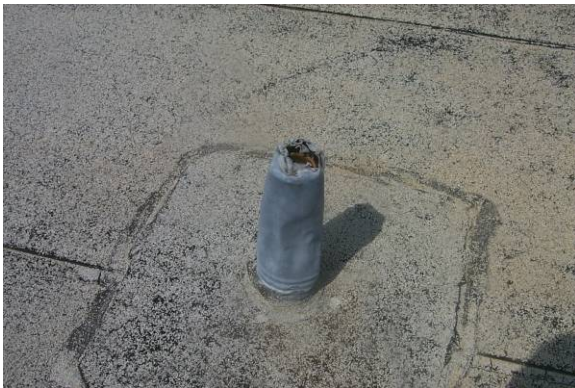
FP-M-2: Top of flashing sleeve is not sealed or has not been rolled down into an existing plumbing vent stack.

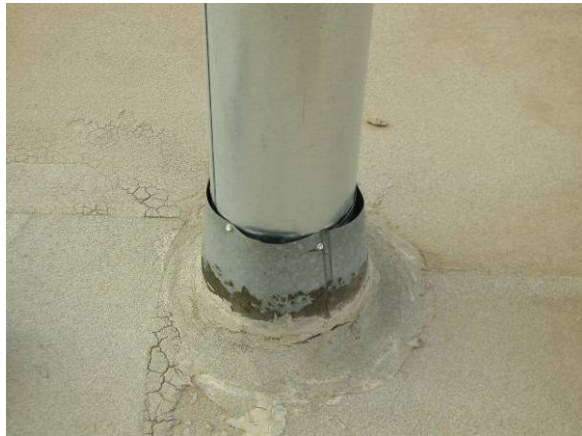
FP-M-3: The sleeve or umbrella is open or no umbrella is present (where required).

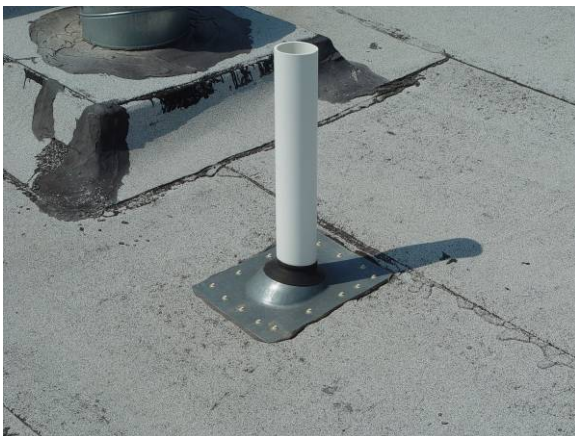
FP-H-1: Flashing sleeve or metal curb has been installed with no stripping plies.

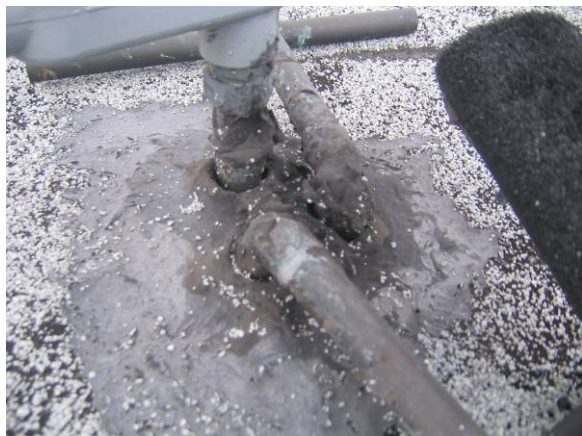
FP-H-3: No flashing sleeve is present.

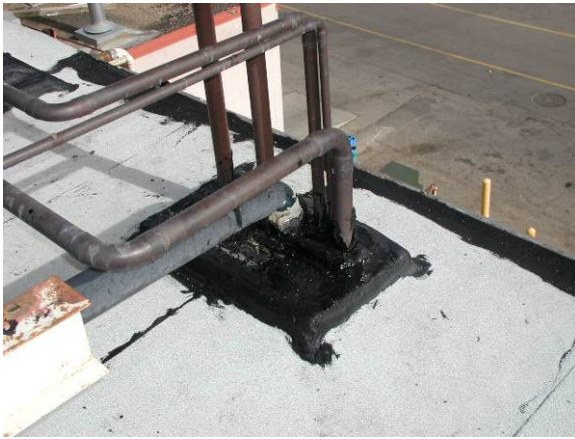
PP-L-1: Pitch pans are rated low severity as a minimum due to the maintenance problems associated with them.

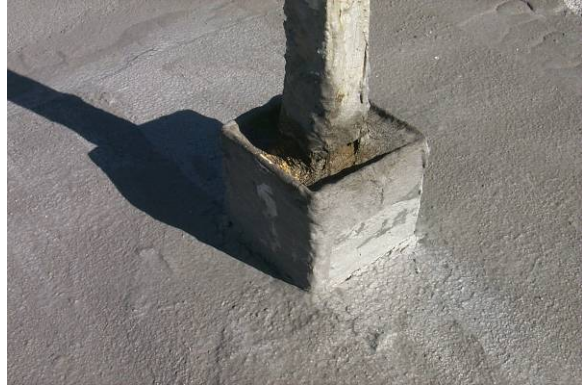
PP-H-2: Sealing material does not fill pitch pan to top of metal rim.

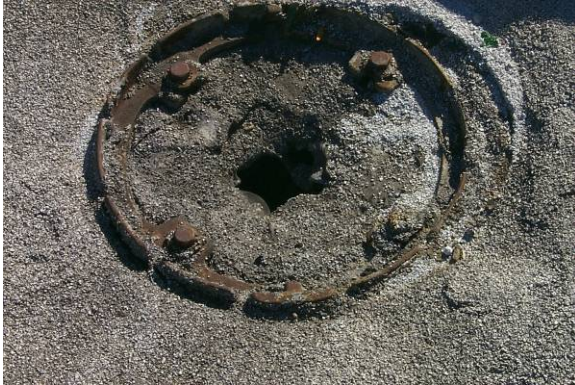
DR-L-1: Bitumen has flowed into the drain leader but the drain is not clogged. (Strainer was removed for photograph.)

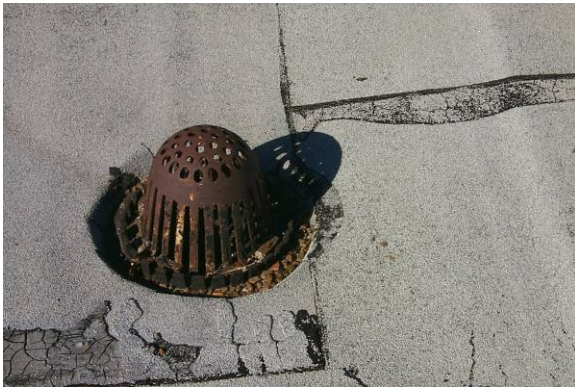
DR-M-4: Field seam exists under clamping ring.

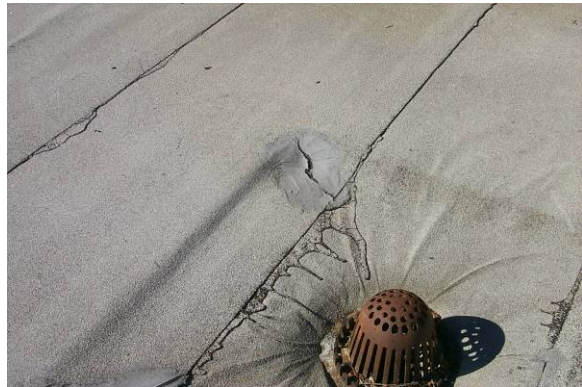
DR-H-1: Holes, splits, or tears in stripping ply caused by deterioration or physical damage.

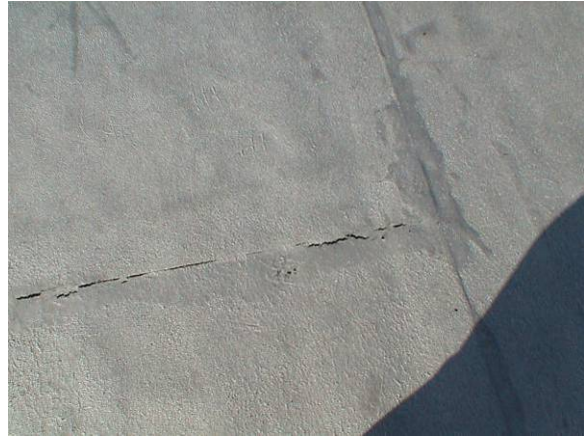
DS-L-1: Seam is open less than 1/2 inch.

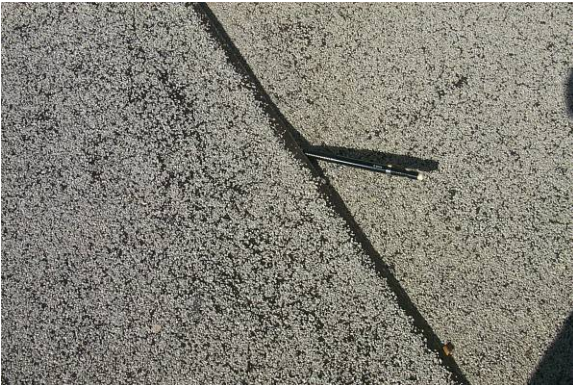
DS-M-1: Seam is open 1/2 inch or more, but does not allow water to penetrate the membrane.

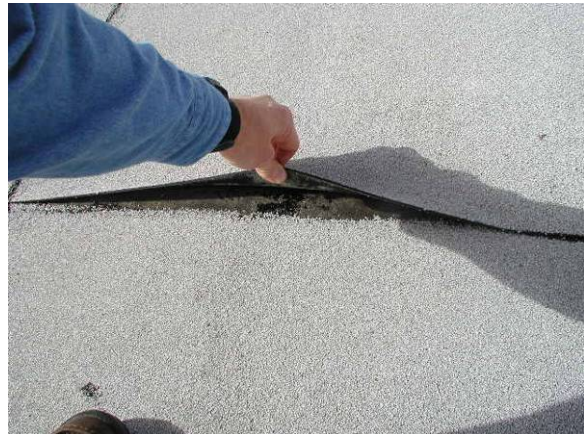
DS-H-1: Seam is open through its entire depth, allowing water to penetrate.

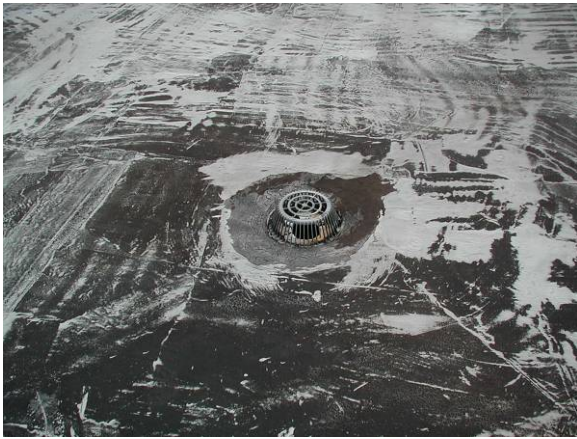
SR-L-2: On smooth liquid applied surfacing, there is loss of coating but no visible deterioration of surfacing ply.

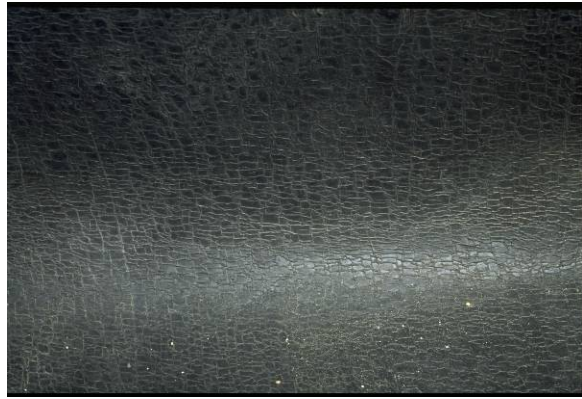
SR-L-3: On smooth liquid applied surfacing, there is evidence of crazing of top surface with hairline cracks (alligatoring).

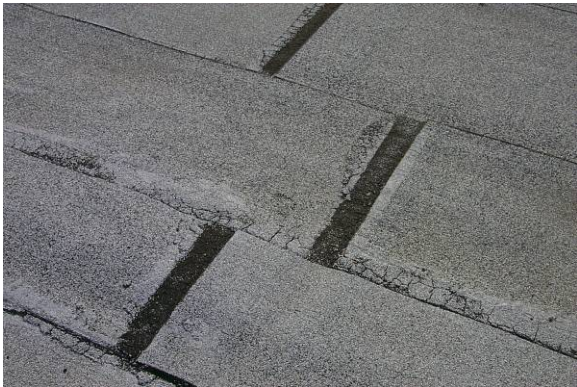
SR-M-2: On mineral surfaced capsheet surfacing, there is loss of granules, exposing the surfacing ply.

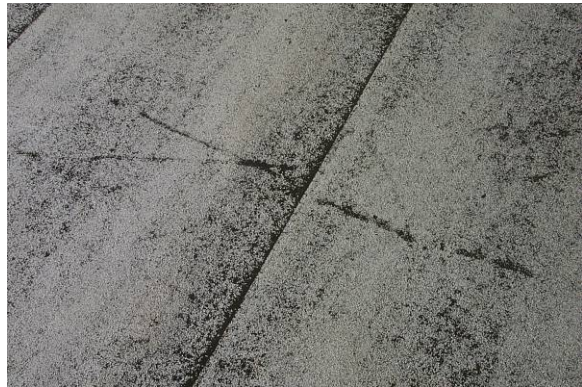
SR-M-2: On mineral surfaced capsheet surfacing, there is loss of granules, exposing the surfacing ply.

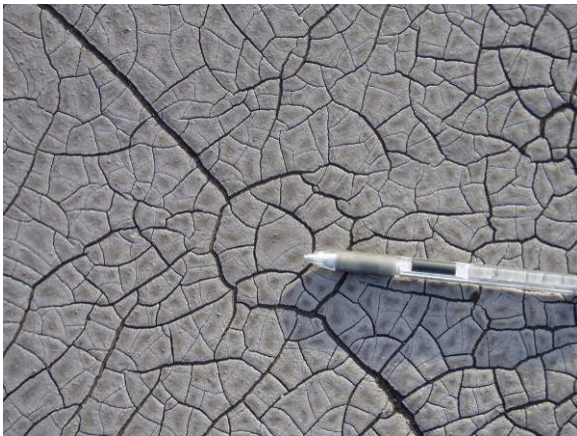
SR-M-4: On smooth liquid-applied surfacing, alligator cracks extend down through coating to the surfacing ply.

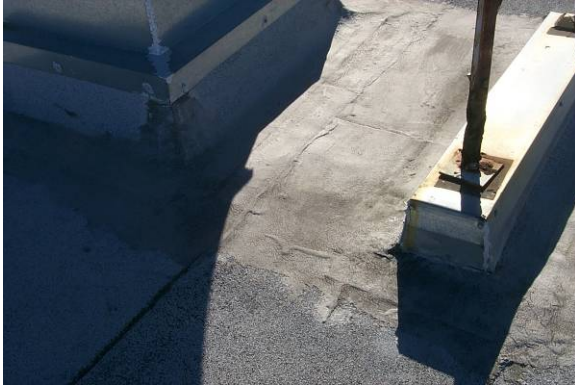
PA-M-1: The materials and workmanship of the patch are not equal to or better than the existing membrane.

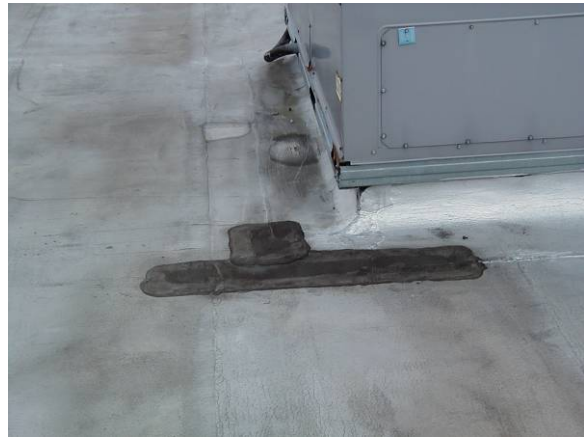
PA-M-1: The materials and workmanship of the patch are not equal to or better than the existing membrane.

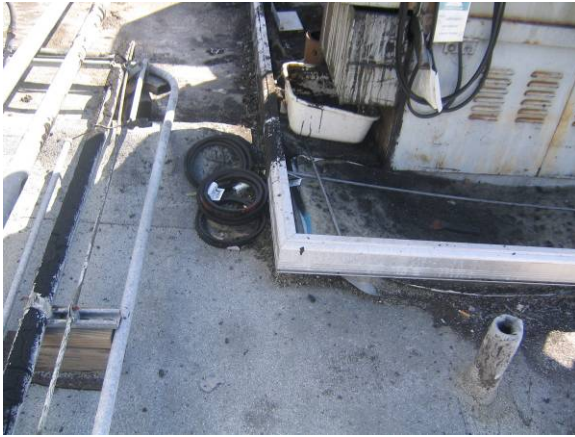
DV-M-1: The collection of foreign objects which are not removed from the roof during the inspection.

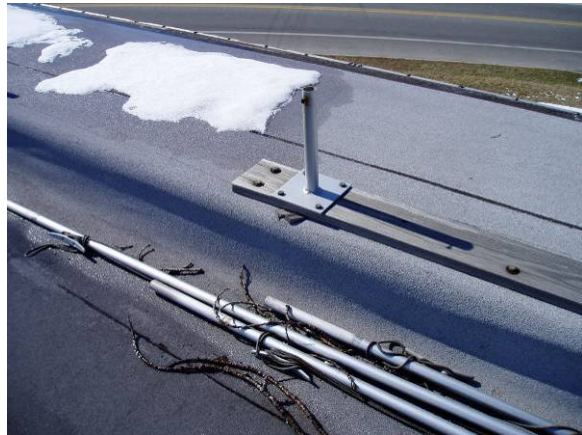
EQ-H-2: The equipment is bolted through the membrane and the bolts appear not to be sealed.

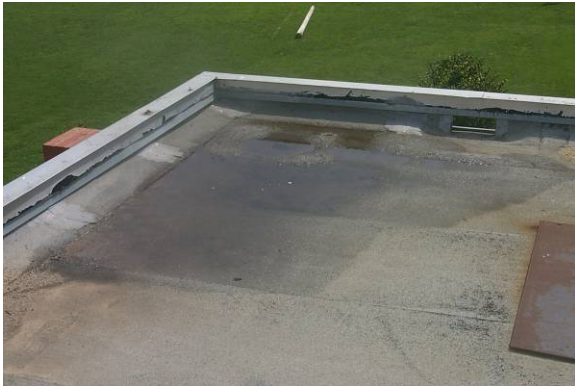
PD-L-1: Ponding is rated low severity due to the maintenance problems associated with it.

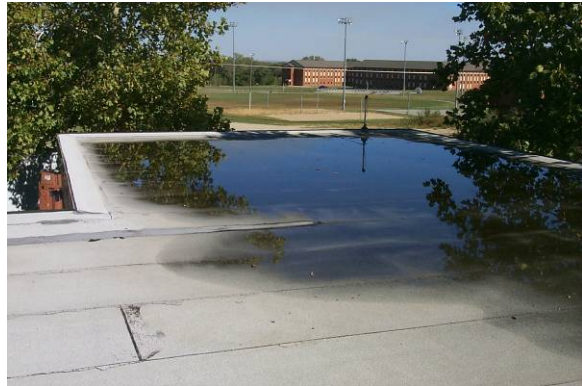
PD-L-1: Ponding is rated low severity due to the maintenance problems associated with it.
