**AFRL-RX-WP-TP-2011-4299**

**OBSERVATIONS ON THE ROLE OF HYDROGEN IN FACET  
FORMATION IN NEAR- $\alpha$  TITANIUM (Preprint)**

**A.L. Pilchak**

**J.C. Williams**

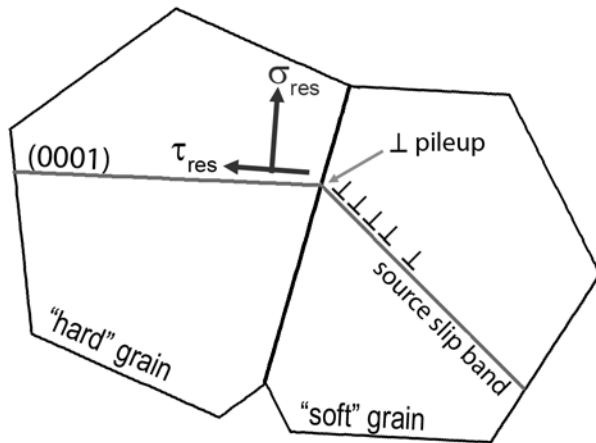
Figure 1. Schematic representation of the Stroh model as modified by Evans and Bache [6] for dwell fatigue.

Dwell fatigue failures created in the laboratory and occurring in service are generally characterized as having subsurface crack initiation sites with planar facets that can be either inclined or nearly perpendicular to the loading direction depending on the magnitude of applied stress [6,8,12]. Furthermore, dwell fatigue facets have been widely generalized as being “on or near” the basal plane [6,12-15]. Early work by Evans [12] suggested that the facet planes were oriented within  $5^\circ$  of the basal plane, and were also nearly perpendicular to the loading direction. Thus, it became necessary to rationalize how slip could occur on basal planes that were oriented nearly perpendicular to the loading direction that had essentially zero resolved shear stress. Later, Evans and Bache [6] proposed a conceptual model based on Stroh's formulation of the stress field around a dislocation pileup in an isotropic material and subsequent crack nucleation from this pileup. This model is shown schematically in Figure 1.

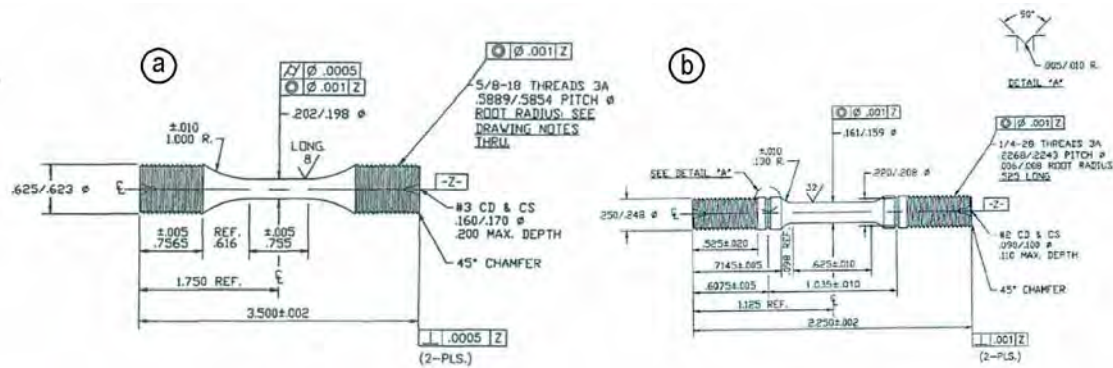
Figure 2. Specimen drawings for (a) cyclic and dwell tests and (b) static loading tests.

A 12.7 cm diameter, 127 cm long Ti-8Al-1Mo-1V bar was provided by Timet (Henderson, NV). Blanks for mechanical test specimens were extracted transverse to the bar axis by wire electrical discharge machining. All of the tests were performed on material in the as-received condition. The blanks were machined into round specimens with one of the two geometries shown in Figure 2. The specimens were tested under four different loading conditions, continuous cycling at 30 Hz, 2 min dwell periods with 1 second each down- and up-ramp loading, static loading at room temperature in lab air and static loading in 3.5 pct. NaCl. All of the tests were run in load control and the peak stress attained during any one test was constant for all tests at 758 MPa, which was 95 pct. of the yield strength measured from a tensile test conducted according to ASTM E8 standards. The load ratio was 0.1 for the continuous cycling and dwell tests. The cyclic tests were performed on a servohydraulic test frame that had been precisely aligned with a strain gauged standard specimen prior to testing. The stress corrosion and static loading experiments were performed on an M-Cert Test System (InterCorr International, Inc., Houston, Texas) which is controlled by a precision step-motor. Since Ti-811 exhibits increased susceptibility to stress corrosion cracking in 3.5 pct. NaCl in the presence of a notch [18], a diamond scribe was used to arbitrarily scratch 1 mm to 2 mm lines around the circumference of the gauge section in several random locations perpendicular to the loading direction.

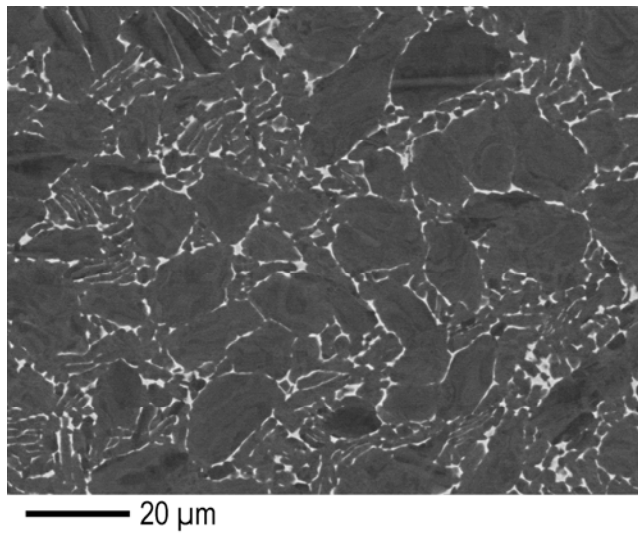
Figure 3. Microstructure of the as received Ti-811 bar.

The microstructure (Figure 3) and microtexture (Figure 4) of the as-received bar was characterized with scanning electron microscopy and EBSD methods. The bi-modal microstructure consisted of a globular  $\alpha$  grains approximately  $10\text{ }\mu\text{m}$  to  $15\text{ }\mu\text{m}$  in diameter. The secondary  $\alpha$ , on the other hand, was not arranged into well-defined colonies as in classical bi-modal microstructures. Instead, the secondary  $\alpha$ , which accounted for approximately 30 vol. pct. to 35 vol. pct. of the microstructure, was relatively coarse and in many locations appeared to have multiple variants of  $\alpha$  phase. EBSD analysis has shown that, in many locations, the secondary  $\alpha$  has adopted similar basal plane orientation as the adjacent primary  $\alpha$  grains, although this is certainly not a “rule” of the phase transformation. With respect to texture, there was a weak  $10\bar{1}0$  partial fiber aligned with the bar axis (Figure 4). EBSD scans made on longitudinal sections that contained the bar axis in the plane of polish revealed that there were elongated microtextured regions that had widths ranging from approximately  $100\text{ }\mu\text{m}$  to  $500\text{ }\mu\text{m}$  (Figure 5). Based on these data, specimens were cut transverse to the bar axis. As a consequence of the axial symmetry about the bar axis, there is an equal distribution of basal poles oriented between  $0^\circ$  and  $90^\circ$  to the loading direction. Therefore, the macroscopic texture of the as-received bar should not influence the grain orientation in which crack

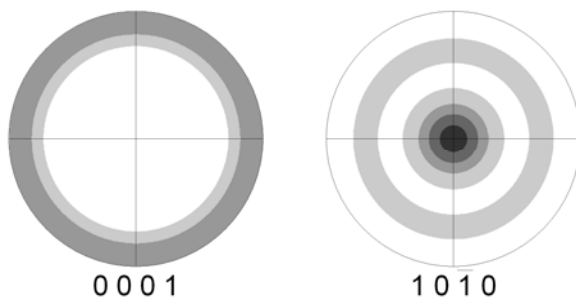
Figure 4. The texture of the as-received bar calculated from large area EBSD scans. A weak  $10\bar{1}0$  partial fiber is present along the bar axis which is perpendicular to plane of projection. The levels of intensity are in intervals of 0.5 multiples of the probability of a random distribution.

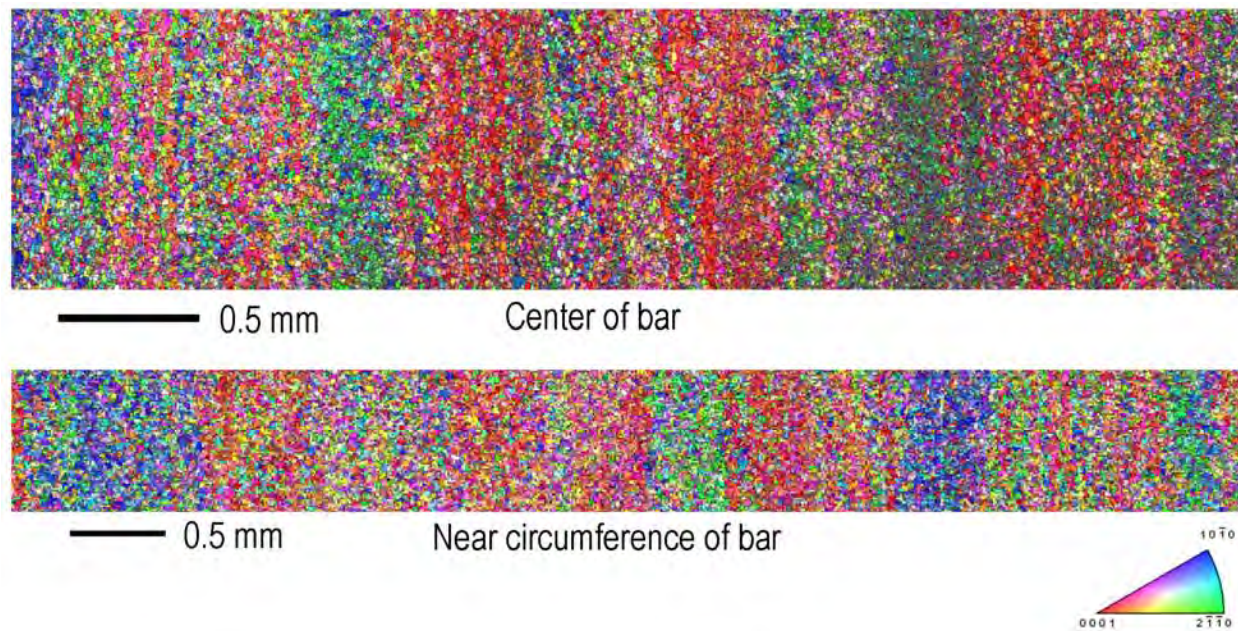
Figure 5. Normal direction inverse pole figure EBSD maps of longitudinal sections of the bar cut from near the center and edge showing elongated bands of microtexture. The loading direction is perpendicular to the plane of polish

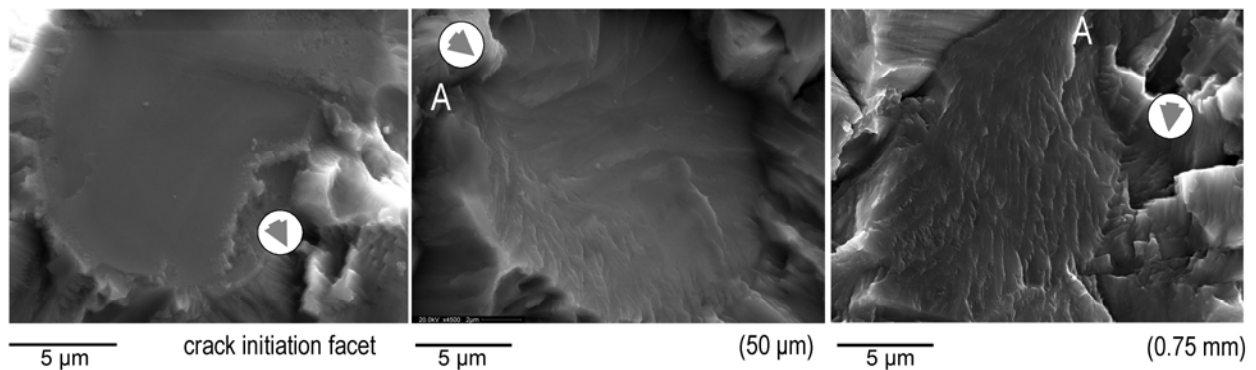
Figure 8. The effect of crack length on facet topography in the cyclically loaded specimen in the as-received condition. The local crack propagation direction is indicated by the arrows while the letter A designates the point at which the crack entered the grain.

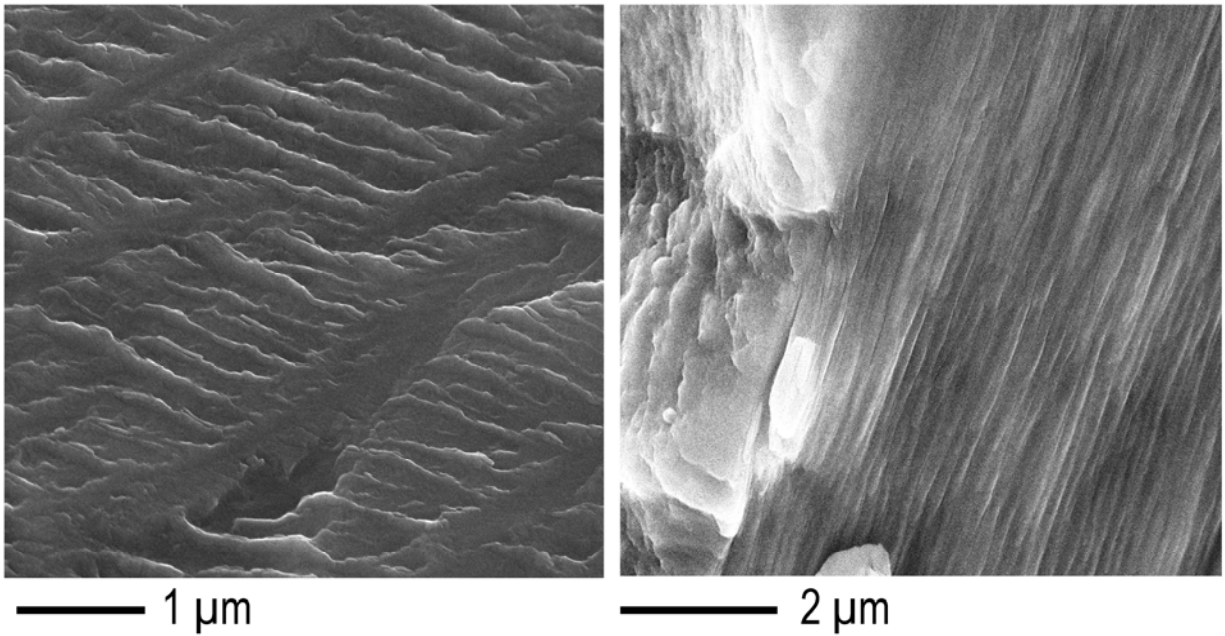
Figure 9. High magnification secondary electron images of two different facet surfaces in the continuously cycled specimen at crack lengths  $\sim 100\ \mu\text{m}$ . The markings on the facet surfaces suggest the crack growth rate is on the order of  $150\ \text{nm} / \text{cycle}$ .

There was a single clearly identifiable fatigue crack initiation site in the specimen loaded by continuous cycling. This region is shown at two levels of magnification in Figure 6 and Figure 7. Although there was no large, continuous faceted region consistent with the microtextured regions in this specimen there were many facets were observed at the crack initiation site (Figure 7). While some of the facets directly bordered one another, there were many locations separated by sharp, planar features such as those identified as numbers 2 and 3 in Figure 7. In the strictest sense, these could be called facets, but we reserve that term for the more planar features identified by the remaining numbers (1, 4, 5 and 6) that are formed by transgranular fracture through a primary  $\alpha$  grain with a fracture plane nearer the basal plane than any other low index plane as will be shown later. Except for the initiation facet, there were markings on the facet surfaces that were indicative of the local crack propagation direction (Figure 8). Subsequent facet surfaces were observed to be progressively and continuously more rough with increasing crack length. In addition, the number of steps on the facet surfaces seemed to increase in density with each grain boundary encountered by the crack front. For the case of continuous cycling, this is related to the increase in the cyclic crack tip plastic zone size with increasing crack length [27] which results in a larger fracture process zone on each subsequent cycle. At high magnifications while utilizing the TLD, striations were occasionally visible on some facets. Two examples are shown in Figure 9 where, on the left, the striations resemble slip steps on the facet surface while, on the right, they resemble more conventional striations. At a crack length of approximately 100  $\mu\text{m}$ , the spacing of these striations is on the order of 150 nm cycle<sup>-1</sup>.

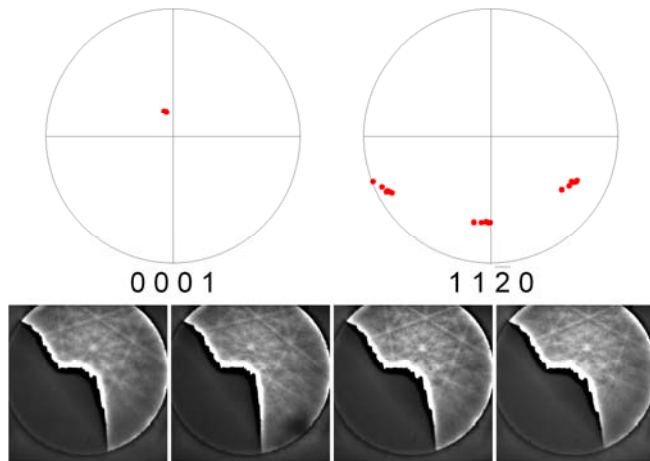
Figure 11. 0001 and  $11\bar{2}0$  pole figures showing all of the orientations indexed from the crack initiation facet (H2-1-1) in the continuously cycled specimen. The basal pole remains in the same position, however there is a rotation of  $10^\circ$  about [0001] over a distance of approximately  $7\ \mu\text{m}$  on the facet. Four of the seven total EBSD patterns are shown to provide an indication of pattern quality. Although part of the detector is shadowed by other parts on the fracture surface, there are sufficient zone axes present to make an accurate determination of the crystallographic orientation with a high degree of confidence.

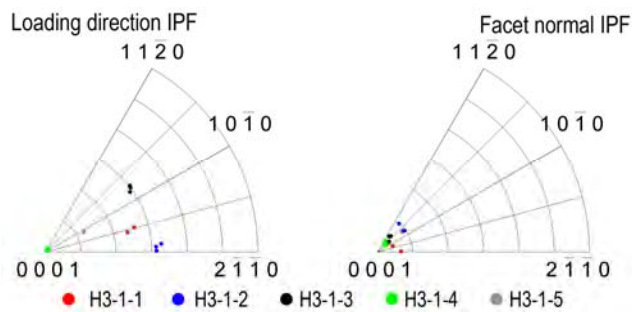
Figure 16. Initiation and propagation facet crystallography for the as-received SCC specimen. Facets H3-1-4 and H3-1-5 are propagation facets while the others are the near-initiation site facets.

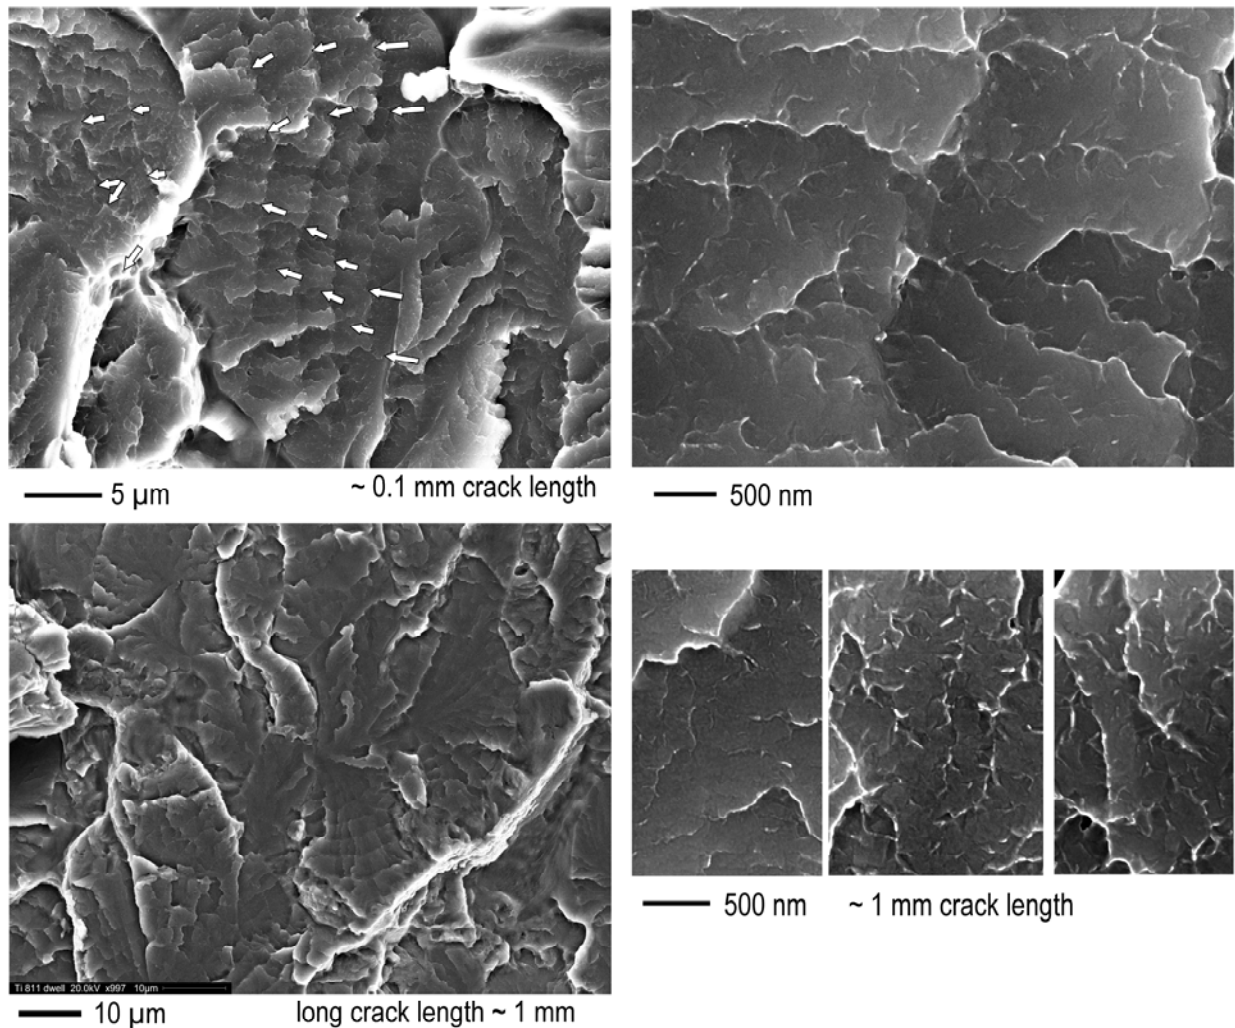
Figure 21. Secondary electron images showing very little variation among the facet surface topography as a function of crack length in the dwell fatigued specimen. A secondary initiation site is also evident in the center of the lower left image.

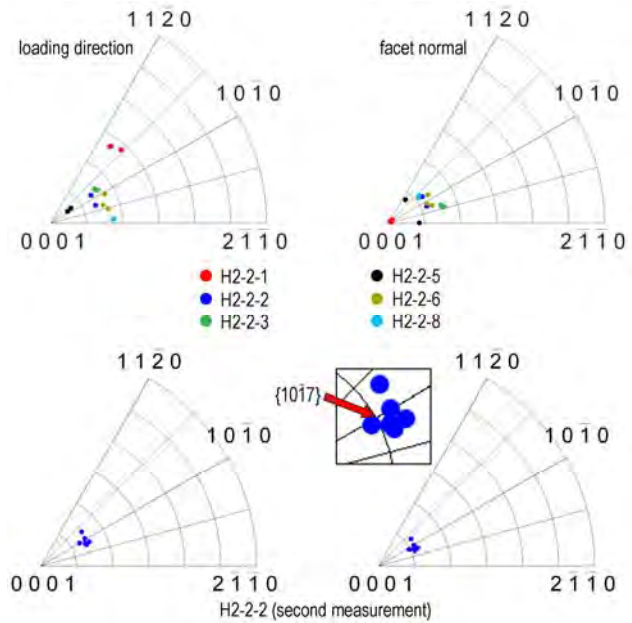
Figure 22. Dwell fatigue facet crystallography. Equal angle inverse pole figures showing the orientations of the faceted grains identified in Figure 19 with respect to the loading direction and facet normal.

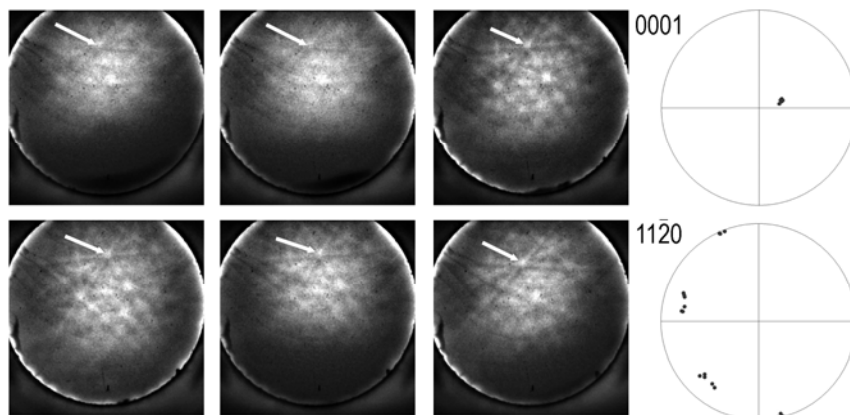
Figure 23. EBSD patterns collected from the as-fractured H2-2-2 facet during the second analysis at locations successively further from the initiation site. The white arrows identify the  $[1\bar{2}13]$  zone axis, which shifted subtly, in each pattern. The indexed orientations are represented on the 0001 and  $11\bar{2}0$  pole figures and reveal a  $\sim 10^\circ$  rotation about  $[0001]$ .

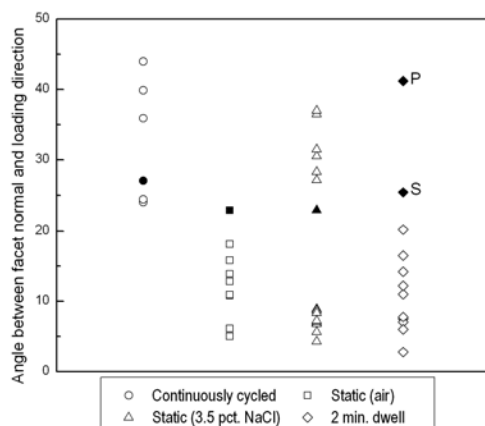
Figure 25. Angle between facet normal and loading direction. Filled symbols indicate initiation facets while open symbols designate propagation facets. Letters P and S designate the primary and secondary initiation sites studied on the dwell specimen.

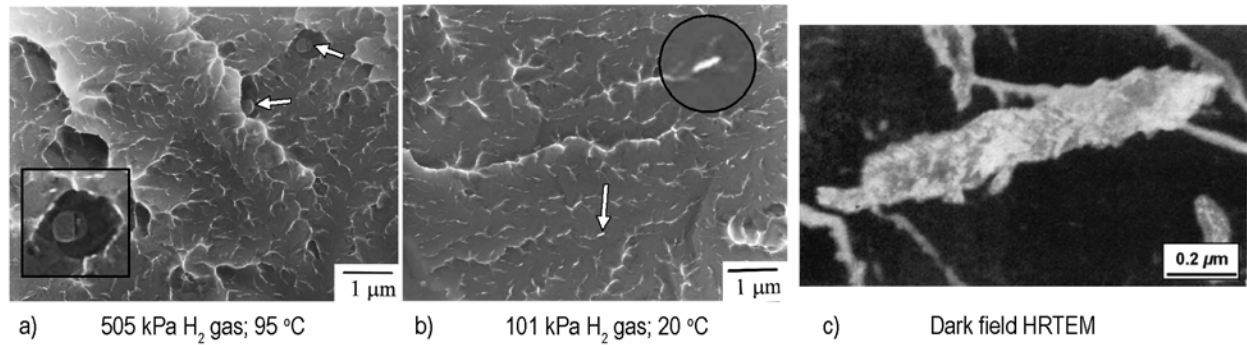
Figure 26. (a) and (b) Surface topography of facets formed by static loading in Ti-6Al-4V alloy in H<sub>2</sub> gas [66]. The arrows in (a) point to features that are presumably plate-like TiH<sub>2</sub> precipitates, the top of which is shown at higher magnification in the 1 µm wide inset. Smaller, bright particles similar to those observed on the Ti-811 facets in the present study were also observed. One is identified by the arrow in (b) and also shown at higher magnification in the 0.5 µm diameter inset. (c) A dark field TEM image of a precipitate like the one identified in (b), except in the alloy Ti-8Al-1Mo-2V, lifted from the fracture surface in an acetate replica [67].

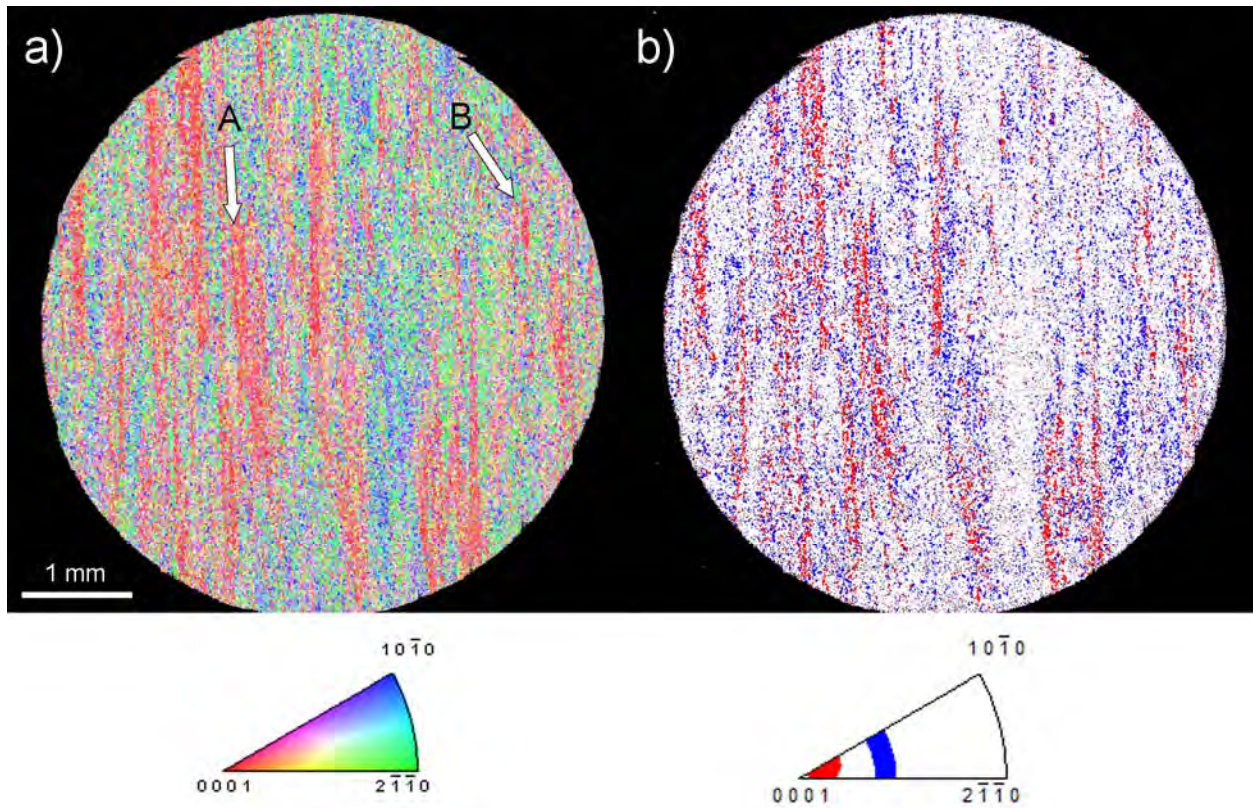
Figure 29. (a) Loading direction inverse pole figure map of a transverse cross section of the dwell fatigue specimen approximately 1.3 mm beneath the fracture surface. In (b), those grains with basal poles inclined 40° to 50° from the loading direction have been colored blue while the red grains are those with a  $\{10\bar{1}7\}$  plane that is no more than 10° away from being orthogonal to the loading direction, as indicated by the inverse pole figures beneath each diagram. See text for details regarding locations A and B in (a).

Now that the preferred orientation of crack initiating grains and crack propagation grains has been identified, it is possible to discuss the effect of microtexture region size on dwell fatigue life. Consider the EBSD map of the transverse cross section of the dwell fatigue specimen collected approximately 1.3 mm below the fracture surface, but still well within the reduced section of the specimen, shown in Figure 29. These data illustrate that there is a range of sizes and aspect ratios of microtextured regions with c-axes near, or slightly inclined to, the loading direction (red hues) and so it becomes useful to understand why crack initiation might be favorable in one location compared to another. In addition, once a crack has initiated, it is useful to know which neighborhoods will facilitate faceted crack growth and ultimately lead to fracture of the component in comparison to those that result in crack arrest. For discussion purposes, consider the following simple example.

Two cracks initiate on the same dwell cycle at locations A and B in Figure 29a. They initiate at grains like those described in detail above that happen to be near the interface between “hard” and “soft” microtextured regions because of the locally higher stresses developed here due to load shedding [46]. After crack initiation, continued growth of the crack depends on its surrounding microstructure. based on the tilt fractography / EBSD studies, we have identified that grains with  $\{10\bar{1}7\}$  planes nearly perpendicular to the loading direction provide easy propagation paths. Thus, in Figure 29b, we have color coded grains with high resolved shear stress on the basal plane, initiation grains, in blue, whereas the easy propagation paths are identified by the color red. Both cracks advance on each subsequent dwell cycle through their respective microtextured regions. Upon reaching the edge of the microtextured region, crack B is arrested because the soft oriented grains on the other side are able to accommodate its plastic zone, similar to what has been observed during continuous cycling [30,76]. The crack does not grow readily because there are no more basal planes suitably oriented for faceted growth. Crack A, on the other hand continues to propagate through the larger microtextured region until it too reaches a soft oriented grain. Outside of the faceted region, dwell fatigue cracks have been observed to propagate by more conventional striation growth [26] which is controlled by crack tip plasticity. Therefore, it is reasonable that the driving force for further crack propagation is proportional to  $\Delta K$ , which would be considerably larger for crack A suggesting that it would most likely propagate to catastrophic failure. Thus, the size and shape of the microtextured region is the most important attribute affecting dwell fatigue life because, in materials with large microtextured regions, a concomitantly large internal crack can develop while the crack is still growing at high rates under relatively microstructure insensitive conditions until faceted growth is exhausted. Then, this internal flaw serves as the initial condition for the second stage of crack growth which appears to occur by more conventional striation growth mechanisms. For modeling purposes, it is likely that the size and
