AFRL-RX-WP-TP-2011-4301

**STRESS CORROSION CRACKING FACET
CRYSTALLOGRAPHY OF Ti-8Al-1Mo-1V (Preprint)**

A.L. Pilchak

MAY 2011

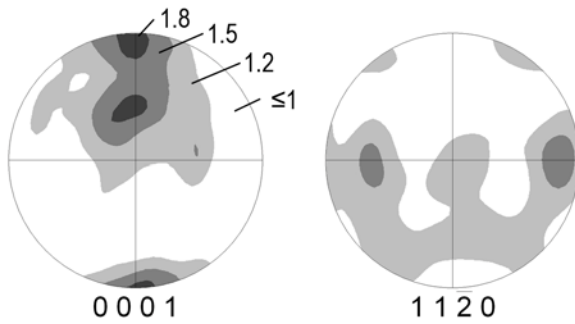
Figure 4. Equal angle projections showing the texture of the as-received bar. The tensile axis of the specimens is perpendicular to the plan of the projection.

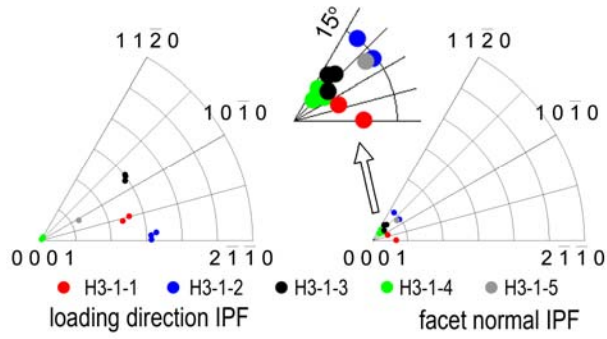
Figure 8. Facet crystallography of the as-received specimen (H3-1).

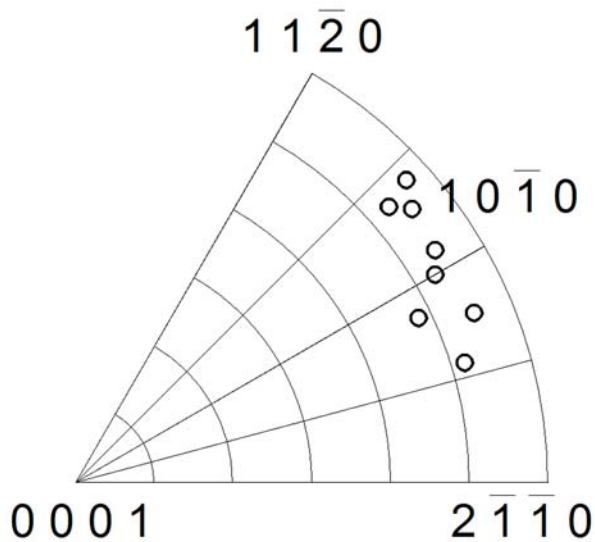
Figure 10. In-plane crack propagation direction orientation measurements. Each point on the equal angle projection represents the orientation of grain H3-1-4 with respect to unit vectors parallel to one of the ridges on the facet surfaces.
