AFRL-RX-TY-TR-2011-0048

**FIREFIGHTING AND EMERGENCY RESPONSE  
STUDY OF ADVANCED COMPOSITES AIRCRAFT  
Objective 3: Penetrating and Overhauling Wreckage**

October 2011

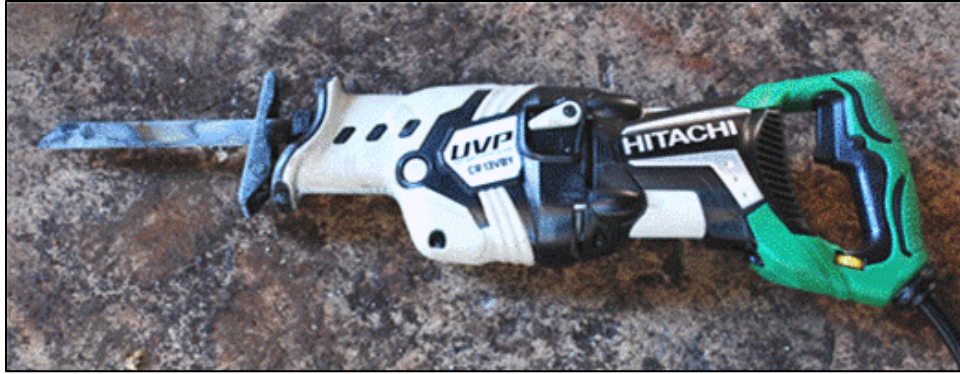
A Hitachi 12-amp corded reciprocating saw was used as the representative saw for this portion of the testing (Figure 3). An 8-in Lenox carbide blade (Model ES-20576) and an 8-in Lenox diamond coated blade (Model ES-10833) were each tested in the same saw. Figure 4 shows a close-up of the Lenox 8-in carbide and diamond reciprocating saw blades. From the picture it is evident that the carbide saw blade had a much coarser grit than did the diamond coated blade.

**Figure 3. Hitachi Reciprocating Saw**

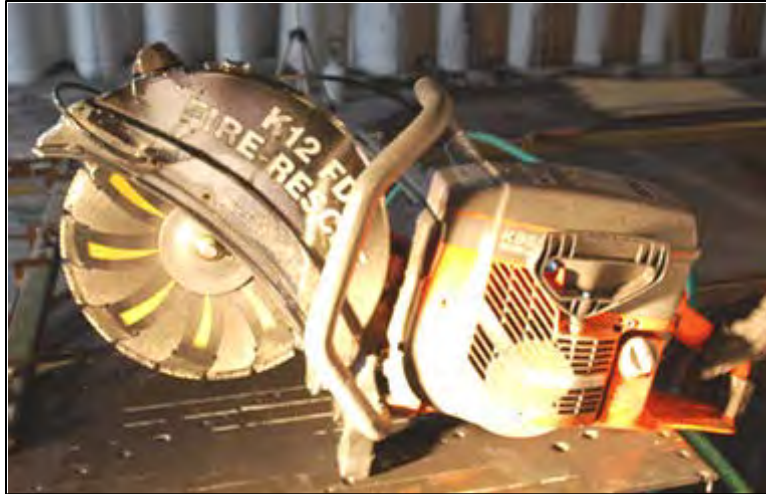
A Partner K-12, 14-in gas powered circular saw was used as the representative saw for this portion of the testing (Figure 5). The 12-in Fire Hooks Unlimited carbide blade that came standard with the saw was used for testing as this represented a general purpose blade used by fire departments for a variety of cutting needs. The circular saw blades were purchased from a firefighting equipment supplier. The blade was constructed of 24 carbide tips on a steel body that were twice the width of the body of the blade. A MK Diamond Fire Tiger Tooth 12-in diamond coated blade was used for comparison. This blade had diamond particles directly fused to a steel core. Figure 6 shows the carbide and diamond saw blade teeth.

**Figure 5. Partner K-12 14-in Gas Powered Circular Saw**

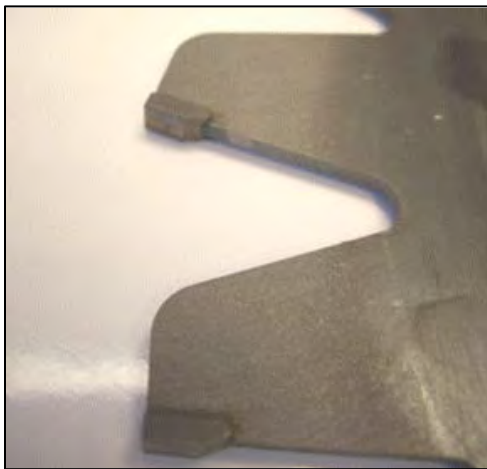
**Figure 6. Close-Up of Carbide (left) and Diamond (right) Circular Saw Blades before Cutting**

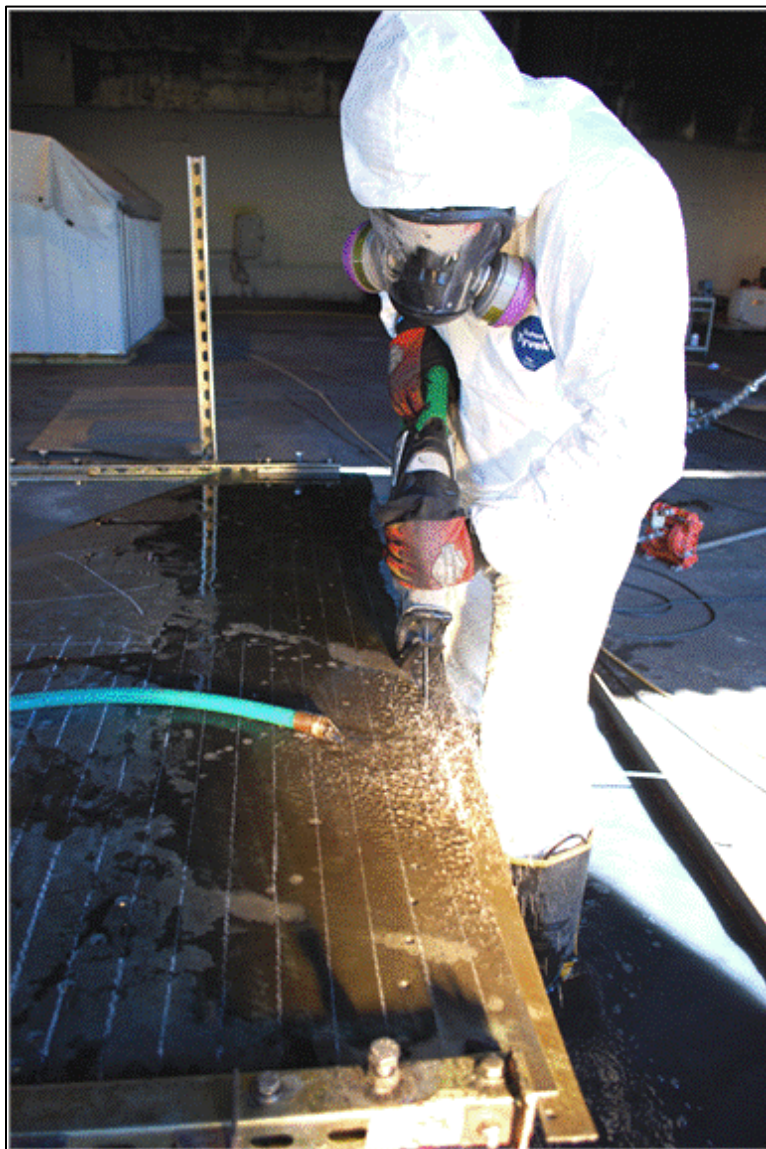
The reciprocating and circular saws were used to cut strips from F-16 composite sheets along pre-measured lines. Figure 9 shows the operator cutting with the reciprocating saw, and

**Figure 9. Reciprocating Saw Being Used to Cut F-16 Composite Sheets**

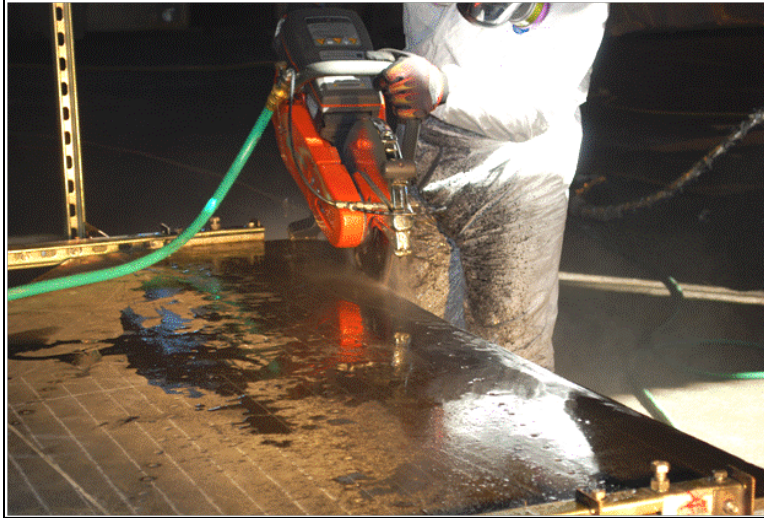
Figure 10 shows the operator cutting with the circular saw. Water was used during cutting to keep the blades cool and to minimize the composite fibers dispersed into the air. The K-12 circular saw was outfitted with a water spray system that sprayed water directly onto the blade, while in the case of the reciprocating saw a hose was used to wet the sample as it was cut. The water was collected, filtered and disposed of in accordance with procedures established by AFRL. The operator wore a Tyvek suit, full-face respirator with P100 cartridge, gloves and boots during all cutting evaluations. Each F-16 stabilizer section represented 127 linear ft of composite cutting. Cutting speed was calculated for each cut by dividing the total length of the cut by the total time taken to make the cut, as determined from video records. The saw operator made an effort to apply consistent force on the saw during all cutting operations in an attempt to reduce inconsistencies in measured cutting speed.

**Figure 10. Circular Saw Being Used to Cut F-16 Composite Sheets**

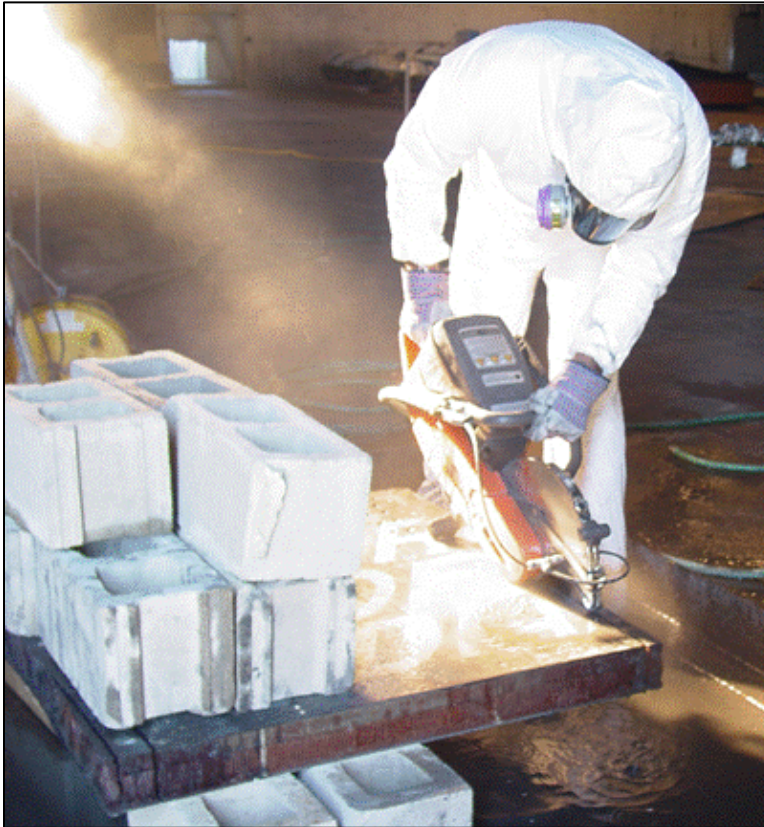
**Figure 11. Cutting B-2 Composite Door Using Circular Saw**

For cutting the B-2 door, the Partner K-12 circular saw with new 12-in carbide and diamond blades was used. Each blade was used to cut 1.5 in strips of composite from the door. The door provided enough material to cut 13 strips with the carbide blade and 14 strips with the diamond blade. Because of variations in thickness of the door, the test stand could not accommodate it.

Instead, cinder blocks were used to keep the door raised above ground and balanced so that it could be cut (Figure 11). The door appeared to be uniform in construction, however after cutting it was discovered that the side cut with the carbide blade was thicker than the side cut with the diamond blade. The blades used to cut the door were not sent to IMR Test Labs for image analysis of wear.

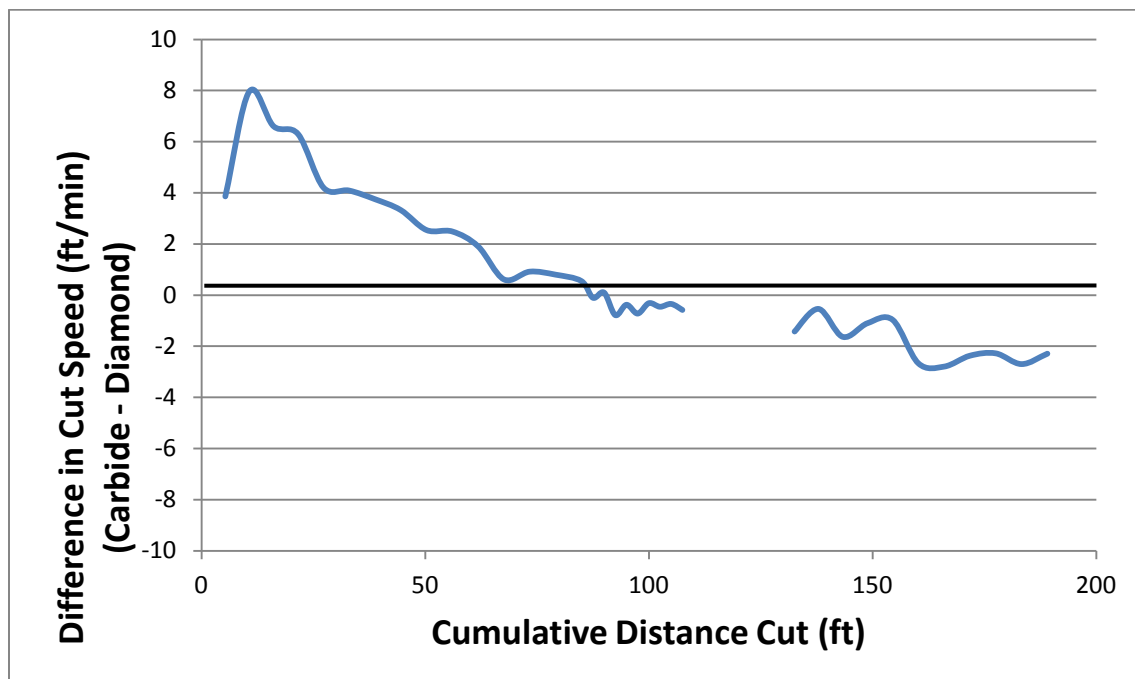
Figure 12 shows a comparison of the average cutting speed for both the carbide and diamond reciprocating saw blades. The graph shows the carbide blade cutting speed minus the diamond blade cutting speed, as a function of cumulative length cut. Figure 13 shows the total cumulative length of composite cut by each type of blade.

When the blades were new, the carbide blade cut faster than the diamond blade; however, after cutting 90 ft, the carbide blade had dulled to the point of being about equal in cutting speed to the diamond blade, and after that point the diamond blade cut more quickly than the carbide blade. After cutting 107 ft (cut number 24), the carbide blade was incapable of cutting through the sample at the thicker ( $\geq 0.25$  in) end of the composite sample (appears as a gap in the data in Figure 12), though it was capable of cutting an additional 62 ft (up to cut number 11) of thinner ( $\leq 0.15$  in) composite. Compared to the 169 ft cut by the carbide blade, the diamond blade was able to cut a total cumulative length of 382 ft of composite. The diamond blade had a consistent cutting speed through all three sheets of composite. The blade was still sharp and capable of cutting additional composite material; however, there was insufficient composite sample material to continue cutting until the diamond blade became too dull to cut further. Therefore the effective cutting length of the diamond blade was not determined.

Figure 12. Difference in Reciprocating Saw Cutting Speed, Carbide Blade - Diamond Blade

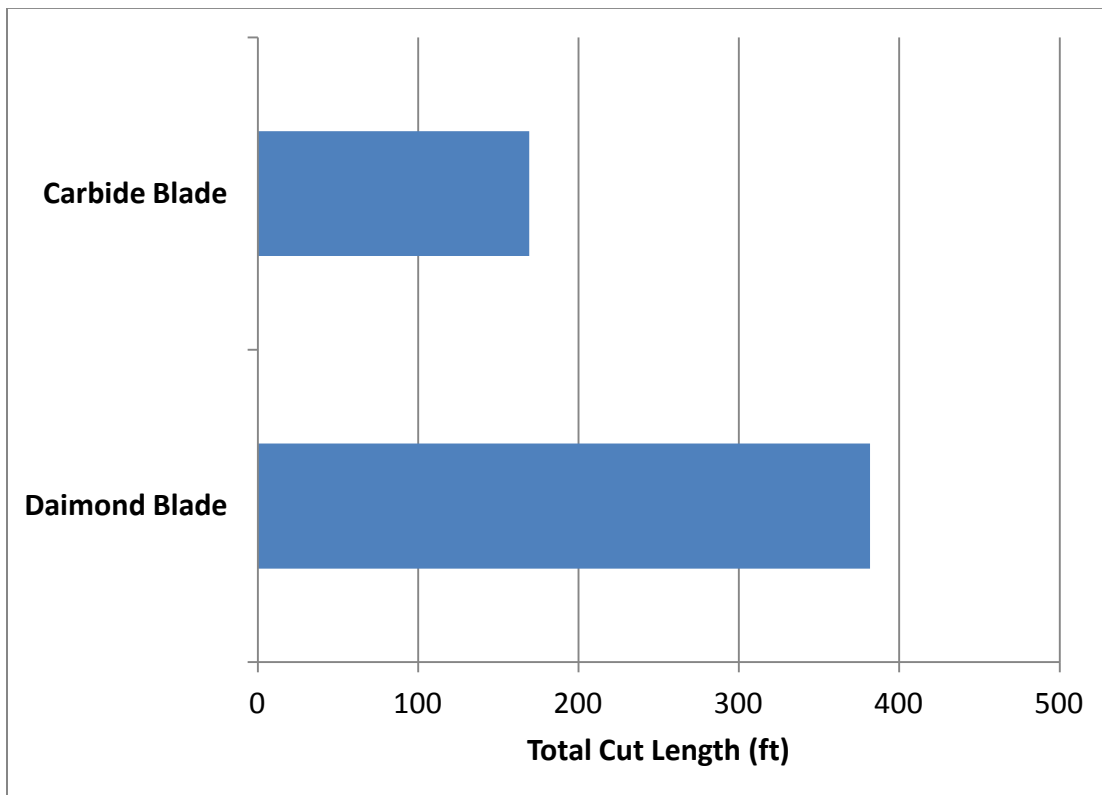
**Figure 13. Comparison of Total Cut Length for Reciprocating Saw Blades**

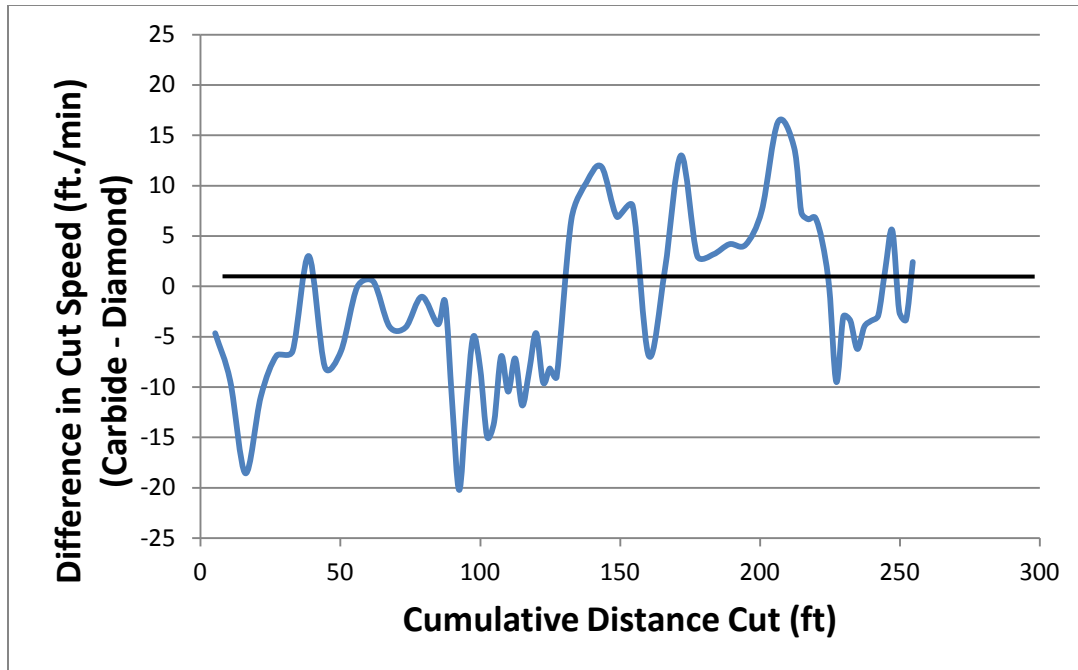
Figure 14 shows a comparison of the average cutting speed for both the carbide and diamond circular saw blades. The graph shows the carbide blade cutting speed minus diamond blade cutting speed, as a function of cumulative length cut. Figure 15 shows the total cumulative length of composite cut by each type of blade.

Up to a cumulative cut length of 255 ft (two full F-16 stabilizer sample sheets), the cutting speeds of the carbide and diamond blades were about the same, demonstrated in Figure 14 by the small and variable difference between the two cutting speeds. However, after 235 ft (cut #24 of the second sheet of F-16 stabilizer composite), the carbide blade began ripping/tearing large chunks of the composite versus clean cutting the material. The carbide blade ripped an additional 32 ft of composite, 255 ft total. The carbide blade may have been able to cut additional material, but no additional material was cut because the blade had dulled to the point of ripping rather than cutting. The diamond blade cut with consistent speed through three composite stabilizers, a cumulative total of 382 ft. The blade was still sharp and capable of cutting additional composite material; however, there was insufficient composite sample material to continue cutting until the diamond blade became too dull to cut further. Therefore the total cutting length of the diamond blade was not determined.

**Figure 14. Difference in Circular Saw Cutting Speed, Carbide Blade - Diamond Blade**

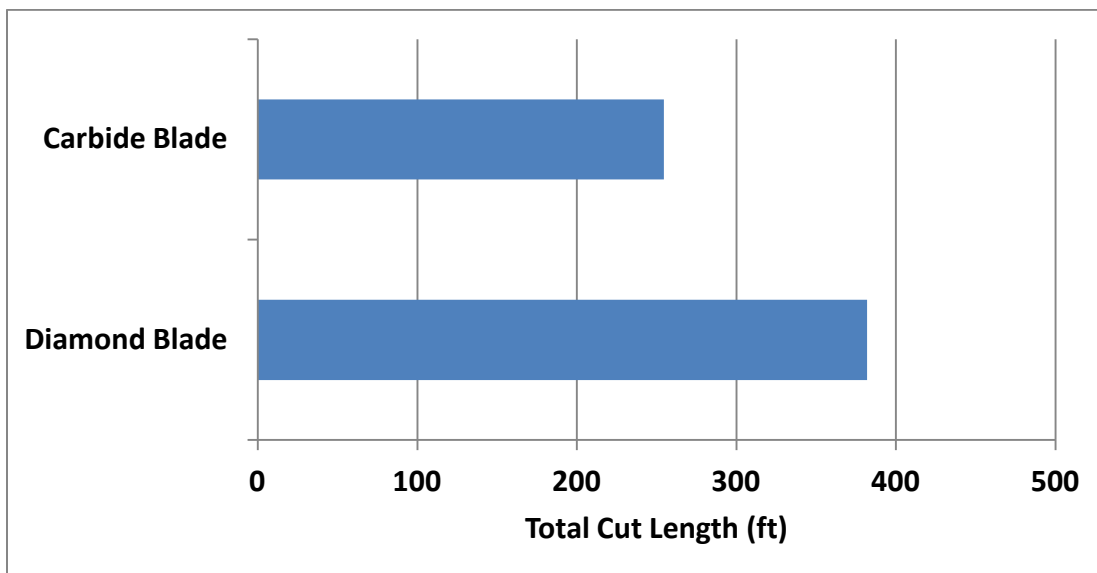
**Figure 15. Comparison of Total Cut Length for Circular Saw Blades**

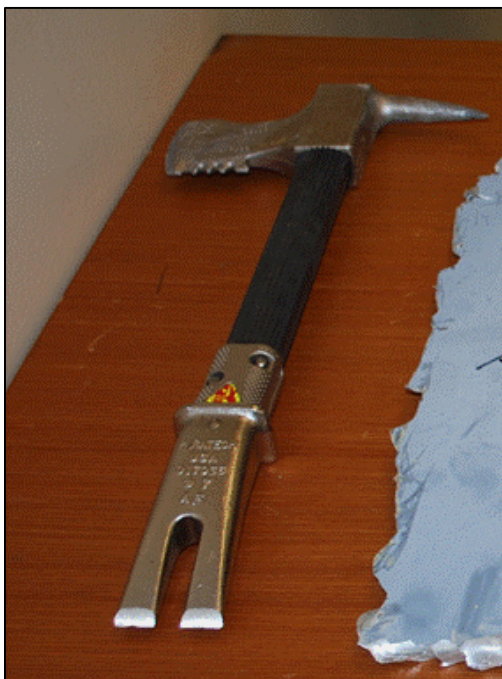
A Paratech brand Pry Axe (Figure 18) was used for all cutting. The Pry Axe was 18 in long and weighed 6.6 lb. Three materials were worked: a 0.08 in thick 5052-H32 aluminum panel; a carbon fiber and epoxy composite panel of varying thickness from an F-16 horizontal stabilizer; and, 0.05 in thick aluminum aircraft engine nacelle cowling from a KC-135. The 5052-H32 aluminum used in this test was a similar type and thickness as that used for aircraft fuselages.

**Figure 18. Paratech Brand Pry Axe**

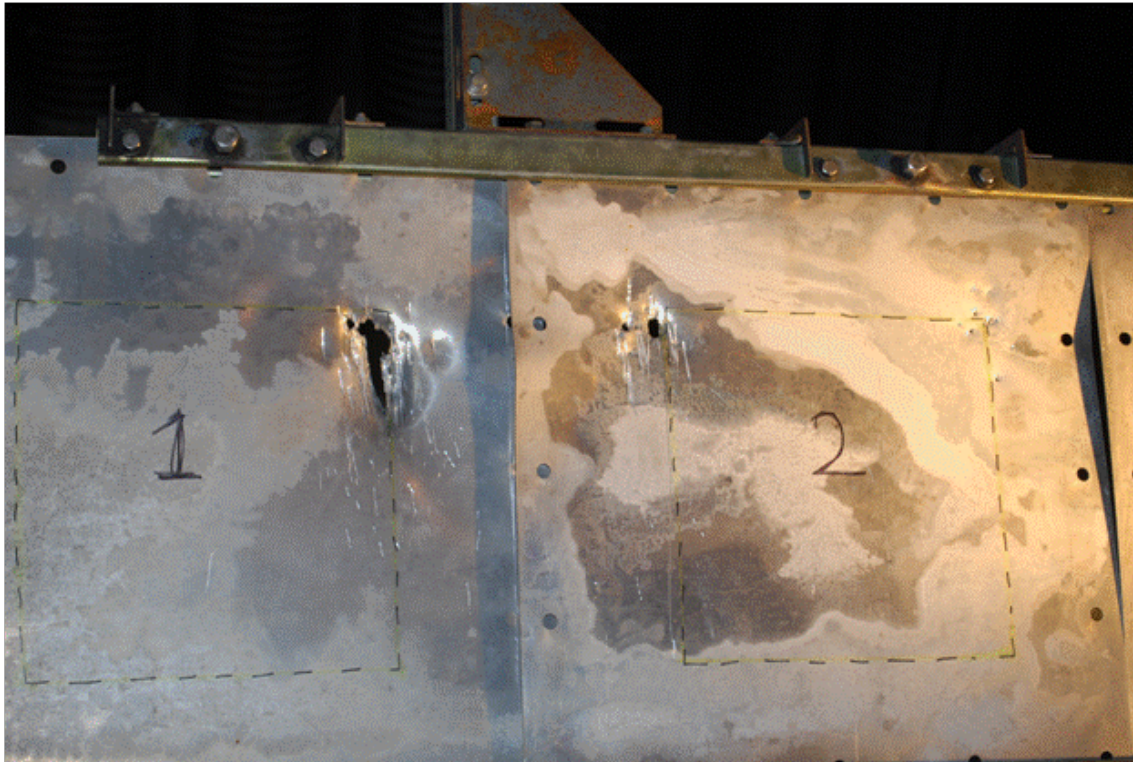
Figure 19 shows the 0.08 in thick 5052-H32 aluminum sheets after cutting with the pry axe. With the pry axe the operator was able to cut only a few inches in the first sheet and could only make a small hole in the second sheet. The operator did not attempt a third sheet since the first two were unsuccessful. The times to make cuts 1 and 2 are shown in Table 3.

**Figure 19. Pry Axe Used on 5052-H32 Aircraft Aluminum**

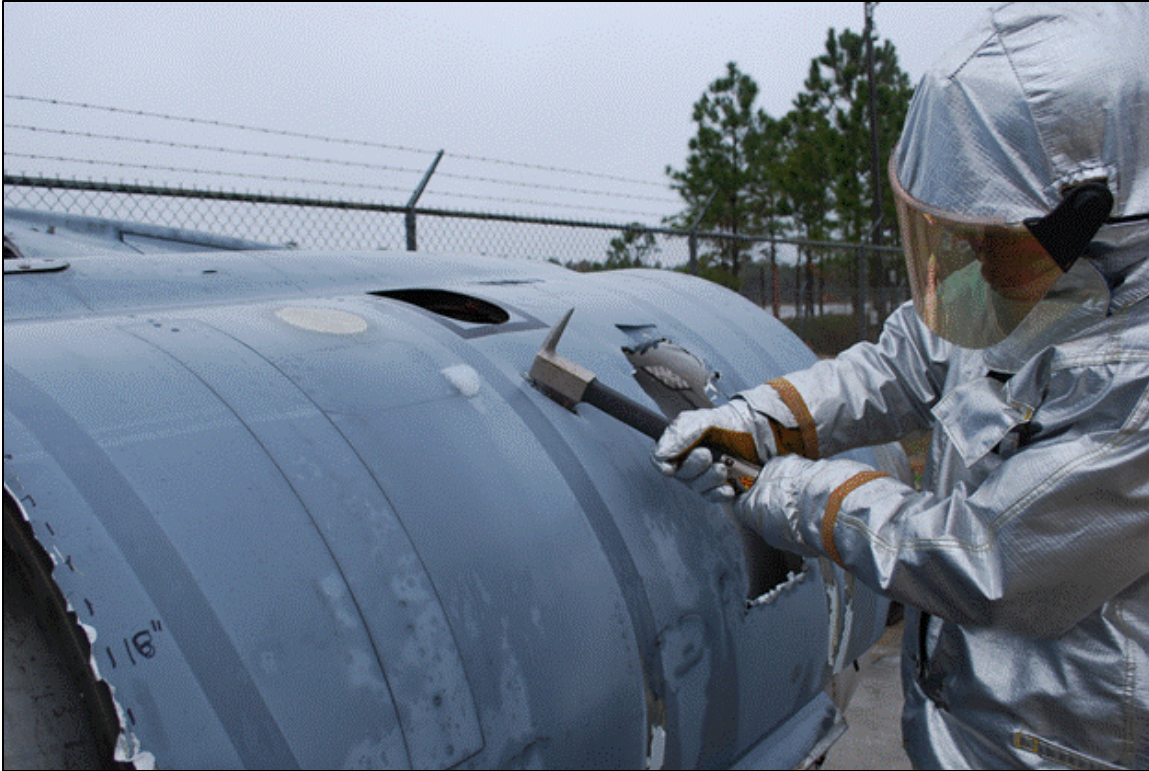
Figure 21 shows the operator using the cutting edge of the pry axe to cut a hole in the 0.05 in aluminum KC-135 aircraft engine nacelle cowling. Three 8 × 18-in holes were cut using this tool. Figure 22 shows the edges of the nacelle after cutting. Results are given in Table 5. The first hole took 56% longer to cut than the second and third holes, which was probably due to the operator becoming more proficient with experience.

**Figure 21. Demonstration of Pry Axe Cutting Access Hole in KC-135 Engine Nacelle Cowling**

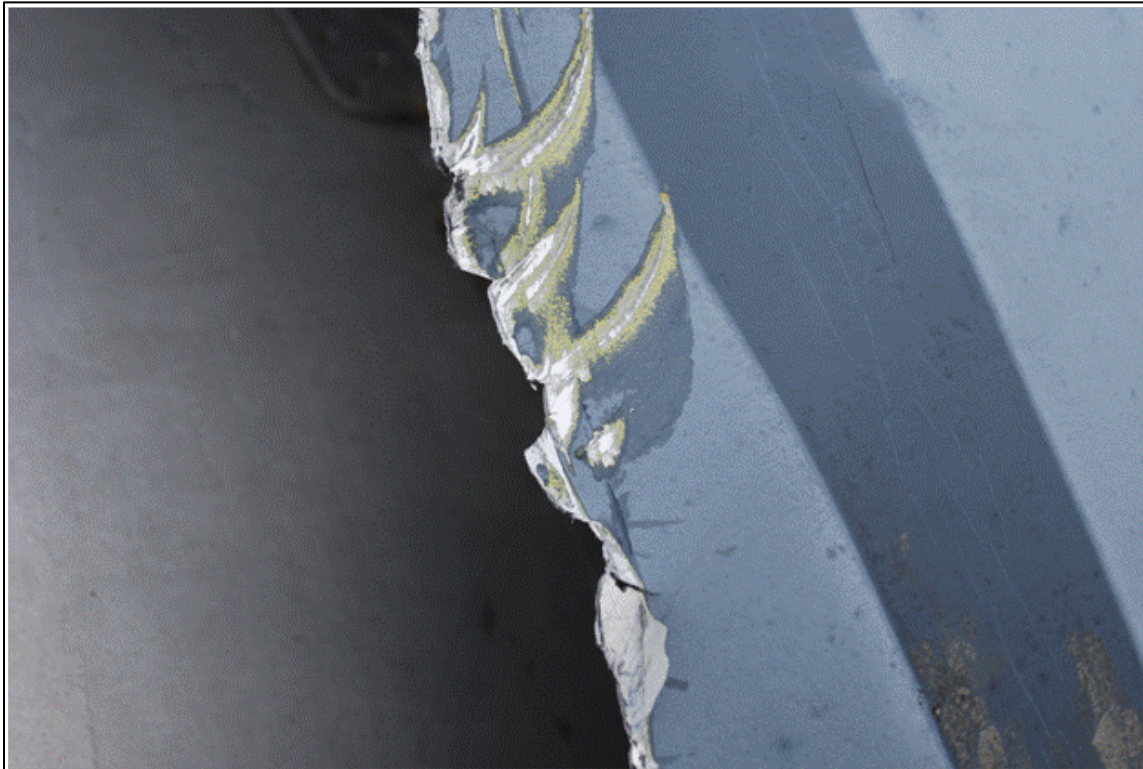
**Figure 22. Edges of KC-135 Engine Nacelle Cowling after Cutting with Pry Axe**

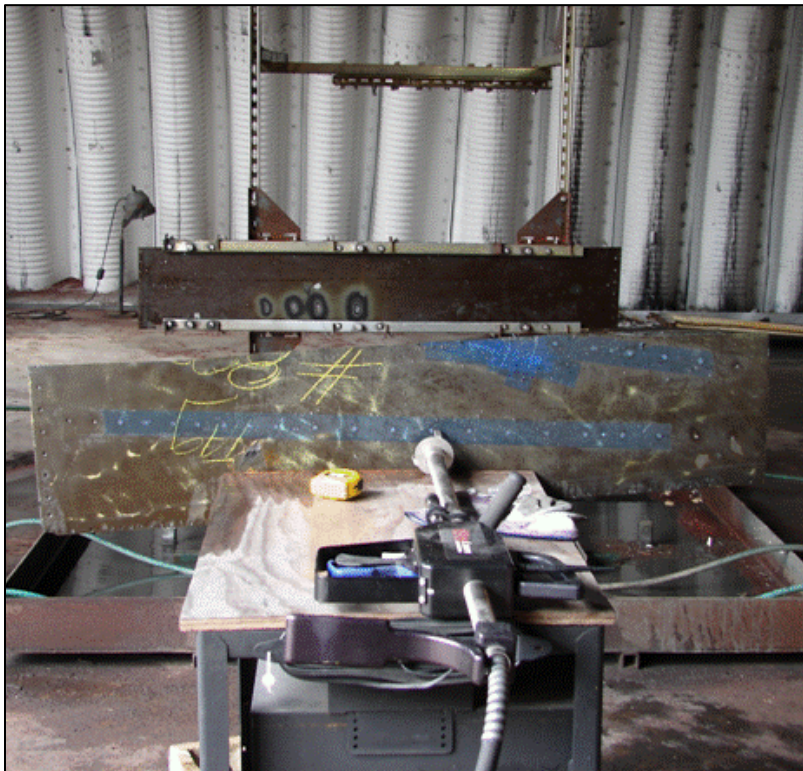
Finding the maximum piercing distance of the water jet stream between two F-16 composite panels was done with two composite panels secured in test stands and arranged parallel, starting at an interval of 5 ft. The lance was positioned against one composite sheet (Figure 24) and then discharged using water and garnet aggregate in piercing mode (10 gal/min and 3500 lb/in<sup>2</sup>). Separation distance was increased and the procedure was repeated until a distance was reached at which the Pyrolance could not penetrate the second panel.

**Figure 24. Setup for Two Composite Panel Penetration Evaluations**

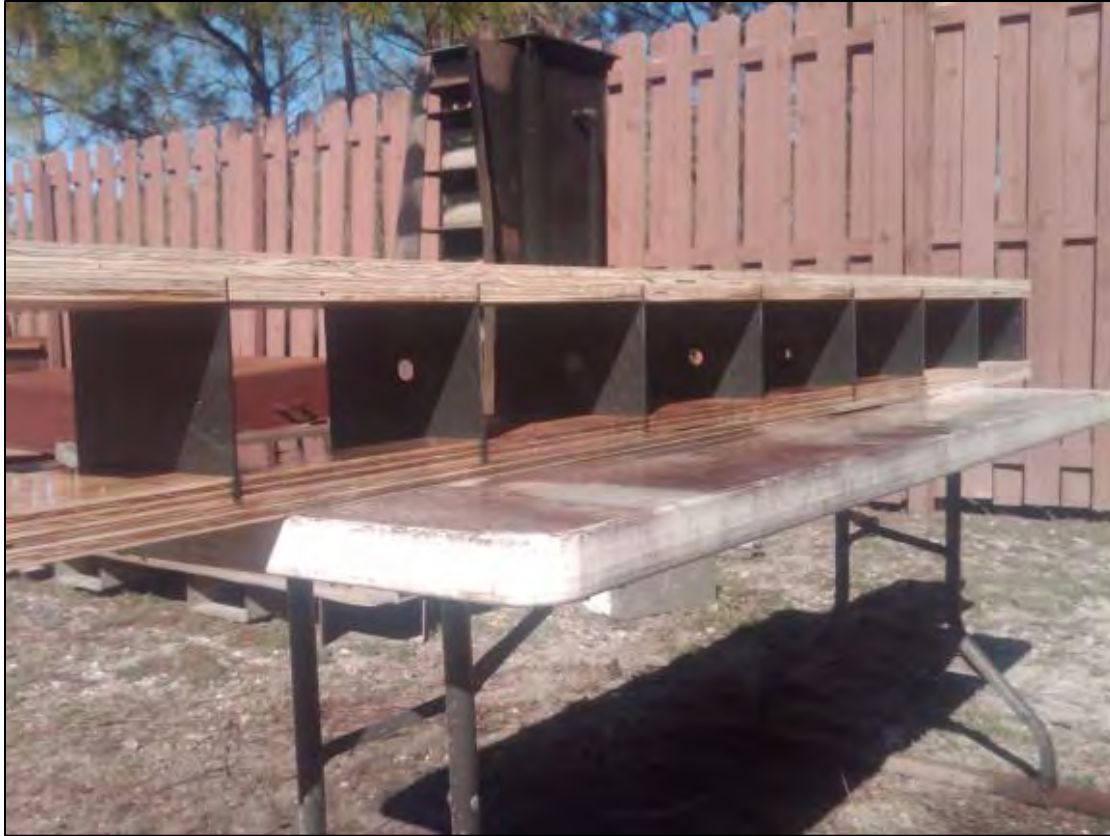
The investigation to determine how many successive composite panels the water jet stream could penetrate effectively was accomplished using eight composite panels of 0.153 in thickness secured 12 in apart in a stand specially designed for test, as shown in Figure 25. The stand was made from two pieces of 2 in thick plywood for the top and bottom, with cuts made 1 in deep every 12 in for setting the composite sheets. The Pyrolance was clamped in a stand, positioned against the first panel, and then discharged in penetration mode for 30 s. Afterward, the number of panels pierced was documented.

**Figure 25. Test Stand for Multiple Panel Composite Piercing**

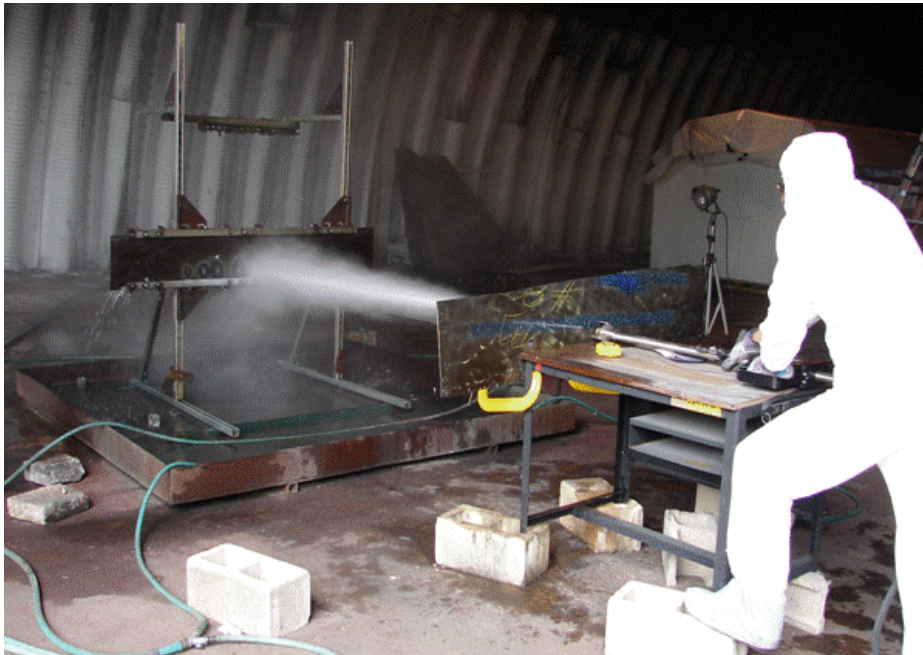
Figure 29 shows a piercing distance check in progress. Figure 30 shows the two panels used for determining maximum piercing distance. Six trials were completed to determine the distance, starting at 5 ft and working up to 9 ft (labeled T-1 and T-5 in Figure 30), which did not pierce the far panel. An additional test (T-6) was conducted at 8.5 ft, which also did not pierce the far panel. Therefore, the maximum distance was 8 ft. It can be seen in Figure 30 that the Pyrolance cut a small hole in the near panel and a much larger hole in the far panel as the water/aggregate stream started to disperse.

**Figure 29. Testing the Effective Piercing Distance of Pyrolance**

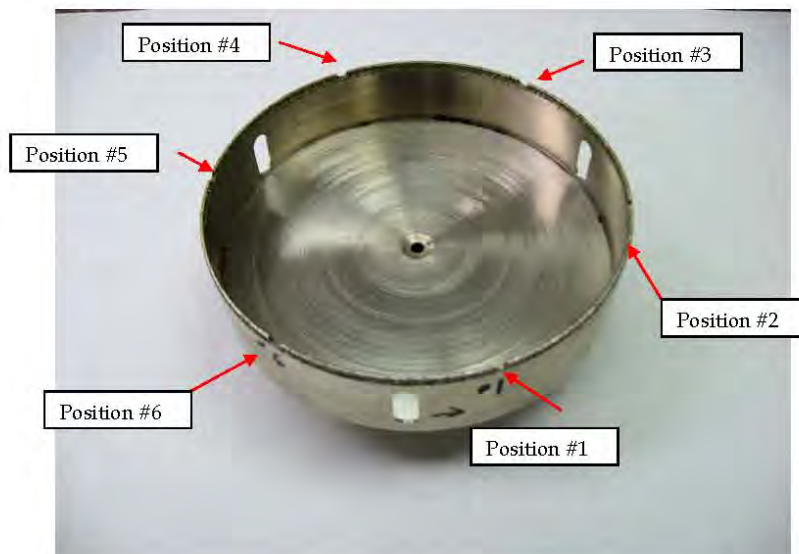
Hole Saw 152 mm - Before Test

Position #	Results (mm)
1	35.454
2	35.592
3	35.412
4	35.788
5	35.460
6	35.620

Figure 3: Macrograph of Hole Saw 152 mm before testing, showing position locations

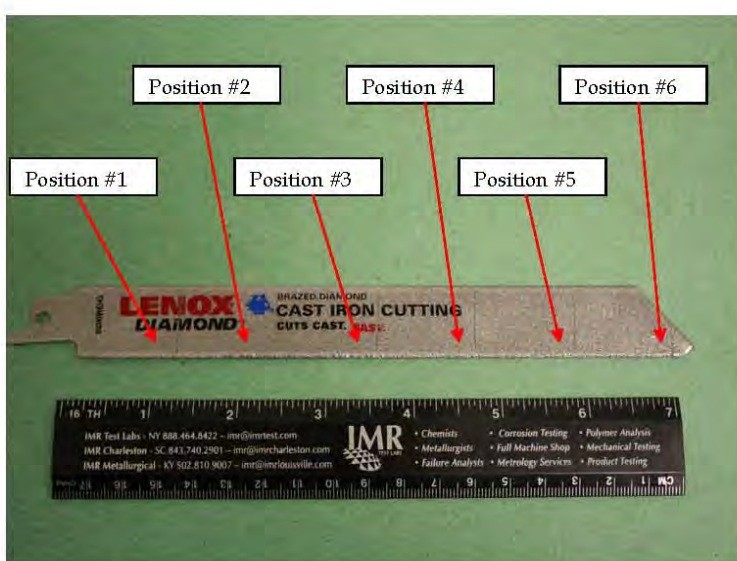
**Lenox Diamond 800RDG**

Position #	Results Before Test (mm)	Results After Test (mm)
1	19.530	19.450
2	19.648	19.550
3	19.532	19.488
4	19.492	19.352
5	19.488	19.362
6	19.516	19.440

**Figure 4:** Macrograph of Lenox Diamond 800RDG before and after testing position locations

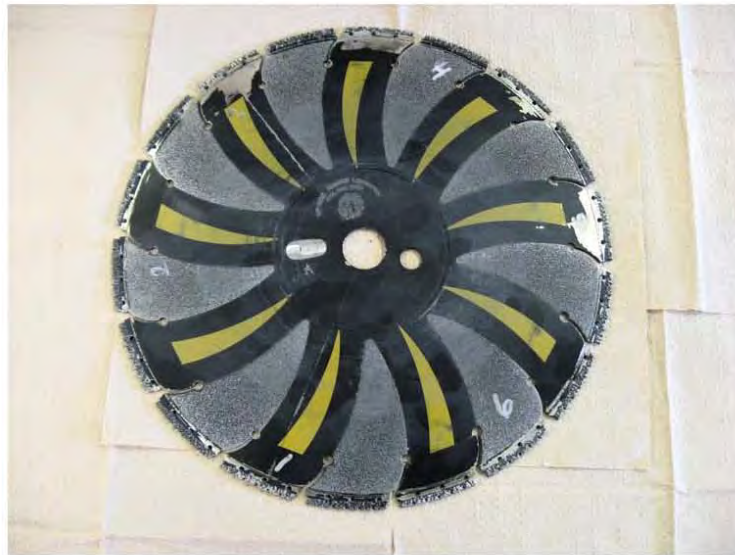
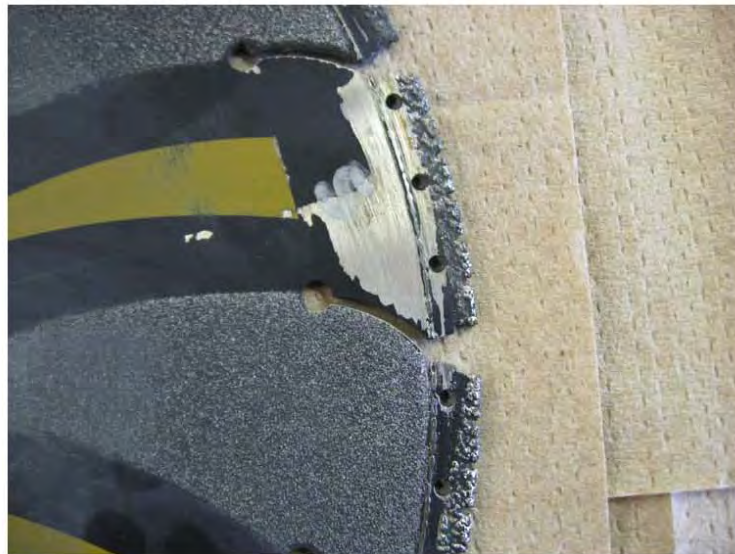
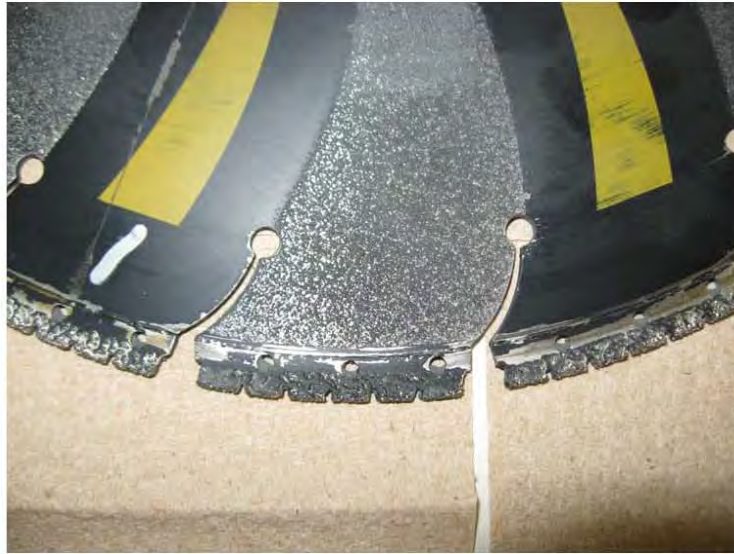
**Circular Saw NDL 18772 No. 2**

Tooth #	Position #1 (mm)		Position #2 (mm)		Position #3 (mm)	
	Before	After	Before	After	Before	After
1	7.196	7.123	7.063	7.040	7.196	7.125
2	7.067	6.958	7.238	7.040	6.968	6.800
3	7.121	7.041	7.177	6.957	7.120	6.958
4	7.064	6.958	6.897	6.792	7.132	6.970
5	7.231	7.041	7.118	7.042	7.080	6.957
6	7.288	7.124	7.006	6.792	7.070	6.875

**Figure 1:** Macrograph of Circular Saw NDL 18772 no. 2, before testing, showing position locations

**Figure 2:** Circular Saw NDL 18772 no. 2, after testing

**Figure 3:** Circular Saw NDL 18772 no. 2, after testing

**Figure 4:** Circular Saw NDL 18772 no. 2, after testing

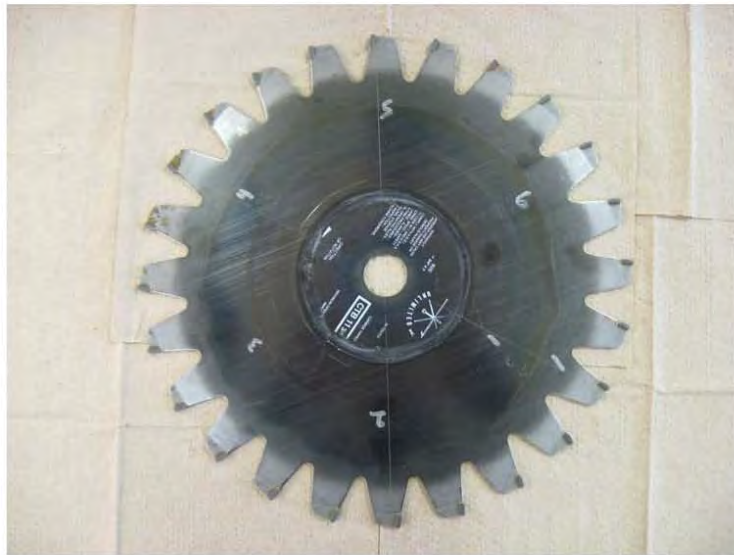
Circular Saw CTB 11 3/4 - 24 No. 2

Tooth No.	Position #1 (mm)		Position #2 (mm)		Position #3 (mm)		Position #4 (degree)	
	Before	After	Before	After	Before	After	Before	After
1	2.326	2.205	7.979	7.945	2.513	2.412	23.495	23.354
2	2.409	2.256	8.009	8.006	2.476	2.324	22.650	22.283
3	2.426	2.273	8.042	8.023	2.492	2.375	22.848	22.039
4	2.410	2.222	8.026	7.972	2.476	2.324	24.570	23.694
5	2.394	2.206	8.026	7.991	2.542	2.409	24.921	23.689
6	2.343	2.239	7.959	7.989	2.493	2.307	23.851	22.842

Figure 5: Macrograph of Circular Saw CTB 11 3/4-24 no. 2, before testing, showing position locations

**Figure 6:** CTB 11 3/4-24 no. 2, after testing

**Figure 7:** CTB 11 3/4-24 no. 2, after testing

**Figure 8:** Circular Saw CTB 11 3/4-24 no. 2, after testing

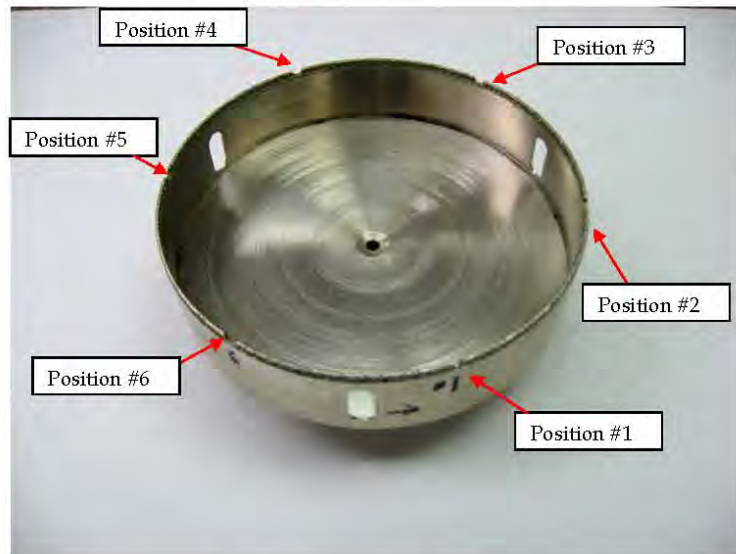
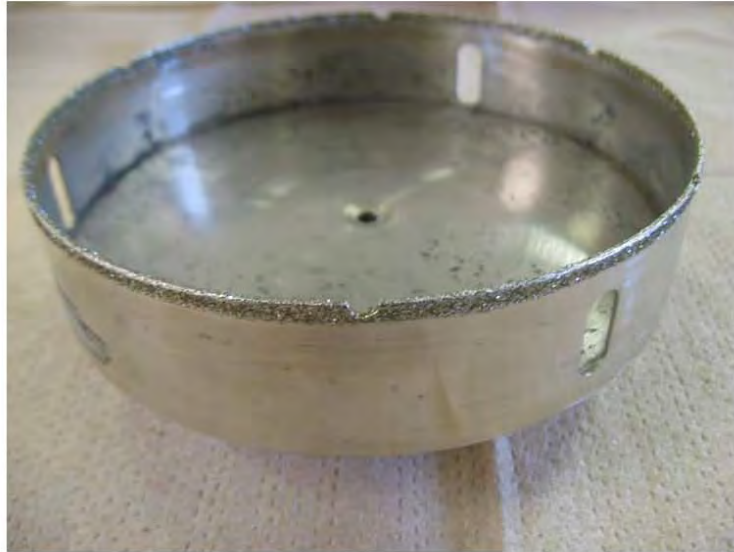
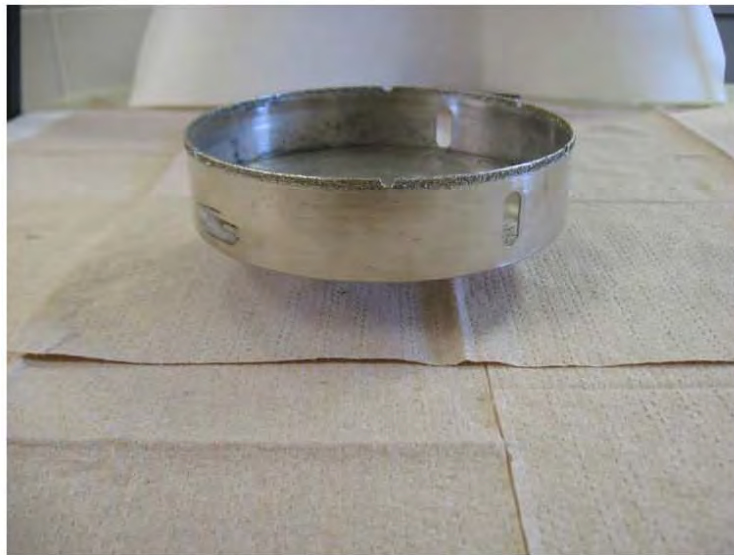
Position #	Before Test (mm)	After Test (mm)
1	35.454	35.426
2	35.592	35.512
3	35.412	35.380
4	35.788	35.584
5	35.460	35.370
6	35.620	35.436

Figure 9: Macrograph of Hole Saw 152 mm before testing, showing position locations

**Figure 10:** Hole Saw 152 mm after testing

**Figure 11:** Hole Saw 152 mm after testing

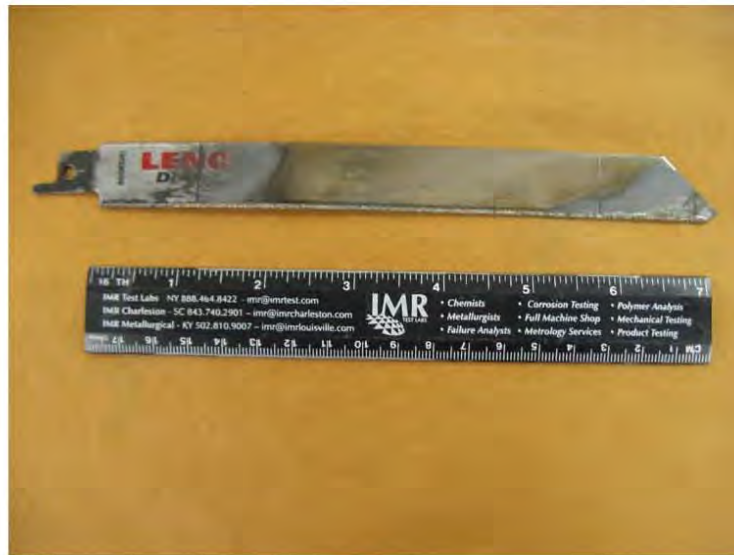
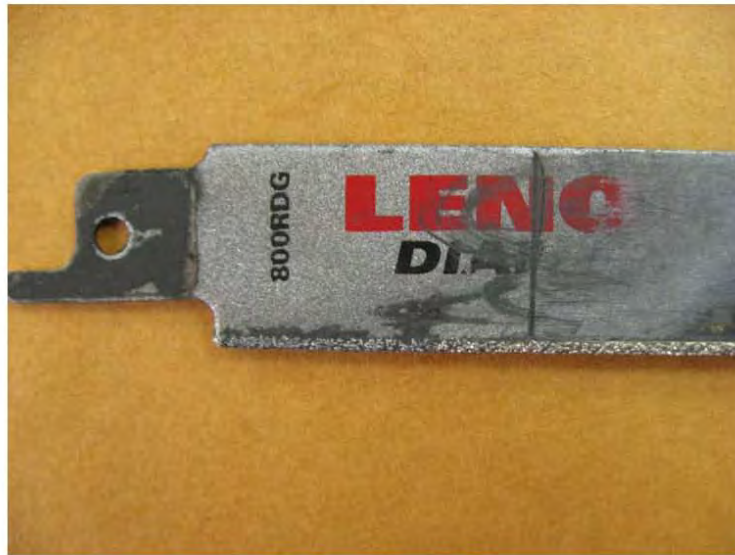
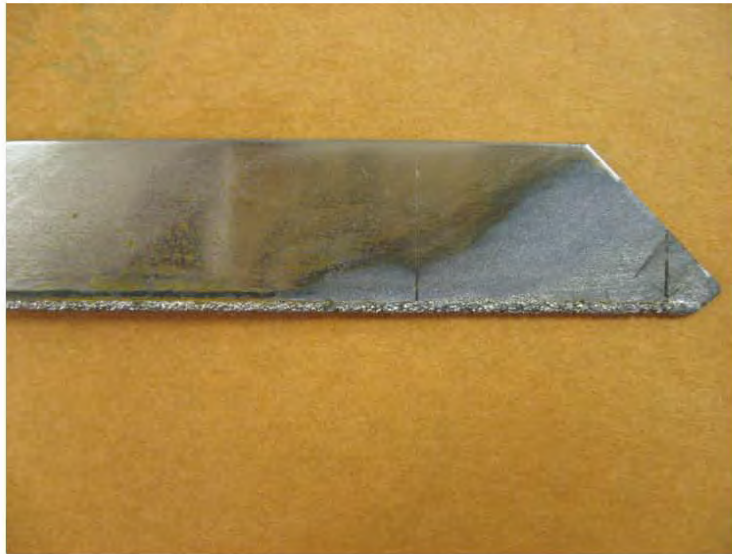
Lenox Diamond 800RDG

Position #	Results After Test (mm)
1	19.438
2	19.448
3	19.486
4	19.348
5	19.354
6	19.364

Figure 1: Lenox Diamond 800 RDG third round of testing

**Figure 2:** Lenox Diamond 800 RDG third round of testing

**Figure 3:** Lenox Diamond 800 RDG third round of testing

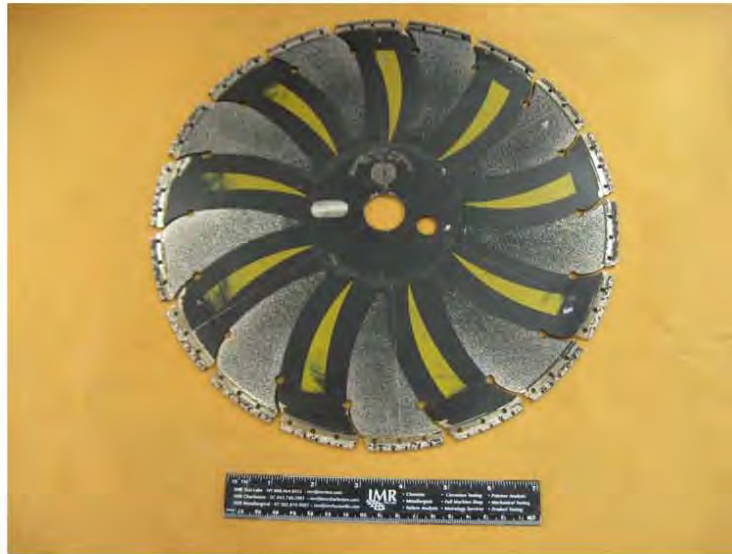
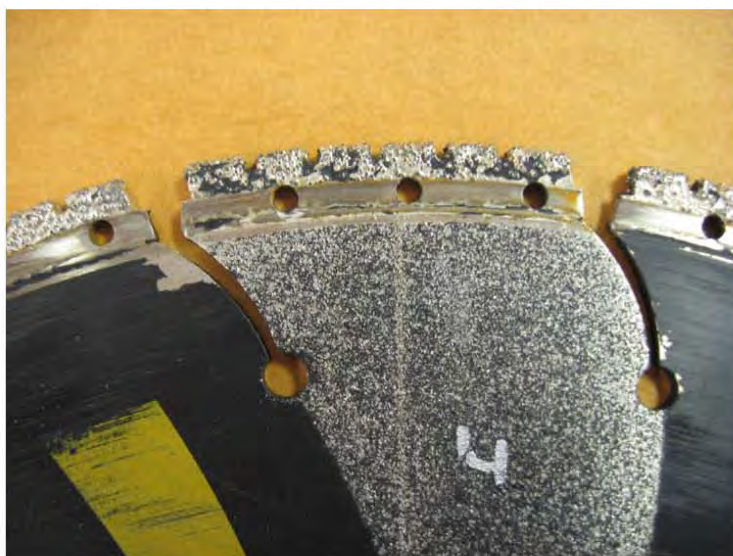
Circular Saw NDL 18772 - After Test

Tooth #	Position # 1 (mm)	Position # 2 (mm)	Position # 3 (mm)
1	6.960	6.994	7.095
2	6.927	6.960	6.788
3	6.994	6.893	6.893
4	6.926	6.825	6.964
5	6.960	7.028	6.927
6	6.859	6.758	6.859

Figure 4: Circular Saw NDL 18772 after third round of testing

**Figure 5:** Circular Saw NDL 18772 after third round of testing

**Figure 6:** Circular Saw NDL 18772 after third round of testing

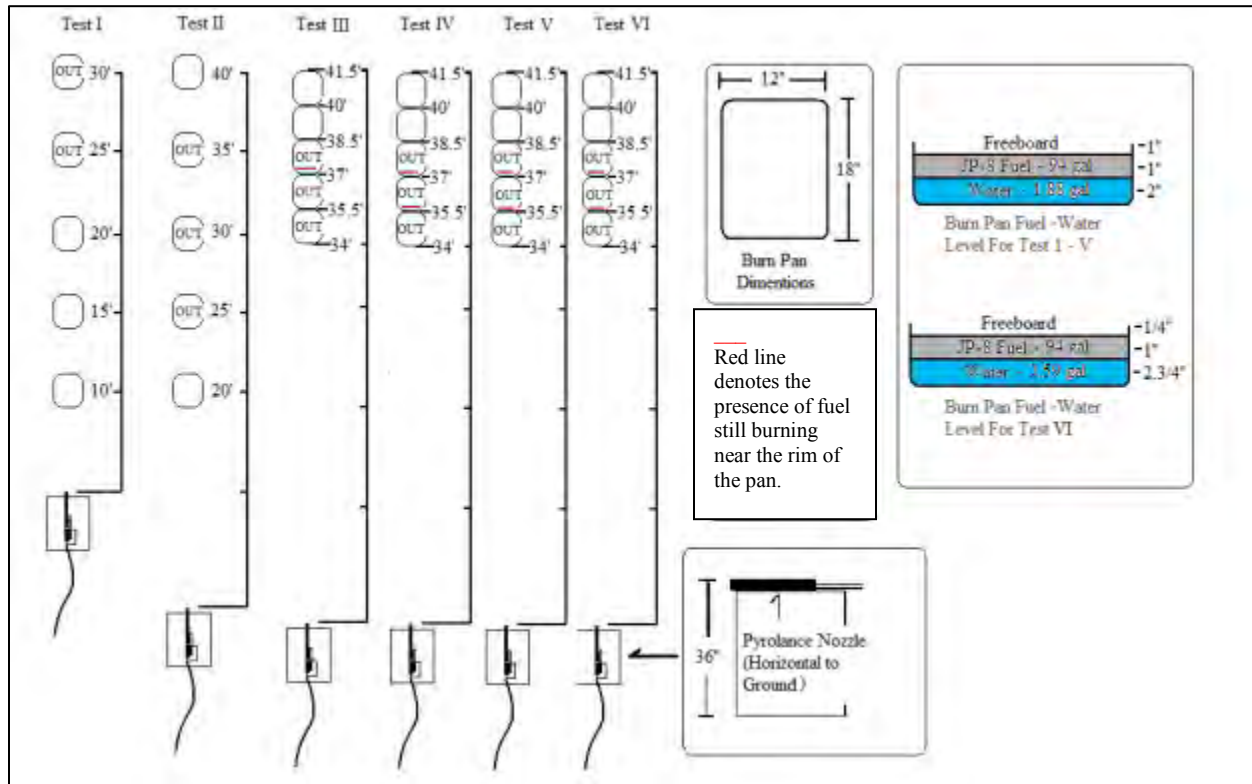
Figure D-1. Schematic of Pyrolance Throw Distance Testing

- Five pans measuring 12-in wide  $\times$  18-in long  $\times$  4-in deep were placed 5 ft apart on center.
- The nozzle was placed horizontally 36 in off the ground and 10 ft from first pan on center.
- The pans were filled with 2 in of water and 1 in of JP-8 allowing 1 in of freeboard.
- A 30 s pre-burn was accomplished after the last pan was ignited.
- The Pyrolance water tank was pre-mixed with 47 gallons of water and 3 gallons of 3% AFFF for a 6% concentration.
- The system was discharged for 60 s and the number of pans extinguished was recorded. Any pans not extinguished during testing were extinguished with a carbon dioxide handheld fire extinguisher.
- Pans 4 and 5 were extinguished during Test 1. Pan 5 was 30 ft 9 in from nozzle tip.

- The results from Test 2 were evaluated and the nozzle was moved back an additional 14 ft and placed. All five pans were spaced together to establish the maximum effective extinguishing distance  $\pm 1$  ft.
- The nozzle was placed horizontally 36 in off the ground and 34 ft from front lip of the first pan.
- Pans 1 and 2 were completely extinguished and pan 3 had some fuel near the front rim of the pan still burning. The small amount of area that remained burning in pan 3 was due to the 1 in of freeboard left in the pan reigniting the fuel. The maximum effective extinguishing distance was 37 ft.

- The results from Test 3 were evaluated and three additional tests were conducted to verify the effective extinguishment distance.
- Pan 1 was completely extinguished and pans 2 and 3 had some fuel near the front rim of the pan still burning. The maximum effective extinguishing distance was 35 ft 6 in for all three tests.
