## **EVALUATION OF PROTECTION SCHEMES FOR ULTRAHIGH-STRENGTH STEEL ALLOYS FOR LANDING GEAR APPLICATIONS**

C. Kern, K. Sassaman, and C. Kuehmann  
QuesTek Innovations LLC  
1820 Ridge Avenue  
Evanston, IL 60201

### **ABSTRACT**

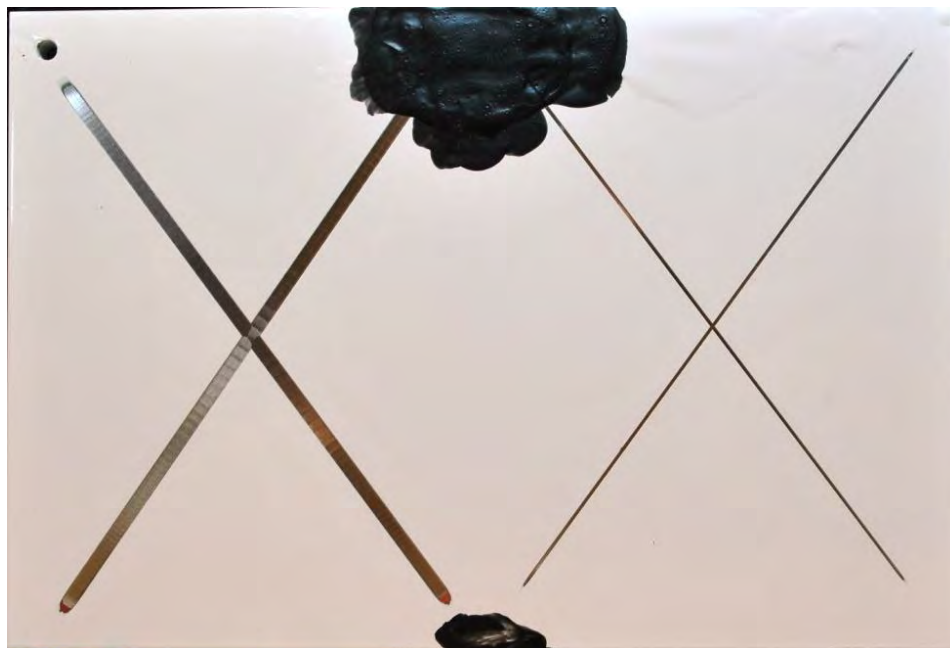
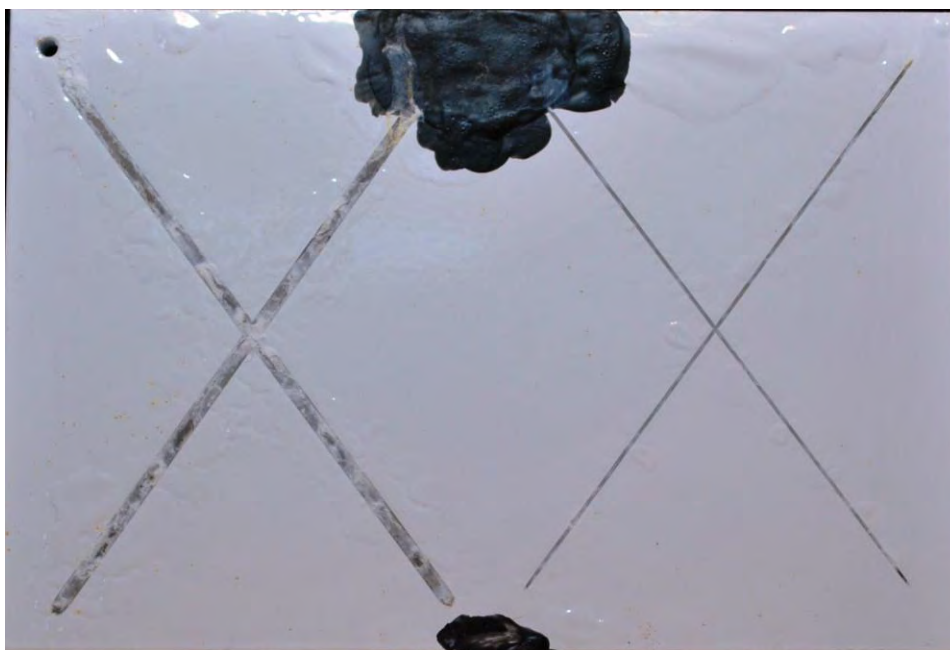
**Figure 35 - UNS K91973 test panel with zinc-nickel, phosphate, pre-primer, primer, and paint protection scheme prior to test (top) and after 500 hour test (bottom) per ASTM B117. Blistering of the paint was observed near the scribes.**

UNS K91973 (zinc-nickel + phosphate + pre-primer + primer + paint). The UNS K91973 panel with the zinc-nickel, phosphate, pre-primer, primer, and paint protection scheme exhibited medium-dense to dense blistering along both the 2.5 mm and the 0.5 mm scribes, as seen in Figure 35. Figure 36 shows regions of zinc-nickel oxide and base metal in the 2.5 mm scribe intersection and along the scribe line. Zinc-nickel oxide and base metal were also the only constituents present in the 0.5 mm scribe intersection and along the scribe line, as seen in Figure 37.
