TEMPERATURE AND PRESSURE PROFILES
OBTAINED DURING BURN OF A
SIDEWINDER MARK 17 MOD 5 MOTOR
IN A 15,300 CUBIC-FOOT MAGAZINE

DL Technical Report No. TR-3139
September 1974

TEMPERATURE AND PRESSURE PROFILES OBTAINED
DURING BURN OF A SIDEWINDER MK 17 MOD 5 MOTOR IN A
15,300 CUBIC-FOOT MAGAZINE

ABSTRACT

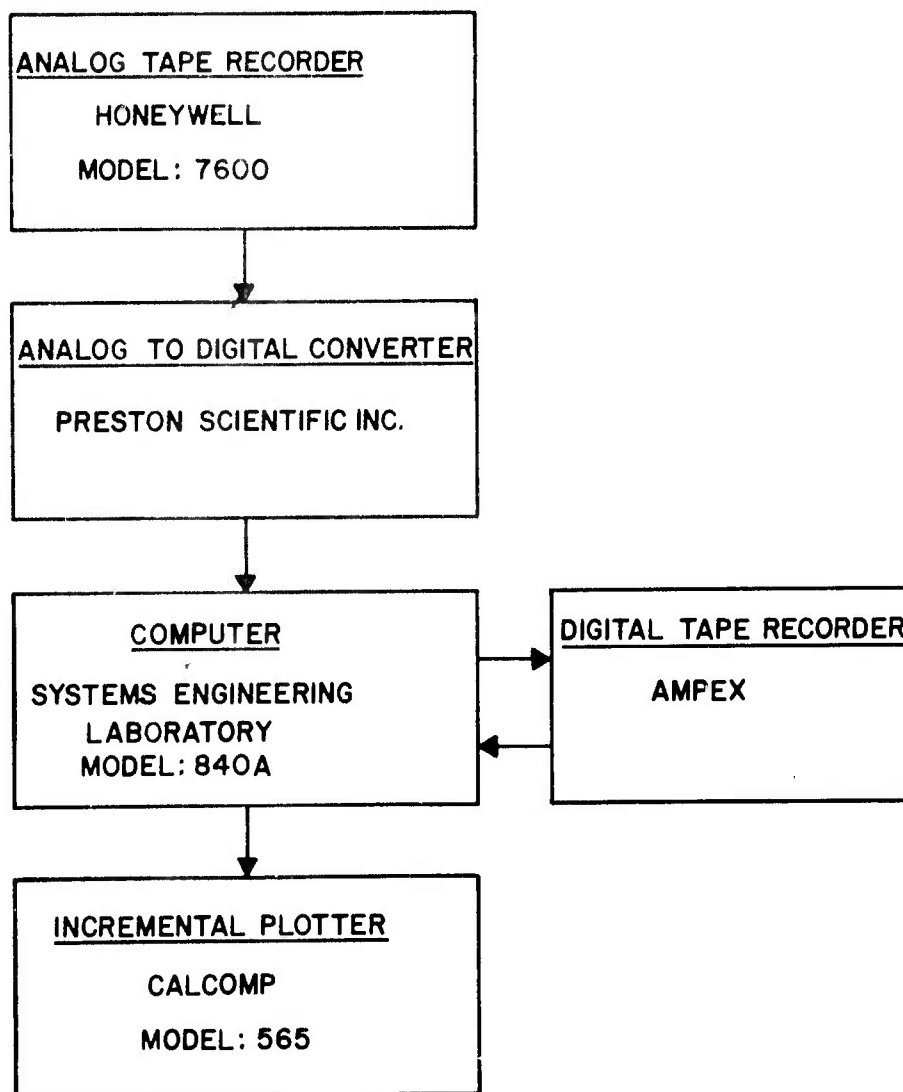
FIGURE A-6

Pressure Data Reduction System

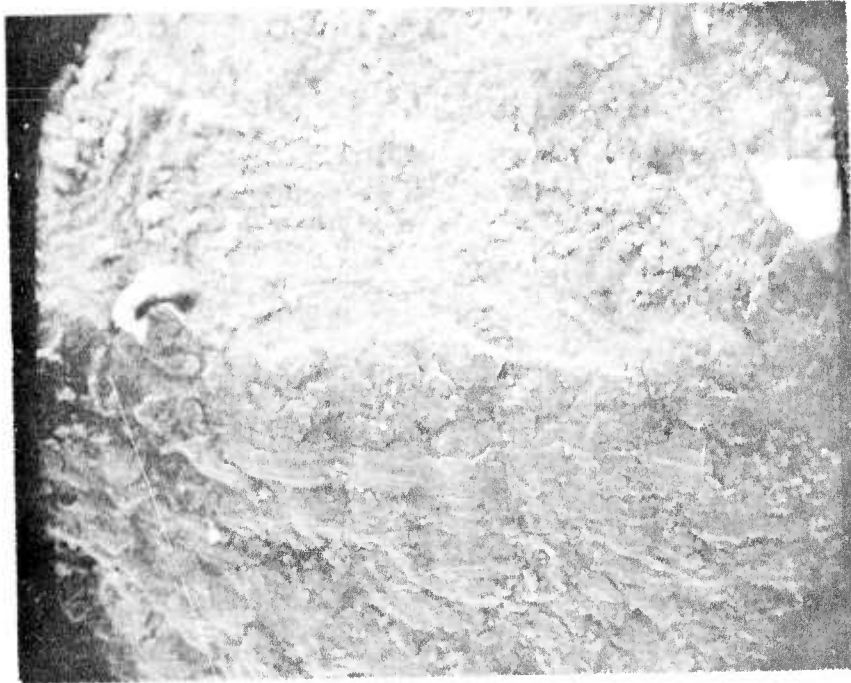
FIGURE D-4

**Electron Microscope Photograph of Ruptured Vent Shear-Bolt
Test No. 2 7 August 1973**

(5) The magazine vented 1.7 seconds after motor ignition. Venting occurred through a 1.23-sq-ft opening. Failure of the blow-out patch shear-bolt (notched to release at 15 psig) resulted in premature magazine venting. Figure 4 of Appendix D (an electron microscope photograph of the recovered shear-bolt) shows the oxides (dark areas) formed in the stress fracture in the shear-bolt. The stress fracture occurred during the first test and the oxides were formed during the time interval between Test No. 1 and Test No. 2.
