J79-15/-17 TURBOJET ENGINE ACCIDENT INVESTIGATION PROCEDURES

F-4 SYSTEM PROGRAM OFFICE

AUGUST 1975

TECHNICAL REPORT ASD-TR-75-19

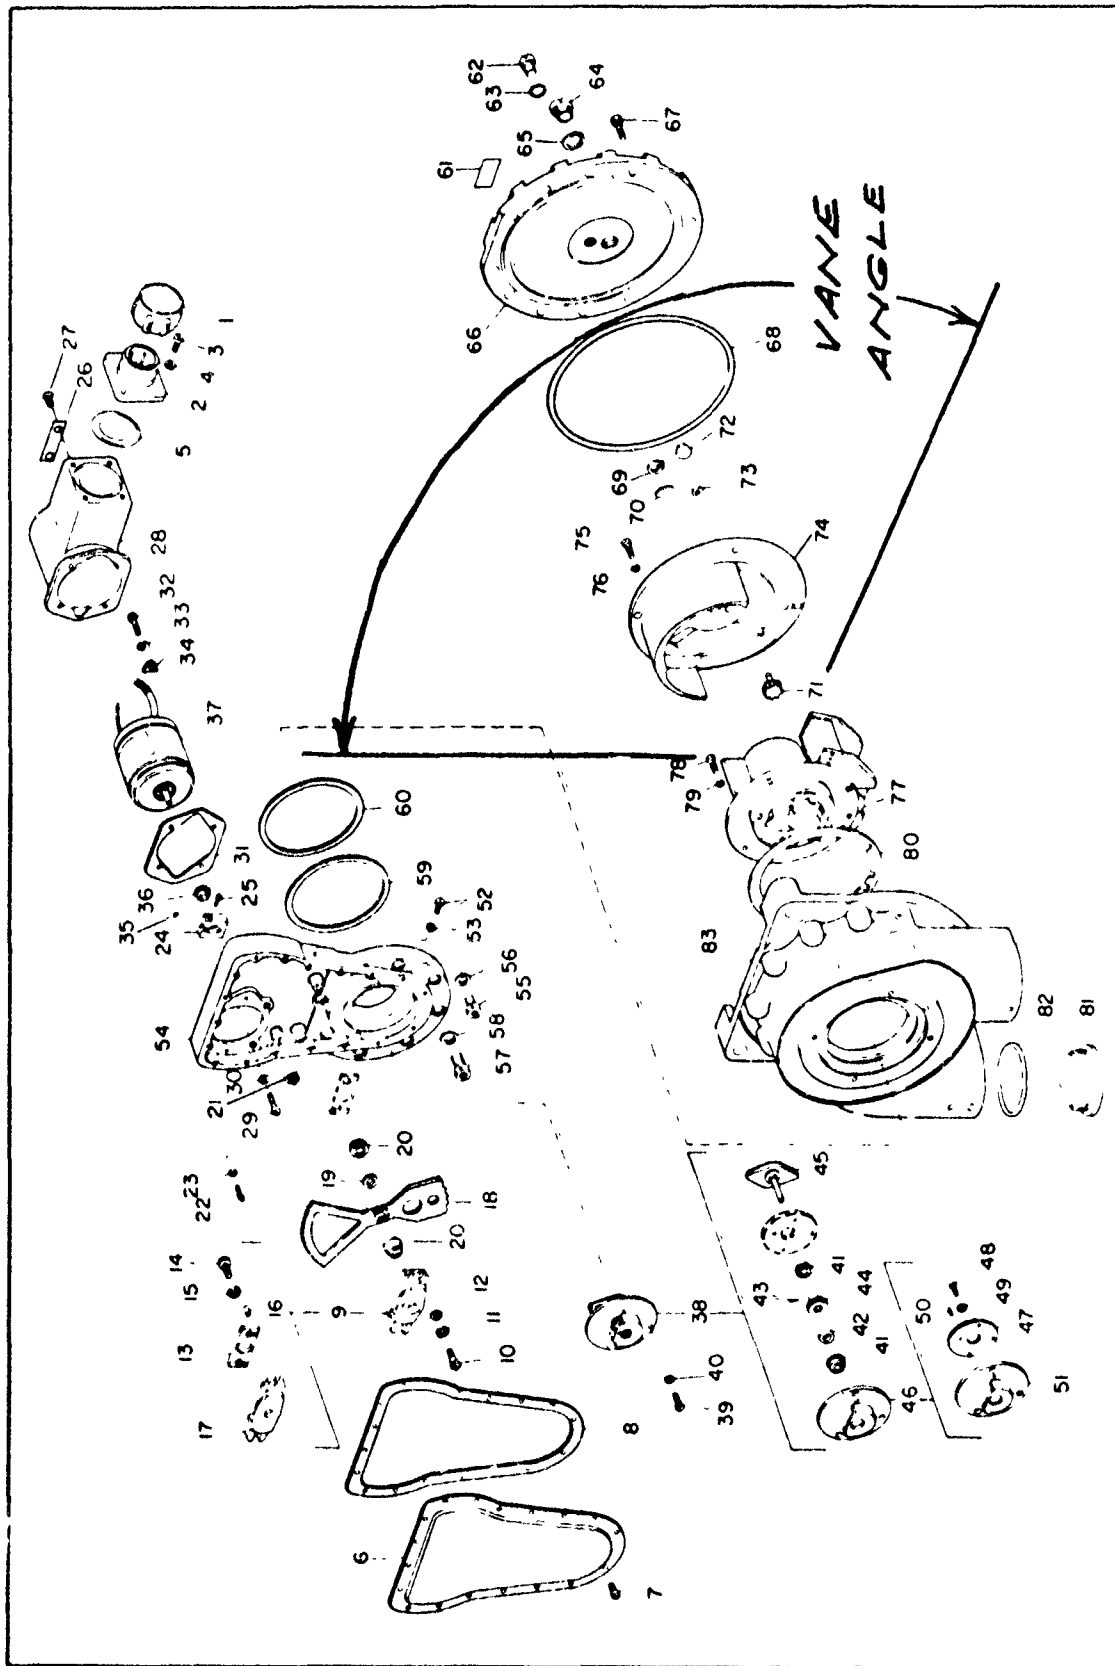
Figure 2 Exploded View - Main Assembly, Fuel Flow Transmitter, Part No. 9115-16-A1A

The vane of the damping mechanism assembly (Item 77, Figure 2) is under spring tension and rests against the tongue in the zero flow position. As flow rate increases, the vane rotates. The vane angle is a function of the fuel flow rate (Figure 3). The vane angle is measured on the damping mechanism assembly between the tongue on the zero flow side and the vane.

To determine fuel flow rate at time of impact, remove the bottom cover (Item 66, Figure 2) of the fuel flow transmitter. The vane may be stuck in the position it was in at time of impact. If so, measure the vane angle and from Figure 3 determine the fuel flow rate. If the vane is not stuck, examine the face of the damping mechanism assembly to see if the vane made an imprint on the face at time of impact. From this vane imprint, determine the vane angle at time of impact and determine the flow rate from Figure 3.

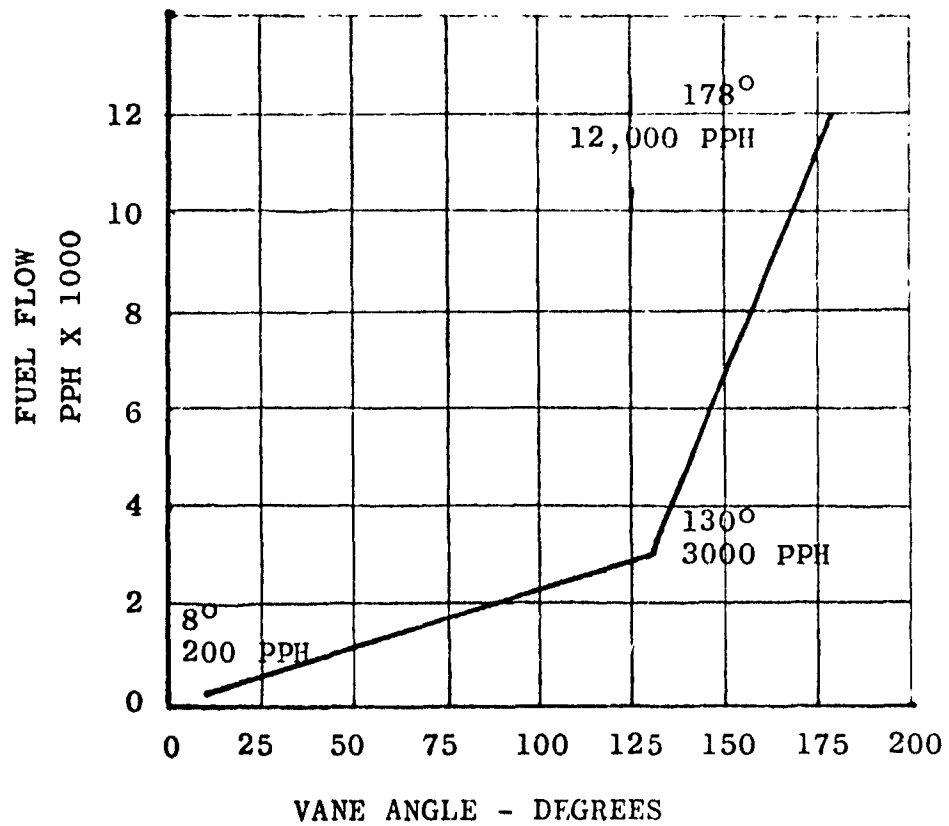
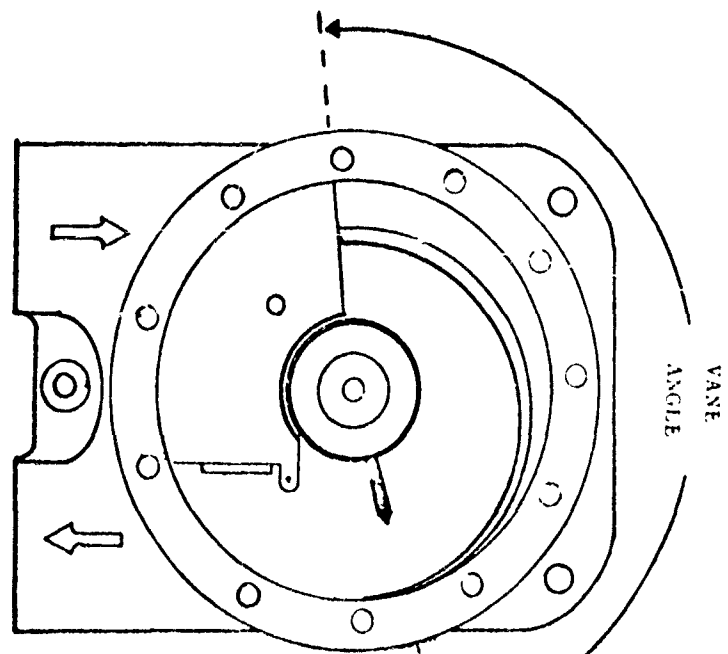
Figure 3 - Fuel Flow Transmitter Flow vs Angle (Typical For F4/J79 Installation)

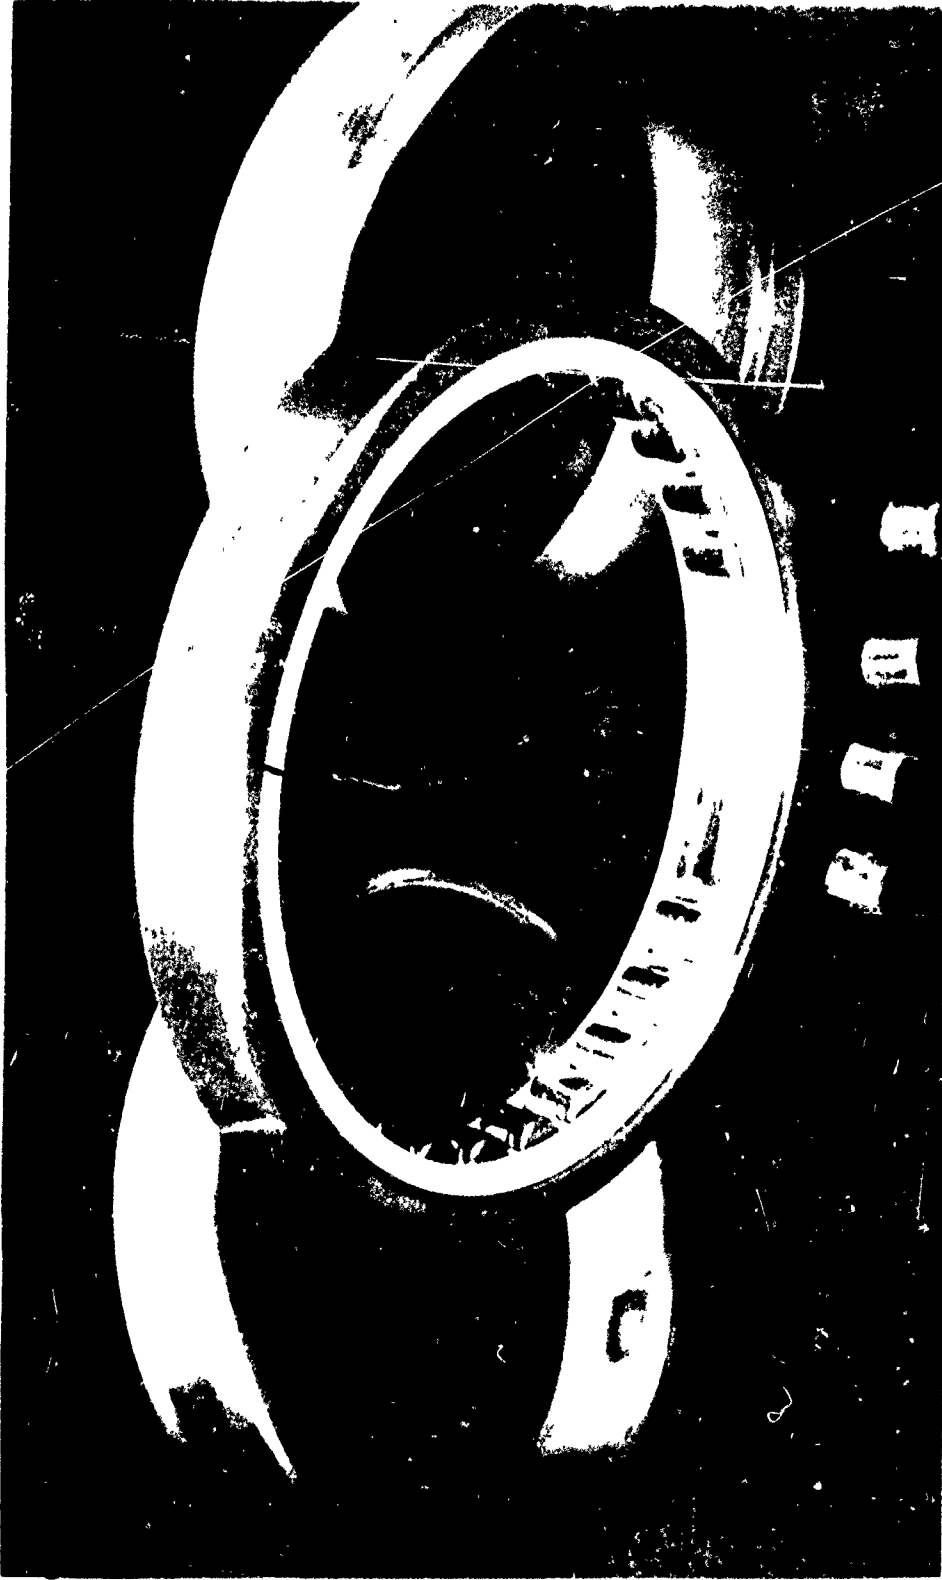
Figure 5 - Number Three Bearing Failure Type of Failure Associated with Misalignment

Bearings may fail because of off-squareness or misalignment during installation. For example, an electric pencil used to etch a number on the outer ring face can raise the metal on the bearing surface from .0004 to .0006 inch. The face then far exceeds the raceway to face run-out tolerance of 0.00015 inch. Burrs and foreign particles will have the same effect as the electric pencil. Any misalignment causes overloading of the bearing. Improper loading is indicated by metal transfer or a cocked ball-path on the bearing races. Misalignment can also cause broken retainer rings and can split bearing balls into two equal half balls. See Figure 5.

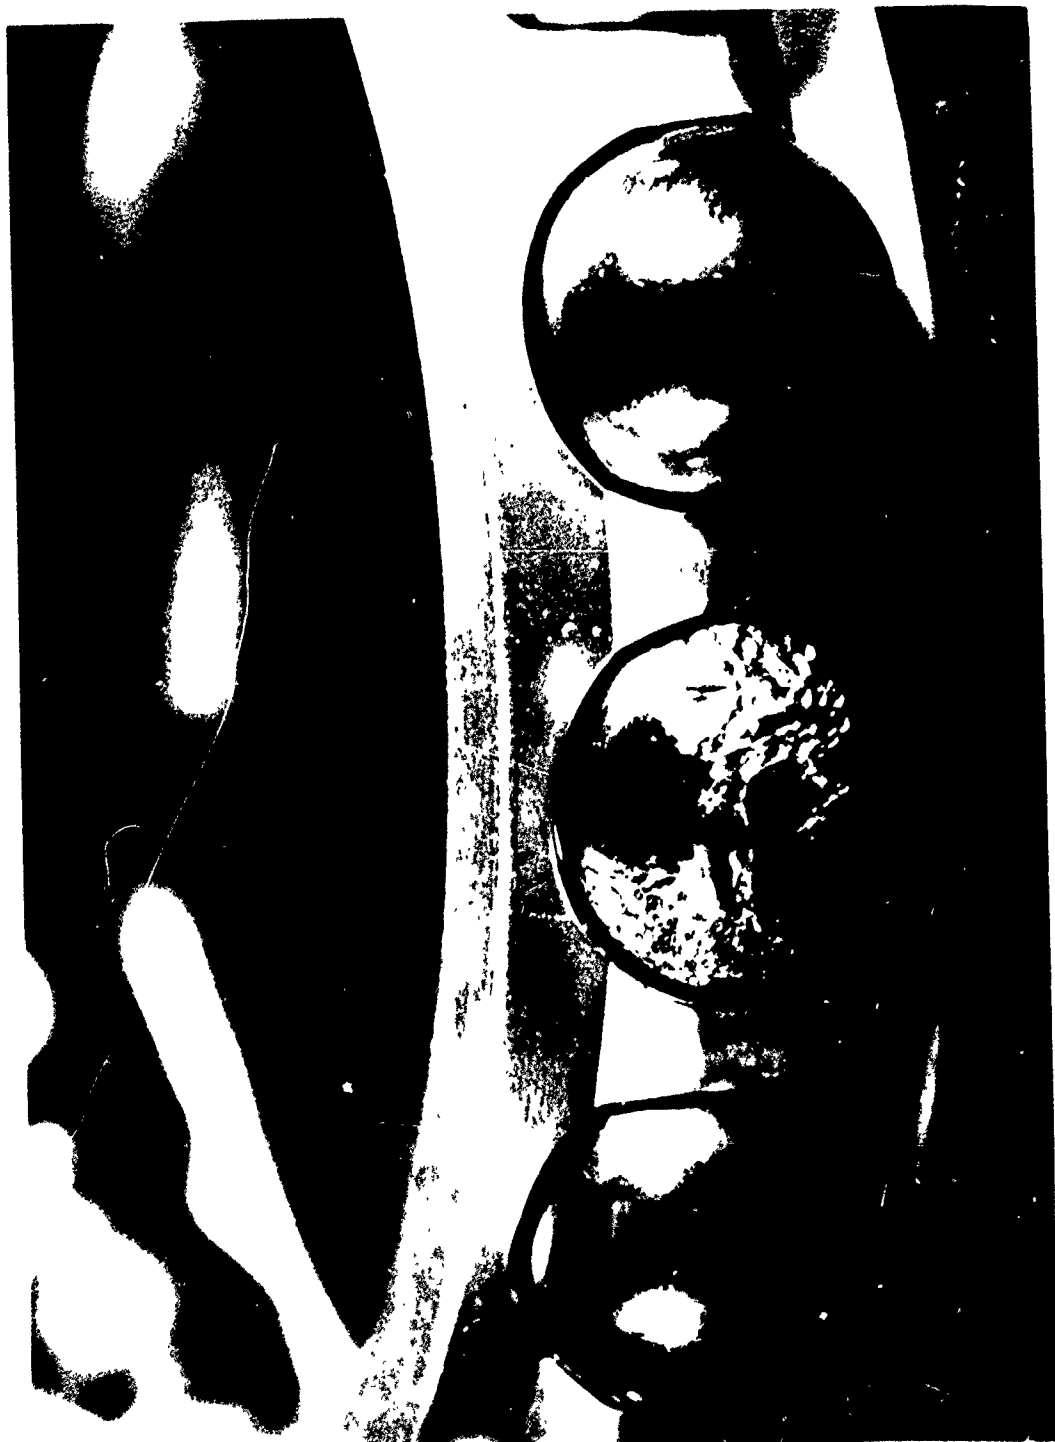
Figure 6 - Thrust Bearing Failure from Fatigue and Spalling of the Balls

Bearing fatigue is caused by repeated shock, stress, or excessive loading. Bearing age is also a contributing factor. See Figure 6.

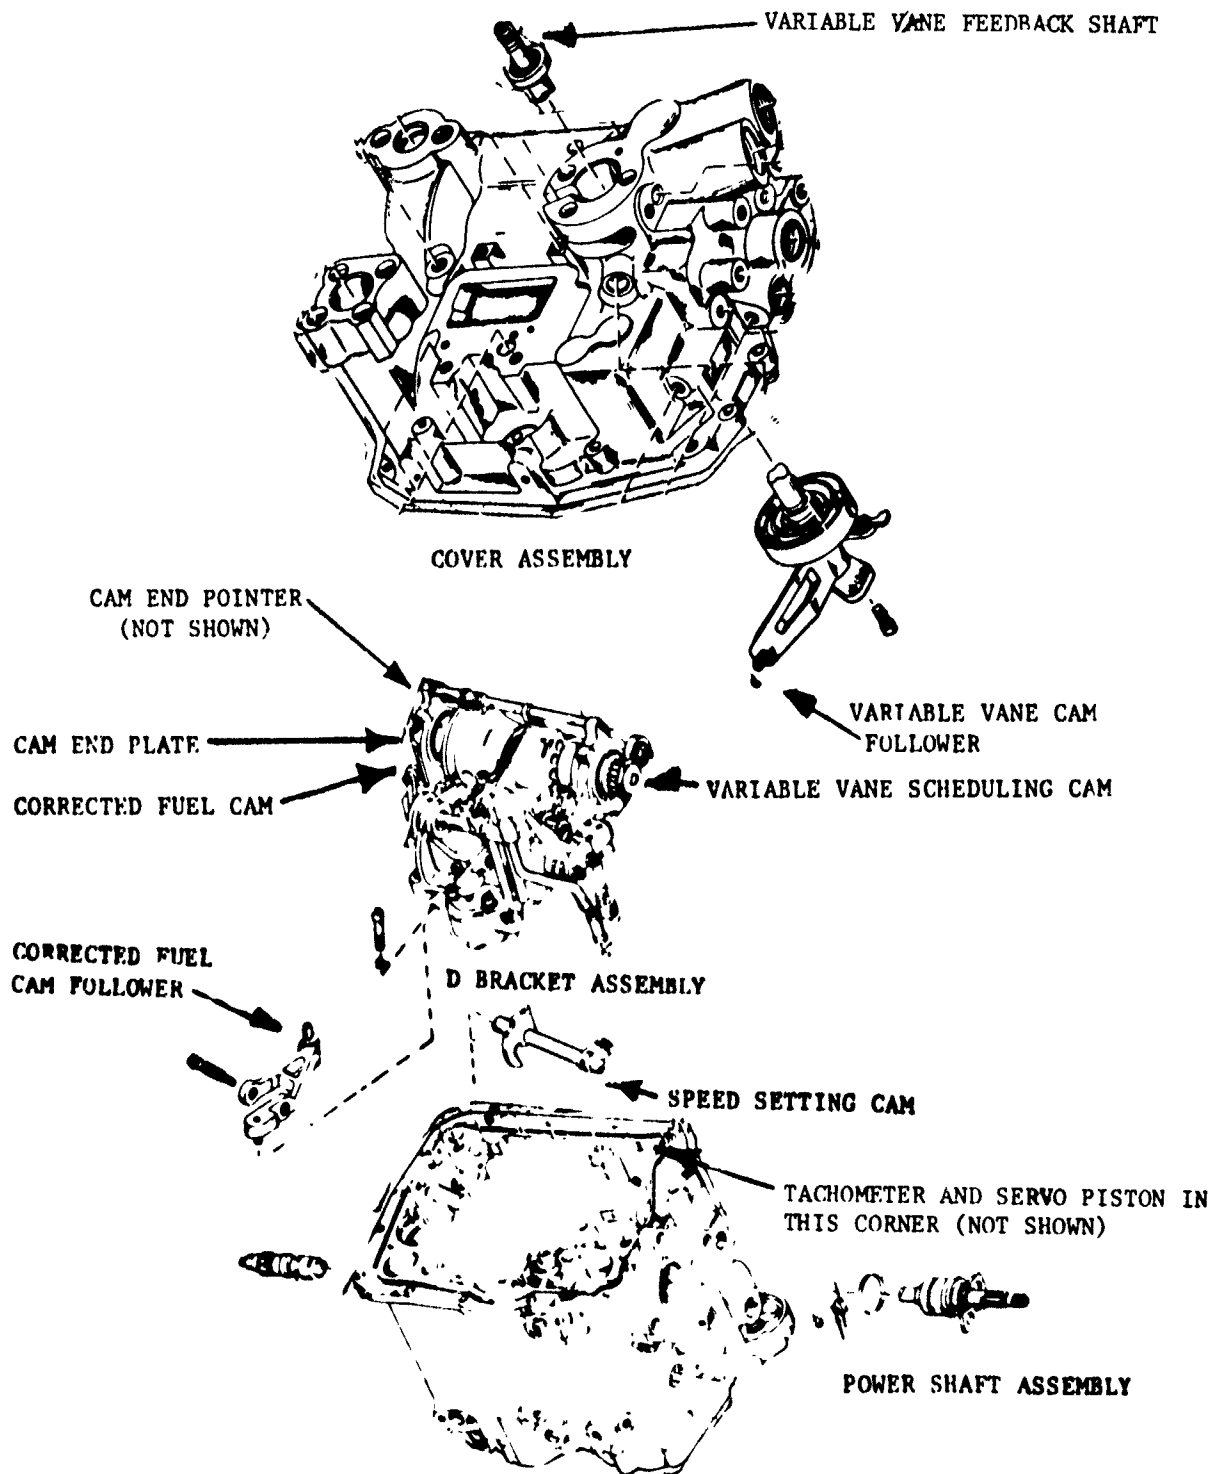
FIGURE 7 MAIN FUEL CONTROL J79-15 AND -17

In order to use the components within the main fuel control for RPM determination, remove the control cover assembly by removing the fifteen screws around the periphery of the assembly, See Figure 7. This exposes the tach rack, tach servo piston, 3D bracket, and 3D shaft assembly consisting of corrected fuel cam and variable vane scheduling cam.

The tachometer servo piston may be used for RPM determination, Figure 7. The distance (X) as seen in Figure 8 should be measured prior to disturbing the remainder of the internal parts of the control. After this measurement has been taken, the percent RPM may be determined from the chart at the top of Figure 8.

On the left end of the 3D shaft assembly, as seen in Figure 7, may be found the cam end plate and the cam end pointer. The zero degree cam angle for the end plate is 95° clockwise from the index hole in the end plate. Change in engine RPM rotates the 3D shaft assembly. Changes in compressor inlet temperature (CIT) translates the 3D shaft. If the shaft assembly is jammed as a result of the impact, the number of degrees that the end pointer indicates from the above described zero degree mark should be measured in a counter clockwise direction. After this has been accomplished, the chart in Figure 9 should be used to determine the percent RPM that the engine was operating at the time of impact.

The inlet guide vane feedback box mounted on the variable vane feedback shaft of the main fuel control (Figures 7 and 13) may be used for variable vane position determination. Measure the over-travel X, as shown at the bottom of Figure 11. Use the chart at the top of Figure 11 to determine the degree open

The compressor inlet temperature (CIT) can be determined by measuring the distance between the 3D cam end plate and the end bracket (as shown in Figure 17). The 3D cam end plate and the end bracket are within the main fuel control (Figure 7). If the CIT is to be determined by another method, such as by

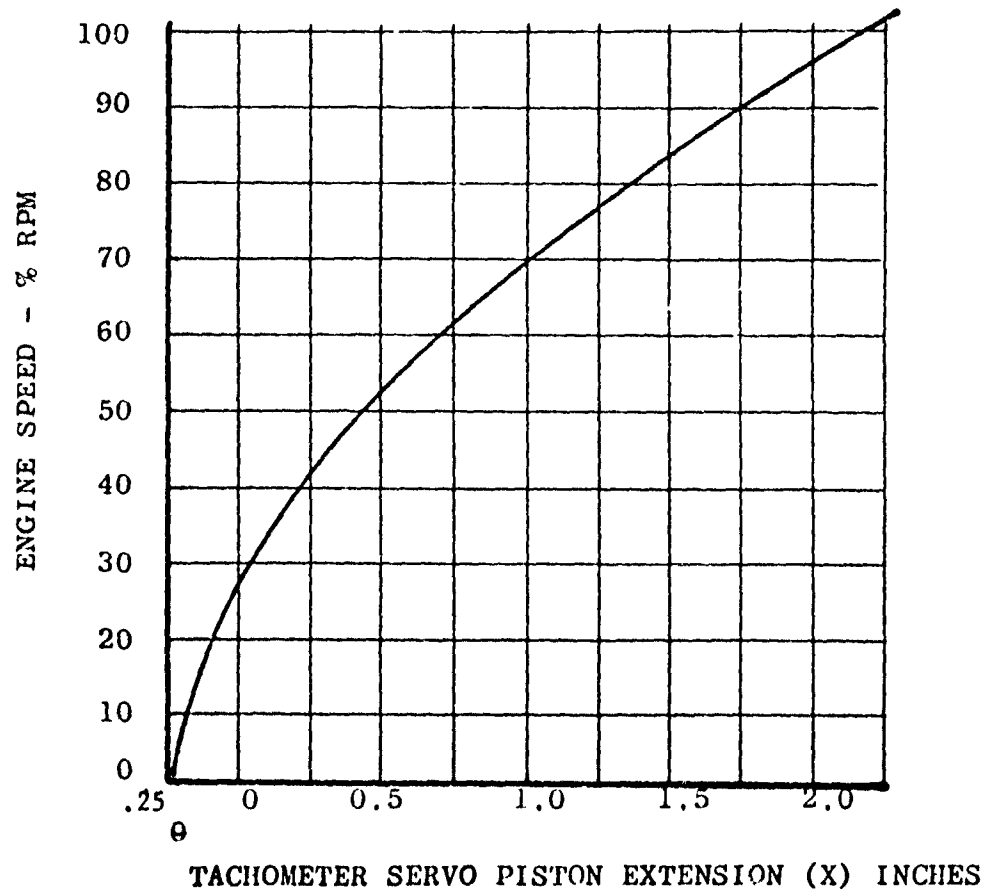
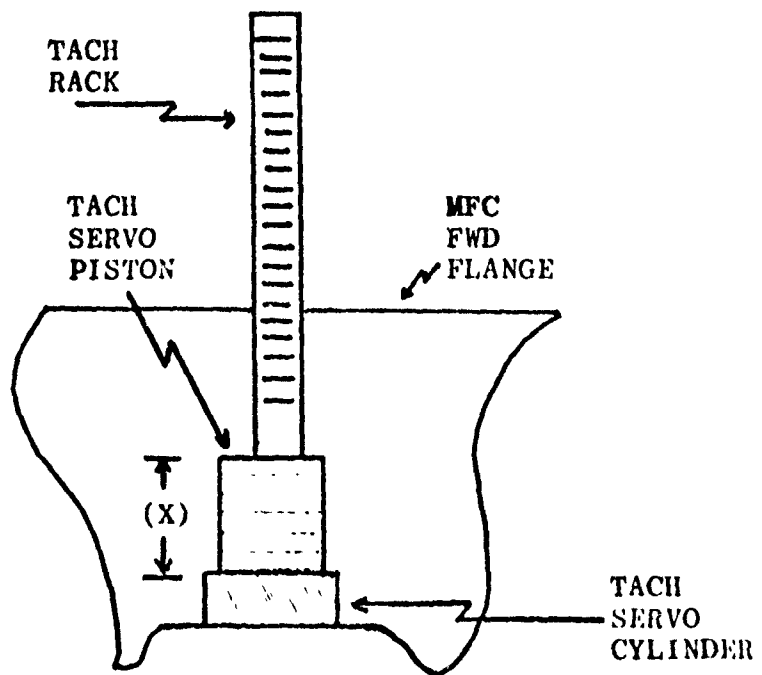
Figure 8 - J79-15/-17 Main Fuel Control Tachometer Servo Piston Extension vs Percent RPM

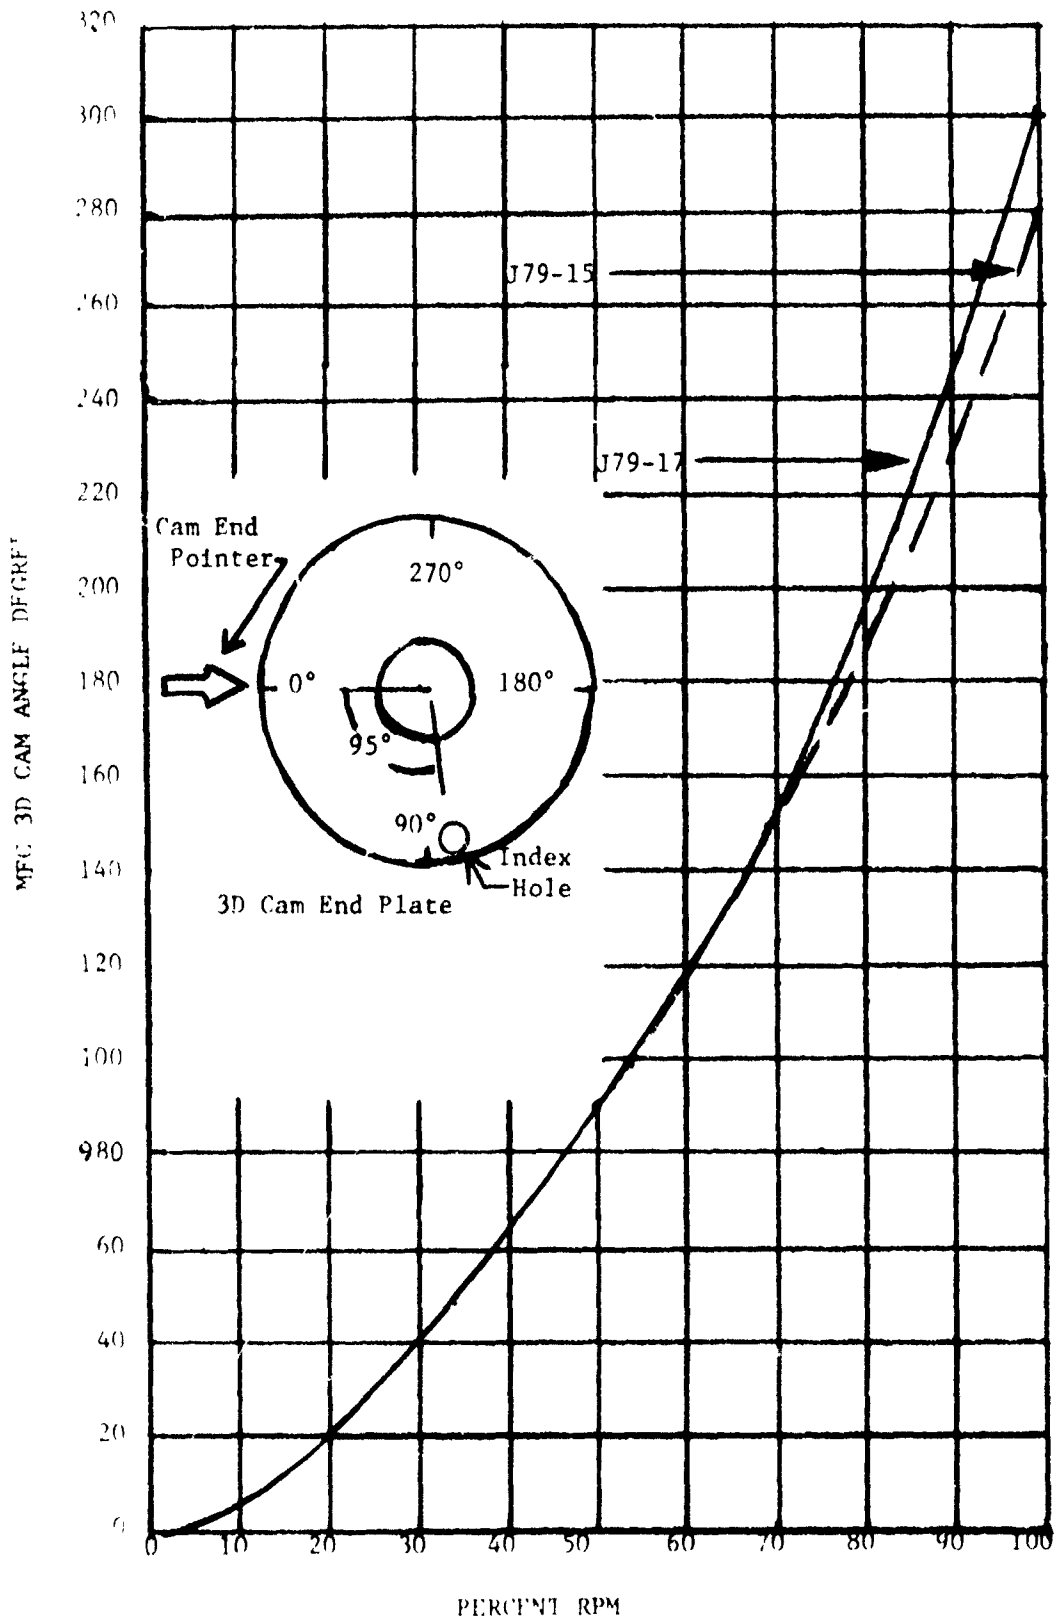
Figure 9 - 3D Cam Angle vs RPM

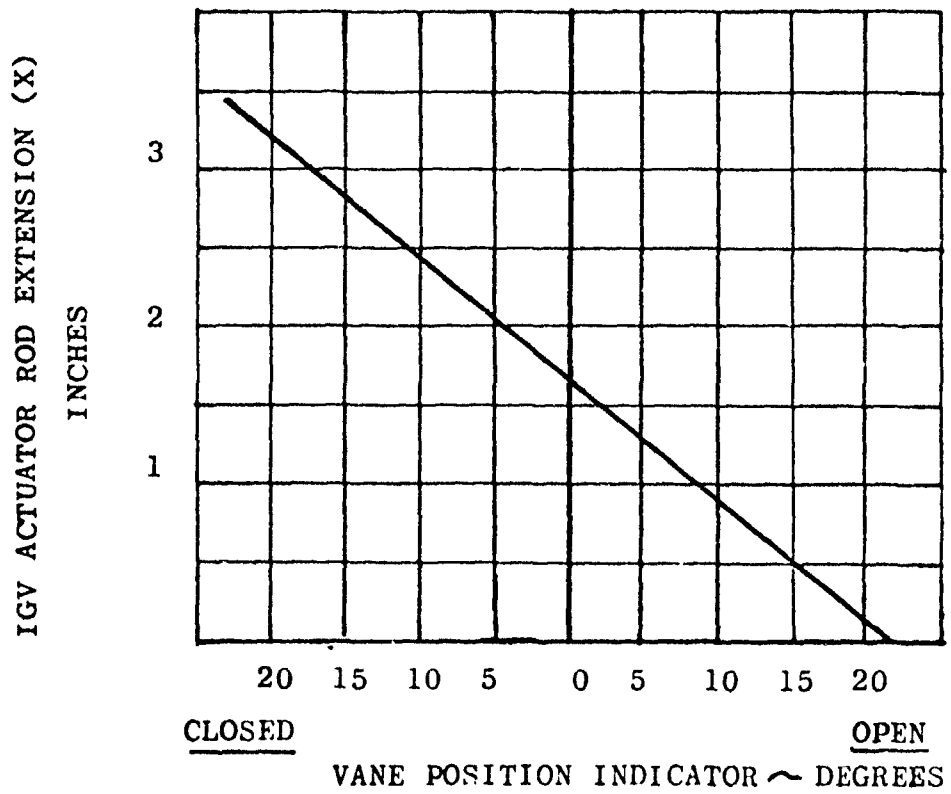
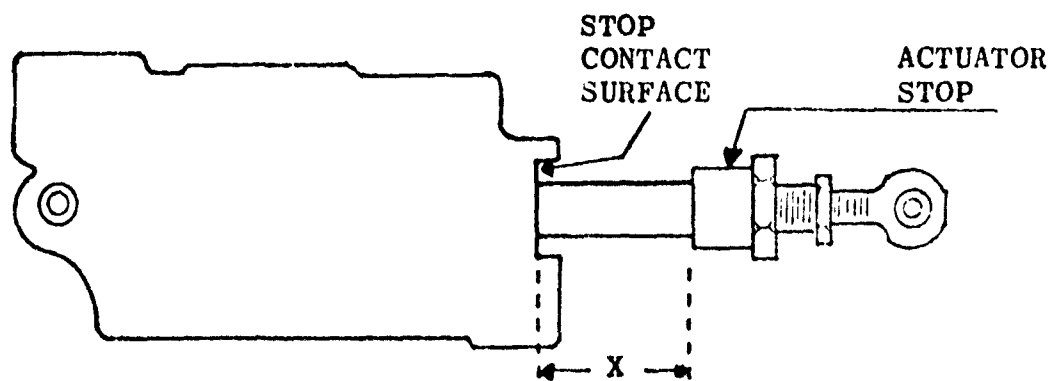
Figure 10 - J79-15/-17 IGV Actuator Rod Extension vs Vane Position Indicator

As may be seen in Figure 12, there is a definite relationship between the variable vane positions and RPM for a given compressor inlet temperature. The position of the variable vane actuators may be used to determine the position of the variable vanes. For this determination measure the distance X as shown on the bottom of Figure 10. After this extension has been measured, use the chart at the top of Figure 10 to determine the degree open or closed for the variable vanes.

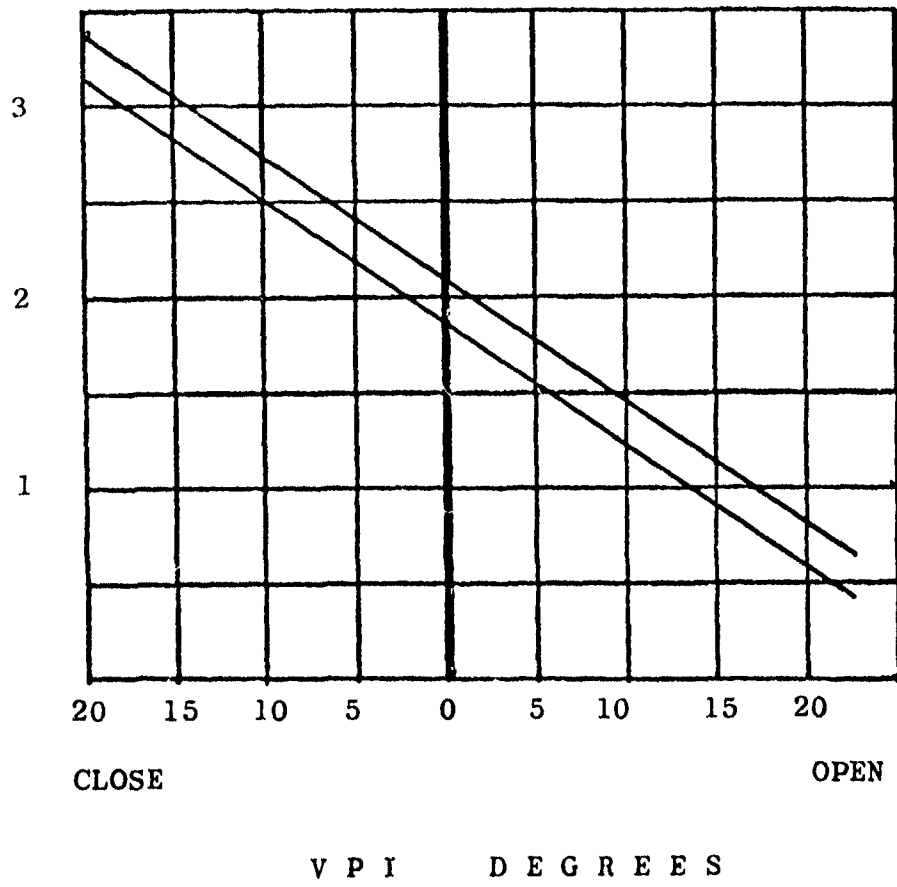
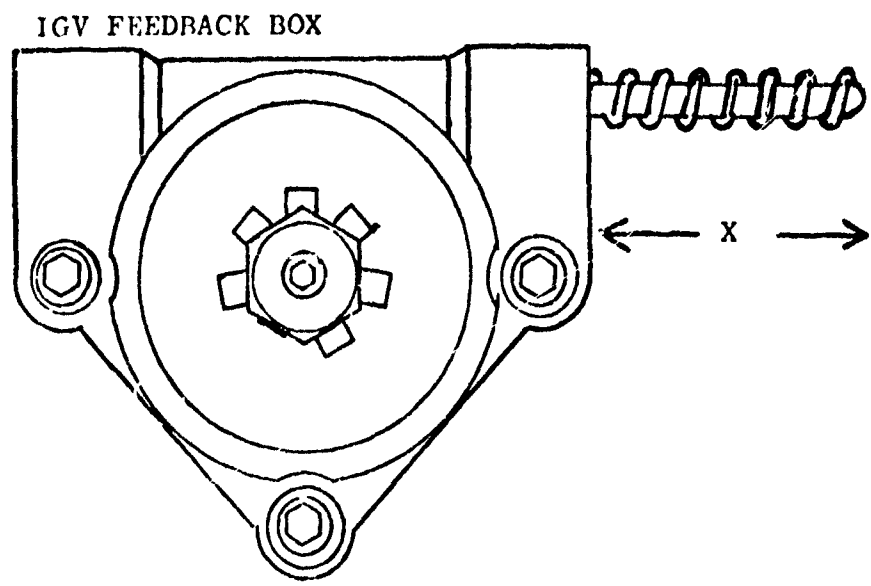
IGV FEEDBACK
OVERTRAVEL "X" INCH

Figure 11 - J79-15/-17 IGV Feedback Overtravel vs VPI Degrees

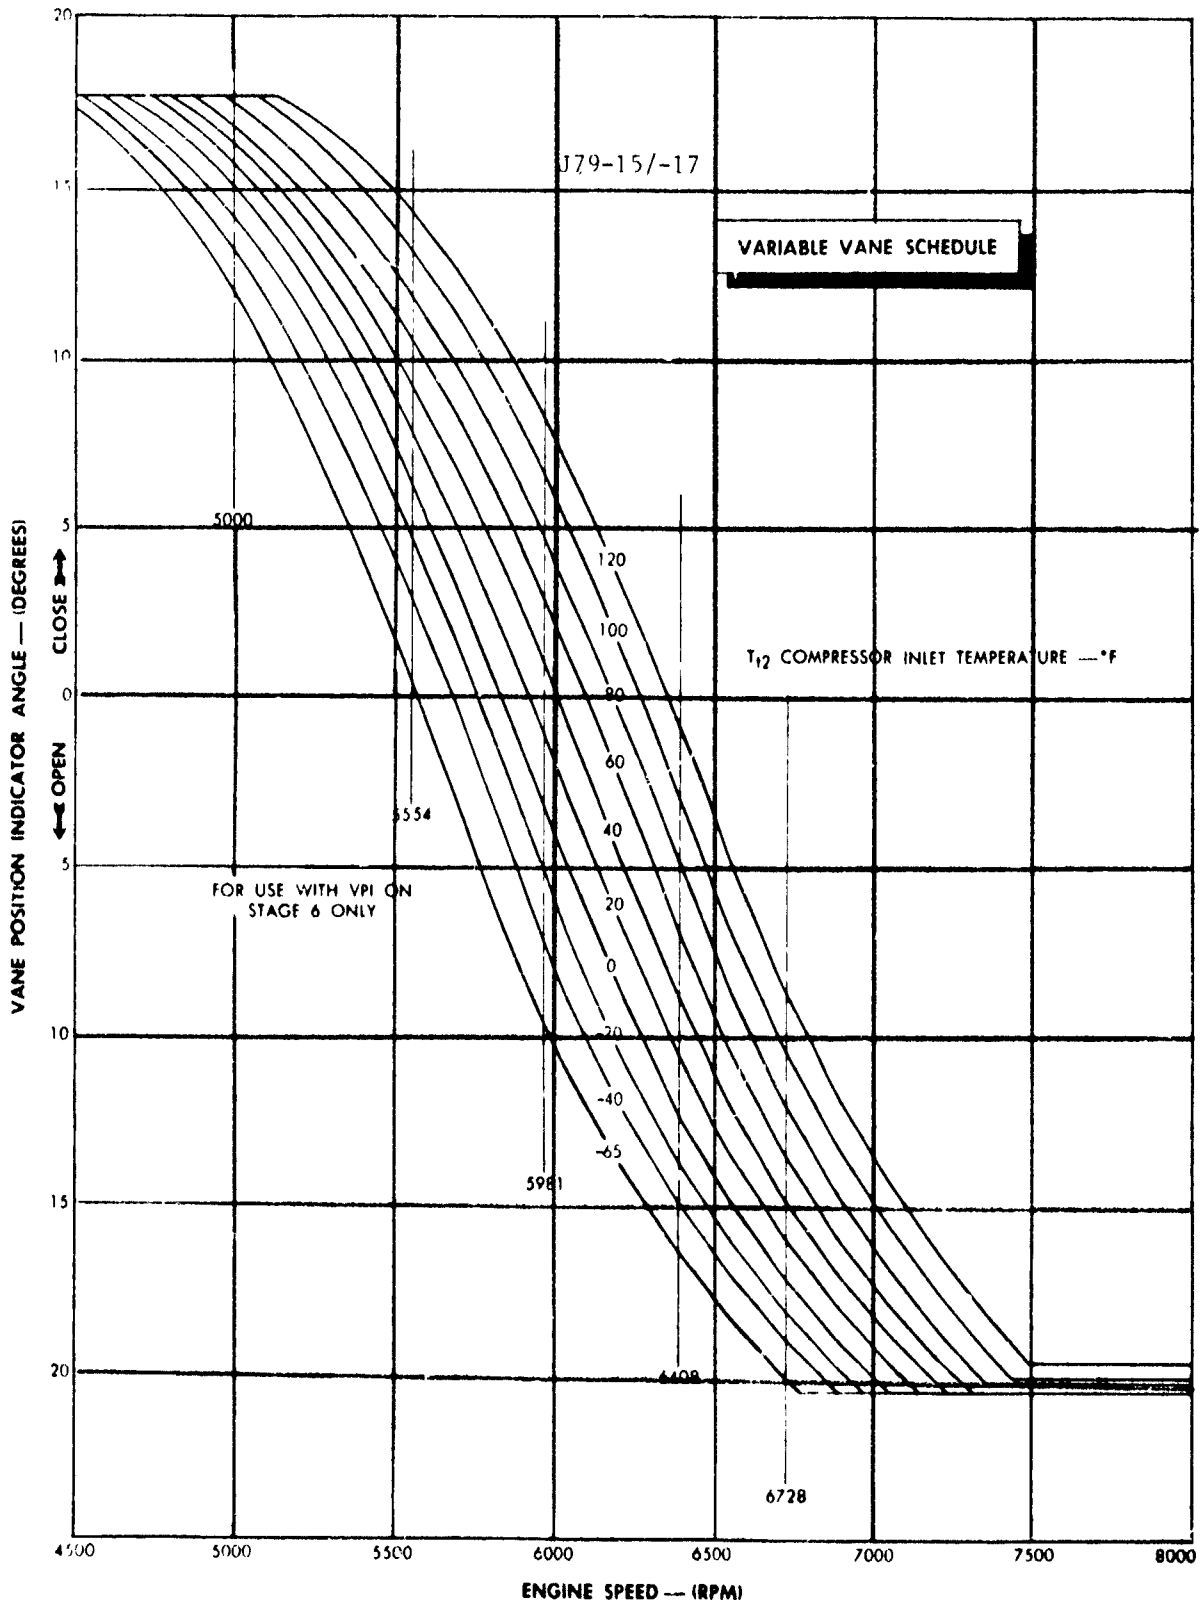
Figure 12 Variable Vane Schedule
-33-

Knowing the variable vane position and the CIT, the RPM can be determined from Figure 12.

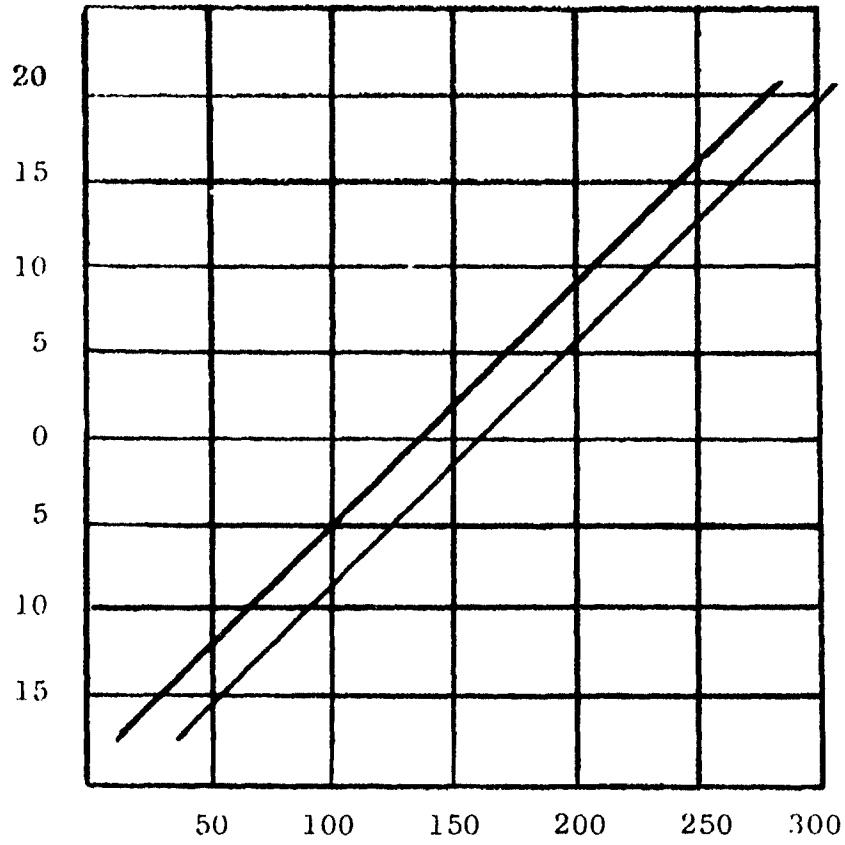
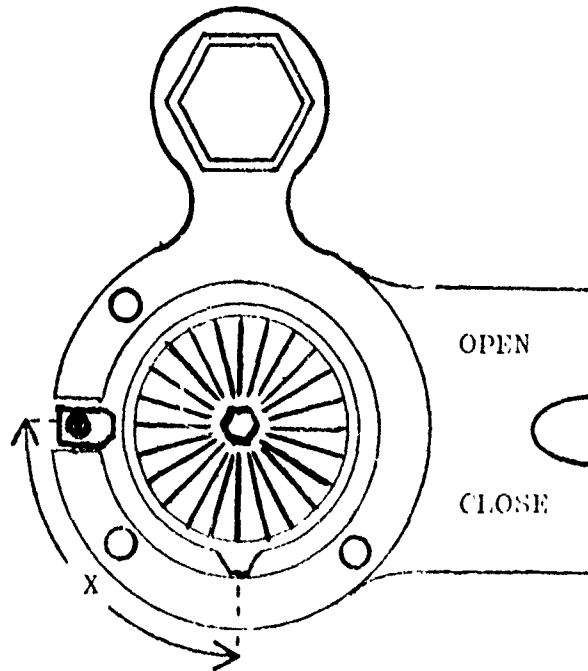
Figure 14 - Main Fuel Control IG V Feedback Position vs Vane Position Indicator Setting

The position of the indicator on the variable vane feedback shaft, with respect to the stop block as shown in Figure 14, may also be used for variable vane position determination. To use this method the feedback box must be removed from the feedback shaft. Care should be exercised in removing the nut on the end of the shaft to prevent turning the shaft. The degree X should be measured as shown in Figure 14. This measurement should be applied to the chart at the top of Figure 14 to determine the vane position.

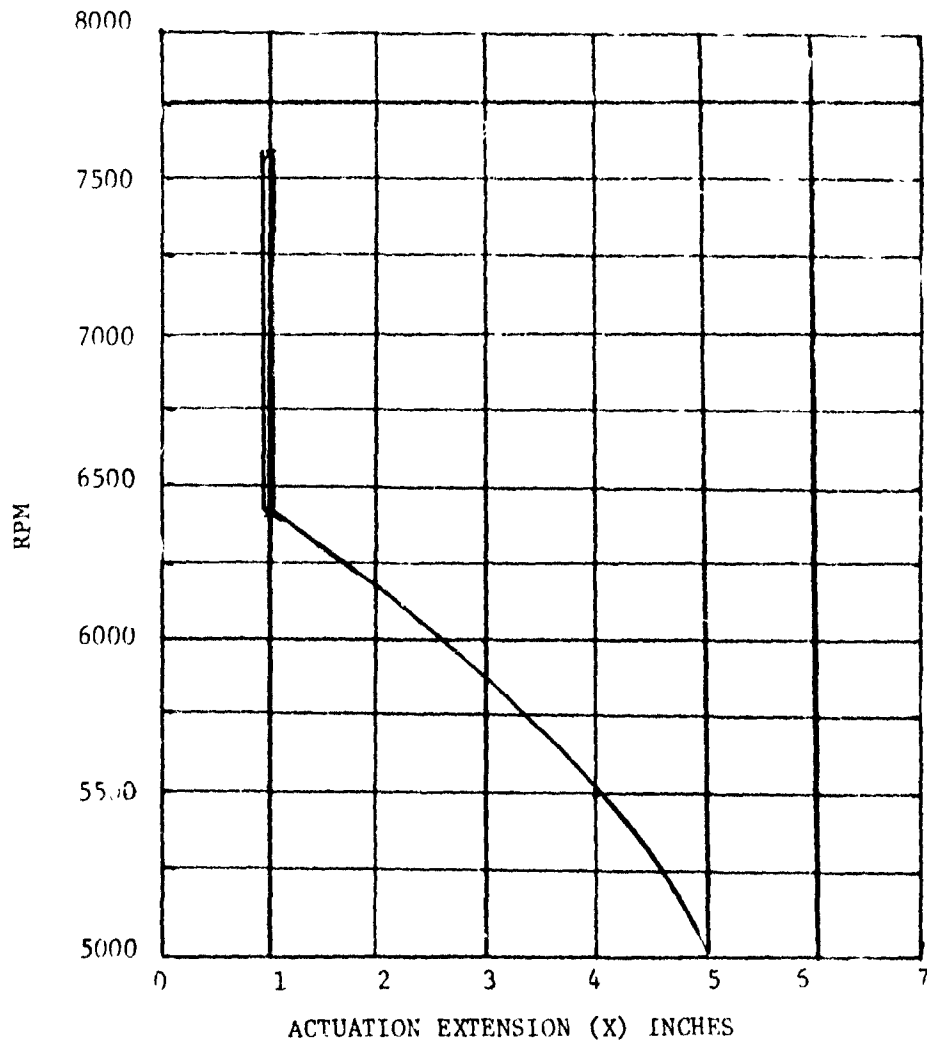
Figure 15 - J79 Exhaust Nozzle Actuator Extension vs RPM

A rough estimate of RPM may be made by measuring the distance X (Figures 15 and 16) on the variable exhaust nozzle actuator as illustrated and applying this measurement to the chart at the top of the page. It must be recognized that the chart is based on the engine following a fixed mechanical schedule as a function of throttle angle. However, the nozzle will vary from the mechanical schedule whenever Exhaust Gas Temperature (EGT) exceeds the T_5 vs RPM reference schedule. For this reason only a rough estimate of RPM may be determined by this means.

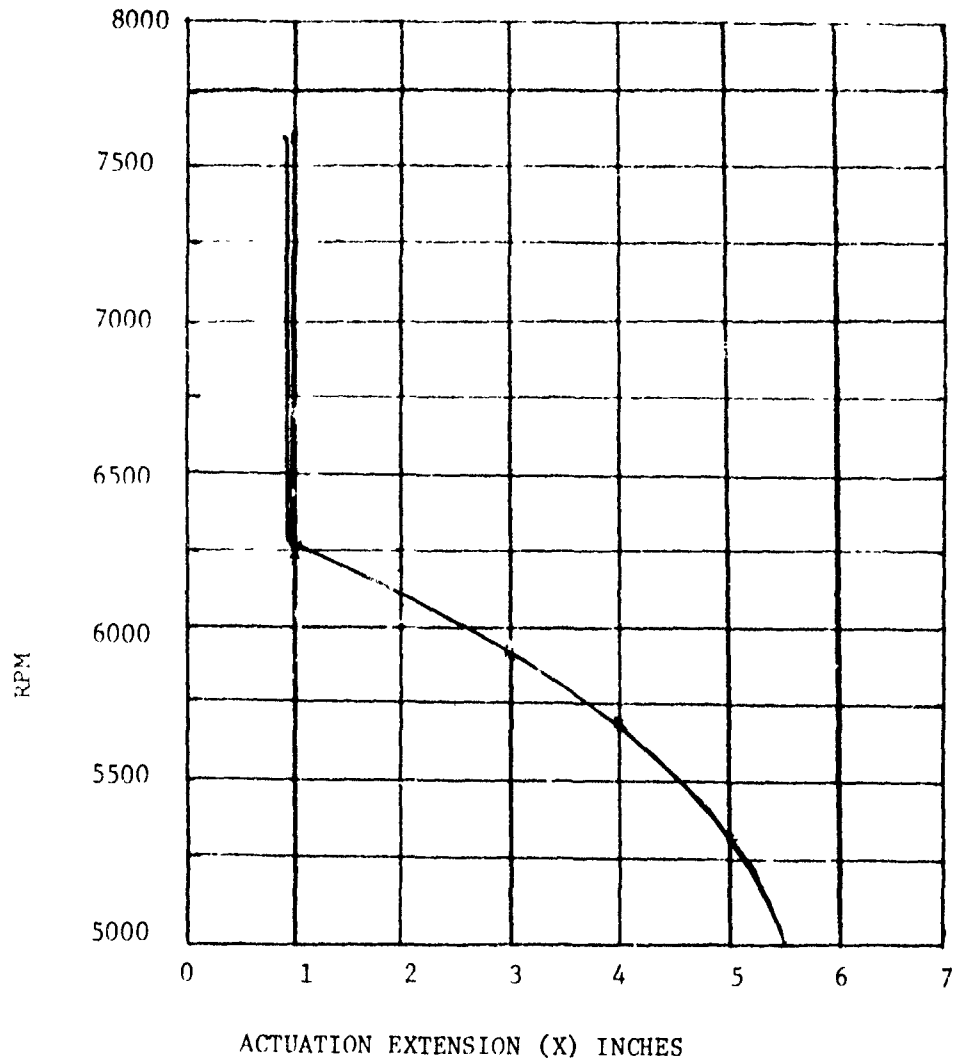
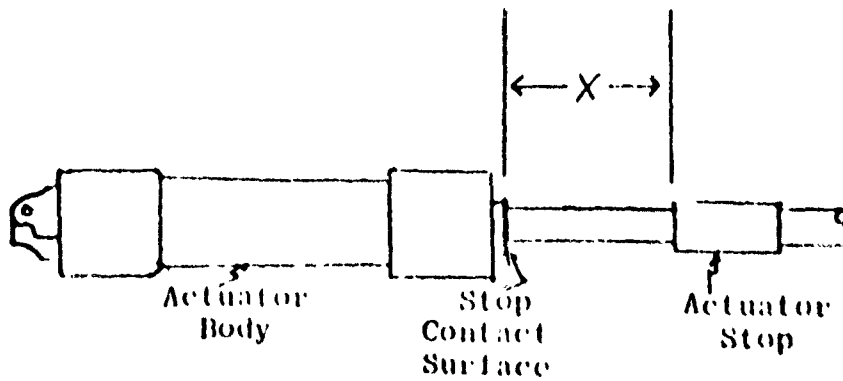
Figure 16 - J79-17 Exhaust Nozzle Actuator Extension vs RPM

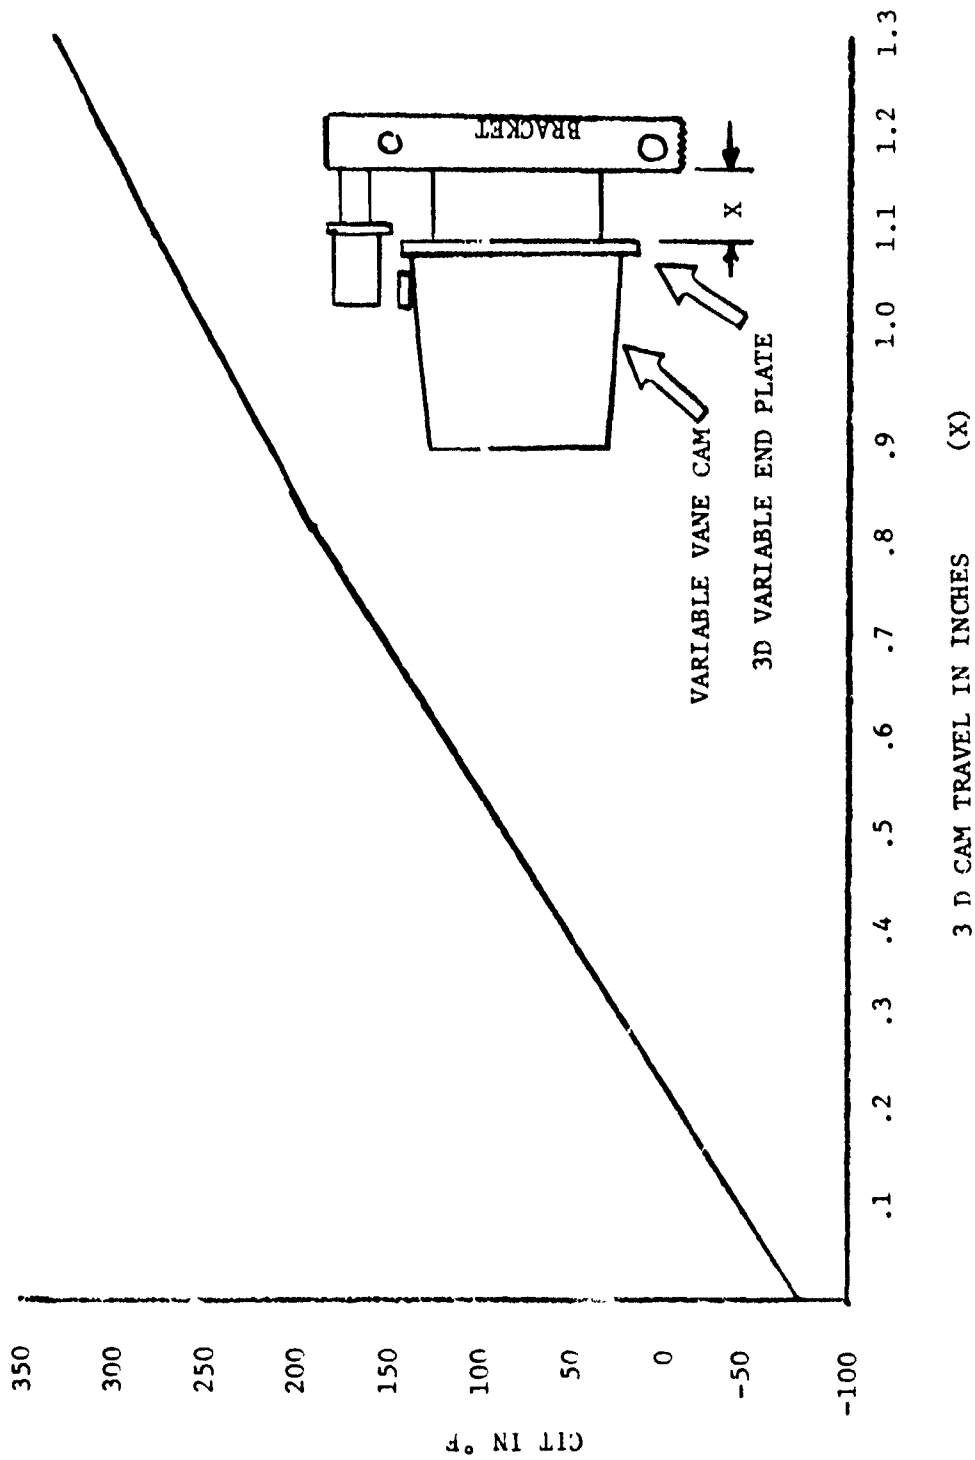
Figure 17 -- Main Fuel Control 3D Cam Travel vs CIT
