J79-15/-17 TURBOJET ENGINE ACCIDENT INVESTIGATION PROCEDURES

F-4 SYSTEM PROGRAM OFFICE

AUGUST 1975

TECHNICAL REPORT ASD-TR-75-19

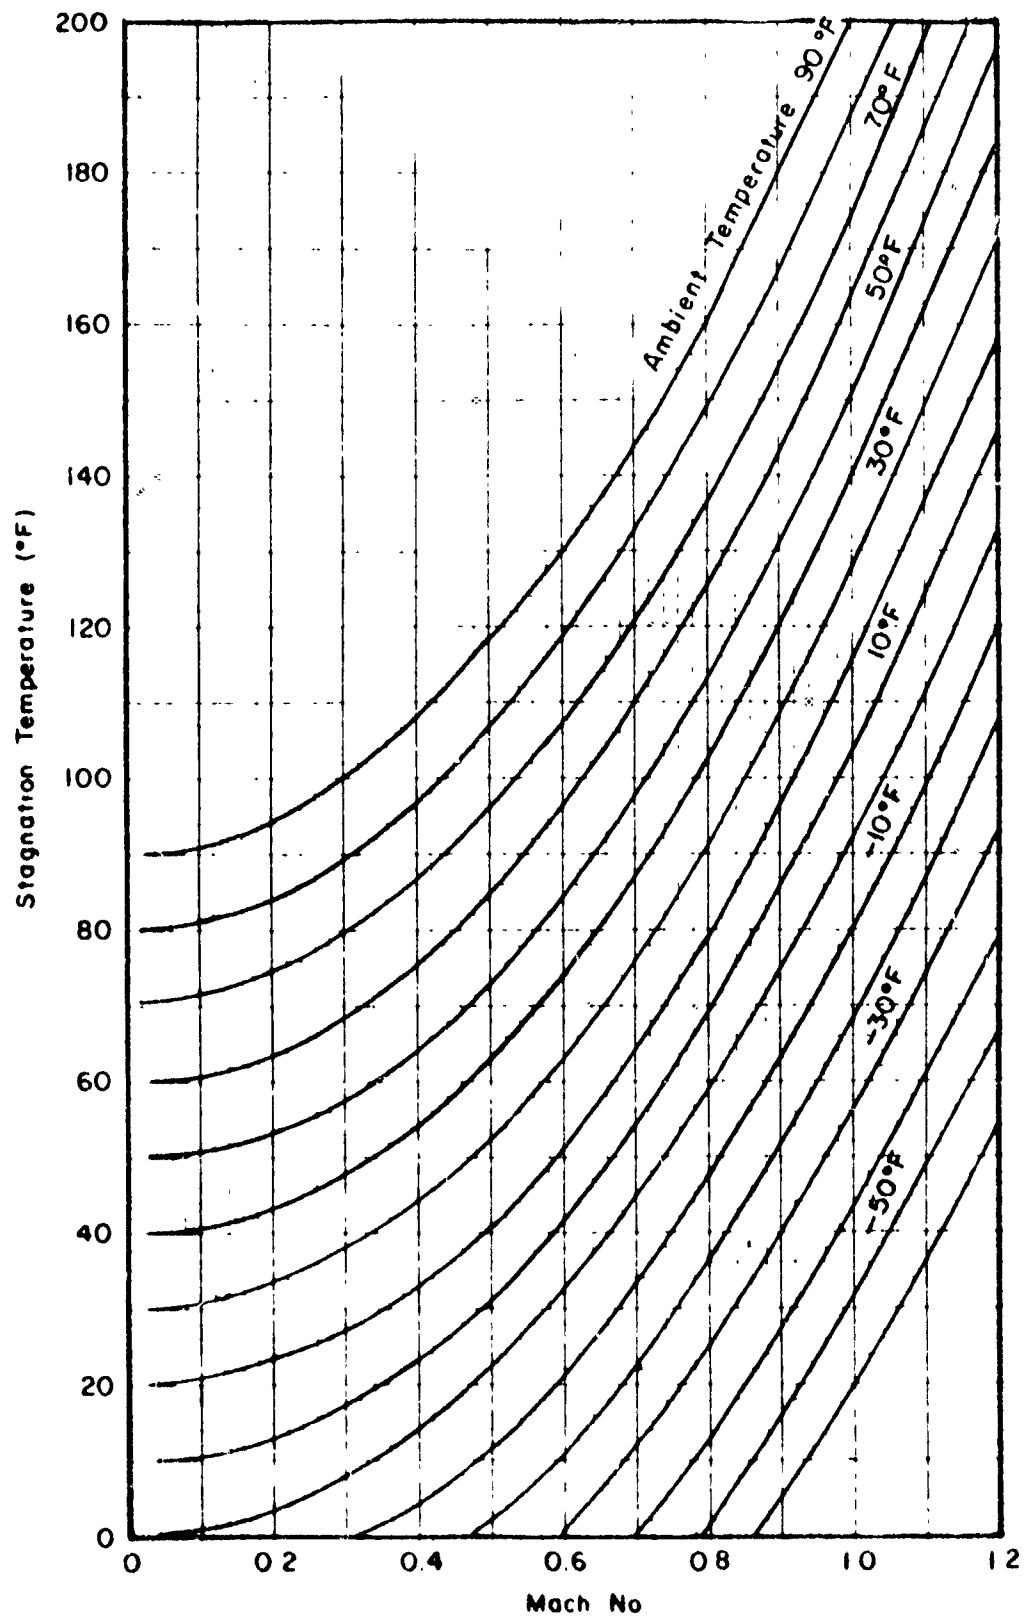
Figure 1P Mach No vs. Stagnation Temperature

knowing the ambient temperature, it must be corrected for the temperature increase due to the ram effect. Figure 18 can be used to determine inlet temperature if airspeed and ambient temperature are known.

In the case of rapid descent from colder temperatures, the temperatures as sensed by the control may be as much as 15°F cooler than actual stagnation temperature. Therefore, if high speed impact from altitude is suspected, the stagnation temperatures taken from Figure 18 should be reduced by 15°F.

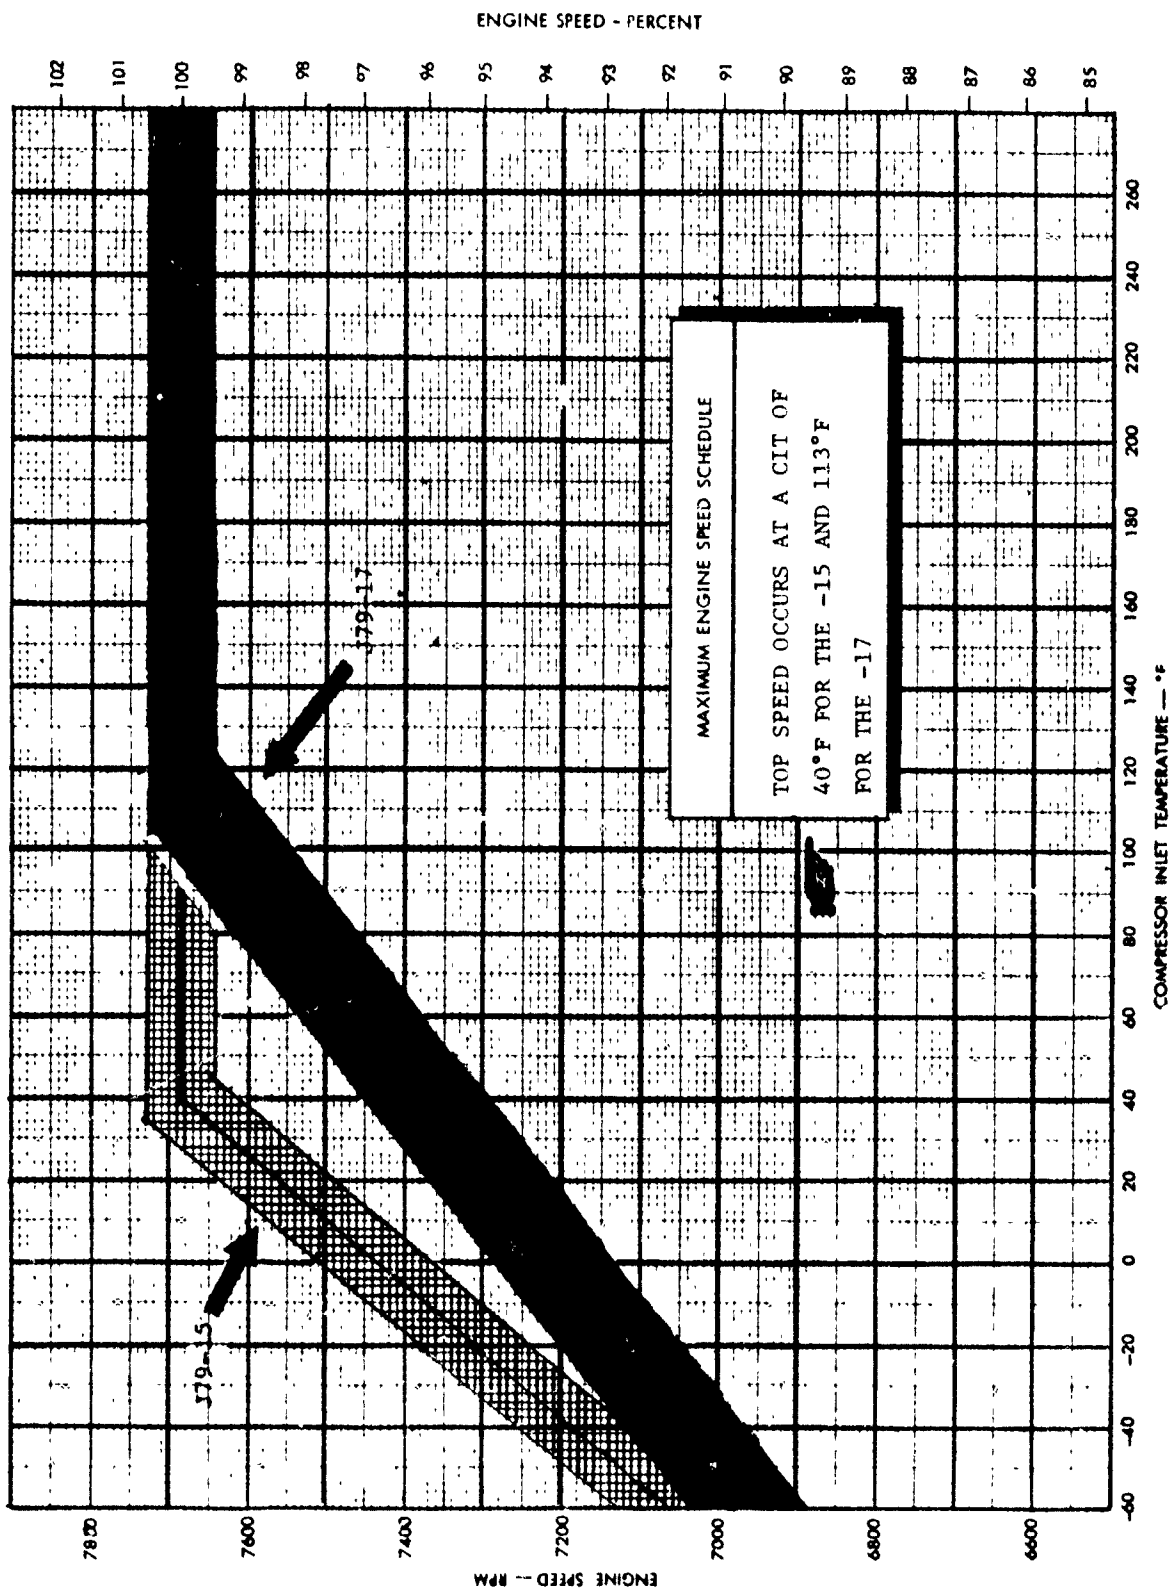
FIGURE 19 - ENGINE SPEED VS CIT

Figure 19 illustrates the maximum RPM vs CIT.

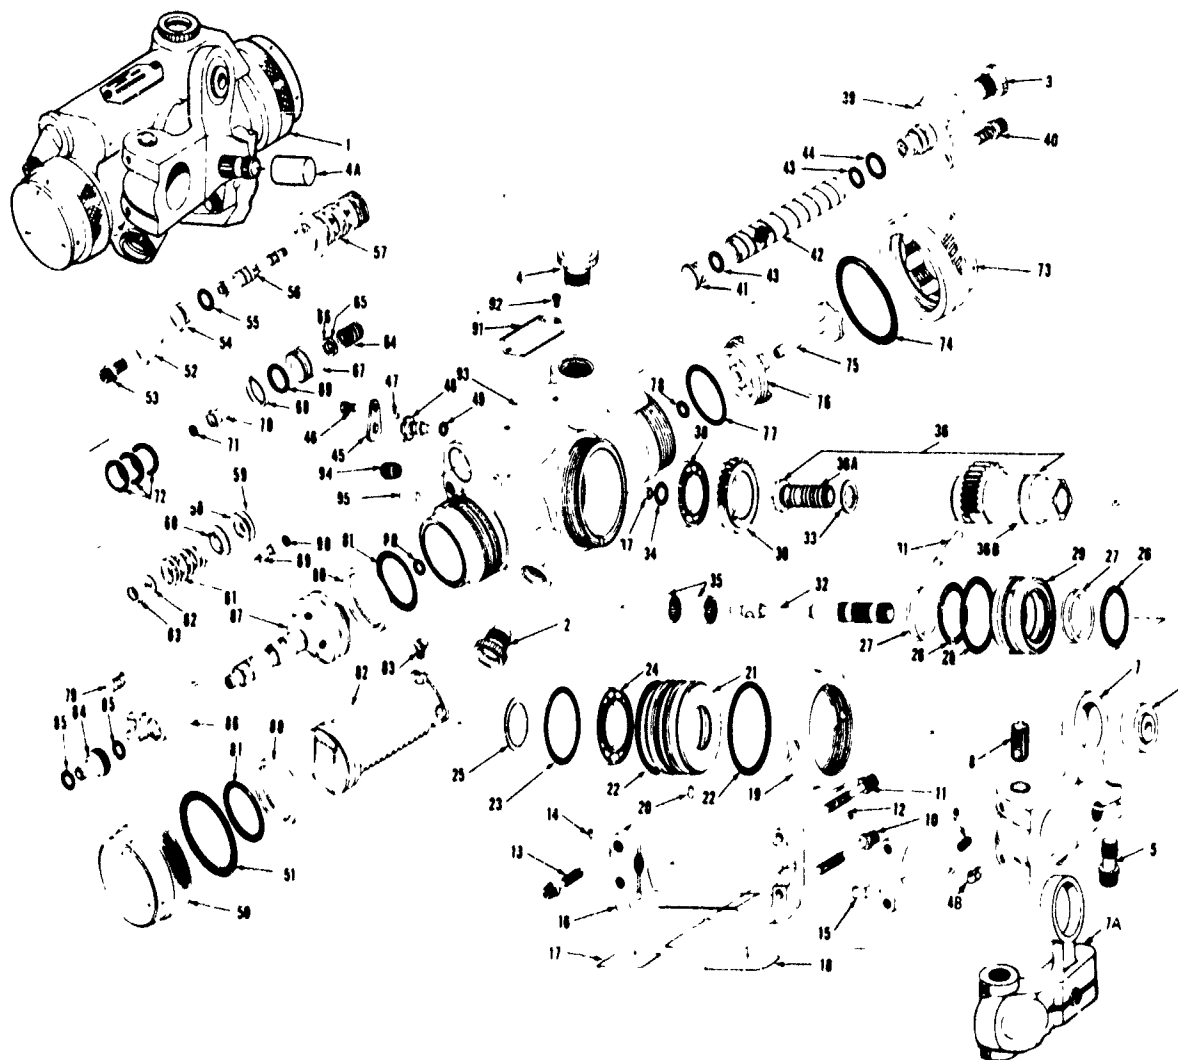
FIGURE 20 - TORQUE BOOSTER ASSEMBLY

The throttle position at time of impact can be determined by examination of the torque booster. To make this determination, the end cap (Item 73 of Figure 20) should be removed. A measurement should be taken from the end of the torque booster housing and the piston assembly, (Item 82 of Figure 20) as shown in Figure 21. After this dimension is obtained, the throttle position may be determined through the use of the chart illustrated in Figure 21.

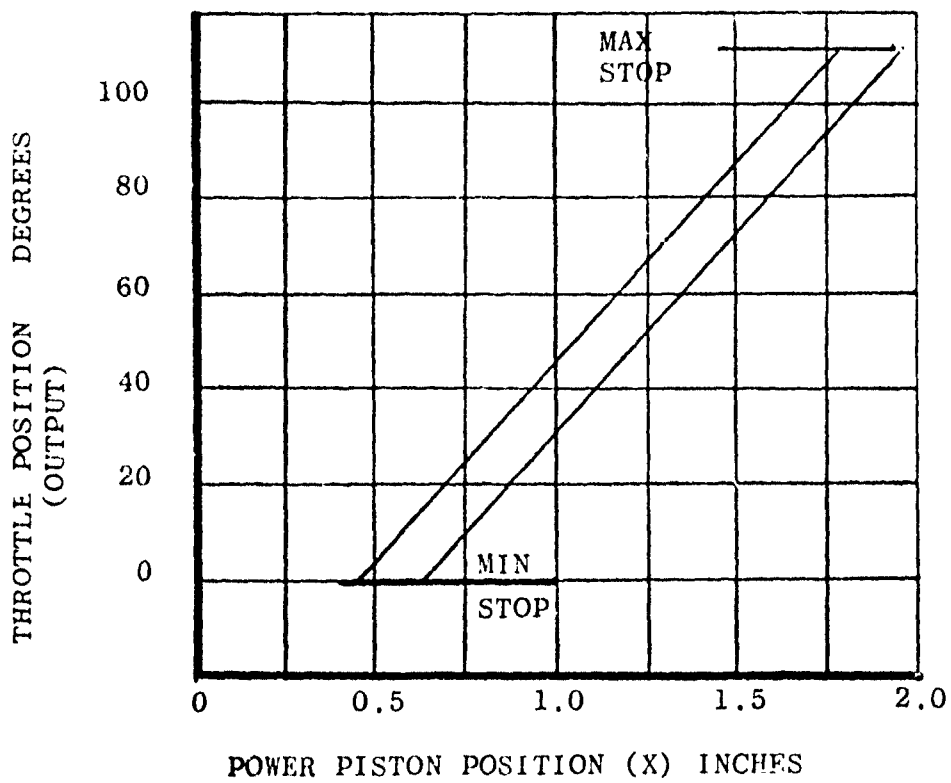
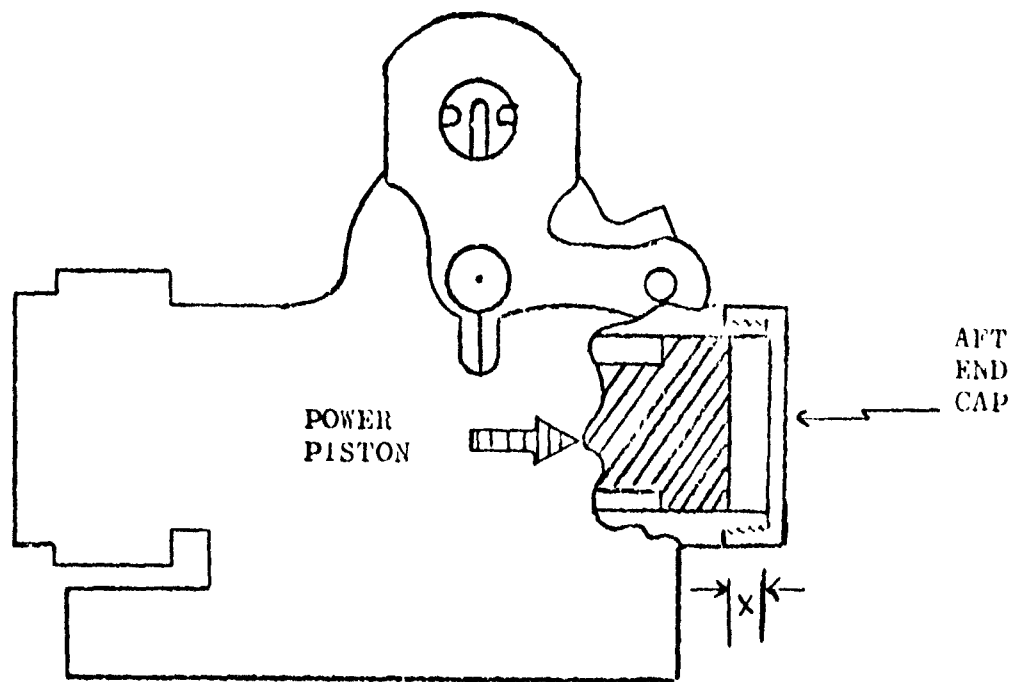
Figure 21 - Throttle Torque Booster - Power Piston Position vs Throttle Output Position

The above procedure assumes that the piston assembly did not move as a result of the impact. Careful examination of the walls of the torque booster cylinder may reveal impact marks that indicate the piston was at a different position at time of impact. If this is the case, align the piston with the impact marks prior to making the measurement as displayed in Figure 21.

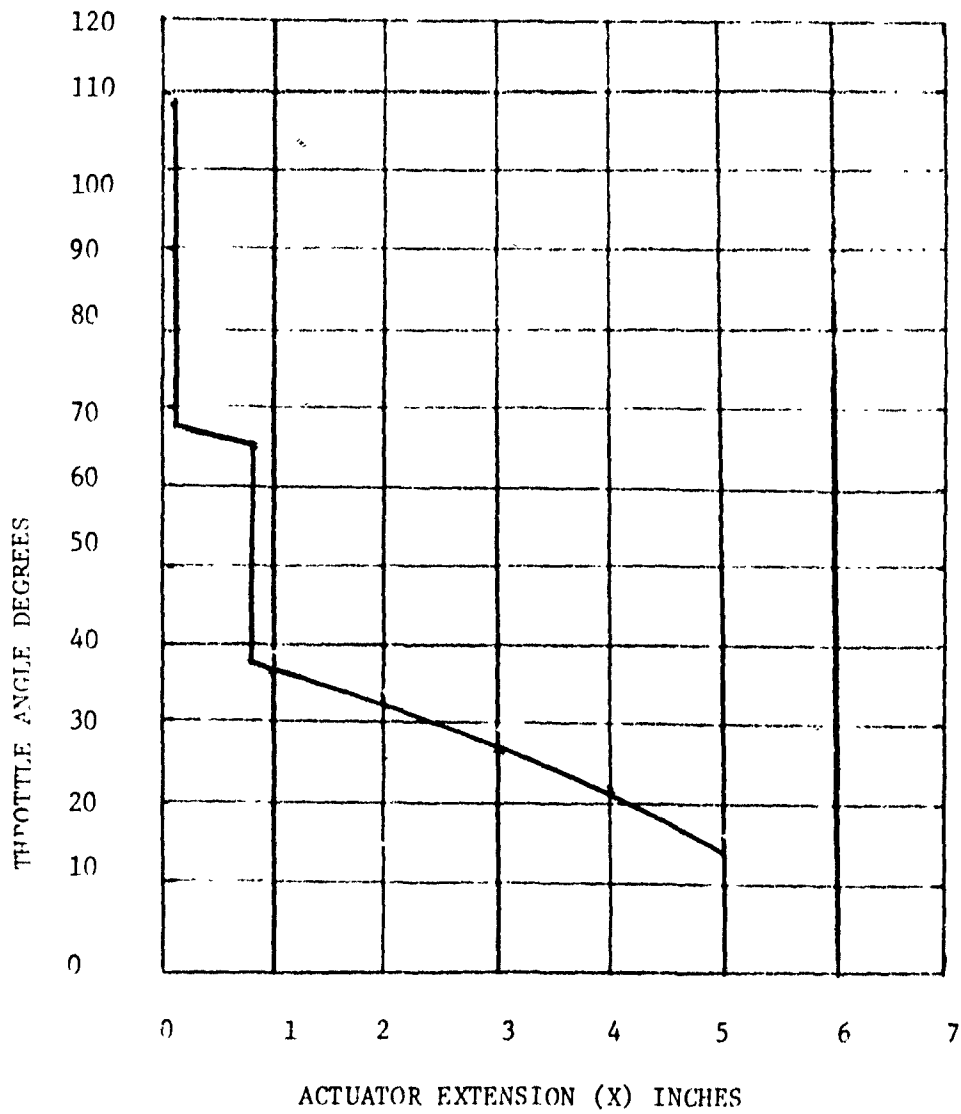
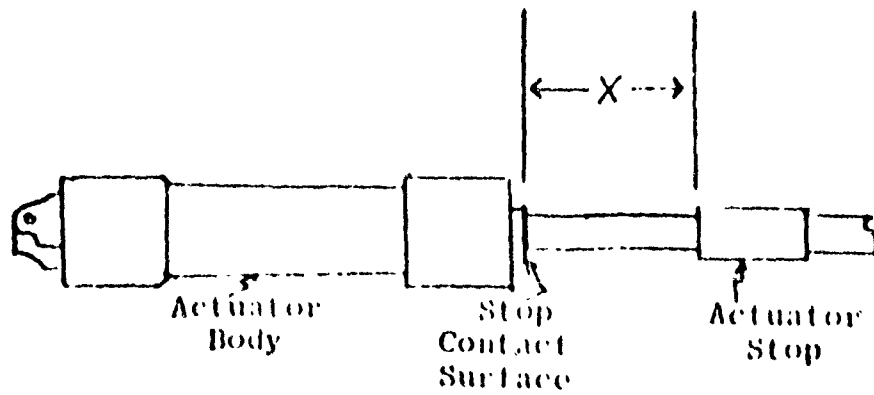
FIGURE 22 - J79-15 EXHAUST NOZZLE ACTUATOR EXTENSION VS THROTTLE ANGLE

A rough estimate of throttle angle may be made by measuring the distance X (Figures 22 and 23) of the variable exhaust nozzle actuator as illustrated and applying this measurement to the chart at the top of the page. This is a rough estimate.

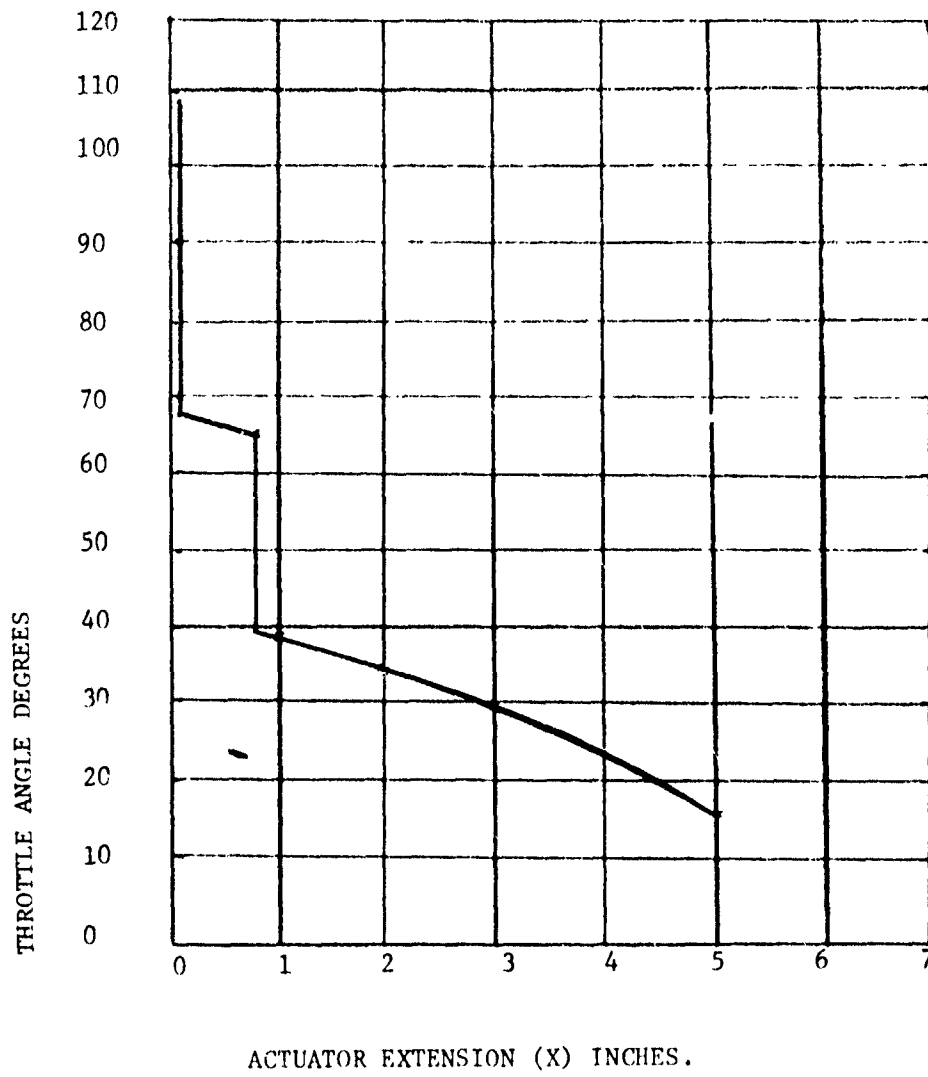
Figure 23 - .179-17 EXHAUST NOZZLE ACTUATOR EXTENSION VS THROTTLE ANGLE

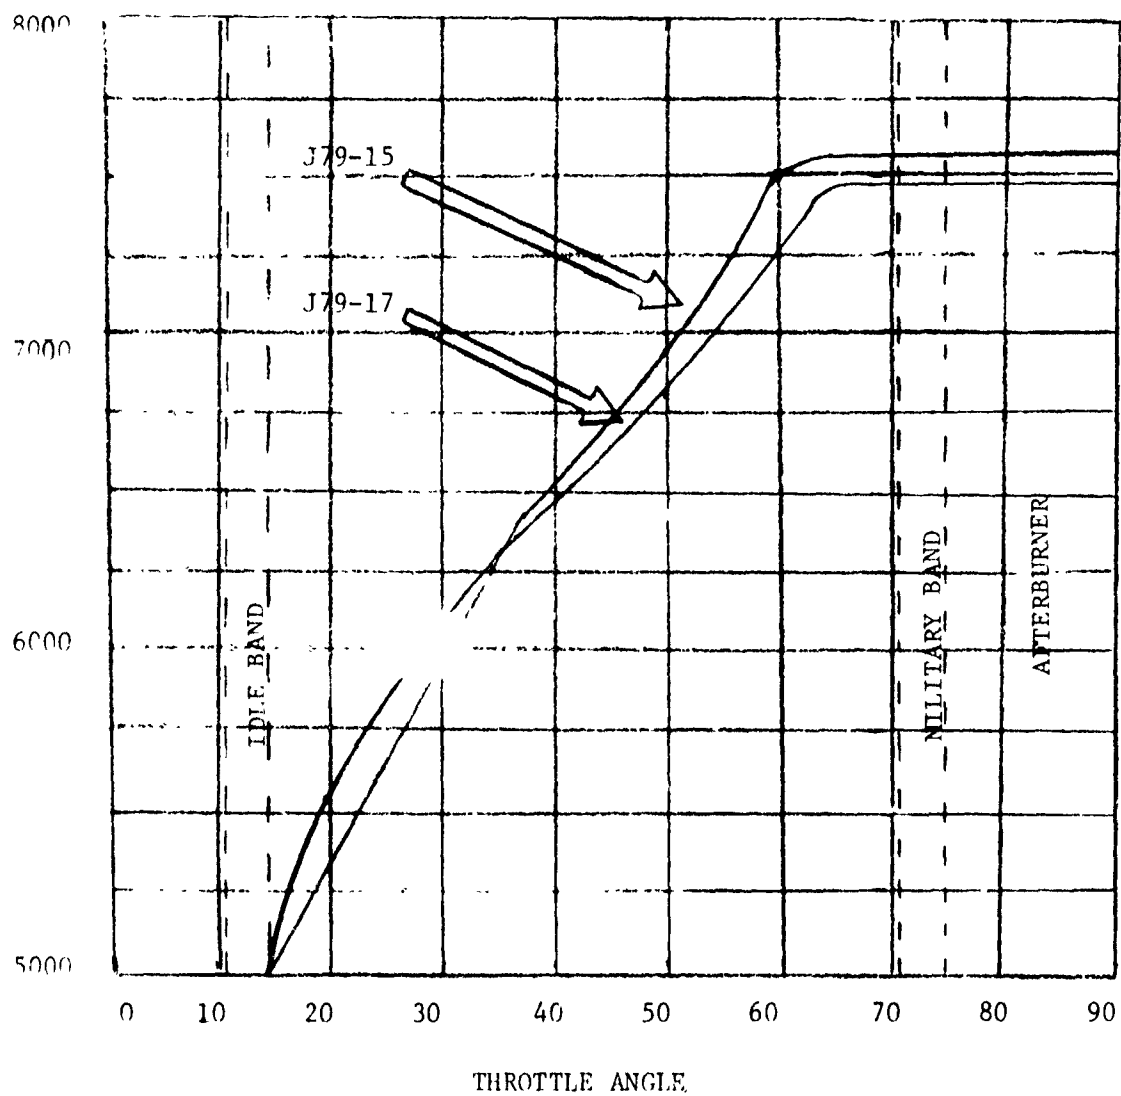
FIGURE 24 - THROTTLE ANGLE VS RPM

After the throttle angle has been established, the RPM of the engine may be determined through the use of Figure 24.

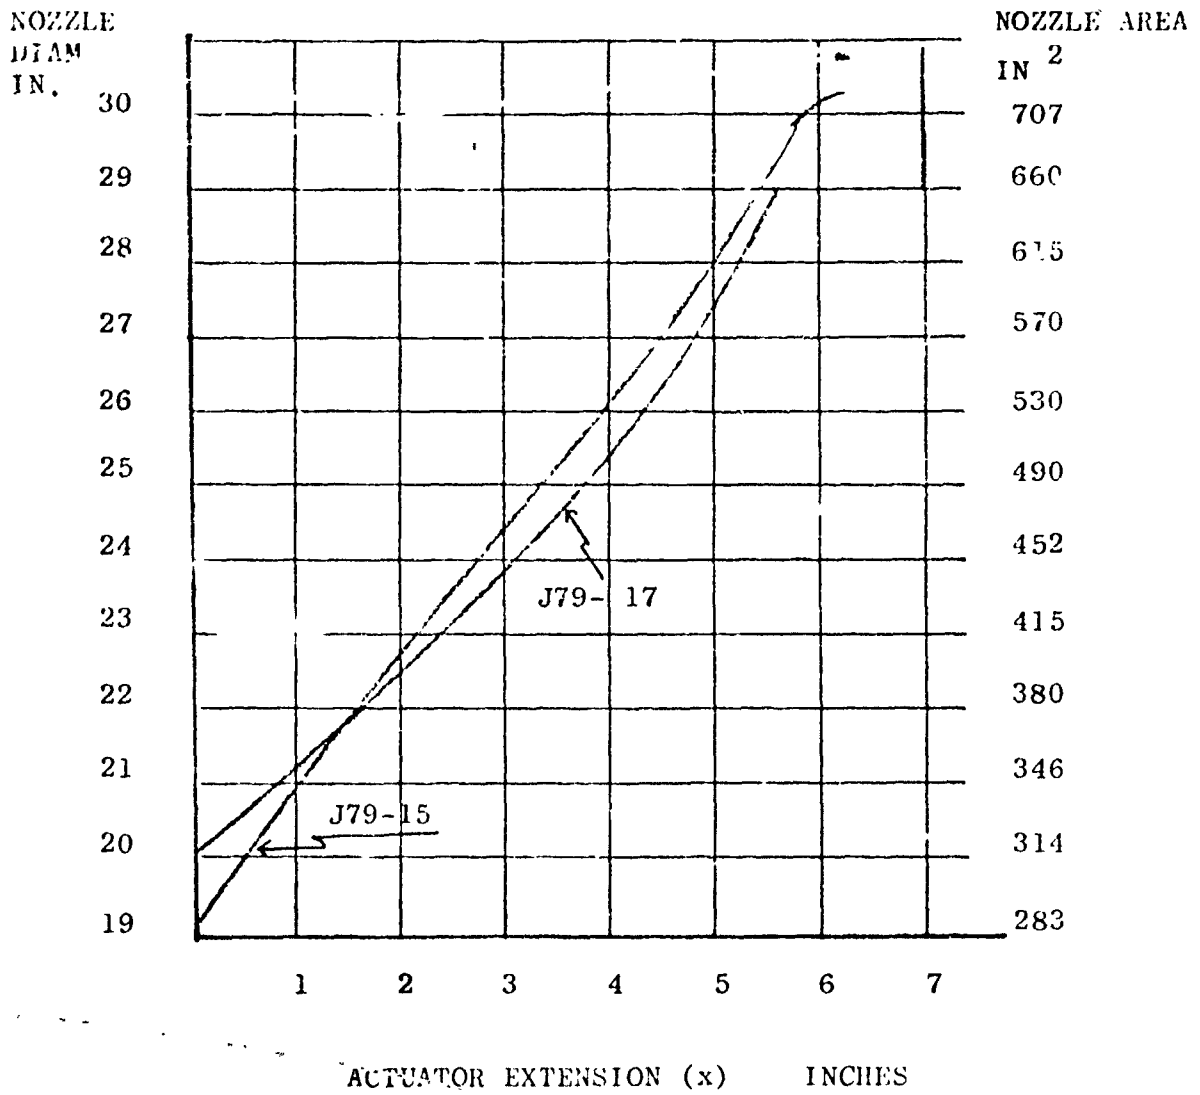
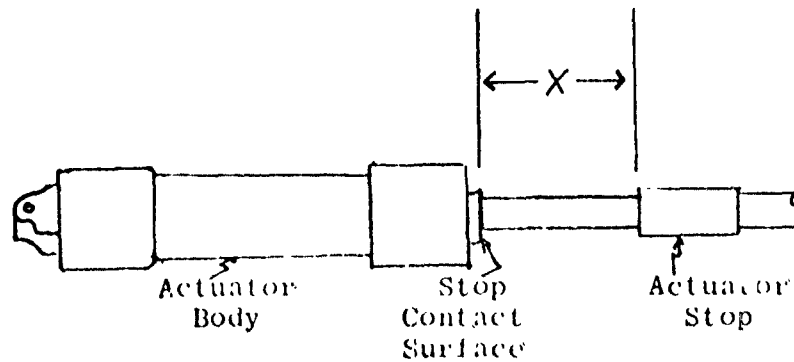
Figure 25 - Actuator Extension vs Nozzle Position

The position of the actuator rod with respect to actuator body may be used to determine nozzle area. The actuator extension X as shown on the bottom of Figure 25 should be used with the chart at the top of the figure to determine the nozzle area.

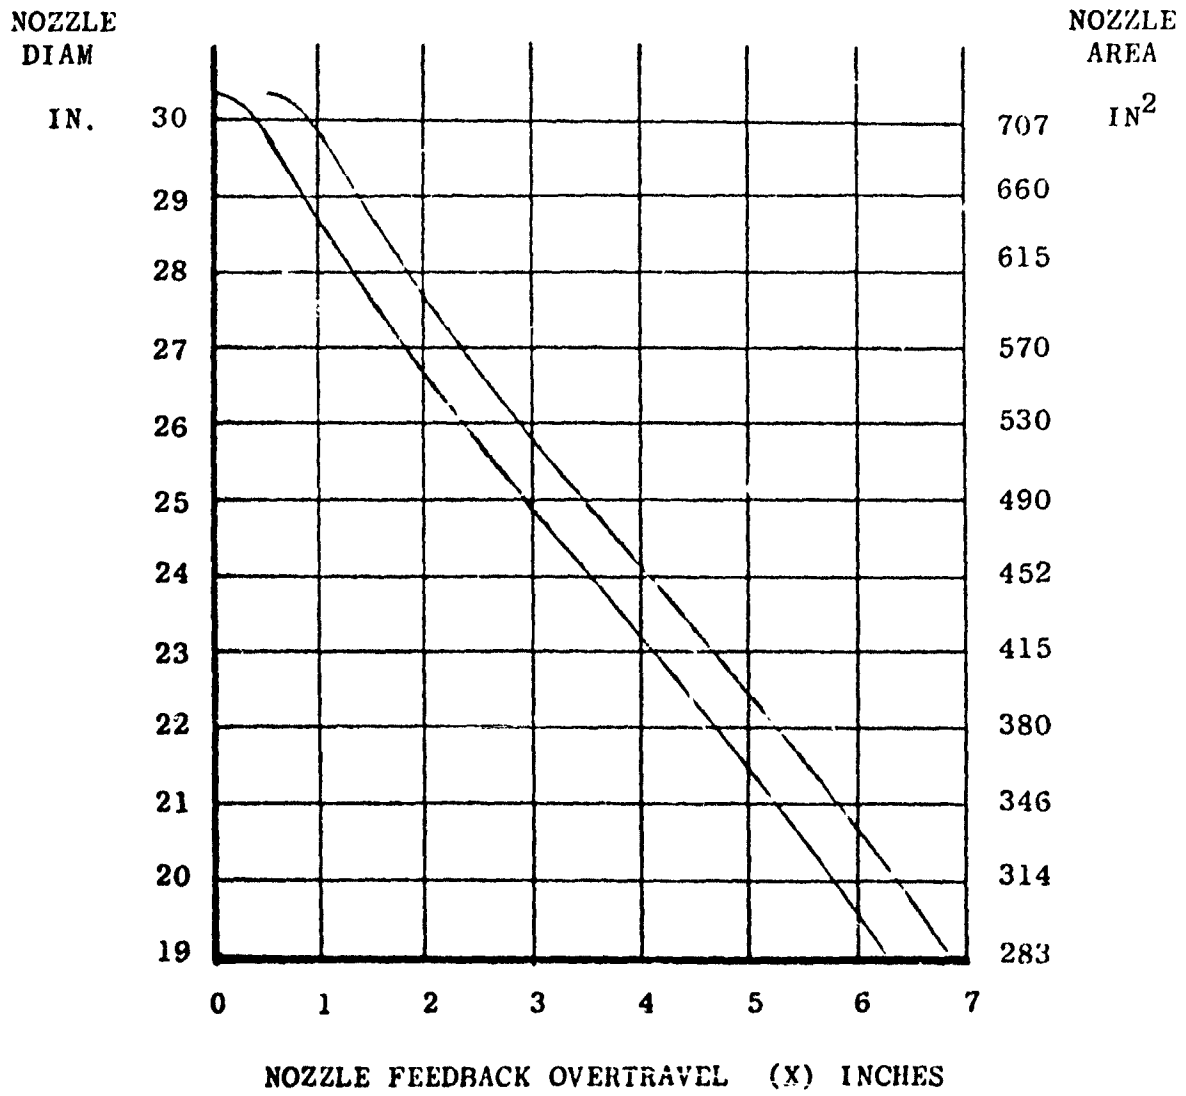
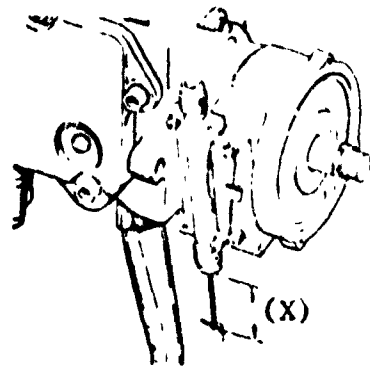
Figure 26 - J79-15 Exhaust Nozzle Feed Back Overtravel vs Nozzle Position

For the J79-15 engine the overtravel distance X as shown on the bottom of Figure 26 should be applied to the chart at the top of the figure for nozzle area determination.

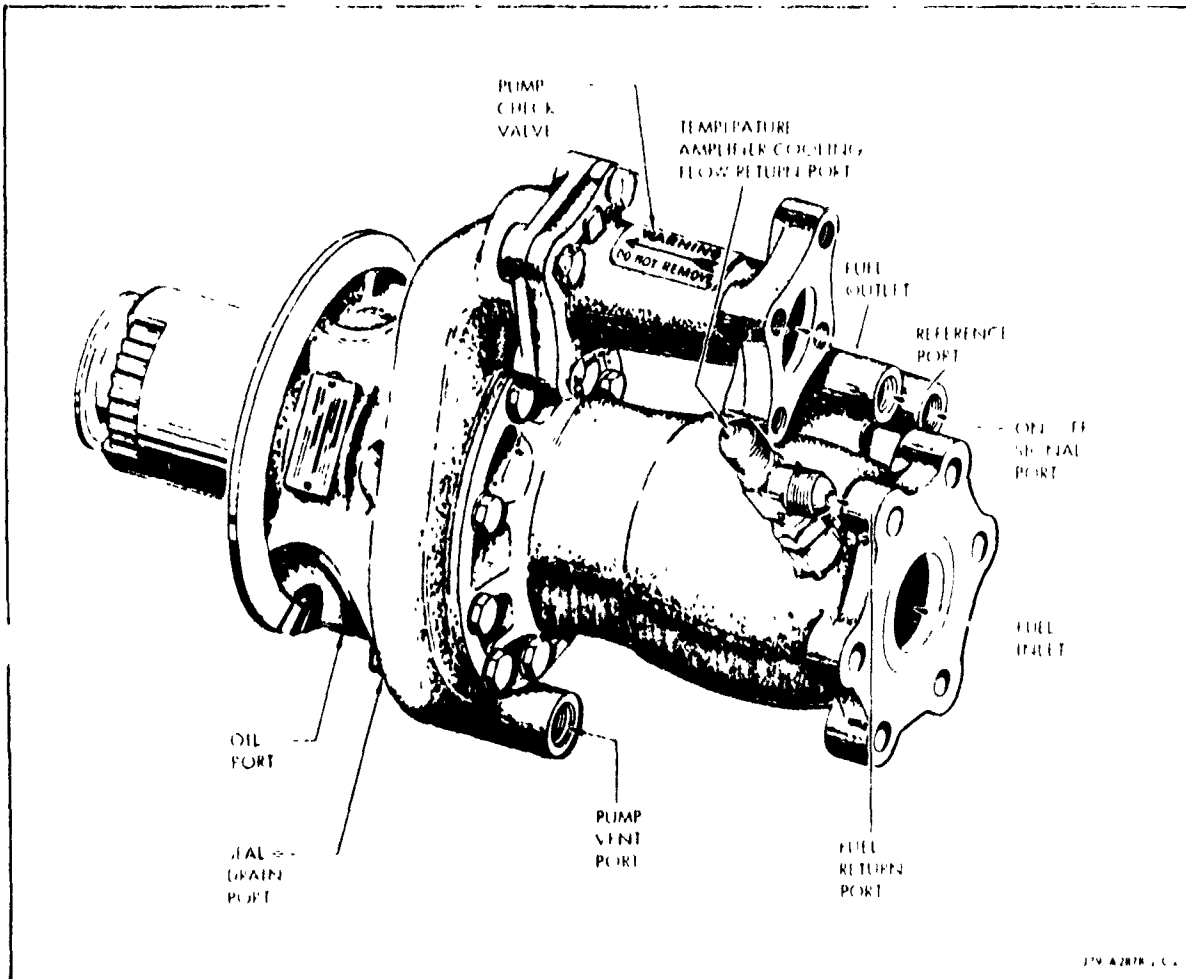
FIGURE 28 - EXTERNAL VIEW OF THE AFTERBURNER FUEL PUMP

The on-off signal from the MFC enters the A/B pump at the on-off signal port, see Figure 28. This signal pressure is ported to in the inducer side of the piston. The piston moves the valve diaphragm from its seat allowing fuel to enter the inducer of the pump, see Figure 29.

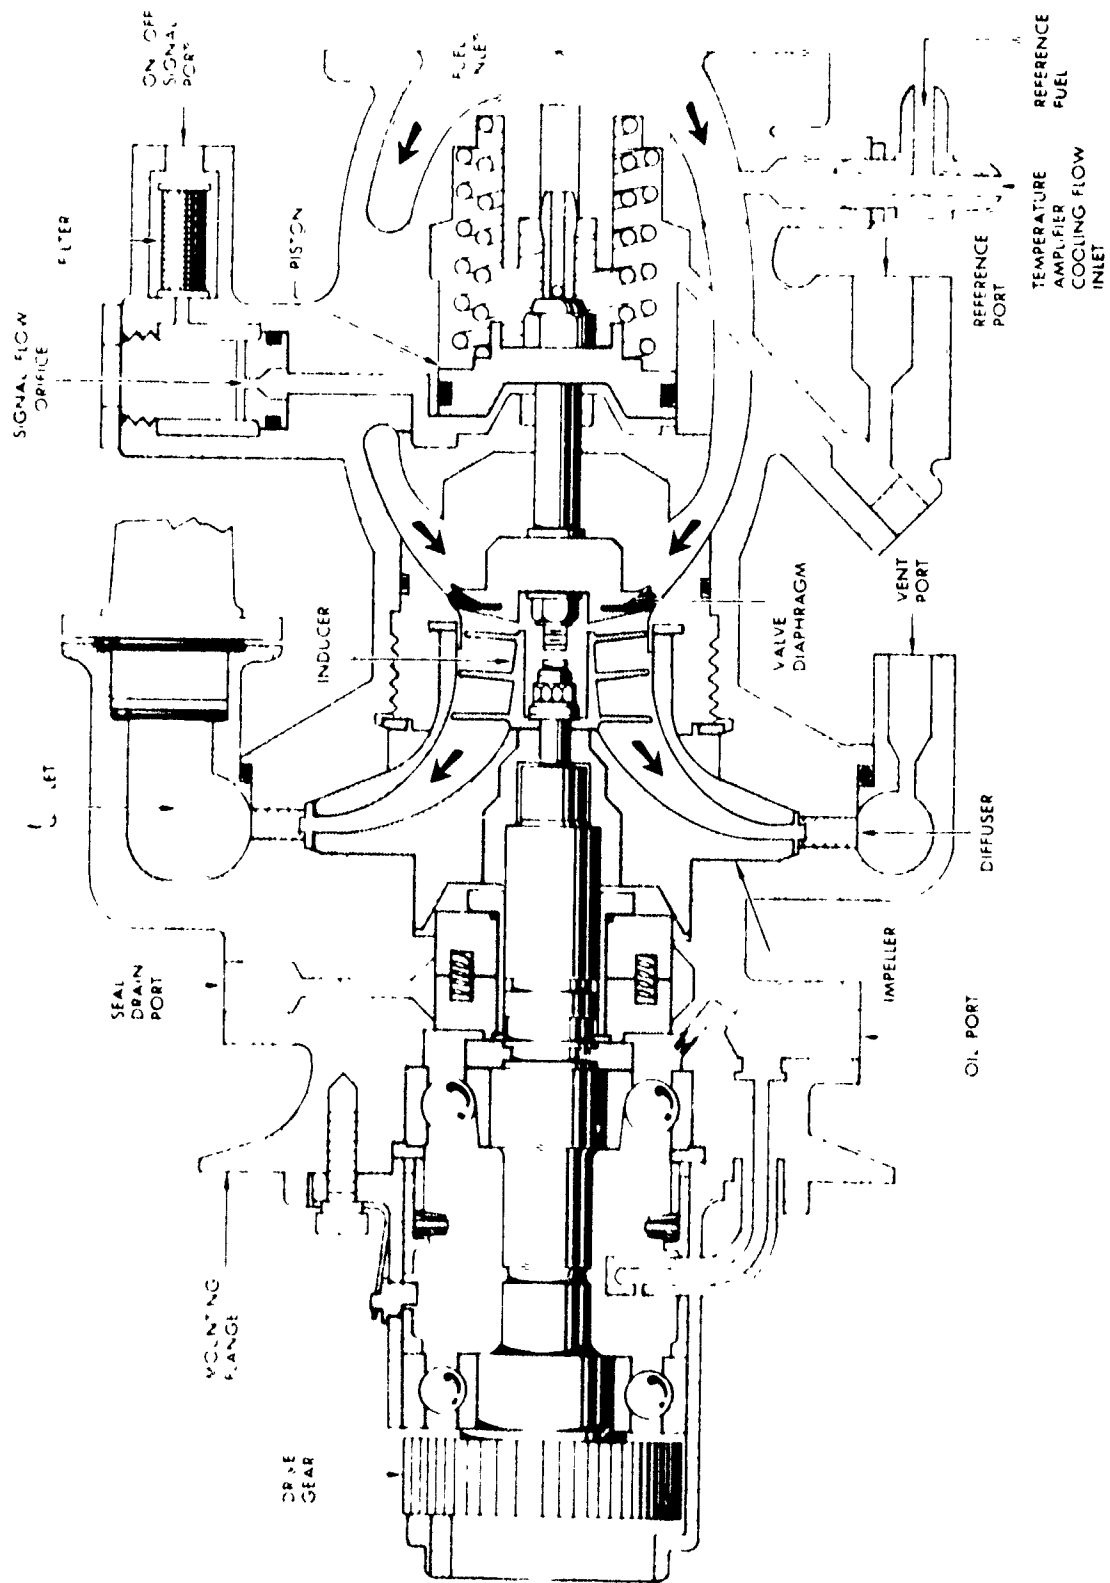
FIGURE 29 - CUTAWAY VIEW OF THE AFTERBURNER FUEL PUMP

Examination of the impact marks of the piston within the cylinder or the position of the valve diaphragm with respect to its seat, see Figure 29, should enable the investigator to determine whether the valve was open for A/B operation at time of impact.

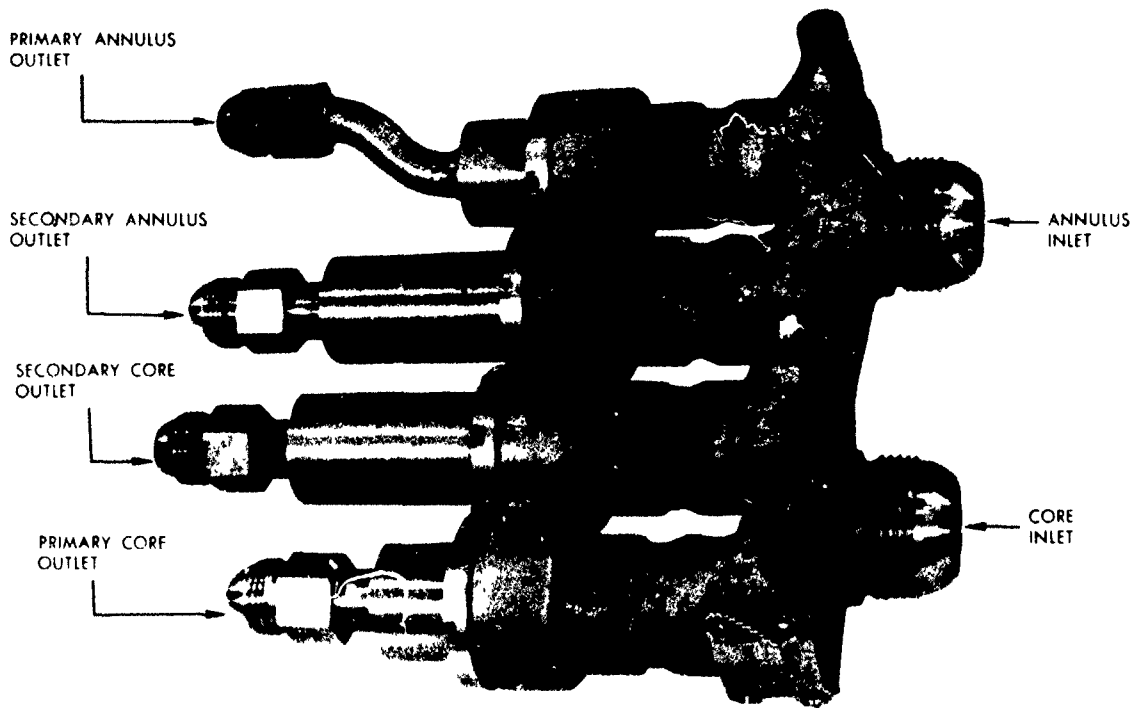
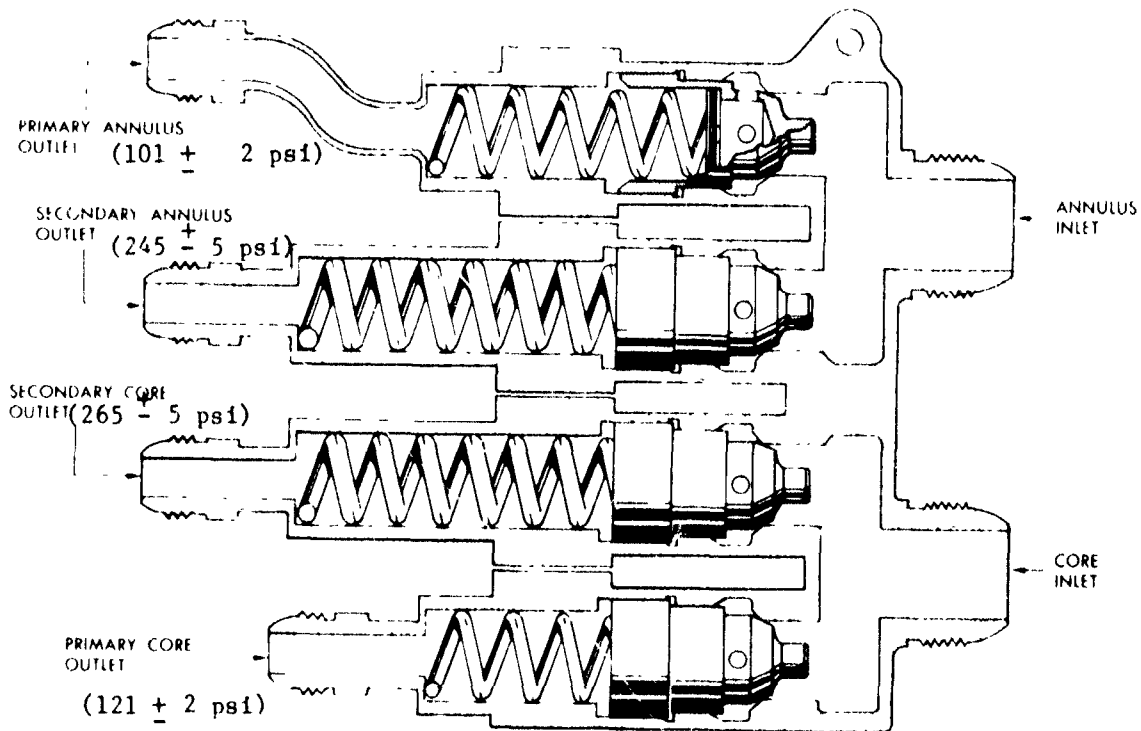
Figure 30 - Afterburner Fuel Pressurizing Valve Schematic

After it has been determined that the afterburner was in operation, the next question to be resolved is the extent of modulation. The afterburner fuel pressurizing valve can be used for this determination, see Figure 30. The valves are opened by fuel pressure from the afterburner fuel control. Sequence of operation opens the primary core, primary annulus, secondary annulus and secondary core in that order. They may jam in the position they were in at time of impact. Air pressure or fluid flow introduced at the core and annulus inlets will indi-

cate if the valves are jammed. It may be necessary to inspect the cylinders of the valves for impact marks to determine their position. Minimum A/B operation would be the primary core valve only being opened and maximum A/B operation would be indicated by all four valves opened.

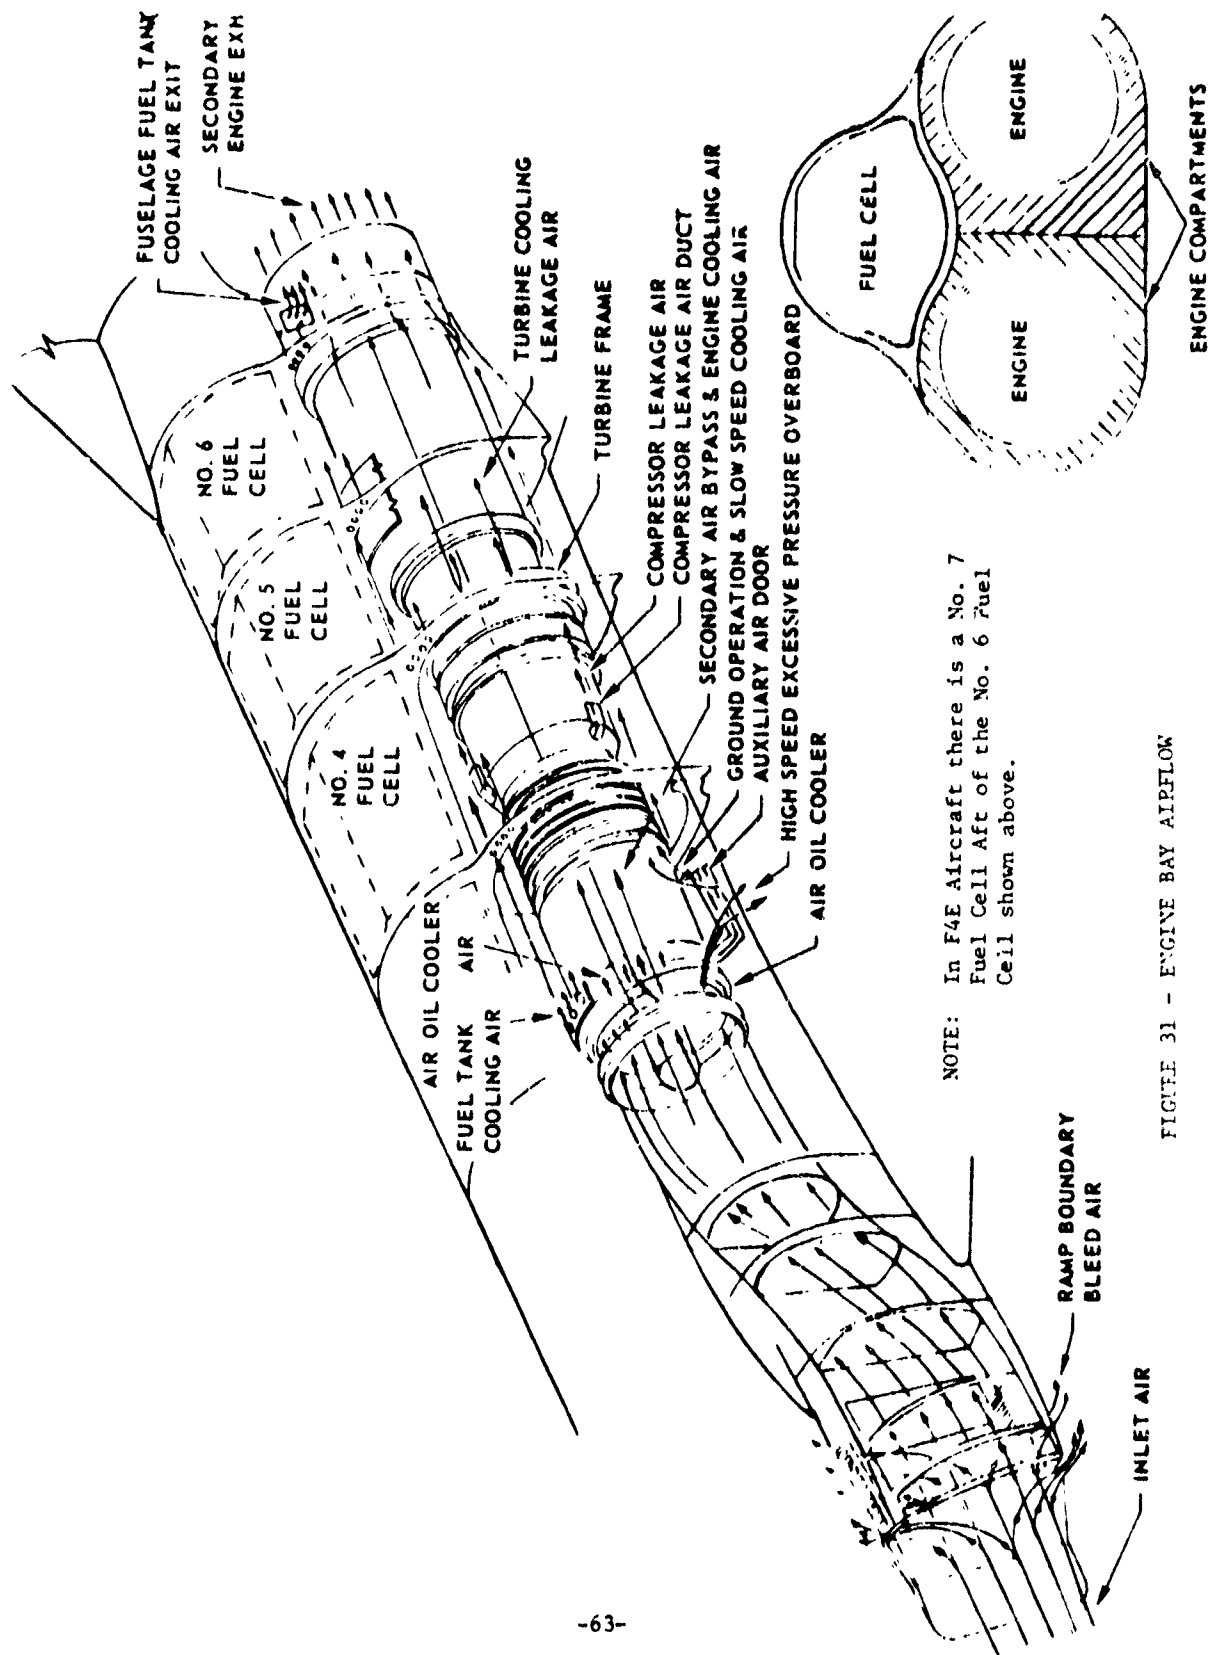
NOTE: In F4E Aircraft there is a No. 7 Fuel Cell Aft of the No. 6 Fuel Cell shown above.

FIGURE 31 - ENGINE BAY AIRFLOW

In order for an accident investigator to understand and properly analyze the events preceding and at the time of ignition of combustibles it is imperative that he has knowledge of the air flow both exterior to the aircraft and within the engine bay. See Figures 31, 32 and 33. He must also understand the normal functions of the auxiliary air doors and pressurization of the 600 gallon centerline fuel tank.

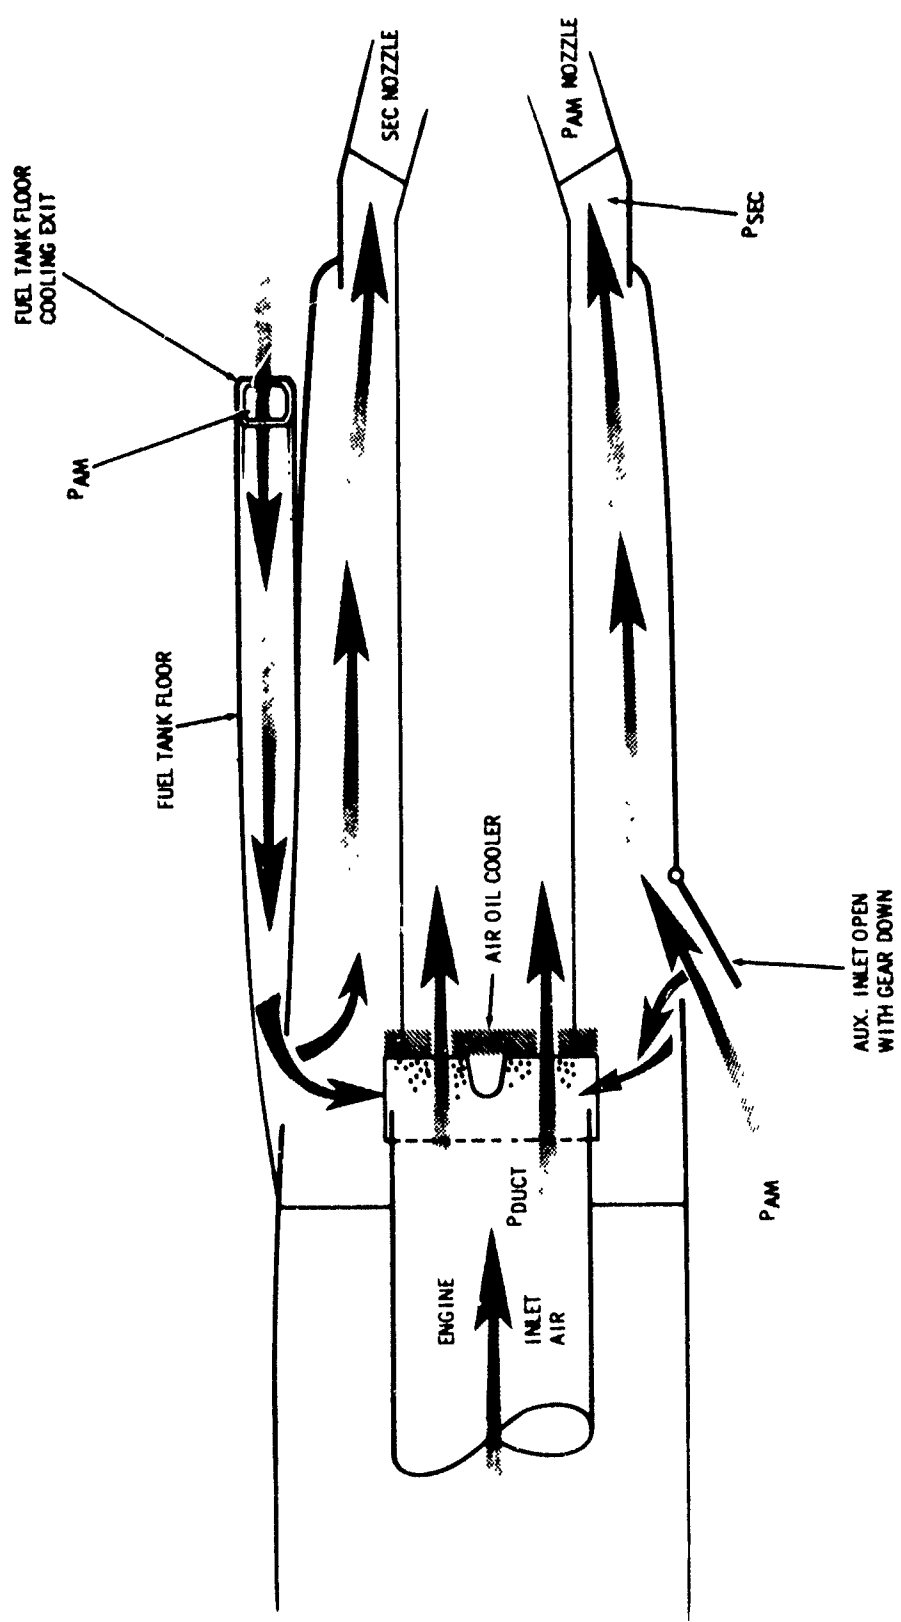
FIGURE 32

F-4 ENGINE COOLING AIR FLOW GROUND AND LOW SPEED OPERATION - GEAR DOWN
