J79-15/-17 TURBOJET ENGINE ACCIDENT INVESTIGATION PROCEDURES

F-4 SYSTEM PROGRAM OFFICE

AUGUST 1975

TECHNICAL REPORT ASD-TR-75-19

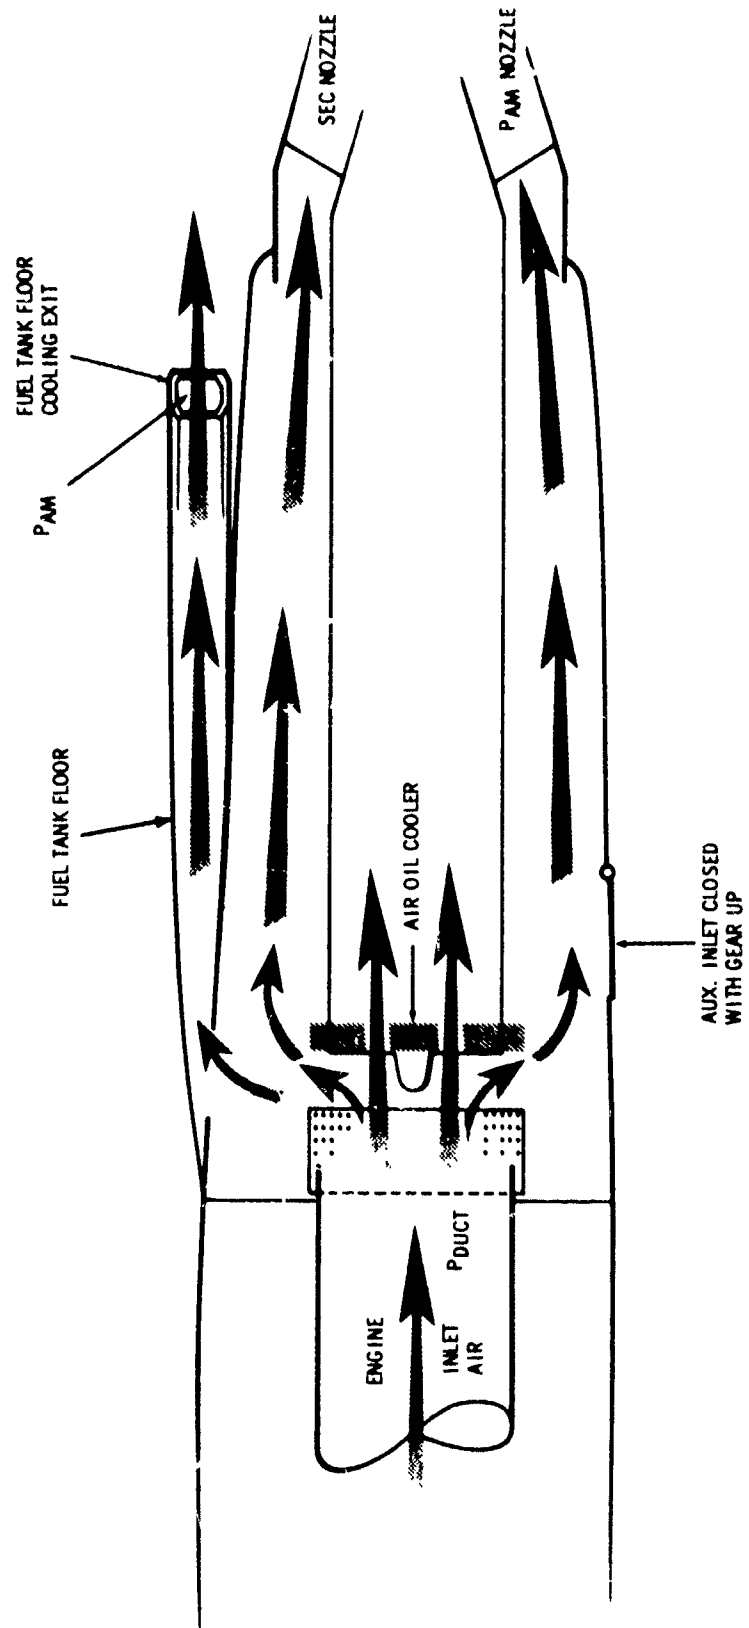
FIGURE 33

F-4 ENGINE COOLING AIR FLOW

IN-FLIGHT OPERATION - GEAR UP

In order for an accident investigator to understand and properly analyze the events preceding and at the time of ignition of combustibles it is imperative that he has knowledge of the air flow both exterior to the aircraft and within the engine bay. See Figures 31, 32 and 33. He must also understand the normal functions of the auxiliary air doors and pressurization of the 600 gallon centerline fuel tank.

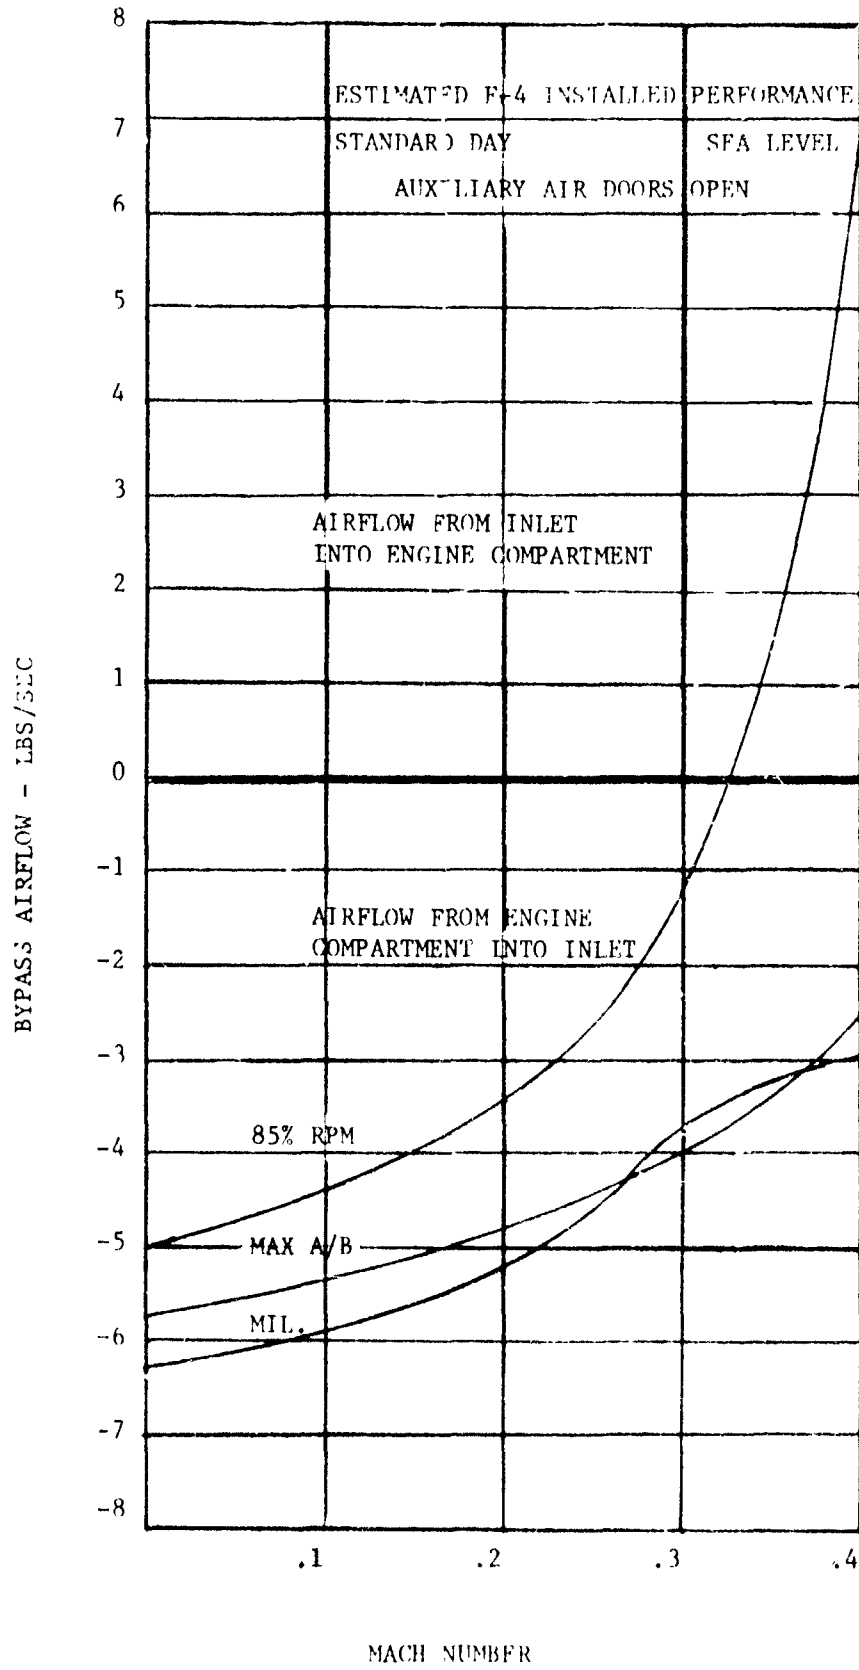
Figure 34 - Bypass Airflow vs Mach Number

During ground operations and takeoff the auxiliary air doors are open. The normal air flow path is through the auxiliary air doors, into the engine compartment, forward into the engine inlet or aft out through the A/B nozzle. The maximum landing gear down speed is 250 knots (approximately M.38). As may be seen from Figure 34, the engine compartment is operating at pressures less than atmospheric, (The air flow is through the auxiliary air doors into the engine bay) during the climb in military or Max A/B with the landing gear down and auxiliary air doors open. For this reason any combustible fluid that contacts the aircraft skin or flows around the various doors during this phase of flight will have a tendency to be sucked into the engine bay.

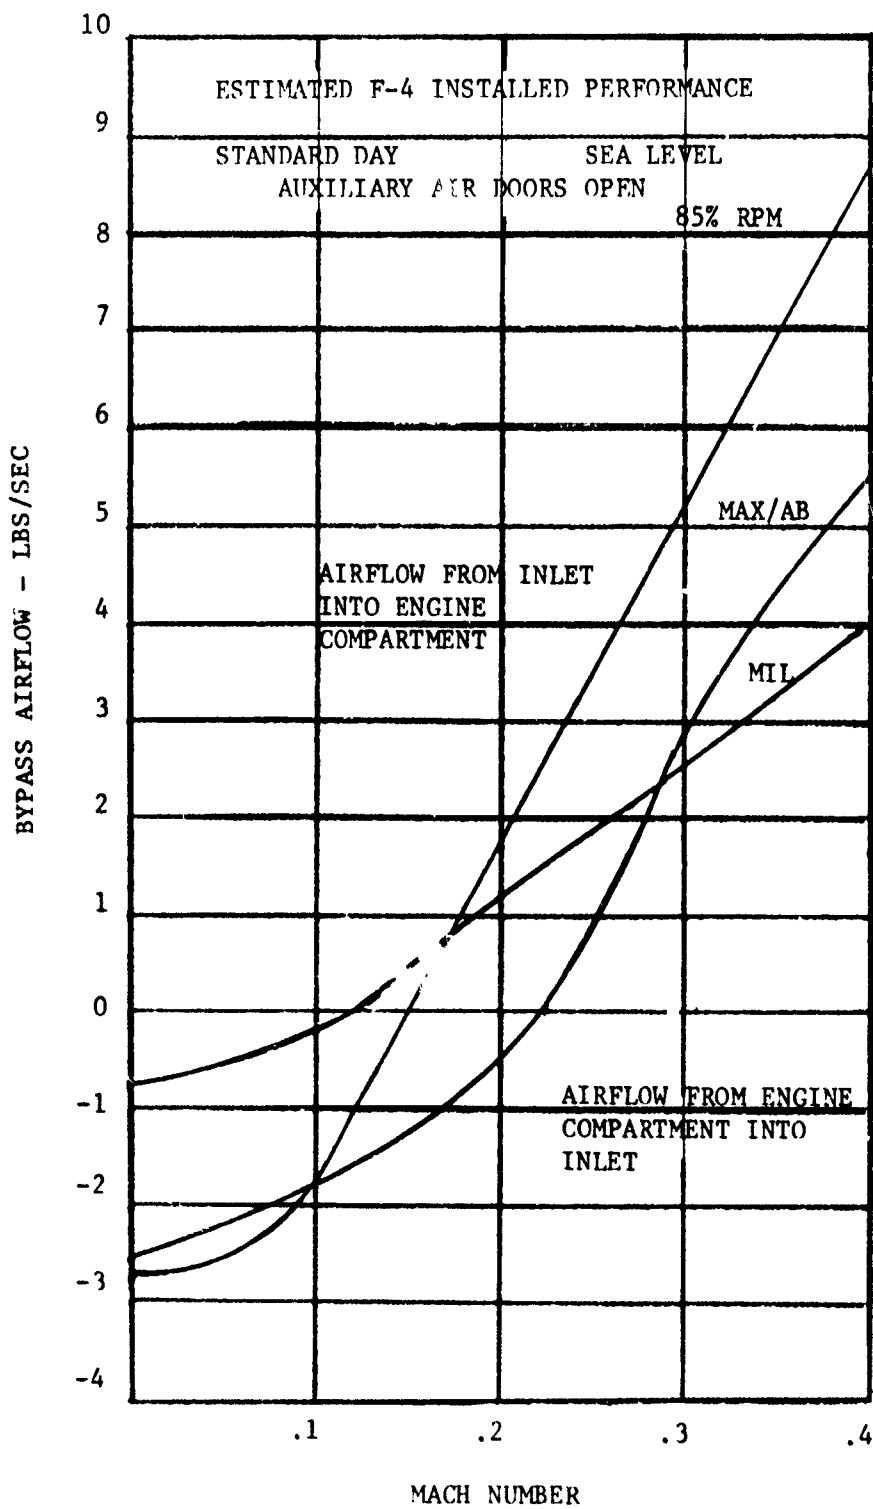
Figure 35 - Bypass Airflow vs Mach Number

As may be seen from Figure 35, retracting the landing gear which in turn closes the auxiliary air doors (even at minimum climb speed approximately M.25), the airflow at the front of the engine compartment changes from airflow from the engine compartment into the inlet to airflow from the inlet into the engine compartment. Therefore, there is a short period of time during the retraction of the landing gear that the airflow is not flowing in either direction. It is at this time that a combustible coming into contact with the hot parts of the engine would be most susceptible to igniting. With the auxiliary doors closed, the engine bay operates with positive pressure above approximately M.22 under all operational modes, see Figure 35. For air flow rates through the engine compartment, see Figures 36 and 37.

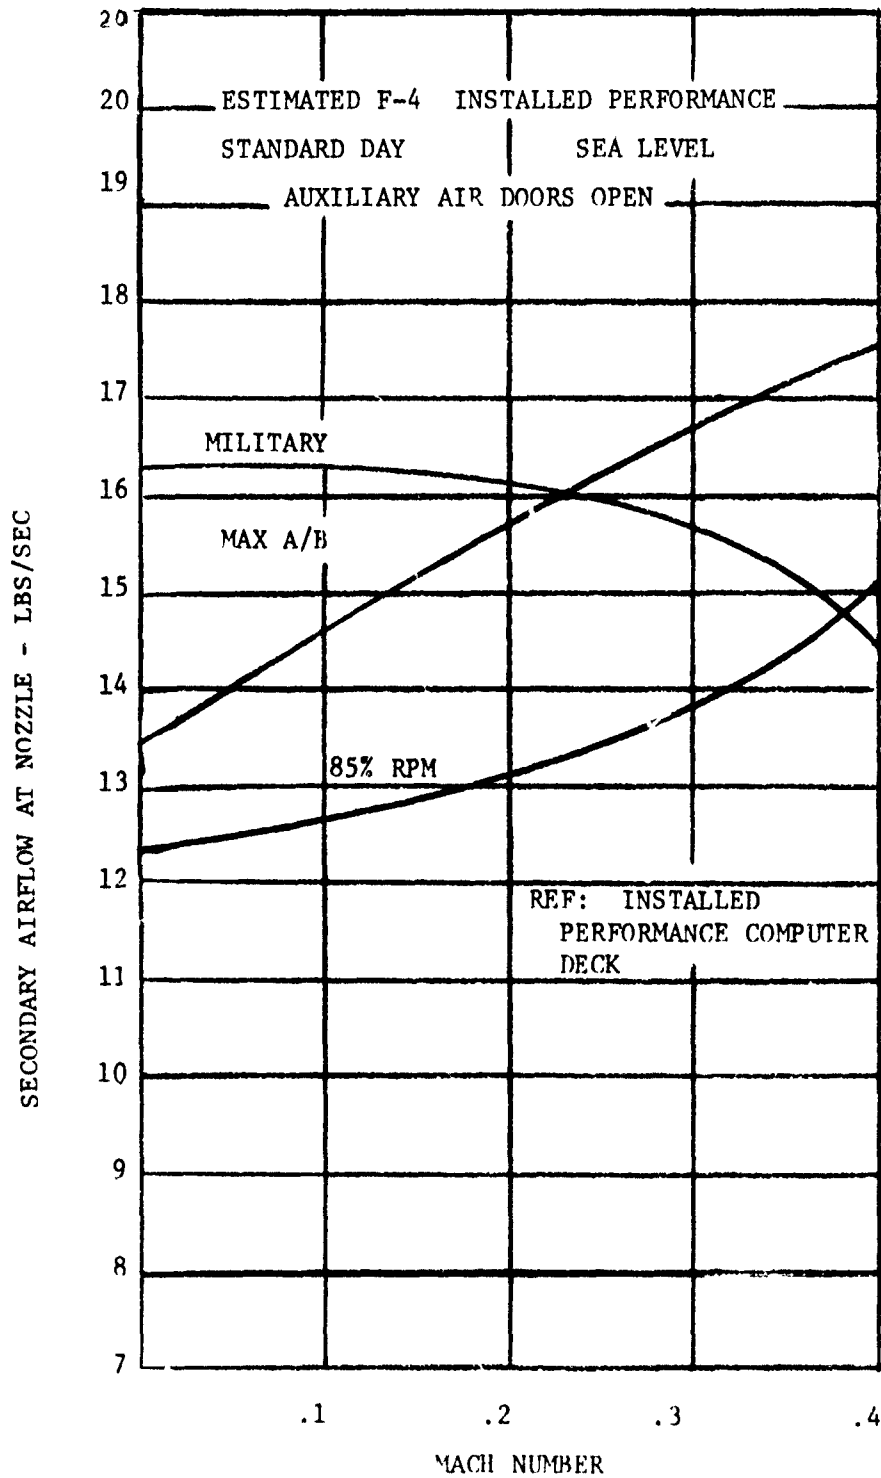
Figure 36 - Secondary Airflow at Nozzle vs Mach Number

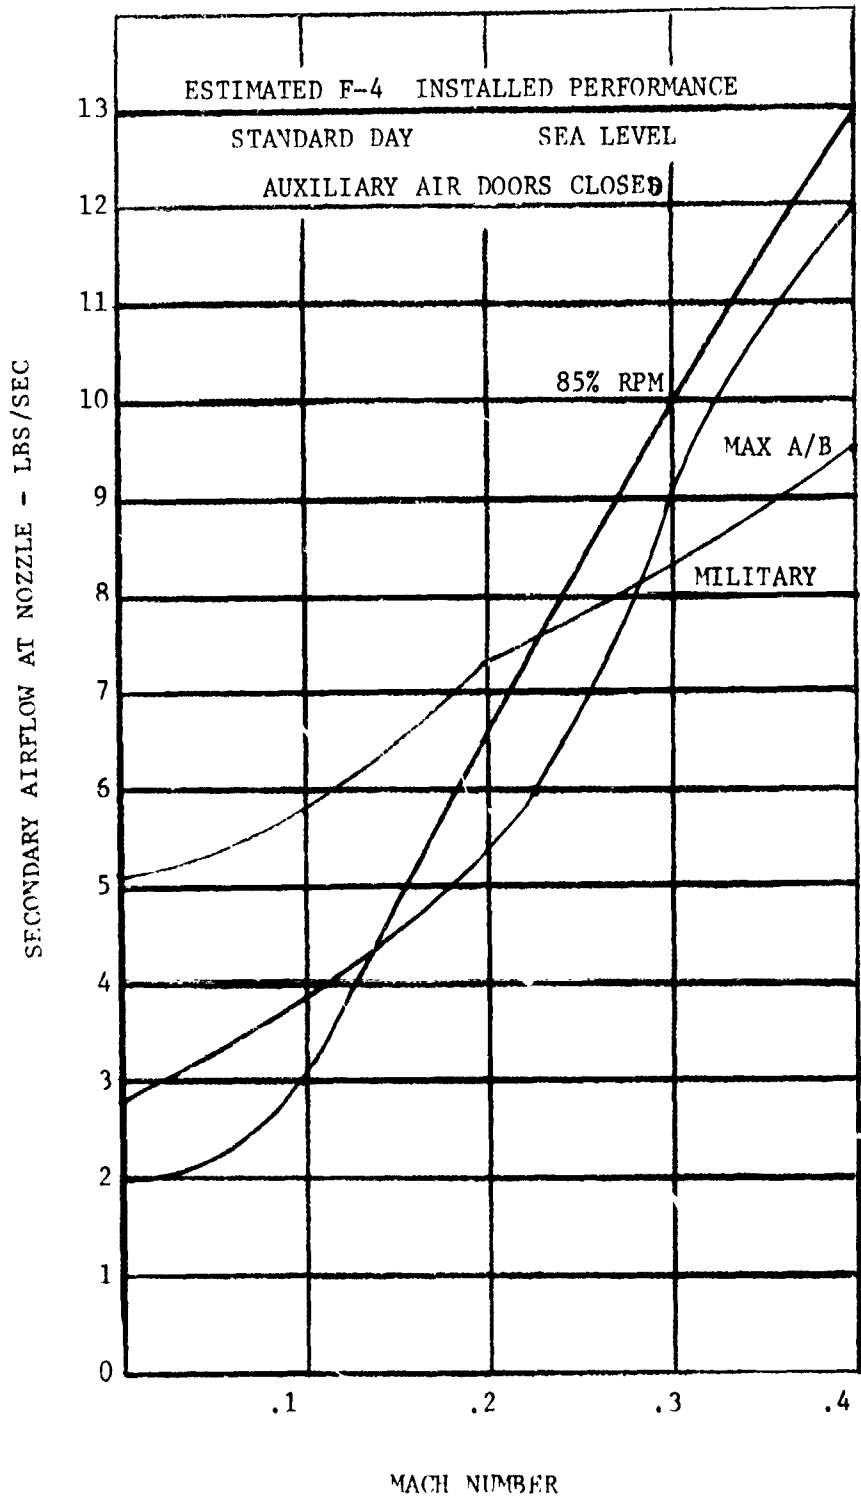
Figure 37 - Secondary Airflow at Nozzle vs Mach Number

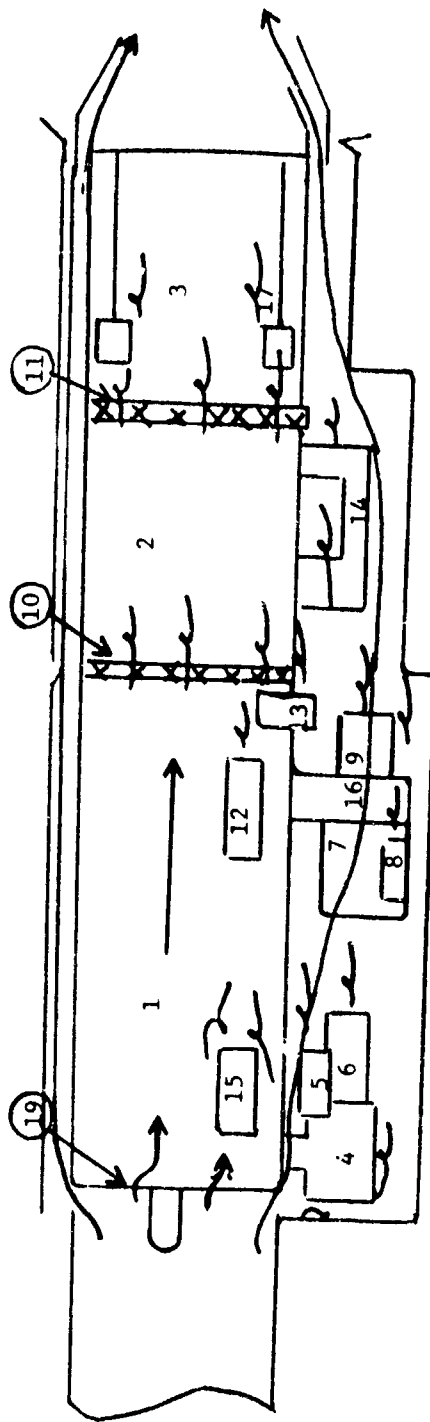
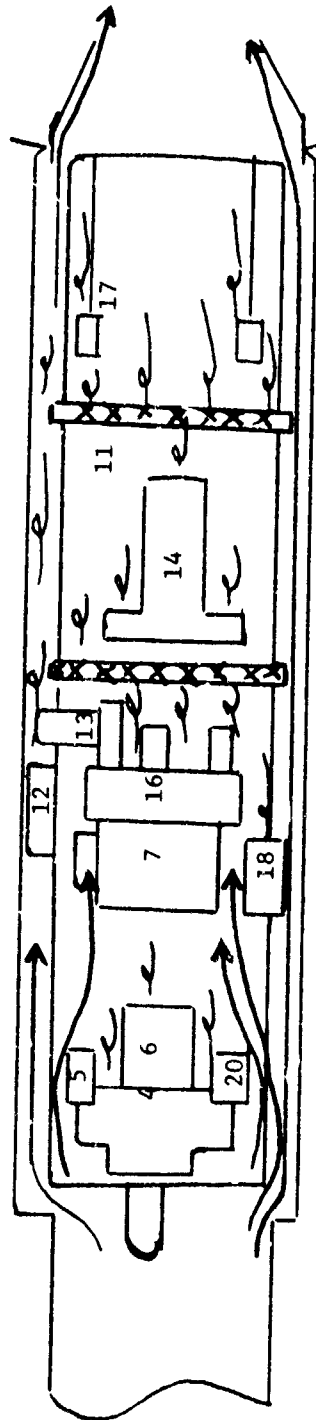
ENGINE LEFT VIEW

ENGINE BOTTOM VIEW

Figure 41. Air Flow and Eddy Currents Within The Engine Bay

The tunnels are to the left and right of the gear boxes and mounted accessories. The major quiescent areas are just aft of the gear boxes and at the A/B fuel spray-bar and manifold assembly. See Figure 41.

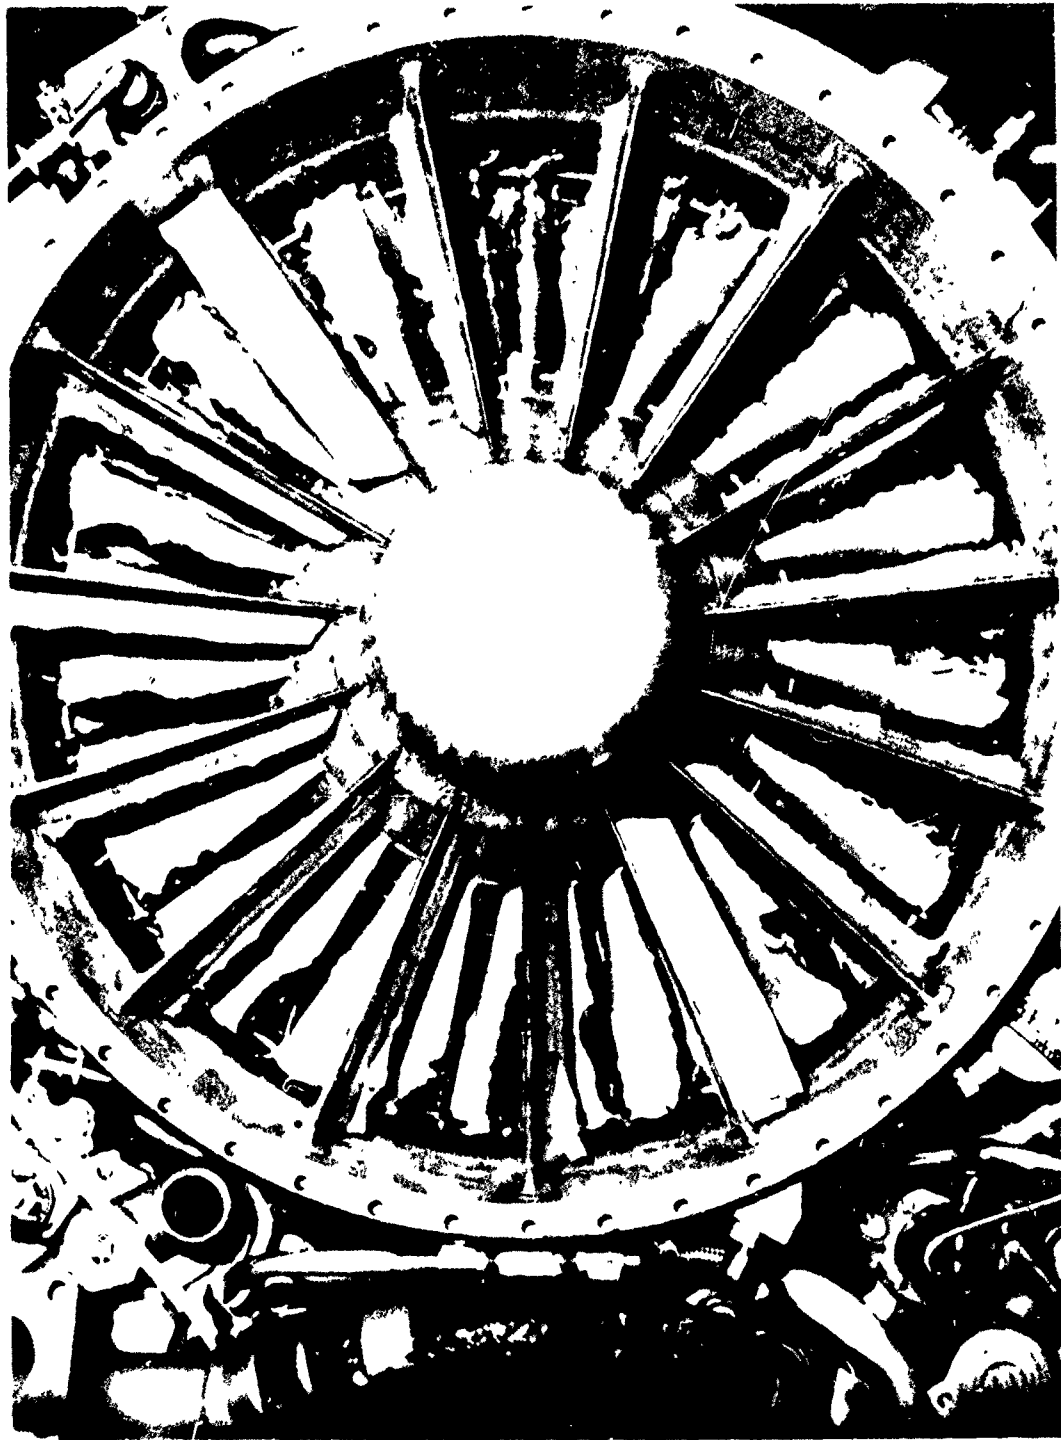
Figure 45 View of Front of Compressor After Ingesting A Foreign Object at 100% RPM Which Resulted From First Stage Blade Failure (185 Engine)

The amount of damage resulting from FOD is a function of air-speed, size of the foreign object and engine RPM. However, there are typical damage patterns from FOD. Often an imprint or other evidence can be seen on a compressor blade that may be helpful in determining the kind of foreign object that entered the engine. See Figures 45 through 48.

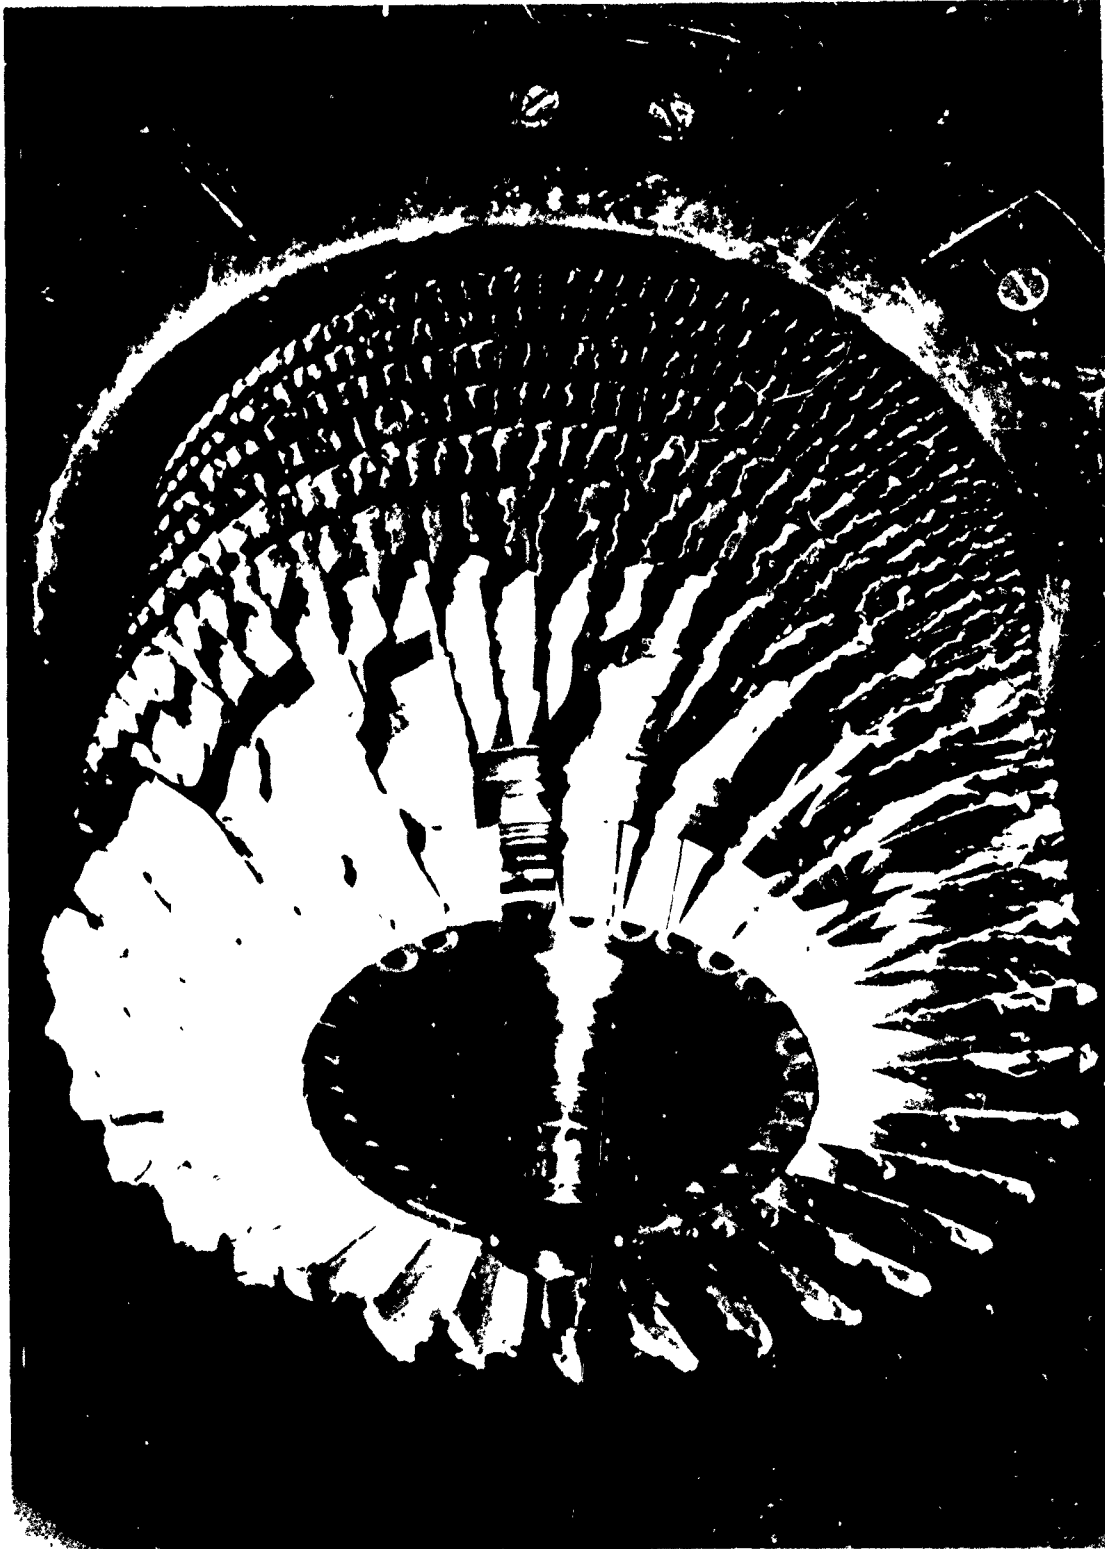
Figure 46 - View of Compressor Rotor After Ingesting a Foreign Object at 100% RPM Which Resulted from First Stage Blade Failure (I85 Engine)

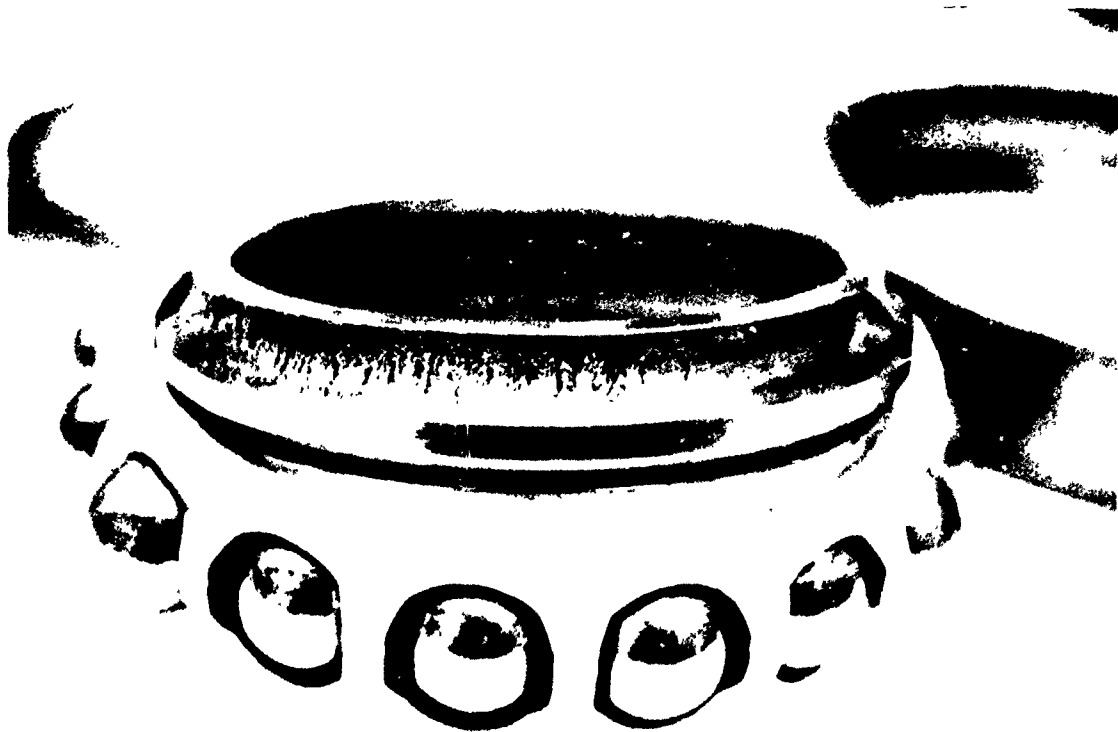
Figure 52 - Incipient No. 2 Bearing Fatigue Failure

This bearing has started to fail in fatigue. If this bearing had continued in service, it would only be a matter of a few hours before it would fail completely, and major damage to the engine would result from the rotor shifting forward.

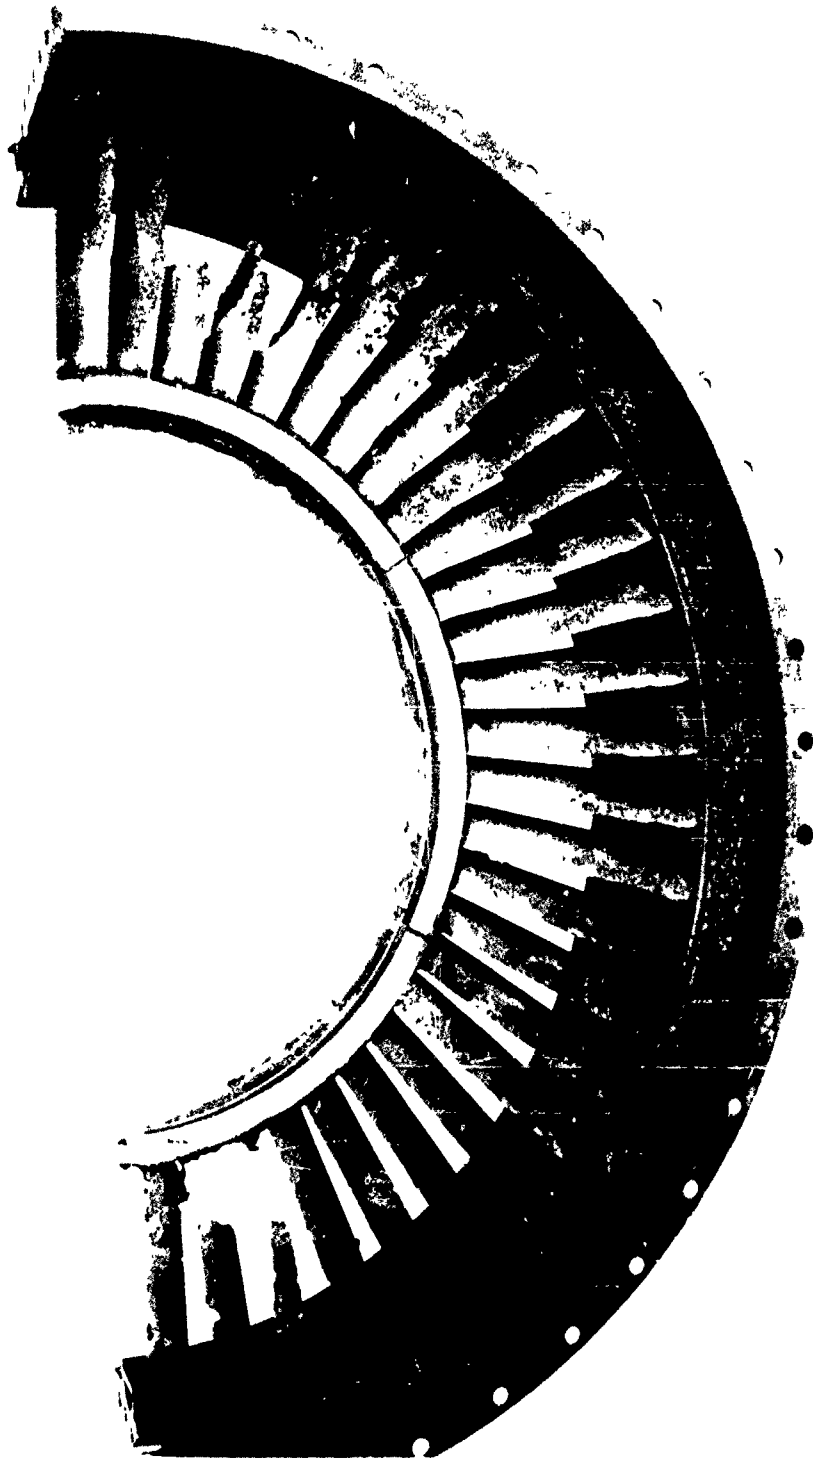
Figure 54 - Burned 2nd Stage Turbine Nozzle (185 Engine)

Both turbine nozzles should be checked for signs of burnouts that could indicate a possible combustion or fuel flow malfunction. Hot streaks from these causes will cause metal burning. See Figure 54.

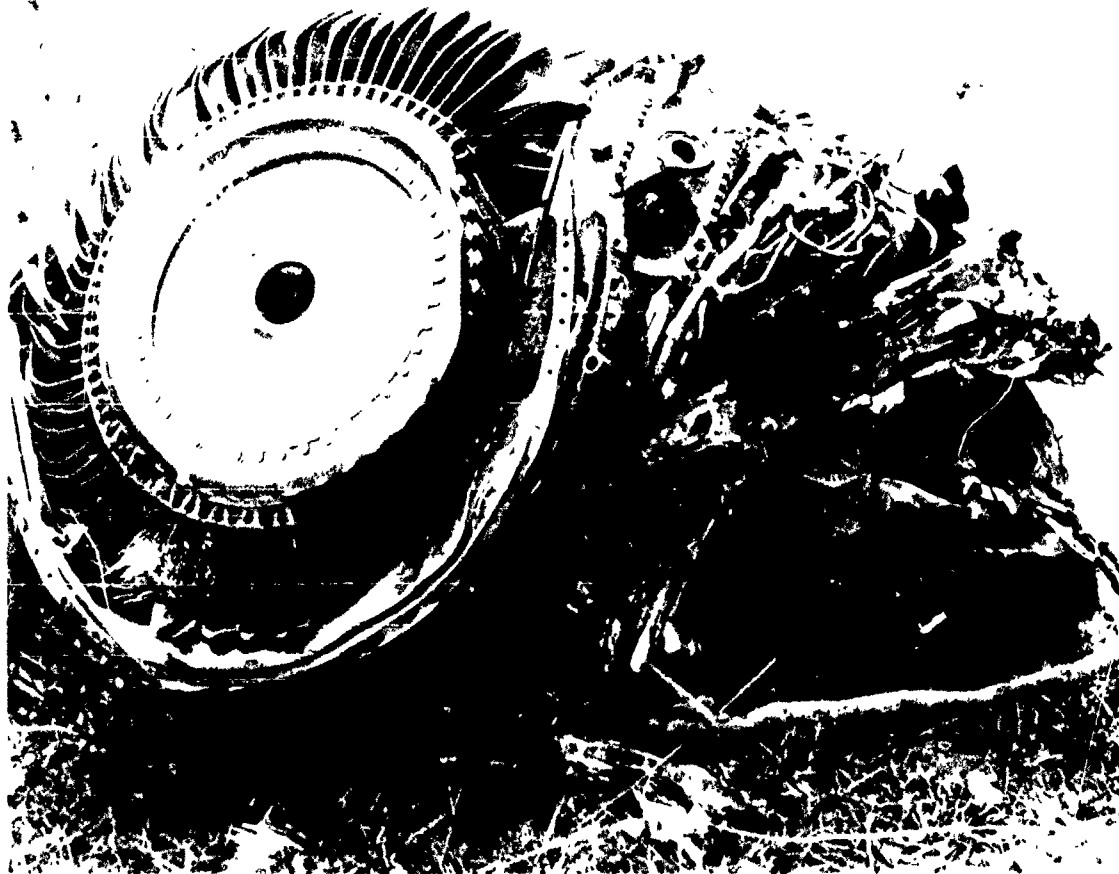
FIGURE 55 - TURBINE ROTOR THAT WAS OPERATING AT 83-85% RPM AT
TIME OF IMPACT. NOTE HIGH IMPACT DAMAGE.

High speed rotational damage will be indicated in the turbine section by the bending of turbine blades opposite to the direction of rotation by low speed rubbing of the turbine disc, blades, shroud ring, or exhaust cone. Low speed rubs are identified by lack of concentricity and little or no metal discoloration. See Figures 55 and '6.

Moderate to severe impact normally results in shearing or breaking of the turbine blades at their roots. Therefore, shearing or breaking of the turbine blades at their roots is not indicative of engine RPM at time of impact. This type failure should not be used to estimate RPM unless no other means of making the estimate is available. See Figure 55.

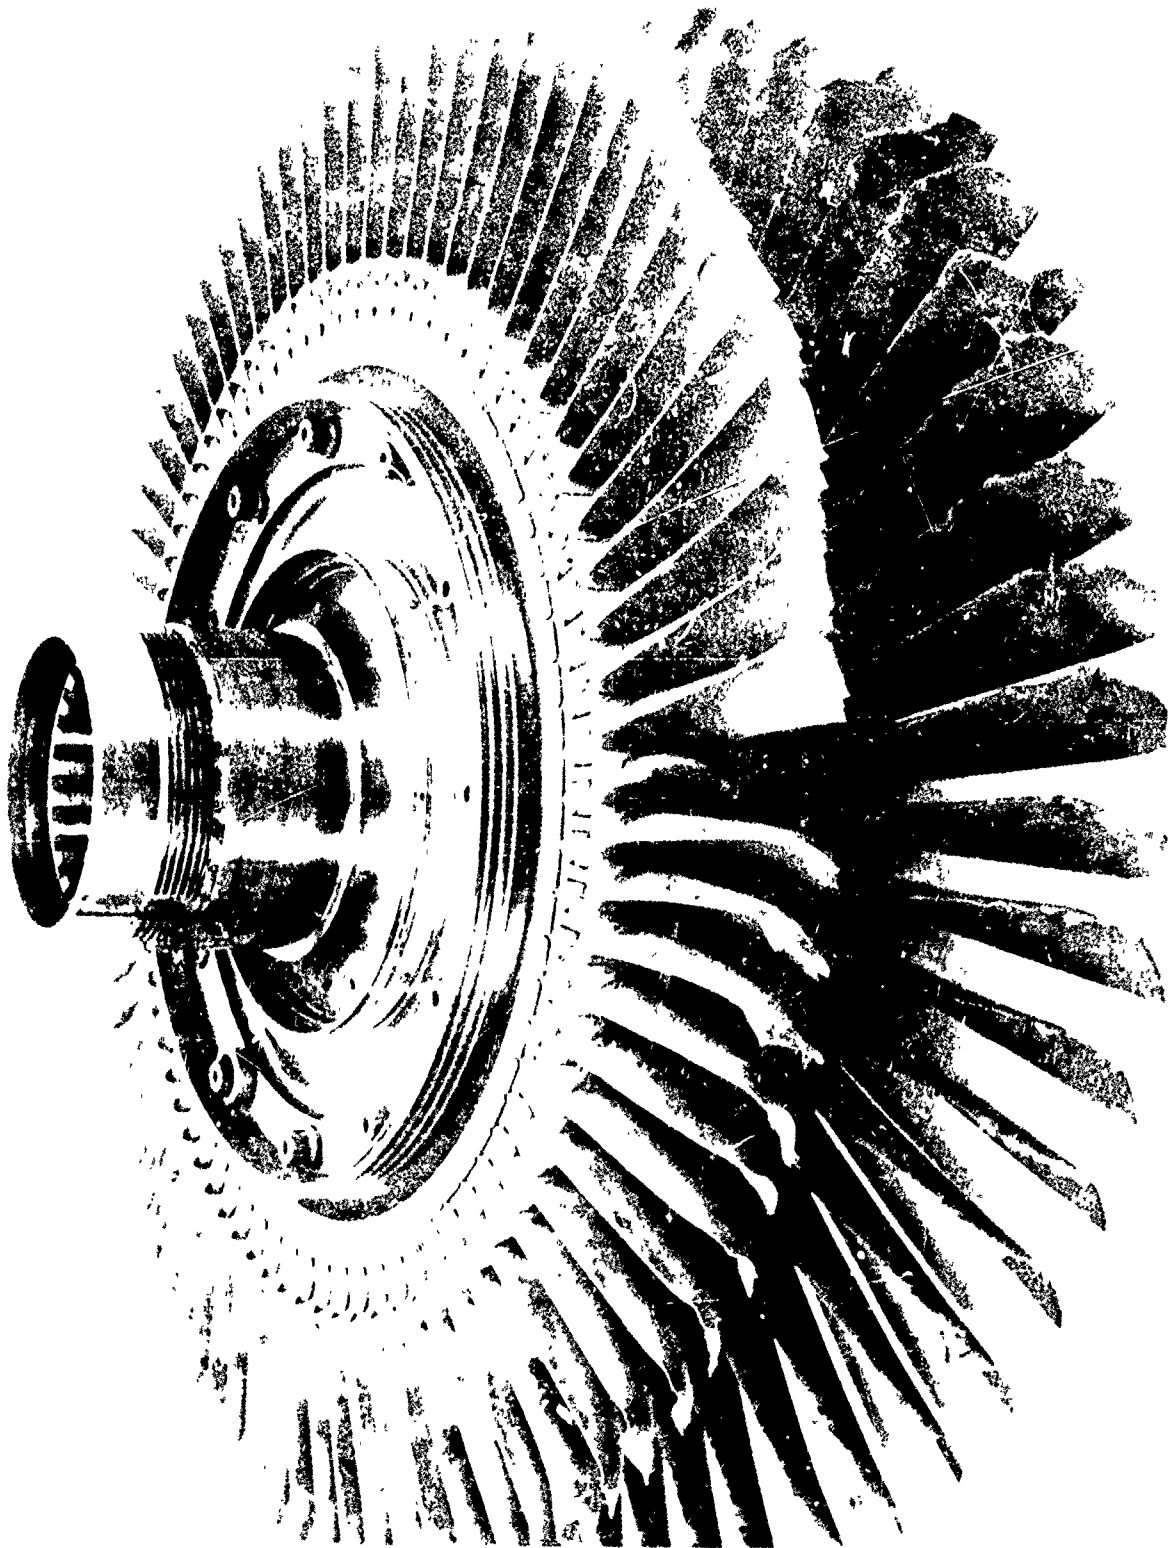
Figure 58 - Second Stage Turbine Blade that Failed From Stress Rupture At 100% RPM Power During Pre-Overtemperature Operation (185 Jet Engines)

rupture are positive identification of an engine that had been running in an over temperature condition for at least several seconds. Over temperature can result from an engine stall. See Figures 57 and 58. An engine stall will not necessarily burn off blades, and the absence of this type of failure does not rule out the possibility of a stall.

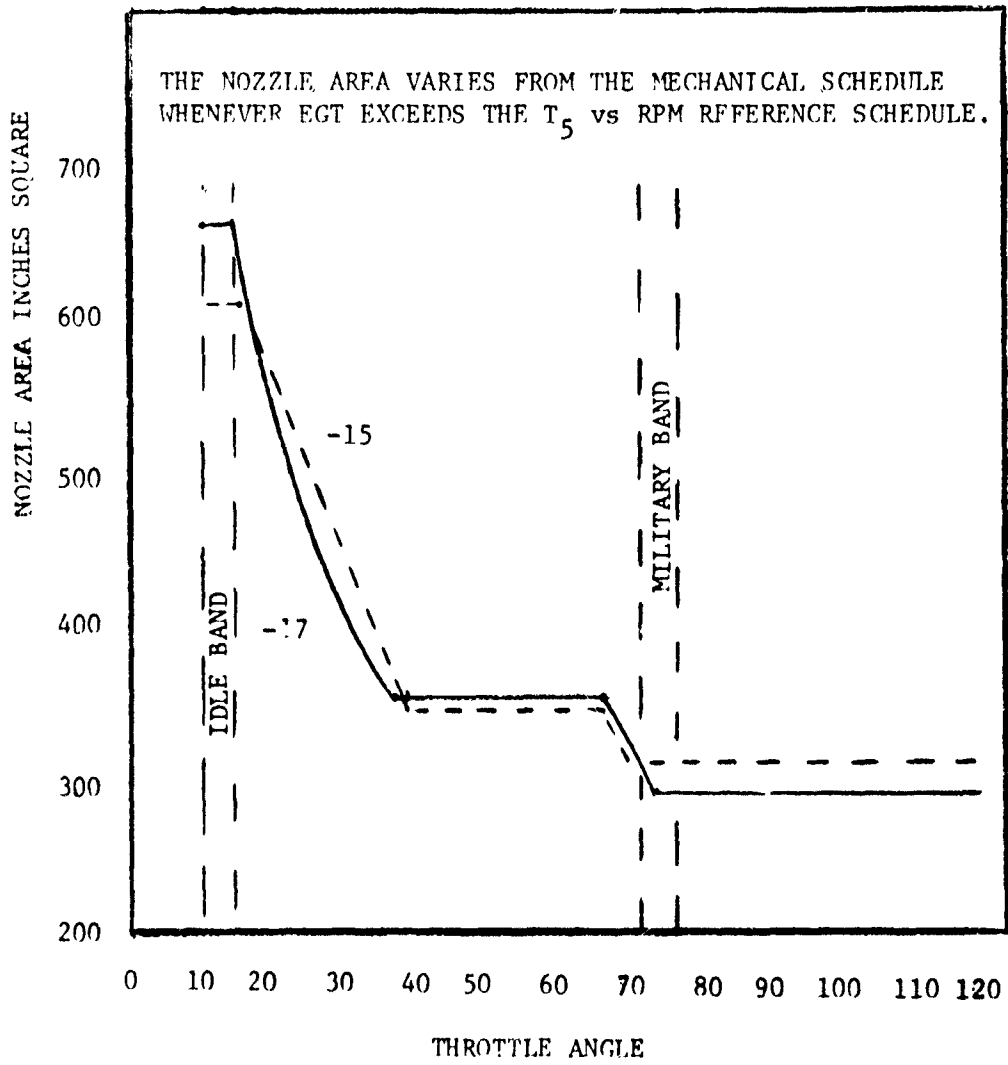
Figure 60 - Nozzle Area vs Throttle Angle

The area of the variable exhaust nozzle varies with throttle angle in accordance with a fixed mechanical schedule until such time as the EGT exceeds the T_5 vs RPM reference schedule. When this happens the nozzle area may be larger than that illustrated in Figure 60. However, this figure should provide the investigator with a close approximation of the area for a given throttle angle. Determination of throttle angle was discussed in Section V. If the nozzle area is larger than it should be for any given engine operating condition, a loss of thrust will result.

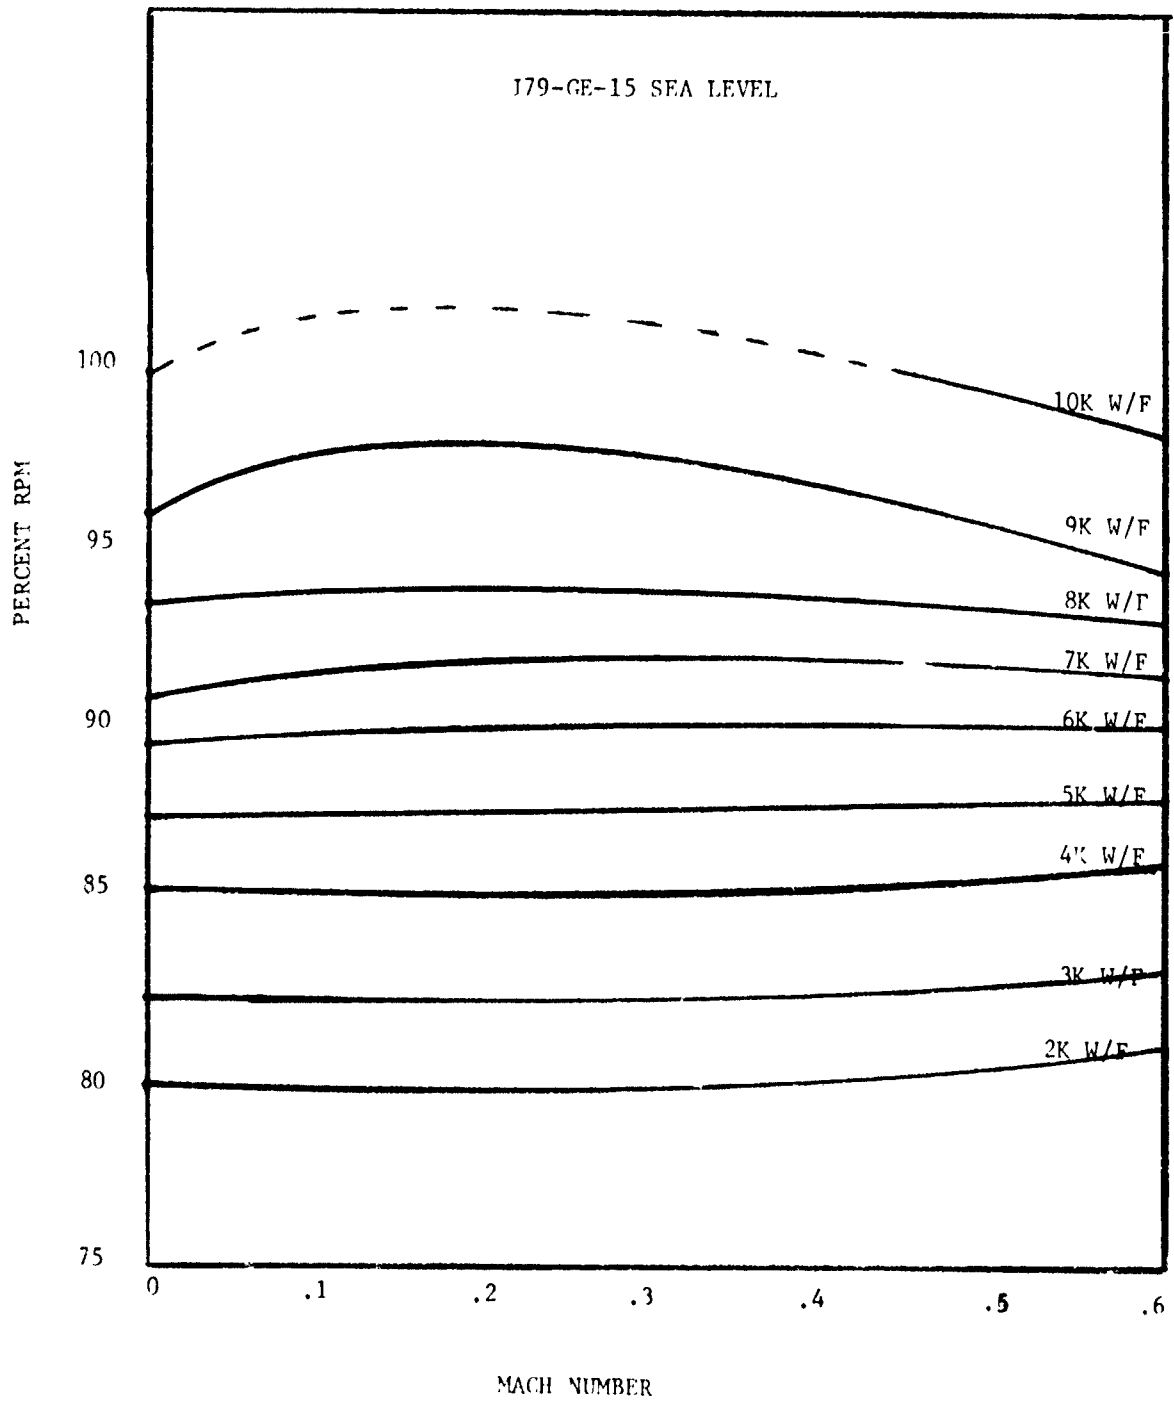
Figure 61 - J79-15 Fuel Flow for various RPMs and Mach Numbers (Sea Level)

Having established two of the following parameters RPM, MACH number, fuel flow, or thrust, the other parameters can be determined through the use of Figures 61 through 68. It should be noted that the figures are drawn for both the -15 and -17 engines under sea level and 5000 foot altitudes. Interpolations of the figures must be made to more closely approximate the conditions at time of impact.

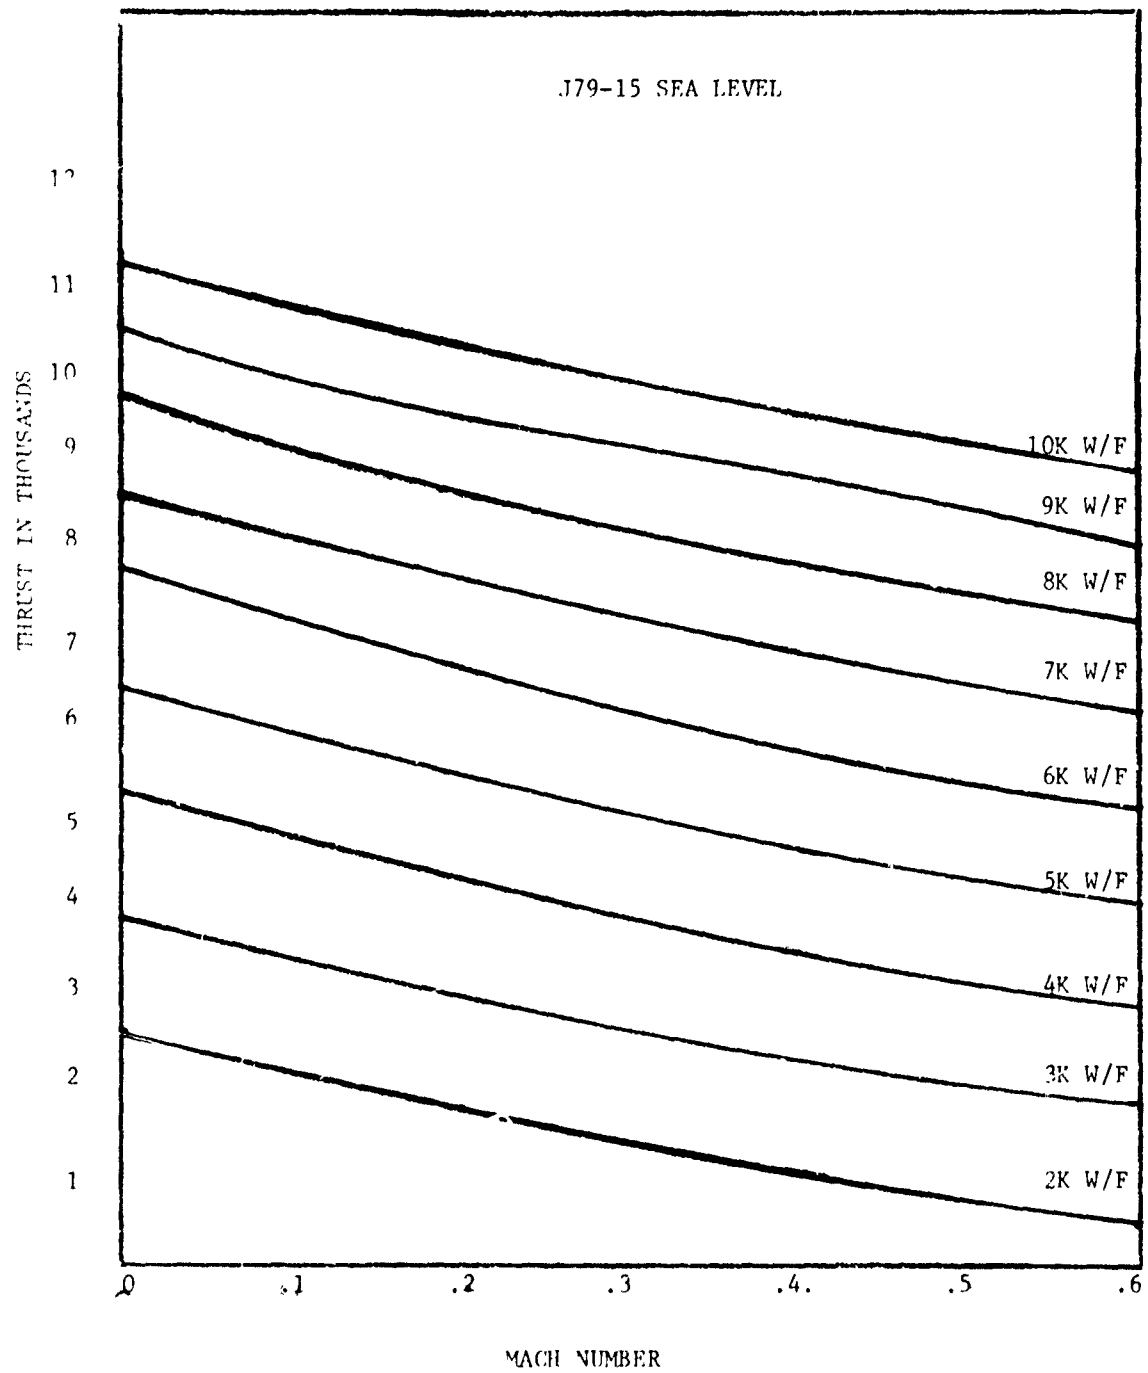
Figure 62 - J79-15 Fuel Flow at Various Thrust Settings and Mach Numbers (Sea Level)
