J79-15/-17 TURBOJET ENGINE ACCIDENT INVESTIGATION PROCEDURES

F-4 SYSTEM PROGRAM OFFICE

AUGUST 1975

TECHNICAL REPORT ASD-TR-75-19

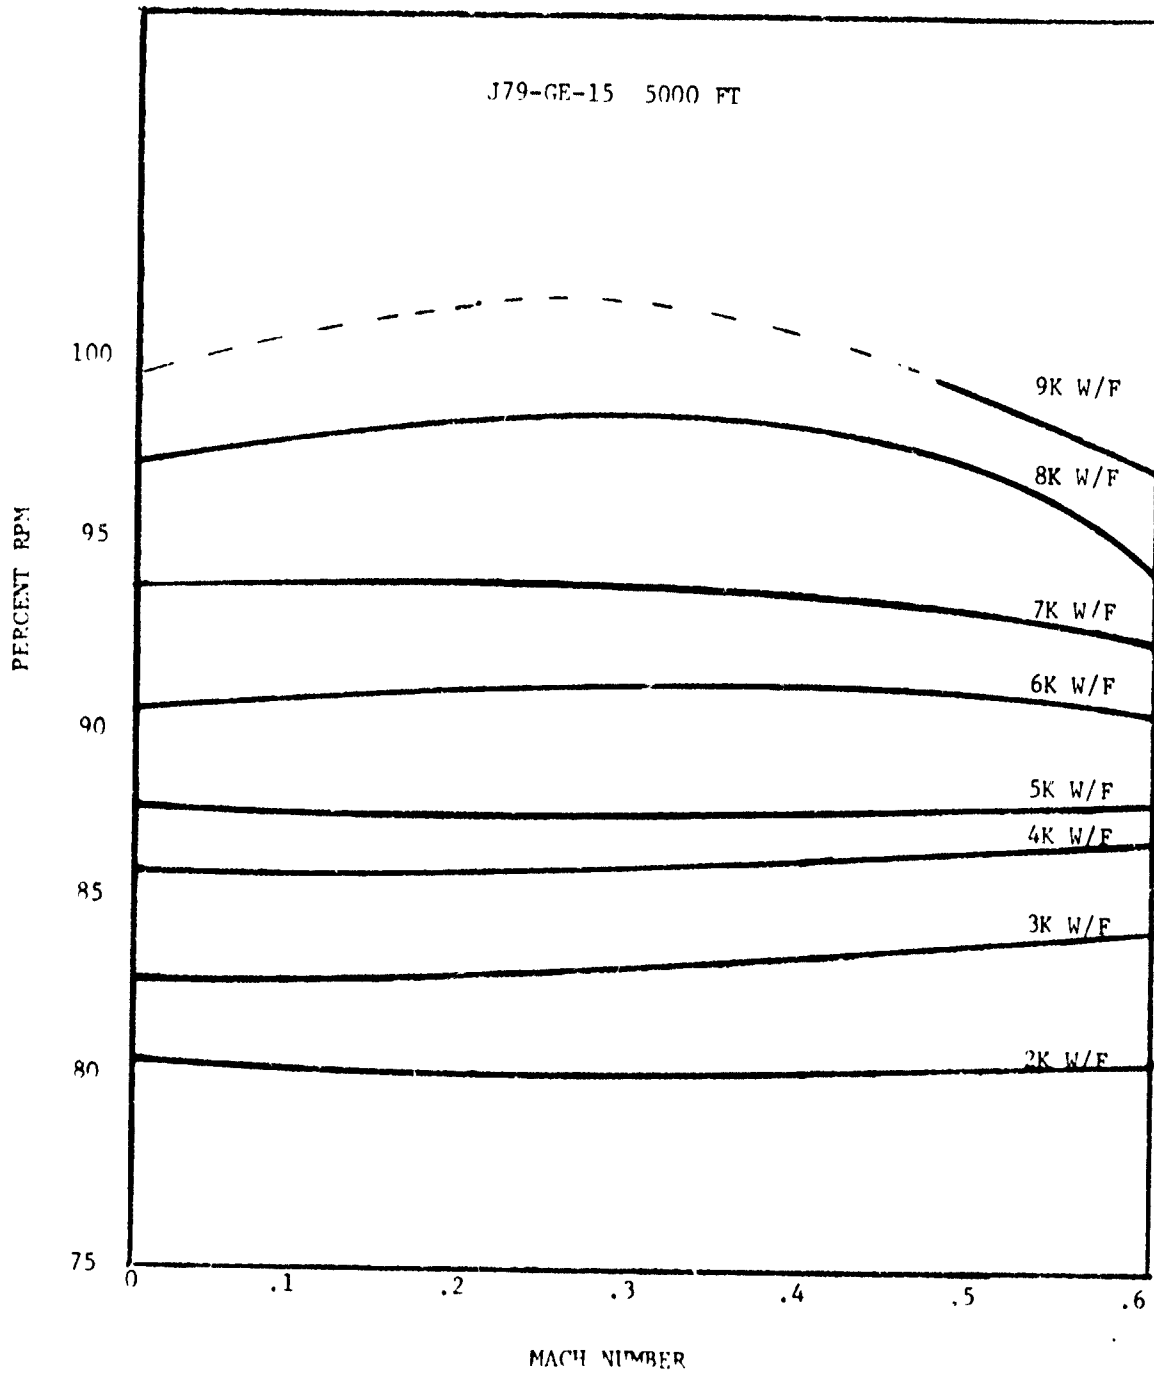
Figure 63 - J79-15 Fuel Flow at Various RPMs and Mach Numbers (5000 Feet)

Having established two of the following parameters RPM, MACH number, fuel flow, or thrust, the other parameters can be determined through the use of Figures 61 through 68. It should be noted that the figures are drawn for both the -15 and -17 engines under sea level and 5000 foot altitudes. Interpolations of the figures must be made to more closely approximate the conditions at time of impact.

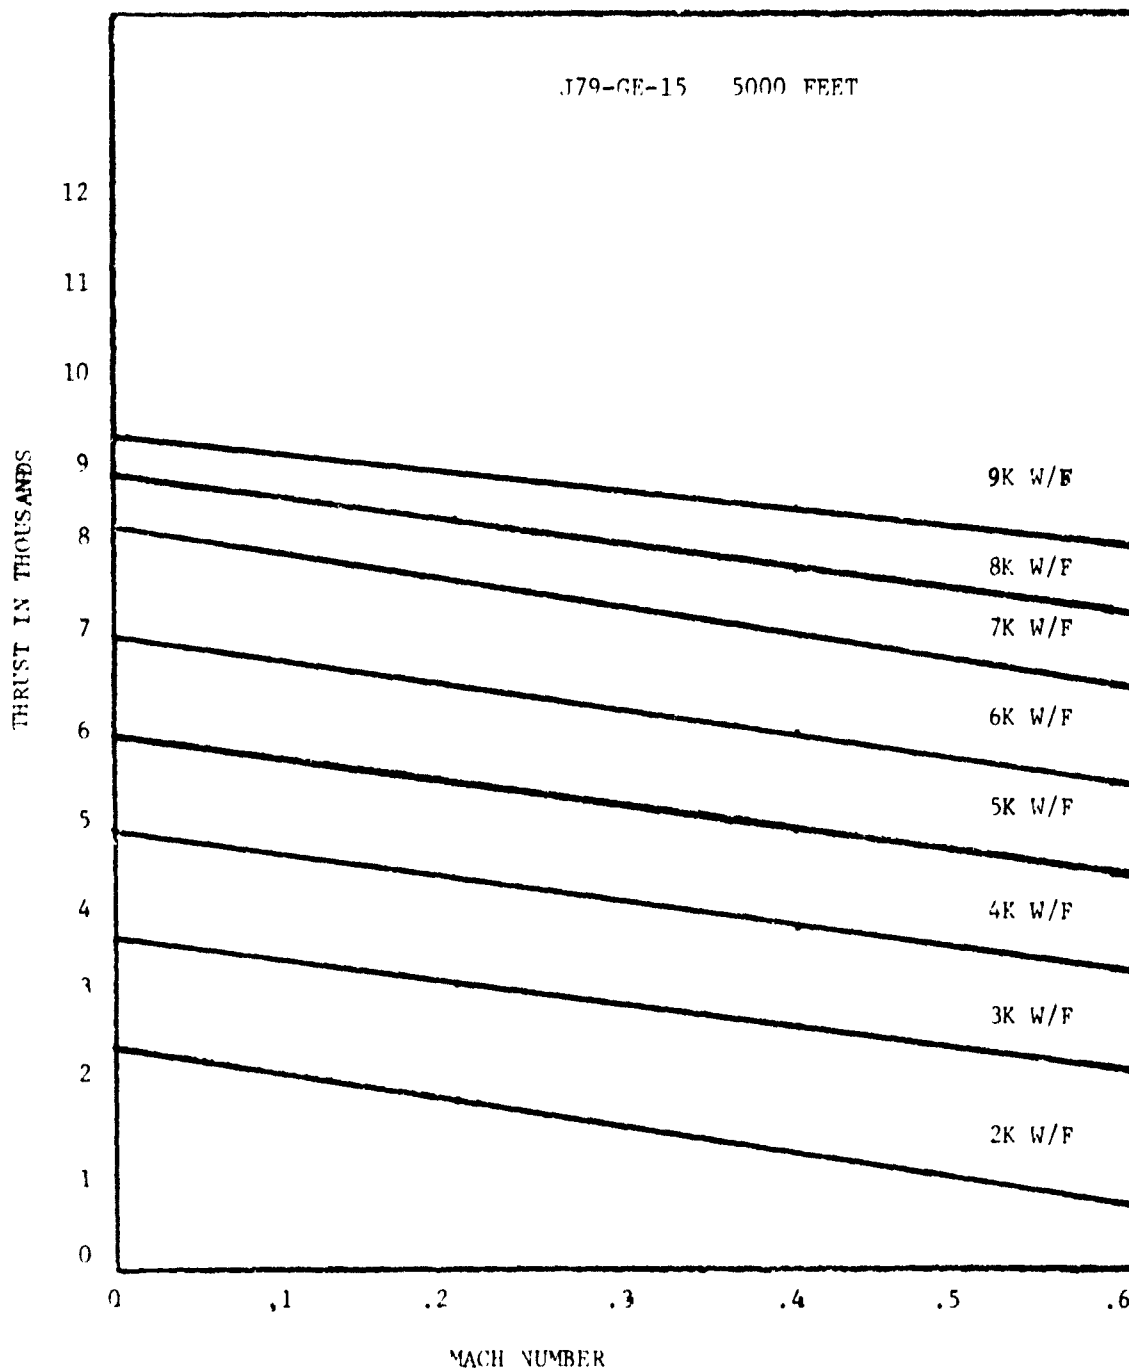
Figure 64 - J79-15 Fuel Flow at Various Thrust Settings and Mach Numbers (5000 Feet)

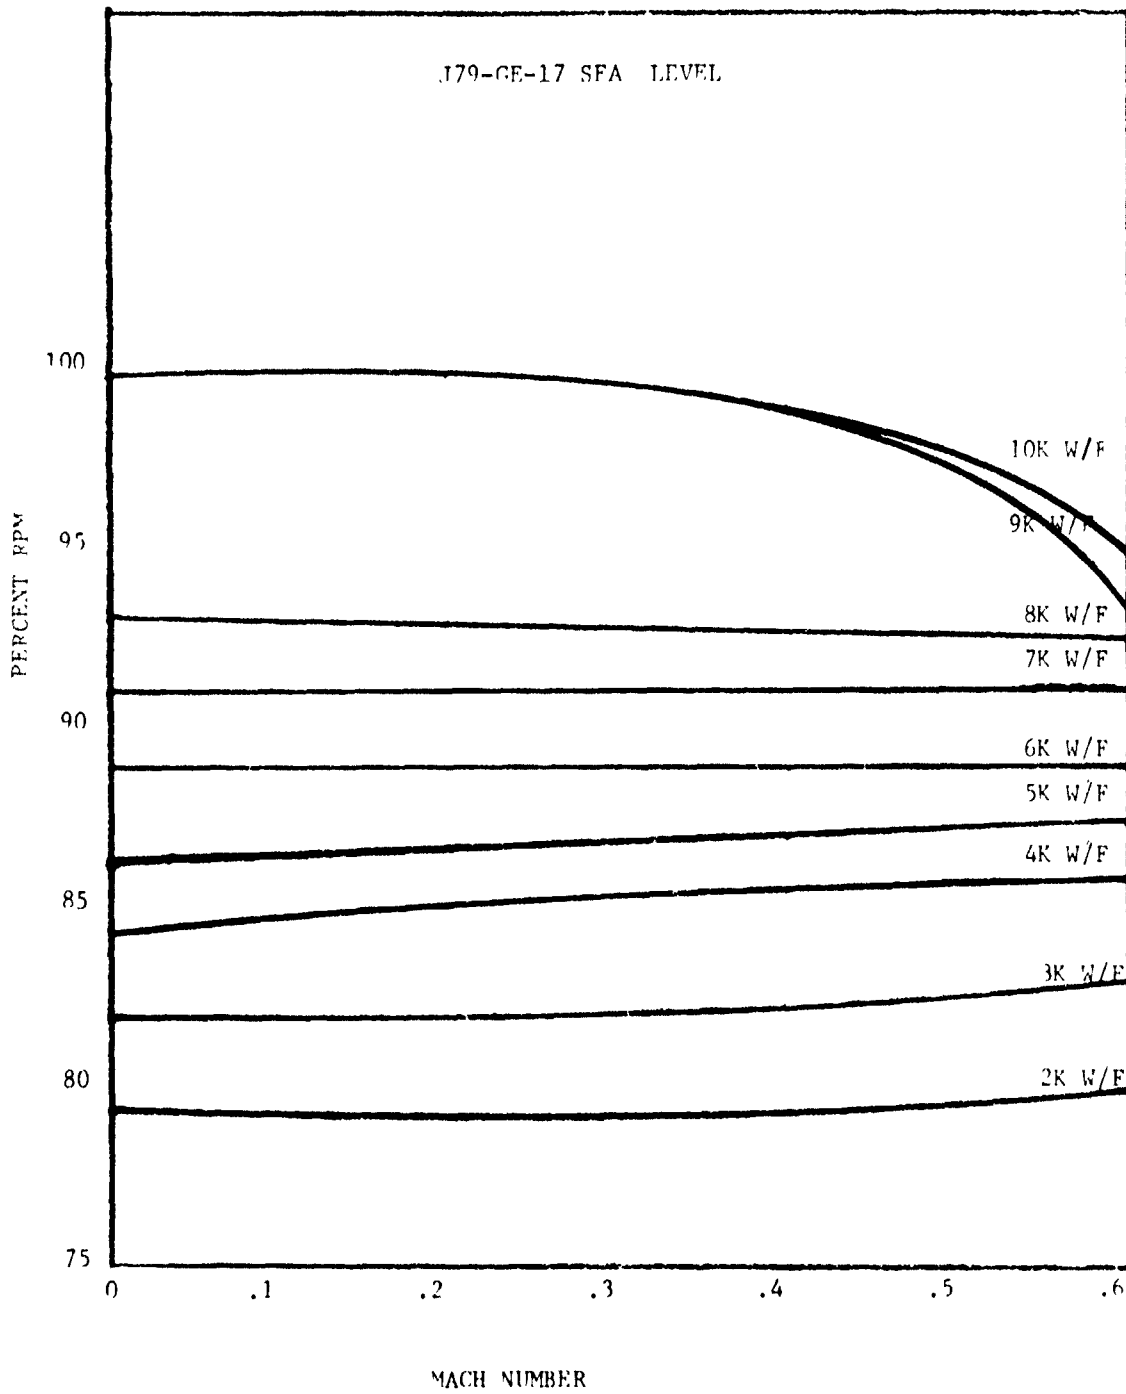
Figure 65 - J79-17 Fuel Flow at Various RPMs and Mach Numbers (Sea Level)

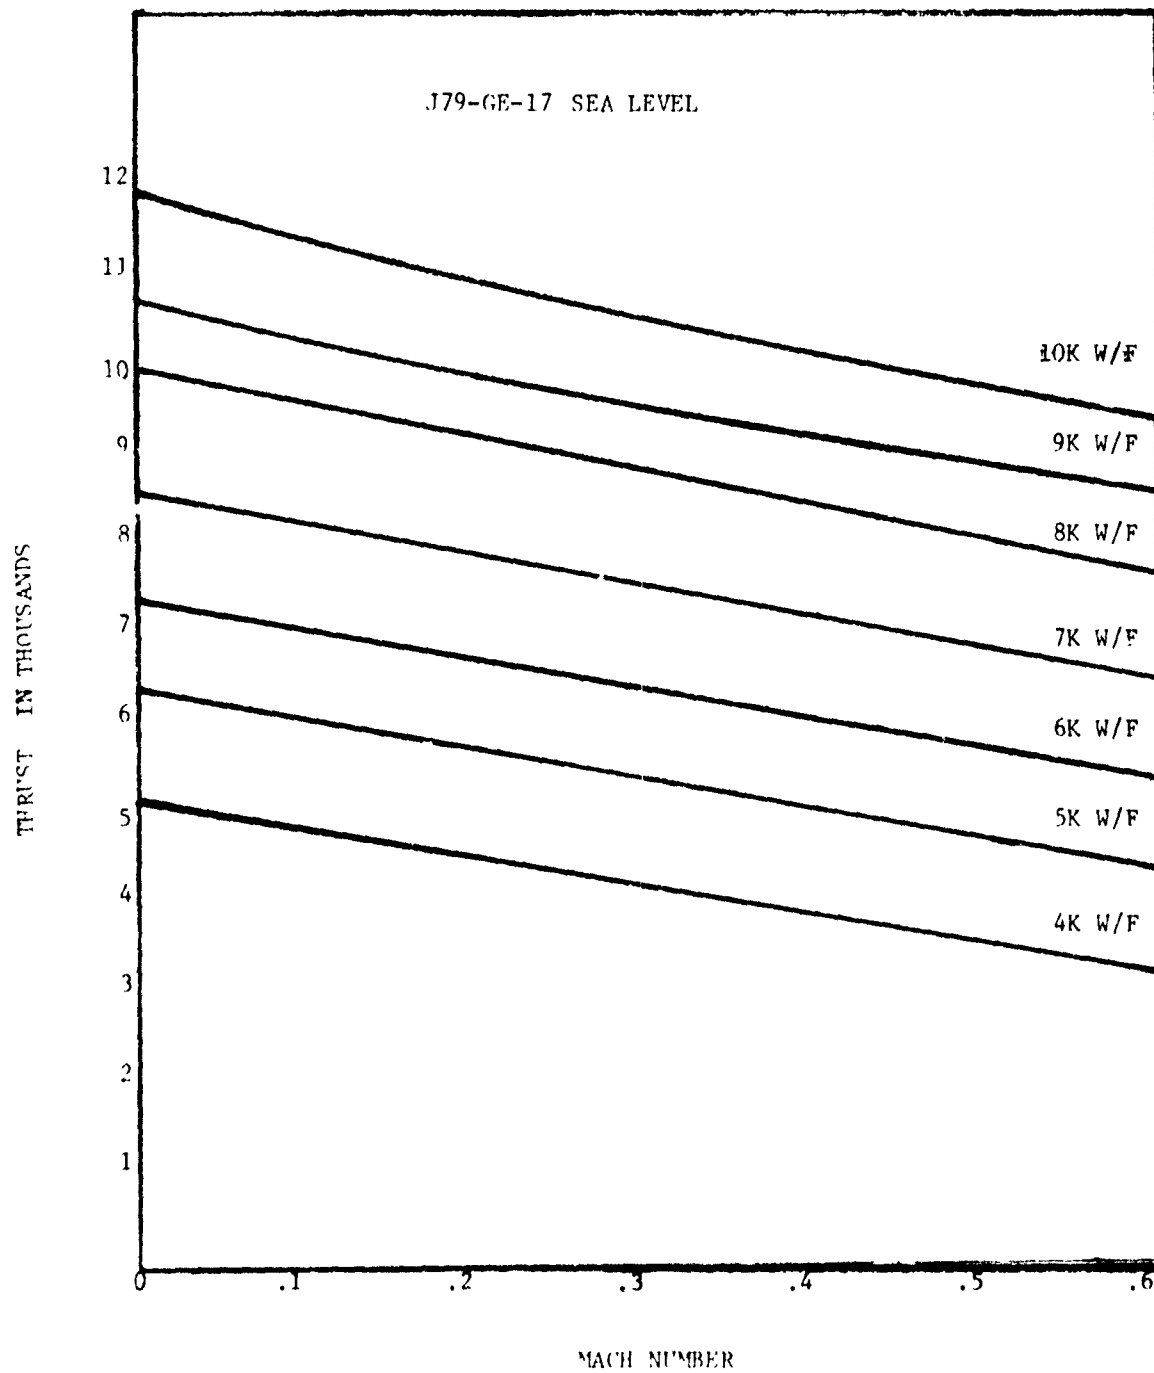
Figure 66 - J79-17 Fuel Flow at Various Thrust Settings and Mach Numbers (Sea Level)

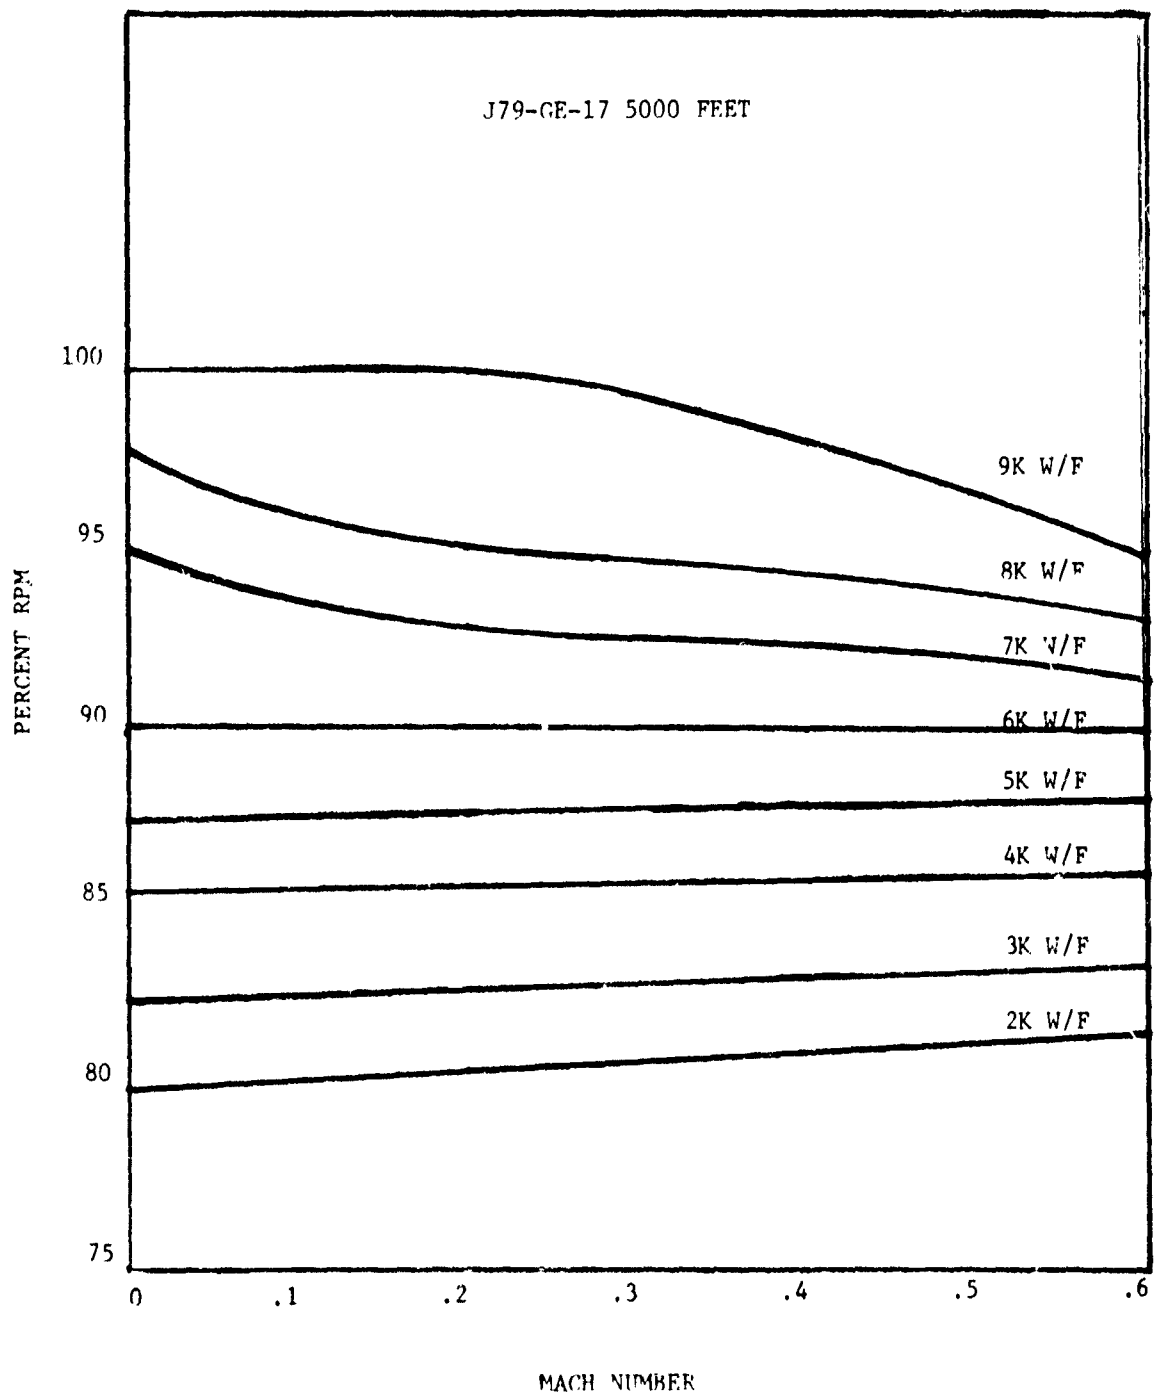
Figure 67 - J79-17 Fuel Flow at Various RPMs and Mach Numbers (5000 Feet)

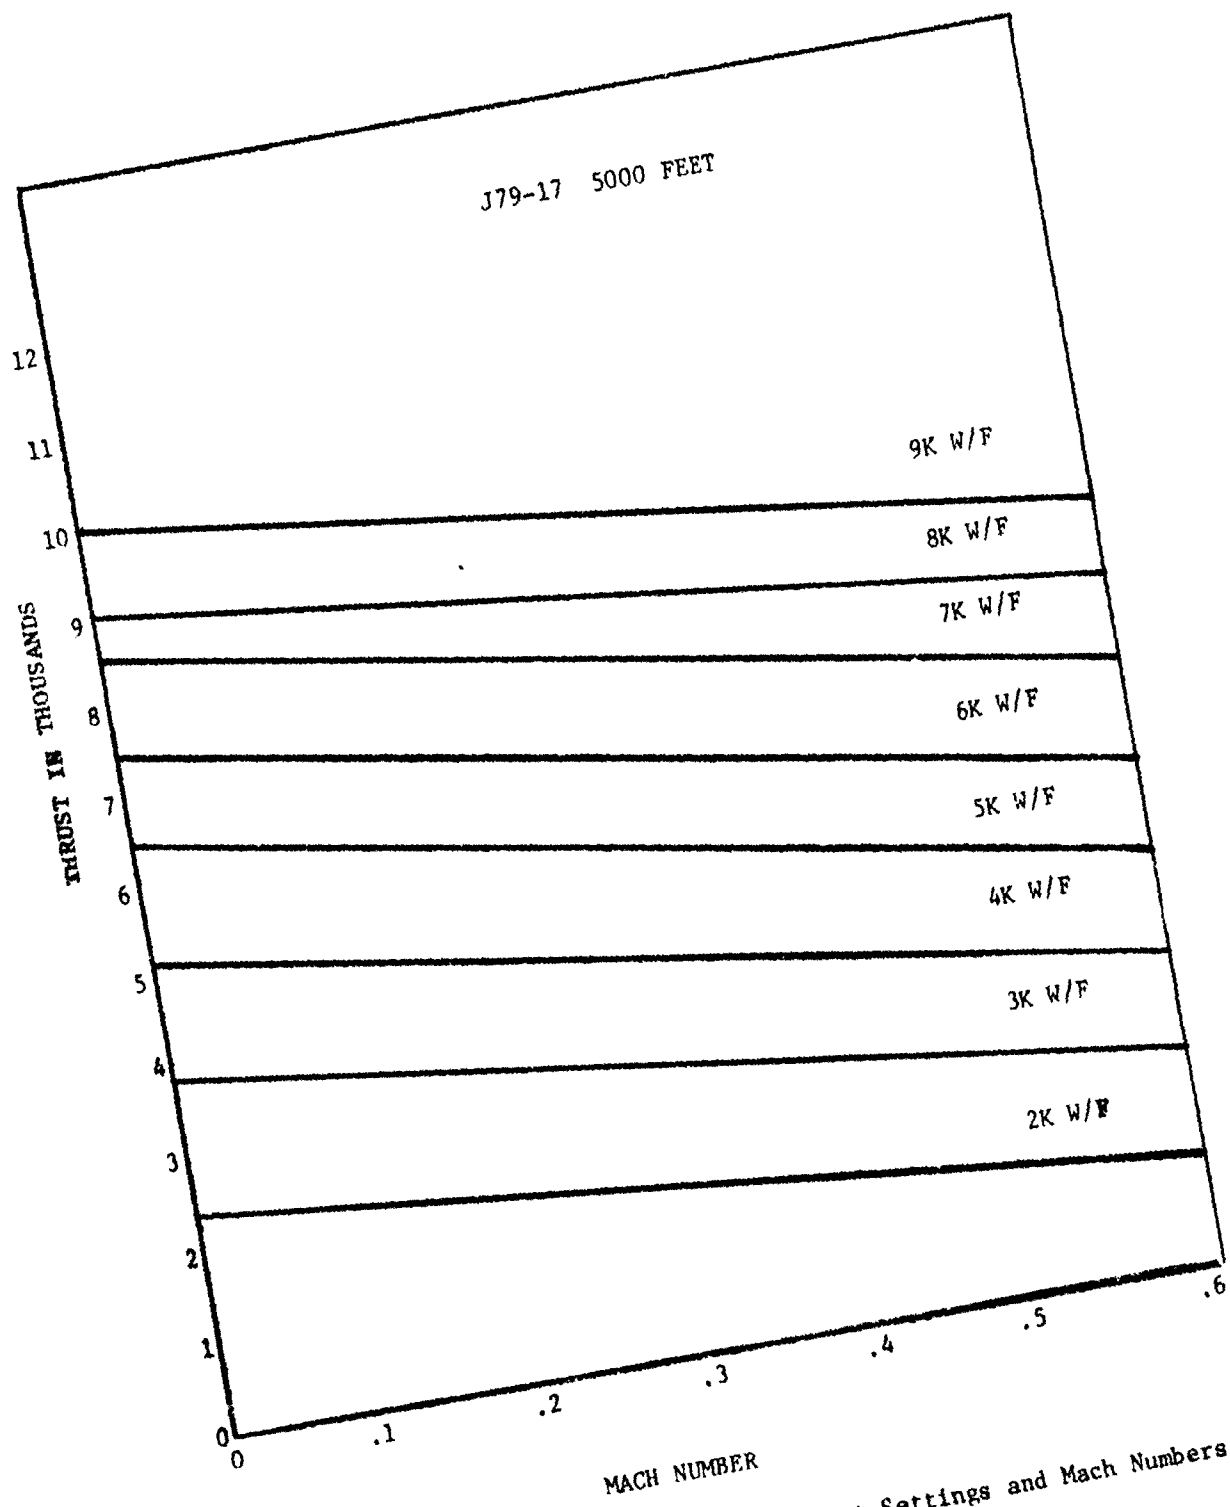
Figure 68 - J79-17 Fuel Flow at Various Thrust Settings and Mach Numbers (5000 Feet)

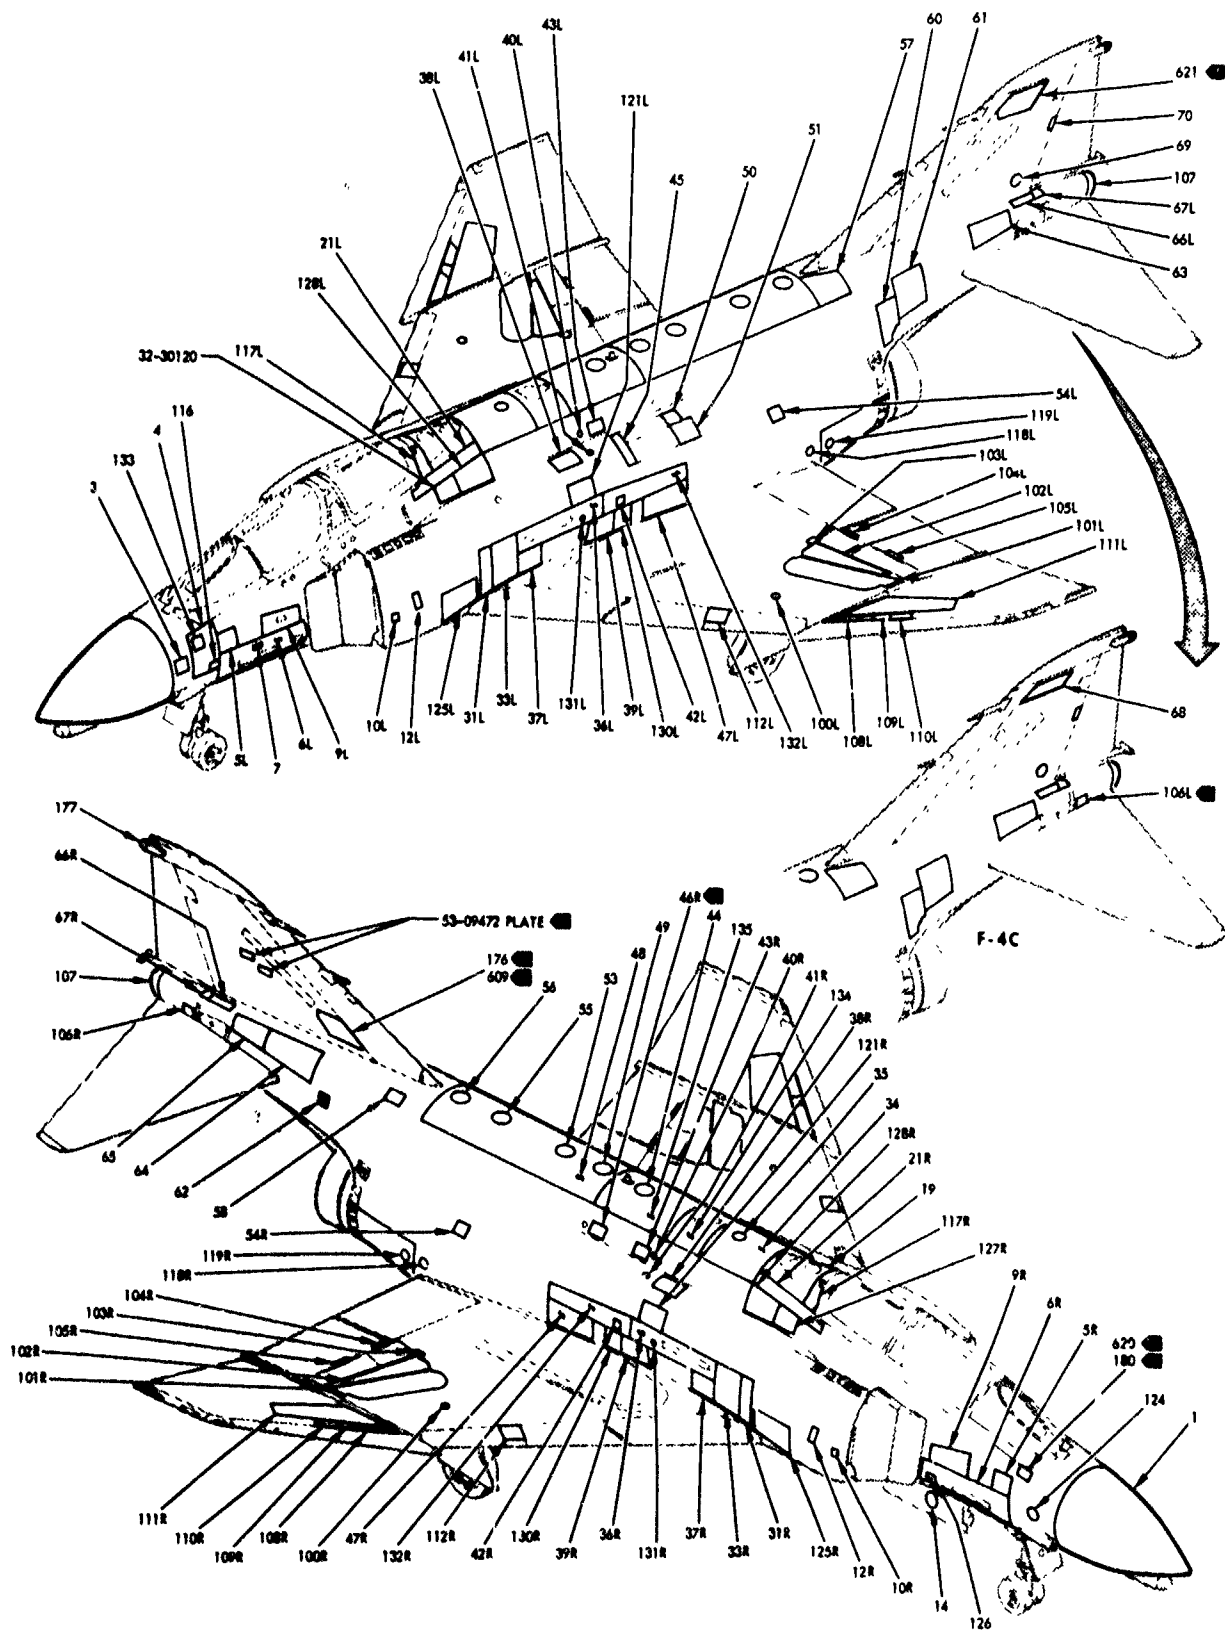
F-1 Upper External Access Openings for F-4C/D Aircraft

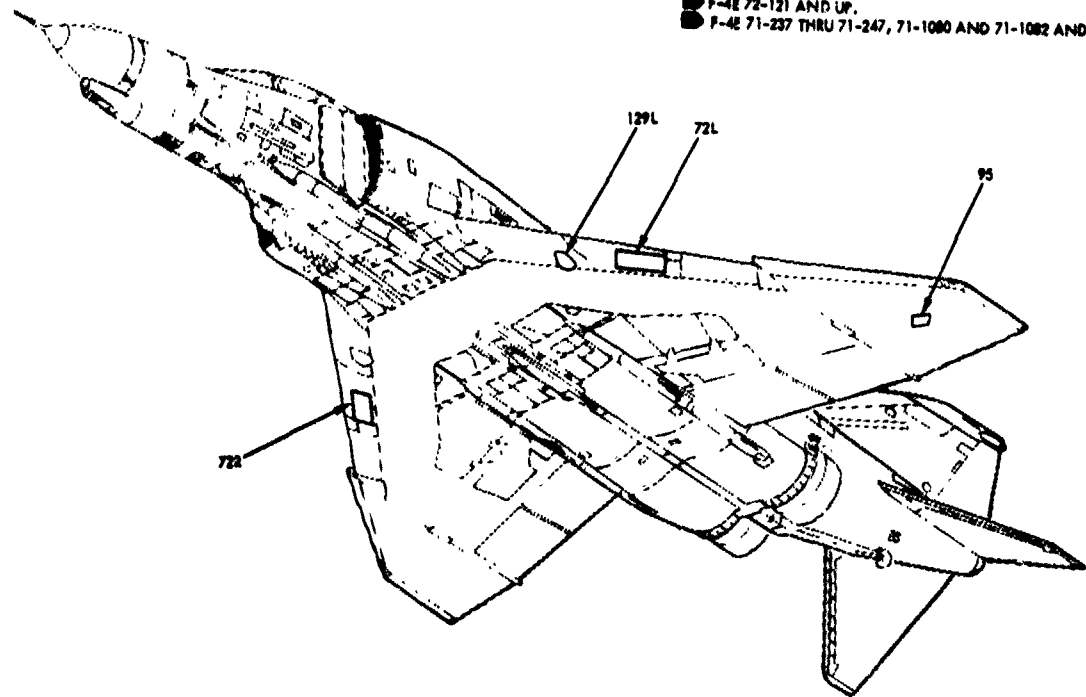
E-5 External Access Openings for F-4E Aircraft (Before Leading Edge Slats)

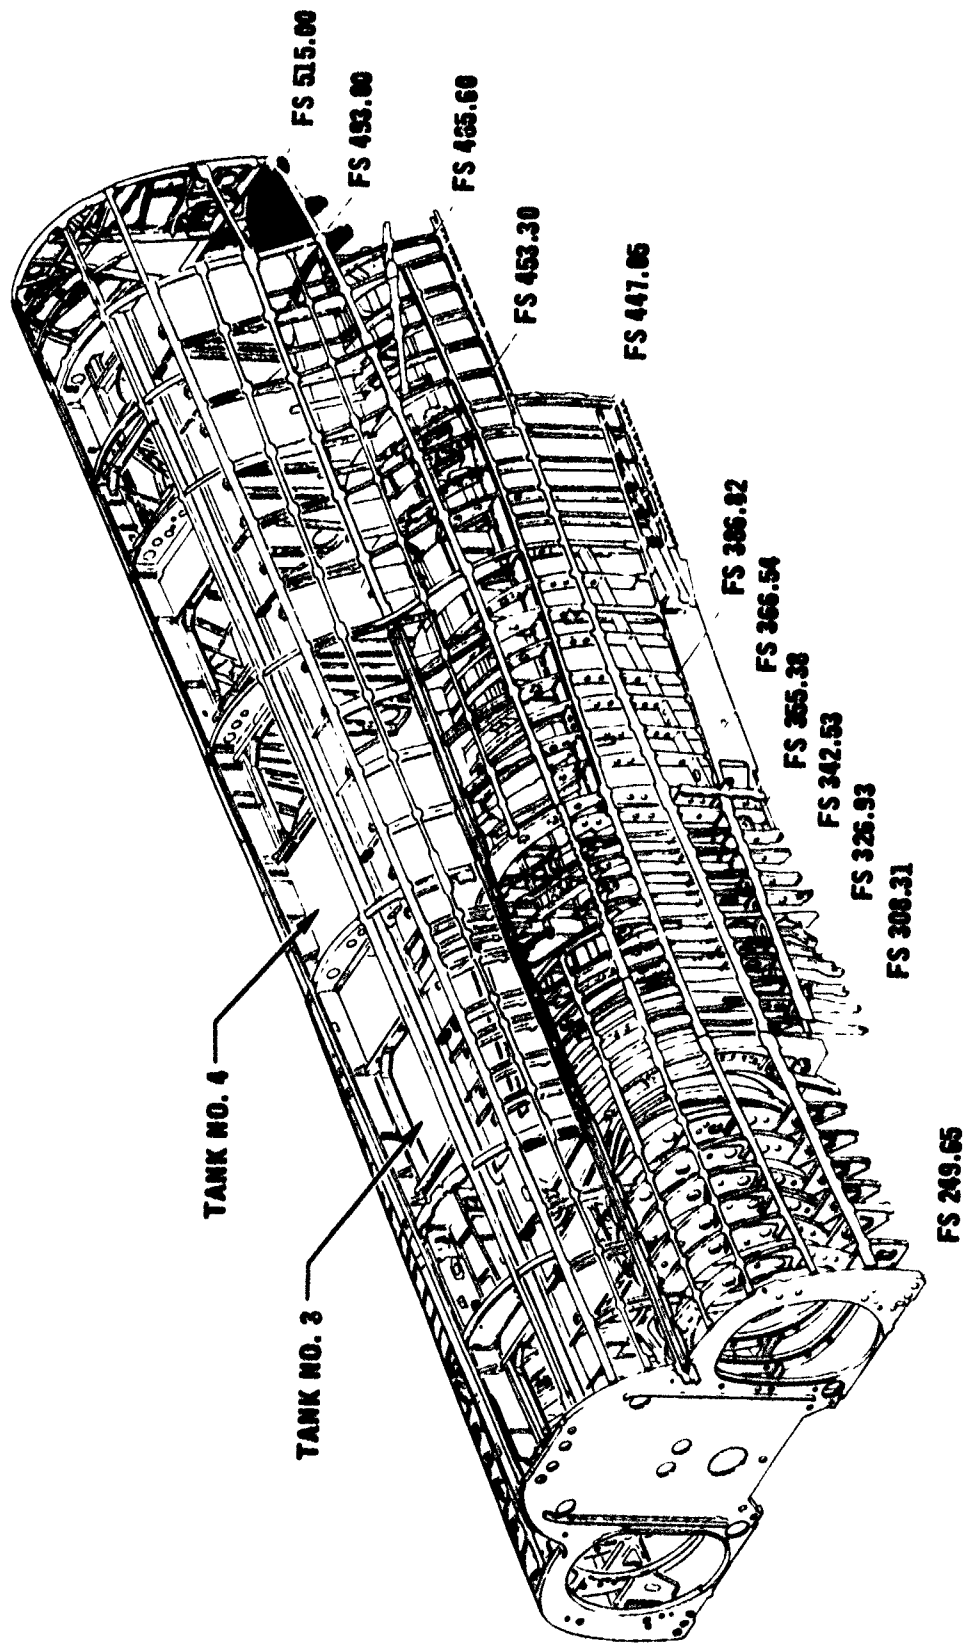
E-10 CENTER FUSELAGE STRUCTURE

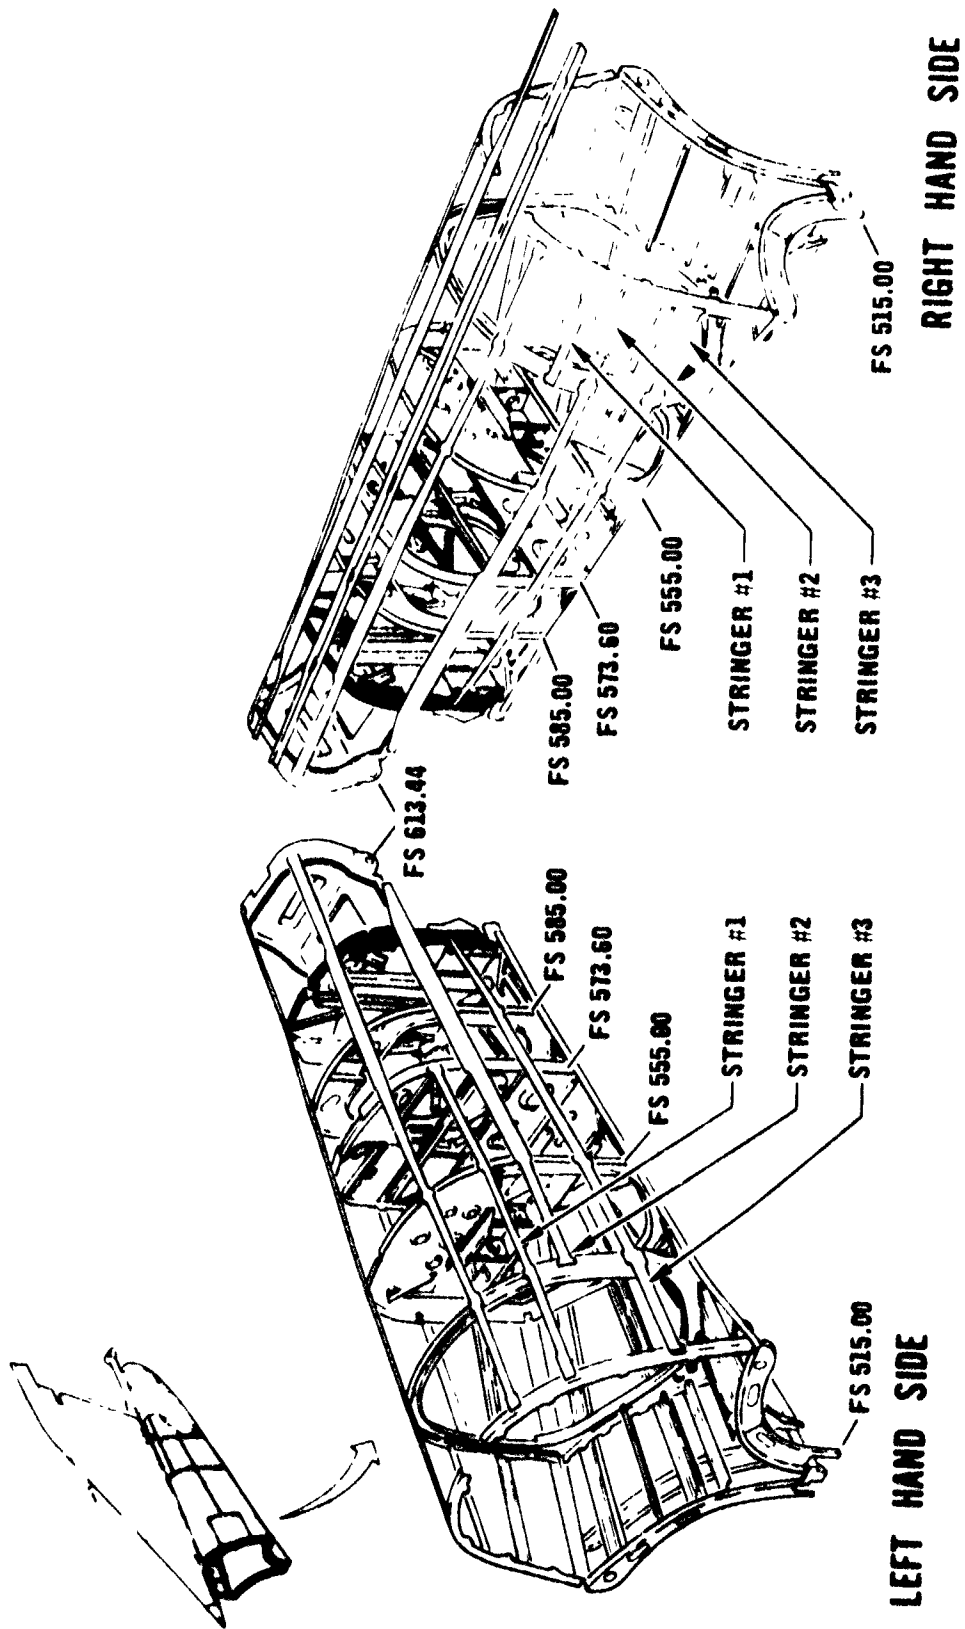
E-11 AFT FUSELAGE

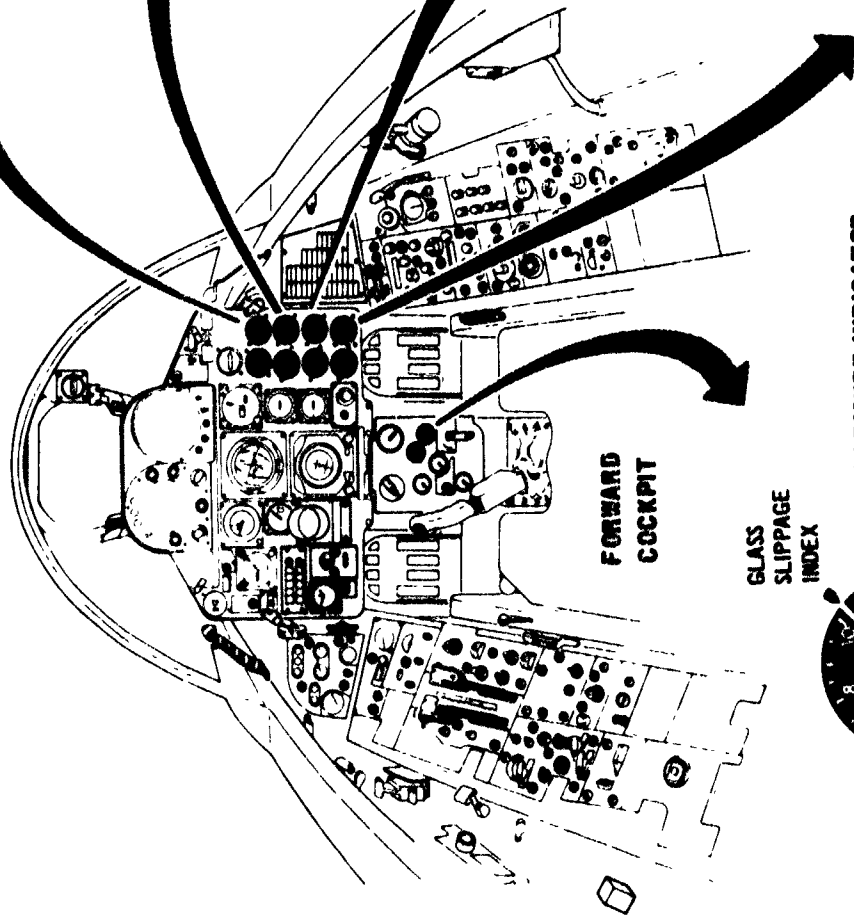
E-13 ENGINE CONTROLS

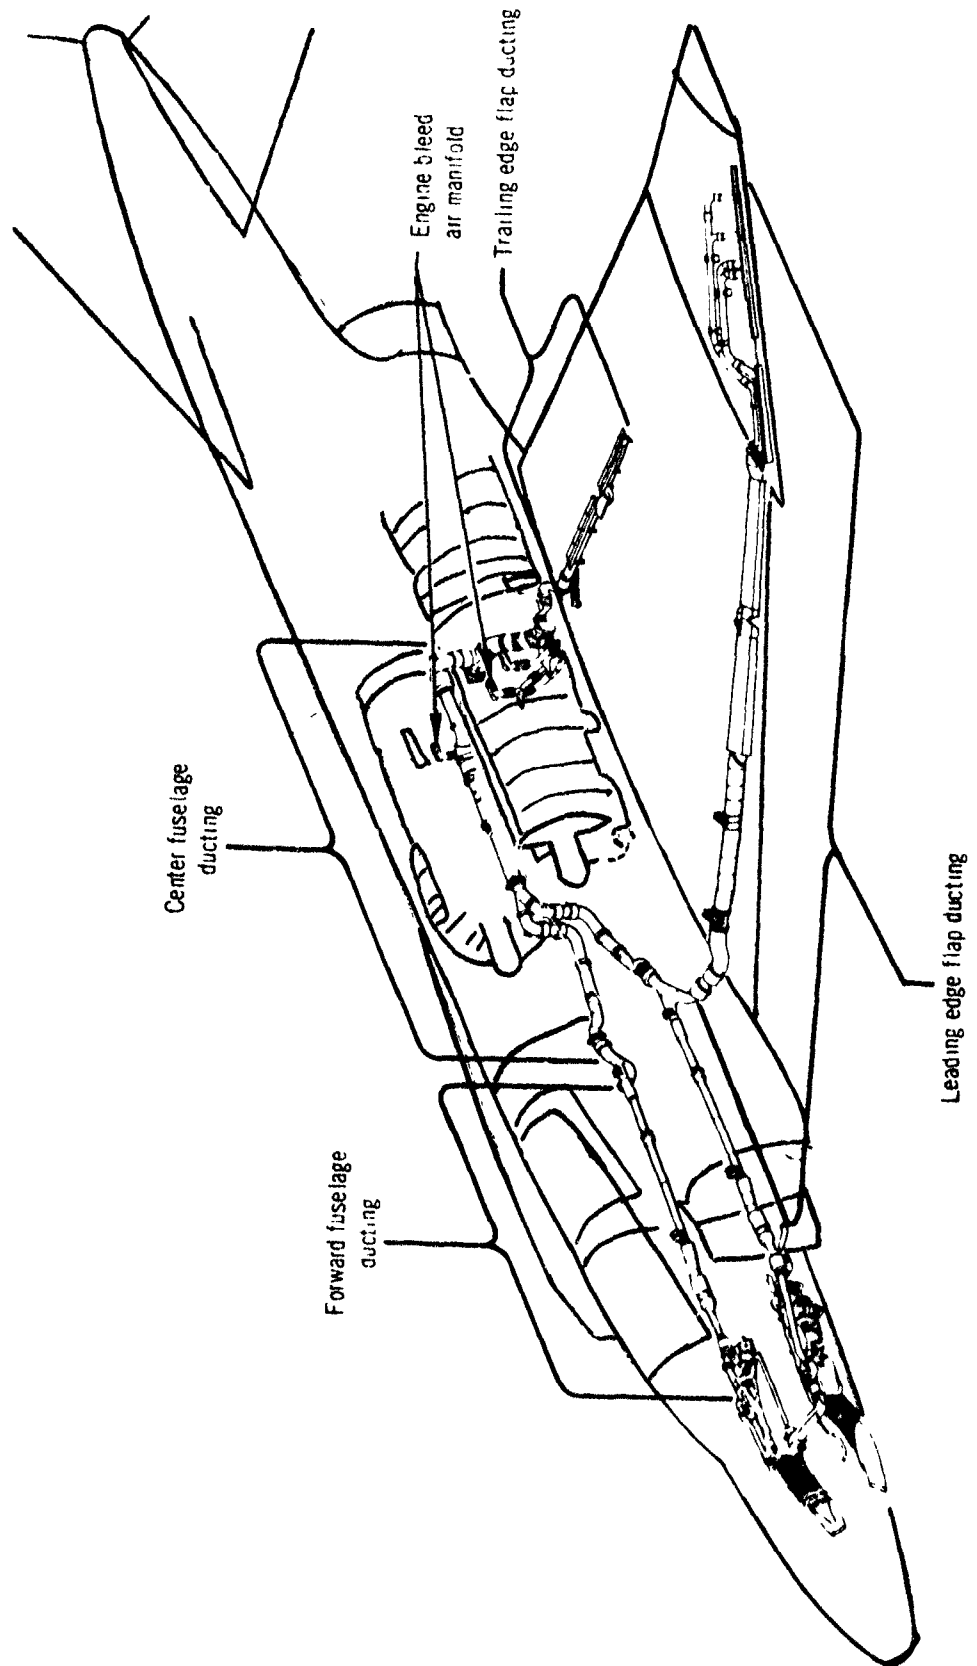
F-14 ENGINE BLEED AIR AND B.L.C. SYSTEM

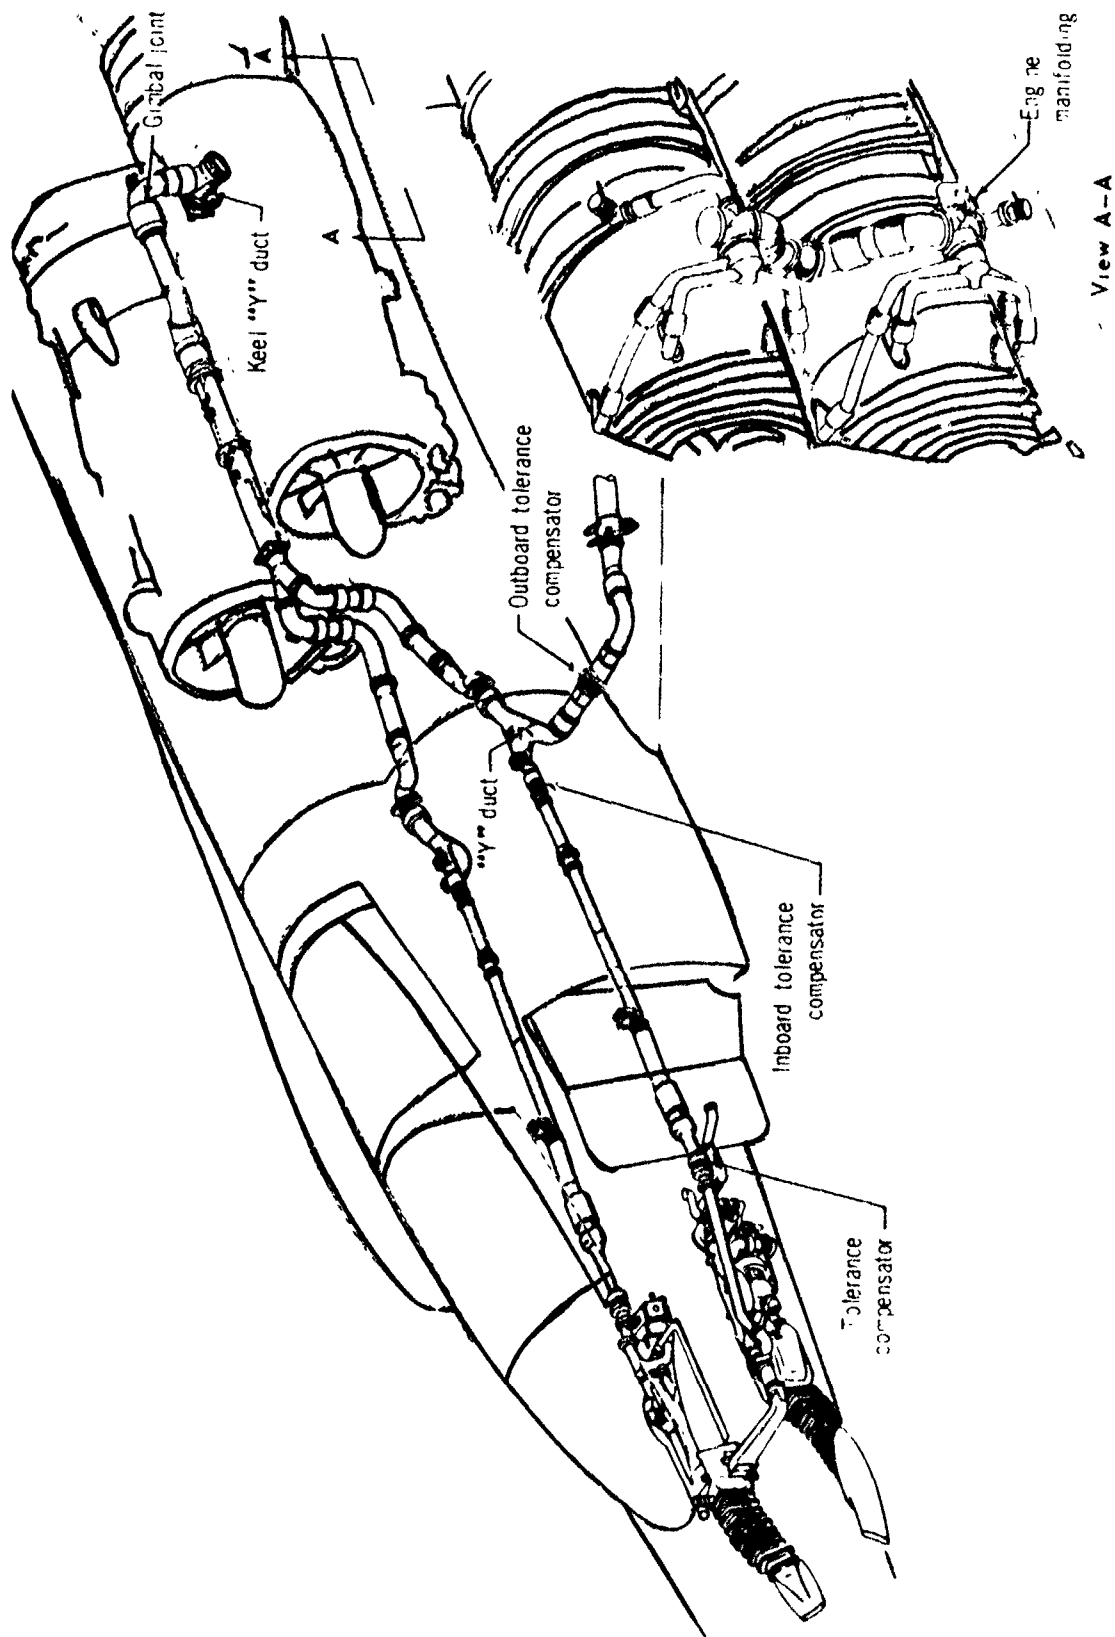
E-15 PORTION OF ENGINE BLEED AIR SYSTEM PRESSURIZED FOR ALL FLIGHT CONDITIONS

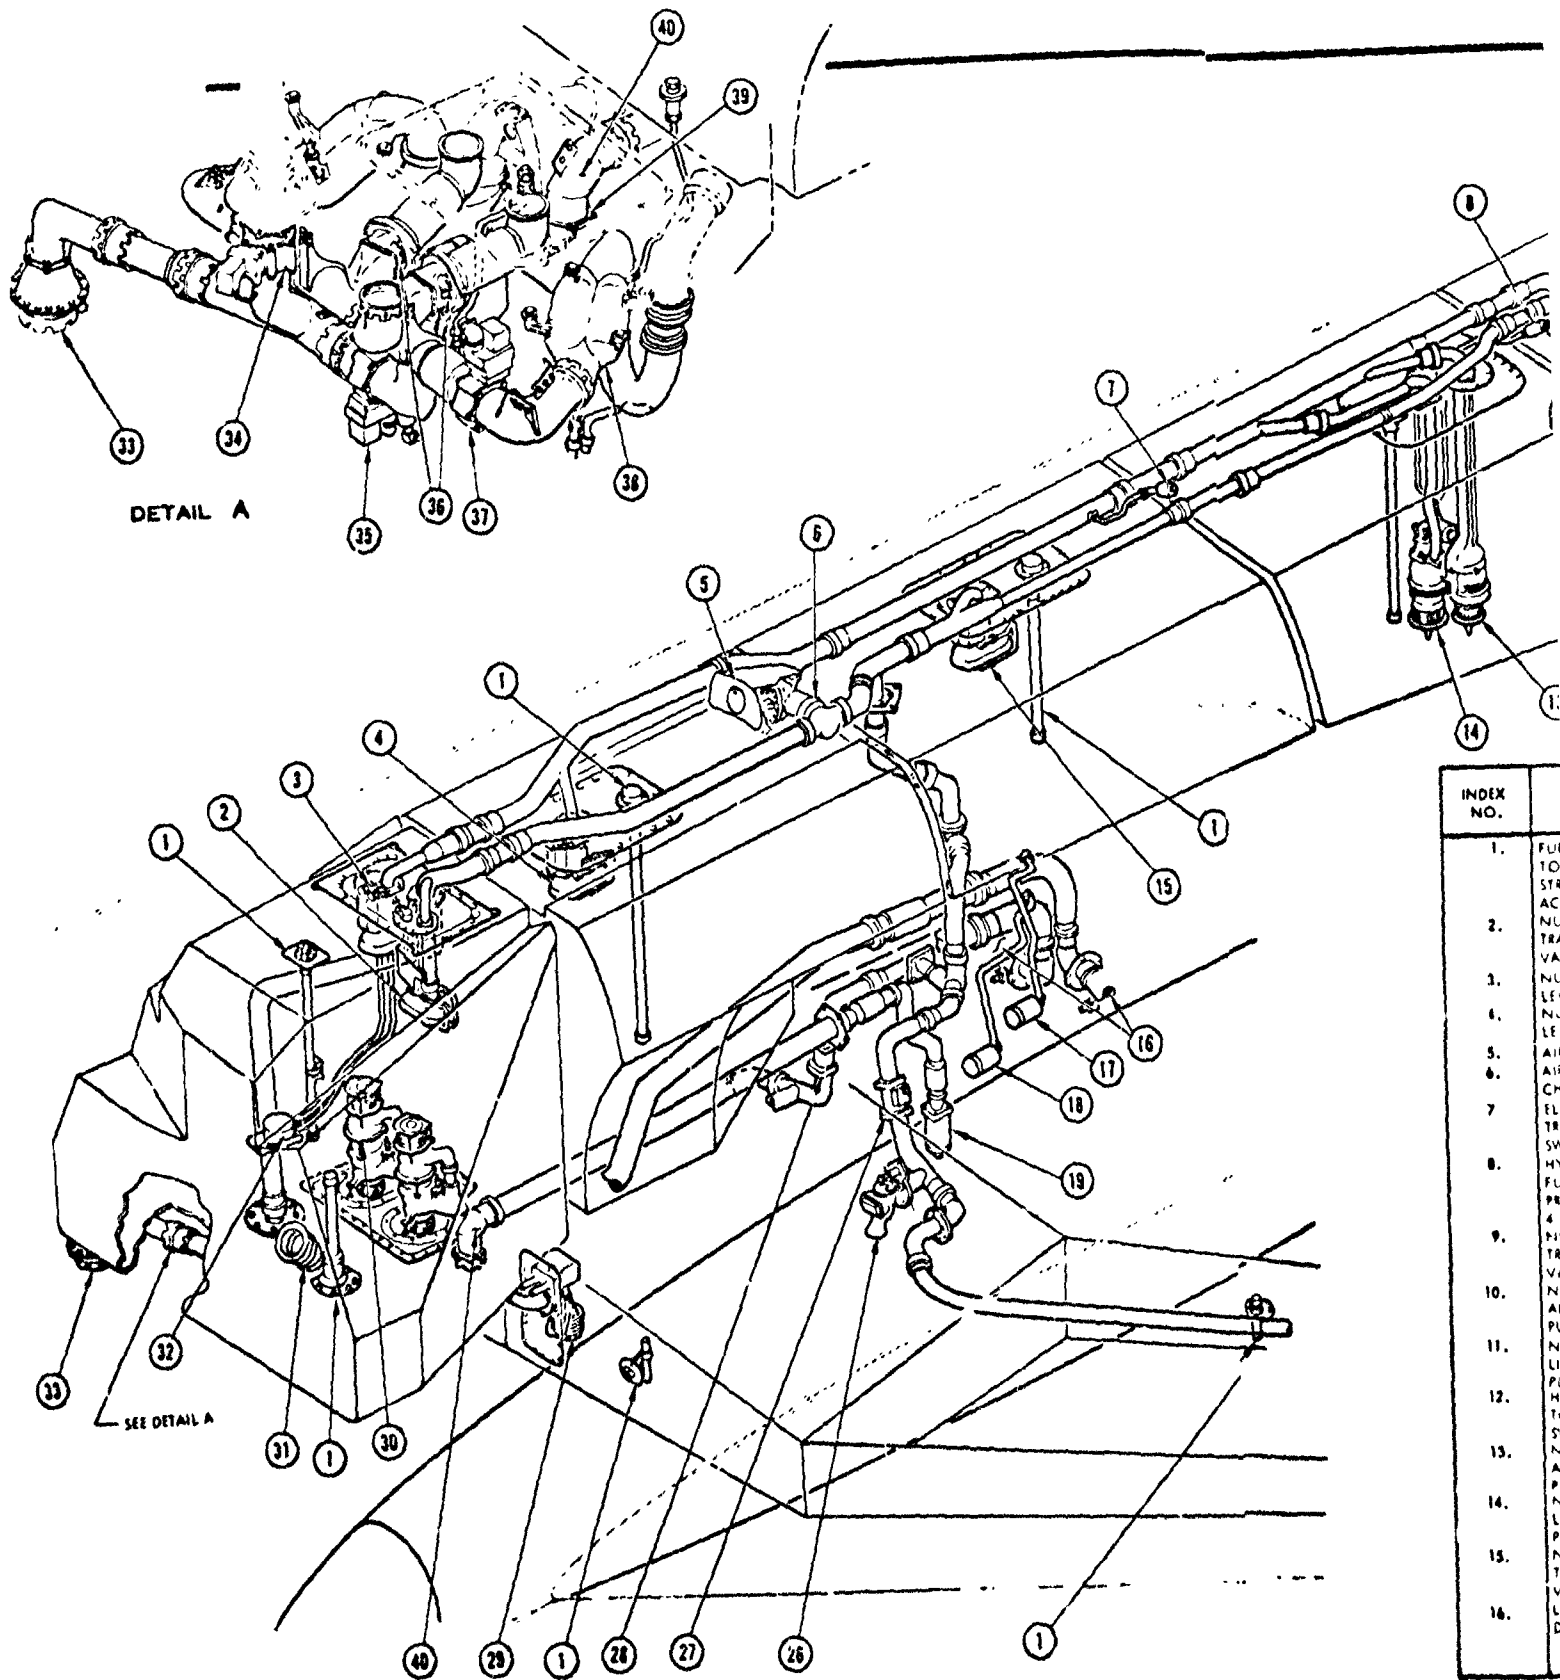
E-17 F-4C FUEL SYSTEM
