J79-15/-17 TURBOJET ENGINE ACCIDENT INVESTIGATION PROCEDURES

F-4 SYSTEM PROGRAM OFFICE

AUGUST 1975

TECHNICAL REPORT ASD-TR-75-19

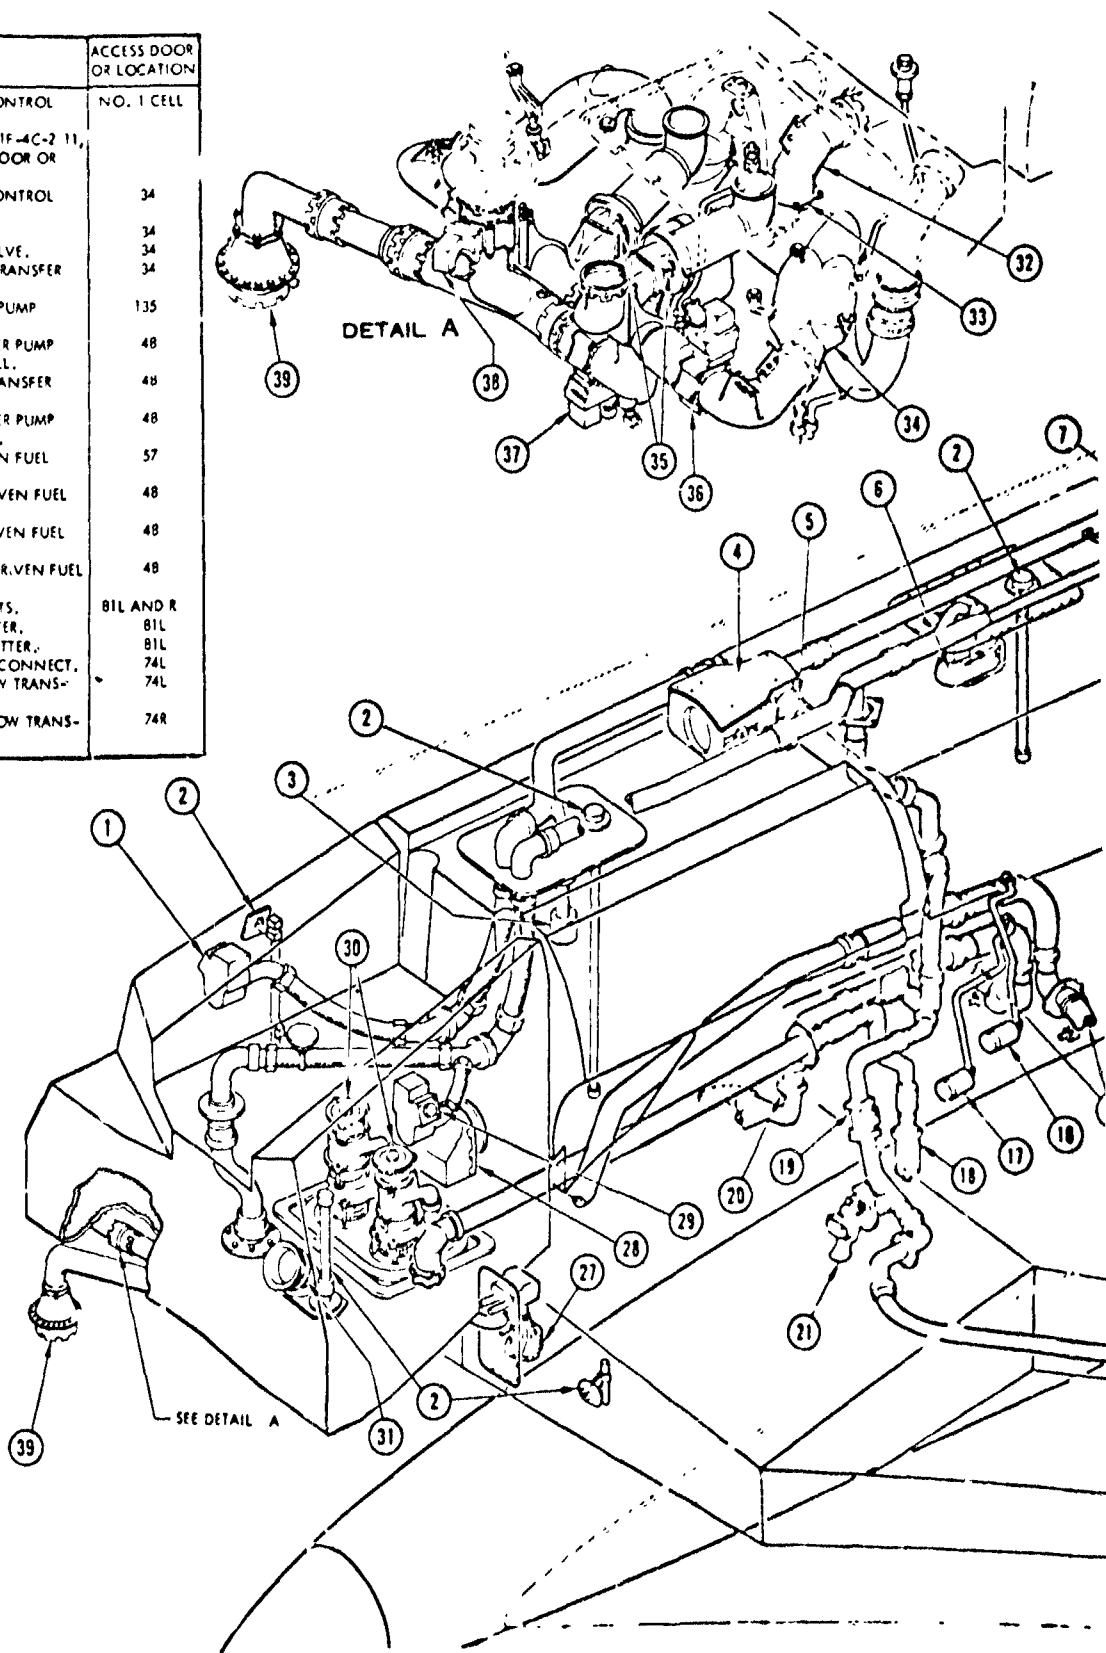
E-18 F-4D/RF-4C FUEL SYSTEM

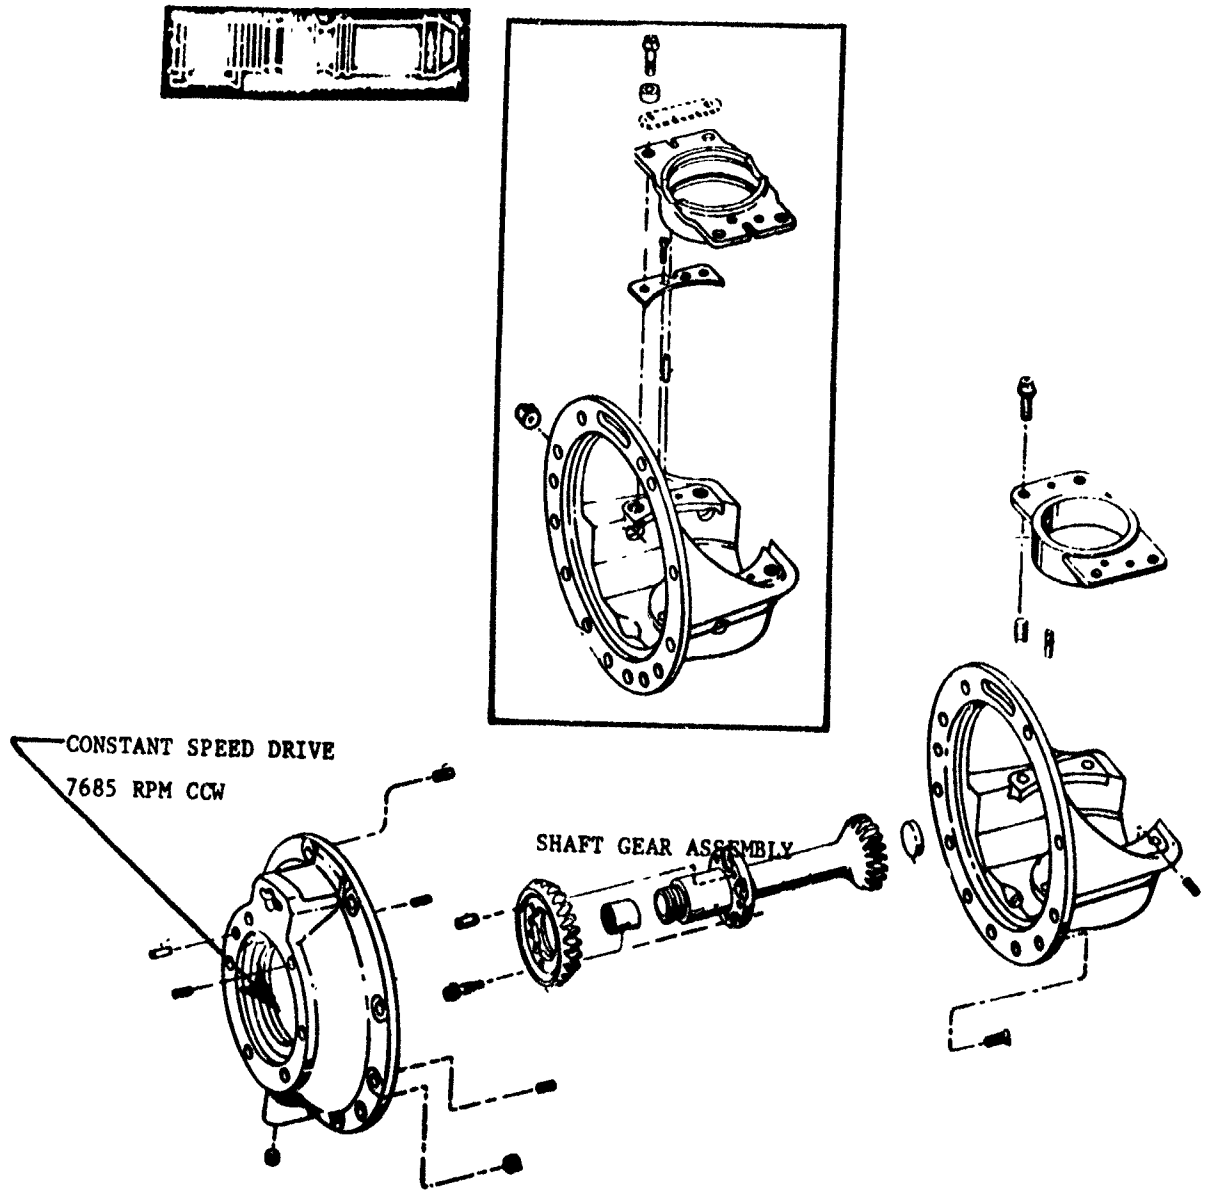
E-20 FRONT GEARBOX CASING AND SHAFT GEAR (J79-15-AND-17)

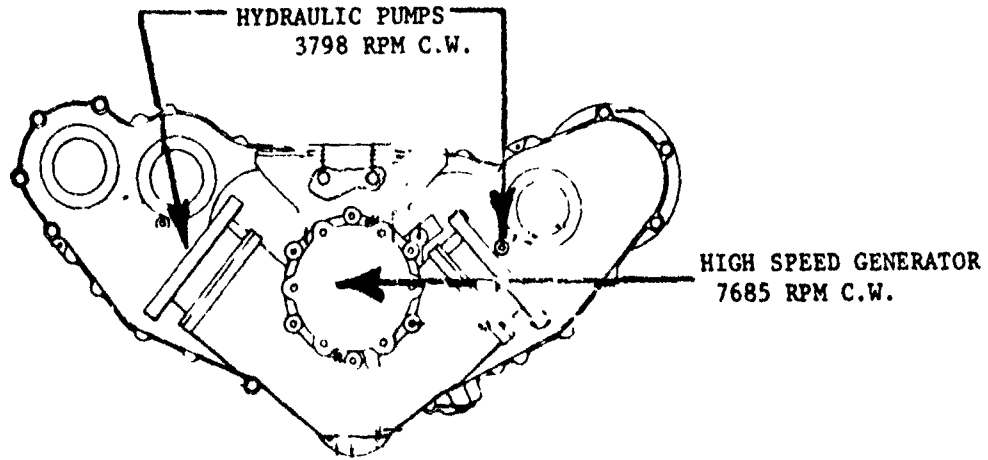
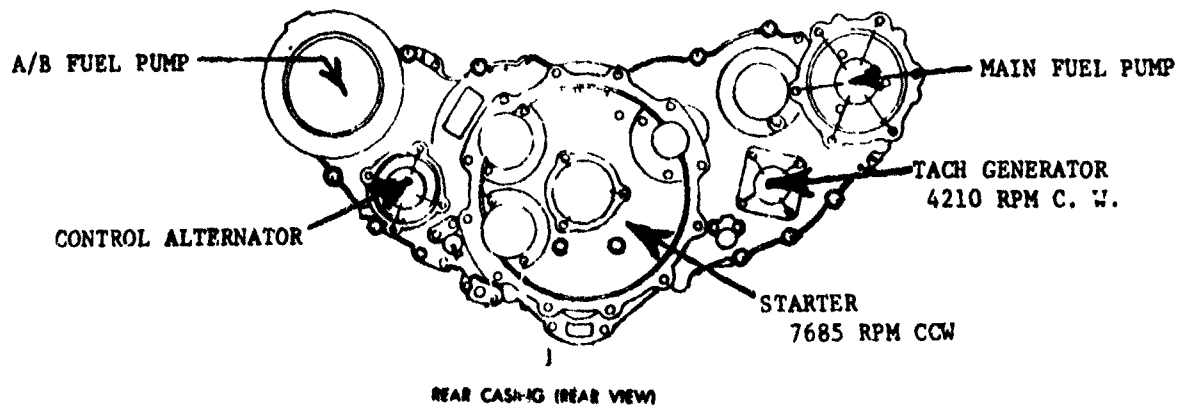
E-21 TRANSFER GEAR BOX (J79-15 -AND -17

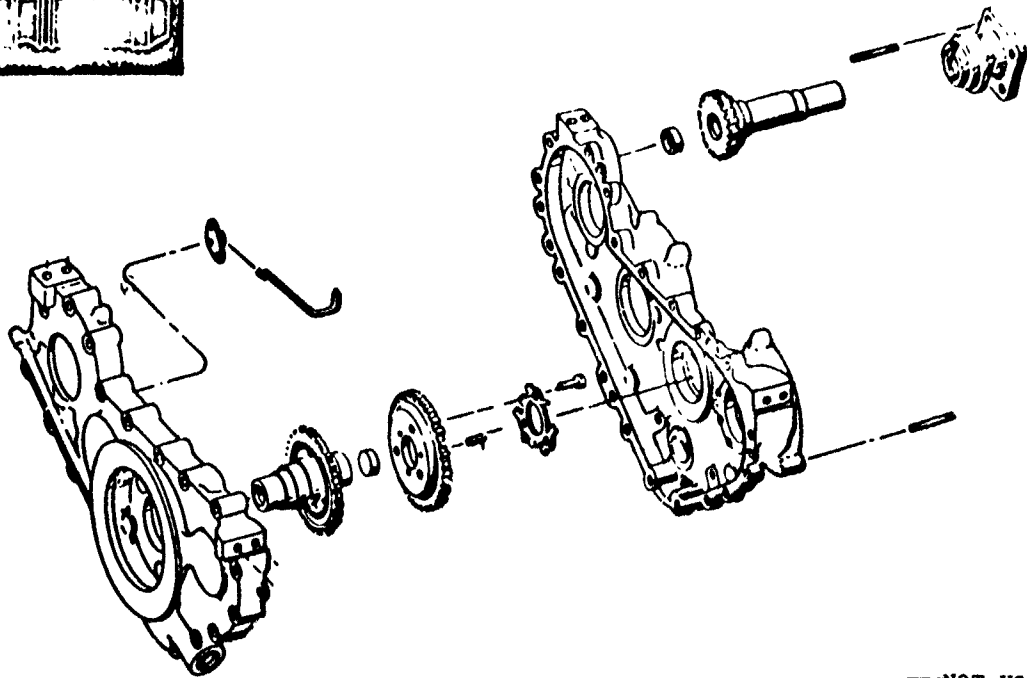
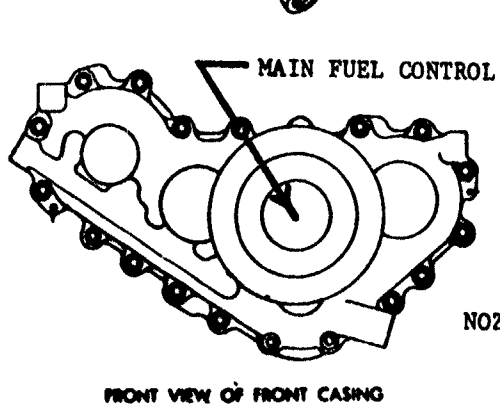
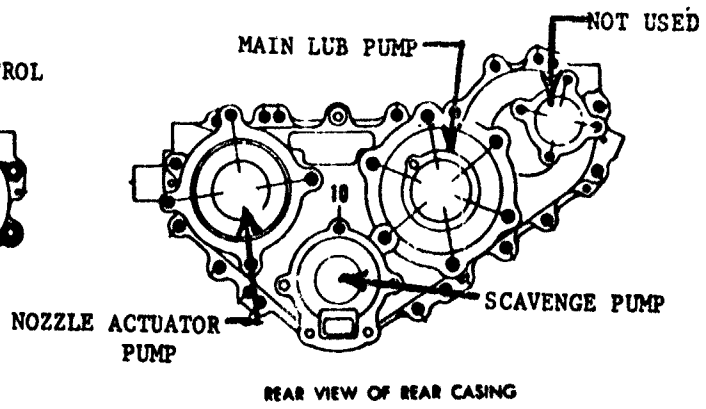
E-22 REAR GEAR BOX (J79-15 AND -17)
