## The Analysis of Fracture Surfaces by Electron Microscopy

Regis M. N. Pelloux

THE ANALYSIS OF FRACTURE SURFACES BY ELECTRON MICROSCOPY

(Revised Edition of Boeing Document D1-82-0169)

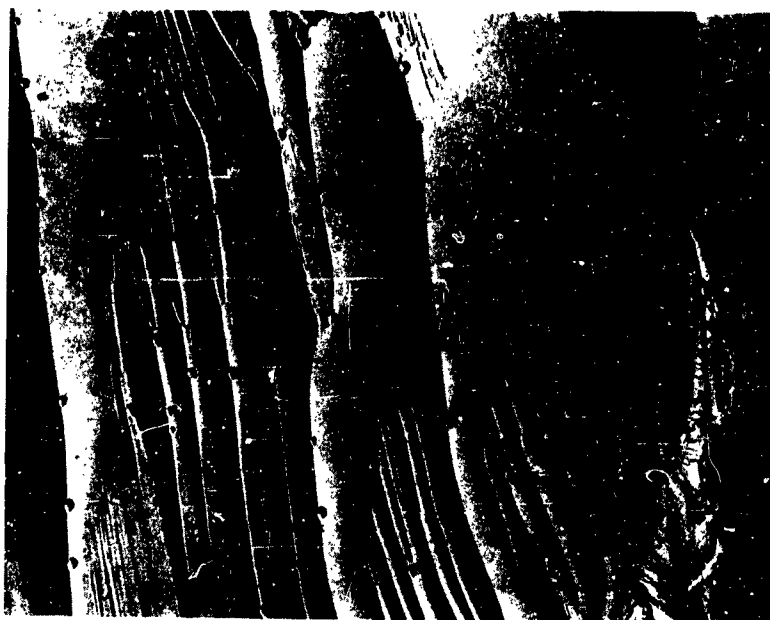
2a - The river markings along ABC probably originate at a sub-boundary. The river markings are clearly due to cleavage along a secondary cleavage plane.

Figure 2 (a,b) - CLEAVAGE FRACTURE. Typical river markings on a cleavage plane in an Alnico alloy (two step replicas).

Figures 2 and 3 illustrate the cleavage fracture of an Alnico alloy. Figure 4 represents the brittle cleavage fracture surface of a Charpy impact bar or a pearlite free steel broken at 78°K. These three figures illustrate most of the main features of a cleavage fracture; that is:

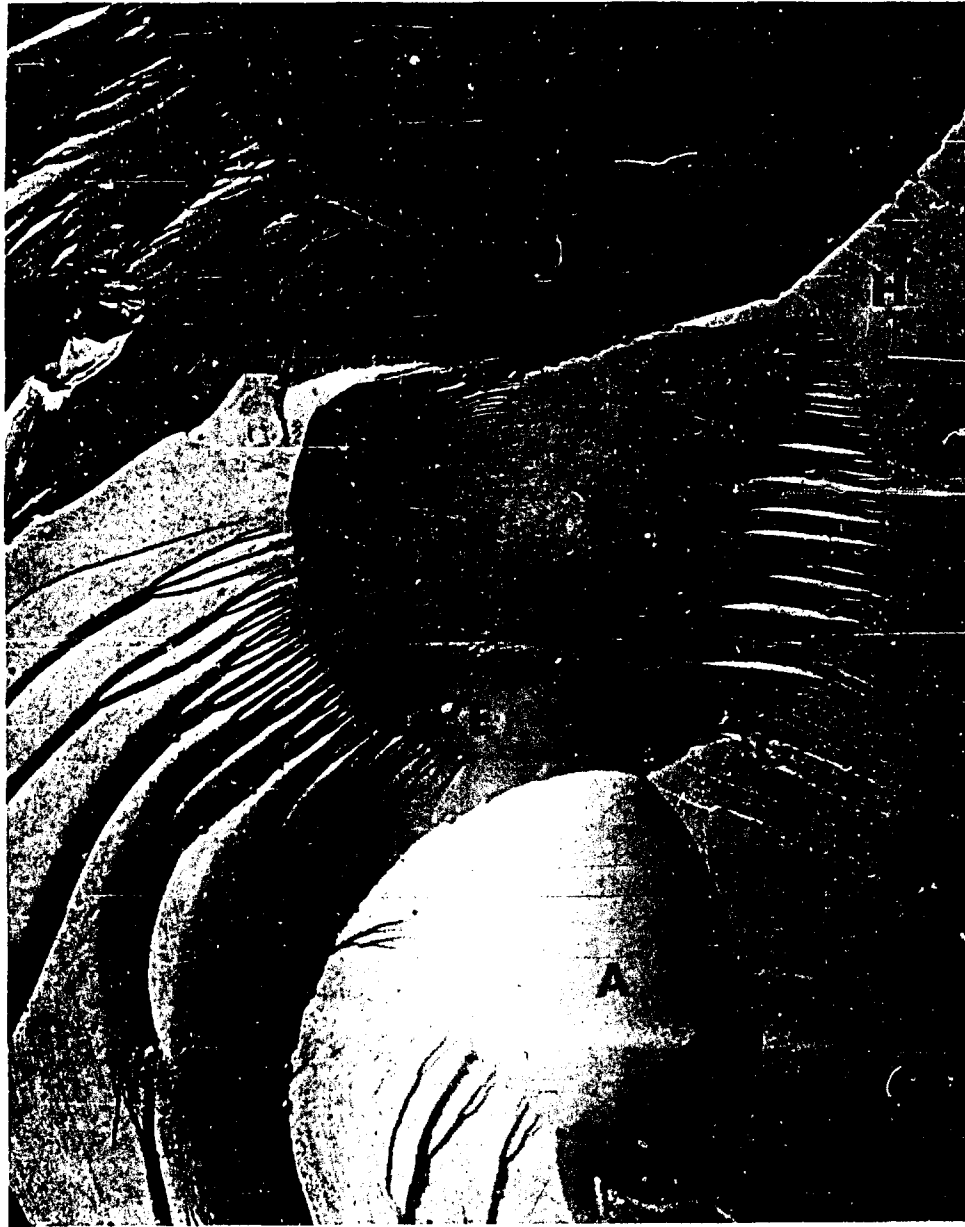
Figure 3a

- CLEAVAGE FRACTURE. Typical cleavage fracture through many grains of an Alnico alloy. The grain boundaries EF and GH are clearly at the origin of the formation of river markings. In grains A and B fracture was intercrystalline (two step replica).

the appearance of large cleavage steps originating at the boundary. This is well illustrated at the boundaries EF and GH on Figure 3. When two adjacent grains have a large orientation difference the crack front very often follows the grain boundary in order to go from one cleavage direction to another. The details of how individual grain cleavage cracks are joined along grain boundaries are in many cases obscured by the collapse of the replicating film. Crussard<sup>(2)</sup> has shown that in polycrystalline aggregates cleavage fracture is a discontinuous process, many different cleavage cracks being nucleated ahead of the main crack and often propagating in opposite directions in adjacent grains. The junction of these microcracks with the main crack front takes place by cleavage along secondary cleavage planes or separation along grain boundaries. It may also happen that some grains are so poorly oriented for cleavage that they deform extensively and fail by plastic rupture.

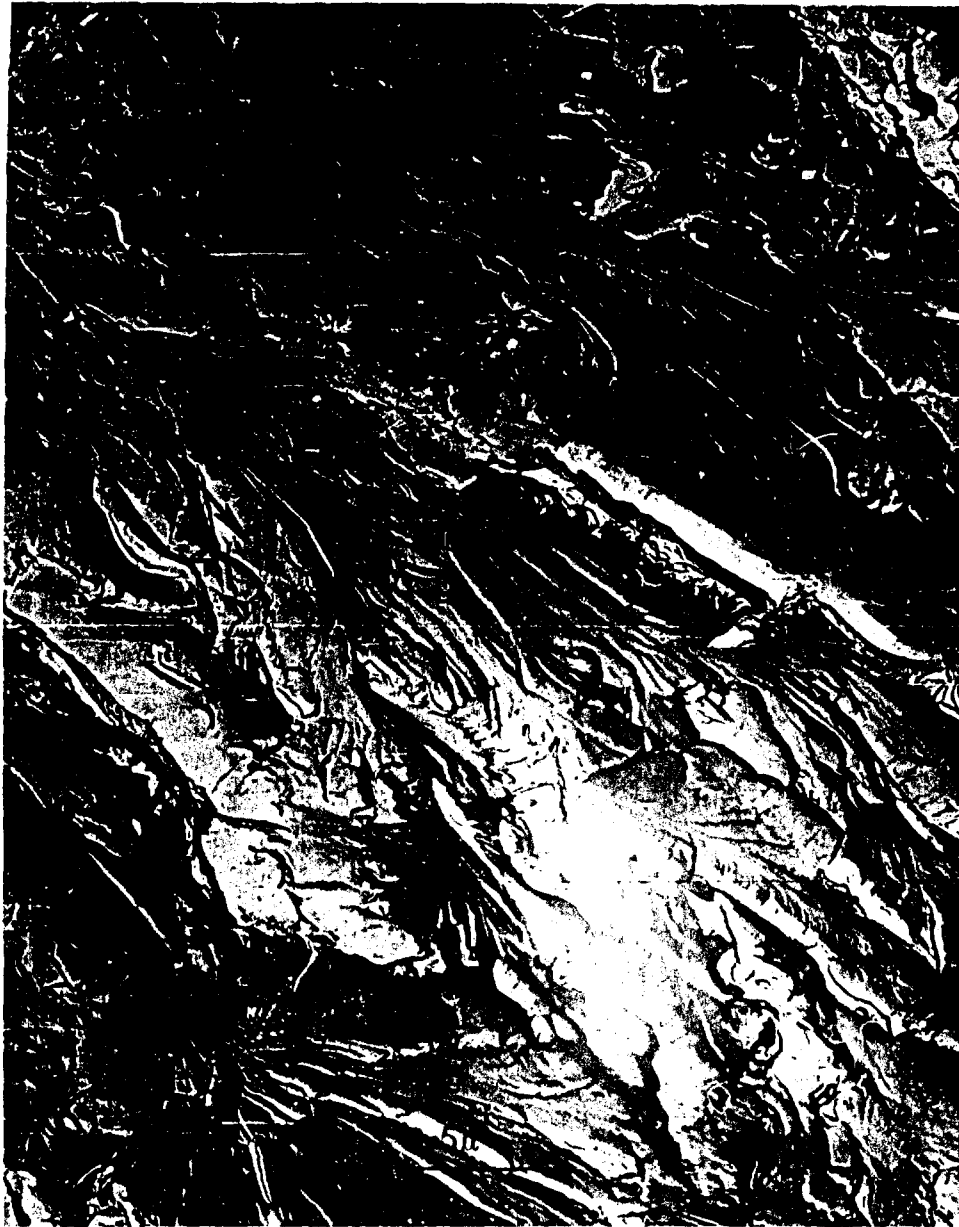
Figure 3b

- CLEAVAGE FRACTURE. Cleavage fracture in a TZM molybdenum alloy. The large cleavage "feathers" are made up of many cleavage facets. Extensive tear takes place between the large regions of cleavage (two step replicas).

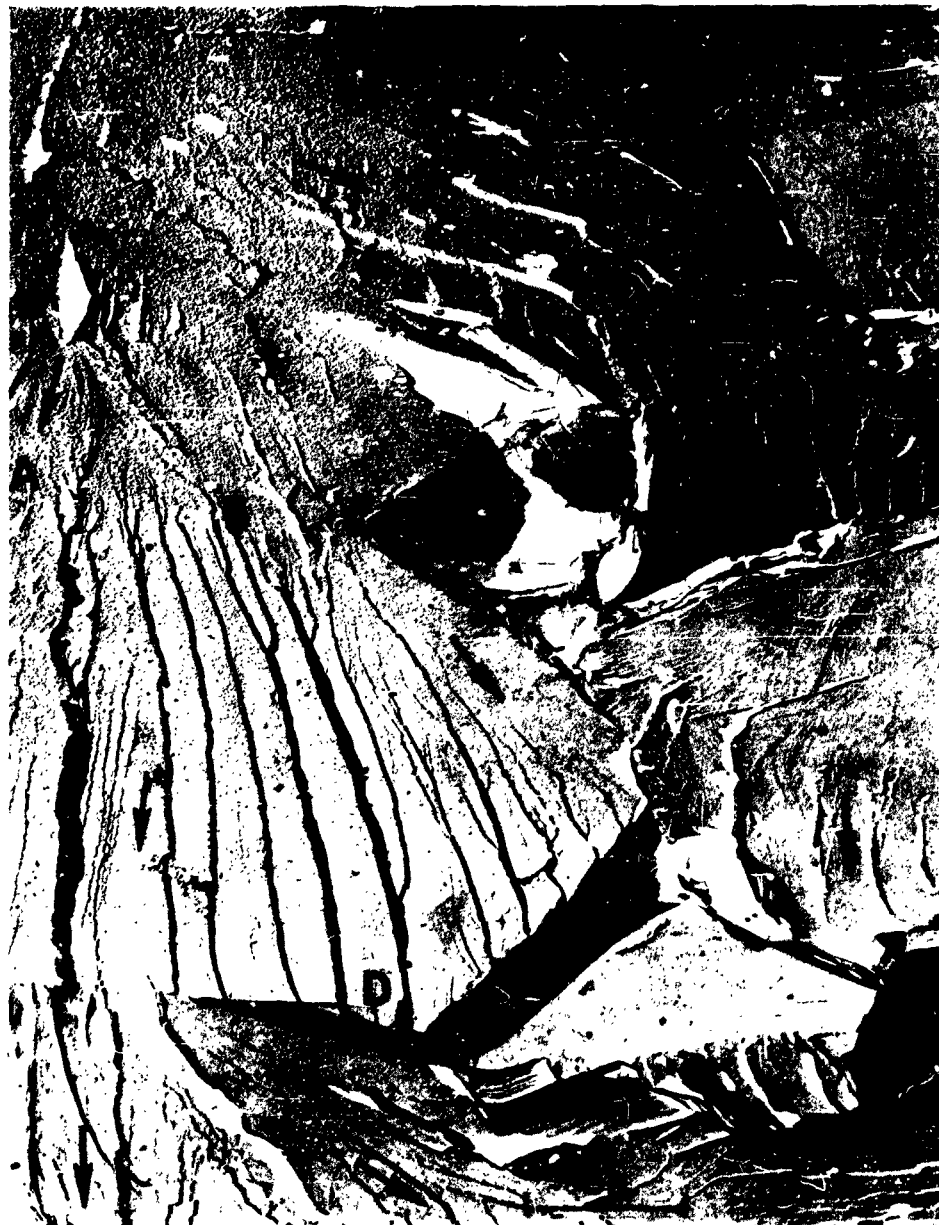
Figure 4

- CLEAVAGE FRACTURE. Fracture surface of a pearlite free steel broken by impact at  $78^{\circ}\text{K}$ . ABC is a grain boundary; ED is a typical river marking. The facet F is due to the cleavage of a deformation twin. Fracture in G is intergranular. (one step replica).

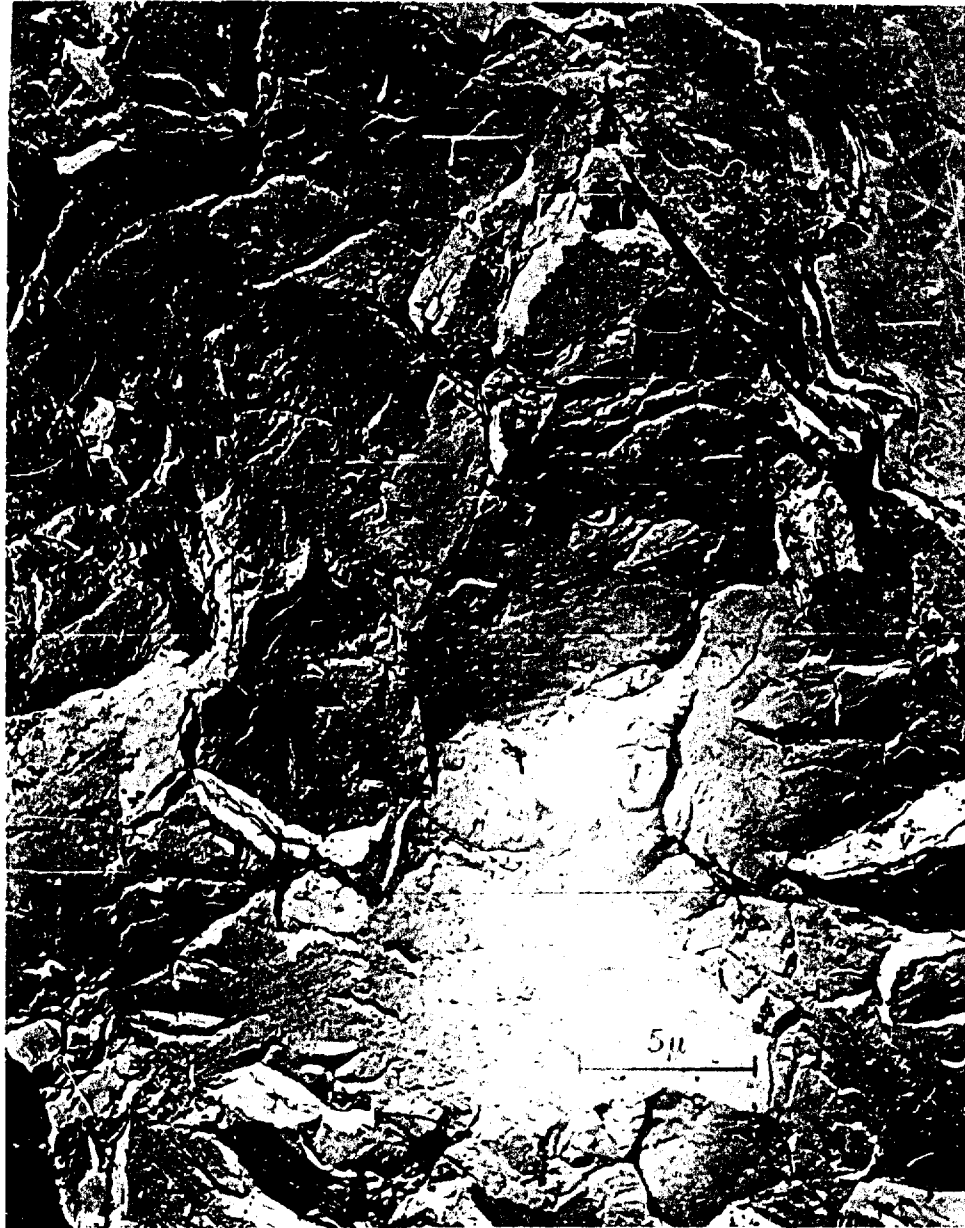
- CLEAVAGE FRACTURE. Fracture surface of 4340 steel broken by impact at 78°K. The cleavage planes are broken up into small facets with coarse and ill defined river markings. The regions between each grain are highly distorted. In the center of the micrograph, it is difficult to differentiate between a cleavage fracture and an intergranular fracture (one step replica).

Figure 5 illustrates the brittle fracture surface of a Charpy impact test bar of A.I.S.I. 4340 steel broken at 78°F. The cleavage facets are small and oriented in all directions and they do not seem to follow the martensite needles. Some coarse and short river markings can be observed on each facet. The facets are joined by highly distorted regions. Some intergranular fracture appears to be always present.

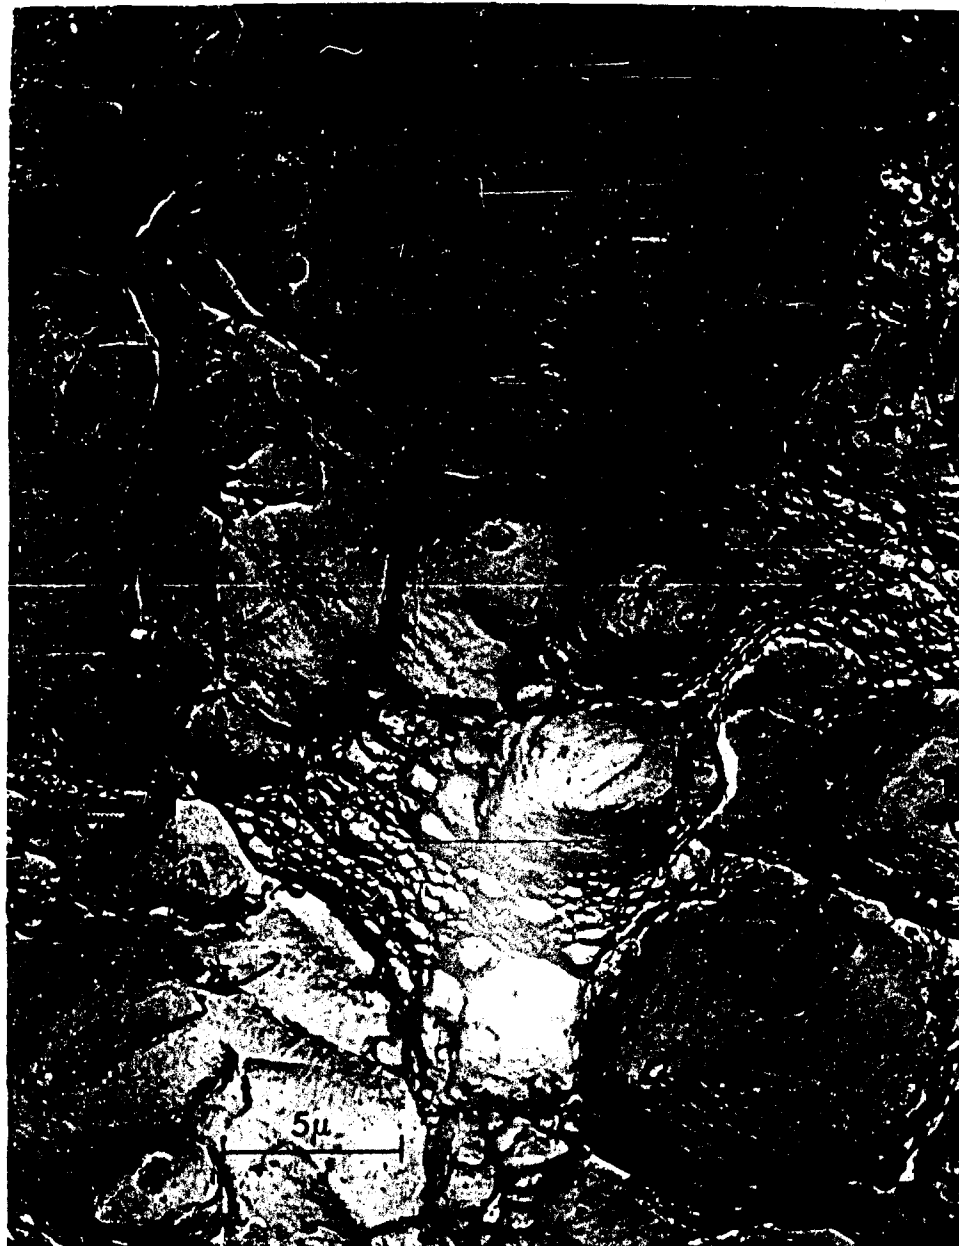
Figure 11B - PLASTIC FRACTURE - Example of plastic dimples in a 2219 aluminum alloy. Note the range of sizes of dimples.

Figures 11, 12, 13 and 14 illustrate the different sizes and shapes of dimples observed in some common materials. In age hardening alloys such as the aluminum alloys or the maraging steels where most of the second phase particles are coherent with the matrix, it is evident that the size of the dimples is much larger than the spacing between the precipitates. In steels such as 4340, it has been observed that the higher the fracture toughness, the larger the dimples. This shows that only a limited number of inclusions or precipitates act as crack nucleation sites ahead of the main crack front, and that this number depends on the overall velocity of propagation of the crack. Irwin<sup>(11)</sup> concludes from his observations that an increase in crack velocity is accompanied by an increase in the number of microcracks which are initiated closer and closer to the main crack front. For steels, it is known that the transition from a ductile to a brittle (cleavage) fracture corresponds to a marked increase in the speed of propagation of the crack front. Although it is easy to identify by electron fractography, a true cleavage fracture or a perfect plastic fracture, the features of a ductile-brittle fracture are not very well understood. The expression "quasi-cleavage" is usually employed to describe this type of fracture illustrated by Figure 15. Beaches<sup>(7)</sup> shows that it is

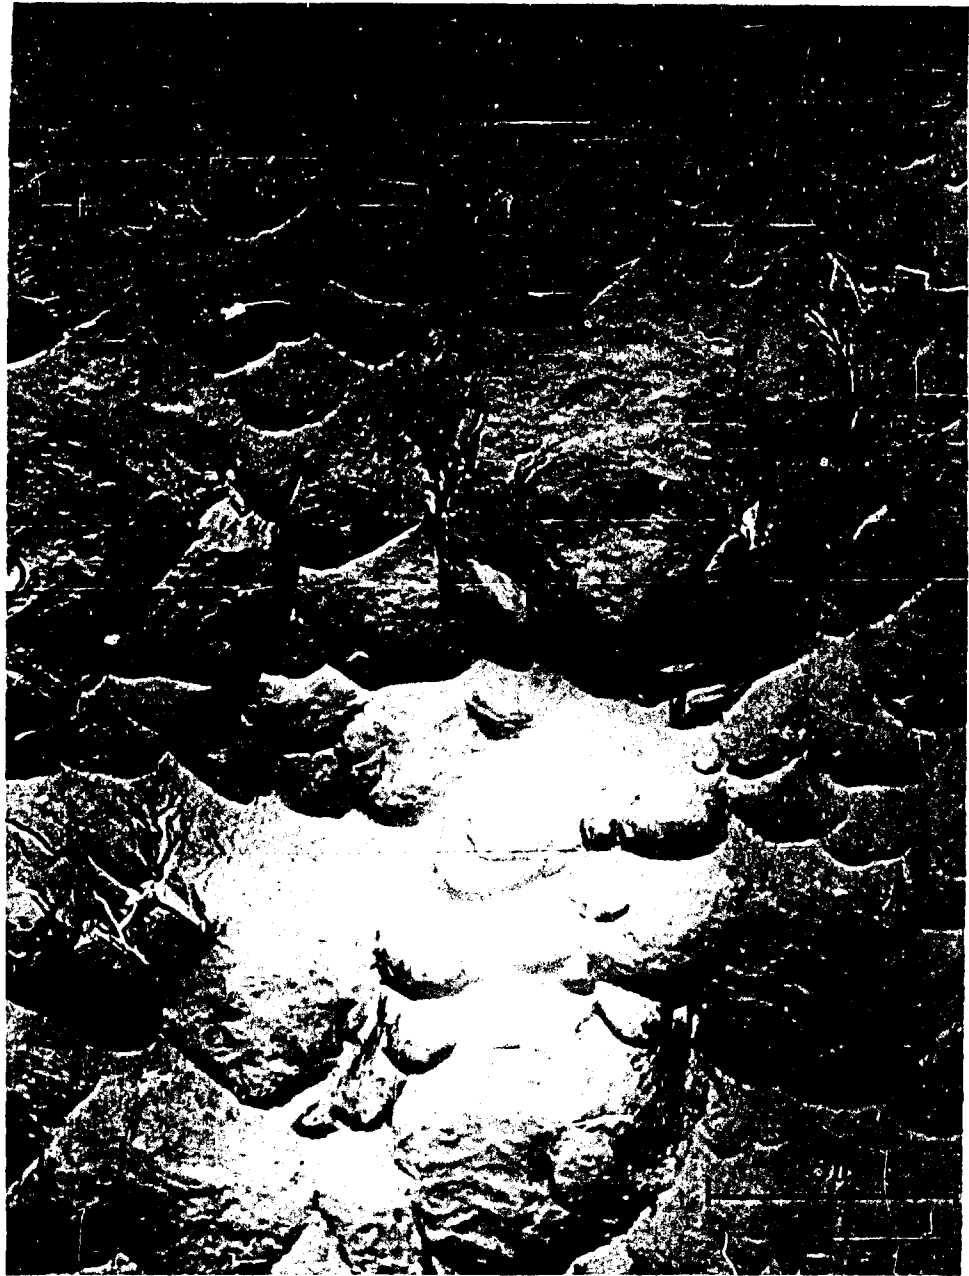
Figure 13 - PLASTIC FRACTURE - Large dimples in a 70-30 brass resulting from a tear fracture. Many of the dimples may have originated at dislocation pile-ups or sub-boundaries (two step replica).

Finally, Rogers<sup>(13)</sup> pointed out that inclusions are not necessarily the only sites of initiation of a plastic fracture. Microcracks may form at dislocation pile-ups or certainly along subboundaries. The smooth, slightly polyhedral dimples observed in 70-30 brass on Figure 13 may result from the decohesion along a slip plane or a subboundary. Dimples may also be initiated at grain boundaries. However, except in the case of ductile intergranular fractures which will be described later, it is, in general, impossible to distinguish the grain boundaries and the grain size on a fracture surface showing extensive dimple formation.

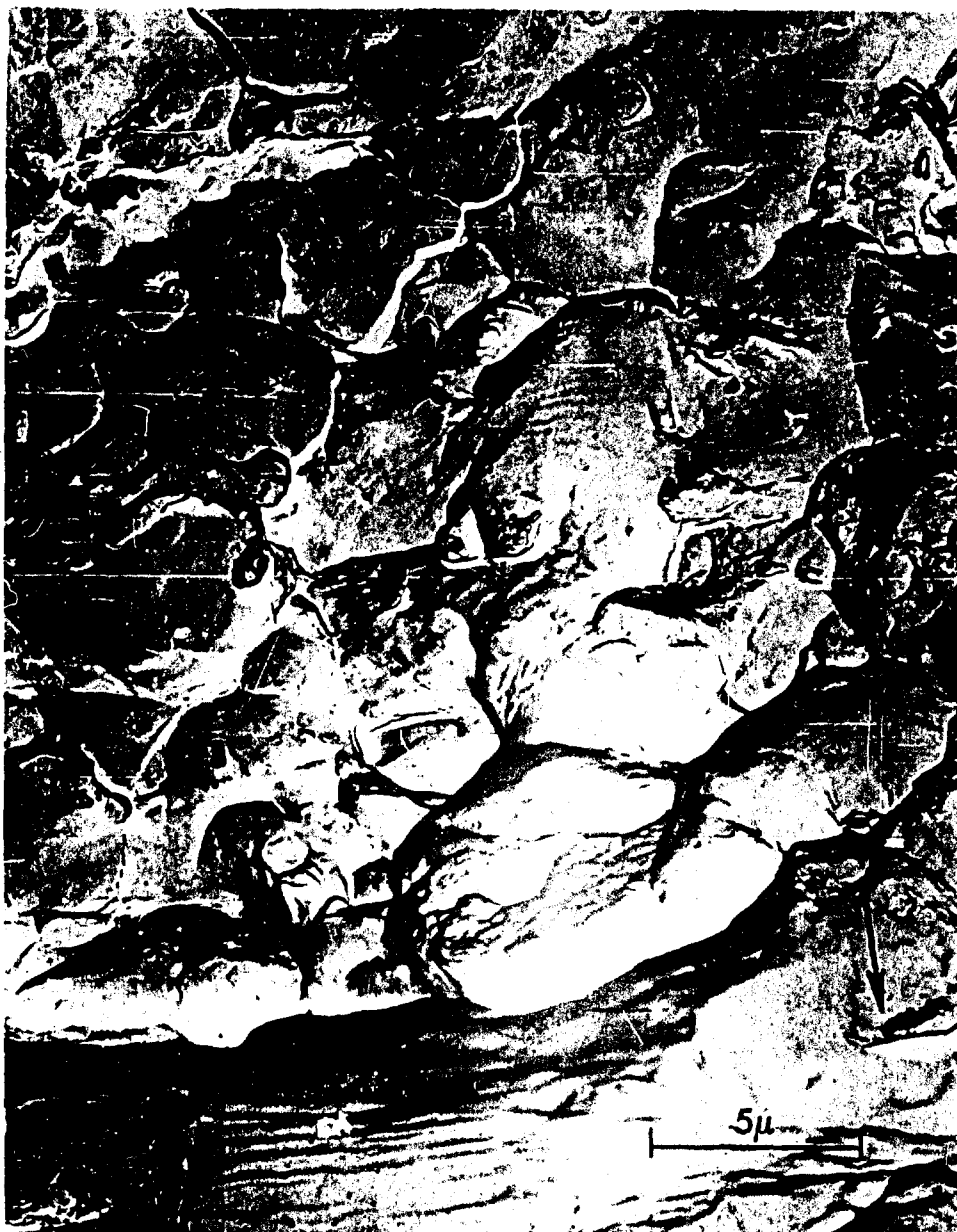
Figure 14 - PLASTIC FRACTURE - Example of large plastic dimples in a titanium alloy (Ti - 6Al - 4V) (two step replica).

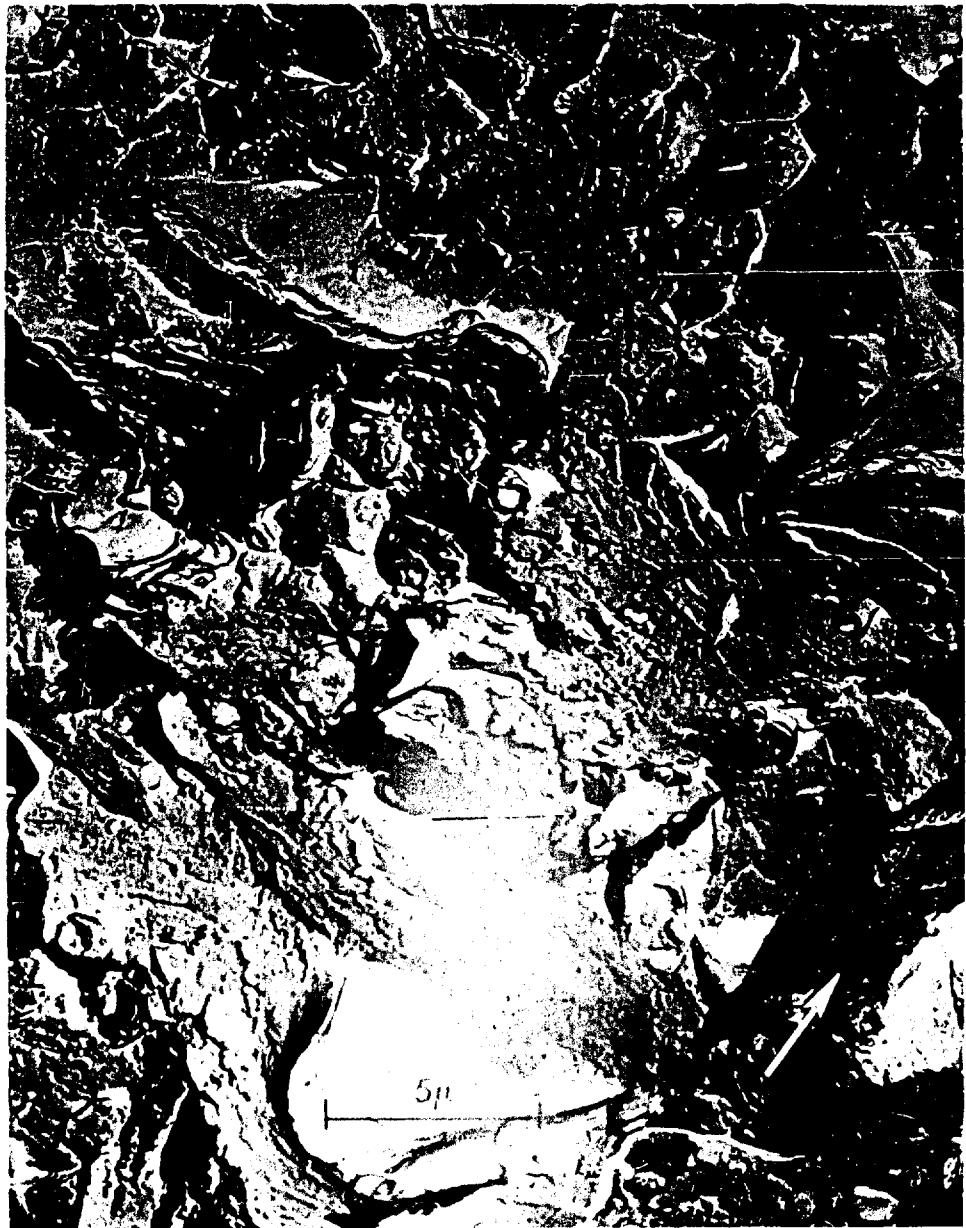
Figure 15

- QUASI CLEAVAGE - Fracture surface of a 4335 steel showing quasi-cleavage. The surface is made up of shallow dimples and small cleavage facets, (two step replica).

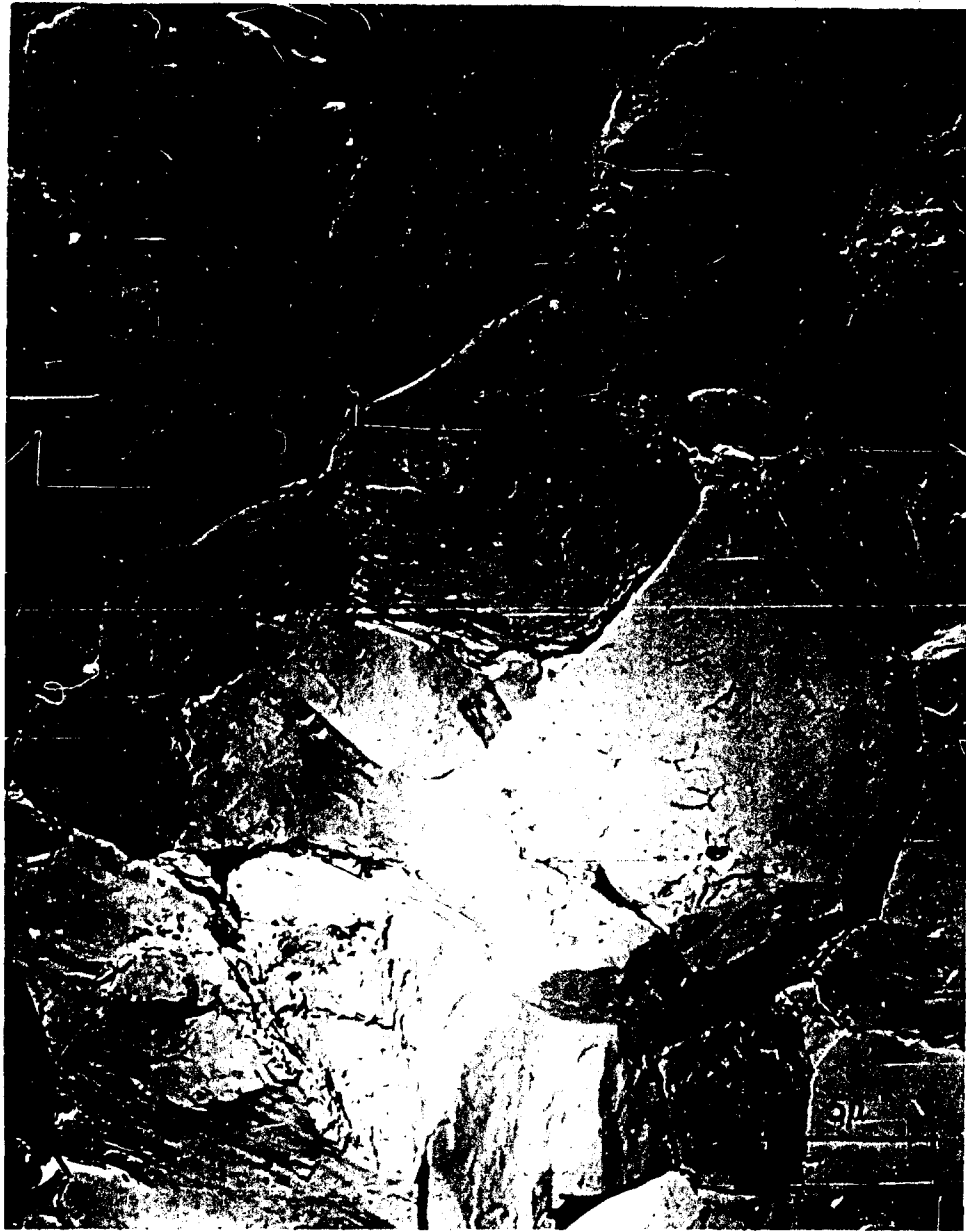
Figure 17 - INTERGRANULAR FRACTURE - Brittle intergranular fracture in a 4340 steel. This intergranular fracture at the origin of a service failure was probably due to stress corrosion and hydrogen embrittlement. Note the hairlines along the grain boundaries, facets and the microcavities in A and B (two step replica).

17 shows that a real intergranular fracture looks almost like the theoretical picture described on Figure 16. On the real fracture each facet of the grains is slightly curved which shows that the conditions for metastable equilibrium of the grain boundary network were satisfied at the austenitizing temperature. The small "hairlines" on each facet are unaccounted for and may be related to the second phase particles or to the mechanism of separation of the grains. Another example of a perfect intergranular fracture is shown on Figure 18 which represents the fatigue fracture surface of a 70-30 brass. An intergranular quench crack in a 4340 steel is shown on Figure 19. Figure 20 represents an intergranular stress corrosion fracture in 7075 aluminum alloys.

no clearly visible features such as crack front arrest lines or nucleation sites. Some controversial microcavities, supposedly due to hydrogen condensation, have been observed in some cases in steels.<sup>(18)</sup> We feel that the "hairlines" observed on the grain boundary facets of Figure 17 are certainly connected with the initiation and propagation of the fracture. However, this conclusion is purely qualitative.

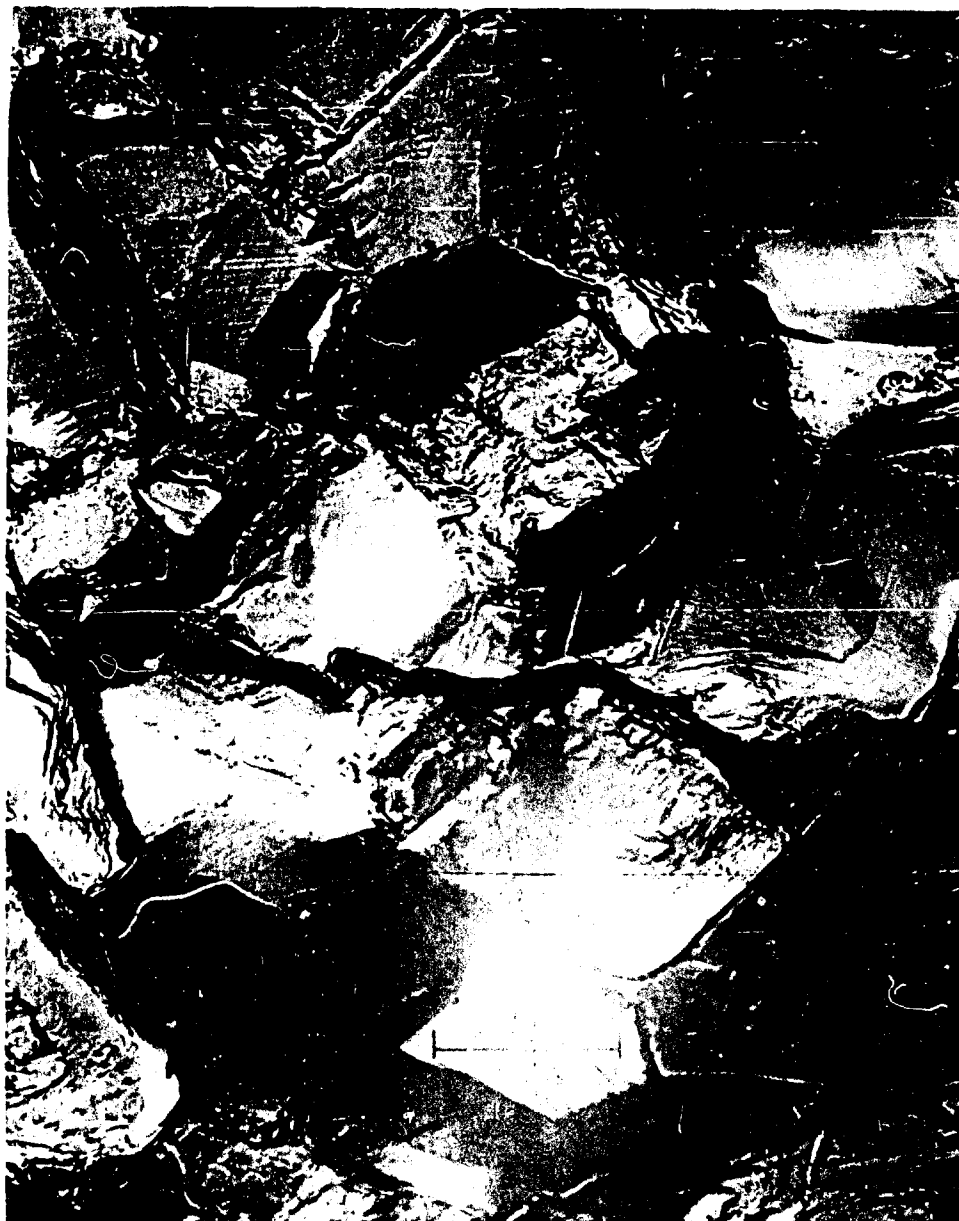
Figure 18 - INTERGRANULAR FRACTURE - Brittle intergranular fracture in a 70-30 brass. This fracture is the result of a slow crack propagation under cyclic load in a centrally notched panel of brass. (Two step replica).

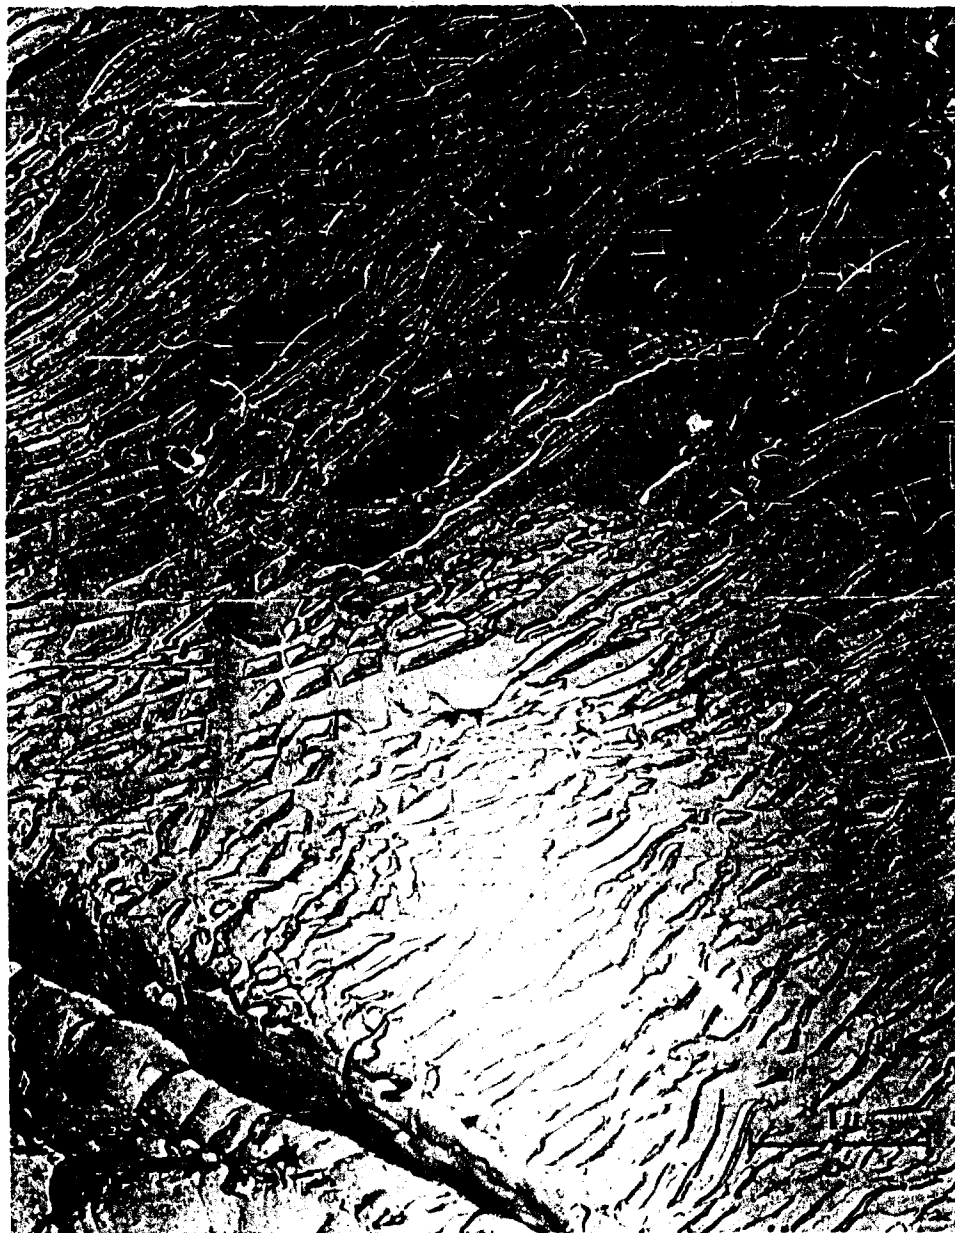
Figure 21 - INTERGRANULAR FRACTURE - Brittle intergranular fracture and network of carbides along the grain boundary facet in AM335. (two step replica)

had been embrittled by intergranular carbide precipitation. They found that the grain boundary film does not have to be continuous to produce intergranular fracture. The fracture was observed to occur at the carbide matrix interface or sometimes by cleavage at the carbide plate. Figure 21 shows an example of an intergranular fracture in AM355 due to  $M_{23}C_6$  carbides.

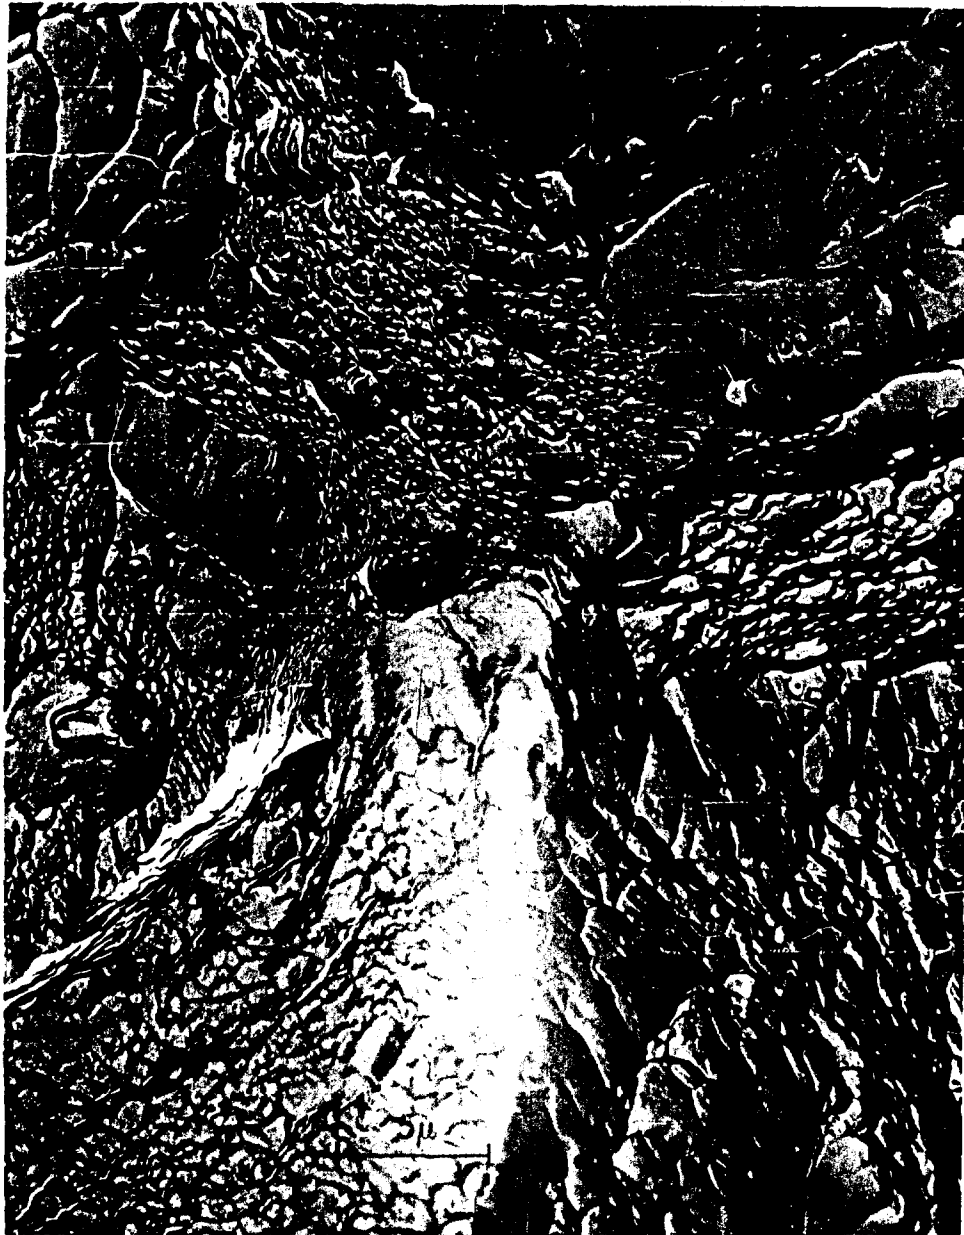
Figure 25 - INTERGRANULAR FRACTURE - Plastic intergranular fracture in a 2219 alloy. The difference in orientation of the grain boundary facets is well marked and the shear direction is given by the direction of elongation of the dimples. (two step replica)

A second mode of grain boundary separation is the plastic intergranular fracture. The separation along the grain boundaries is accompanied by an extensive shear deformation and formation of elongated shear dimples. Figures 24 and 25 show a plastic grain boundary fracture in a 2219 aluminum alloy. This type of fracture is usually connected with the well-known delamination fracture of some aluminum alloys which result from a depletion of second phase precipitates along the grain boundaries. Another example of plastic intergranular fracture takes place during creep at high temperatures when voids form along grain boundaries by diffusion of vacancies.

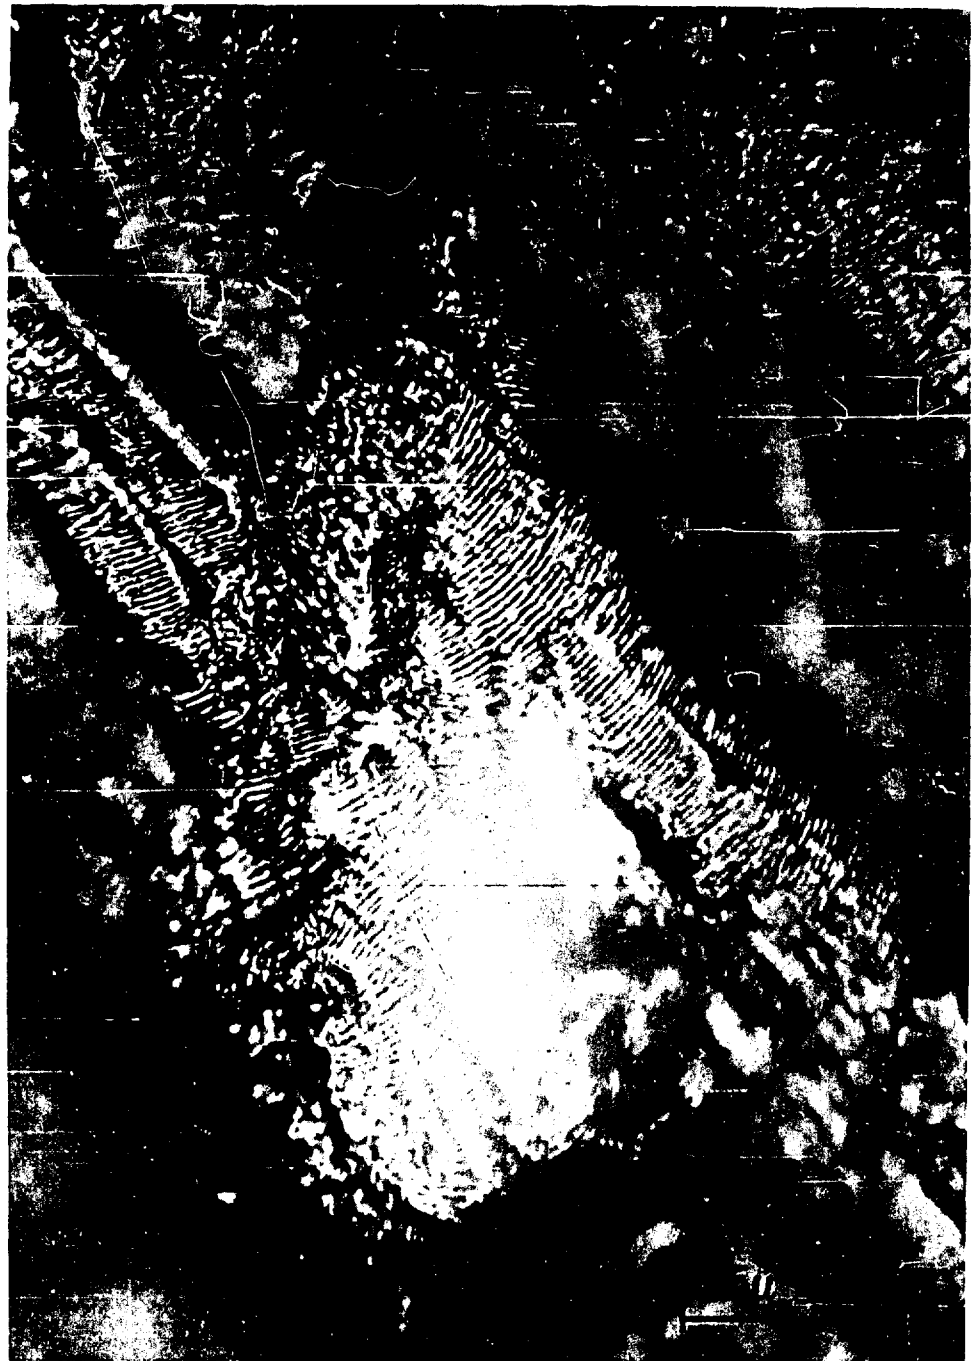
Figure 26

- FATIGUE FRACTURE - Optical micrograph of a fatigue fracture in a 7178 aluminum alloy. The regions out of focus are due to the small depth of field of the optical microscope. (two step replica).

The examination of the fatigue fracture surface of an aluminum alloy by optical microscopy shows dull and bright regions. The dull zones are depressions usually with a large inclusion visible at the bottom of the depression. The bright zones show a series of regular striations as illustrated by Figure 26. The examination of the same surface by electron microscopy shows that the depressions are made up of dimples characteristic of a rapid, plastic fracture. The striations of the bright zones are clearly resolved (Figure 27) and in the case of a fatigue test under a constant stress level, the spacing of the striations is locally very uniform. The examination of program loaded fatigue fractures has demonstrated that each of the characteristic fatigue striations first observed by Zapffe and Worden<sup>(19)</sup> is produced by a single cycle of stress,<sup>(4)</sup> thus the striations also called crack front arrest lines, represent the successive positions of a transgranular front at each load cycle.

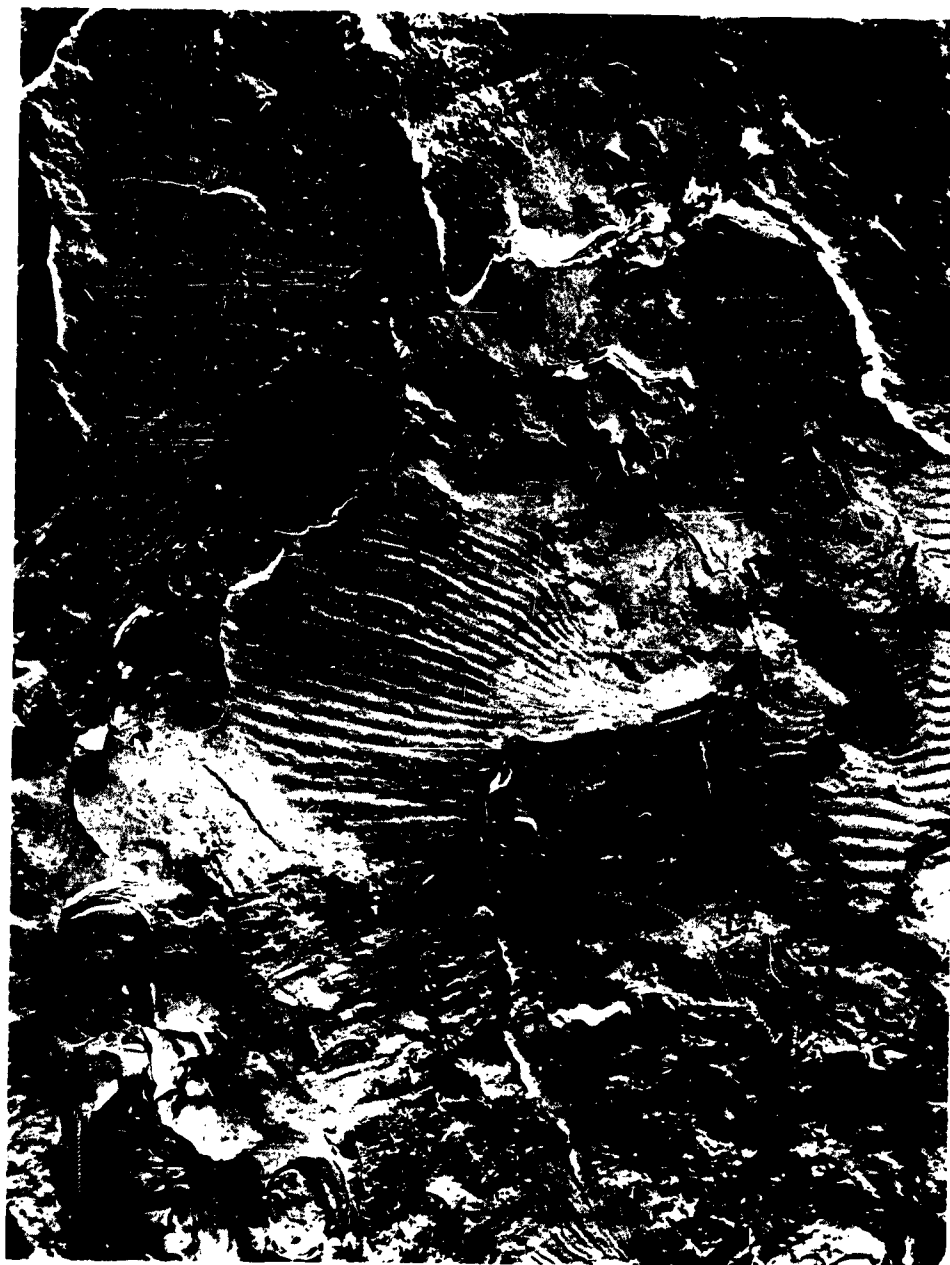
Figure 27

- FATIGUE FRACTURE - Electron micrograph of a fatigue fracture in a 7178 aluminum alloy. By contrast with Fig. 26 this micrograph shows the larger depth of field of the electron microscope. The flat regions where the crack propagated in a cyclic manner are connected by ductile regions where fracture took place suddenly around inclusions or by shear.

The ductile striations are more common and they have also been observed in polymers which would show that their formation is not necessarily related to the crystallographic nature of metals. Figures 27 and 30 give some good examples of ductile fatigue striations. The exact mechanism of formation of these striations is not clearly understood. Sketch 28e presents different profiles of fatigue striations. Smith and Laird<sup>(21)</sup> and McEvily<sup>(22)</sup> have shown that in the case of high stress fatigue, the profiles of the two fracture surfaces do not match. Under conditions of low stress fatigue, it is not clear at this stage, whether the profiles are of the type II or type III represented on Figure 28.

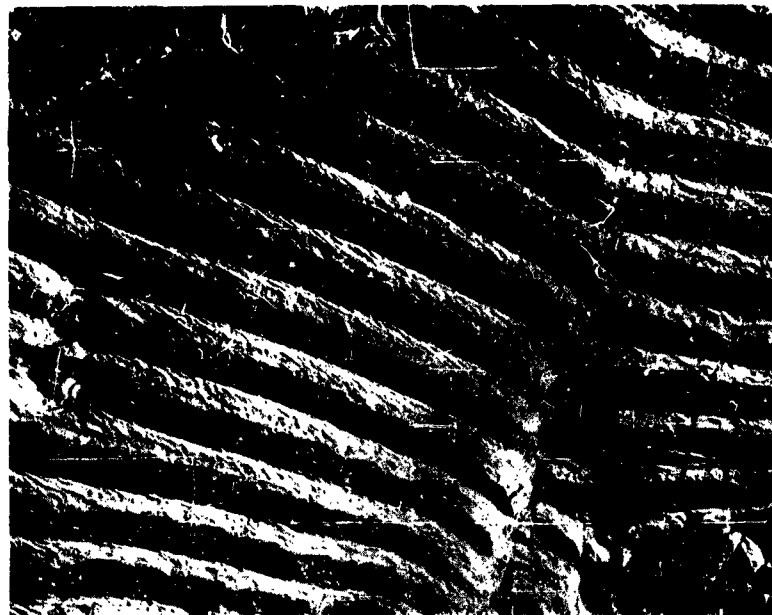
Figure 30 (a,b)- FATIGUE FRACTURE - Examples of ductile fatigue striations in a 7178 aluminum alloy. Figure 30b shows clearly the role of the grain boundaries in slowing down the progression of the crack front (two step replica).

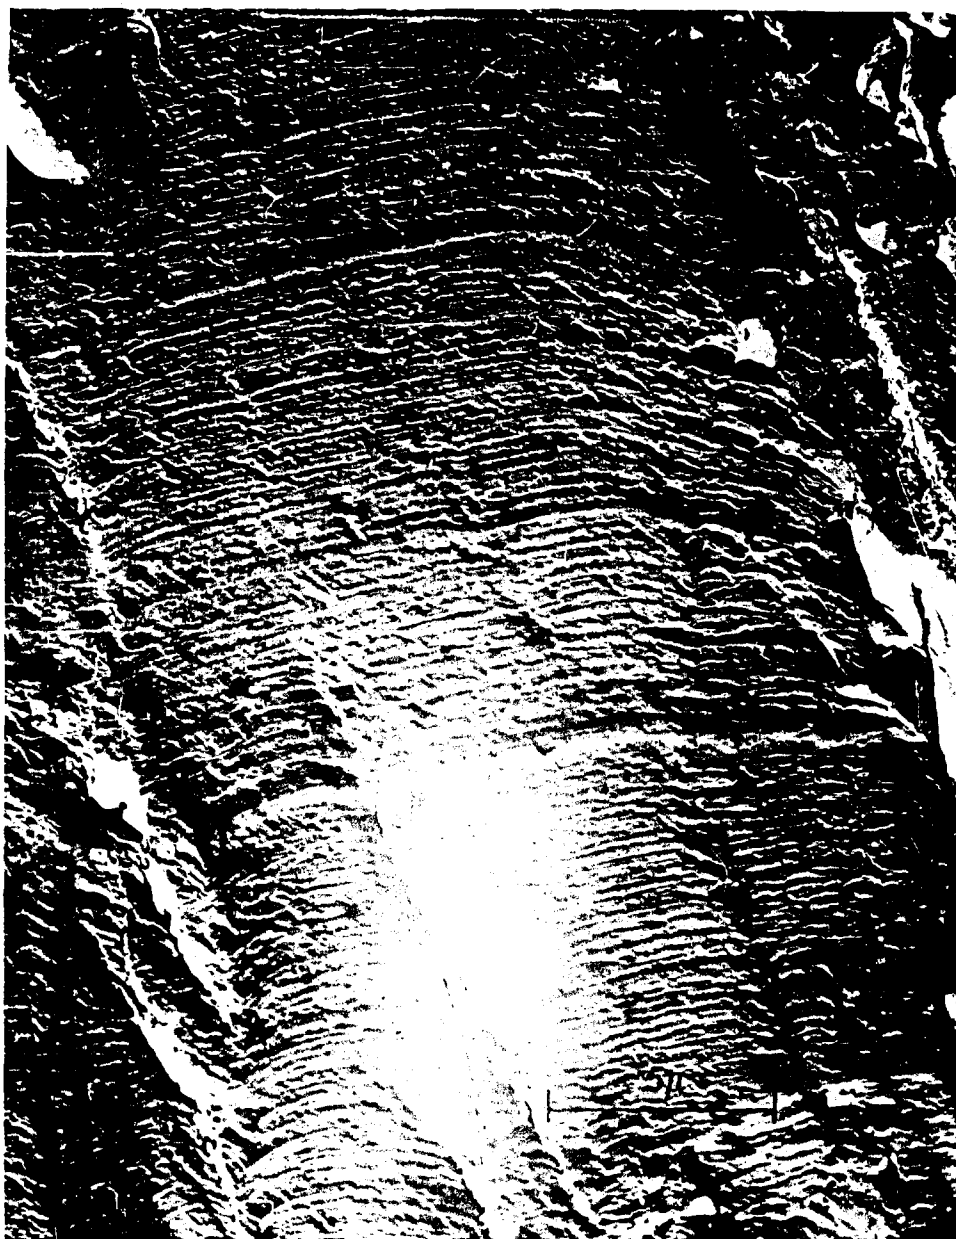
- FATIGUE FRACTURE - Under a random load the spacing of the striations is not uniform. The influence of peak overloads on the rate of advance of the front is clearly indicated - 7178 aluminum alloy. (two step replica).

Figure 32 shows that under a random load, the spacing of the striations may vary considerably. The well defined fatigue striations provide us with a perfect marker which should be used to measure the true influence of a peak overload on the rate of crack propagation.
