## The Analysis of Fracture Surfaces by Electron Microscopy

Regis M. N. Pelloux

THE ANALYSIS OF FRACTURE SURFACES BY ELECTRON MICROSCOPY

(Revised Edition of Boeing Document D1-82-0169)

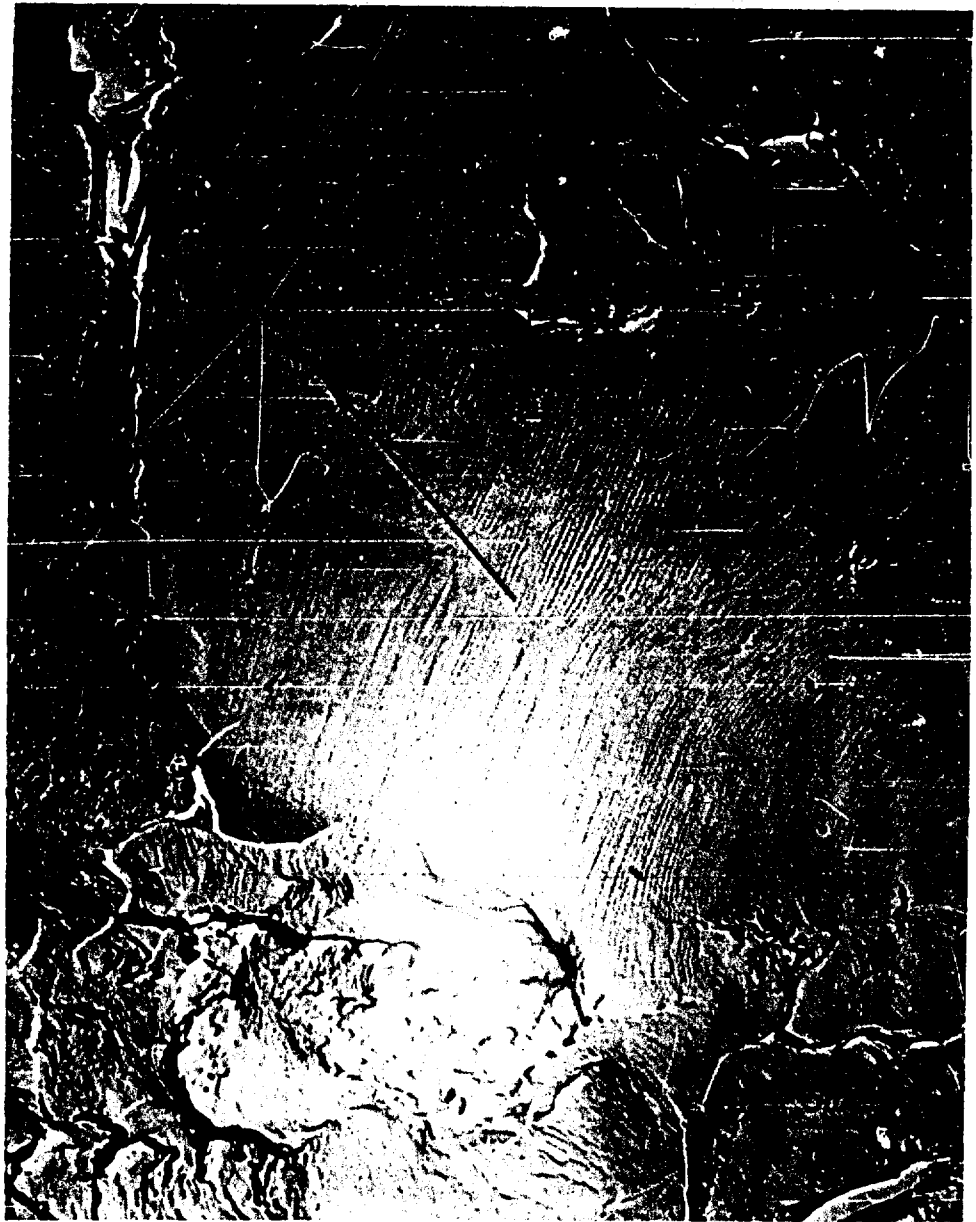
Figure 34

- FATIGUE FRACTURE - Fatigue striations in Ti - 6 Al -  
4 V alloy (two step replica).

Other examples of fatigue striations are shown on Figures 33, 34, 35 and 36. In general, the striations in different materials are not as sharply defined as they are in high strength aluminum alloys. In steels for instance, the successive positions of the crack front do not appear clearly defined; the striations are short and discontinuous. Very often, according to the ratio of the maximum to the minimum stress, the details of the fracture surface have been destroyed by the rubbing action of the two fracture faces.

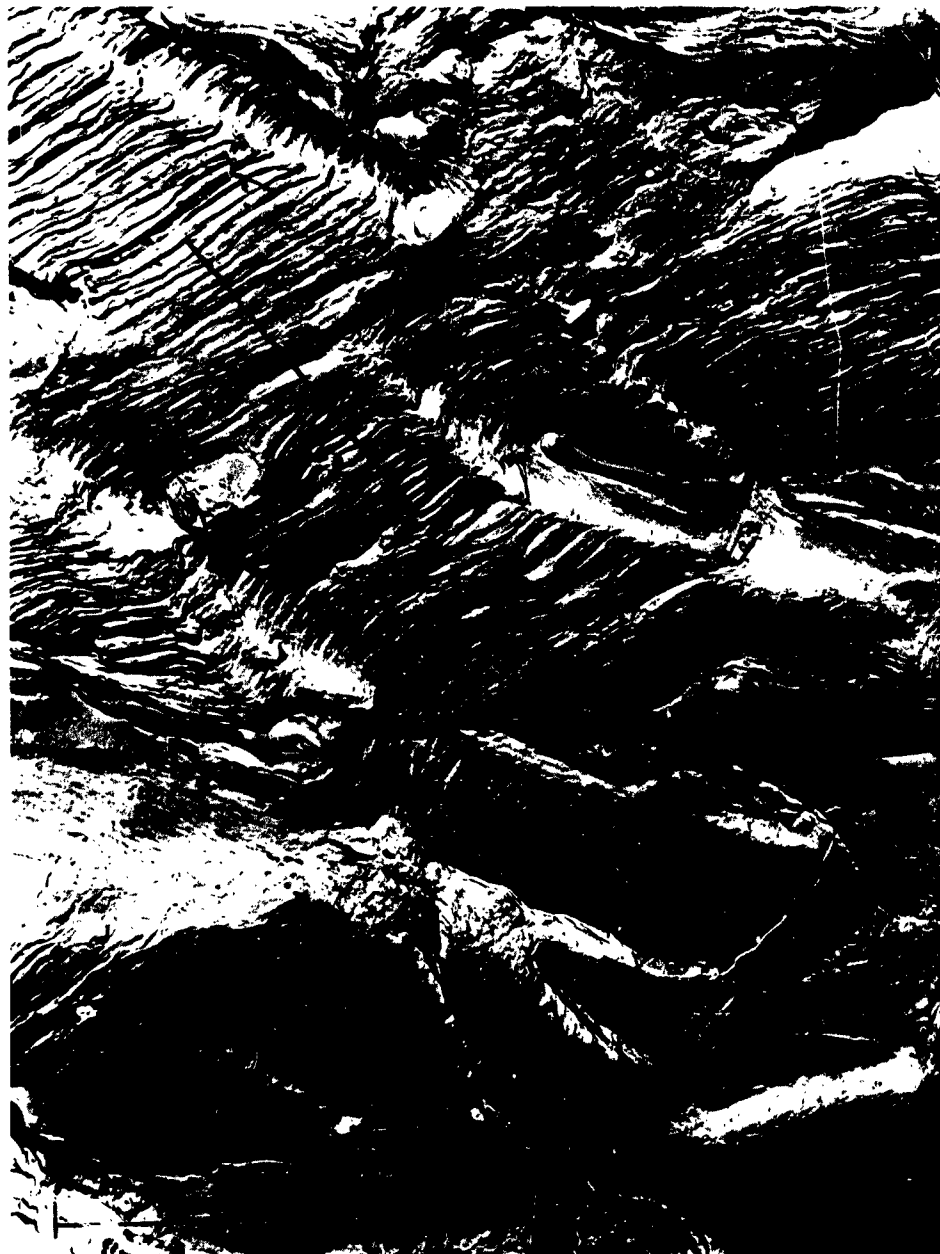
Figure 35

- FATIGUE FRACTURE - Fatigue striations in a welded zone of a 2219 aluminum alloy. The large second phase particles are probably eutectic particles of  $Al_2Cu$  (two step replica).
