TRECOM TECHNICAL REPORT 64-34

**GEMINI 1-TON, AMPHIBIOUS, OFF-HIGHWAY,  
AIR-TRANSPORTABLE VEHICLE  
CONCEPT EVALUATION PROGRAM**

FINAL REPORT

Engineering Division  
Hawker Siddeley Canada Ltd.

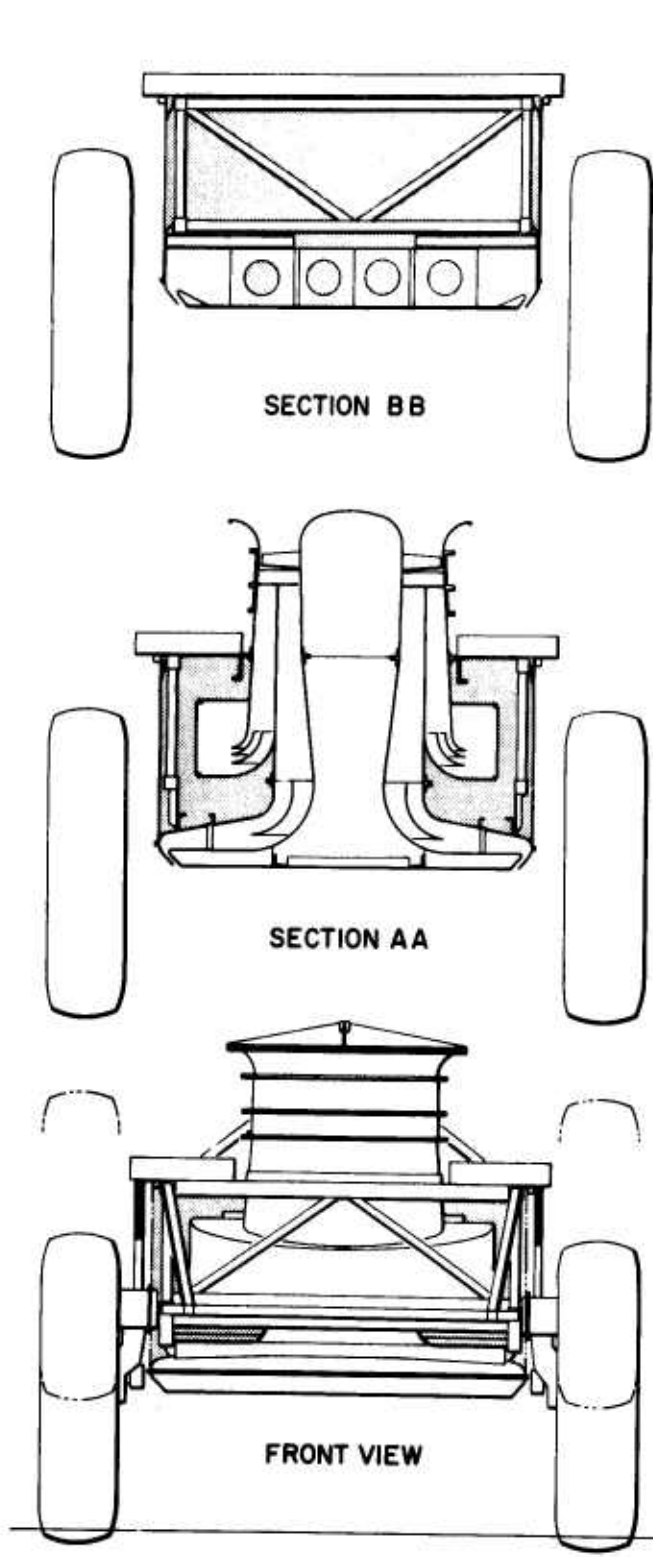
Figure 2. General Arrangement

General Arrangement of Gemini Phase I Test Vehicle

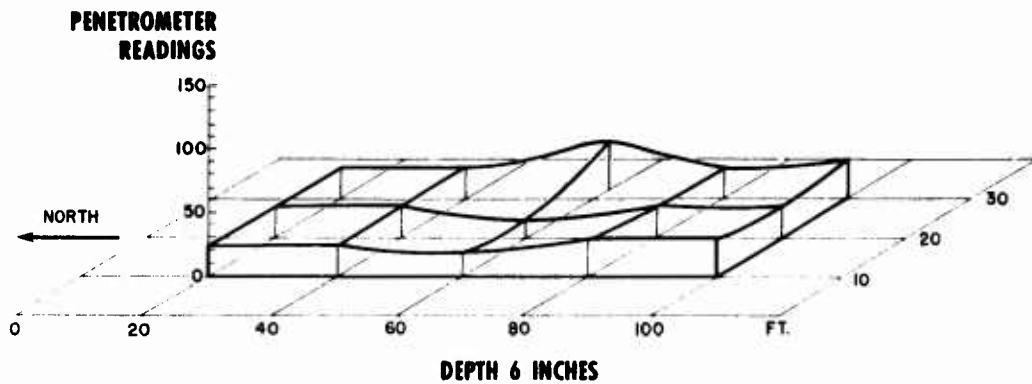
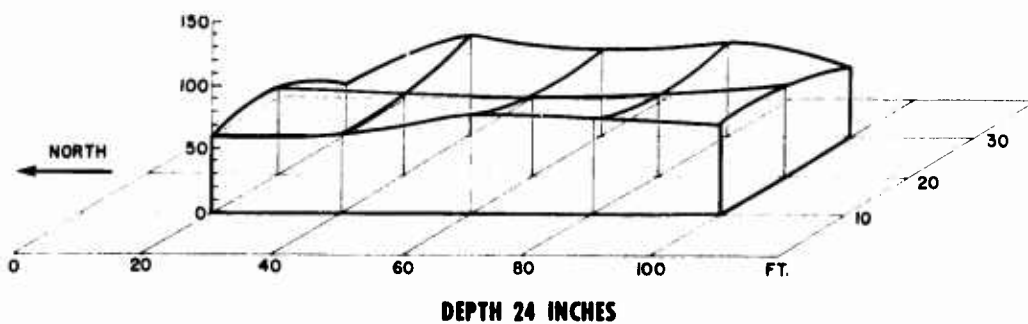
Figure 9. Penetrometer Readings - East Clay Bed

Charts are attached (Figures 8 and 9) showing the readings observed in both clay beds using the penetrometer supplied by USATRECOM. In all tests to date in these beds, the maximum wheel rut depth has been 9 inches (and for most of the tests, less than 6 to 7 inches), so that the readings for the top 12 to 18 inches are a good indication of the consistency of the clay in which the operations were conducted. It will be observed from the plots on Figures 8 and 9 that the center of the clay beds where the runs were made had cone penetrometer readings of about 30 for the top 12 inches.

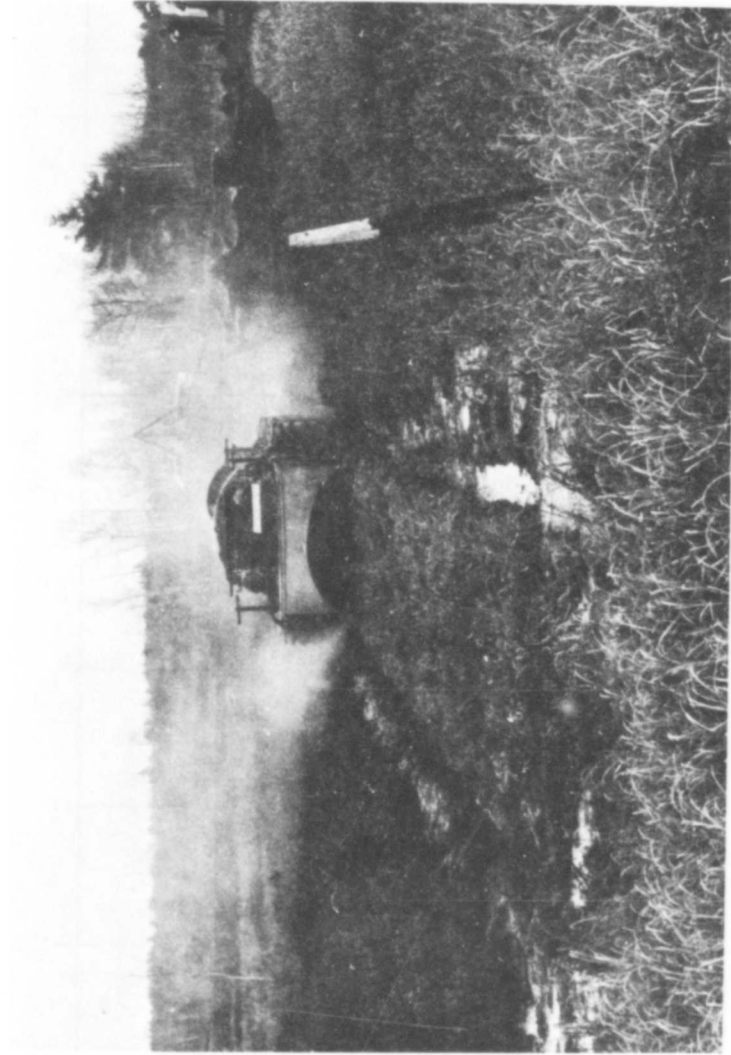
Figure 14. Gemini Phase I Test Vehicle Crossing Muskeg

On completion of these clay tests, the vehicle was transported to a muskeg site north of Parry Sound, Ontario. Figure 14 shows the vehicle making a pass across the muskeg test site. The vehicle successfully performed 32 passes through low-bearing FI-type muskeg along the same path. It was then moved to an undisturbed area of the same site, and 33 passes were made. At intervals, the screw jacks were used to lower the wheels further as the ruts became deeper until finally the wheel rut depth was on the order of 18 to 20 inches below the original surface level.
