USAAMRDL TECHNICAL REPORT 72-12

DESIGN STUDY OF REPAIRABLE MAIN ROTOR BLADES

This report presents the results of a design study of repairable main rotor blades. The designs studied are applicable to the Army's UH-1H helicopter with semirigid teetering rotor system. The program included development of analysis methodology, including a model for rotor blade life cycle costs, establishment of design concepts, analysis of these concepts from both a technical and cost viewpoint, and selection of a final recommended configuration for future development. As partial support for the concept of field repairability of rotor blades, an experimental evaluation of a major repair was conducted under simulated field conditions. The procedure used and the results of this evaluation are included as an appendix to this report.

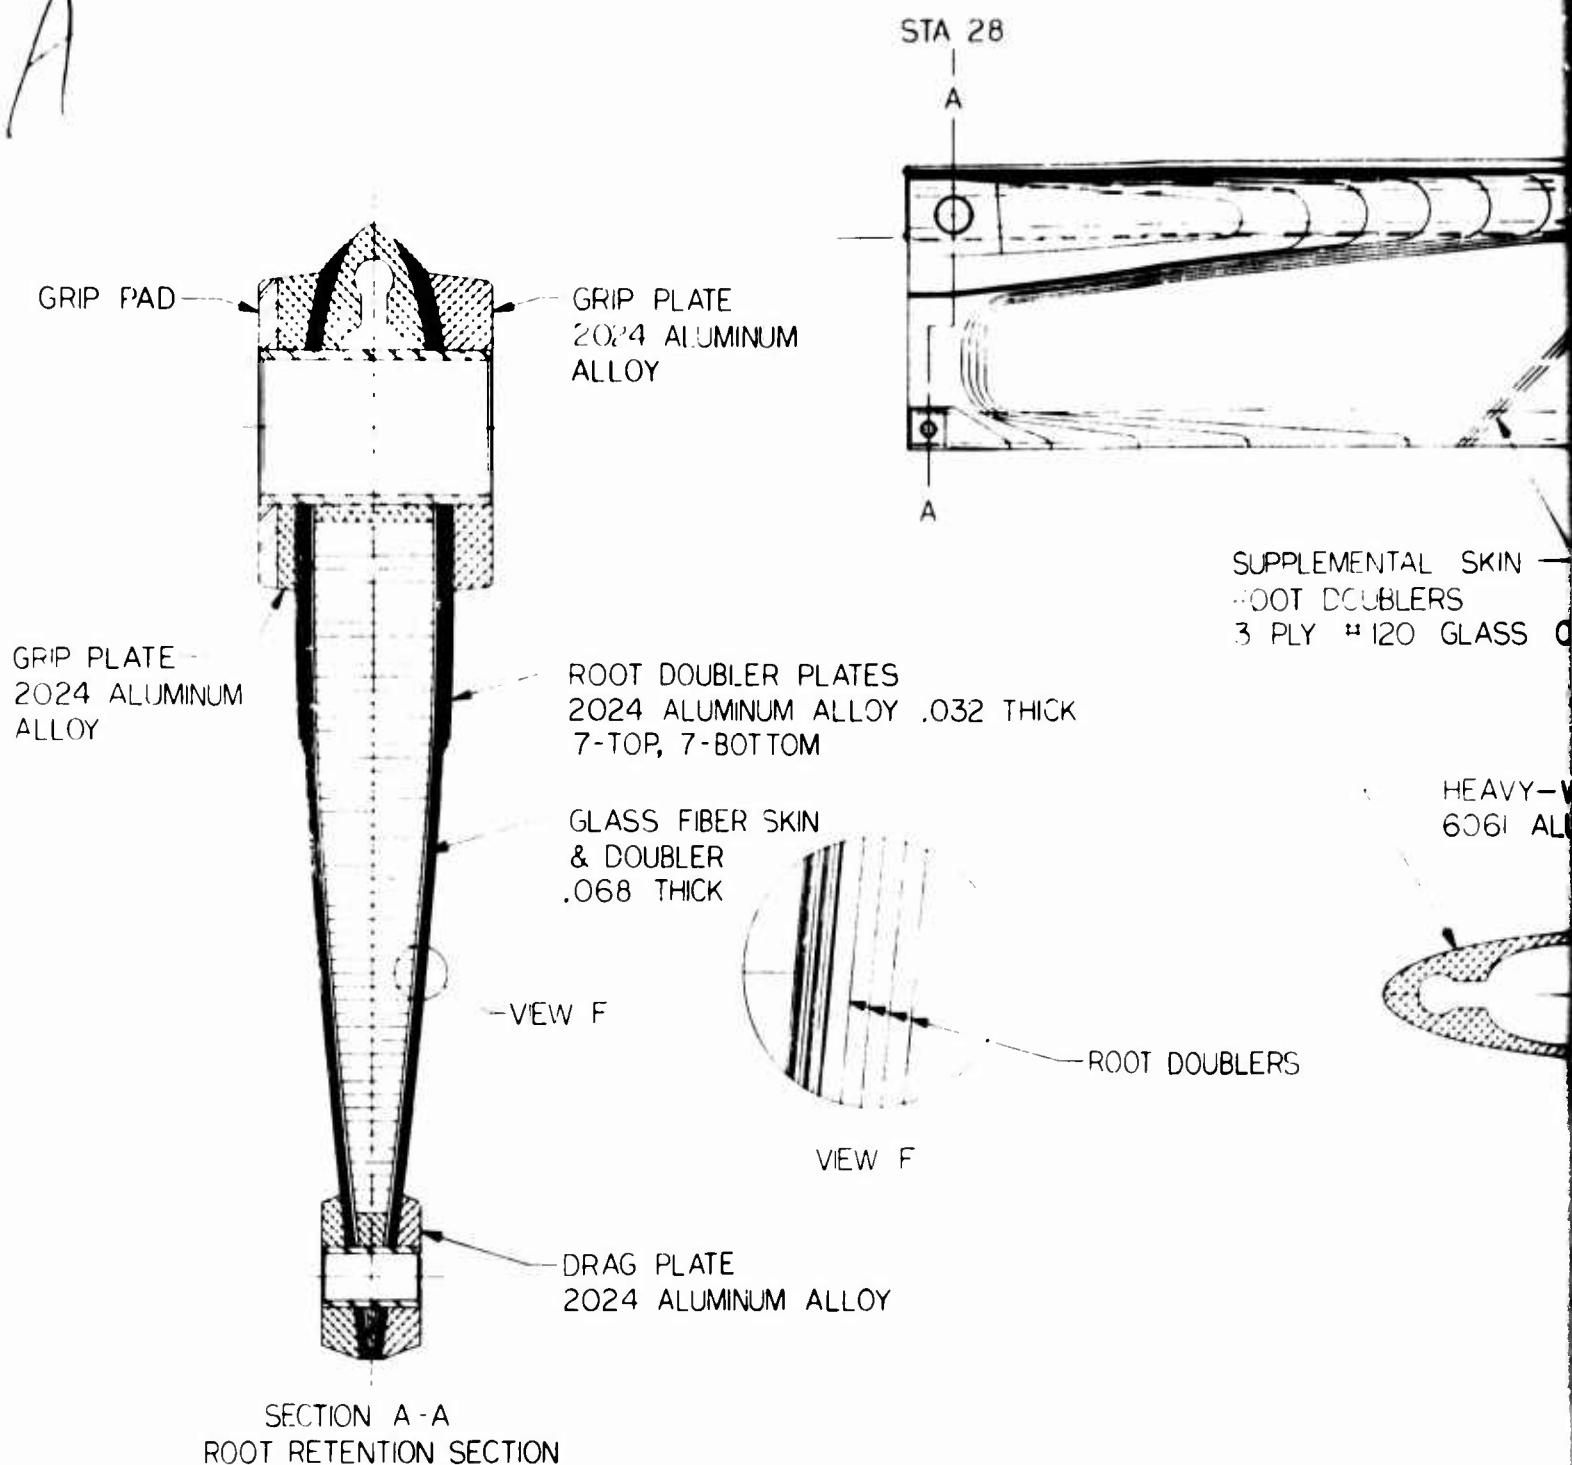
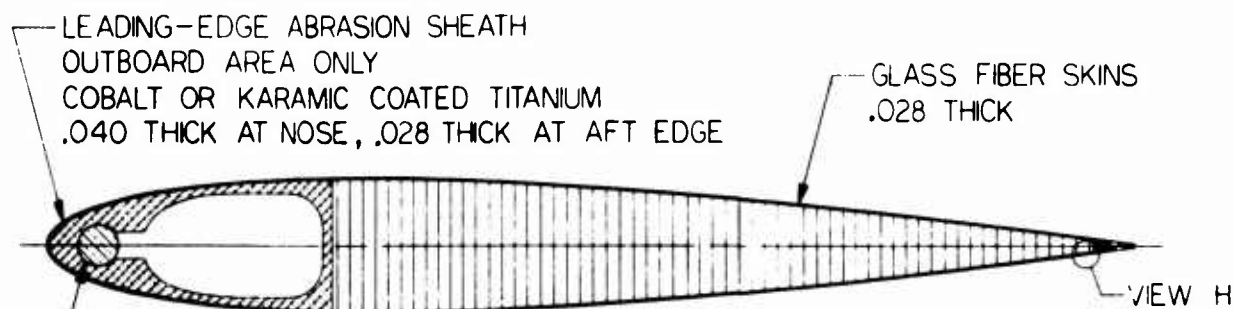
Figure 6. Configuration V, Selected Repairable Rotor Blade Design.

SECTION C-C
TYPICAL OUTBOARD SECTION

BALLAST WEIGHT
NAVAL BRASS ROD, 0.75 DIA
BONDED IN POSITION USING
ADHESIVE WITH SCRIM CLOTH

ALUMINUM HONEYCOMB
1/4 -.0010 CELL

ROD
END OF ABRASION SHEATH

BALLAST RETENTION SYSTEM
4-0.375 DIA PINS THROUGH
SPAR AND STEEL BEARING PLUG

GLASS FIBER SKINS
.028 THICK

The selected repairable rotor blade design is shown in Figure 6 as Configuration V. This recommended design incorporates features of the basic Configurations I and III discussed subsequently. The basic outboard sections of Configuration III have been retained, but the blade root utilizes the laminated doubler buildup of Configuration I. The step extrusion of Configuration III is eliminated, with the excess material that entails, as is the machining operation which is required to remove that material. In addition, an element of uncertainty is also eliminated. The step in extrusion cross section, which would occur in the neighborhood of Station 82, a highly loaded blade section, would introduce nonuniform grain flow to the spar at this station. This grain flow would not be parallel to the finished blade surface and would, therefore, contribute to a slight reduction of material properties locally. The influence of this disturbance on the fatigue performance of the basic spar material would require some detailed evaluation and would have to be considered a part of the development risk for Configuration III. The spar for Configuration V is a constant cross section with machining only where bonded attachments are made. Costs for blanking, forming and bonding the root doublers are incurred; however, a net saving in new blade cost is effected.

A life-cycle cost analysis for the Configuration V blade, based on data derived from Configurations I and III, indicates a net savings over a 10-year aircraft life cycle of 46%

compared to the present UH-1H blade. In addition to this cost advantage, Configuration V offers the simplest possible repair of leading-edge damage over most of the blade length and also contains fewer parts than the current UH-1H blade. The risks incurred in development of the Configuration V blade are minimal. Preliminary analysis has shown this design to meet all basic technical requirements.

The use of 6061 aluminum alloy for the spar in a highly loaded semirigid rotor system could be considered to introduce an element of risk. While the ultimate strength of this material is lower than that attainable with other alloys, the fatigue strength of large manufactured parts is not correspondingly reduced. The spar employed here utilizes a heavy wall and nose section in order that it can sustain damage from external sources and continue in use with only minor repair necessary. The heavy wall design also results in comparatively low operating stress levels and is, therefore, compatible with the lower strength alloy. At the blade root where the high bending and centrifugal loads are reacted through the retention pin, a system of bonded external doublers and plates is used to transfer the load. This bonded assembly may be made from the same high-strength alloy presently used on the UH-1H blade and will, therefore, provide essentially the same strength.

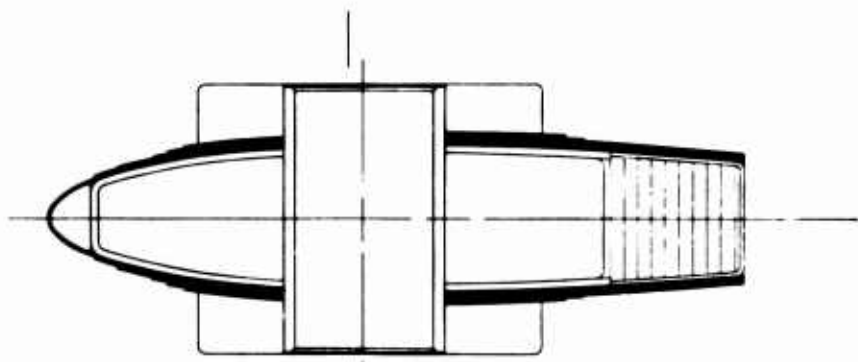
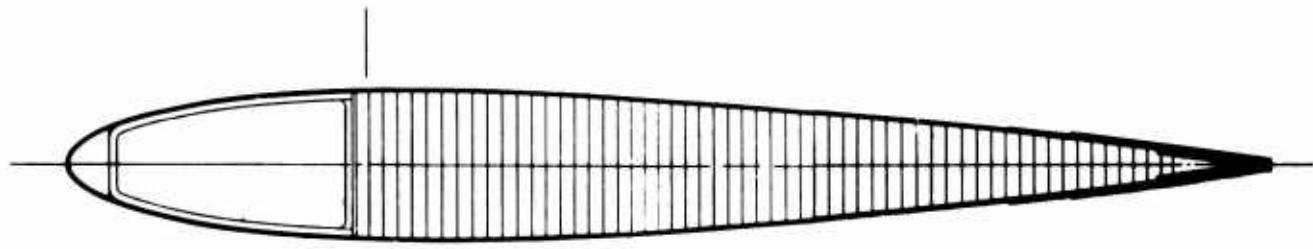
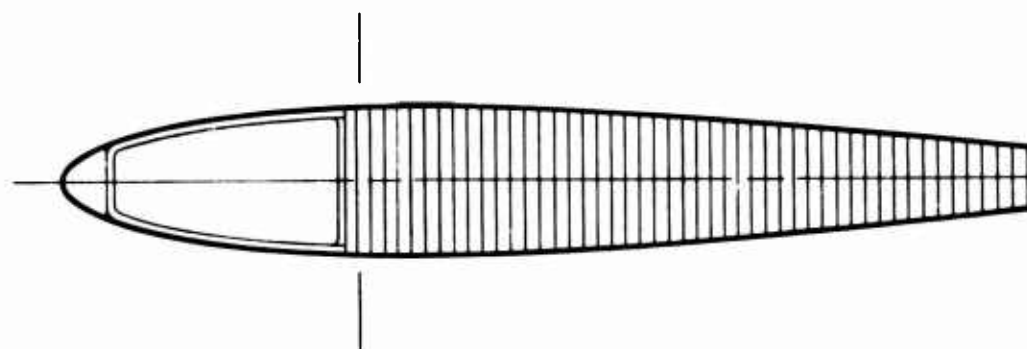
Figure 8. Configuration II, Repairable Rotor Blade
Using Minimum Planform Titanium Spar.

DESIGN CONSIDERATIONS

1. REDUCED BLADE PLANFORM - LOWER VULNERABILITY, LESS NONREPAIRABLE AREA.
2. TAPERED TITANIUM SPAR - DIFFUSION BONDED SHEET MATERIAL.
3. FIBERGLASS SKINS.
4. LEADING-EDGE BALLAST WEIGHT -
HIGH MODULUS INBOARD FOR STIFFNESS -
HIGH DENSITY OUTBOARD FOR CHORD BALANCE.

1. REDUCED VULNERABILITY
2. AFT STRUCTURE READILY REPAIRABLE WITH PROPERLY DESIGNED KIT.

SECTION A
MAIN RETENTION PIN AREA

SECTION B
TRAILING EDGE SPLICE AREA

SECTION C
TYPICAL OUTBOARD AREA

One of the goals of Configuration II shown in Figure 8 was to provide a minimum planform spar and to eliminate as much of the nonrepairable area of the blade as possible. To do this

it was necessary to use a spar material with high strength and modulus of elasticity; titanium alloy Ti-6AL-4V was chosen. The configuration employs a modified retention scheme with two pins oriented spanwise, both piercing the main spar. The drag brace and some heavy root end structure are thereby eliminated, as is some of the vulnerable trailing-edge buildup. The main spar could have been formed from separate pieces and adhesively bonded; however, it appeared that higher integrity and reliability could be achieved by use of diffusion bonding. Preliminary evaluations of this process have shown the ability to produce excellent material properties for rotor blade applications. The process also lends itself to the fabrication of a tapered spar, which is necessary in approaching the minimum planform desired.

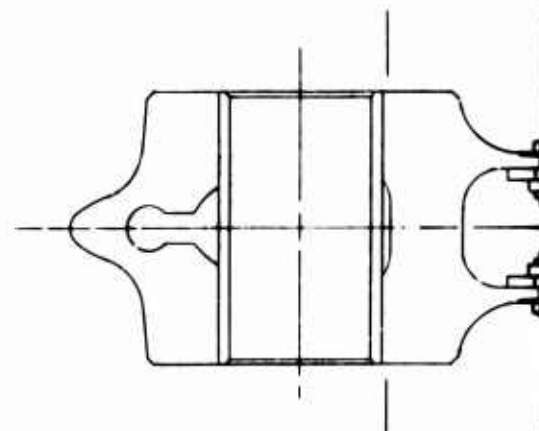
Figure 9. Configuration III, Repairable Rotor Blade Using Heavy Wall Aluminum Spar.

DESIGN CONSIDERATIONS

1. HEAVY-WALL ALUMINUM SPAR FOR EASY BLENDING OF DAMAGE.
2. INTEGRAL ROOT END STRUCTURE, STEP EXTRUSION.
3. GLASS FIBER SKINS AND TRAILING EDGE.

REPAIRABILITY

1. LEADING EDGE READILY BLENDED TO REMOVE DAMAGE.
2. GLASS FIBER AFT STRUCTURE READILY REPAIRED WITH PROPERLY DESIGNED KIT.

SECTION AT ROOT

OUTBOARD SECTION

This design, based on a heavy-wall, stepped-extrusion main spar, is illustrated in Figure 9. The intent of this configuration is to supply a rugged spar which can withstand damage from external sources and continue in operation with only minor blendings, as is done with many propeller blades. No separate erosion protection is normally required; however, for a severe erosion environment, special protection may be provided for the tip area. The stepped extrusion reduces the possibility for inherent damage by making the buildup at the main retention pin an integral part of the spar.

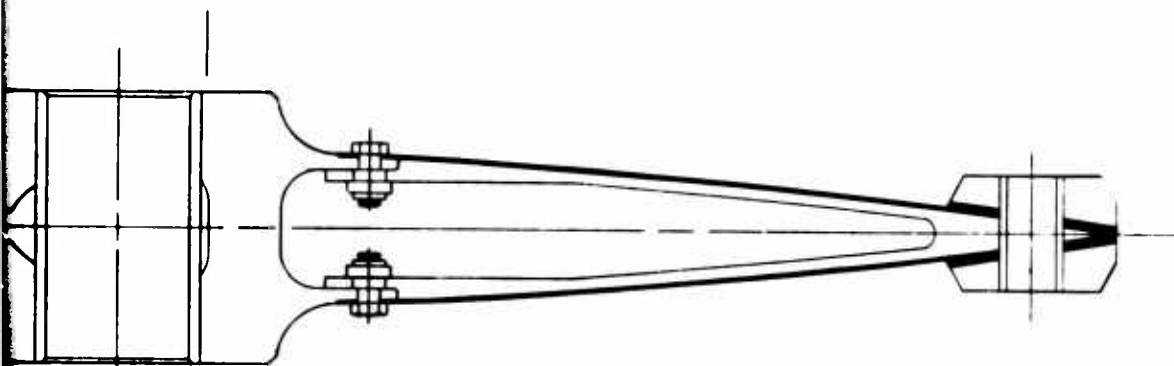
Figure 10. Configuration IV, Repairable Rotor Blade Using Composite Material Spar.

SECTION AT ROOT END

OUTBOARD SECTION

DESIGN CONSIDERATIONS

1. BASIC BLADE STRUCTURE MADE ENTIRELY OF DIRECTED GLASS FILAMENTS FOR IMPROVED REPAIRABILITY.
2. ROOT END RETENTION AND DOUBLERS REINFORCED WITH TITANIUM PLATES.
3. INTRODUCTION OF AIRFOIL VARIATIONS POSSIBLE.
4. TORSIONAL STIFFNESS DIFFICULT TO ACHIEVE.

This design, illustrated in Figure 10, uses unidirectional glass fiber as the primary structural material for main spar and trailing-edge spline. A relatively heavy wall spar is required with a layup schedule that will provide the integral root end buildup along with adequate bending and torsional stiffness. At the root of the spar, titanium doubler plates are incorporated into the layup to provide improved bearing strength and resistance to splitting. Edges of the doubler plates are beveled to minimize disturbance of filament load path. Titanium grip plates are also provided at the retention and drag pin holes, top and bottom surface. Leading-edge ballast is bonded to the front of the "D" shaped spar and encapsulated by the protective sheath. Ballast weight is brass outboard but is replaced with unidirectional fiberglass inboard, which contributes significantly to edgewise stiffness. The leading-edge erosion protection is provided by a segmented sheath and has the same material options described for Configuration I.

At the blade root, a machined fitting connects the main retention pin and drag brace pin. External skin doublers also provide connection as well as improving local skin shear strength. The trailing-edge spline is made up of a "V" of fiberglass cloth which houses a wedge of unidirectional material. The aft segment of the wedge is glass fiber and runs from root to tip, while the forward segment uses carbon filaments which run from the root and taper out at station 140. Carbon is used also for inboard spar doublers, which are replaced by glass doublers outboard of station 120. This limited use of advanced composite material is significant in attainment of the desired natural frequencies at minimal increase in weight and cost of the blade. Blade skins and honeycomb are similar to those used in Configuration I but incorporate a more extensive doubler system in the basic skin layup at the blade root.

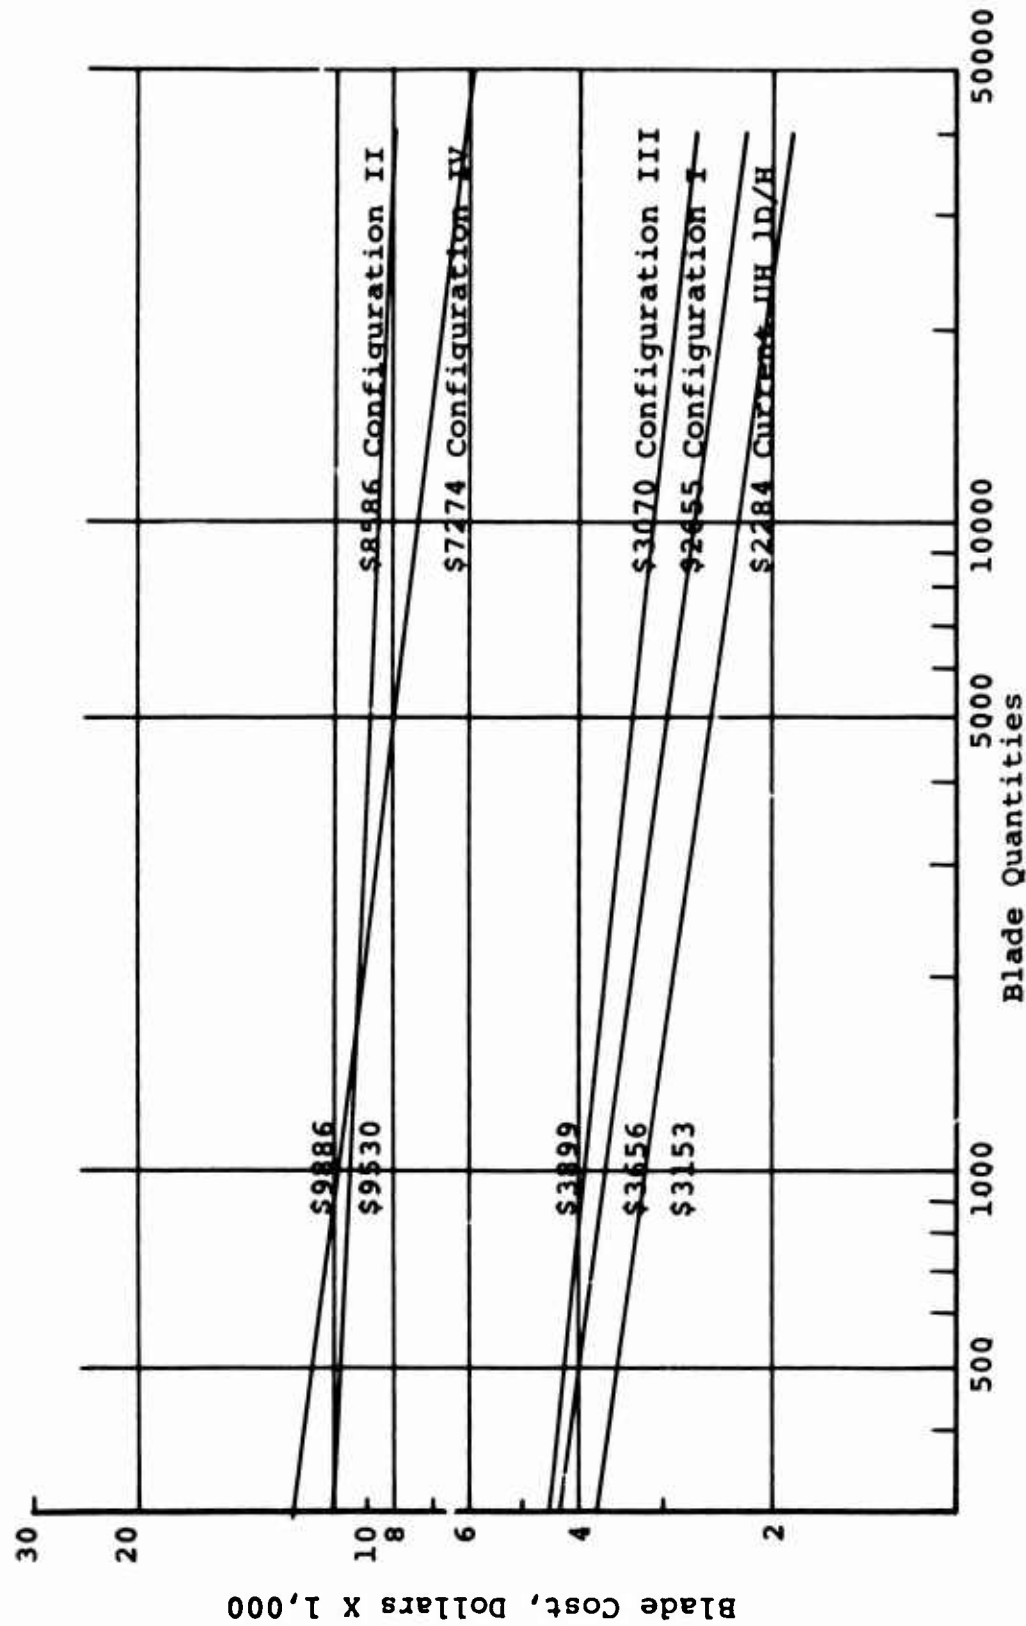
Figure 12. Blade Candidate Cost Estimates

Cost Curves, No Profit, No RDTE

With a given concept defined physically, a cost estimate to produce the blade was made and the experience curve slope established as shown in Figure 12. The adjusted candidate blade costs, based on mid-1971 rates, are shown in Table V along with the production cost estimate of the UH-1D/H blade. To the production cost is added the nonrecurring cost amortized over 10,000 blades and profit. This price is considered the FOB price to the Government in the cost analysis. The nonrecurring costs include design and analysis along with static, fatigue, whirl, and flight testing. RDTE costs for the UH-1D/H blade are assumed to be the same as for Configuration I, since many of the blade components are common to the existing blade. The cost of producing the UH-1D/H blade was estimated in the same manner as the candidate blades. For the 10,000th unit, this blade price was less than the stated value of \$3000, Appendix VI. The price of all blades was therefore adjusted so that the candidate blade prices are consistent with the given UH-1D/H blade price.

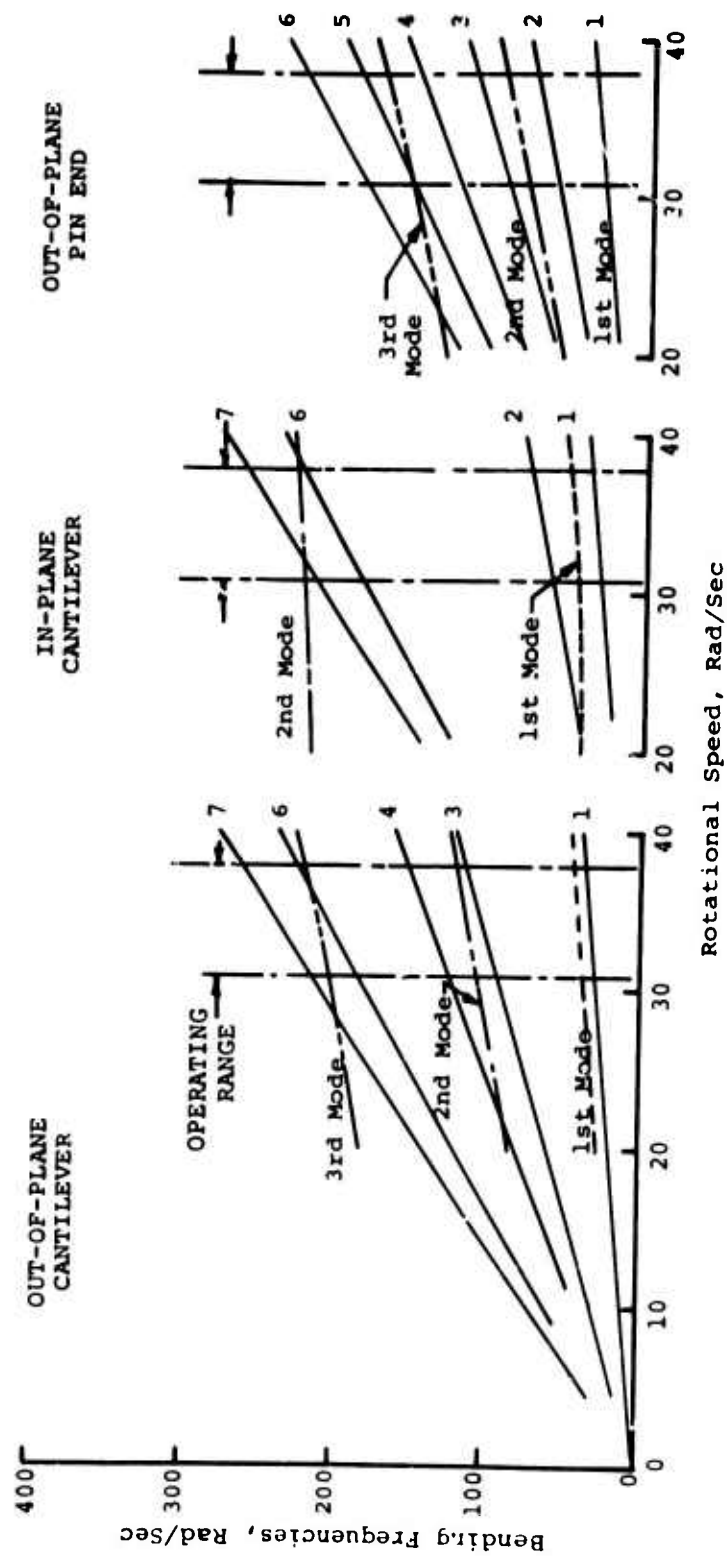
Figure 17. Natural Frequencies of Configuration I.

The natural frequencies of all candidate designs were calculated for comparison to the same frequencies calculated for the current UH-1H blade. Reasonable duplication of frequencies calculated by the same procedures for the same conditions was sufficient to warrant further study of a particular configuration. The natural frequencies and modes are obtained using matrix iteration on the response matrices for the zeroth harmonic. This procedure, which has been separately programmed for the computer, was used to calculate the natural frequencies and modes for the several configurations as a function of rotational speed. For these calculations, the pitch at the three-quarter radius was taken to be +5 degrees. The representative end conditions were cantilever out-of-plane bending, cantilever in-plane bending, and pin-ended out-of-plane bending. By this means, the proximity to resonance in the operating range could be checked for any configuration. The natural frequencies are presented in terms of "fan" plots of natural frequency versus rotational speed for three or four harmonics at the three end conditions for the current UH-1H blade and for each of the candidate designs. These plots are presented in Figures 16 through 20. A review of these results indicates that the candidate designs closely duplicate the frequencies of the current blade for the modes calculated and that this favorable comparison indicates that further study of all designs is justified.

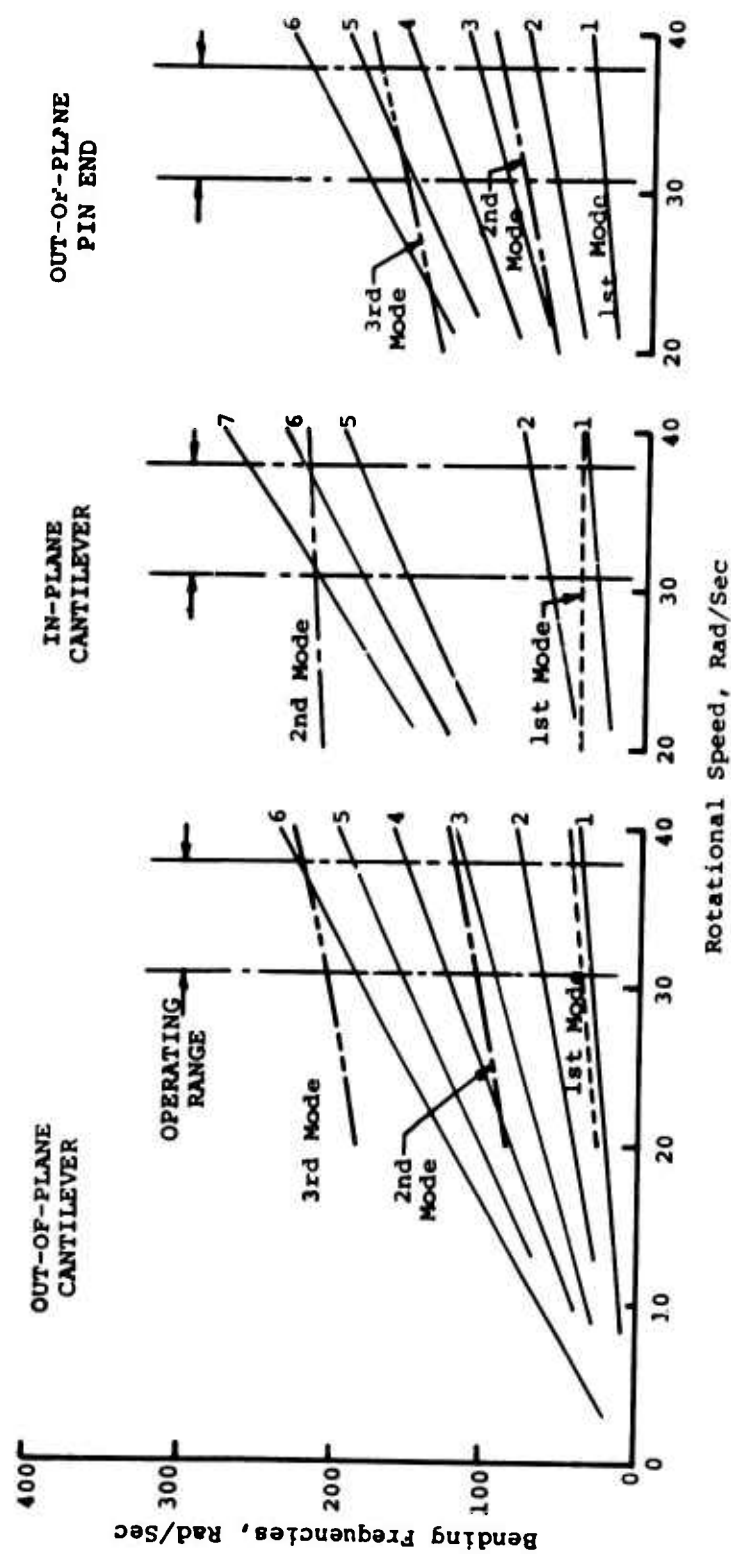
Figure 19. Natural Frequencies of Configuration III.

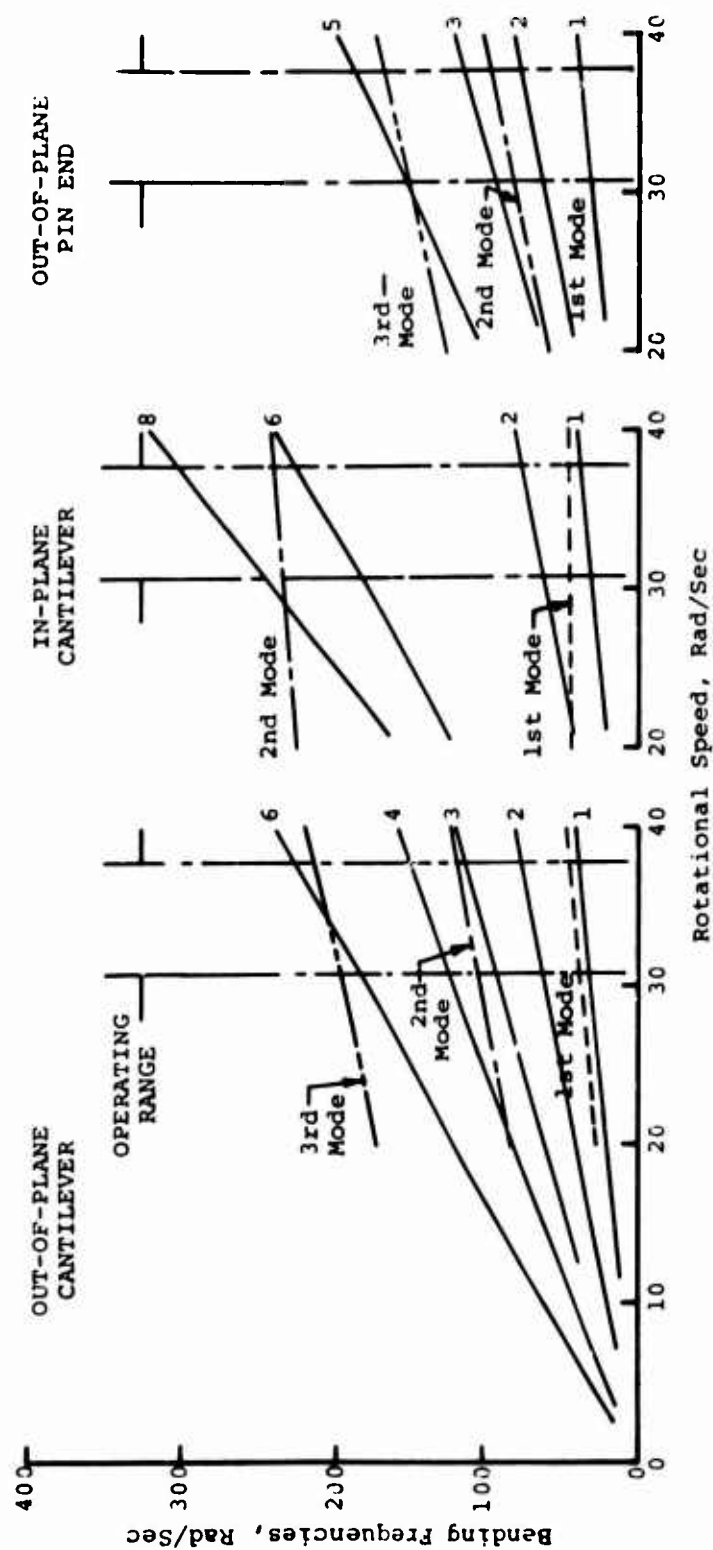
Figure 20. Natural Frequencies of Configuration IV.

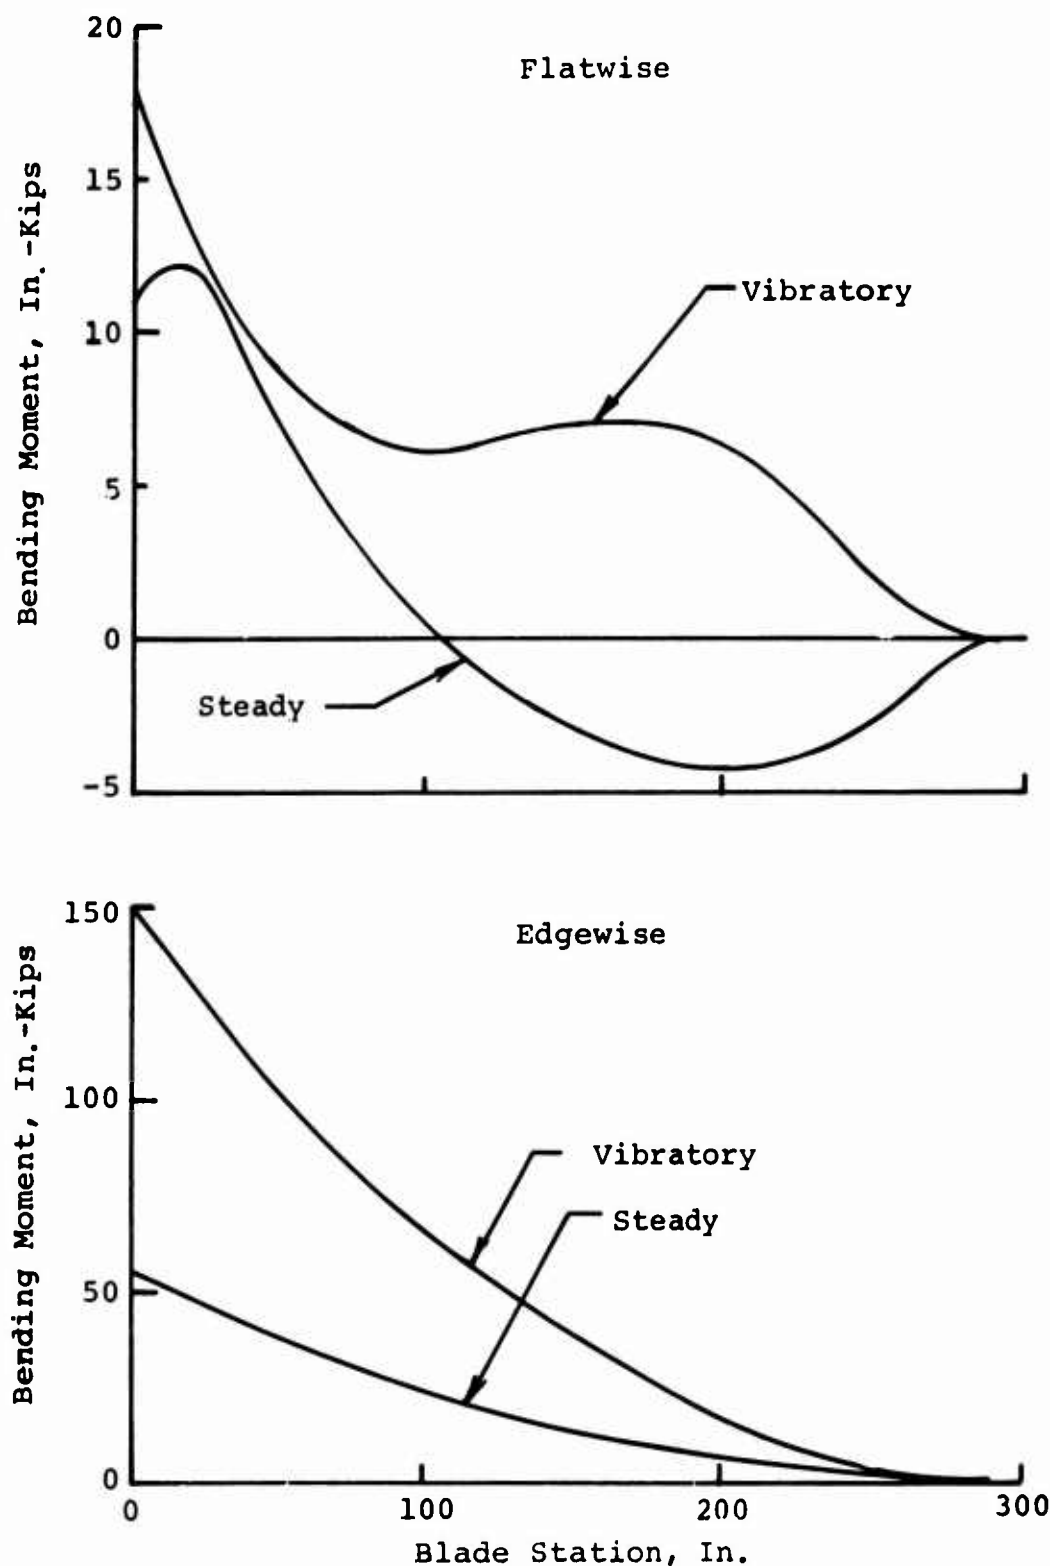
Figure 21. Flatwise and Edgewise Flight Loading for the Current UH-1H Blade.

The results of these analyses are the steady and vibratory flight bending moment distributions presented in Figures 21 through 25 for the current UH-1H blade and the four candidate designs.

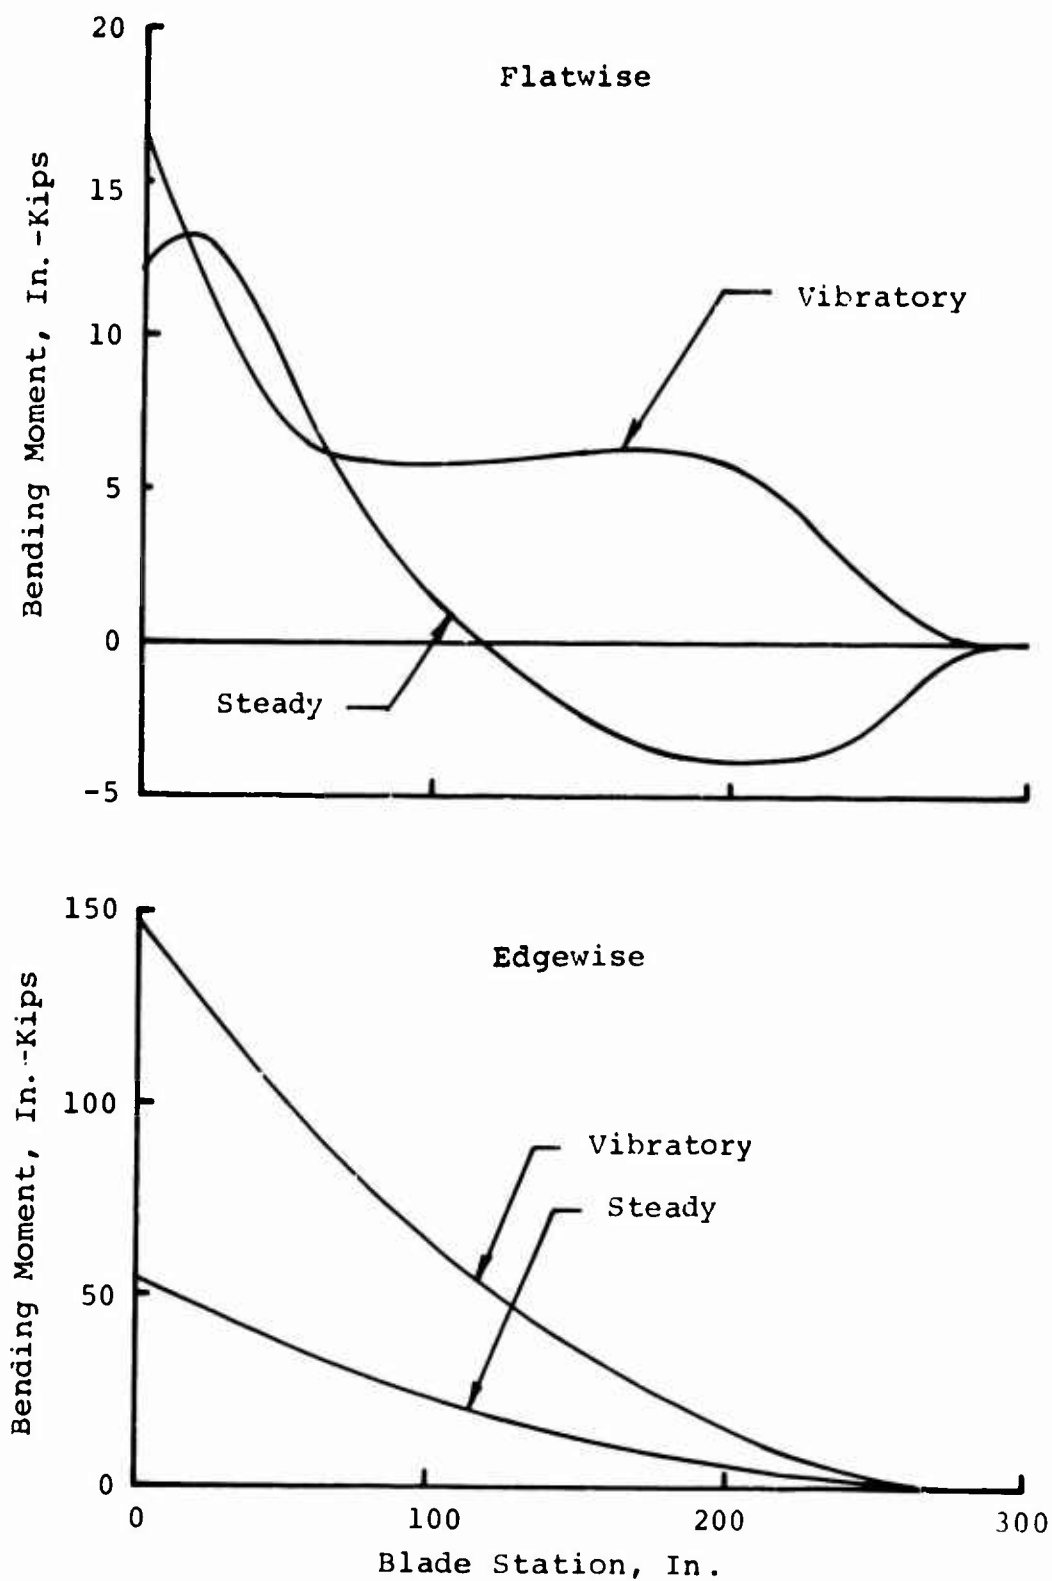
Figure 22. Flatwise and Edgewise Flight Loading for the Configuration I Blade.

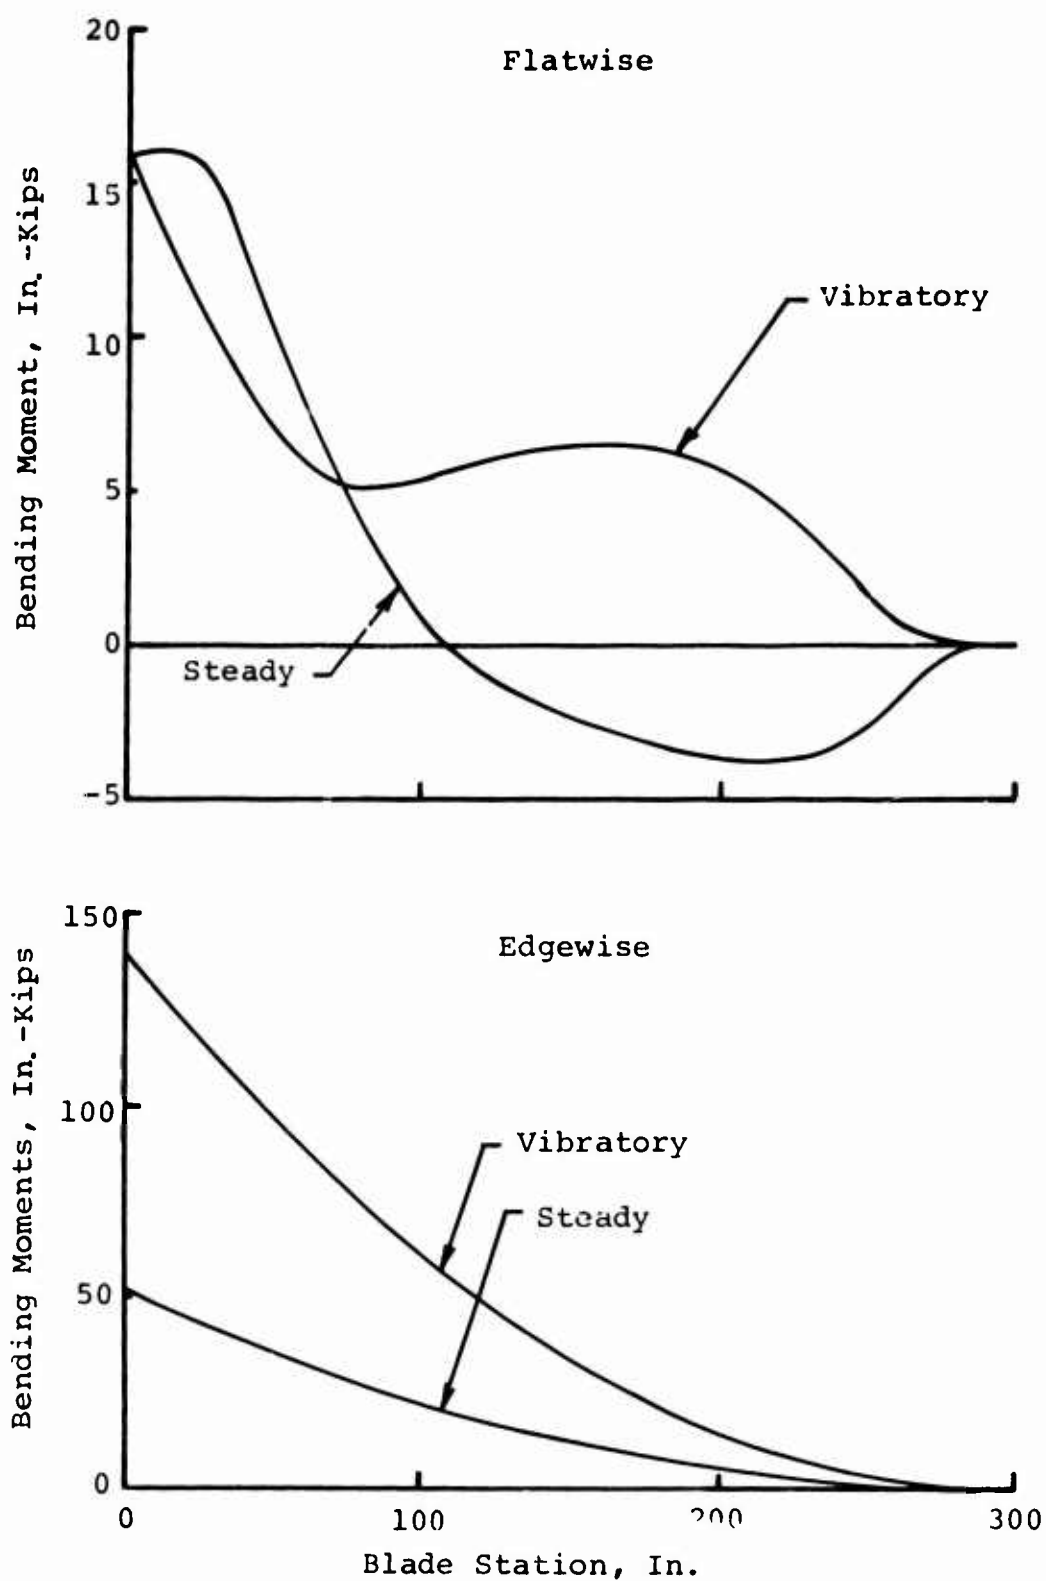
Figure 23 Flatwise and Edgewise Flight Loading for Configuration II Blade.

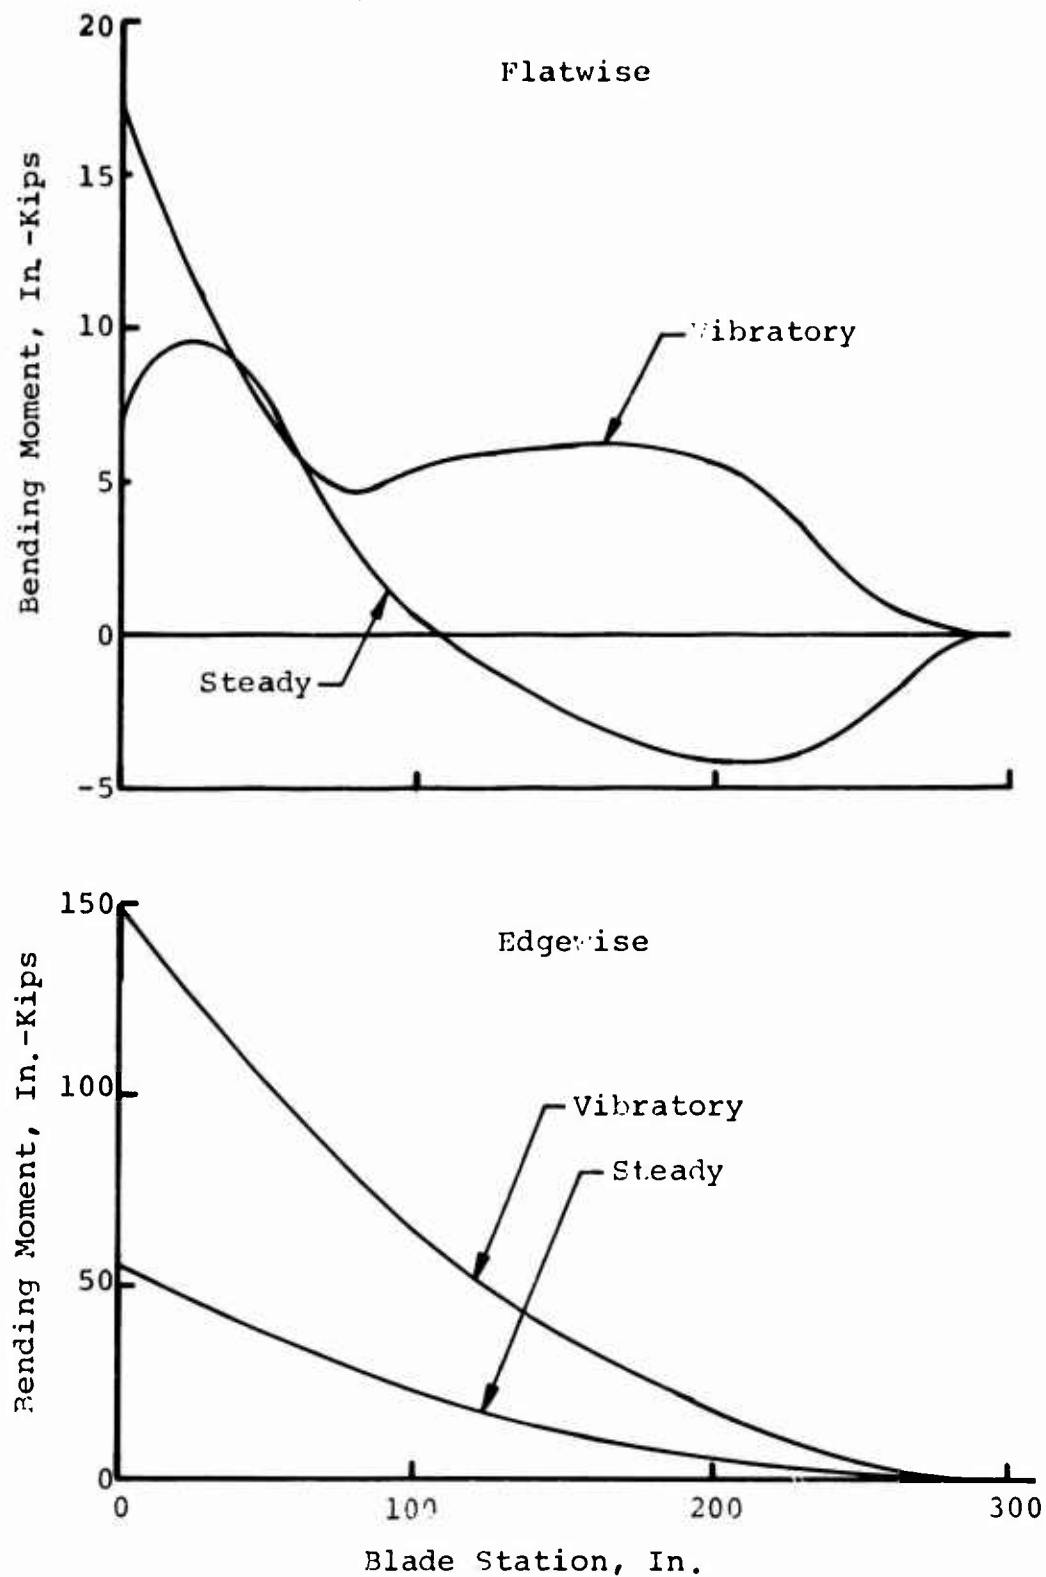
Figure 24. Flatwise and Edgewise Flight Loading for Configuration III Blade.

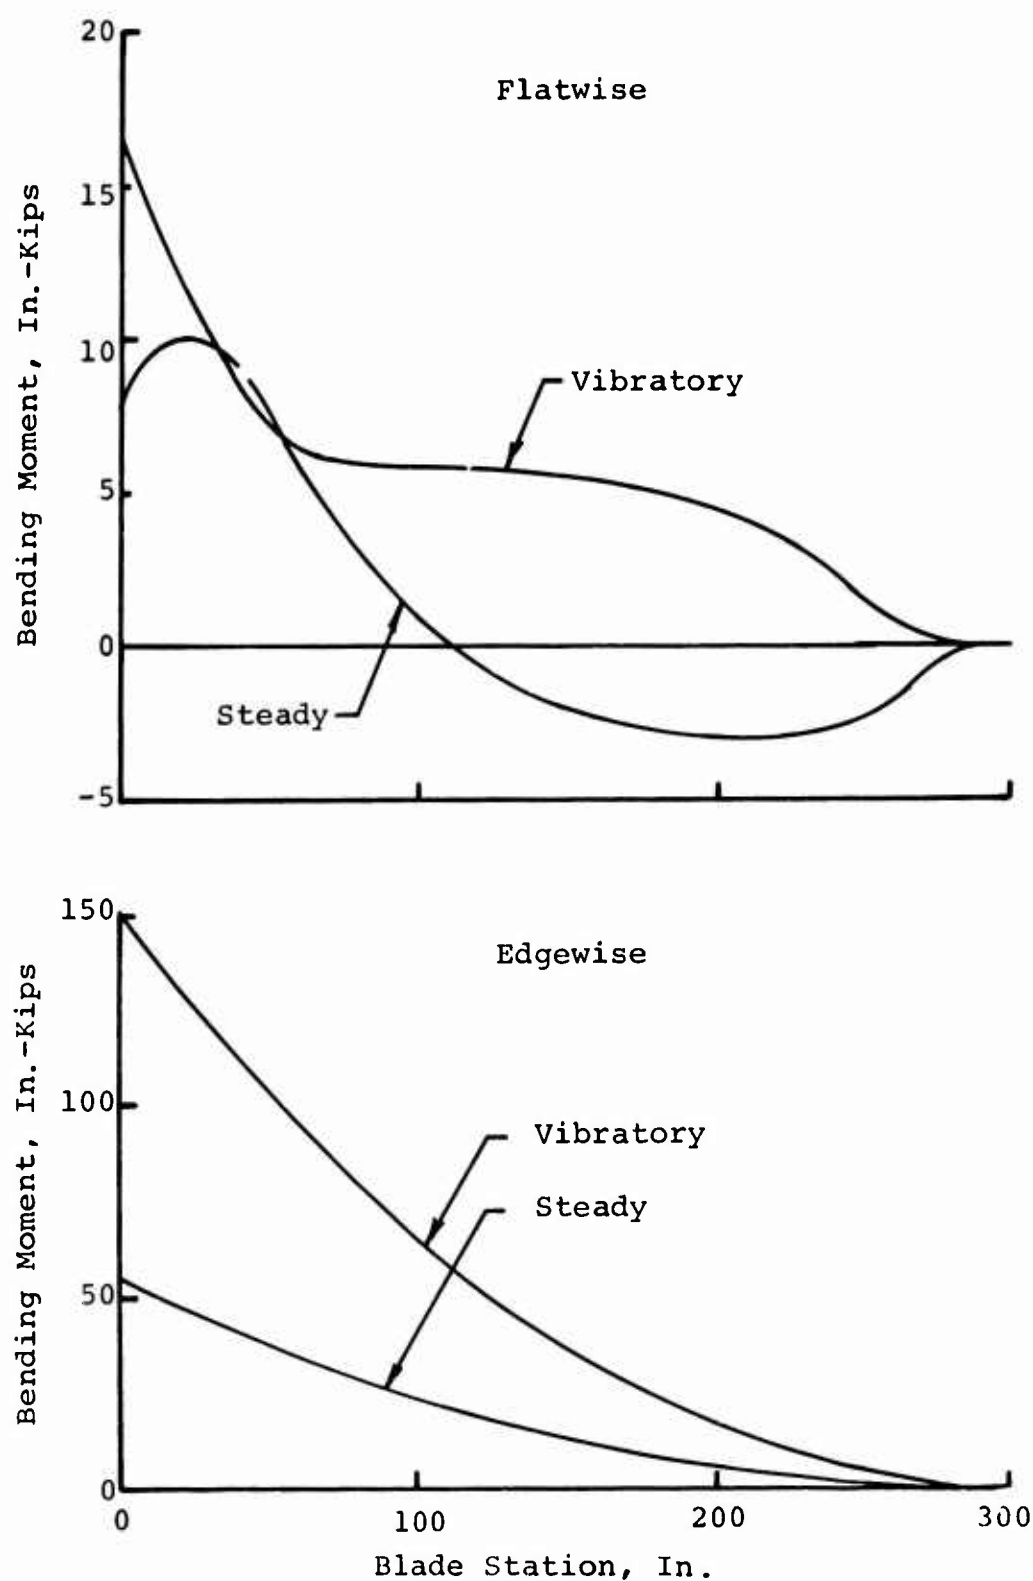
Figure 25. Flatwise and Edgewise Flight Loading for Configuration IV Blade.

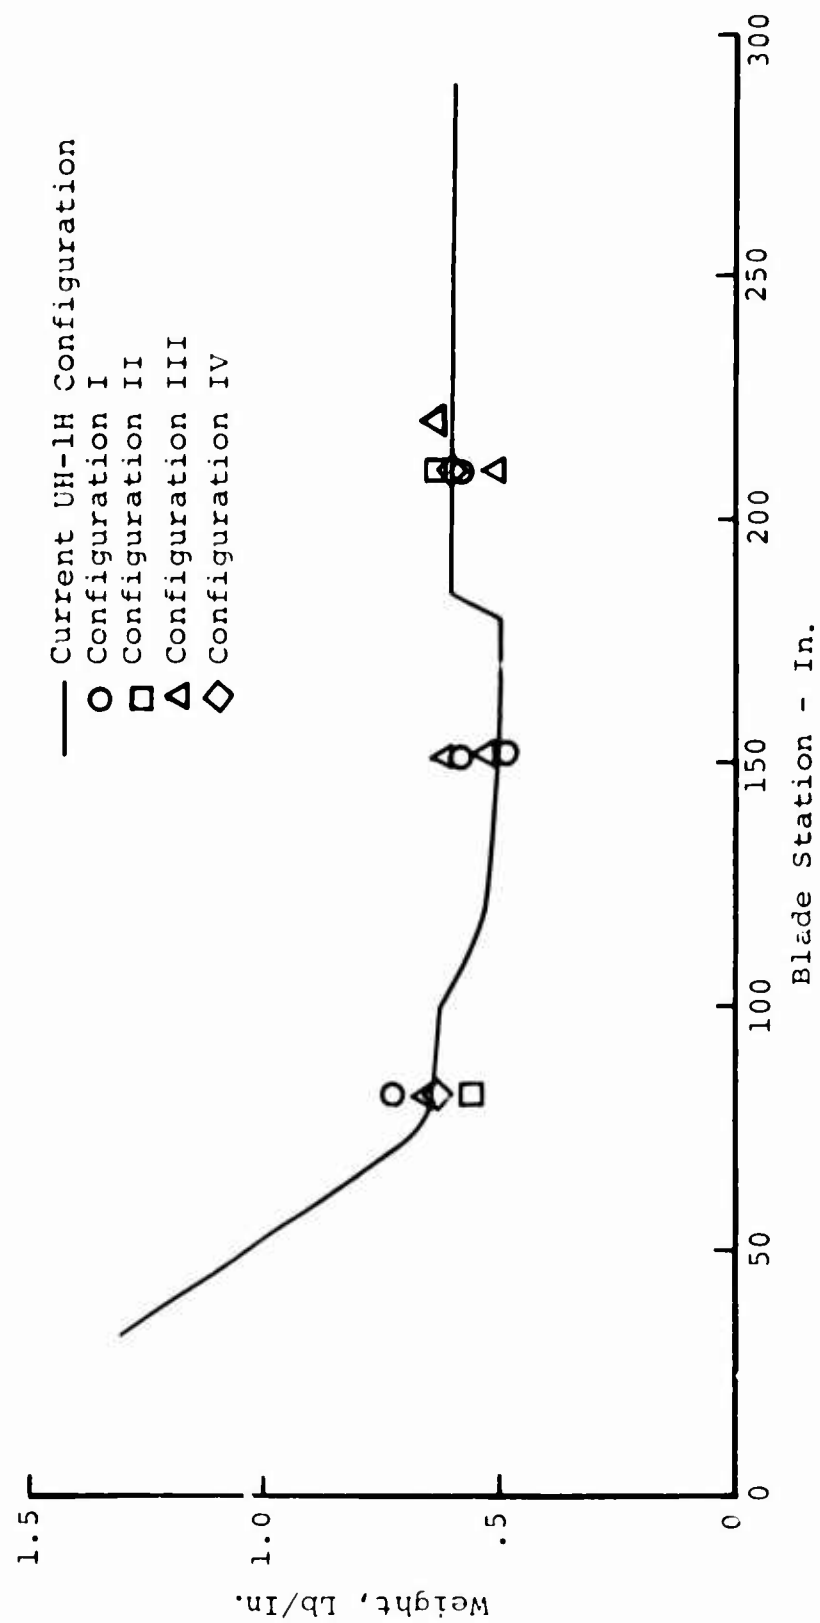
Figure 26. Blade Spanwise Weight Distribution.

Stiffness and mass properties for the above stations were calculated for Configurations I through IV by means of a computer program and compared to the current UH-1H blade. Figures 26, 27, and 28 show the results of these calculations compared to those for the current blade. In general, a fairly close agreement between the section properties developed for the four configurations and those for the UH-1H is shown.
