USAAMRDL TECHNICAL REPORT 72-12

DESIGN STUDY OF REPAIRABLE MAIN ROTOR BLADES

This report presents the results of a design study of repairable main rotor blades. The designs studied are applicable to the Army's UH-1H helicopter with semirigid teetering rotor system. The program included development of analysis methodology, including a model for rotor blade life cycle costs, establishment of design concepts, analysis of these concepts from both a technical and cost viewpoint, and selection of a final recommended configuration for future development. As partial support for the concept of field repairability of rotor blades, an experimental evaluation of a major repair was conducted under simulated field conditions. The procedure used and the results of this evaluation are included as an appendix to this report.

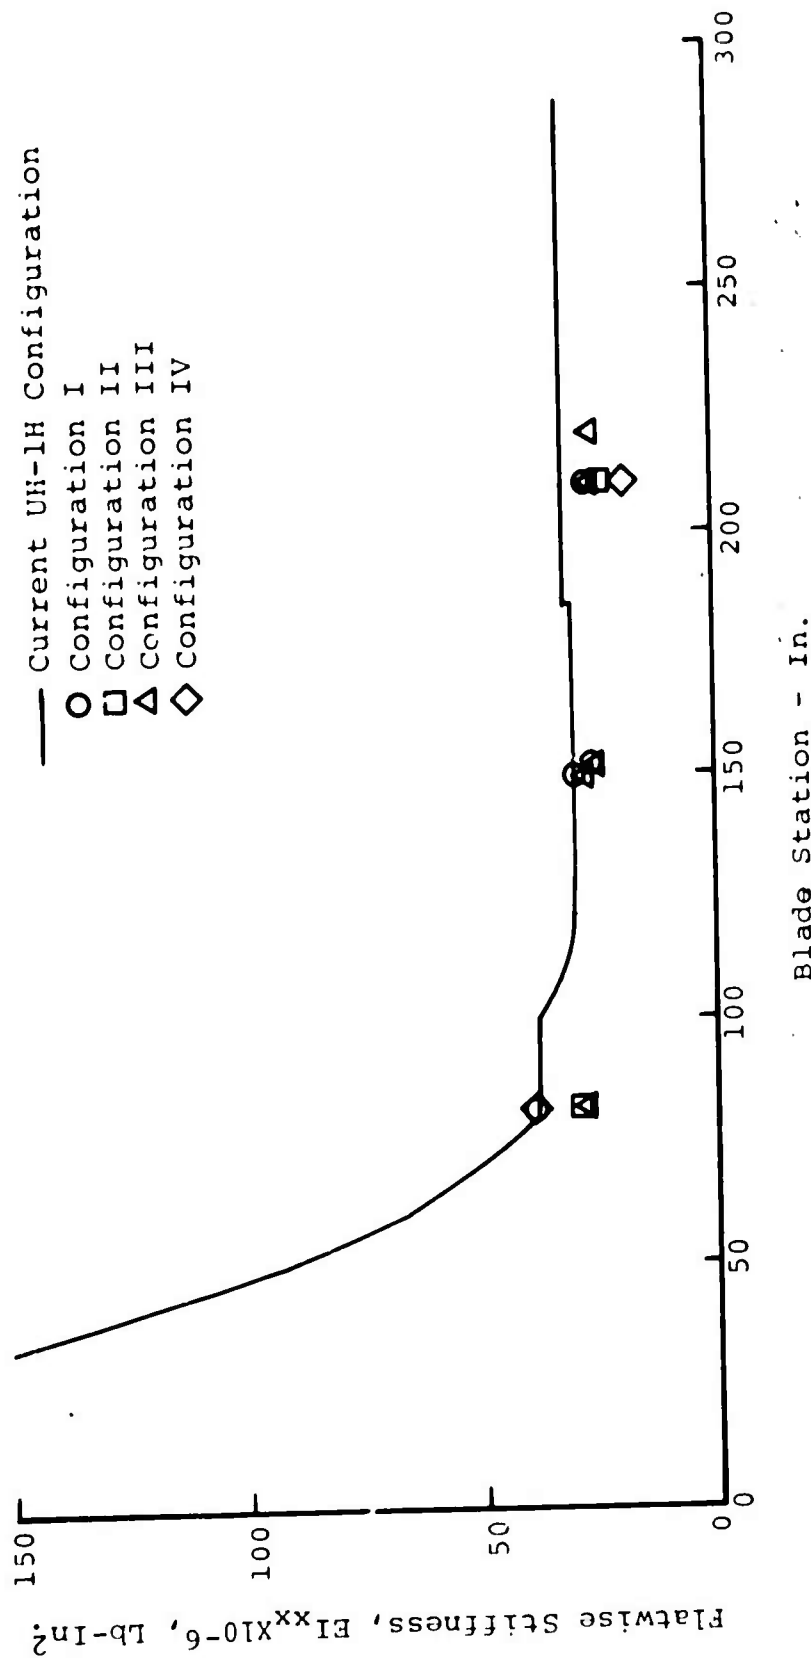
Figure 27. Flatwise Stiffness Distribution.

Stiffness and mass properties for the above stations were calculated for Configurations I through IV by means of a computer program and compared to the current UH-1H blade. Figures 26, 27, and 28 show the results of these calculations compared to those for the current blade. In general, a fairly close agreement between the section properties developed for the four configurations and those for the UH-1H is shown.

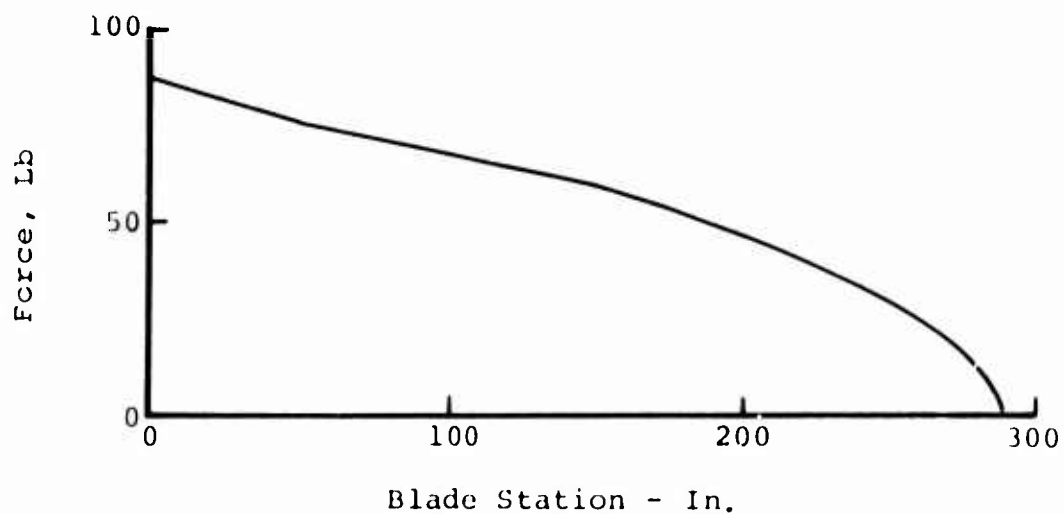
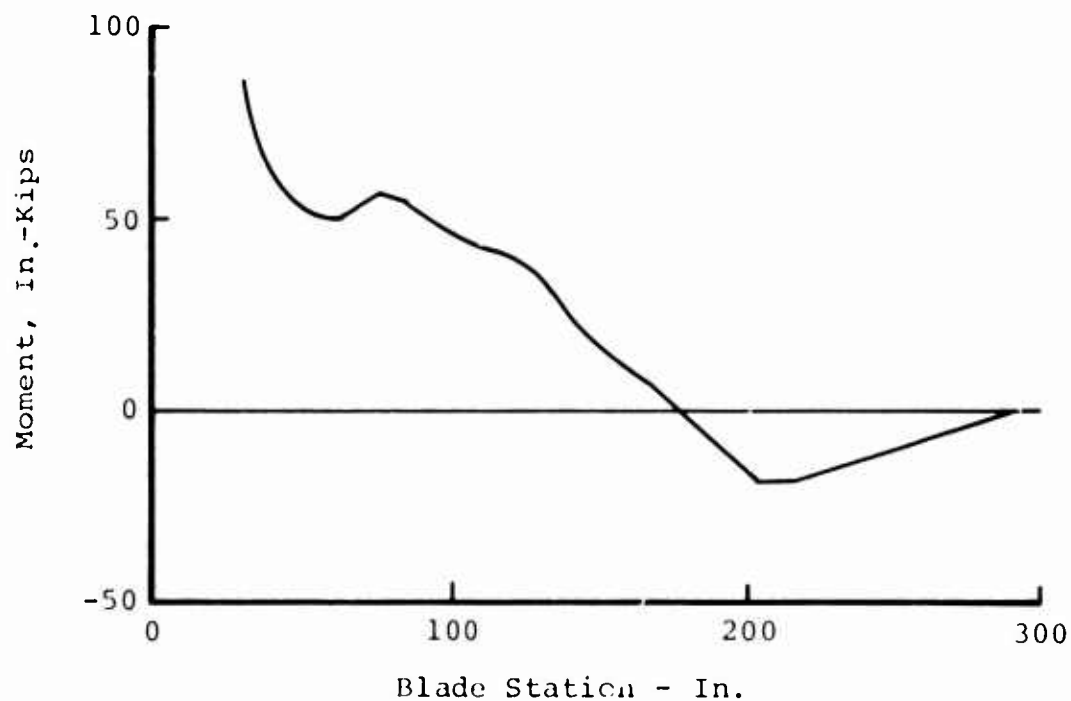
(a) Centrifugal Force at a Rotor Speed of 315 rpm for the UH-1H Blade.

(b) Steady Edgewise Moment Due to Centrifugal Force at a Rotor Speed of 315 rpm for the UH-1H Blade.

Figure 29. Rotor Blade Centrifugal Loading.

The blade loads considered in the basic stress analysis were derived for a rotor speed of 315 rpm and a forward velocity of 107 knots, a normal operating condition for the UH-1H helicopter. Steady and vibratory flatwise (out-of-plane) moments and edgewise (in-plane) moments were calculated for this flight condition as previously described. The axial loads due to centrifugal force and the steady edgewise bending moments due to centrifugal force were calculated for each of the significant stations considered. A typical result of these calculations is shown in Figure 29 for the current UH-1H rotor blade.

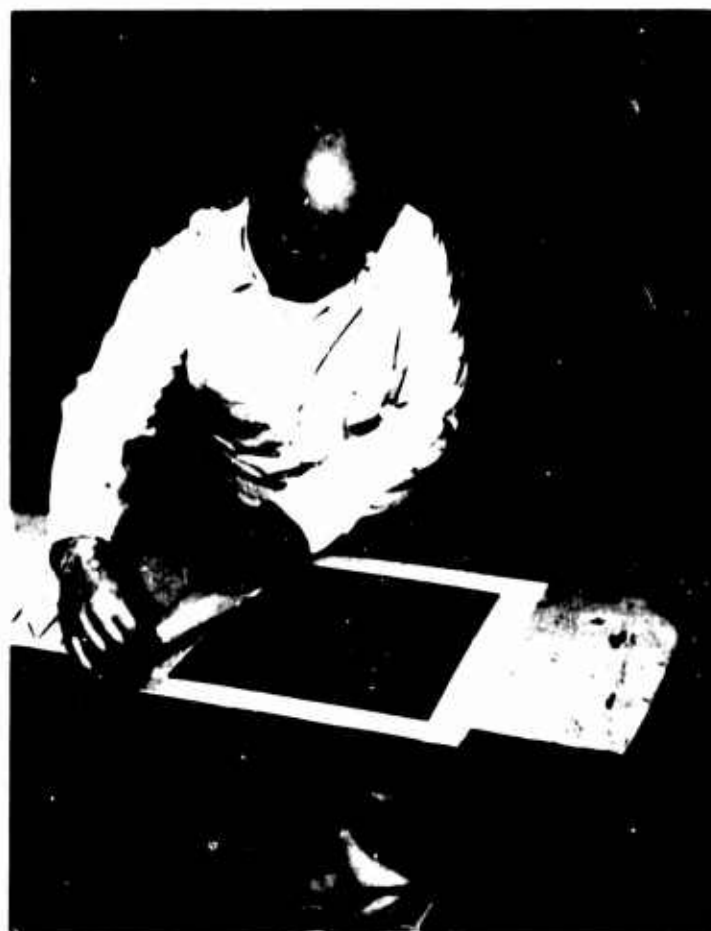
1. Position template to encompass complete damage area.
2. Use knife to sever skins and cut through core, top and bottom. Remove plug and even edges with hacksaw blade.
3. After cutting the hole to proper size, solvent wipe around periphery with MEK to remove all paint from surfaces to be bonded.
4. Mask off area approximately 1/8 inch beyond perimeter of patch, both surfaces (Figure 30).

Figure 30. Masking Blade Repair Area.

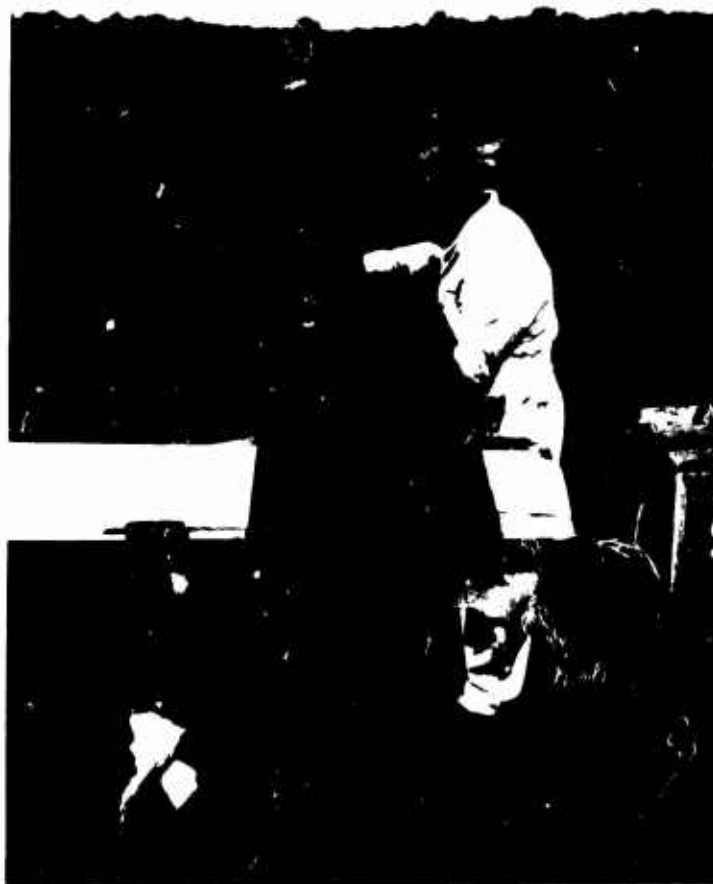
19. Position the heating blanket and tape in place with green Mylar tape.
20. Wrap inflatable bladder around the blade repair area, starting at the trailing edge. Apply the ⁴ straps and inflate to 10-15 psi (Figures 36 and 37).

Figure 36. Positioning Bladder.
