TECHNICAL REPORT NO. 74-14

SCRATCH RESISTANT PLASTIC WINDOWS  
FOR M151 TRUCK

U. S. ARMY LAND WARFARE LABORATORY  
Aberdeen Proving Ground, Maryland 21005

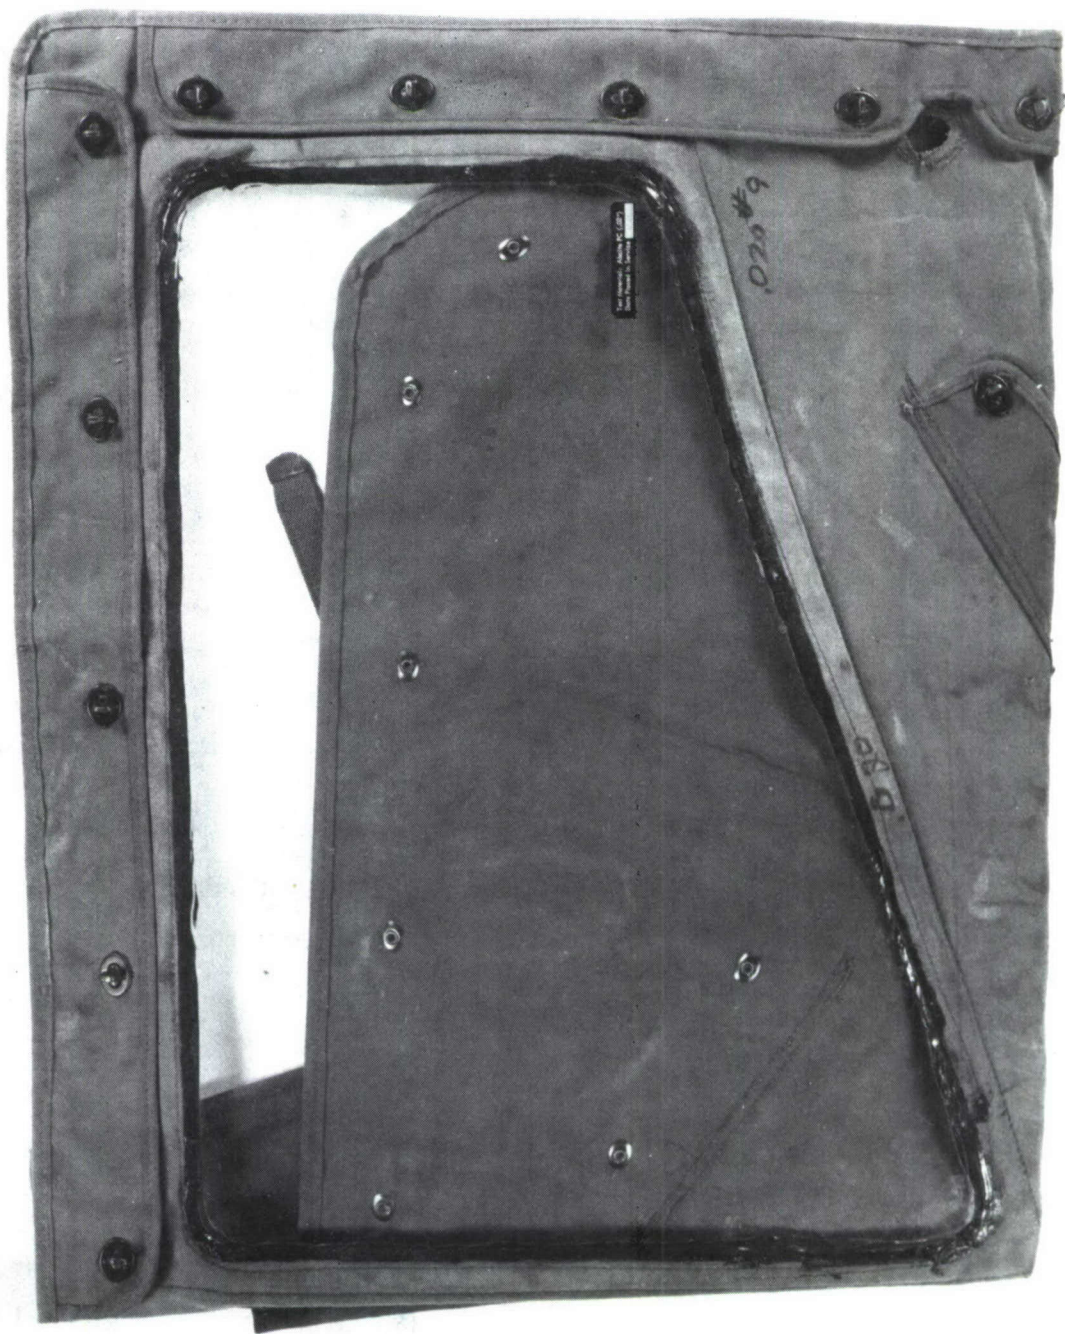
Figure 1. Scratch Resistant Window Material Installed in M151 Door Curtain

The coated plastic window materials are shown installed in Figures 1, 2, and 3. The acrylic windows are rigid and cannot be folded. However, the canvas portions of the various soft-top panels may be folded to reduce the dimensions sufficiently for stowage, as shown in Figure 1. Both the 0.02 and 0.04-inch thick polycarbonate windows may be folded or rolled as shown in Figures 2 and 3.

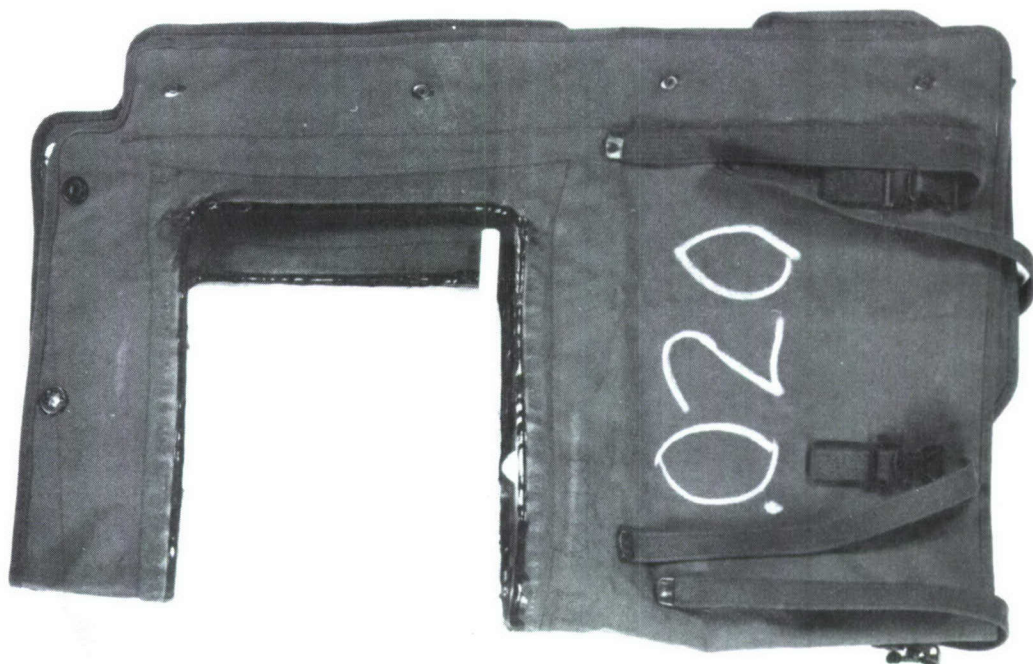
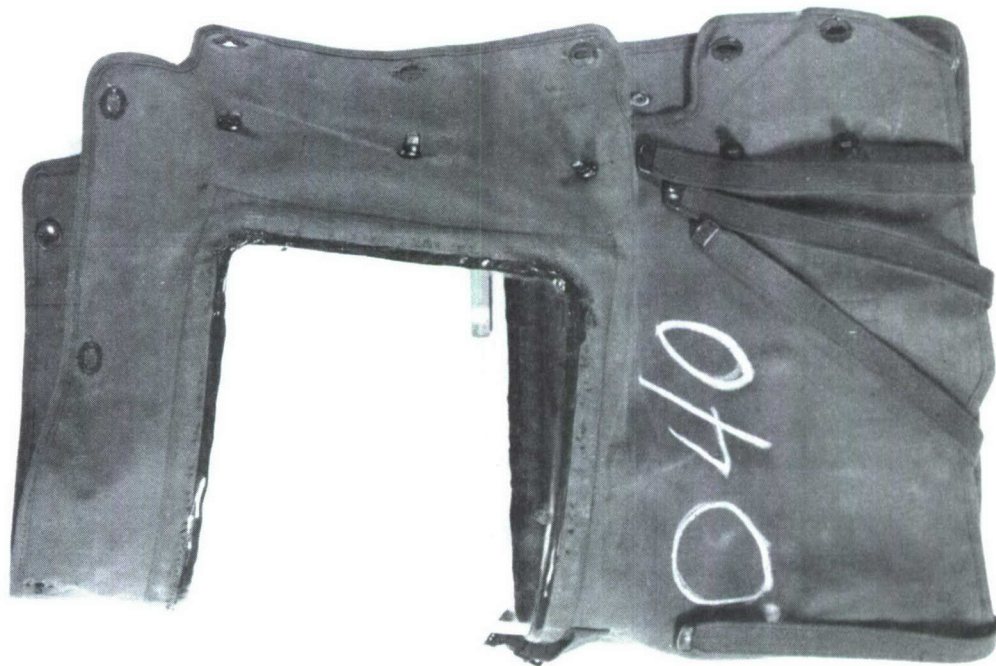
Figure 2. Scratch Resistant Polycarbonate Windows Installed in M151 Side Curtains

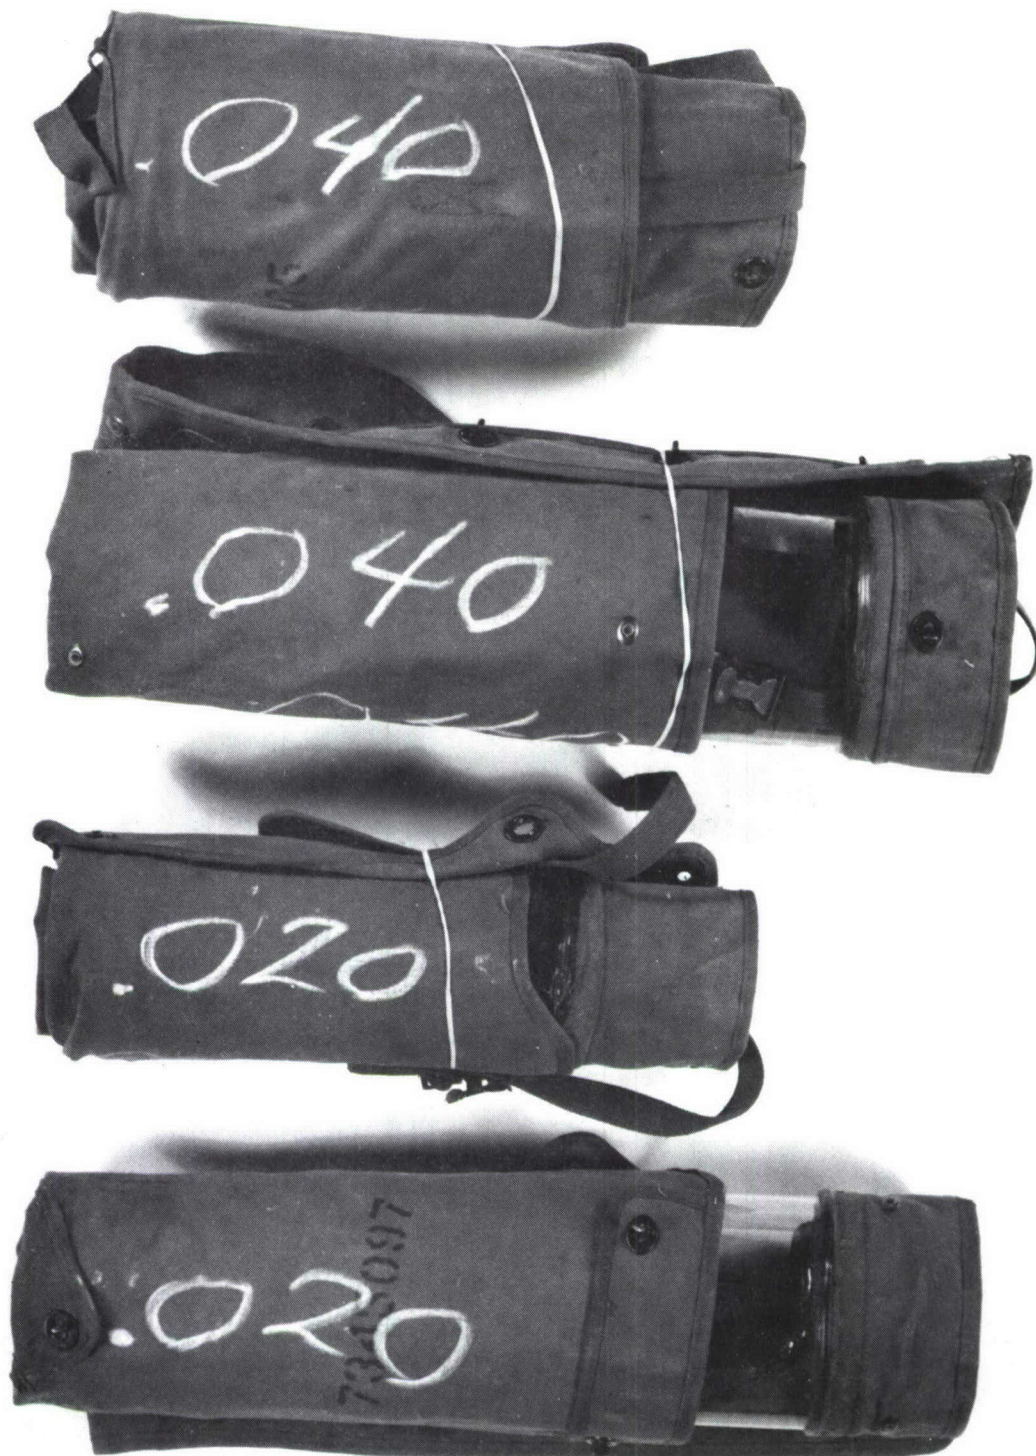
Figure 3. Scratch Resistant Polycarbonate Windows Installed in M151 Curtains
