REPORT NO. CG-ECV-1-77

# MARINE BORERS

CIVIL ENGINEERING DIVISION  
OFFICE OF ENGINEERING

FINAL REPORT

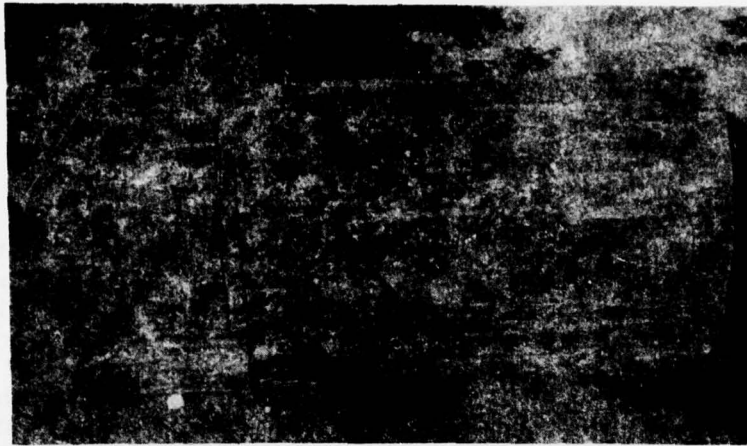
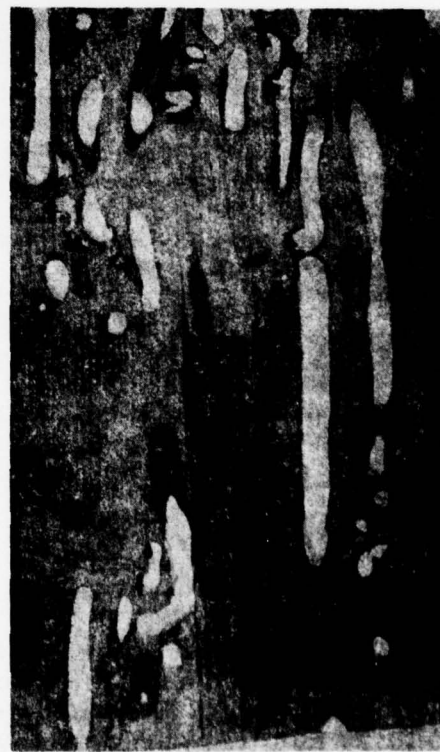
Figure 2

Creosote Treated Pile Section with no visible damage.

Cross-section of Above Pile showing heavy Teredine damage and loss of cross-section.

Longitudinal Section of Same Pile showing the eccentricity of the voids and extensive loss of cross-section.

The most destructive borers and also the most difficult to detect are in the Mollusca Subfamily. Results of their actions are shown in Figure 2. The *Teredo* (Mollusca Subfamily) can destroy an unprotected pile in less than a year, whereas *Limnoria* (Crustacea Subfamily) may take up to 8 years. The area of attack of the marine borer generally extends from the mud line to the high water line, as shown in Figure 6. In the past it was thought that *Limnoria* showed the greatest attack at the mean tide and *Teredo* at the mud line. However, experiments have shown that this is not necessarily the case. In some localities *Teredo* or *Limnoria* may show a particular area of concentration relative to the mean tide line of the pile, yet the point of attack on a pile in another locality may be different.

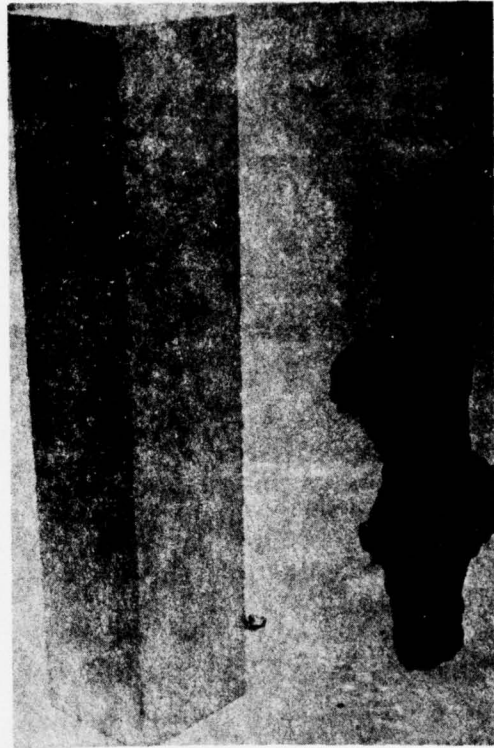
Figure 5

Surface Borer *Limnoria lignorum*  
approximately 2-3 mm in length.

Test material before and after  
Limnoria attack.

Pile in foreground with classic *Limnoria* 'hourglassing',  
two other piles completely destroyed.

2. Crustacean Borers - There are three important Crustacean borers: *Limnoria*, *Sphaeroma* and *Chelura*. *Limnoria*, the most widely distributed of the genera, is illustrated in Figure 5. The *Limnoria* are surface gougers which resemble small lobsters or wood lice about  $1/8$  inch (3.2 mm) in length and a width of about  $1/3$  the length. The mouth of the *Limnoria* contains a pair of strong, horney-tipped mandibles with which the boring is done. Its body has numerous pairs of legs ending in sharp, hooked claws so that it can move freely and cling to timber. It uses its gill plates for swimming. *Limnoria* destroy timber by producing a lacy network of tunnels at the wood surface, seldom penetrating more than a  $1/4$  of an inch (6.4 mm). As these lacy networks of tunnels are eroded away by wave action the animal penetrates deeper into the wood. As many as 400 borers per square inch (645 sq. mm) have been counted on timber under heavy attack. The points of greatest concentration are found near the mud line and mean tide level (See Figure 6) but they may be either distributed uniformly or concentrated anywhere between these limits.

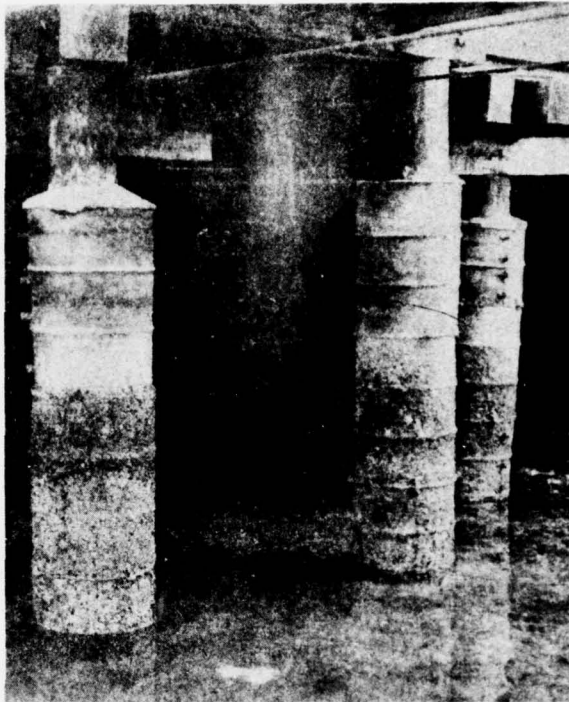
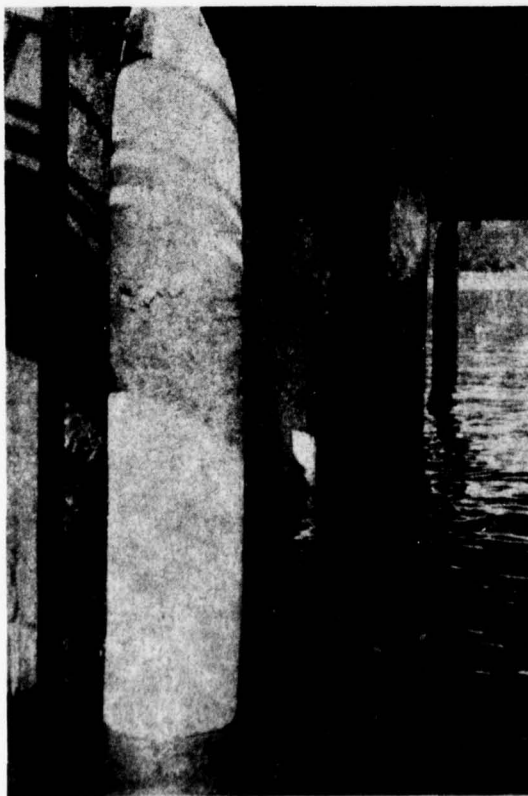
Figure 13

Fabric "sock" or bag installed as a mold around length of damaged pile, reinforcing steel placed and bag pumped full of concrete. Works well on steel H-beam, pipe and pre-stressed concrete pilings as well as on wood.

is installed as a mold around the length of a damaged pile, reinforcing mesh or rods are placed around the pile inside the sock and the sock is pumped full of concrete. (See Figure 13). This process has been used successfully even on piling which are subjected to considerable lateral bending.
