UNDERWRITERS' LABS INC NORTHBROOK ILL
FIRE TESTS OF POLYURETHANE FOAM ROOF DECK CONSTRUCTION ON STEEL--ETC(U)
DEC 78 K RHODES

REPORT DOCUMENTATION PAGE		READ INSTRUCTIONS BEFORE COMPLETING FORM
1. REPORT NUMBER CR-79.004	2. GOVT ACCESSION NO.	3. RECIPIENT'S CATALOG NUMBER
4. TITLE (and Subtitle) FIRE TESTS OF POLYURETHANE FOAM ROOF DECK CONSTRUCTION ON STEEL DECKS		5. TYPE OF REPORT & PERIOD COVERED Final Rept. December 1978

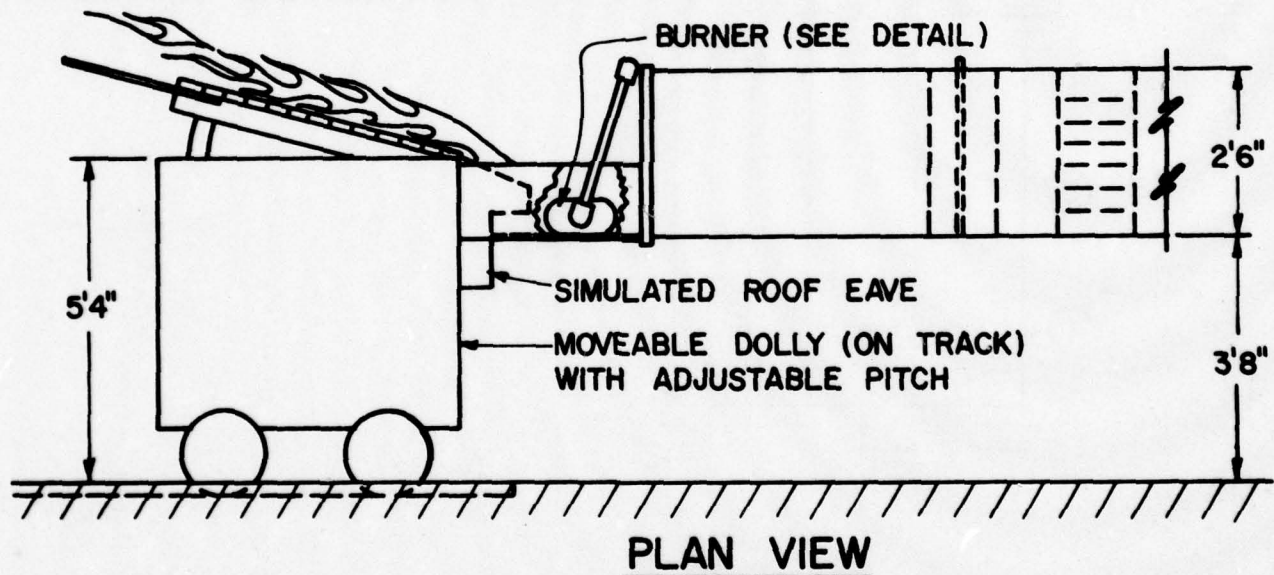
ILL. 1
USNC77

ROOFING TEST APPARATUS - SCHEMATIC

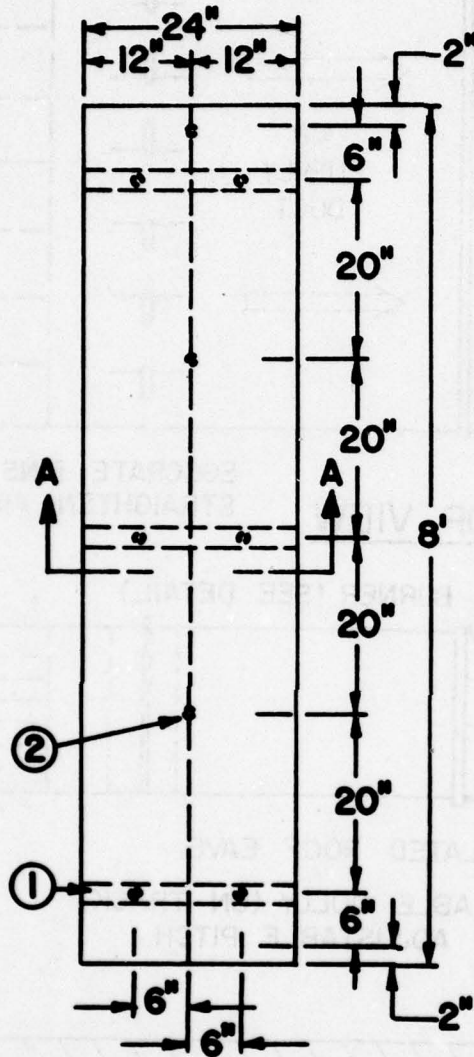
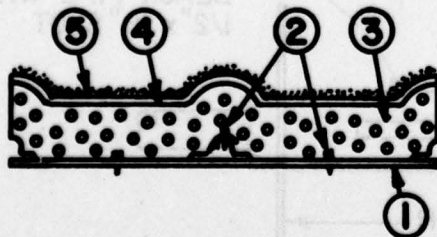
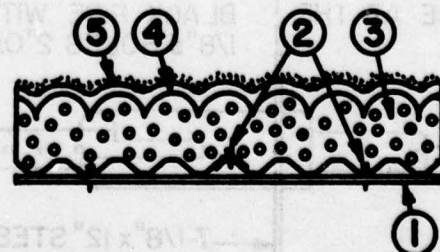
ILL. 2
USNC77

TUNNEL TEST SAMPLES

- ①—2-1/2" WIDE, 14 GA. STL. BAR
- ②—NO. 1/4-14x1-1/4" TEKS/3
- ③—3" SPRAY-APPLIED FOAM
- ④—FLUID-APPLIED COATING
- ⑤—NO. 11 ROOFING GRANULES

SECTION A-A
(RIB PANELS)

SECTION A-A
(9/16" CORRUGATED DECK)

The spray applied foamed plastic and coating built-up roof covering systems were applied to nominal 2 by 8 ft sections of 26 gauge galvanized steel deck (raised rib and corrugated) with a longitudinal centerline seam. The joint detail, support and fastener schedule are shown by ILL. 2. A chlorinated rubber primer was used to provide a recommended bond coat for the foamed plastic material to the steel deck.

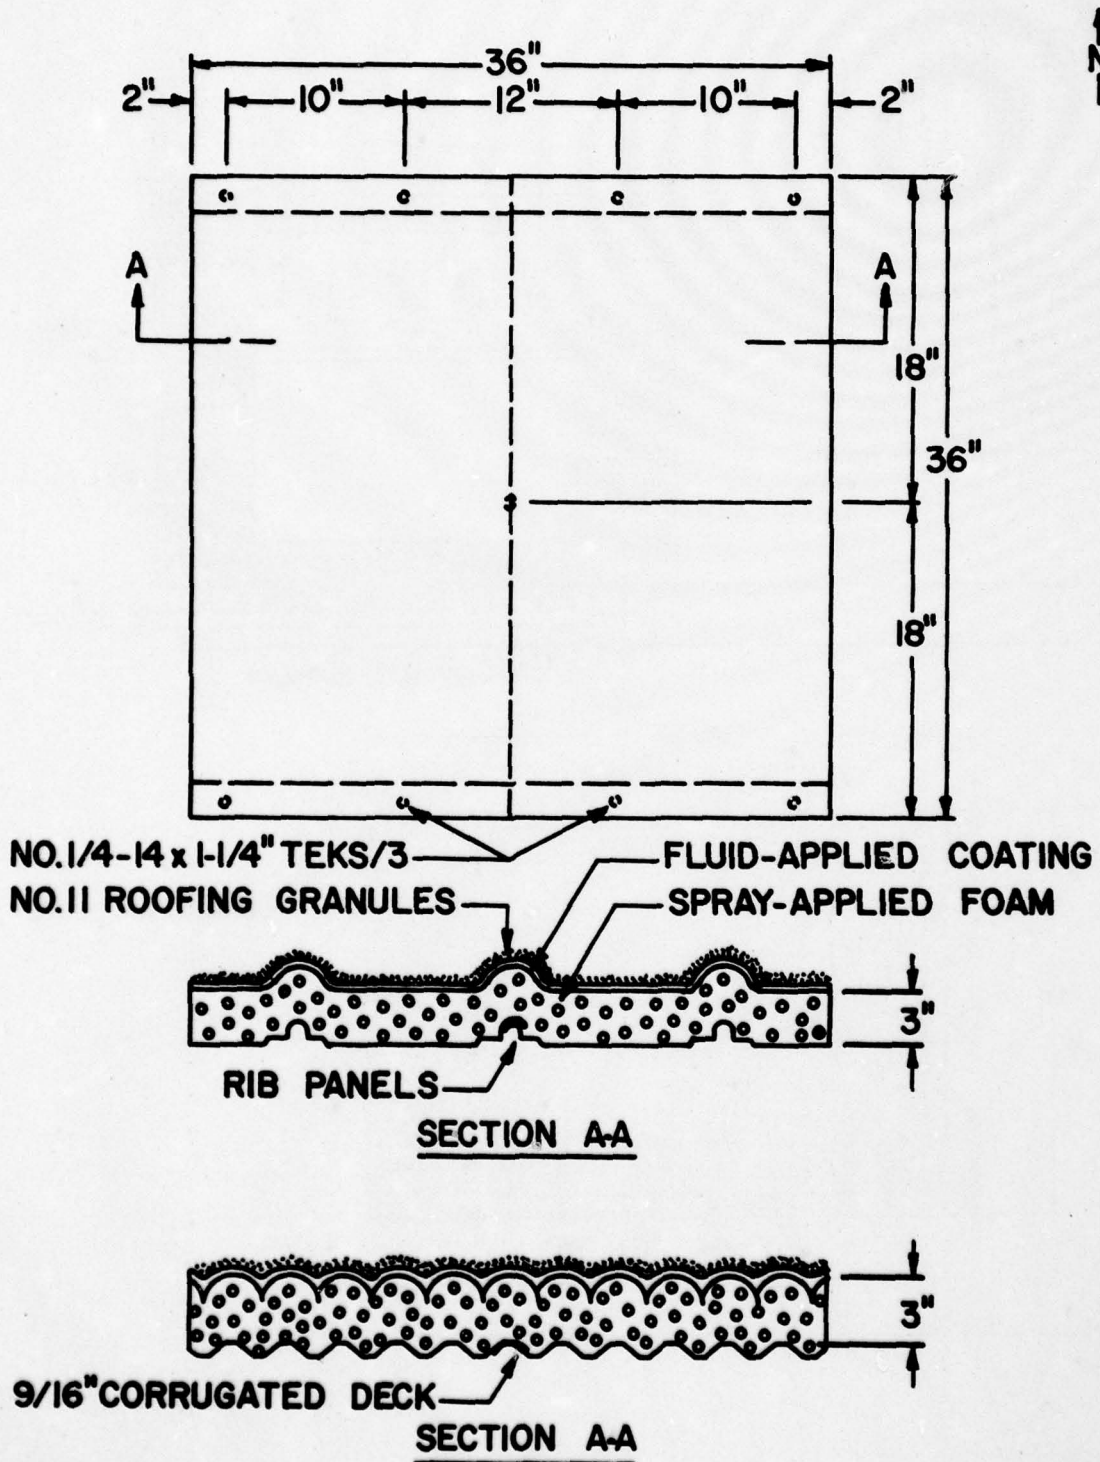
SMALL SCALE FIRE TEST SAMPLES

The built-up roof covering systems were applied to nominal 3 by 3 ft sections of steel deck with a longitudinal centerline seam. The joint detail, support and fastener schedule are shown by ILL. 5. A chlorinated rubber primer was used to provide a recommended bond coat for the foamed plastic material to the steel deck.

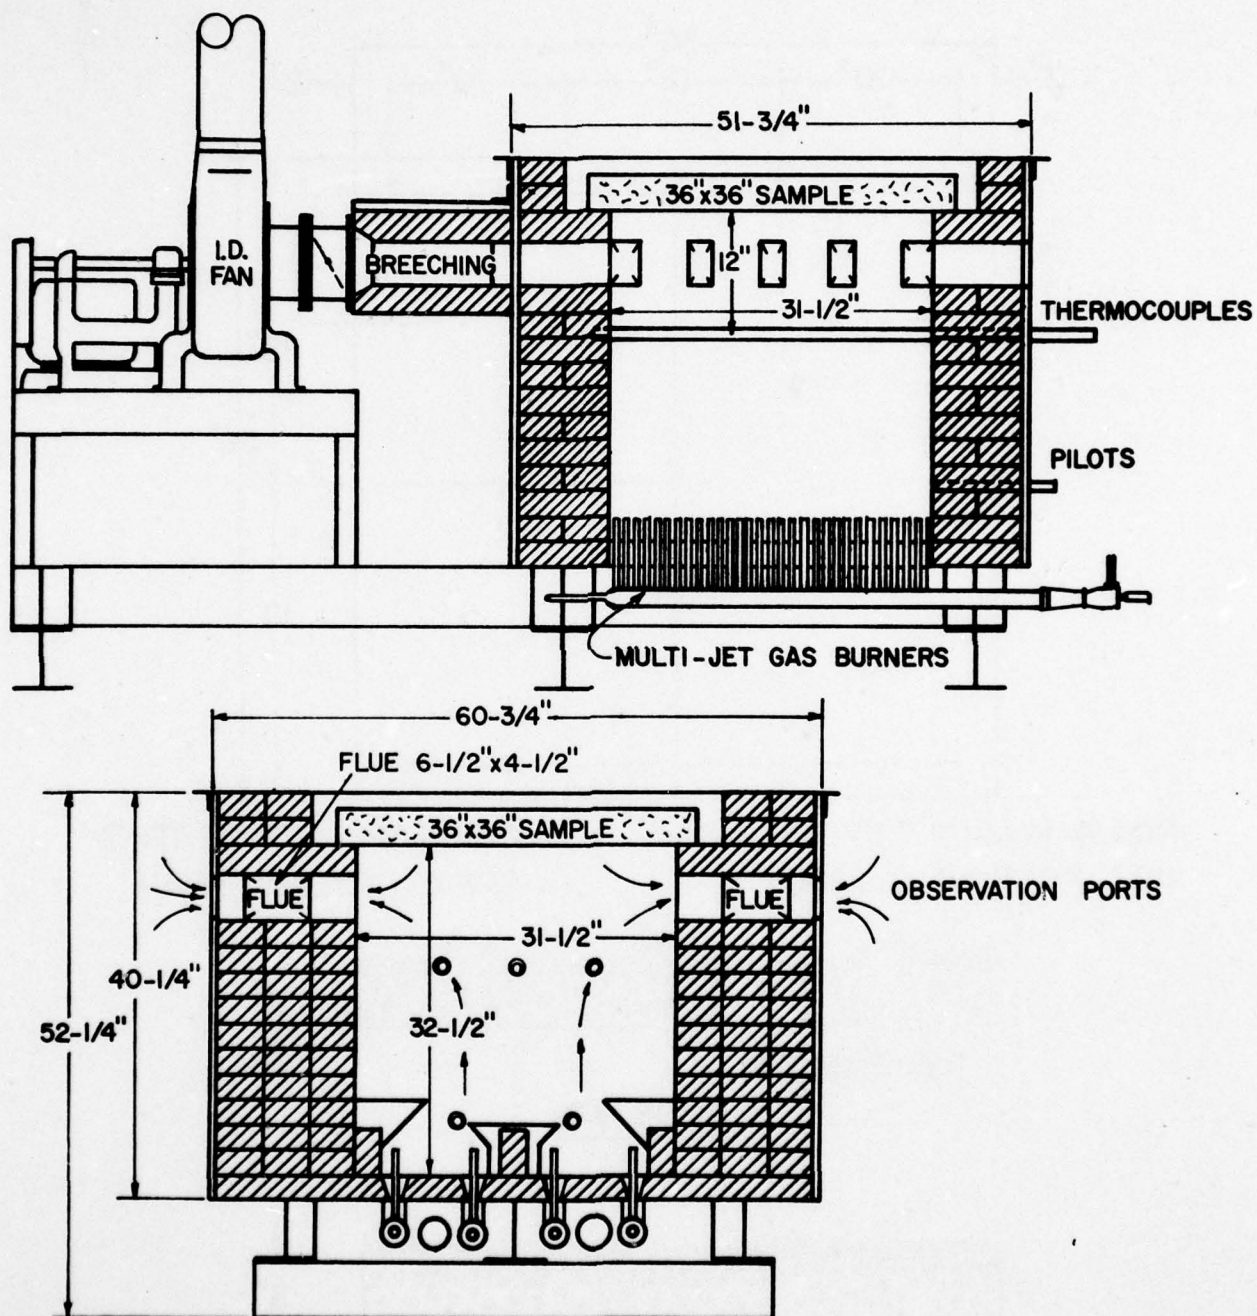
ILL. 6
USNC77

SMALL SCALE HORIZONTAL EXPOSURE FURNACE

The small-scale furnace shown by ILL. 6 is intended to provide fire exposure conditions similar to those of UL 263, "Fire Tests Of Building Construction and Materials," but on smaller samples than are required by UL263. The small-scale furnace fire allows the same time-temperature curve specified by UL 263 as shown on ILL. 16. It is fired with a natural gas diffusion flame.

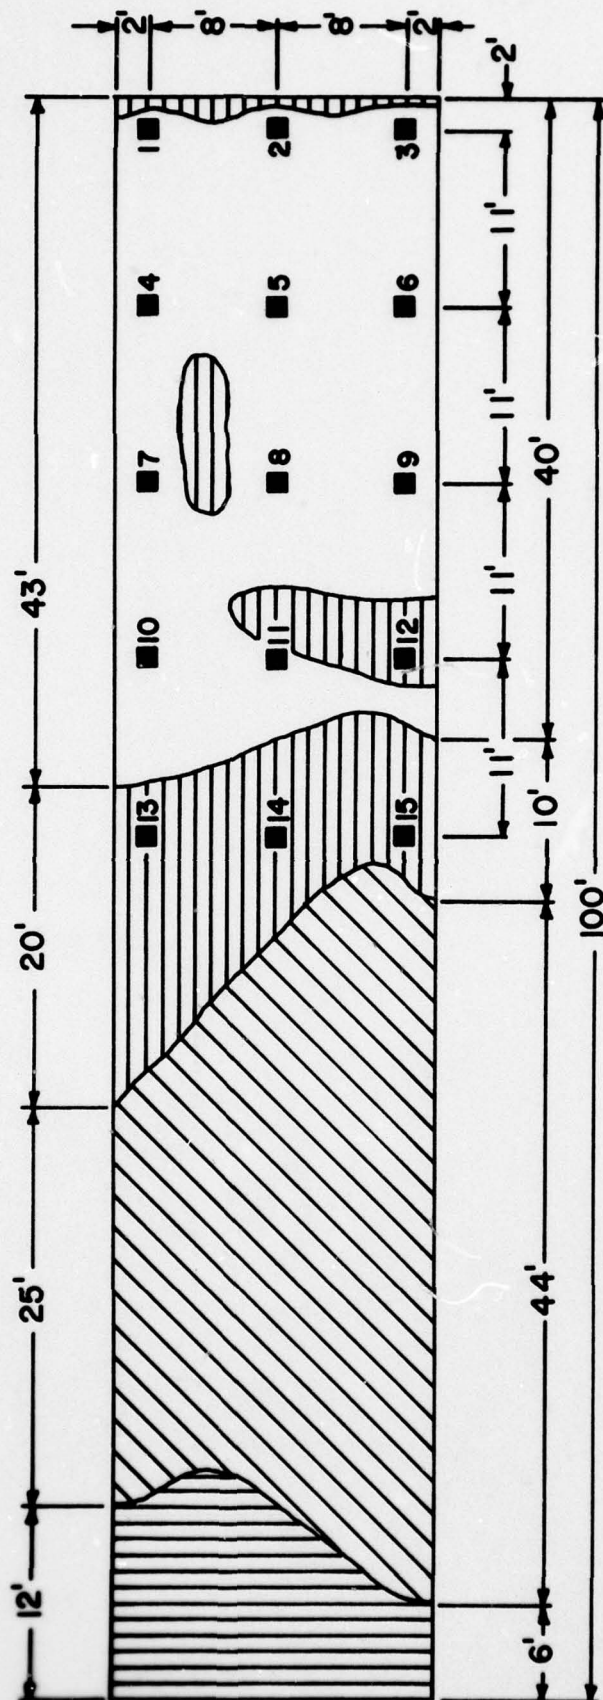
WIND DIRECTION
FROM NORTHWEST
DURING TEST

OBSERVATIONS AFTER TEST

■ CROSS SECTION CUT LOCATION

EXTERIOR
