COAST GUARD WASHINGTON DC
MARINE CASUALTY REPORT. OCEAN EXPRESS (DRILLING UNIT); CAPSIZIN--ETC(U)
JUN 78

1. Report No. USCG-16732/61865	2. Government Accession No.	3. Recipient's Catalog No. <i>11</i>
4. Title and Subject: Marine Board Casualty Report, OCEAN EXPRESS (Drilling Unit); Capsizing and Sinking in the Gulf of Mexico on 15 April 1976 with loss of life

13. Type of Report and Period Covered MARINE CASUALTY REPORT 15 April 1976		
14. Sponsoring Agency Code		
15. Supplementary Notes <i>S</i>		
16. Abstract: On 15 April 1976, the self-elevating drilling unit OCEAN EXPRESS, capsized and sank while it was being towed by three tugs from one drilling site to another in the Gulf of Mexico. The crew, except for the barge mover, abandoned the rig in two survival capsules. The barge mover was evacuated by a Coast Guard helicopter just seconds before the OCEAN EXPRESS capsized. All of the crew members in one of the capsules safely transferred to an attending vessel. The other capsule capsized in the vicinity of one of the tugs due to wave action and shifting weight. Seven men escaped from the overturned capsule and safely boarded the tugs, however, thirteen other persons were trapped

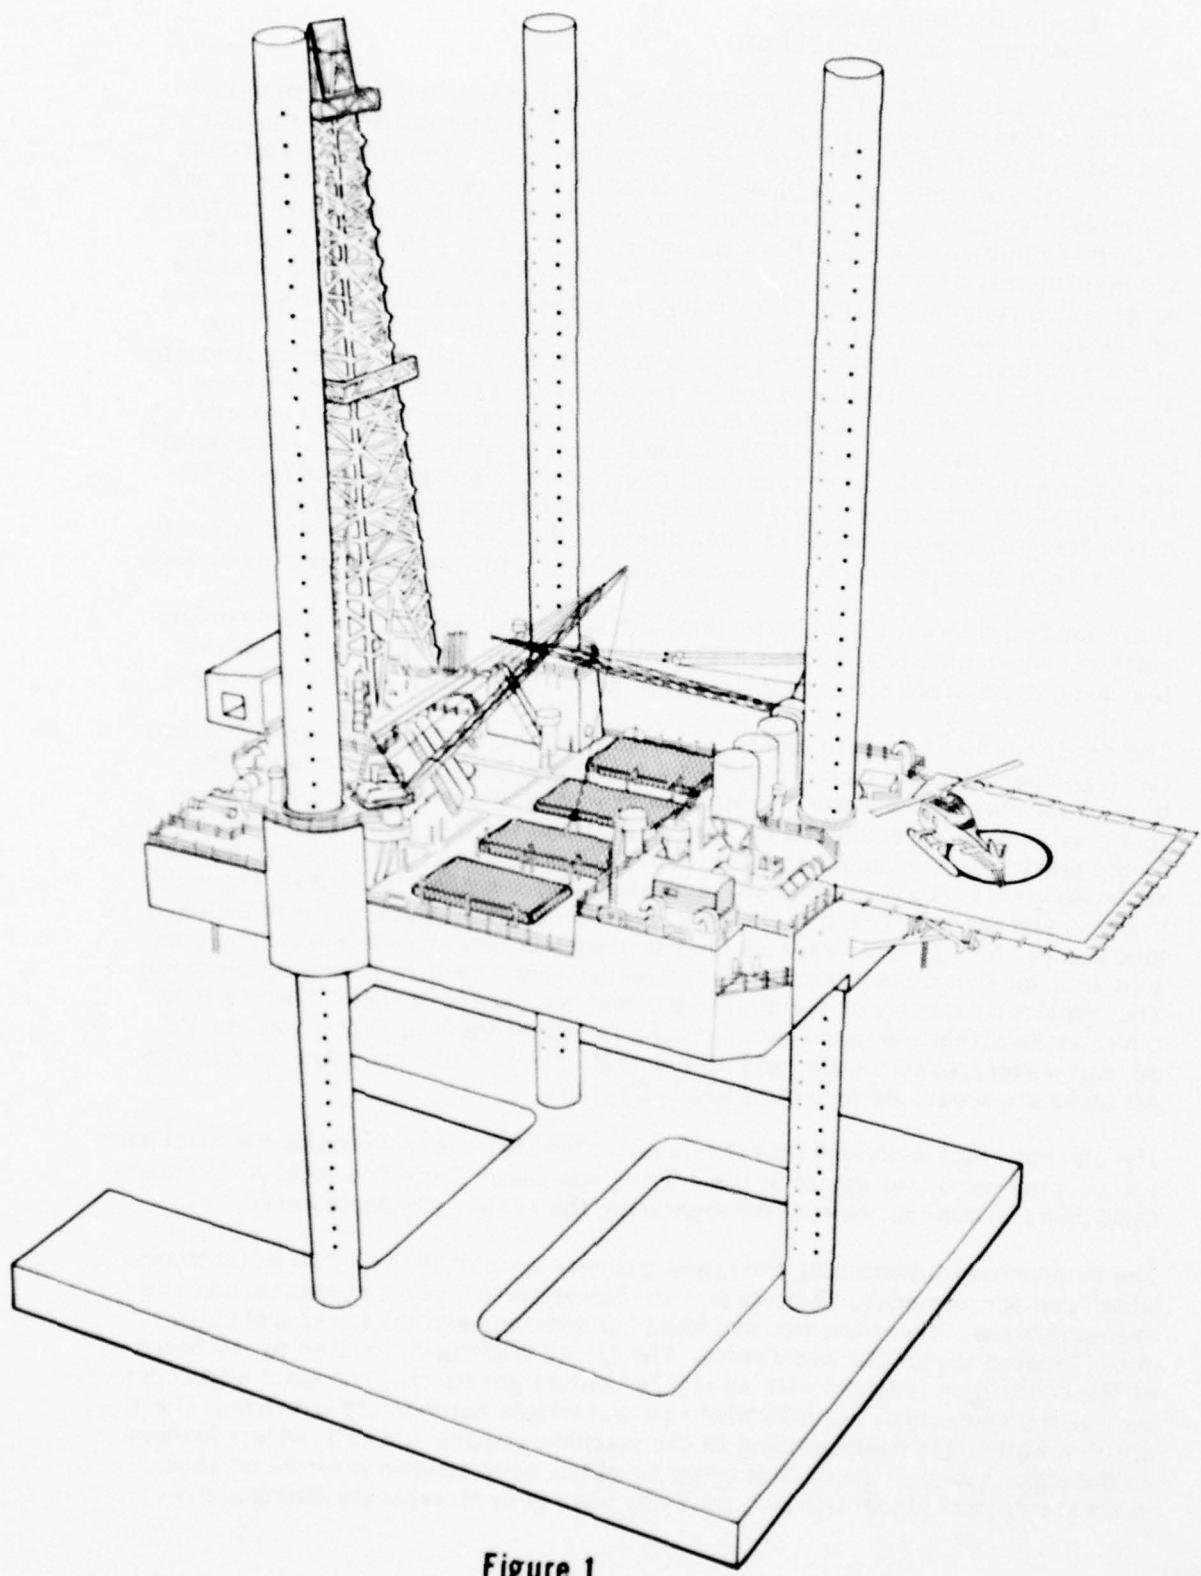
Figure 1

- a. Name: OCEAN EXPRESS (See Figure 1)
 - Official number: 569885
 - Material: Welded steel
 - Service: Self-elevating mobile drilling unit
 - Barge platform: Length: 166 feet
 - Breadth: 109 feet
 - Depth: 16 feet
 - Bottom mat: Length: 210 feet
 - Breadth: 170 feet
 - Depth: 12 feet
 - Classed: ABS (*AI)
 - Year built: 1975
 - Where built: Beaumont, Texas
 - Owner: Odeco Drilling, Inc.
 - Canal Street
 - New Orleans, La.
