**ADVANCED STRUCTURES MAINTENANCE CONCEPTS**

Thomas N. Cook, Michael G. Adami,  
Rocco R. DiGenova, David P. Maass  
Sikorsky Aircraft Division  
United Technologies Corporation  
Stratford, Connecticut 06602

June 1980

This report has been reviewed and the R&M design options and recommendations are considered to be reasonable and acceptable approaches to providing a high degree of R&M for the proposed advanced composite rear fuselage for the UH-60A Black Hawk helicopter.

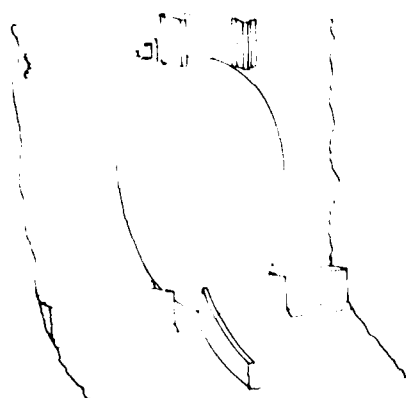
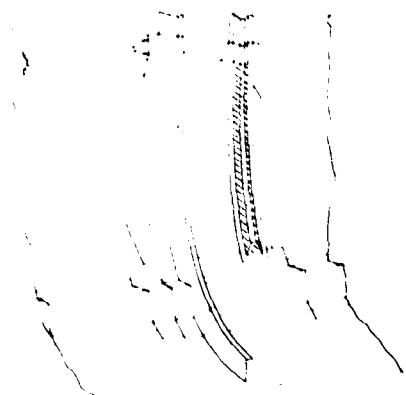
**Step 1. Damage cut away and trimmed.**

**Step 2. Fiberglass skin patch applied (scarfed and tapered lap joints).**

**Step 3. Longer section restored with foam. Longer repaired with fiberglass and graphite tape.**

**Step 4. Frame section restored with foam. Frame repaired with fiberglass and graphite tape.**

**Step 5. Stiffener section restored with foam. Stiffener repaired with fiberglass patch.**

**Completed repair.**

**Figure 43. Custom-Engineered Repair of Large Area Damage to the Composite Rear Fuselage at Sta. 464 (Left Side, View Looking Outboard)**

Figure 43 shows the assumed 12-inch-diameter damage in the identical area of the composite rear fuselage. Sections of the Station 464 frame, a stringer and a longeron are lost. The custom-designed repair is shown in Figure 43. In the first step of the repair, the damaged structure is cut away and trimmed. A backing plate is fabricated and installed and a fiberglass skin patch is prepared, laid up over the hole in the structure and cured. Next, dams are erected around the missing section of the longeron, and foam is sprayed into the section and allowed to cure. The

cured foam is then cut to the shape of the longeron and patch material is prepared, laid up over the foam mandrel and allowed to cure. The frame and stiffener are repaired next using wet patches laid up over fabricated foam mandrels in the same manner that the longeron was repaired. A thorough nondestructive type of inspection is made at each stage of the repair.
