NATIONAL DAM SAFETY PROGRAM. BRAY LAKE DAM (MO 30098); OSAGE - --ETC(U)

**BRAY LAKE DAM
PHELPS COUNTY, MISSOURI
MO 30098**

PHASE 1 INSPECTION REPORT NATIONAL DAM SAFETY PROGRAM

DECEMBER 1979

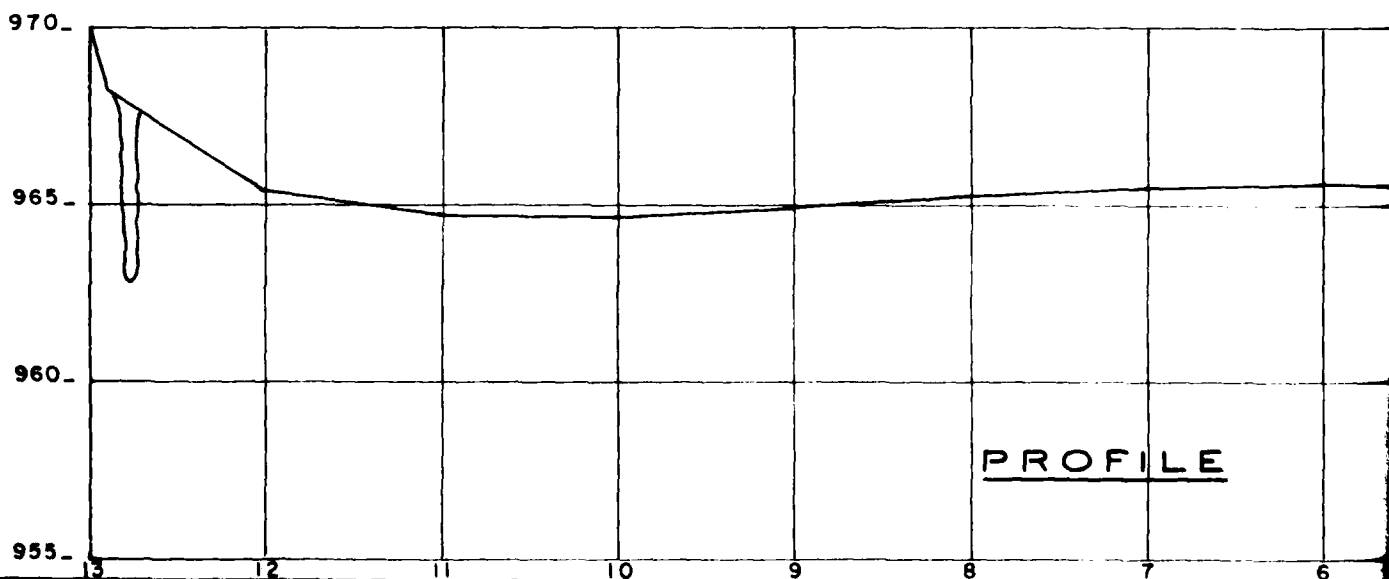
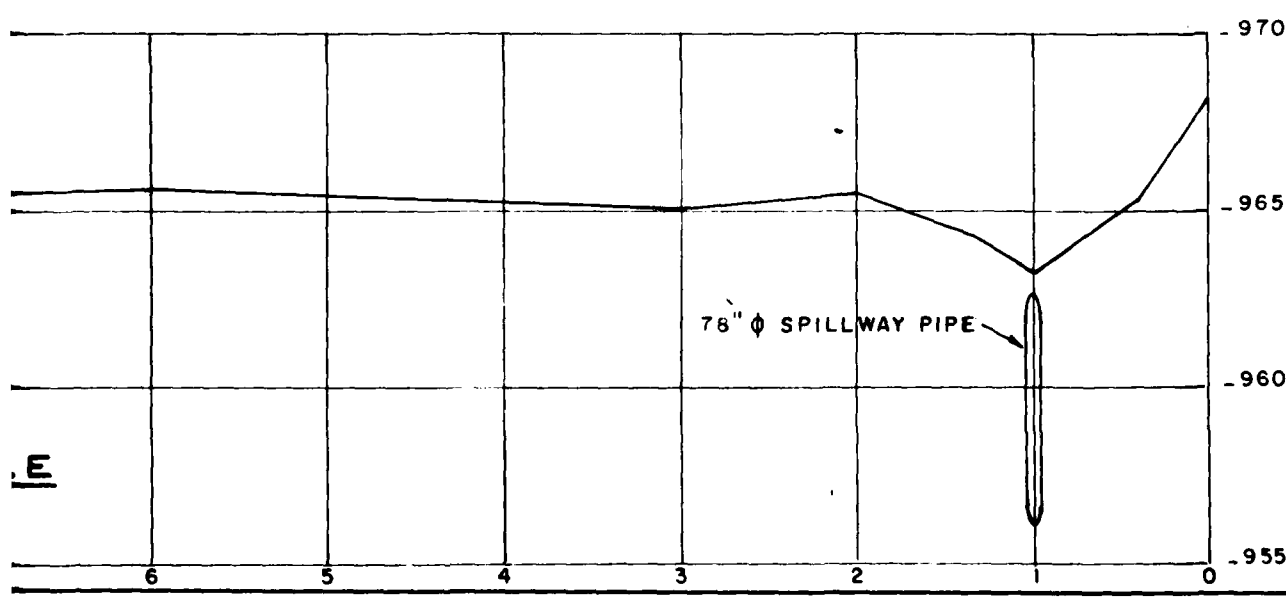
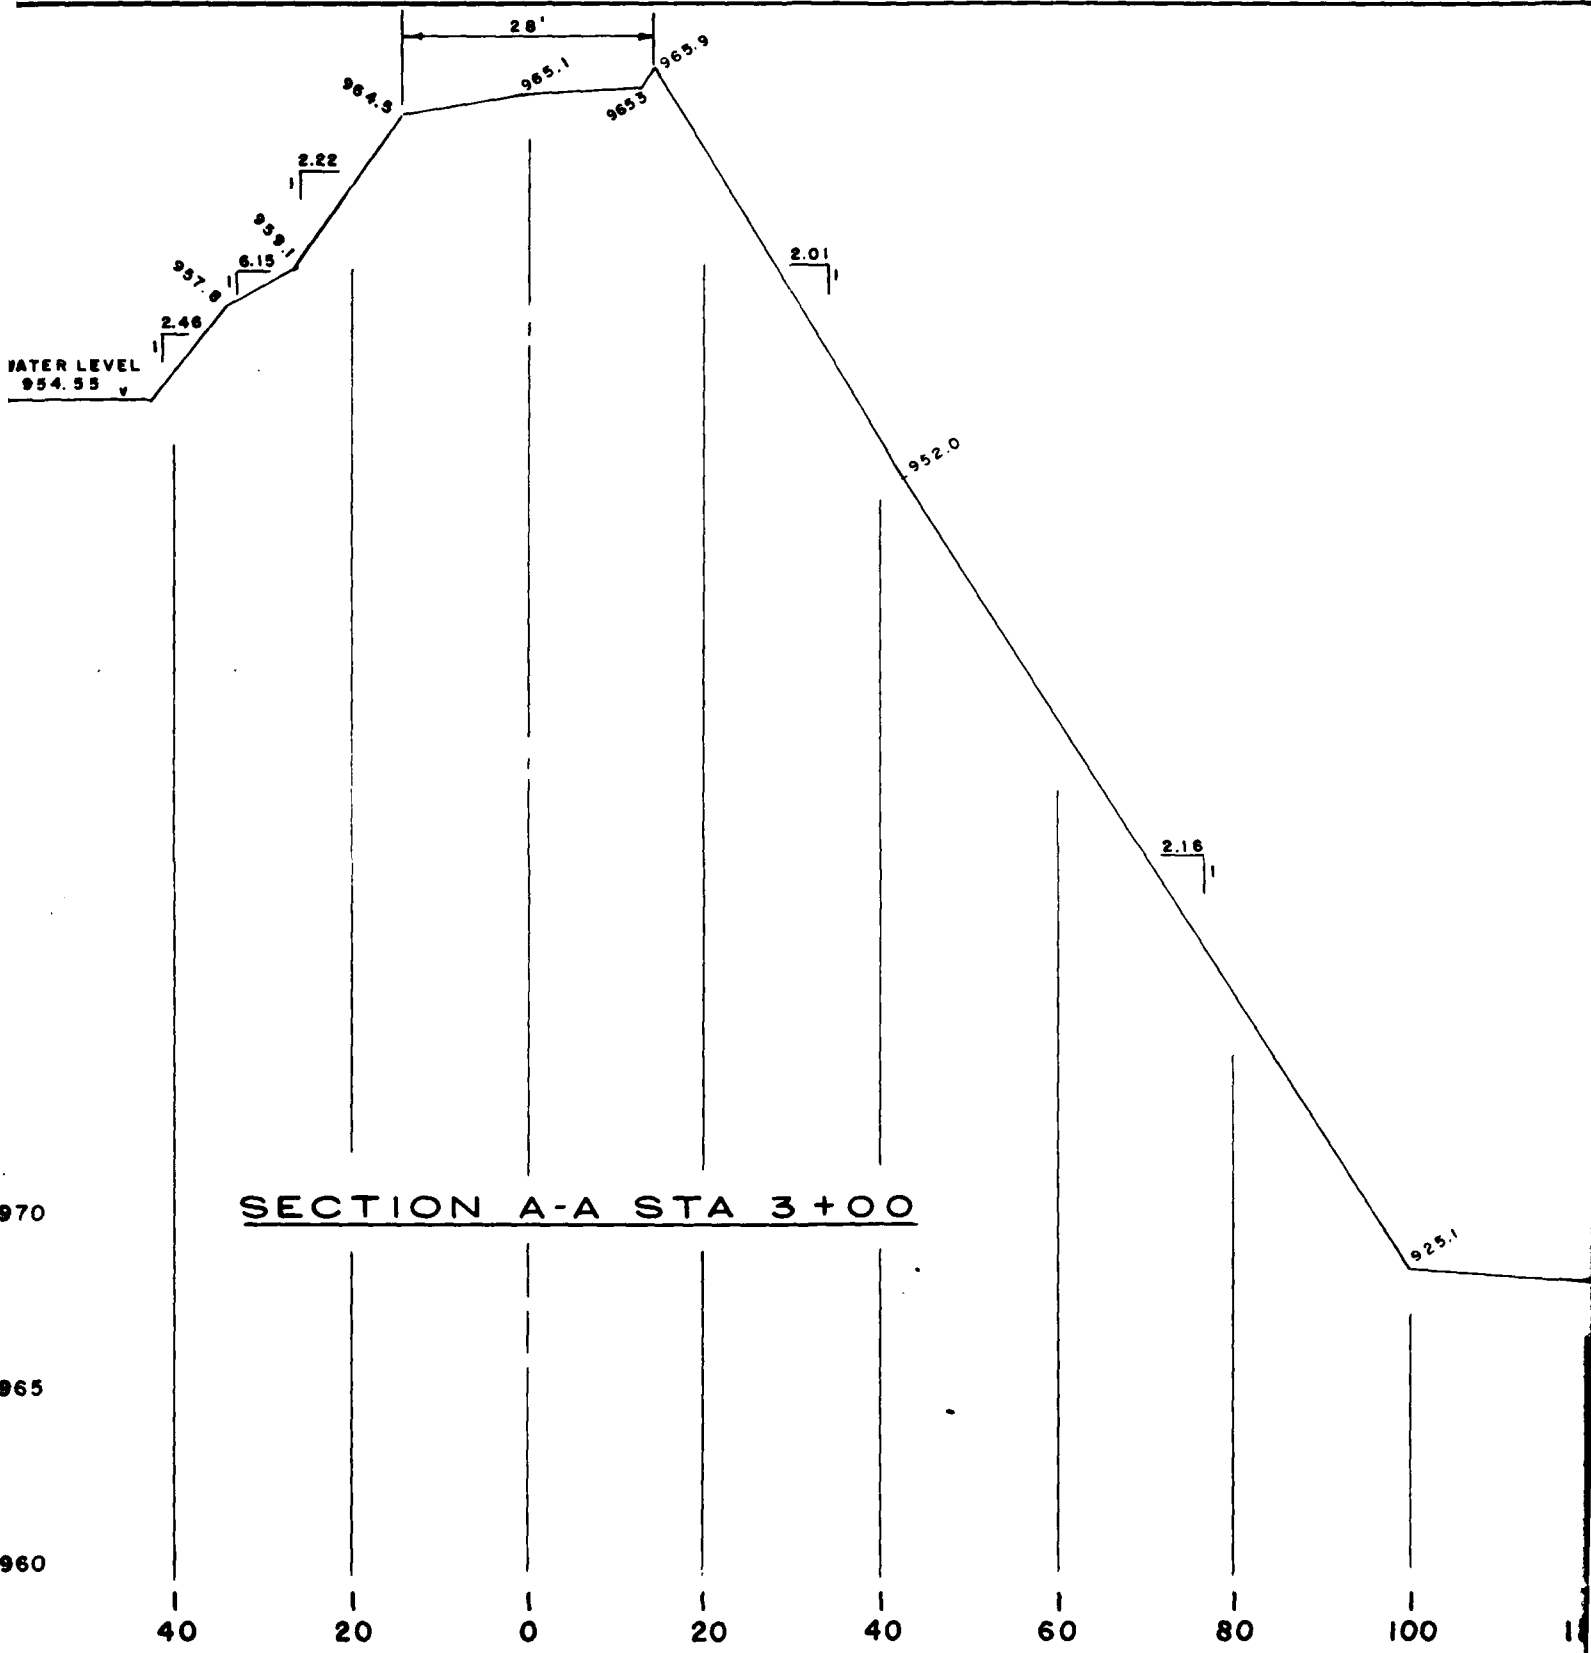
PLAN VIEW

BENCHMARK #1

"X" NAILS ROOT 8" TWIN HICKORY
150 FT. NORTH STA 12+90 ELEV. = 963.13 MSL

SCALE 1" = 100'

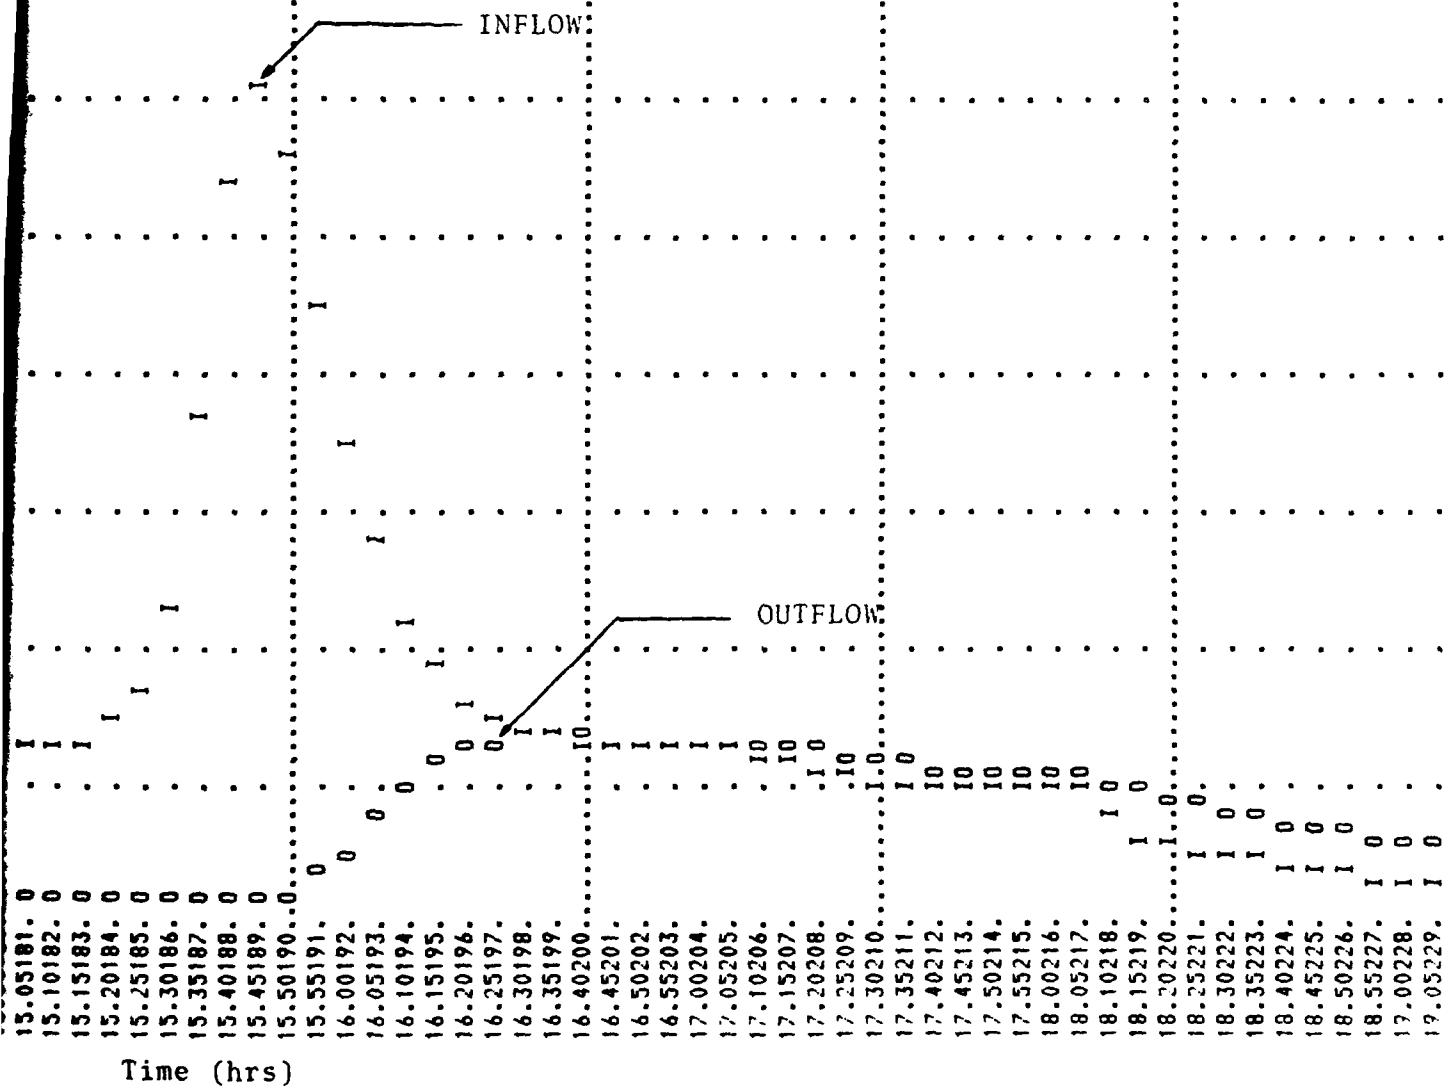
INFLOW-OUTFLOW
HYDROGRAPH
FOR 100% P.M.F.

Max. Inflow = 12,248 c.f.s.
Max. Outflow = 2721 c.f.s.

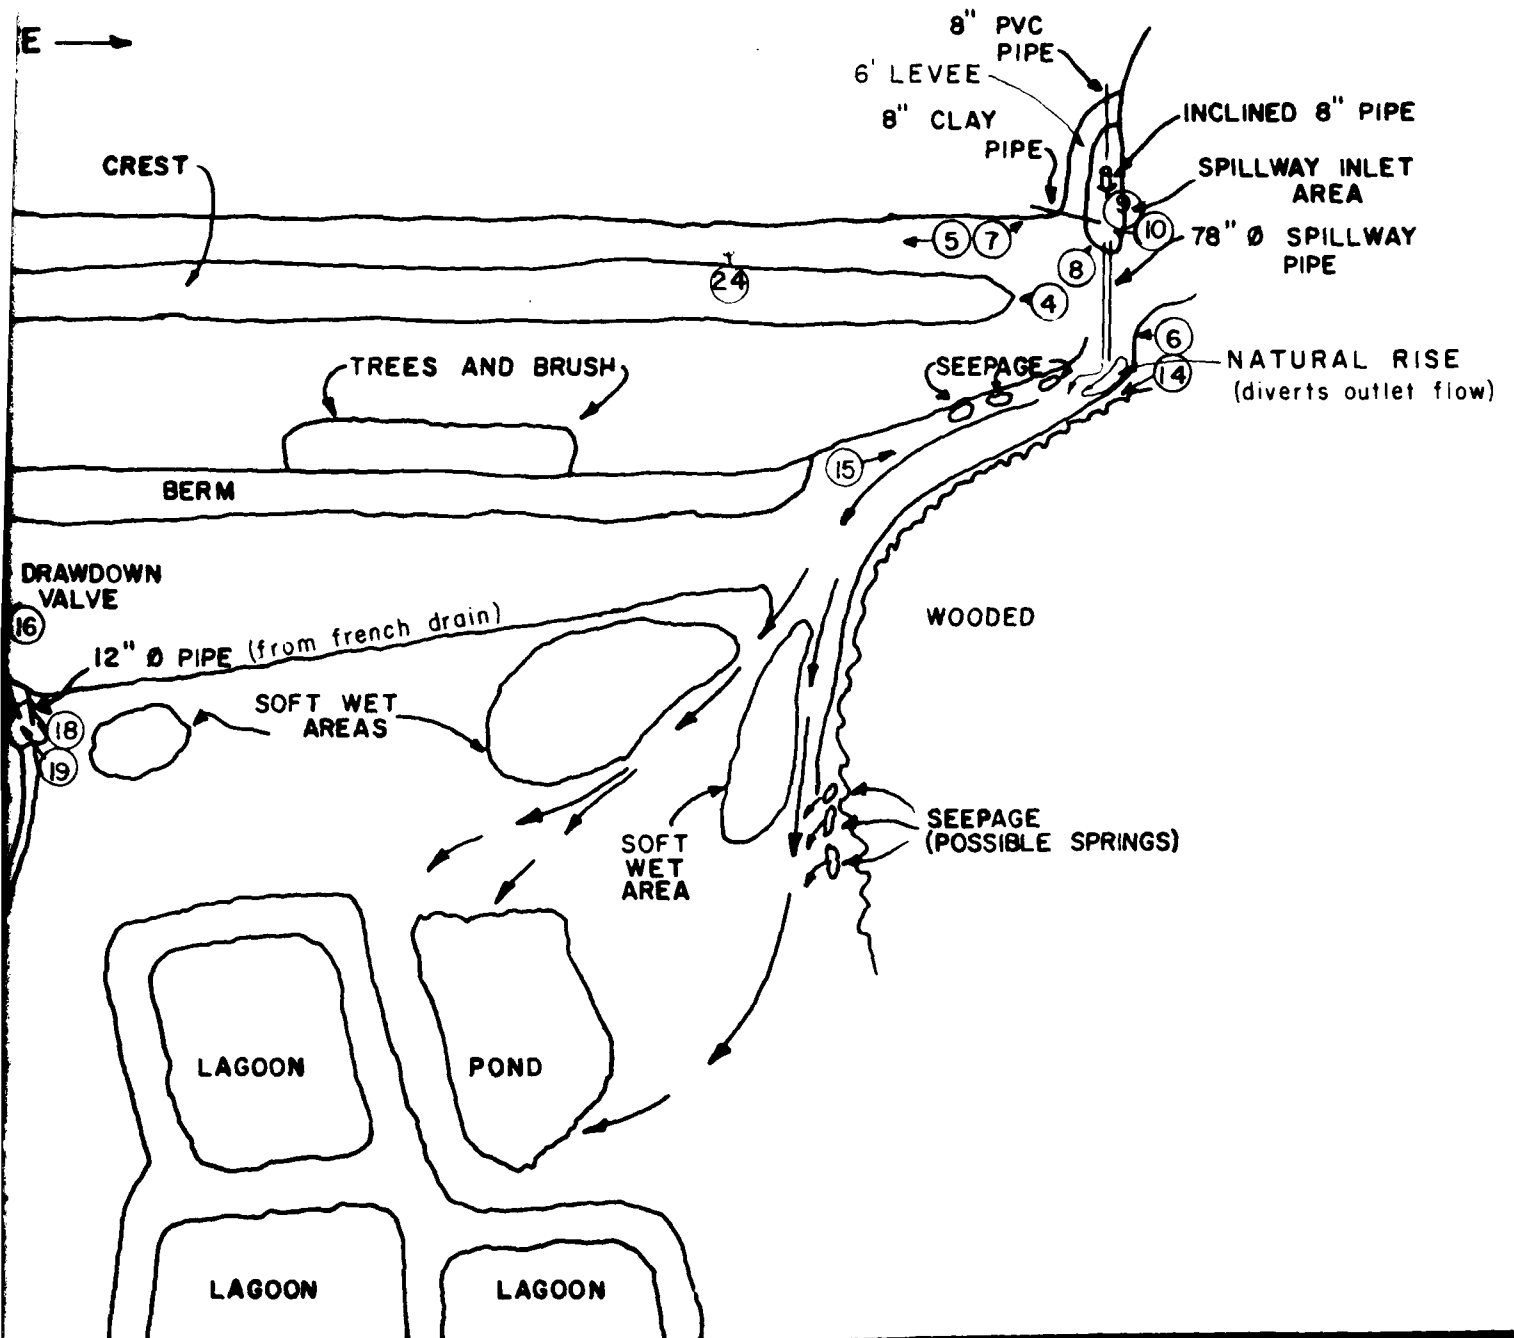
PLAN SKETCH

7+00 6+00 5+00 4+00 3+00 2+00 1+00 0+00
