# Coast Terminal Radar Approach Control Facility (TRACON) Refurbishment

Donald Bottomley  
Felix F. Hierbaum, Jr.

Prepared By  
FAA Technical Center  
Atlantic City Airport, N.J. 08405

August 1982

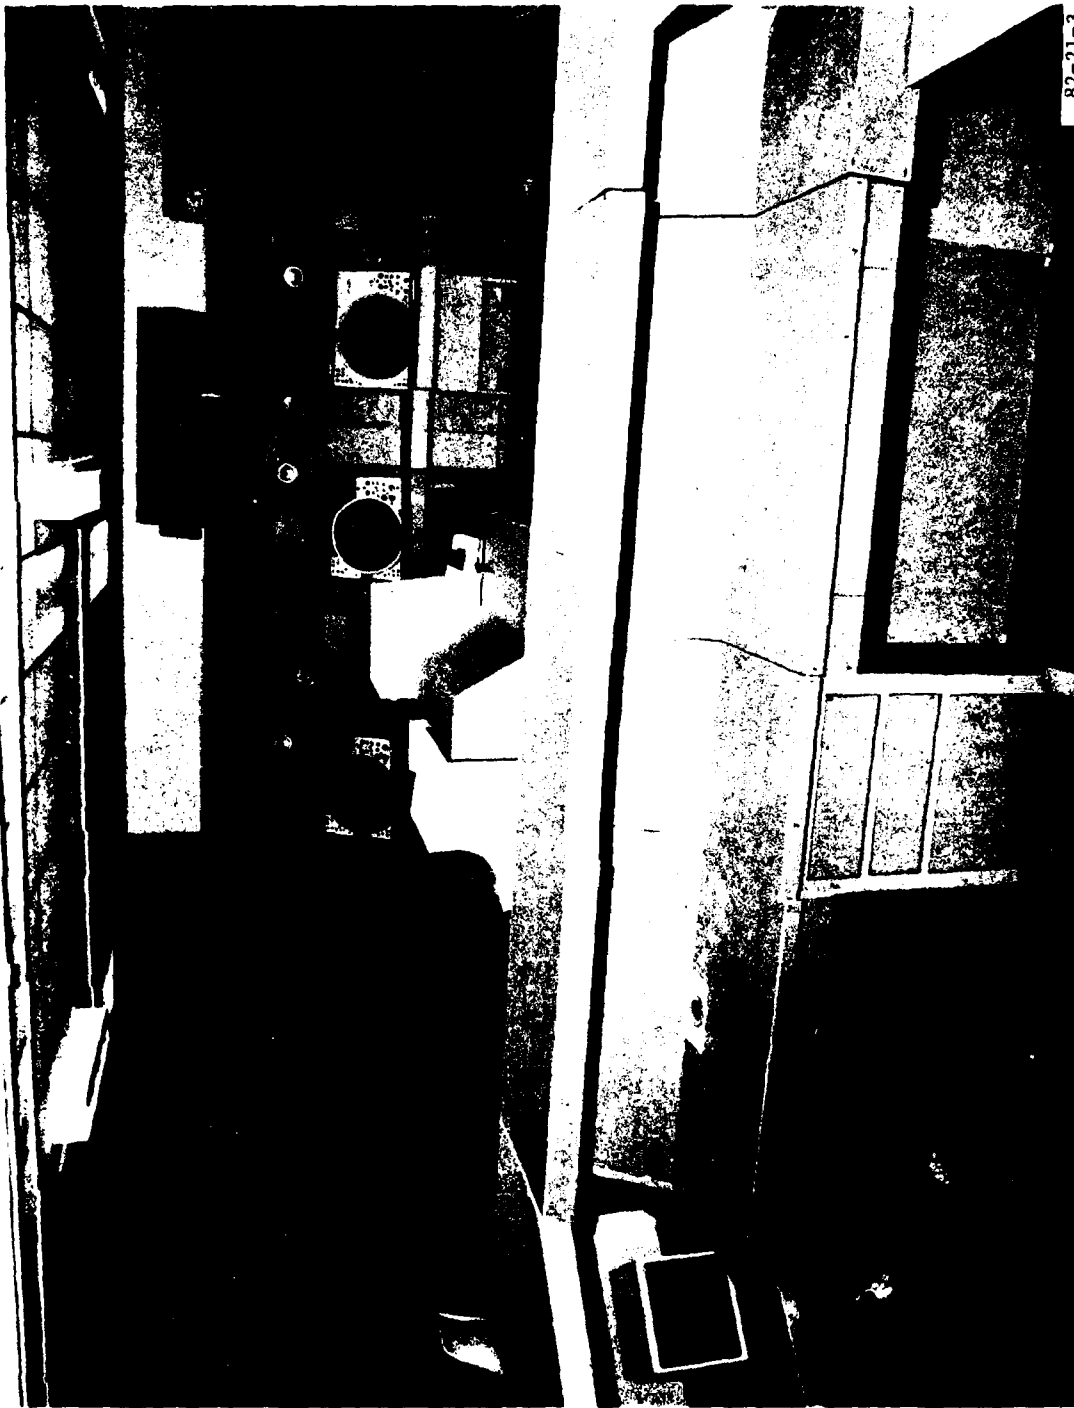
82-21-3

FIGURE 3. SUPERVISORY CONSOLE (FOREGROUND); "LOWBOY" DADS CONSOLE AND NEWPORT, PEDRO, BEACH, AND HARBOR DISPLAYS (BACKGROUND) PLUS ASSOCIATED HANDOFF POSITIONS

A full-scale mockup which contained all of the positions and equipment presently found in the Coast TRACON was fabricated at the Air Traffic Control Facilities Configuration Laboratory. (See figures 2 through 7.) In consonance with this, the present day instrumentation, as used with the Coast TRACON horizontal displays, was located in the vertical console shrouds. Measurements were taken which made it apparent that the overhead frames or shrouds that contain various equipment and controls which can accommodate present day equipment would not be able to meet the requirements for planned, futuristic instrumentation. A divider was used to mark the limits of the floor space associated with the El Toro PAR equipment which was not depicted.
