PITTSBURGH UNIV PA DEPT OF ANTHROPOLOGY  
AN ARCHITECTURAL STUDY OF SOME FOLK STRUCTURES IN THE AREA OF T--ETC(U)  
AUG 82 R C CARLISLE

**An Architectural Study of Some Folk Structures in the Area of the  
Paintsville Lake Dam, Johnson and Morgan Counties, Kentucky**

August 1982

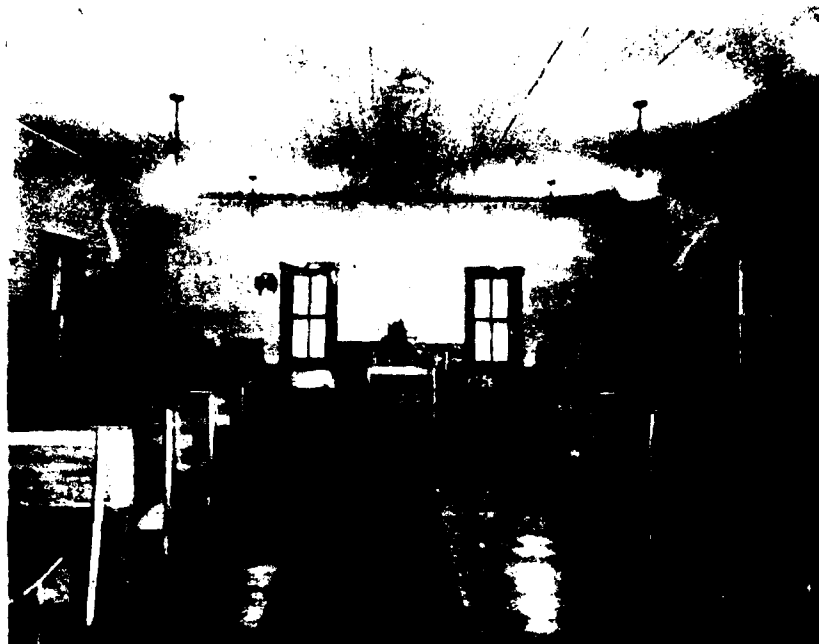
Figure 15. Interior view of sanctuary of the Fishtrap United Baptist Church looking toward the altar area. Note pews, windows and globular electric lights. Prior to the extension of electric service to the area, suspended kerosene lamps were employed (George Van Hoose 1978, pers. comm.).

Entrance through the church's single doorway in the northwest wall leads directly to the sanctuary and the central aisle. At the opposite or southeastern end of the room is a simple wooden altar area (Figures 15, 16) that is raised 7" above the floor. The length of the altar area runs across the width of the room and is itself 7'11" in width. It accommodates two sets of three wooden pews that face each other and are separated by the low wooden pulpit. A solitary pew is placed behind the pulpit. There are a total of nine rows of bench-type straight back wooden pews provided for the congregation on either side of the central aisle (Figure 15). Each congregational pew is 9'11" in length, 1'10" wide and ca. 3' in height. They are spaced at ca. 1'4" intervals. Pews on the altar platform are similar in construction but are 7'10" in length. Pew construction consistently employs milled lumber, but the type of nails used is not available.

Near the altar area (see Figures 15, 17) is a metal floor grate used with the gas heating system.

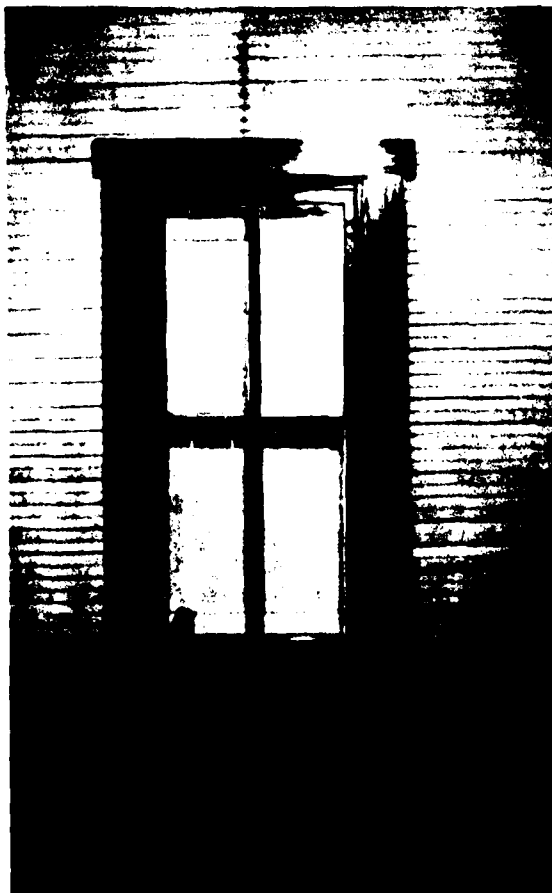
Figure 18. The Fishtrap United Baptist Church, close-up of two over two light double hung sash window. Note absence of window hardware.

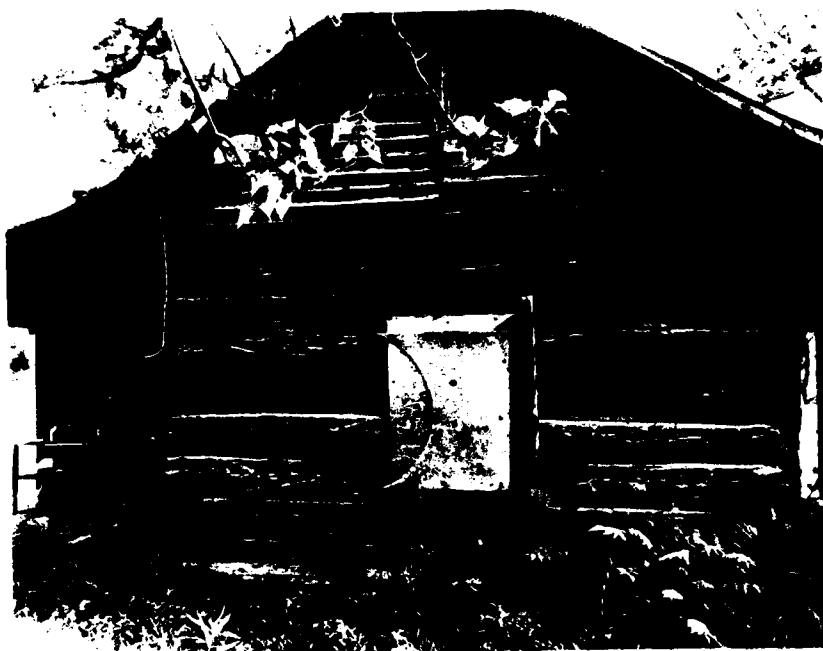
Figure 36. Western elevation of the western pen of the McKenzie dwelling. Note porch on southern elevation at right and the small, offset porch at left. Note also the heavily weathered mud chinking between the logs and the horizontally applied circular sawed weatherboarded gable.

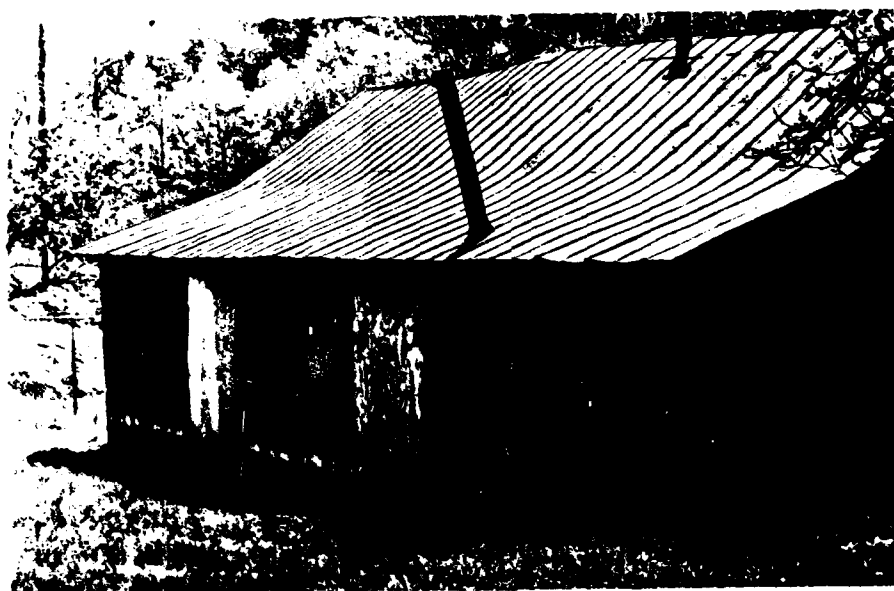
Figure 40. Northern elevation of the McKenzie dwelling showing the board and batten construction of the addition to the log portion of the home. Note rolled metal roofing.

Attached to the north or rear elevation of the two log pens is a 29'4" x 7'7" board and batten construction addition as well as a 7'7" x 5'9" open-walled but roofed porch (see Figures 38-40). Porch flooring (see Figure 38) here consists of a simple arrangement of 15 planks each ca. 6" in width. Everett McKenzie recalled that the present frame addition was constructed ca. 40-45 years ago (ca. 1935-1940) by his brother-in-law, Norman Williams, when Everett's parents, Forest and Lou McKenzie lived in the structure. This addition replaced an earlier log addition that according to Mr. McKenzie adjoined only the eastern pen of the dwelling (McKenzie-Carlisle Interview August 6, 1980). The logs on the north side of the eastern pen, however, are much more weathered than are those on the western pen as though they were exposed to the elements for a considerable amount of time. At present, therefore, it is impossible to specify the composition and configuration of the original addition to the north side of the extant structure.

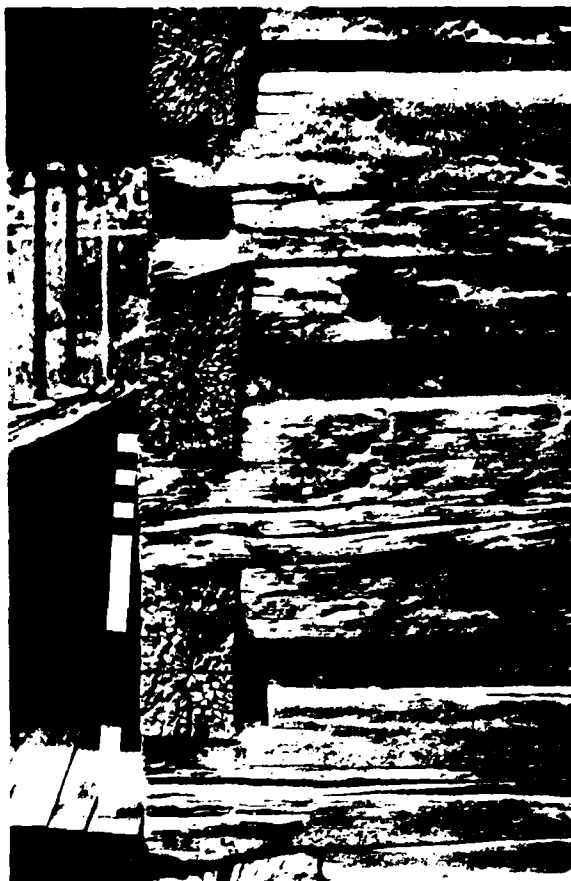
Figure 46. Close-up of southeast corner of the McKenzie dwelling. Note the weathering of the logs and the mud chinking between them as well as the presence of vertically arranged auger holes. The notch in the third log from the bottom may have supported a previous railing around the porch on the south side of the home. The auger holes were used to support a weaving loom that was operated by Everett McKenzie's mother (Everett McKenzie 1980, pers. comm.).

The final exterior architectural feature of note on the log portions of the dwelling are the auger holes on the eastern facade of the eastern pen (see Figure 46). The vertically aligned holes occur 1'1" from the southeast corner of the structure. The lowest of the holes is ca. 1'9" above the porch surface; the highest is bored at 4'7" above the porch. To the right of the last hole are two other holes (all of which are ca. 1" in diameter). These occur at 2'2" and 2'9" from the southeast corner of the structure respectively. Everett McKenzie identified these as anchoring holes for an outside loom used by his grandmother (McKenzie-Carlisle Interview August 6, 1980).

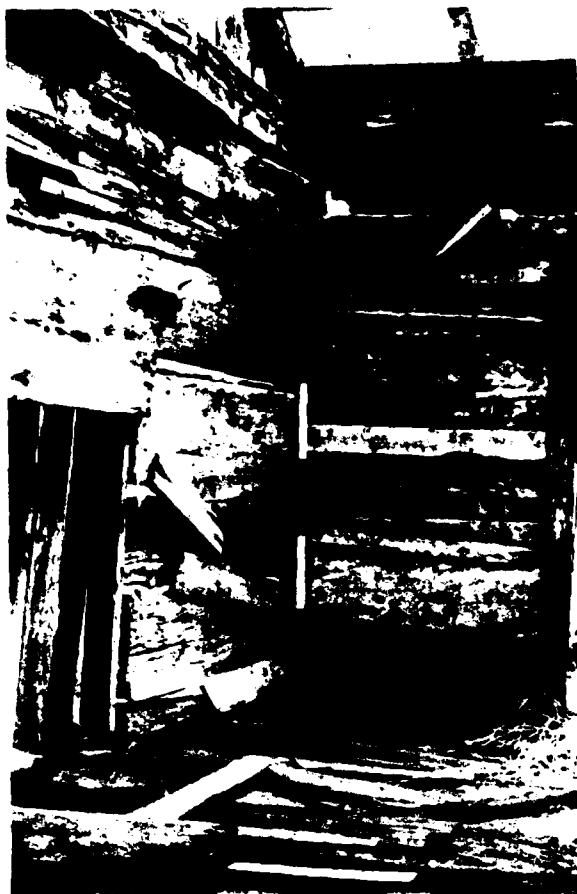
Figure 106. Interior of east corner of the Jim Gilliam dwelling. Note the enclosed fireplace opening at left, the auger hole and notches for the loft floor and the generally dilapidated appearance of the structure.

The floor of the main room of the structure is composed of 21 rows of 5"-6" circular sawed boards ca. 1" in thickness laid in two sections from southwest to northeast. This floor was partially collapsed when the survey was conducted, but a floor to ceiling height of 6'5" was estimated (Figure 106) as measured to the bottom of the six log notches that once carried the joists of the loft floor. Spacing between these joists ranges from 2'1" to 2'6".

It can be seen in Figure 106 that the interior of the structure was not well-preserved at the time that architectural recording was carried out. Many of the attributes that reflect room use, domestic traffic patterns, furnishings, decorative motifs, etc., are therefore absent in this dwelling.

The log walls of the Jim Gilliam dwelling are neither papered nor painted. Gaps between logs in many cases have been covered over with riven or circular sawed boards attached with wire nails (Figure 106).
