DOT/FAA/CT-86/5

Halon Extinguisher Agent Behavior in a Ventilated Small Aircraft

June 1986

Final Report

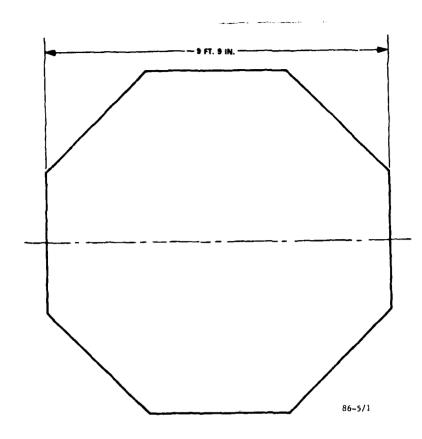
FIGURE 1. GENERAL AVIATION AIRFLOW FACILITY TEST SECTION - CROSS SECTION

A 10-foot diameter by 24-foot-long airflow facility was designed and constructed from flat 4-foot by 8-foot sheets of low carbon steel. The cross section, figure 1, is octagonal in shape. The entrance is a bellmouth design with a 5-foot radius. This extension is attached to an existing 5-foot diameter airflow facility, figures 2 and 3. Performance of the 5-foot facility is near Mach 1 airspeed. Two J57 turbo jet engines provide power to drive the facility by ejector action. The 10-foot diameter extension was designed for a minimum airspeed of 100 knots. Measurements with a Cessna 210C aircraft installed has indicated that airspeeds of 140 to 150 miles per hour (120 to 130 knots) are achievable. The increase over design performance is attributed to the propeller supercharging action, the increased local airspeeds resulting from decrease in tunnel cross-section area from the installed Cessna 210 aircraft, and improved contour development of the wind tunnel walls.

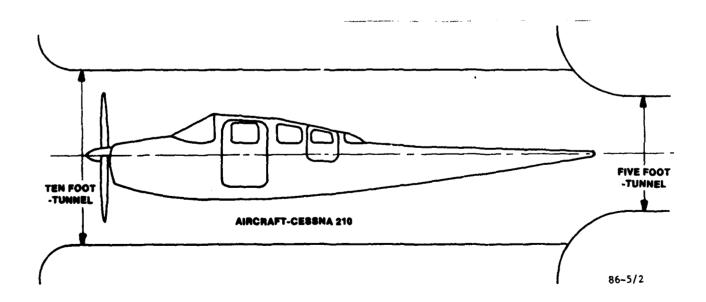
FIGURE 2. GENERAL AVIATION AIRFLOW FACILITY TEST SECTION - PROFILE

The test article is a 1963 model Cessna 210C with retractable landing gear (figures 2 and 3). The airplane is a four-place high-wing monoplane, powered by a single six-cylinder, horizontally-opposed fuel injection Continental IO470 engine. For installation in the facility, mounts were designed, fabricated, and installed at the wing spar attachment points and at the wing strut attachment points. The fuselage was installed in the tunnel with 3/4-inch high carbon steel rods connected to the mounts and to the tunnel walls. The wings were cut at the 32-inch section and then were installed on the fuselage in the tunnel. The sections were installed to provide the cabin ventilation air inlet ports located in the wings. It was necessary to move the ports inboard for inclusion in the 32-inch wing root sections.

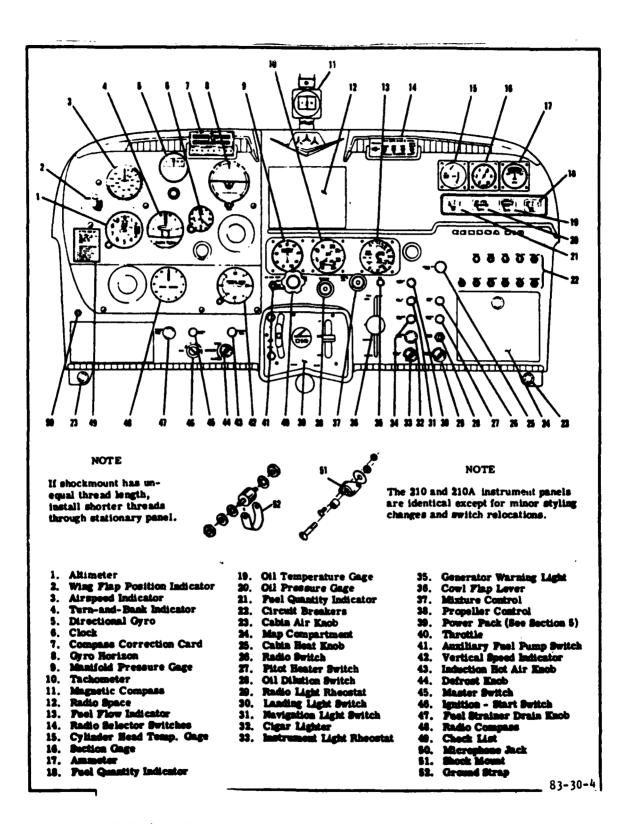
FIGURE 4. INSTRUMENT PANEL - CESSNA MODEL 210C AIRPLANE

The electrical and electronic components are primarily located in and under the instrument panel. The instrument panel for the test aircraft (Cessna 210) is shown in figure 4. Identification of the equipment is also listed. Electrical power for the aircraft is supplied by a 12-volt direct current, negative ground electrical system. A single 12-volt battery supplies power for starting and provides reserve power in the event of a generator or alternator failure. On the extreme left side of the instrument panel, one item that could be involved in a fire is the master switch. Operation of the switch connects the battery solenoid coil and the generator field coil to ground, thereby, activating the power system.

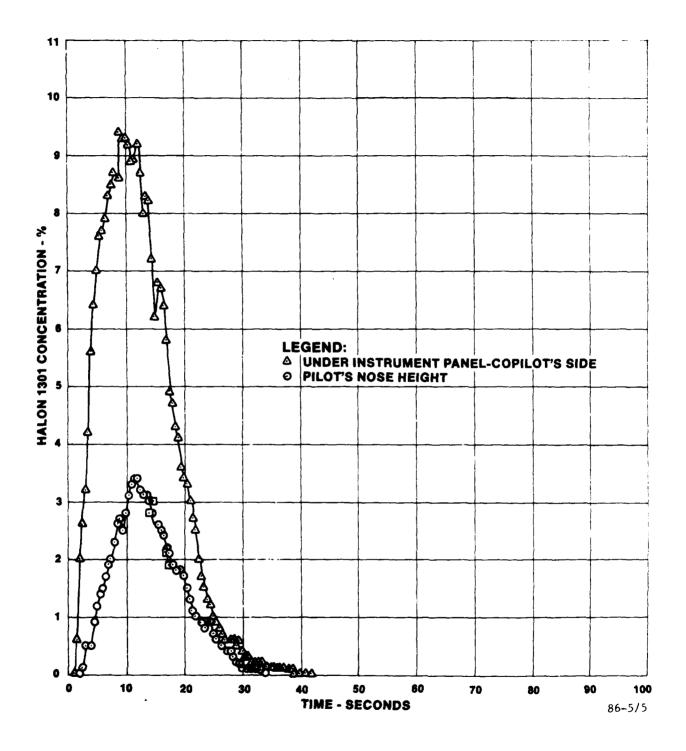
FIGURE 5. HALON 1301 CONCENTRATIONS - 3-POUND EXTINGUISHER DIRECTED UNDER INSTRUMENT PANEL - COPILOT'S SIDE - OVERHEAD VENTS OPEN

The gas measurements for the tests conducted with extinguishers discharged under the instrument panel were plotted against time in seconds and are presented in figures 5 through 12, and certain selected values were tabulated in table 2.

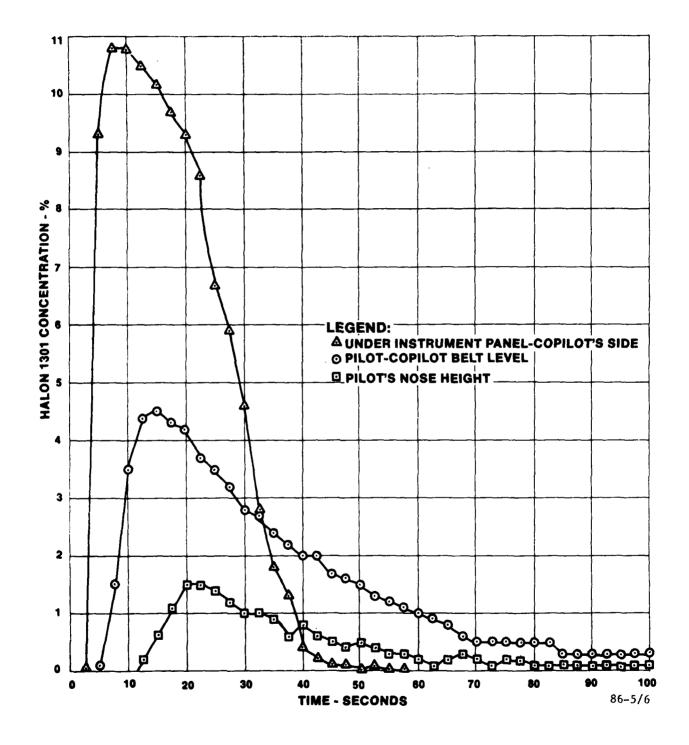
FIGURE 6. HALON 1301 CONCENTRATIONS - 3-POUND EXTINGUISHER DIRECTED UNDER INSTRUMENT PANEL - COPILOT'S SIDE - OVERHEAD VENTS CLOSED

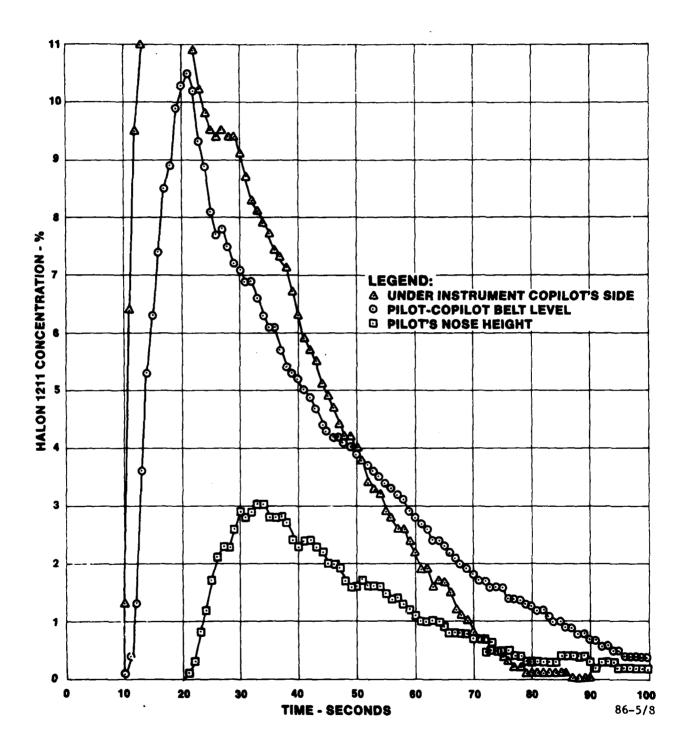
FIGURE 8. HALON 1211 CONCENTRATIONS - 2.5-POUND EXTINGUISHER DIRECTED UNDER INSTRUMENT PANEL - COPILOT'S SIDE - OVERHEAD VENTS CLOSED

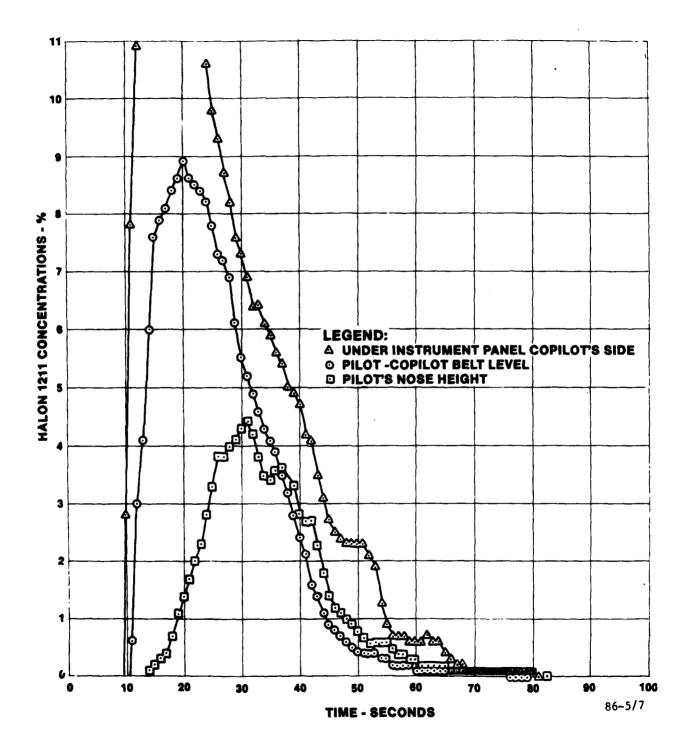
FIGURE 7. HALON 1211 CONCENTRATIONS - 2.5-POUND EXTINGUISHER DIRECTED UNDER INSTRUMENT PANEL - COPILOT'S SIDE - OVERHEAD VENTS OPEN

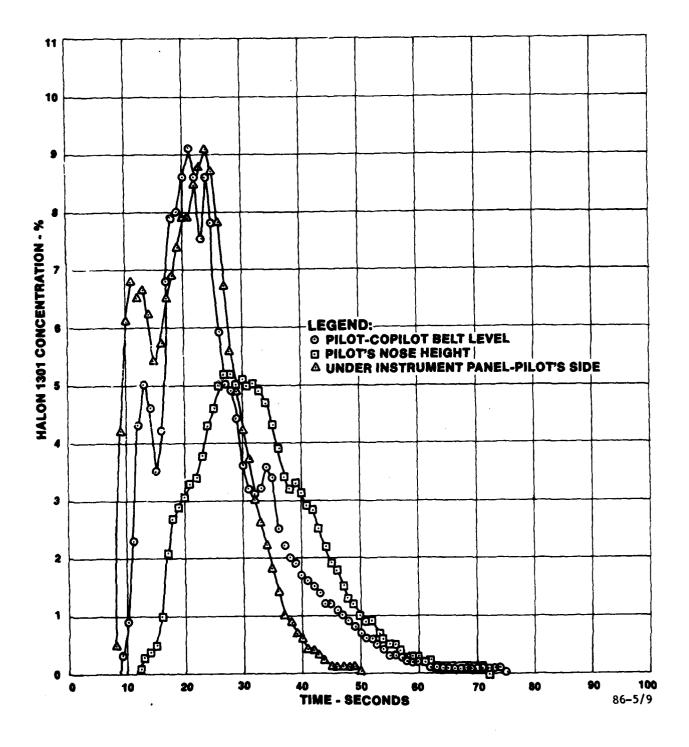
FIGURE 9. HALON 1301 CONCENTRATIONS - 3-POUND EXTINGUISHER DIRECTED UNDER INSTRUMENT PANEL - PILOT'S SIDE - OVERHEAD VENTS OPEN

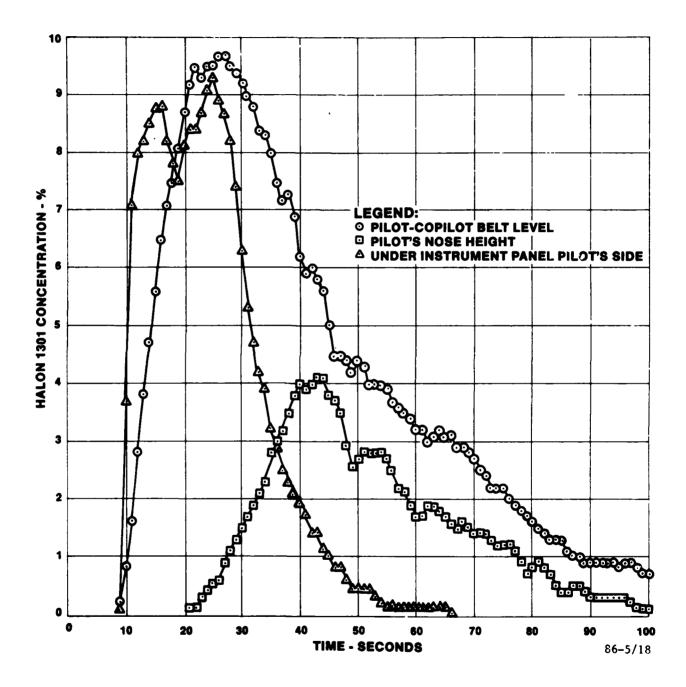
FIGURE 10. HALON 1301 CONCENTRATIONS - 3-POUND EXTINGUISHER DIRECTED TO THE COPILOT'S DOOR - OVERHEAD VENTS CLOSED

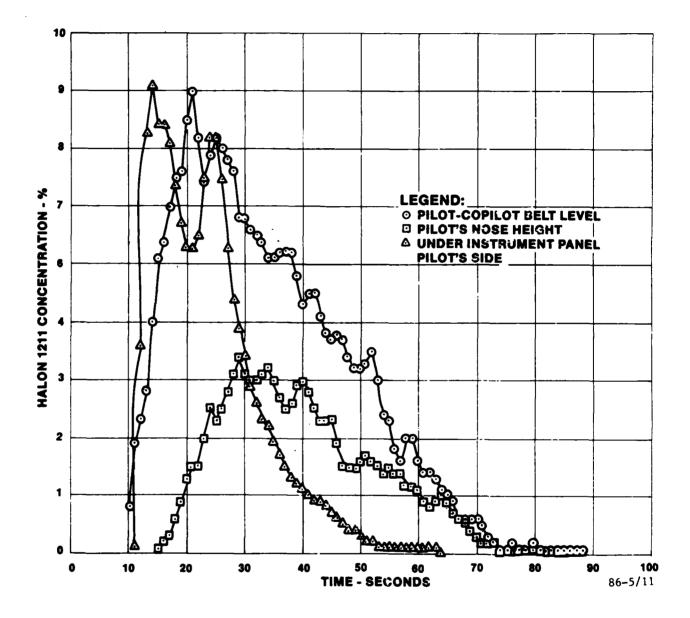
FIGURE 11. HALON 1211 CONCENTRATIONS - 2.5-POUND EXTINGUISHER DIRECTED UNDER INSTRUMENT PANEL - PILOT'S SIDE - OVERHEAD VENTS OPEN

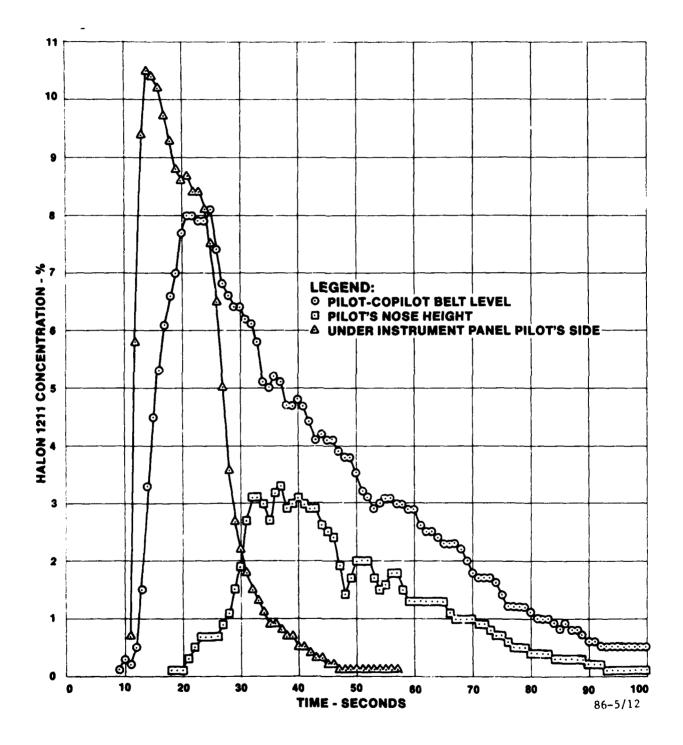
FIGURE 12. HALON 1211 CONCENTRATIONS - 2.5-POUND EXTINGUISHER DIRECTED UNDER INSTRUMENT PANEL - PILOT'S SIDE - OVERHEAD VENTS CLOSED

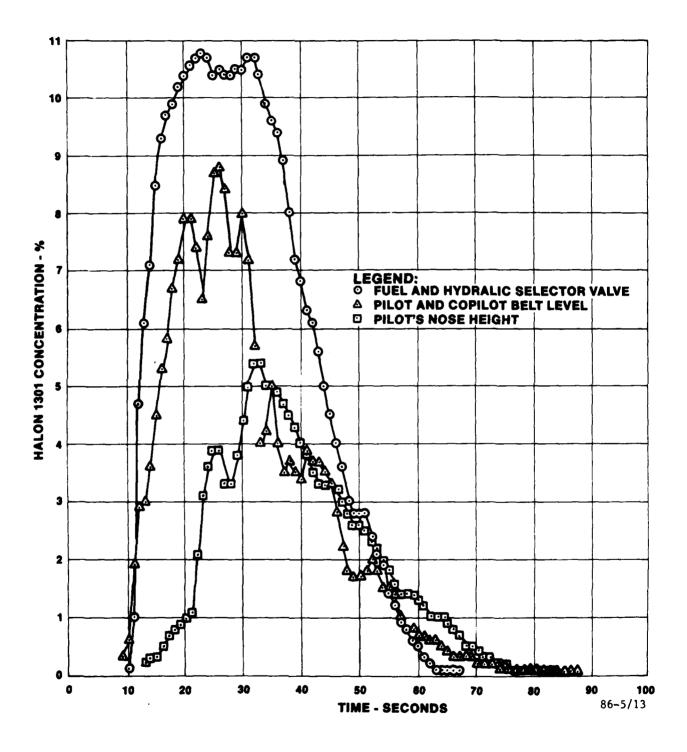
FIGURE 13. HALON 1301 CONCENTRATIONS - 3-POUND EXTINGUISHER DIRECTED TO THE FUEL AND HYDRAULIC SELECTOR VALVES - OVERHEAD VENTS OPEN

The extinguishers were directed to the fuel and hydraulic selector valves located on a console raised approximately 6 inches from floor between the pilot and copilot. Two 2.5-pound Halon 1211 extinguishers and two 3.0-pound Halon 1301 extinguishers were tested with identical ventilation conditions as previously described. The gas measurements are plotted in figures 13 through 16 and selected data are tabulated in table 2. Dose calculated for the pilot's nose was 1.72 and 2.56 percent minutes and is up to 64 percent of the limit for Halon 1211 and 2.69 and 3.10 for Halon 1301 which is 31 percent of the limit dose. Maximum dose at the pilot's and copilot's belt level was 4.88 and 5.78 percent minutes for Halon 1211 and 5.82 and 6.53 of Halon 1301. The pilot could bend over the 10 seconds without exceeding the limit dose when discharging Halon 1211 and could bend over indefinitely after discharging Halon 1301.

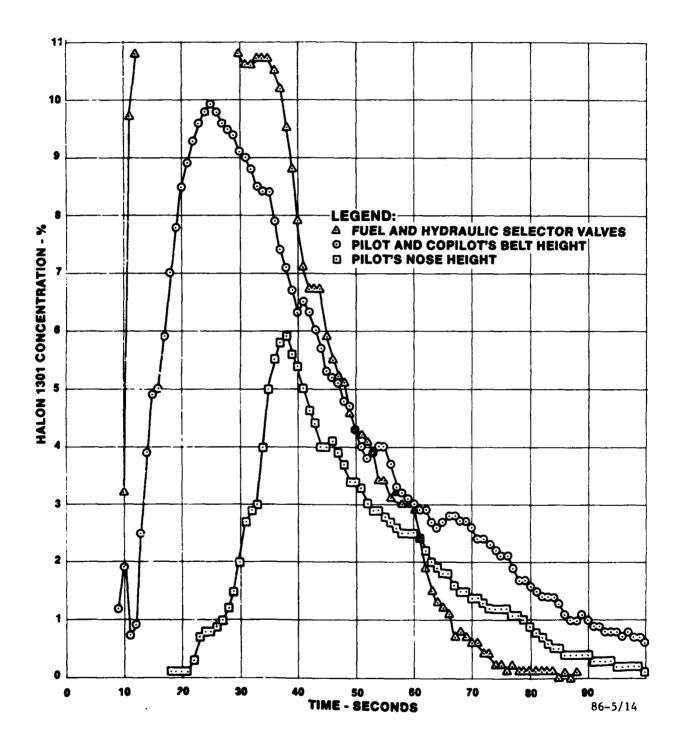
FIGURE 14. HALON 1301 CONCENTRATIONS - 3-POUND EXTINGUISHER DIRECTED TO THE FUEL AND HYDRAULIC SELECTOR VALVES - OVERHEAD VENTS CLOSED

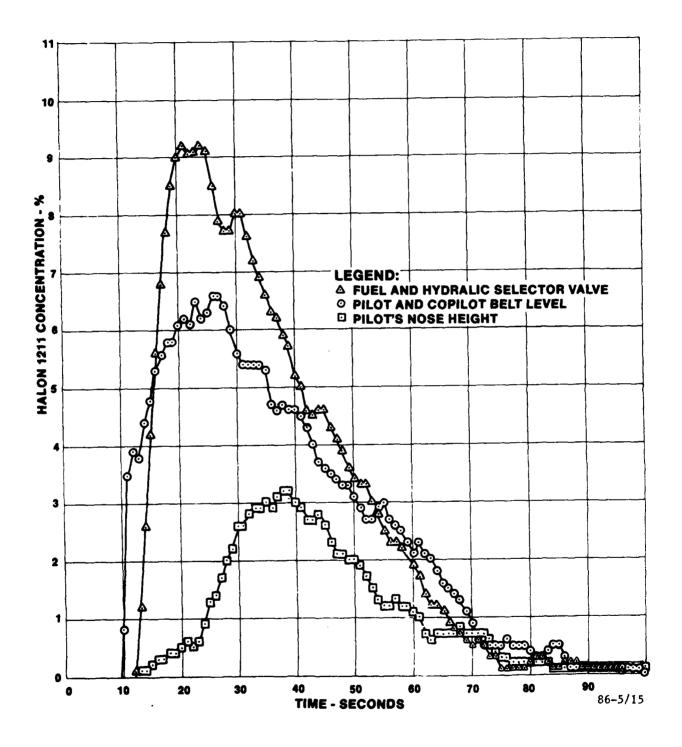
FIGURE 15. HALON 1211 CONCENTRATIONS - 2.5-POUND EXTINGUISHER DIRECTED TO THE FUEL AND HYDRAULIC SELECTOR VALVES - OVERHEAD VENTS OPEN

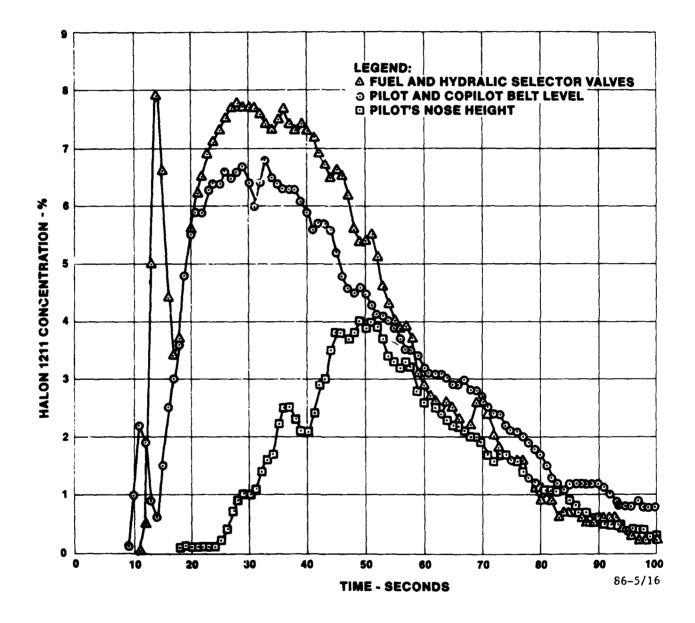
FIGURE 16. HALON 1211 CONCENTRATIONS ~ 2.5-POUND EXTINGUISHER DIRECTED TO THE FUEL AND HYDRAULIC SELECTOR VALVES - OVERHEAD VENTS CLOSED

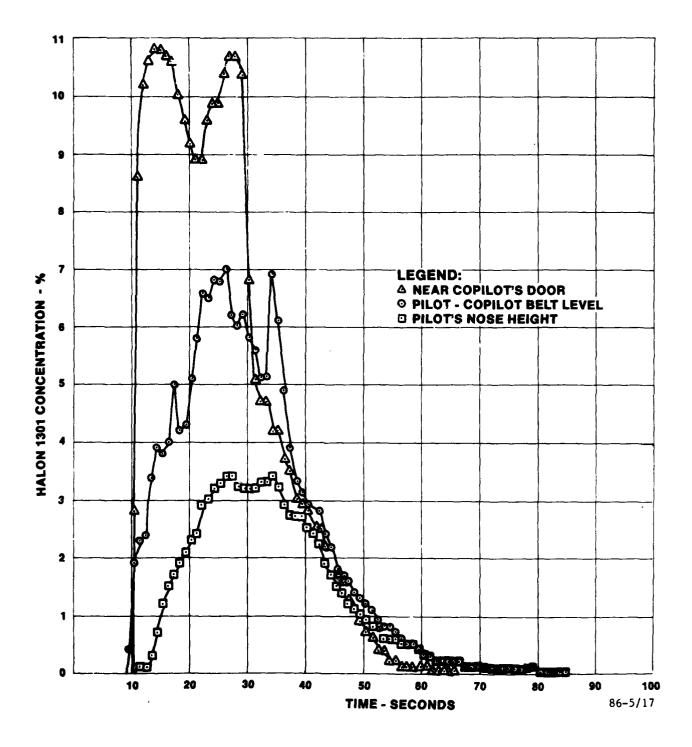
FIGURE 17. HALON 1301 CONCENTRATIONS - 3-POUND EXTINGUISHER DIRECTED TO THE COPILOT'S DOOR - OVERHEAD VENTS OPEN

Two Halon 1211 and two Halon 1301 extinguishers were discharged to the copilot's door at a point below the arm rest. Figures 17 through 20 show the agent concentrations plotted against time. As the discharge location was moved in relation to the pilot, dose calculations are less. The dose for the pilot was only 19 percent of the limit for Halon 1211, and 17 percent of the limit for Halon 1301.

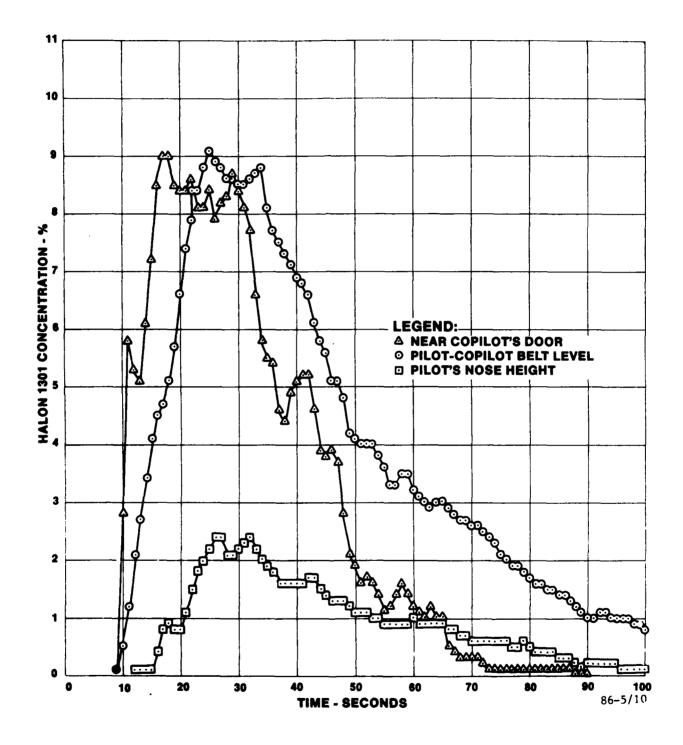
FIGURE 18. HALON 1301 CONCENTRATIONS - 3-POUND EXTINGUISHER DIRECTED UNDER INSTRUMENT PANEL - PILOT'S SIDE - OVERHEAD VENTS CLOSED

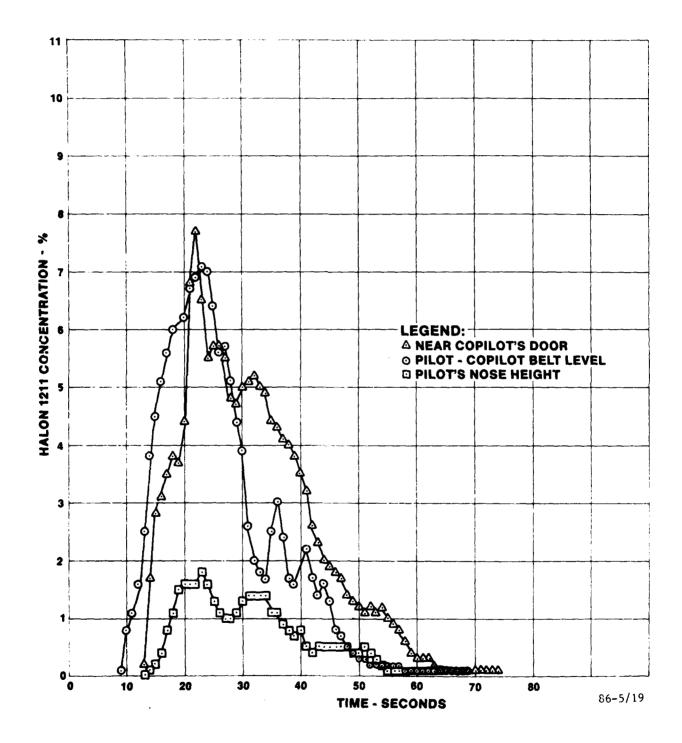
FIGURE 19. HALON 1211 CONCENTRATIONS - 2.5-POUND EXTINGUISHER DIRECTED TO THE COPILOT'S DOOR - OVERHEAD VENTS OPEN

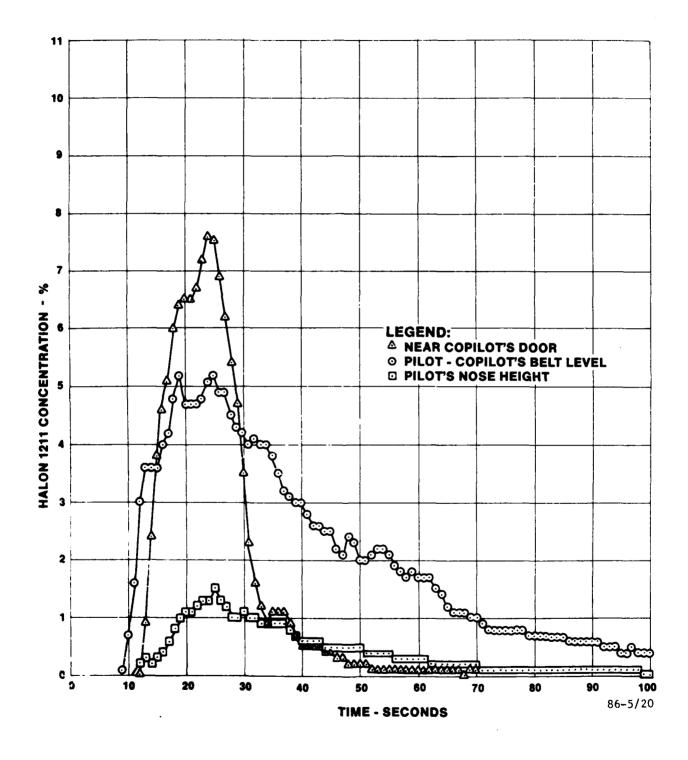
FIGURE 20. HALON 1211 CONCENTRATIONS - 2.5-POUND EXTINGUISHER DIRECTED TO THE COPILOT'S DOOR - OVERHEAD VENTS CLOSED

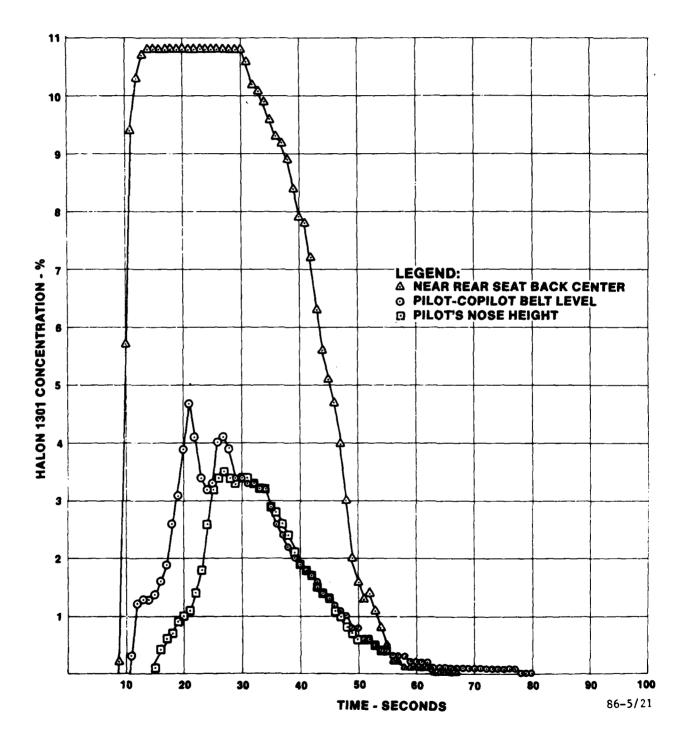
FIGURE 21. HALON 1301 CONCENTRATIONS - 3-POUND EXTINGUISHER DIRECTED TO THE REAR SEAT - OVERHEAD VENTS OPEN

Two Halon 1211 and two Halon 1301 bottles were discharged to the center of the rear seat back. The measurements plotted versus time are in figures 21 through 24 and values are tabulated in table 2. Dose calculations for the pilot's nose was only up to 33 percent of the limit for Halon 1211 and up to 23 percent of the limit for Halon 1301. Dose for the pilot's belt level was also low and was below the limit dose for both agents.

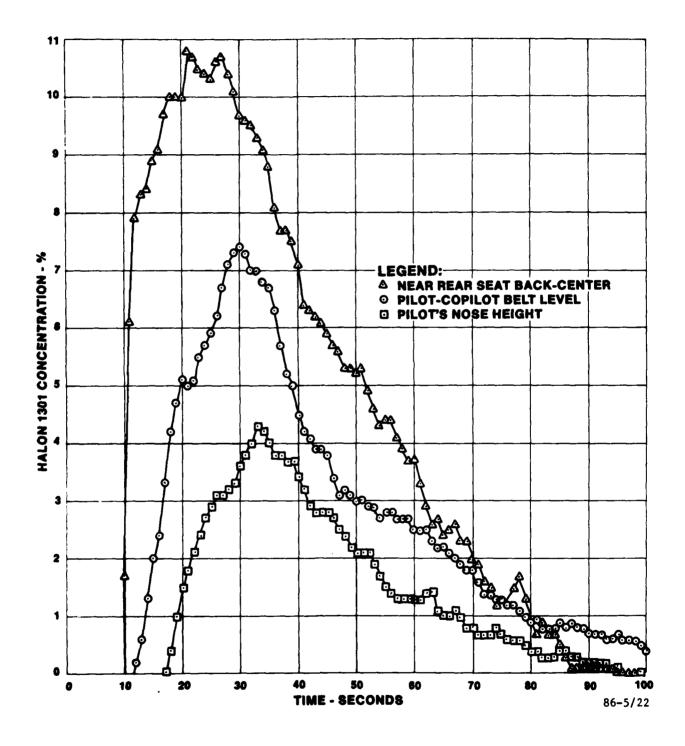
FIGURE 22. HALON 1301 CONCENTRATIONS - 3-POUND EXTINGUISHER DIRECTED TO THE REAR SEAT - OVERHEAD VENTS CLOSED

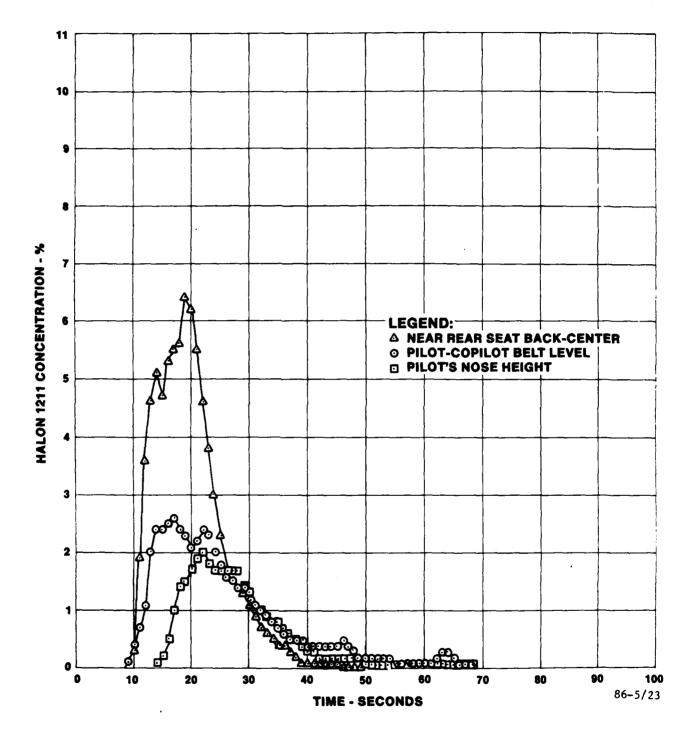
FIGURE 23. HALON 1211 CONCENTRATIONS - 2.5-POUND EXTINGUISHER DIRECTED TO THE REAR SEAT - OVERHEAD VENTS OPEN

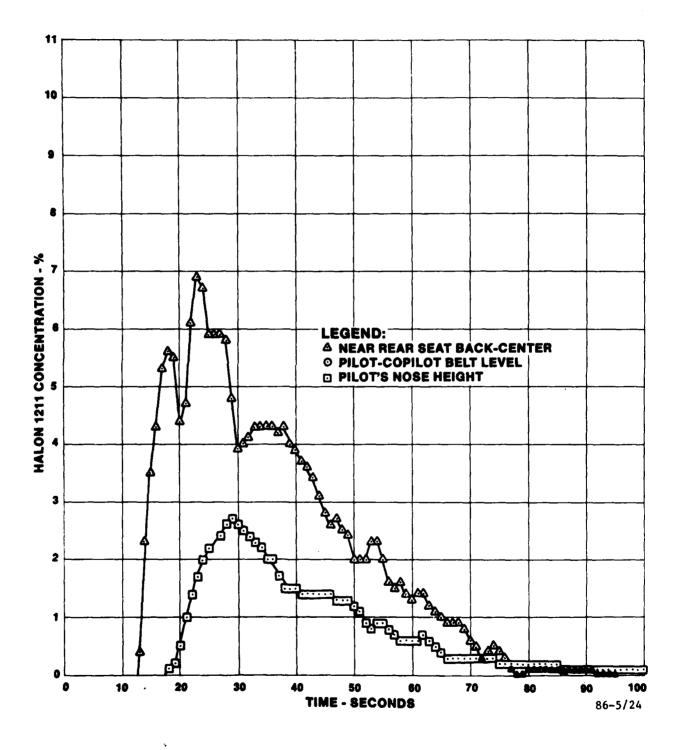
FIGURE 24. HALON 1211 CONCENTRATIONS - 2.5-POUND EXTINGUISHER DIRECTED TO THE REAR SEAT - OVERHEAD VENTS CLOSED

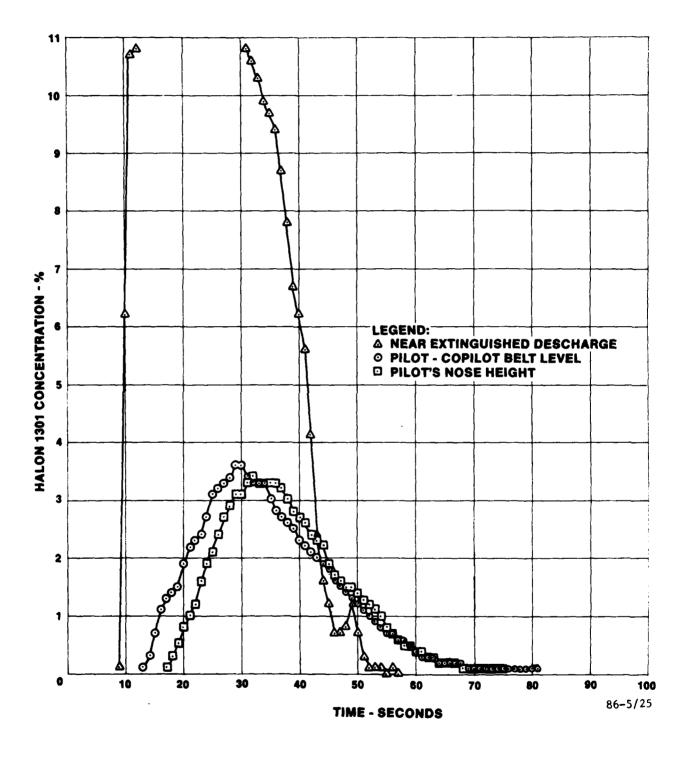
FIGURE 25. HALON 1301 CONCENTRATIONS ~ 3-POUND EXTINGUISHER DIRECTED TO THE BAGGAGE CONPARTMENT - OVERHEAD VENTS OPEN

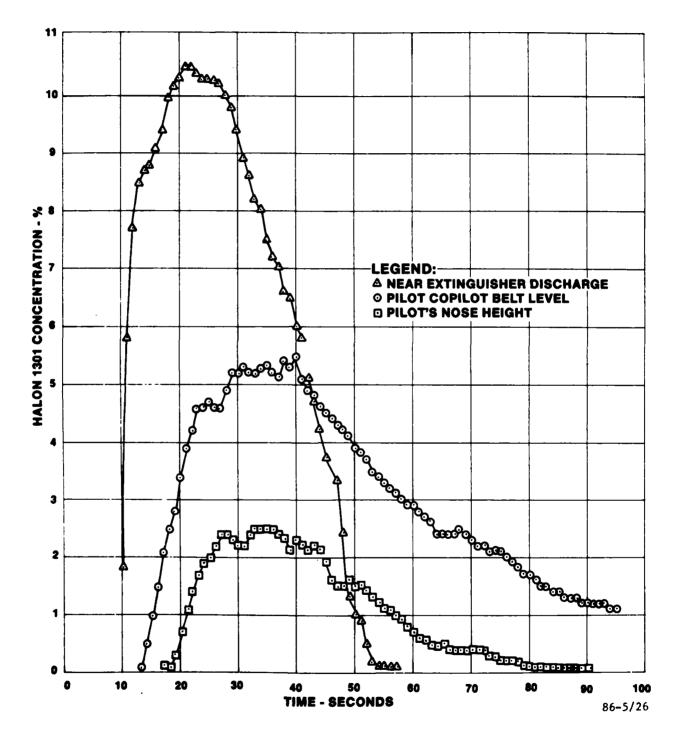
FIGURE 26. HALON 1301 CONCENTRATIONS - 3-POUND EXTINGUISHER DIRECTED TO THE BAGGAGE COMPARTMENT - OVERHEAD VENTS CLOSED

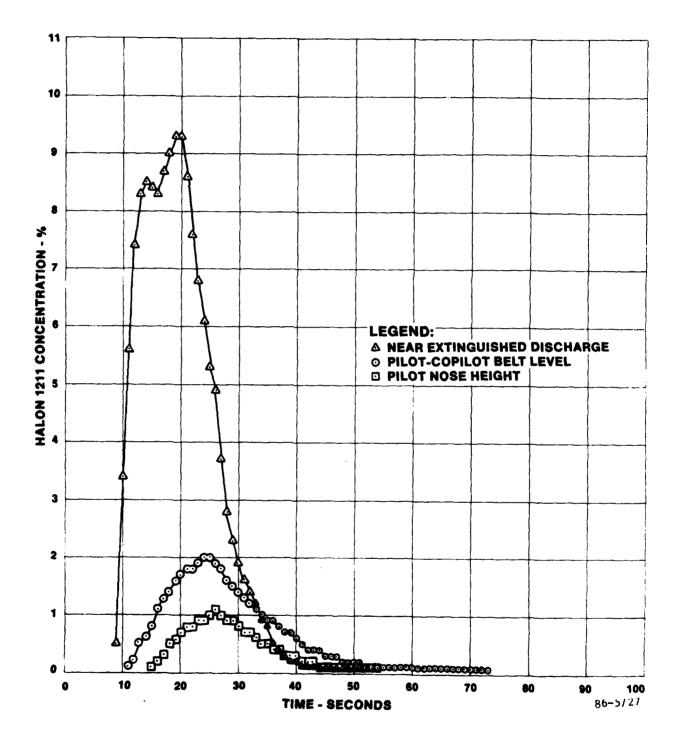
FIGURE 27. HALON 1211 CONCENTRATIONS - 2.5-POUND EXTINGUISHER DIRECTED TO THE BAGGAGE COMPARTMENT - OVERHEAD VENTS OPEN

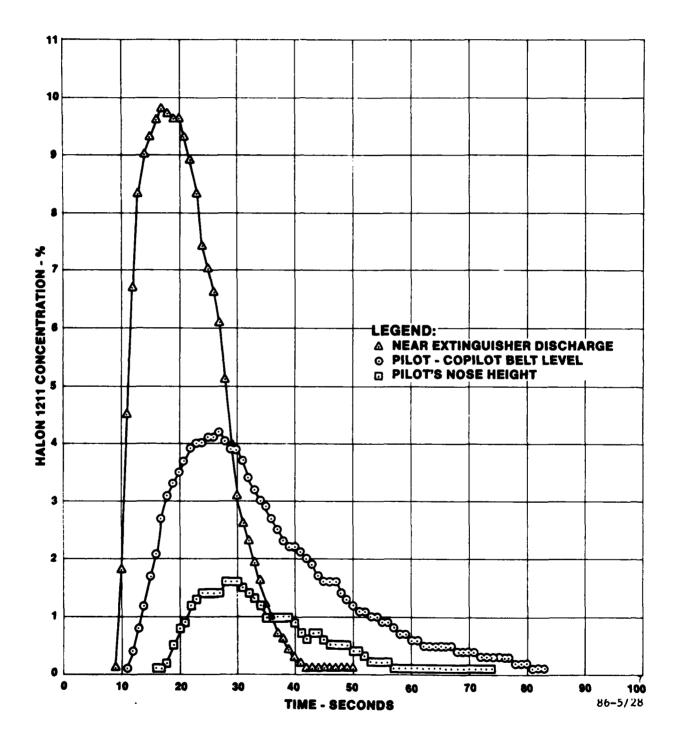
FIGURE 28. HALON 1211 CONCENTRATIONS - 2.5-POUND EXTINGUISHER DIRECTED TO THE BAGGAGE COMPARTMENT - OVERHEAD VENTS CLOSED

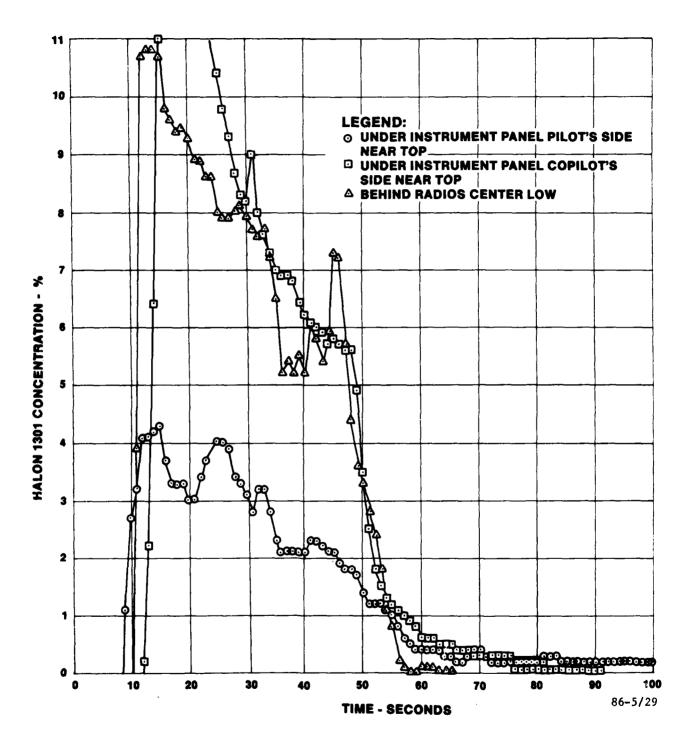
FIGURE 29. HALON 1301 CONCENTRATIONS - 3-POUND EXTINGUISHER DIRECTED UNDER THE INSTRUMENT PANEL - COPILOT'S SIDE - ALL SAMPLE LINES UNDER INSTRUMENT PANEL

An investigation was conducted to determine the distribution of extinguisher agents under the instrument panel. The gas sample lines were arranged to sample near the top of the instrument panel (pilot's side), near the top of the instrument panel (copilot's side), and at the very low center section under the stack of radios and direction finding electronics. The measurements are plotted versus time, figures 29 through 32, and selected values are listed in table 4. One Halon 1211 extinguisher and one 1301 extinguisher were discharged under the instrument panel on the copilot's side and identical testing was completed by discharging the extinguishers under the instrument panel pilot's side. High levels of agent (10 to 11 percent) were measured under the instrument panel on the side where the extinguishers were discharged. On the opposite side of the instrument panel, extinguisher gas concentrations ranged from 3.8 percent to 4.5 percent. Under the stack of radios located in the center section, concentrations ranged from high levels to low levels of 3.8 percent. Thus, both agents exhibited good distribution throughout the sampled area beneath the instrument panel.

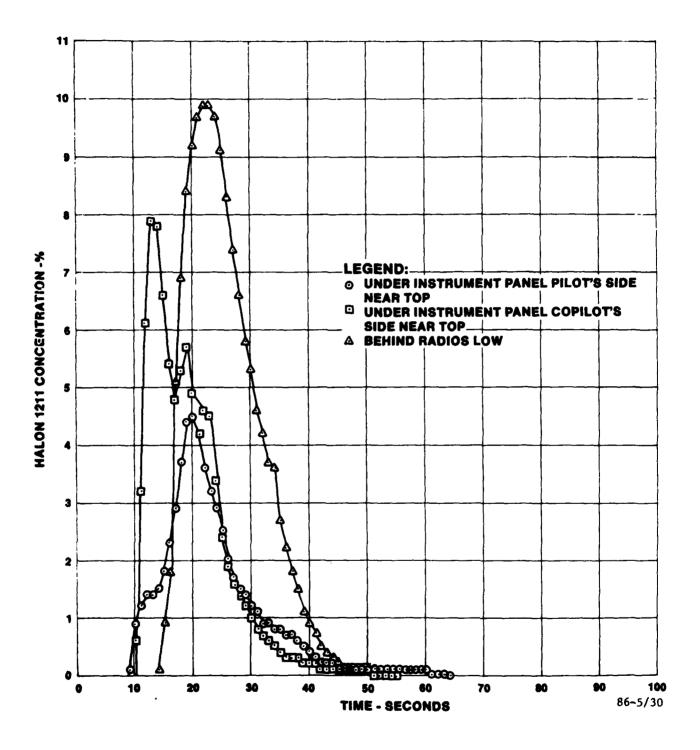
FIGURE 30. HALON 1211 CONCENTRATIONS - 2.5-POUND EXTINGUISHER DIRECTED UNDER THE INSTRUMENT PANEL - COPILOT'S SIDE - ALL SAMPLE LINES UNDER INSTRUMENT PANEL

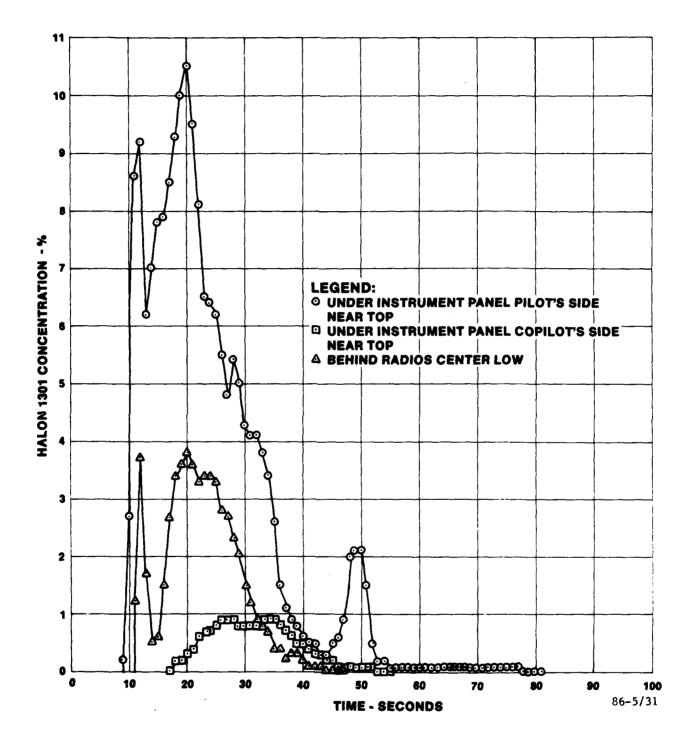
FIGURE 31. HALON 1301 CONCENTRATIONS - 3-POUND EXTINGUISHER DIRECTED UNDER THE INSTRUMENT PANEL - PILOT'S SIDE - ALL SAMPLE LINES UNDER THE INSTRUMENT PANEL

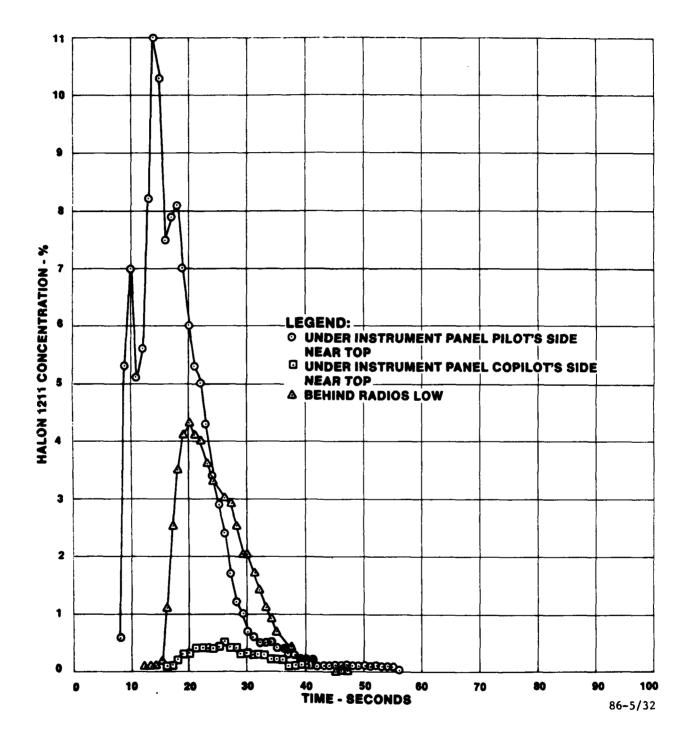
FIGURE 32. HALON 1211 CONCENTRATIONS - 2.5-POUND EXTINGUISHER DIRECTED UNDER THE INSTRUMENT PANEL - PILOT'S SIDE - ALL SAMPLE LINES UNDER THE INSTRUMENT PANEL

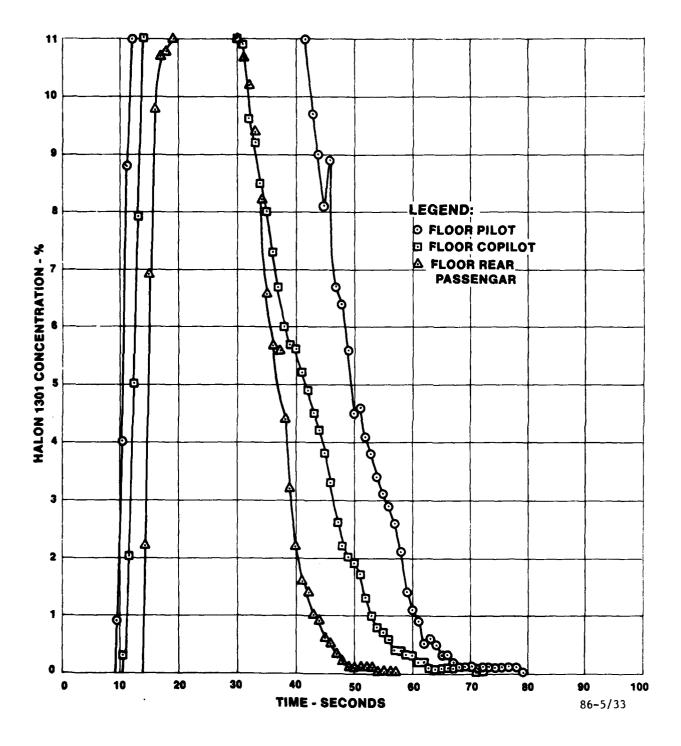
FIGURE 33. HALON 1301 CONCENTRATIONS ~ 3-POUND EXTINGUISHER DIRECTED TO THE FUEL AND HYDRAULIC SELECTOR VALVES - ALL SAMPLE LINES LOCATED ON THE FLOOR

Testing was designed to measure extinguisher agent stratification within the cabin. The three sample lines were placed on the cabin floor. Single sample lines were placed on the floor both near the pilot and the copilot and on the floor by the rear passenger behind the pilot. The measurements are in figures 33 and 34 and selected values are listed in table 5. The highest Halon extinguisher gas concentrations are located on the floor. In all cases, the gas measurement capability was overwhelmed and exceeded the maximum measurement level of 11 percent. Stratification of the Halon agents are presented in figure 35. Average gas measurements were plotted for the pilot-copilot belt level and for the pilot's nose location. As noted, only one test with each Halon was conducted for measurement of the agents for the floor. Stratification of the Halons is significant as they vary from over 11 percent on the floor to 2.65 percent and 4.03 percent at the pilot's nose and it appears that this relationship is near linear, figure 35.

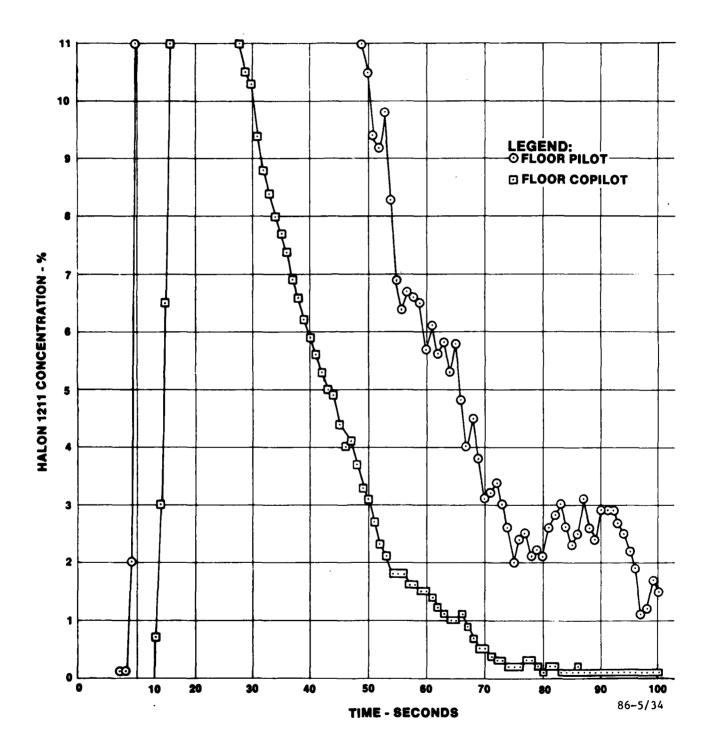
FIGURE 34. HALON 1211 CONCENTRATIONS - 2.5-POUND EXTINGUISHER DIRECTED TO THE FUEL AND HYDRAULIC SELECTOR VALVES - ALL SAMPLE LINES LOCATED ON THE FLOOR
