MISCELLANEOUS PAPER HL-87-6

# SCOUR PROTECTION FOR PIKE ISLAND DAM, OHIO RIVER

## Hydraulic Model Investigation

John E. Hite, Jr.

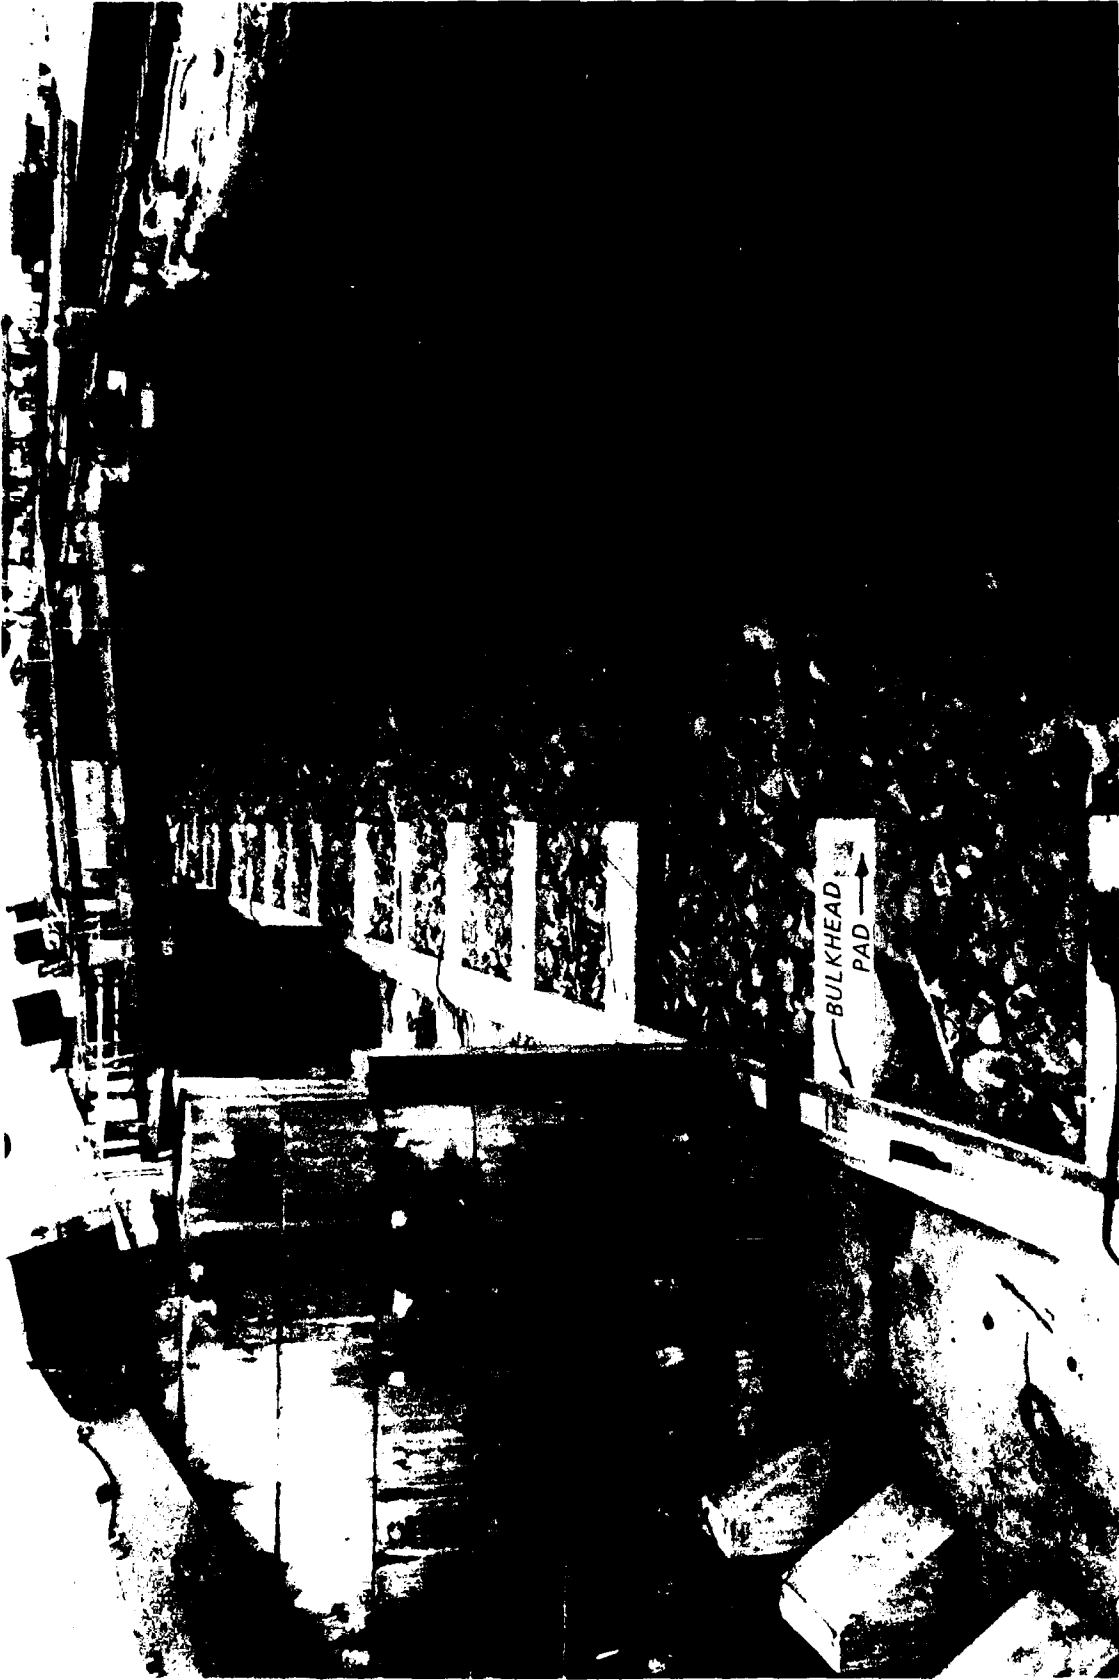
Figure 3. Pike Island Dam under construction
